飛航事故調查報告 第二冊

ASC-AOR-05-04-001

中華民國 91 年 12 月 21 日 復興航空公司 GE791 貨機 ATR-72 型機 國籍標誌及登記號碼 B-22708 澎湖縣馬公市外海墜海

> 行政院飛航安全委員會 AVIATION SAFETY COUNCIL 中華民國 94 年 4 月

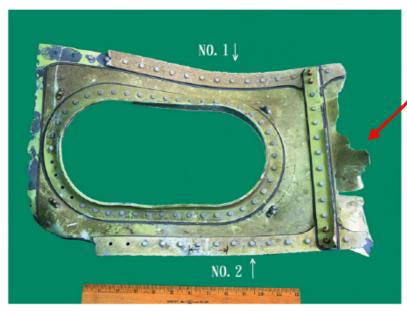
圖 1(a)、(b)分別為客艙窗戶結構損壞件之內面及外面的外觀觀察,其外 圍輪廓斷面均呈現崎嶇不平的斷面形態,尤其是右邊斷面(編號 2 端朝上, 從窗戶結構外面往裡瞧)呈現很大的變形及撕裂的破壞形態。

圖 1. 客艙窗戶結構破損件之外觀觀察。

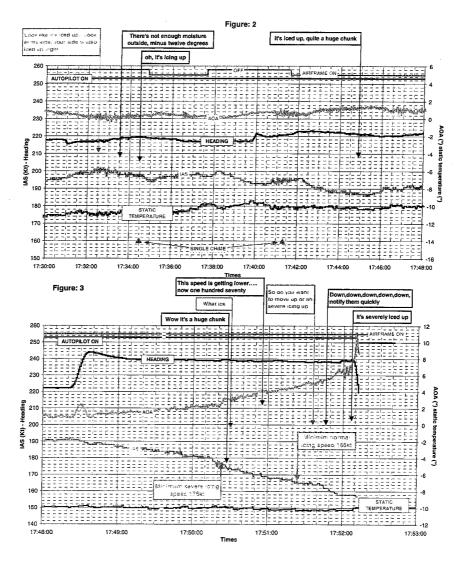
Note: Only the crew's conversation concerning icing events is reported on figure 2 and figure 3

The CVR transcription confirms that a single chime is the signal of ice detector because the first officer says just after the first single chime " Oh it's icing up". After both chime signals, crew action selected airframe de-icing system ON

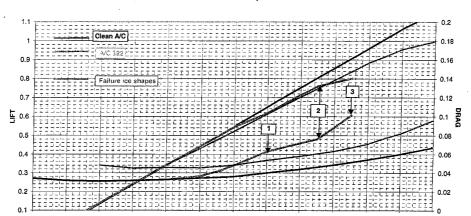
Figure: 5
Performances comparison

This Figure 5 shows the drag and lift computed during the 30mn before autopilot disconnection compared to the drag and lift obtained in aircraft certification with and without normal icing.

Between points 1 and 2 the aircraft 322 has the lift gradient corresponding to an aircraft polluted with ice shapes due to boots not operating (as per certification requirements Appendix C). At the same time the drag increase is more important (about the double) for the MSN 322. This difference is a sign that the aircraft faced a severe icing exposure whose effects were even bigger than ice shapes corresponding to inoperative boots.

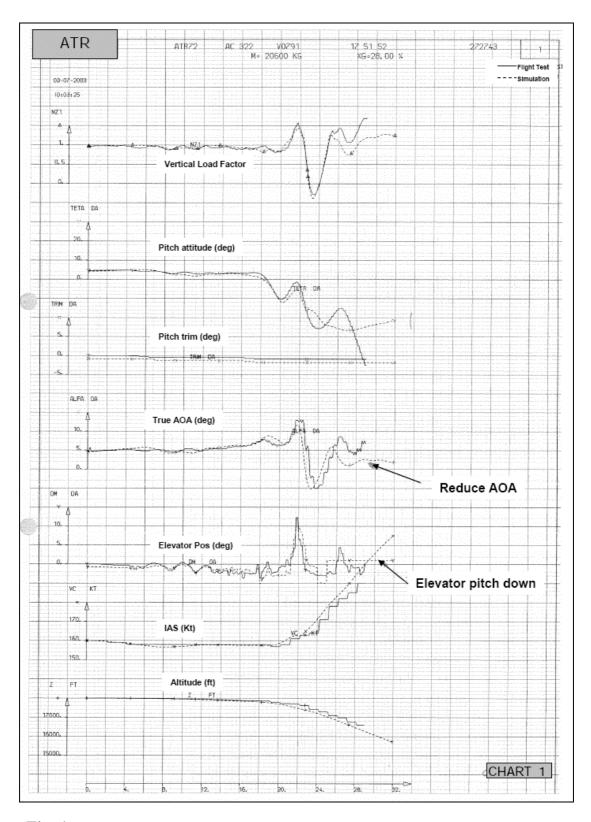
Fig. 1

The figures from 1 to 4 show that the simultaneous application of AFM procedure in the same accident flight conditions leads to the recovery of the correct flight attitude.

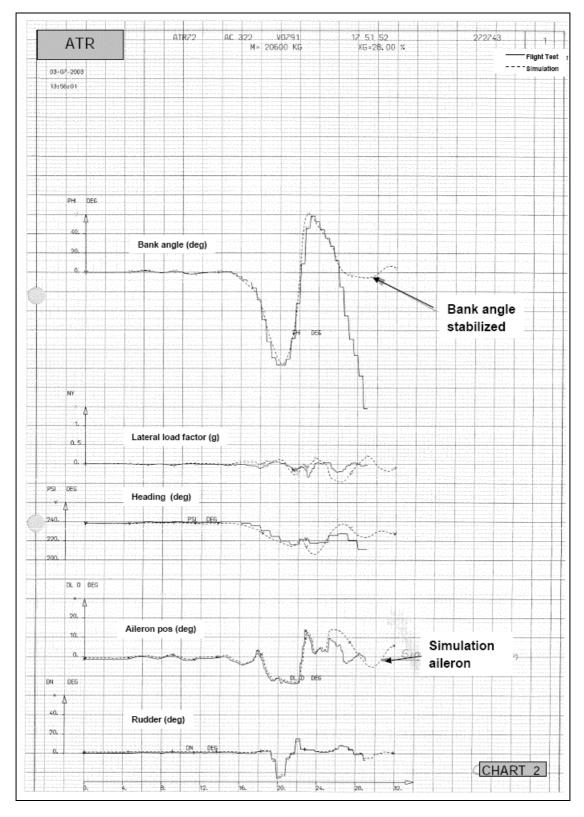
Fig. 2

The figure 2 shows the aileron command and the effect on the bank. The actions on the aileron combined with the angle of attach reduction obtained with elevator push down leads to complete recovery.

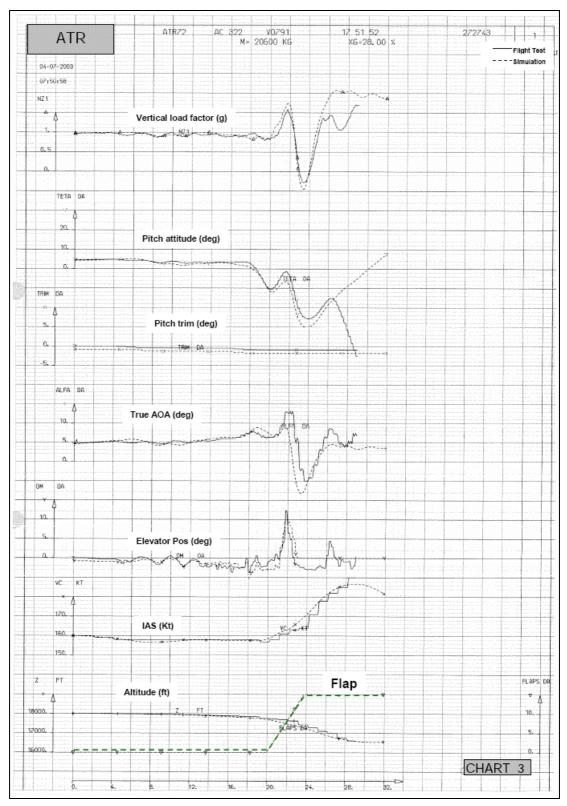
Fig. 3

The figure 3 shows the effect of flap extension on the recovery. The effect on the pitch angle is immediate.

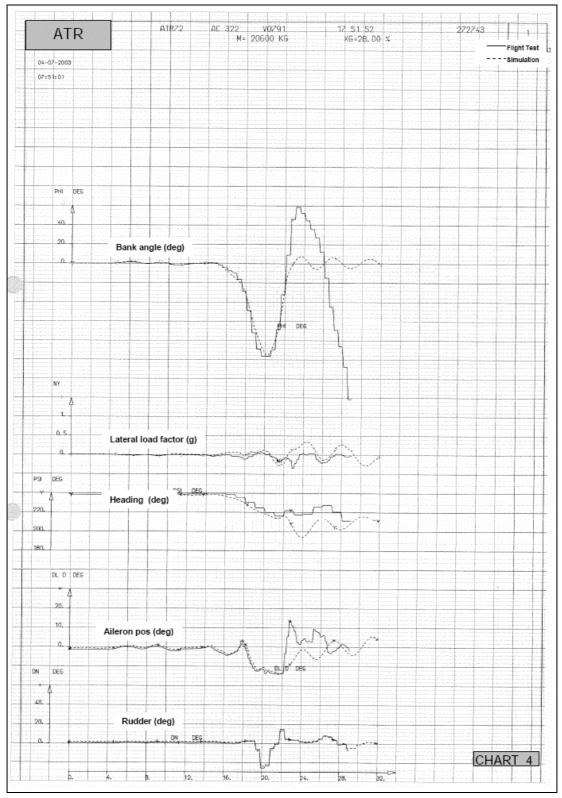
Fig. 4

The figure 4 shows the aileron command combined with flap maneuver and the effect on the bank.

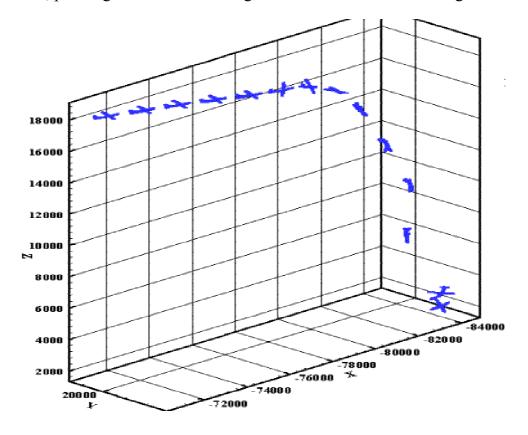
Figure 4 Schematic of GE 791 during the last 288 seconds

The aircraft attitudes and trajectory in the last 283 seconds are re-created in figure 4. As can be seen, the accident scenario started in rolling motion. This will be verified further with engineering plots. Therefore, only three (3) aerodynamic models for the normal force, pitching moment and rolling moment coefficients will be generated.

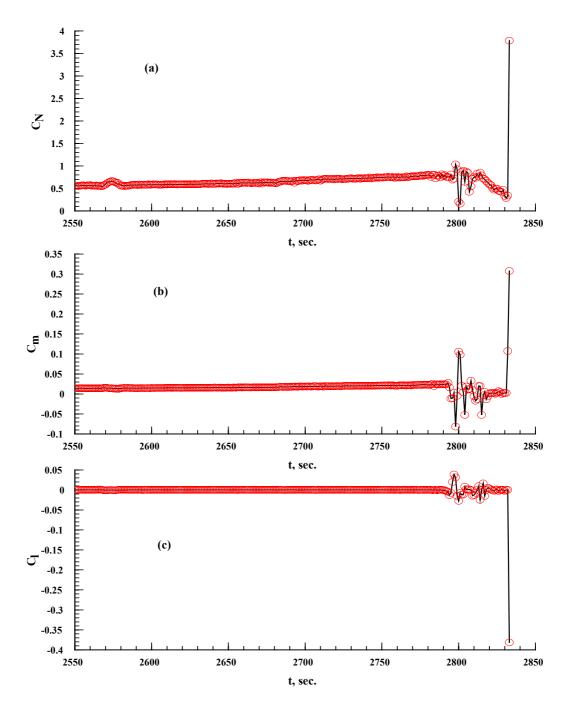
Figure 5 Comparison of predicted aerodynamic coefficients with data along the trajectory

The variation along the flight trajectory for these three coefficients are presented in figure 5. It is seen that the model-predicted results match data very well. In fact, all correlation coefficients exceed 0.999. The yawing moment coefficient model is not established, because the yaw rate and sideslip angle were not significant. And if a specific flight variable is not excited in a motion, flying quality parameter corresponding to that variable cannot be identified or calculated.

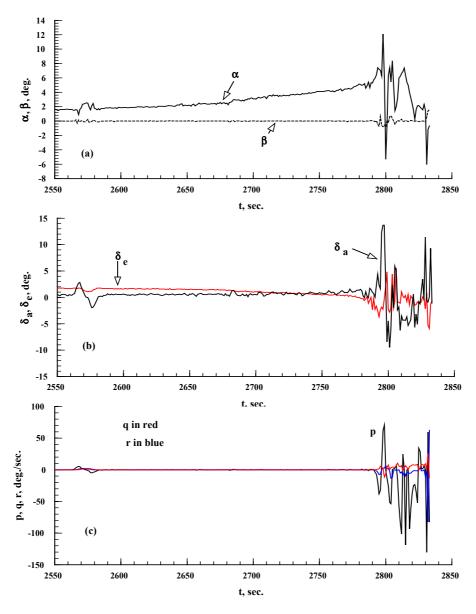
Figure 6 Variation of flight variables of GE 791 along the trajectory

Actually, data of the last 533 seconds are employed in the fuzzy logic modeling technique. In this time period, it was certain that icing on the aircraft would be significant throughout. If the analysis covers a larger time period, an observable flight variable would be needed to distinguish icing level and non-icing conditions. Currently, there is no such variable available in the FDR. Time histories of some primary flight variables are shown in figure 6.

It is seen that large roll rates started at about $\alpha = 6$ deg. (fig. 6a), and the aileron was active (fig. 6b). In figure 6c, it is shown that roll rate is the primary angular rate affecting the motion. In figure 7, the normal force coefficient slope with α before roll excursion is estimated to be about 2.2 per radian. Since the effectiveness of both the elevator and stabilizer before the roll excursion appeared to be small (fig. 7b and fig. 8b), tail icing might have started before wing ice accretion.

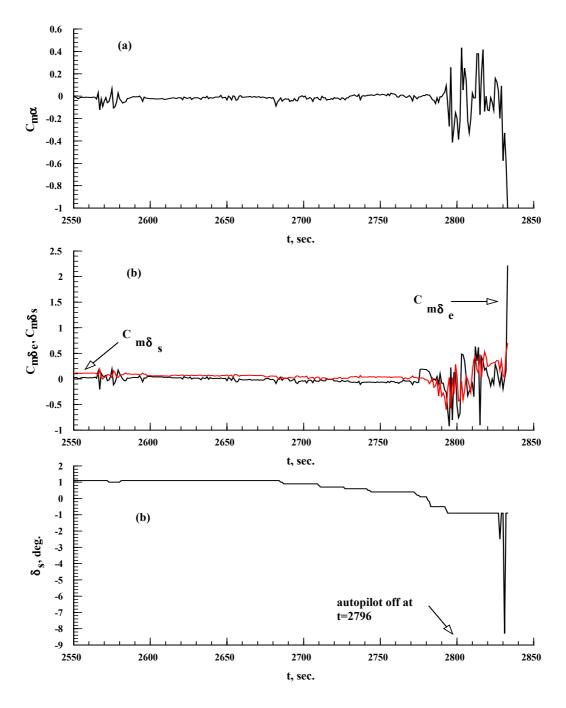
Figure 8 Calculated derivatives for the pitching moment coefficient along the trajectory

The speed decrease at a rate of 0.28 ft./sec per second means that wing ice has increased the aerodynamic drag slightly. In figure 8a, it is seen that longitudinally it was almost neutrally stable (i.e. small negative $C_{m\alpha}$). But the stabilizer angle, although small, moved toward the negative side slowly to produce the nose-up pitching moment probably to counteract the nose-down pitching moment due to ice. Of course, reduced effectiveness of the stabilizer also means it required adjustment continuously.

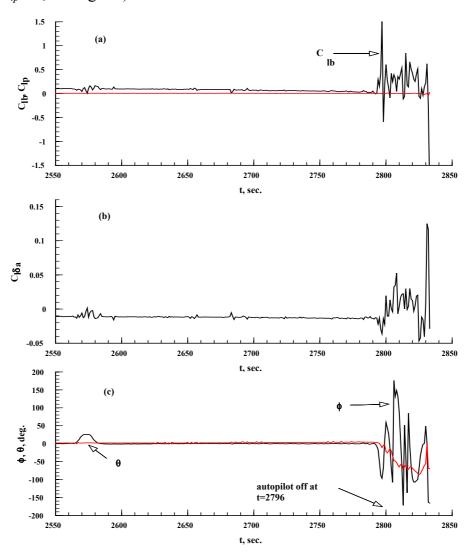
Figure 9 Calculated derivatives for the rolling moment coefficient along the trajectory

The main interest in the present case is in the behavior of rolling moment. Figure 9a shows that the dihedral effect is unstable ($C_{l\beta} > 0$) and the roll damping is also slightly unstable ($C_{lp} > 0$, see fig. 9b).

And the roll control effectiveness is negative ($C_{l\delta a}$ <0) before roll excursion. According to the conventional sign, if the roll control is effective, $C_{l\delta a}$ should be positive. Before the scale in figure 6a for C_{lp} is too small, it is re-plotted in figure 7b to show that it is positive.

to the left under any disturbance, not necessarily due to aileron deflection. Besides, the aileron has lost its effectiveness already (fig. 9b). As the left roll angle became large, $C_{l\beta}$ changed its sign to negative (stable), and the aircraft would roll back. Note that all rolling moment derivatives are primarily contributed from the wing. If wing rock was the cause, it would not be possible to control the aircraft and recover from the disaster, not only because of the issue of control effectiveness, but also a human pilot just can not provide timely roll control input for stability augmentation. To damp wing rock, the only way is to generate artificial damping moment (ref. 6).

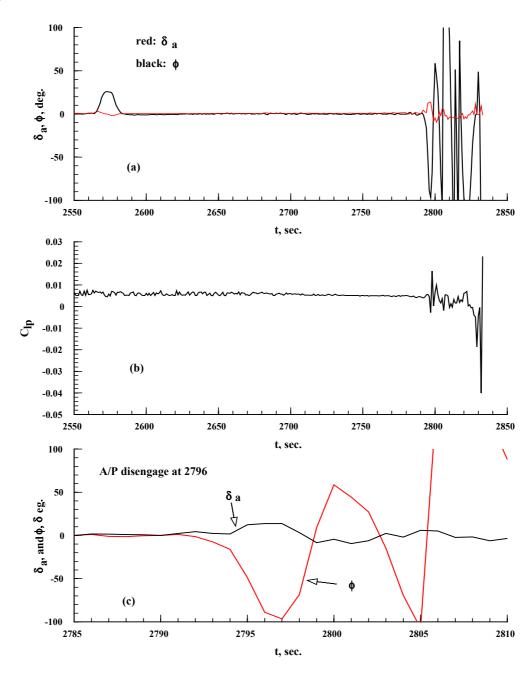
Figure 10 Enlarged plotting of rolling characteristics along the trajectory

In figure 10a with the roll angle and aileron deflection superposed, it is seen that initially the aileron deflection is opposite that of the bank angle before the autopilot disengage. This plot (fig. 10a) is further enlarged in figure 10c. Furthermore, during the roll excursion, there was a divergent roll oscillation. In the first 10 seconds, the rolling motion looks like a wing rock that is a limit-cycle oscillation. But because of increasing angle of attack and the dihedral effect being unstable, the rolling motion became divergent.

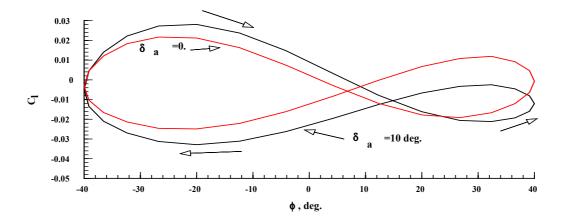
Figure 11a Response in rolling moment with β effect to a rolling oscillation input at k=0.03, M=0.4, V=400 ft./sec., $\alpha=6$ deg.

The results are extracted from the aerodynamic model and presented in figures 11a with β effect and 11b without β effect.

The β effect is present when rolling about the body axis at an angle of attack is performed. On the other hand, if the rolling is about the stability axis, no β would be generated. Figure 6a indicates that β is small; but not zero. Both figures show interesting hysteretic characteristics. It is well known that if hysteretic loop is clockwise, the oscillatory roll damping derivative $(C_{lp})_{osc}$ is positive, implying dynamic instability. On the other hand, a counterclockwise hysteretic loop implies a negative $(C_{lp})_{osc}$, and hence, dynamic stability. Figure 11a shows that left roll is unstable, so that the aircraft will roll

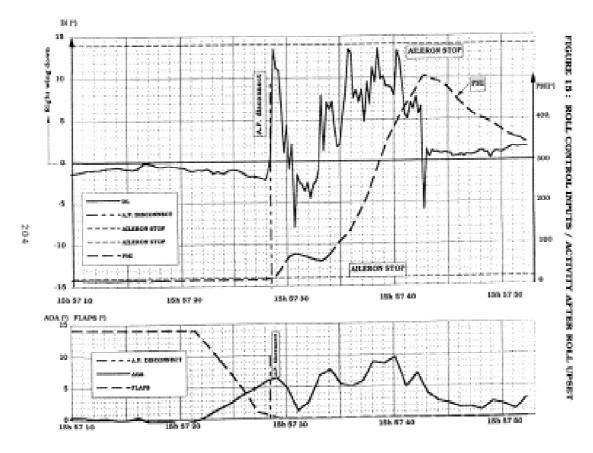
Figure 12 Roll characteristics of an ATR-72 in Roselawn, IN accident

Based on these results, we can now compare the roll excursion scenario between the Roselawn case (fig. 12) and GE 791:

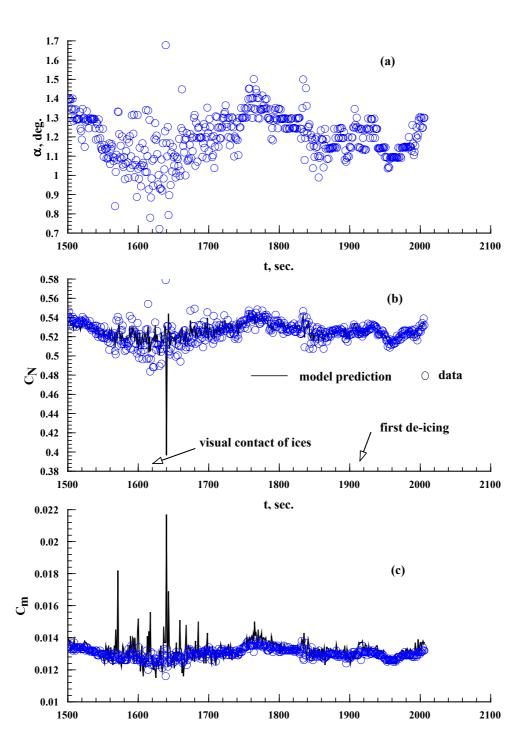
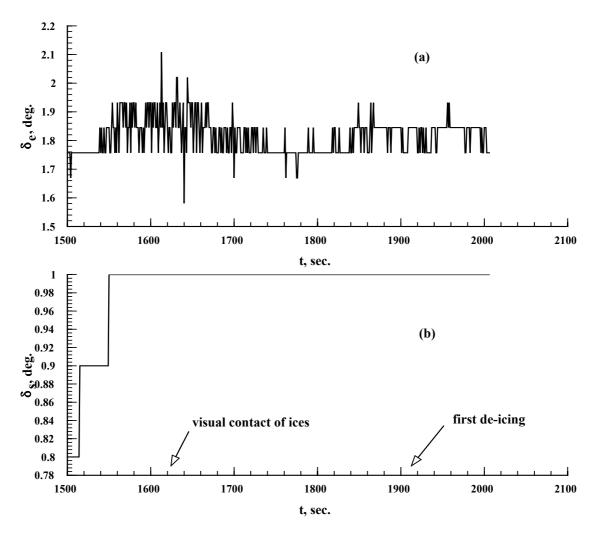
Figure 13 Normal force and pitching moment coefficients for GE 791 in the period of ice built-up

Finally, we will examine the possibility of early ice detection. One proposed scheme of ice detection was based on change in short period mode. However, to detect the short period motion, the aircraft must be intentionally disturbed, by a doublet input for example. This would be too risky. In the case of GE 791, although the first visual contact of icing was established at UTC 17:32:35 (the present time = 1620), significant icing might have developed much earlier. To check if it is possible to determine more accurately possible starting time for "significant" icing built-up, we will use the concept of data correlation. Data between 1450 to 1550 seconds (the present time) in the normal force coefficient are employed to set up the aerodynamic model. The results are plotted in figure 13. It is seen that the correlation is poor because of large errors at some data

Based on these results, it may be concluded that significant icing occurred after 1480 (UTC 17:30:15) and it can be detected by using data correlation.

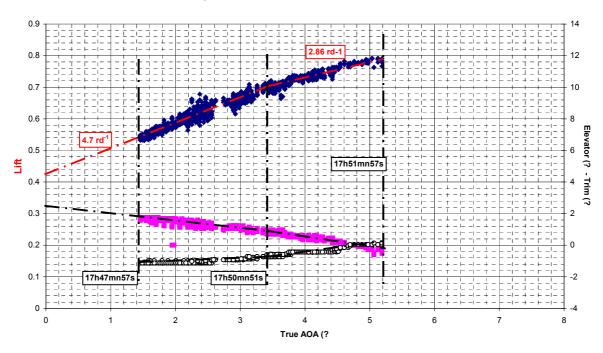
Figure: 1 - AC 322 LONGITUDINAL STABILITY

The figure 1 shows that between 17h 47mn 57s to 17h 50mn 51s the lift coefficient is $4.7^{\text{rd-1}}$ and not $2.2^{\text{rd-1}}$.

According to the figure:1 Cz $_{\alpha}=4.7^{\text{ rd-1}}$ then Cz $_{\alpha}=2.86^{\text{ rd-1}}$ and according to the figure:3 Cz $_{\alpha}=-2.86$ few seconds before the roll departure and Cz $_{\alpha}=2.86$ between roll departure and stall warning.

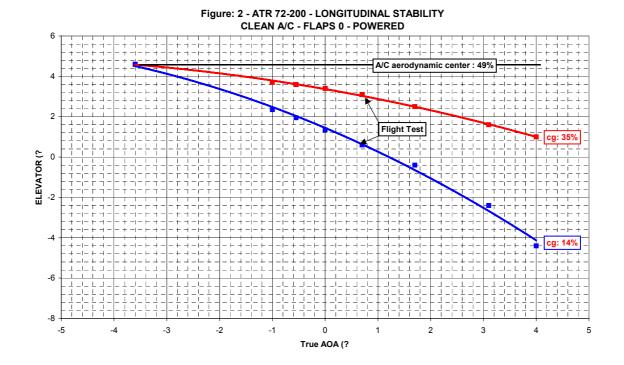
Flight test conducted on ATR 72 200 A/C 98 shows that the aerodynamic center with the same configuration is situated at 49% of the Mean Chord. The small differences in the results are normal and come from: recording equipment and pick up installation, sampling, flight tests acquisition units, storage of data, conversion of recorded parameters into physics data, reading of curves made by specialists. For this reasons 1% of variation is largely tolerable and a closer look could reduce it, but in our case the margin is so huge and we accept the result.

Longitudinal stability of A/C 322 (flight 791) is nominal in this period

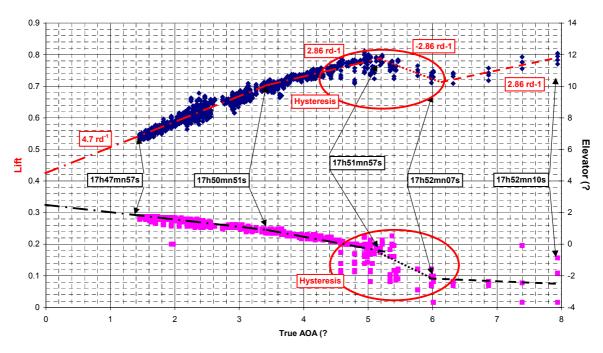
Figure: 3 - AC 322 LONGITUDINAL STABILITY

When the autopilot initiated the descent a flow separation occurs simultaneous on the two wings (no roll) up to AOA=6°, then an asymmetrical left roll appears.

During this period it is difficult to check correctly the longitudinal stability due to the aerodynamic hysteresis phenomenon on the lift (See figure:3). However the elevator efficiency is not affected and after the roll departure (17h52mn07s). The longitudinal stability after stall is reduced (but Aerodynamic center > 28%) and the recovery from stall can be performed because elevator remains always effective.

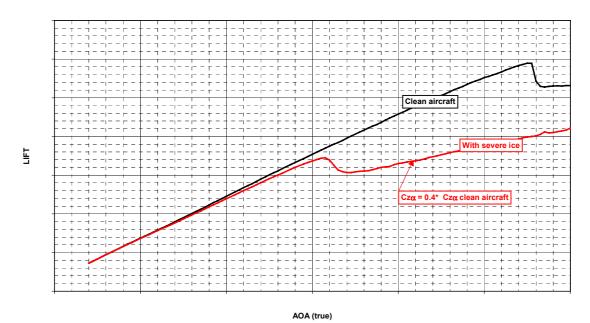
Figure 4: ATR 72 - WIND TUNNEL TEST

Wind tunnel tests conducted on a mockup (1/2 span; Scale: 1/8) with and without Severe Ice on the airframe show a same result on lift coefficient (See Figure 4)

When a flow separation occurs, the figures 3 et 4 show that a significant reduction of angle of attack (about 3°) during few seconds, leads the aircraft in a situation where all aerodynamic parameters are nominal.
