# 飛航事故調查報告

ASC-AOR-06-03-001

復興航空公司 GE536 班機

台北/松山機場落地階段滑出跑道

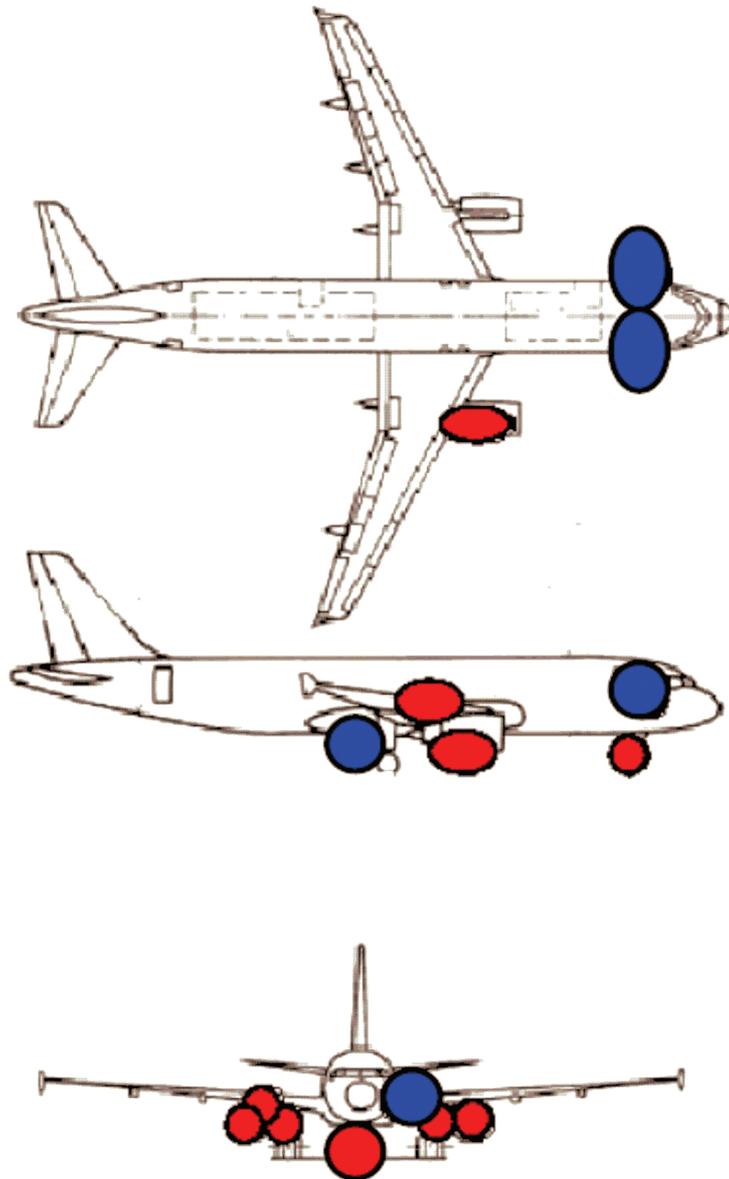
圖 1.12-1 損壞及受污染區域圖

該機損壞（紅點顯示）及受污染區域（藍點表示）如圖 1.12-1。

- 無撞擊損壞；
- 動靜壓管（Pitot/ Static ports）及空調機進氣口（Air Conditioning Pack Intakes）有異物污染；
- 機腹防撞燈罩（Anti Collision Light Lens）損壞。

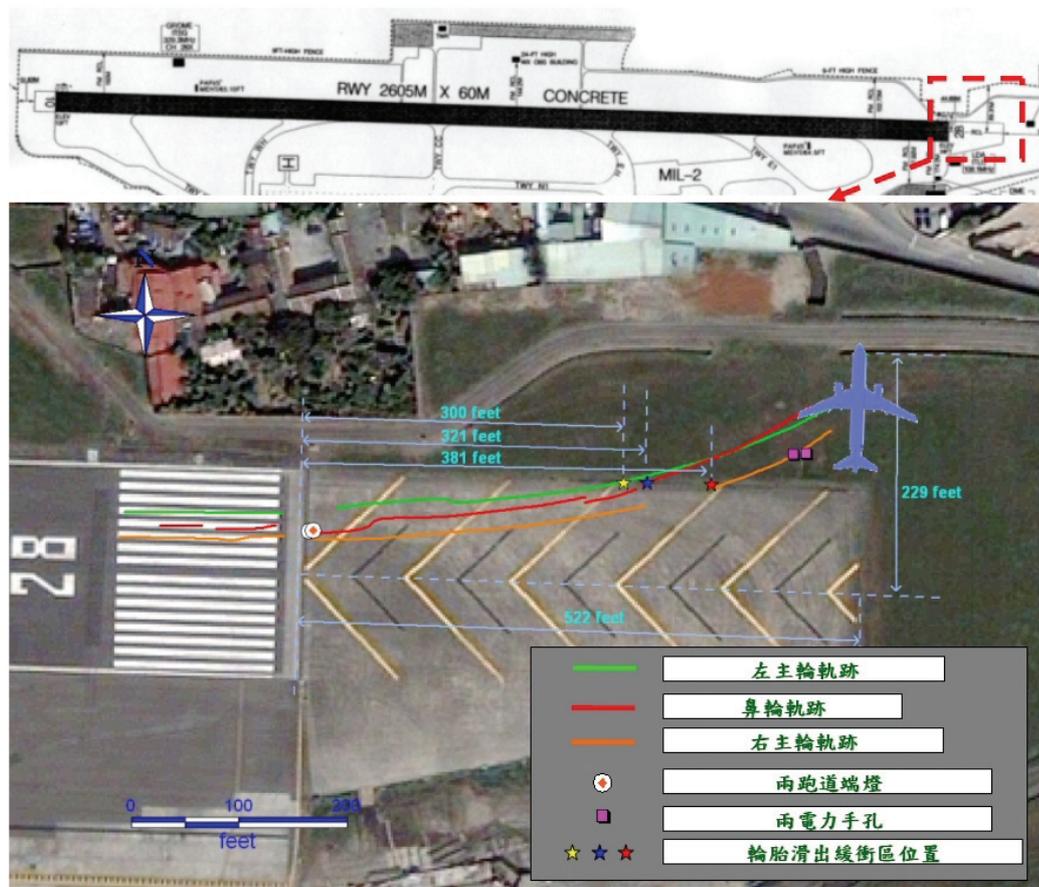
圖 1.18-1 現場量測圖

依據現場量測結果，該機鼻輪於 10 號跑道末端外 321 呎處滑出緩衝區，停止於緩衝區北側約 130 呎處之明溝內（如圖 1.18-2），航向 002 度，機身略為前傾。

該機之胎痕軌跡可由停止位置追溯至緩衝區（如圖 1.18-3），至 28 號跑道頭標線區域止。

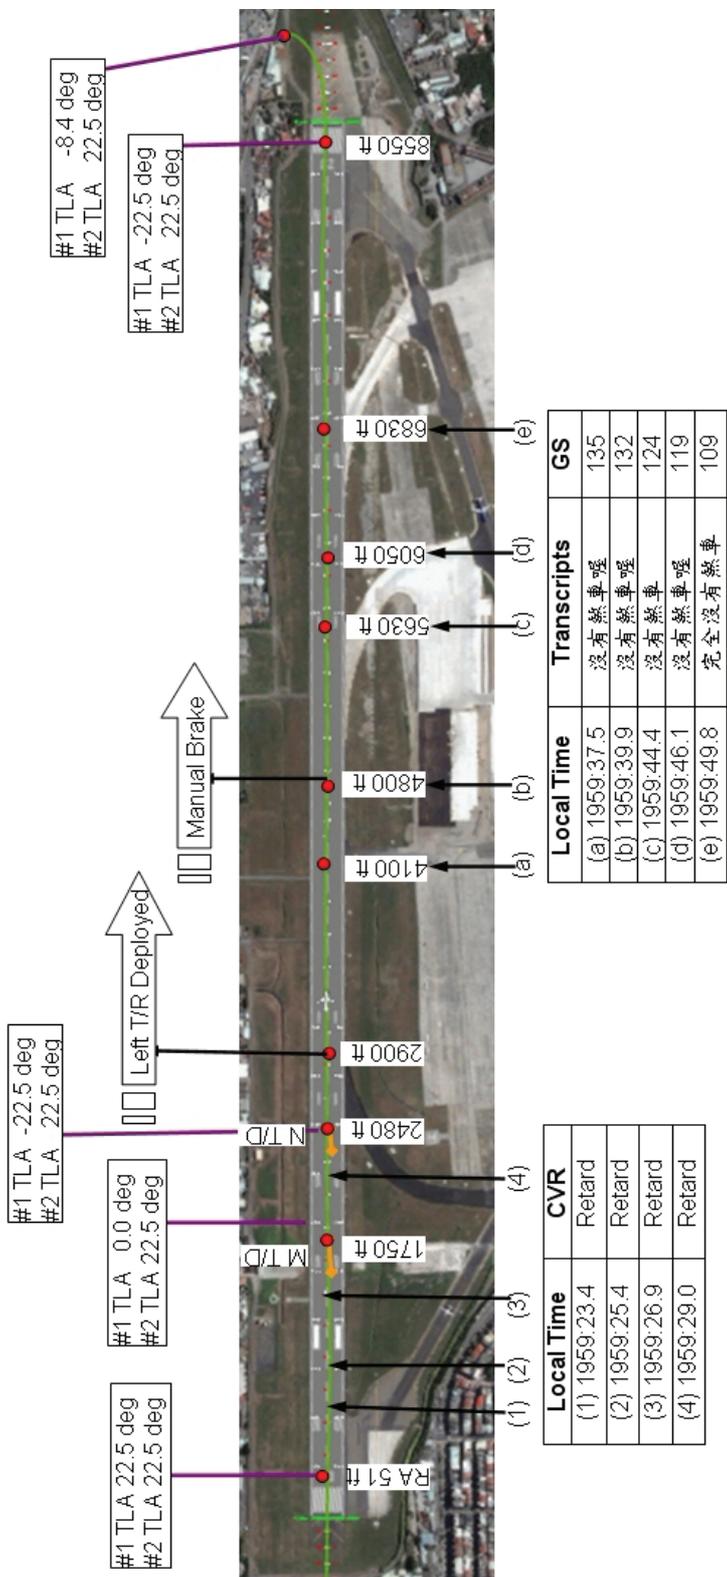
圖 2.3-1 落地階段 CVR 與 FDR 比對結果之相關位置圖

<sup>26</sup> 1959:26.16 時起之 0.5 秒內，垂直加速度值由 1.1g 增為 1.38g，此時該機距 10 號跑道頭約 1,480 呎，主輪減震支柱壓縮參數為「AIR」，如 1.11.2 節及附錄 4；復興提出之數據為 1,450 呎。

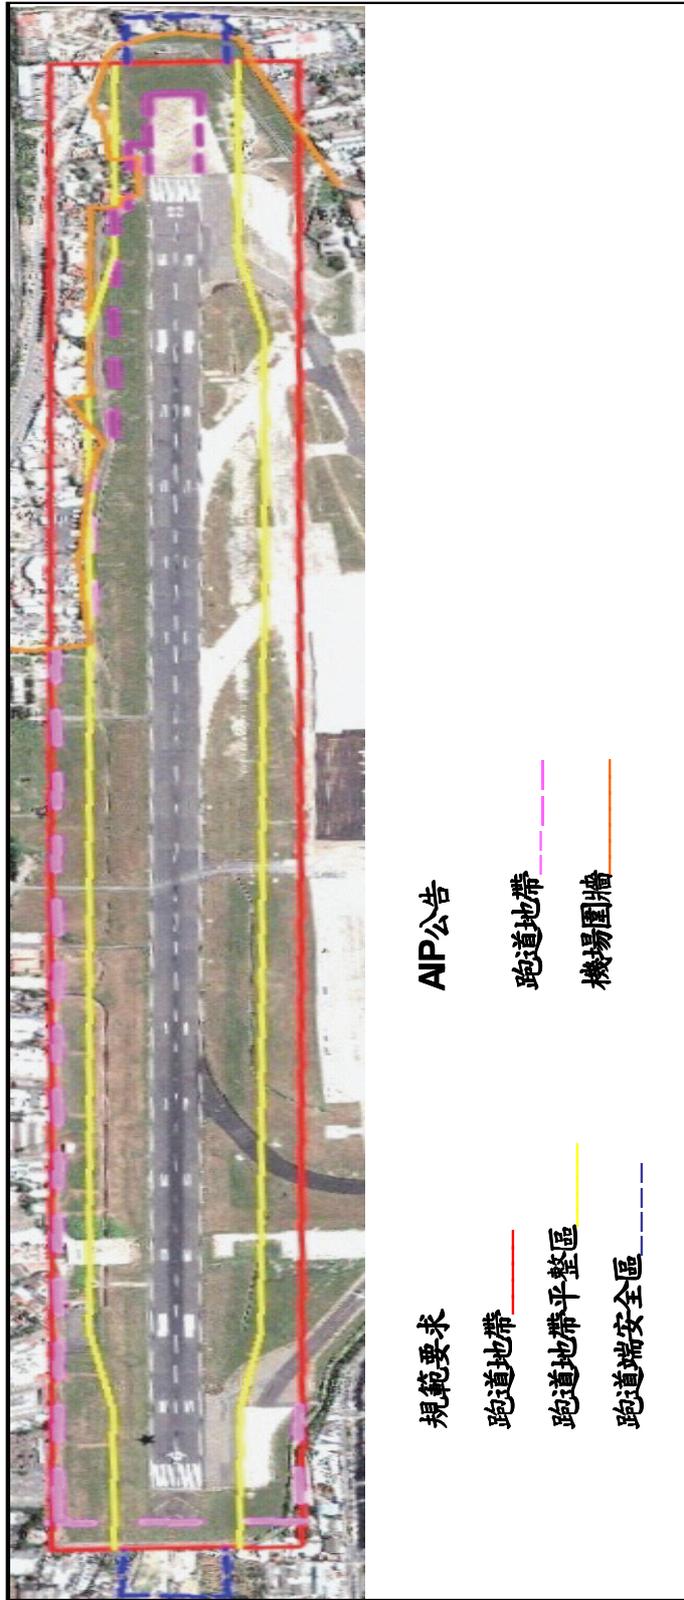
圖 2.6-2 松山機場跑道安全區域規範要求與飛航情報指南宣告之比較圖

依據「民用機場設計暨運作規範」第 3.3.2、3.3.3、3.3.8、3.4.1、3.4.2 及 3.4.4 等節規定，松山機場 10/28 跑道之跑道地帶範圍應為長 2,945 公尺<sup>37</sup>，寬 300 公尺<sup>38</sup> 之矩形。另跑道端安全區長度應自跑道地帶兩端外延伸 90 公尺，寬度則為 120 公尺<sup>39</sup>，如圖 2.6-2 所示。惟松山機場 28 號跑道端邊線北側約 15 公尺處，設有機場圍牆之固定物體，若航空器滑出跑道，有可能造成撞擊圍牆及圍牆外民房之狀況；另該跑道及其緩衝區之中心線北側約 43 公尺至 69 公尺間設有東西向，呈不規則延伸之未加蓋排水溝渠，不符合跑道地帶平整區內應平整之規定。

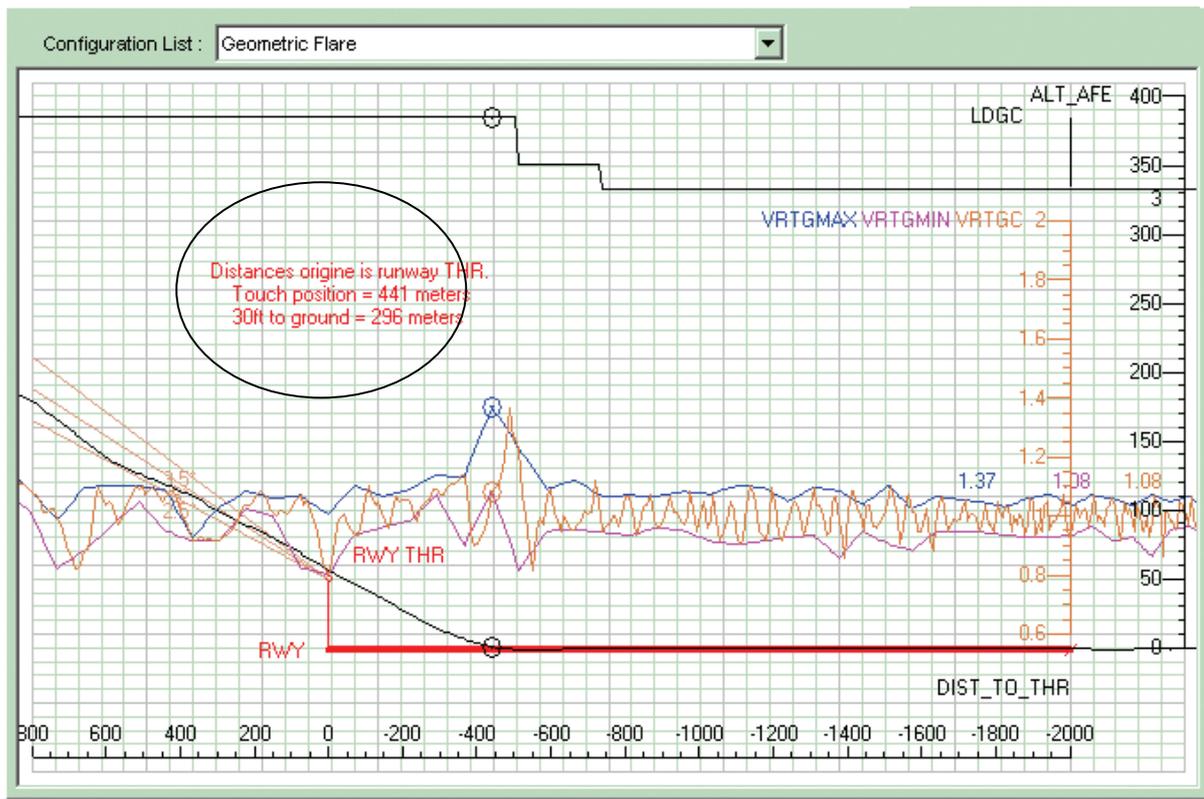
GE536 之著陸點位置距 10 跑頭端約 1,450 呎(441 公尺)
