飛航事故調查報告

ASC-AOR-07-03-001

龐巴迪爾 BD700 型機

於高雄國際機場落地時偏出滑行道

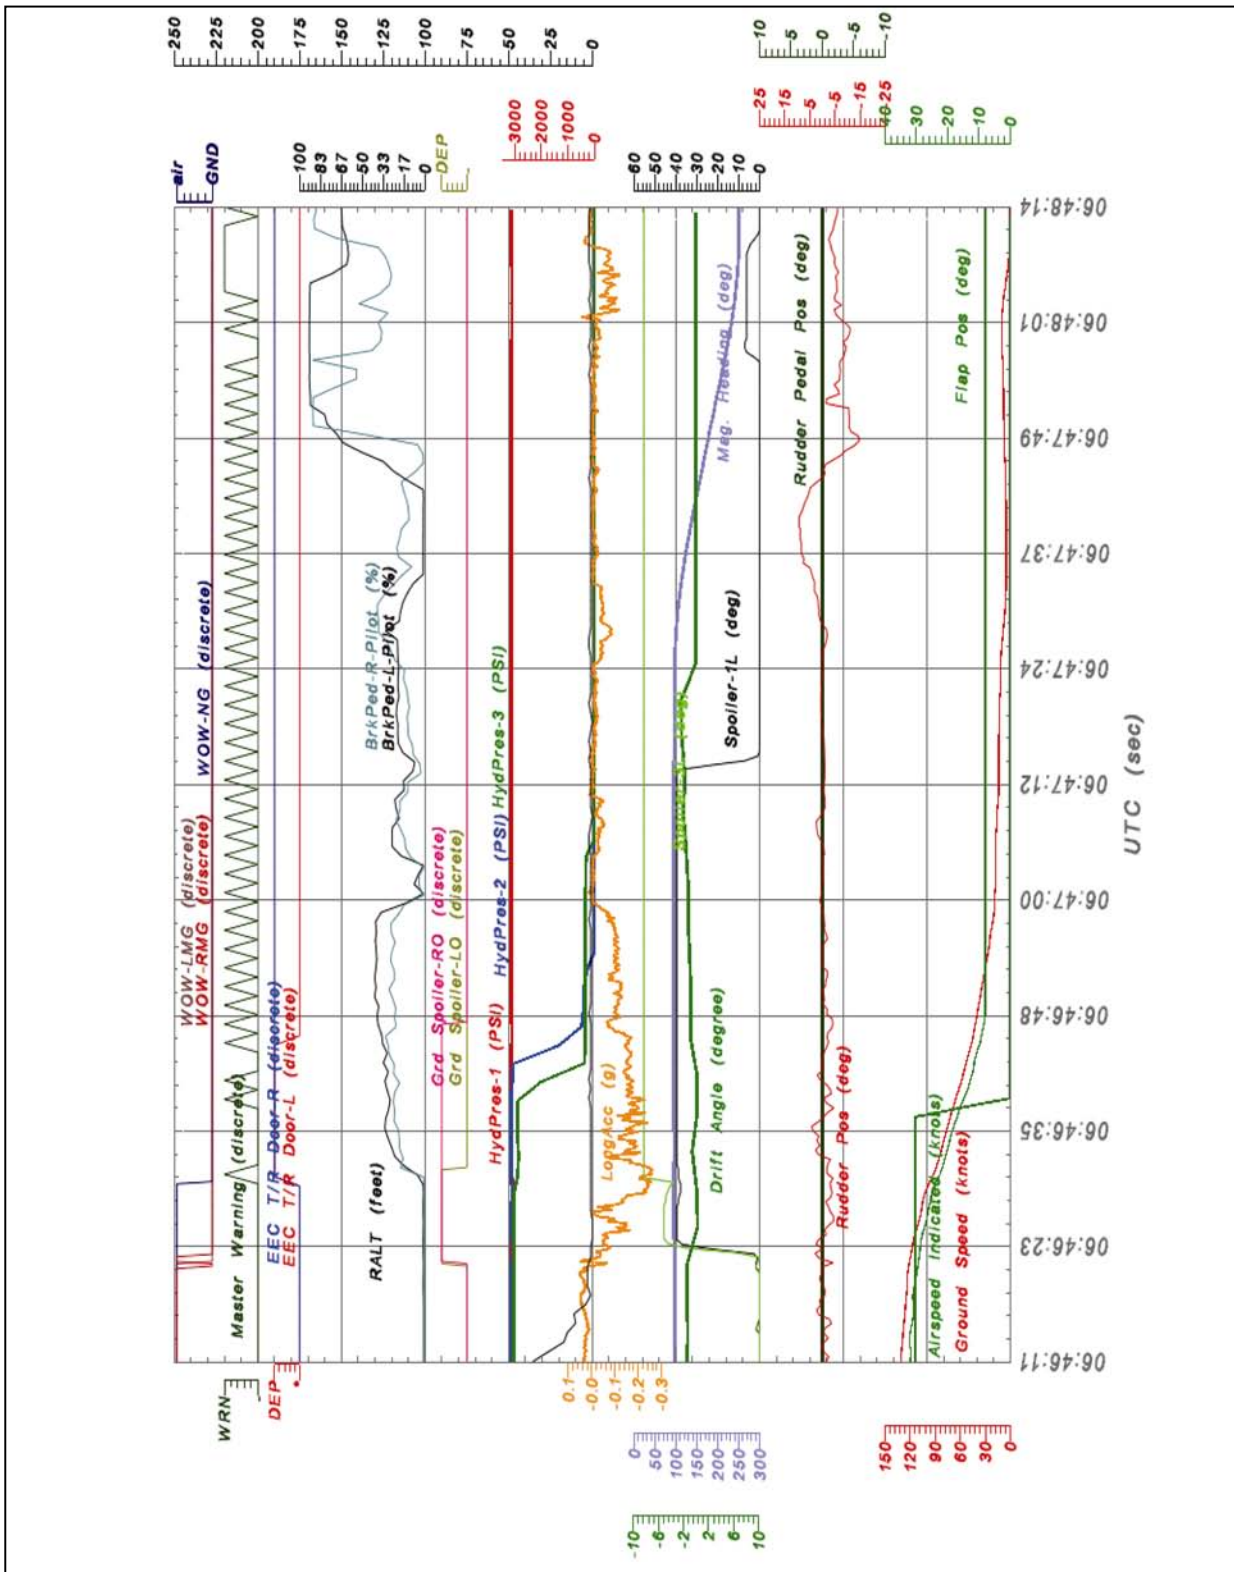
飛航參數繪圖

綜上所述，該機駕駛艙 EICAM 上顯示 2、3 號液壓系統失效之原因，係因降落時駕駛員設定 BCU 為中度自動煞車，主輪著陸後液壓系統壓力進入煞車系統，主輪煞車效果正常，當輪速逐漸慢於機速時，BCU 發訊號給 BCV 將煞車壓力釋放，但 2 號 BCV 因故障卡死未能將煞車壓力釋放，使 2 號主輪未能於滑動時被釋放而鎖死車輪，鎖死之 2 號主輪胎面持續摩擦跑道造成疊層漸少，終因強度不足而爆破，此時 2 號 BCV 可能因管路脈衝將橡膠微粒擠出卡住位置，2 號 BCV 液壓獲得釋放使 2 號主輪恢復滾轉，部分因爆破而掀起之胎面因滾動之離心力拍擊其上方空間，此可能為造成駕駛員感覺脈動之原因。由 FDR 資料得知主輪著陸後 9 秒，自動煞車因駕駛員致動煞車踏板而解除，此時 2、3 號液壓系統壓力亦同時下降（參考附錄二飛航參數繪圖），顯示自動煞車解除前 2、3 號液壓管路已經斷裂，系統已經洩壓，亦表示爆裂輪胎開始轉動並造成結構損壞及 2、3 號液壓管線折斷，液壓油外漏致動警報。

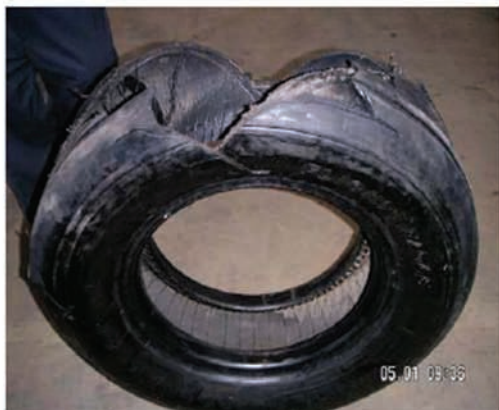
Photo 1: Incident Tire - As Received

There is a portion of the incident tire (approx 10"x8") completely detached down to lower sidewall area from 12 o'clock to 3 o'clock (See photo 1 & 2), as viewed from

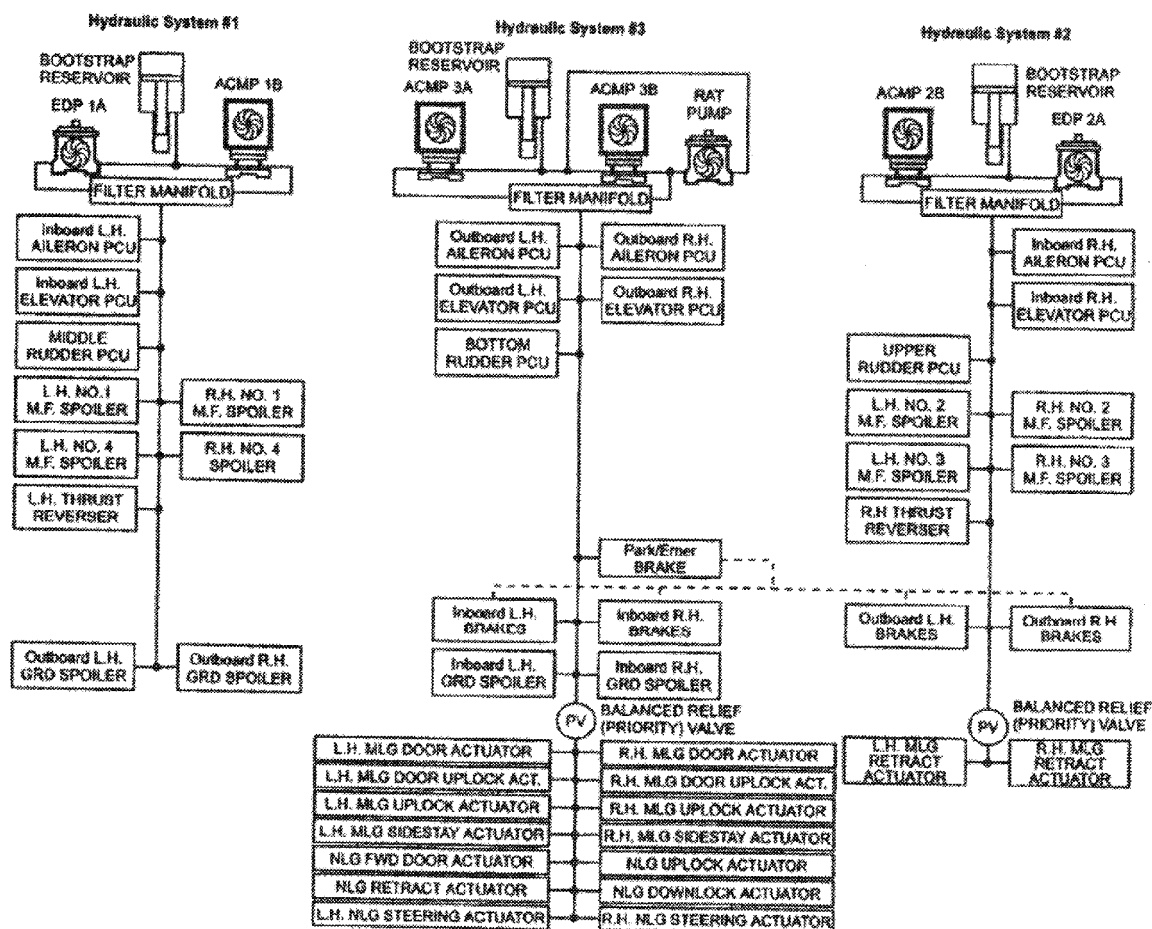
FIGURE 6 - AIRCRAFT HYDRAULIC SYSTEM DISTRIBUTION

- Rupture of HYD #3 line caused rapid loss of function of steering, ground spoilers, plus MLG and NLG actuator, doors and related locks,. Nose gear shimmy damping, and caster mode remained functional. The failure also made availability of inboard brakes, dependent on capacity of brake accumulator. (see Hydraulic System #3 distribution below, Figure 6)

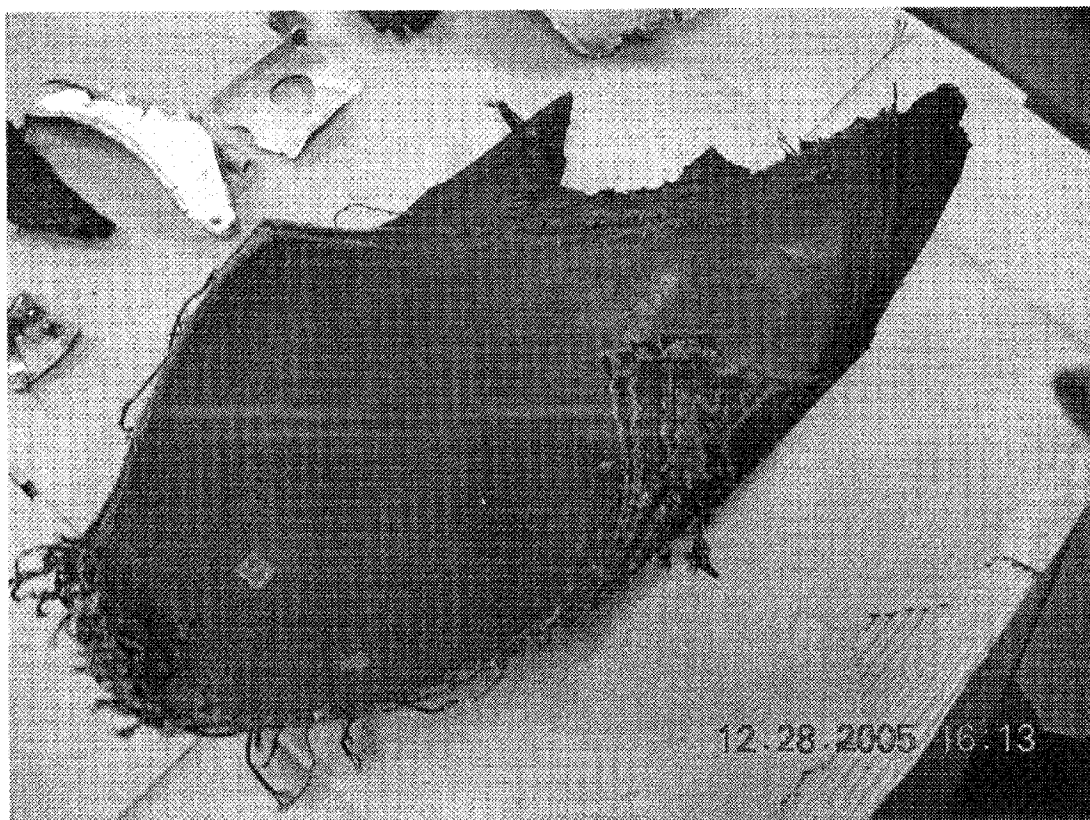
PHOTO 8 - TIRE PIECE "A"

Finally, location of piece "A", as the furthest component found on the runway from touchdown point, is noted as confirmation of above failure scenario. Photos of tire debris at the location where the aircraft had come to rest, shows the location of missing piece "A" relative to the skid patch location (See Photo 1, 8, 9)

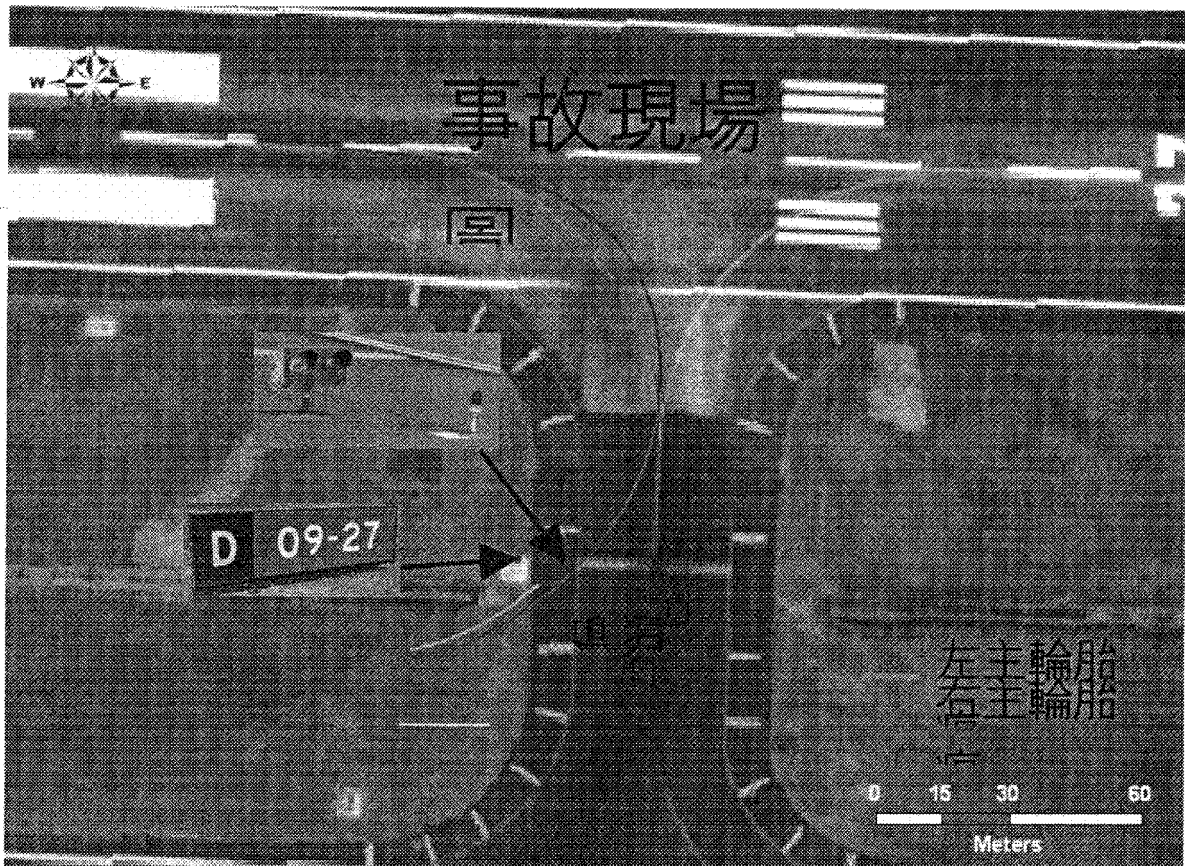
PHOTO 11 - AIRCRAFT EXIT TO TAXIWAY DELTA

The crew also identified loss of nose wheel steering, and stated that the aircraft continued to slow down along the centerline of the runway, with reported loss of normal and emergency braking. The crew reported that the aircraft drifted to the right side of the runway, at a speed of 5 to 10 MPH, then exited onto a taxiway with no brakes, or steering, finally coming to a stop at the adjacent grass area (Ref.1 and 3). (Photos 1, 11)

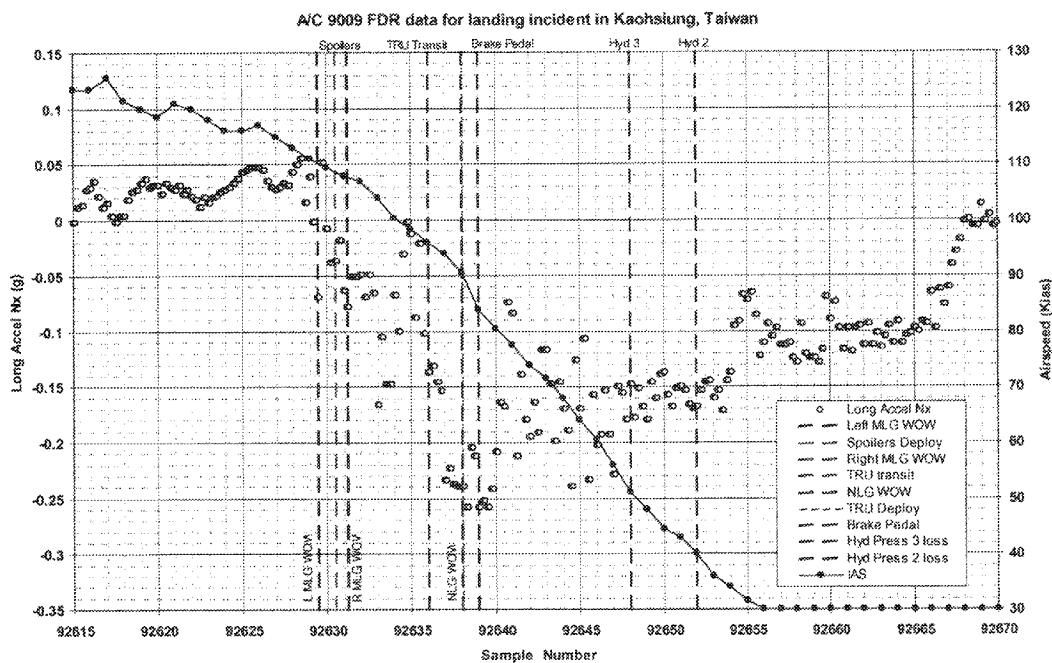
DATA PLOT 2

- 4.1.6 At SR 92648 (TD + 19 Sec), the FDR indicates a rapid drop of Hydraulic #3 pressure (Plots 2 and 5). Similar pressure drop is recorded for Hydraulic #2, at time 92652 (TD + 23 Sec) . These events are also noted in the flight crew de brief statement, are indicative of rupture of the aircraft's Hydraulic #2, #3 tubing, in the aft spar area , which supply the left wing flight controls. Site Photos confirm rupture and separation of hydraulic lines. (Photo 2)
