Aviation Safety Council

Investigation Report

Korean Air Flight 691

**Loss Cabin Pressure at FL320, 30
NM South of Waypoint SALMI**

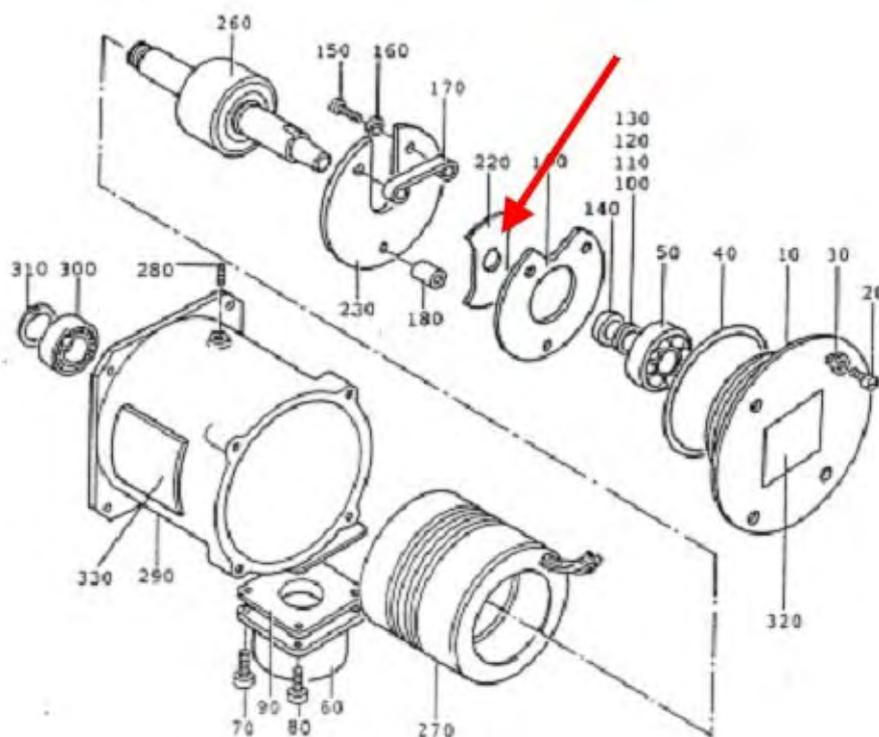
Figure 1.4-3 Motor drive components

When operating in the normal automatic mode (SYS 1 or SYS 2), the appropriate motor on the double motor drive is activated with the input gear wheel of both automatic modes on reduction gearbox. The input drive shaft consists of two bearings, 4 play adjustment shims, a bushing, and a rotor position indicating flange with stop pin. The detail is shown in Figure 1.4-3.

In accordance with the inspection of the failed FWD outflow valve, it showed that a flange in the reduction gearbox which drove the FWD outflow valve was broken (Ref. Fig1.4-3 and 1.4-4). That damaged flange resulted in the malfunction of both auto modes input to drive the FWD outflow valve.

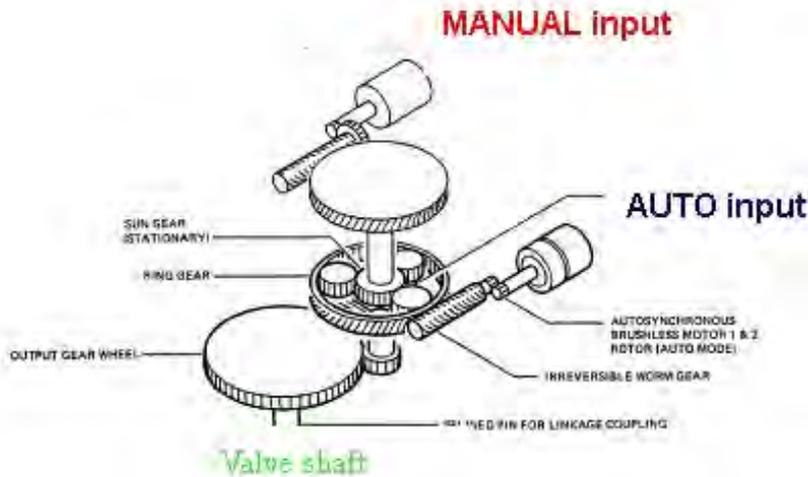
Figure 1.4-4 Out flow valve control modes

The double motor drives the irreversible worm gear. This drives the ring gear and the sun gear remains stationary, the planet gear assembly rotates driving the output gear, which is connected to the butterfly valve by a linkage coupling. Should both automatic systems fail, operating the manual toggle switch located on the cockpit overhead panel activates the single motor drive. Manual control mode is backup by an electric system entirely independent of system 1 and 2 automatic modes. This motor drive a second irreversible worm gear, which drives the tangent gear that connected to the sun gear. Since the ring gear is now stationary, the sun gear drives the planet gear assembly producing the same function as in the automatic mode. Inputs to out flow valve from auto and manual modes are shown in Figure 1.4-4

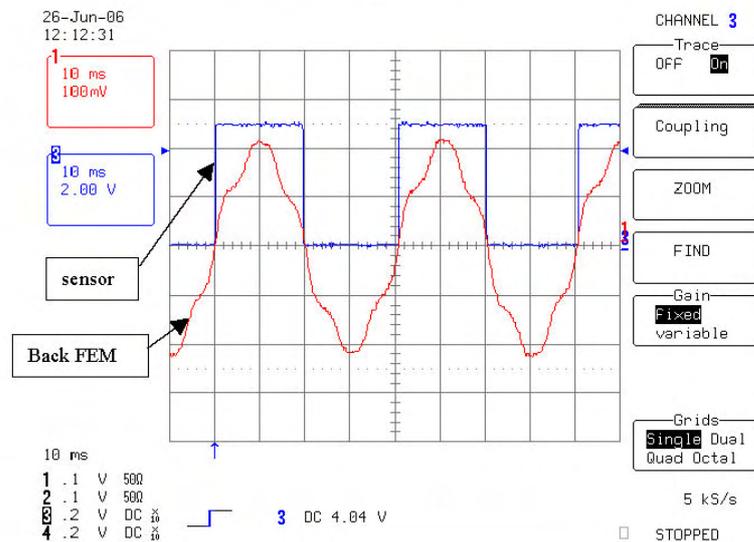
- The aim of this report is to find the reason of non-functionment of this motor with was equipped on the OFV 88005B0306 S/N 693
- Test devices used for the investigation:
 - Test bench p/n LEM69 to visualise sensor signals and back FEM of motor winding
 - Power supply SODILEC (40V/2A) p/n SDL/GA-R40.2 s/n 384919
 - Driving motor PORTESCAP p/n 35NT2R 82-426E7
 - Scope LE CROY LT224 (220Mhz-200Ms/s) s/n 01 230
 - Voltage isolator TEKTRONIX p/n A6909 s/n J310159
- Test procedure:
 - Drive motor in test with PORTESCAP unit and measure sensor signal in proportion to back FEM. See standard view below (only 1 phase/sensor)

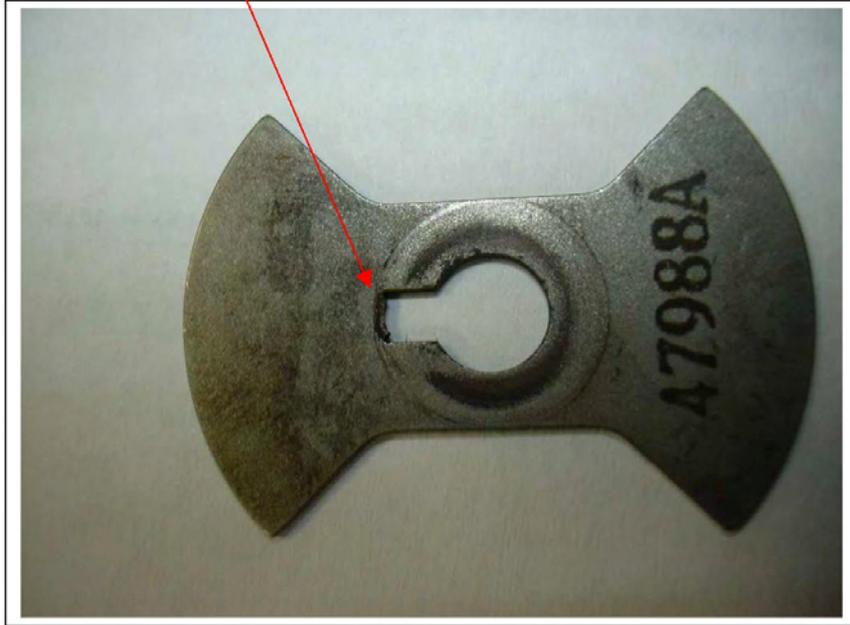
View of broken flange

After further dismantling of the motor (P/N S4090, S/N 815D), the flange was found free on the shaft(item 220 of Figure 1.8-1). The stop pin of the flange was broken. Figure 1.8-1 and 1.8-2 illustrate the differences.

The test report concluded that the broken pin on the flange explained the malfunction of the motor on both modes 1 & 2. It was randomly ordered by the variation of position of the flange.

The broken flange explains the malfunction of the motor on both modes 1&2 . It was randomly ordered by the variation of position of the flange. So, windings were not in accordance with sensors. This failure is considered as an isolated case.
