飛航事故調查報告

ASC-AOR-09-09-001

中華民國 96 年 9 月 20 日
中華航空公司 CI7552 班機
波音 737-800 型機
國籍標誌及登記號碼 B-16805
於日本佐賀機場過境檢查發現
機腹蒙皮 30 吋 (77 公分) 裂縫

行政院飛航安全委員會
AVIATION SAFETY COUNCIL

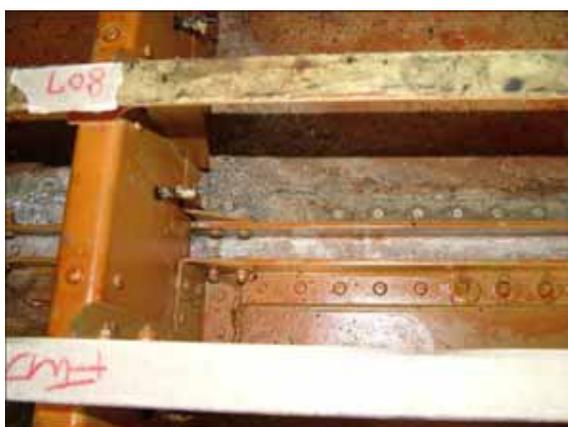
圖 1.12-2 (E) 站位 807 隔框前側蒙皮腐蝕細部照片

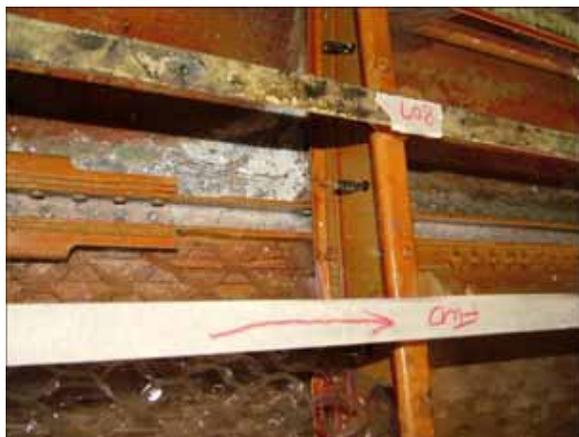
圖 1.12-2 (G) 站位 807 隔框後側蒙皮腐蝕照片

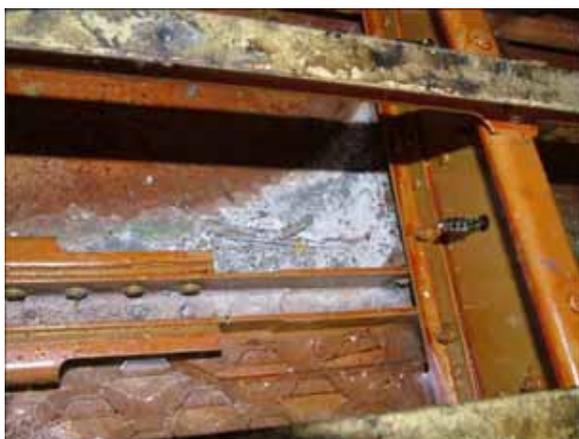
圖 1.12-2 (H) 站位 807 隔框後側蒙皮腐蝕細部照片

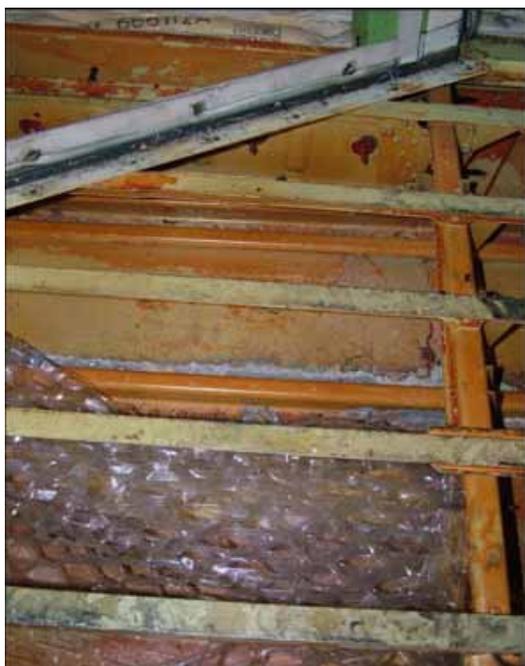
圖 1.12-2 (N) 站位 869.7 裂縫後端所在位置之貨艙內照片

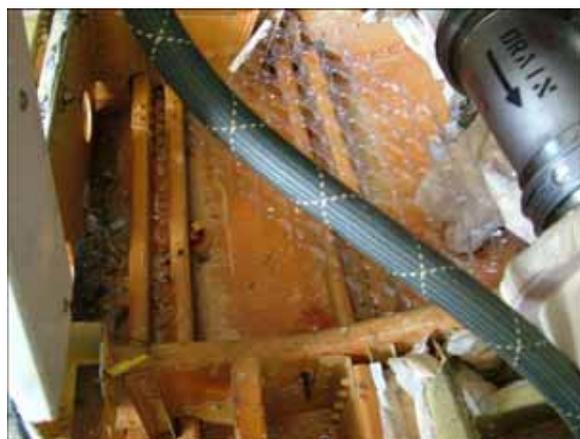
航機外部裂縫照片，如圖 1.12-1 (A) ~ (D)所示；航機裂縫所在蒙皮內表面，以及其他機腹結構於鏽蝕被打磨移除前之照片，詳圖 1.12-2(A) ~ (S)所示。由照片除了可確認裂縫位置之外，另可判讀機腹結構腐蝕之位置，均分佈於編號 S-27L 之縱桁左側蒙皮，與 S-27L 縱桁凹槽，另位於廢水櫃出口接頭正下方的縱向連接片底側也嚴重腐蝕。

圖 1.12-2 (Q) 廢水櫃出口與縱向連接片相關位置照片

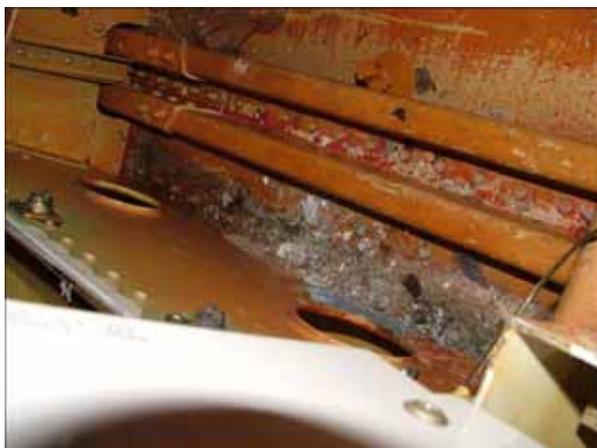
圖 1.12-2 (R) 縱向連接片腐蝕照片

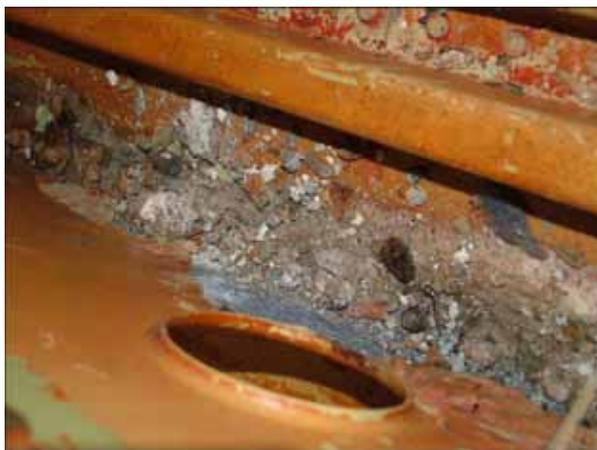
圖 1.12-2 (S) 縱向連接片腐蝕細部照片

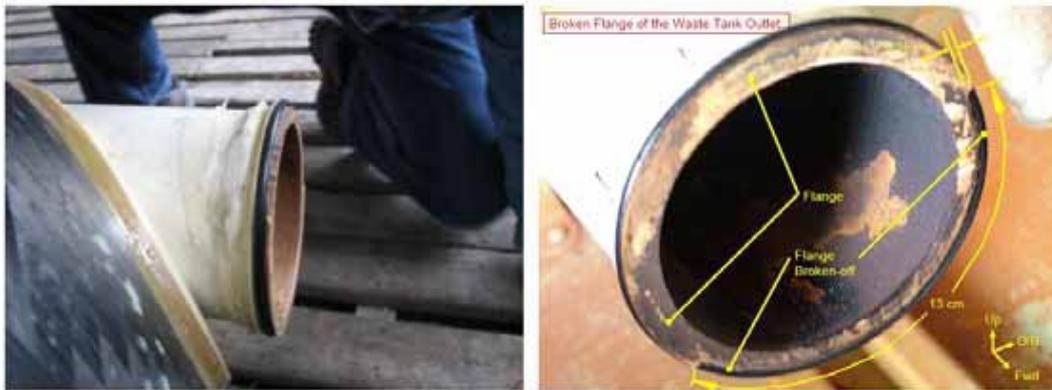
拆檢廢水櫃系統，發現廢水櫃出口管與廢水管接合處之接合面凸緣損害，詳圖 1.12-8 紅圈處，斷裂區域位於廢水櫃出口管端凸緣右下緣，長約 5 吋，詳圖 1.12-9。

圖 1.12-9 廢水櫃出口管端凸緣損害情形

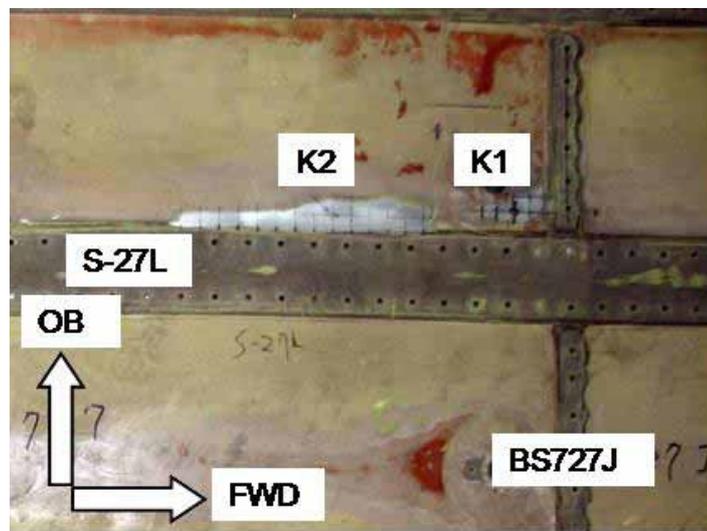
K1 區與 K2 區：腐蝕區域 K1 位於 BS 727J 左側機腹排水閥週圍，緊接 BS 727J 機身橫框，腐蝕區域 K2 緊接於前述腐蝕區，詳圖 1.12-12，圖中機身縱桁 S-27L、橫框及附屬結構件已經拆除，腐蝕區已打磨。

圖 1.12-12 K1、K2 區腐蝕情形

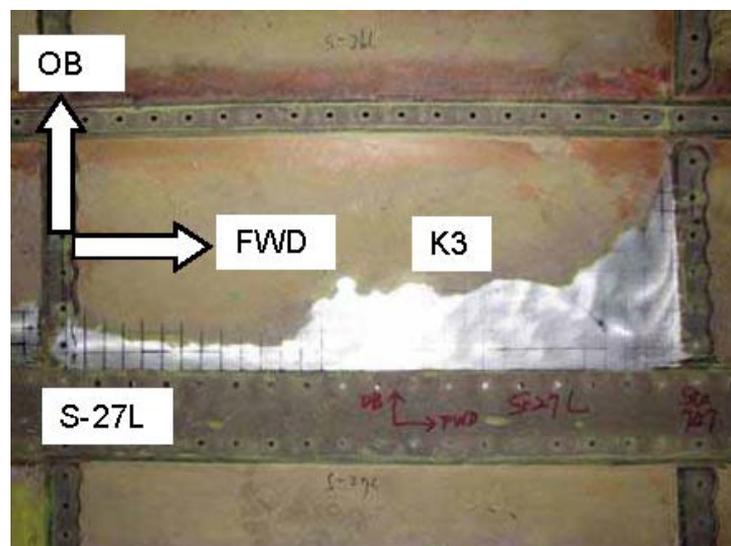
K3 區：腐蝕區域 K3 起於 BS 747 之橫框剪力搭接處，沿 S-27L 縱桁邊緣向後延伸，而以最低水平處腐蝕較為嚴重，詳圖 1.12-13，圖中機身縱桁 S-27L、橫框及附屬結構件已經拆除，腐蝕區已打磨。

圖 1.12-13 K3 區腐蝕情形

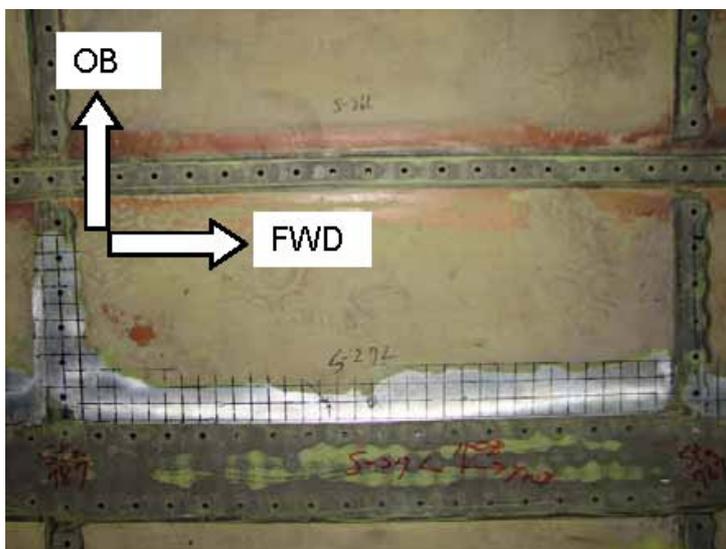
K4 區：腐蝕區域 K4 起於 BS 767 之橫框剪力搭接處，沿 S-27L 縱桁邊緣向後延展至 BS 787 剪力搭接下方，而以最低水平處腐蝕較為嚴重。詳圖 1.12-14，圖中機身縱桁 S-27L、橫框及附屬結構件已經拆除，腐蝕區已打磨。

圖 1.12-14 K4 區腐蝕情形

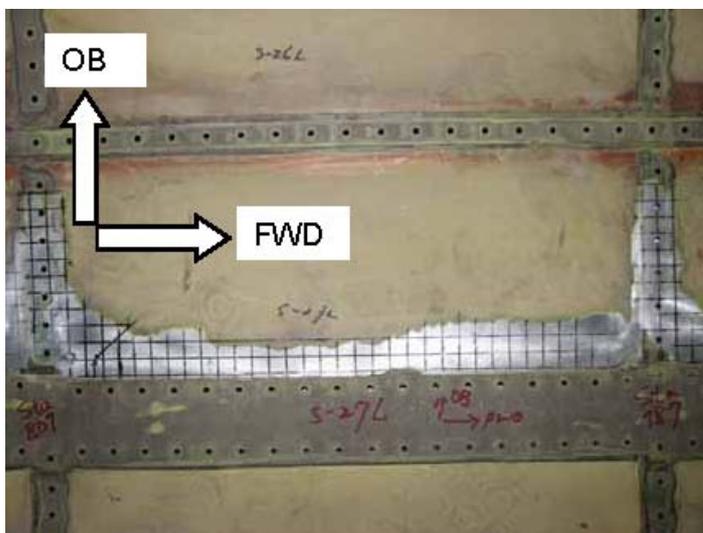
K5 區：腐蝕區域 K5 起於 BS 787 之橫框剪力搭接處，沿 S-27L 縱桁邊緣向後延展至 BS 807 剪力搭接之下方，而以最低水平處腐蝕較為嚴重，詳圖 1.12-15，圖中機身縱桁 S-27L、橫框及附屬結構件已經拆除，腐蝕區已打磨。

圖 1.12-15 K5 區腐蝕情形

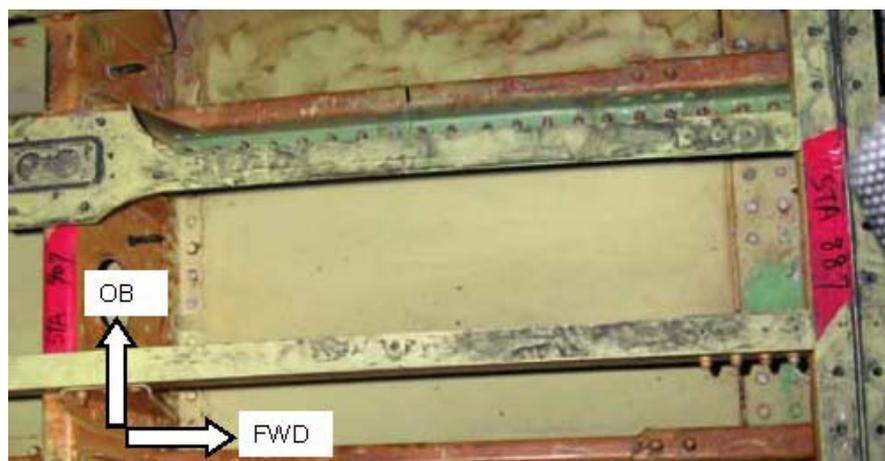
K10 區：腐蝕區位於 BS 887 之機腹前後兩片蒙皮搭接區，亦即機身 46 段與 47 段分界之搭接區，機身 47 段橫框底板上，及 S-27L 外側機身蒙皮發現輕微表面腐蝕，詳圖 1.12-22。

圖 1.12-22 K10 區腐蝕情形

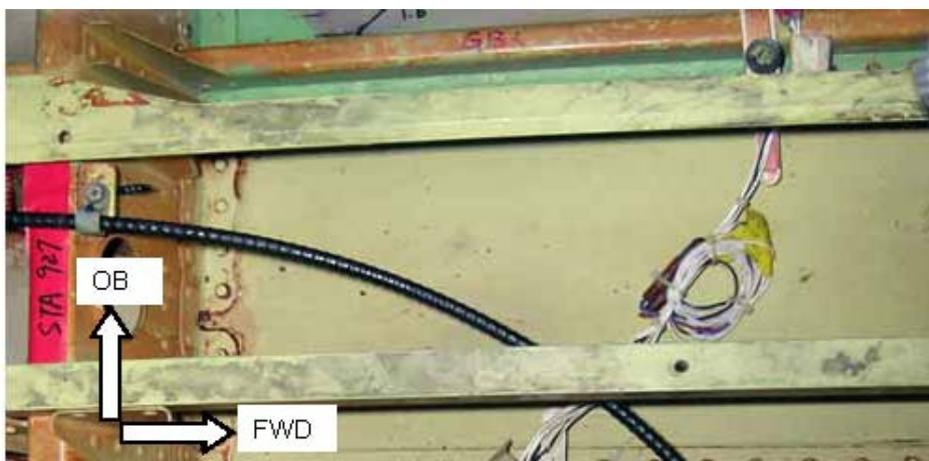
K11 區：腐蝕區位於 BS 927 前方 S-27L 外側，屬輕微表面腐蝕，詳圖 1.12-23

圖 1.12-23 K11 區腐蝕情形

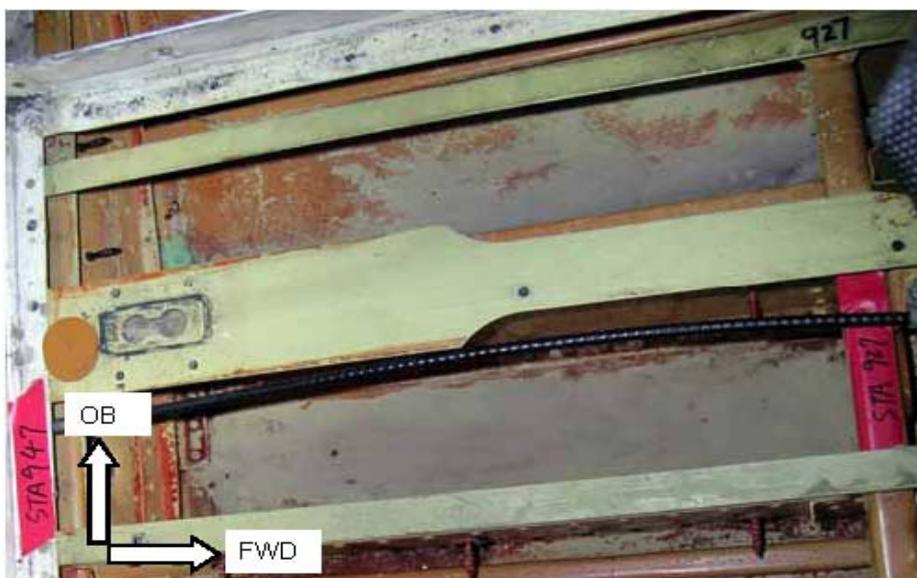
K12 區：腐蝕區位於 BS 947 前方 S-27L 外側，腐蝕區域屬輕微表面腐蝕，詳圖 1.12-24。

圖 1.12-24 K12 區腐蝕情形

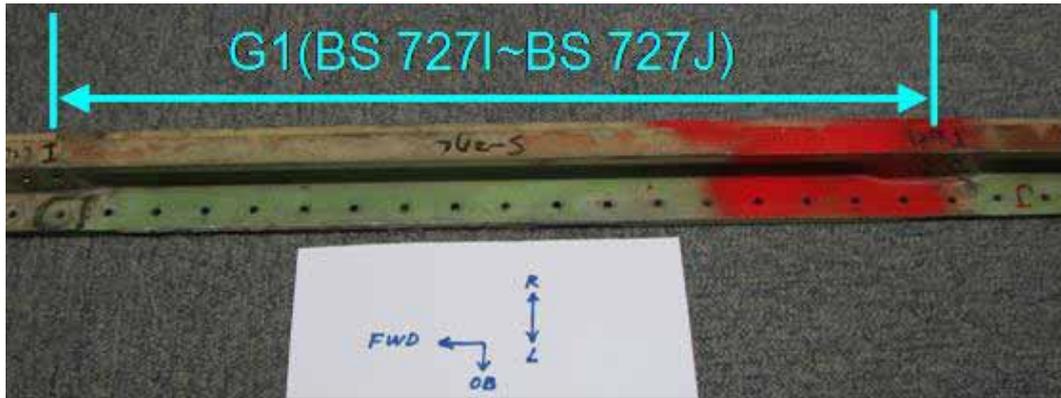
G1 區 (BS 727I~BS 727J)：縱桁為擠製之工型樑 (以下簡稱工型樑)，縱桁左側裙邊表面，平均分布輕度腐蝕，詳圖 1.12-25。該縱桁因應飛渡需要，已執行除銹及塗裝之暫時性修理。

圖 1.12-25 G1 區縱桁腐蝕情形

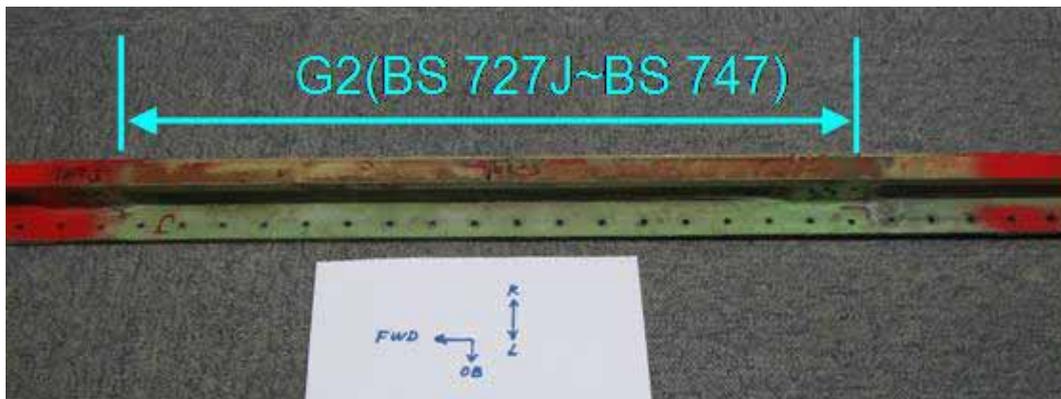
G2 區 (BS 727J~BS 747)：縱桁為工型樑，縱桁左側裙邊表面，平均分布淺層腐蝕，詳圖 1.12-26。該縱桁因應飛渡需要，已執行除銹及塗裝之暫時性修理。

圖 1.12-26 G2 區縱桁腐蝕情形

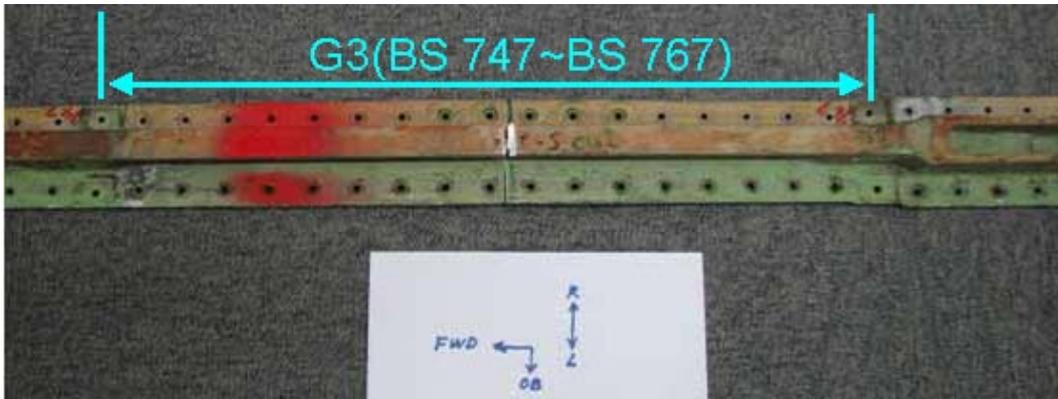
G3 區 (BS 747~BS 767)：縱桁為工型樑，縱桁左側裙邊表面平均分布深淺不一之腐蝕性凹陷，詳圖 1.12-27。

圖 1.12-27 G3 區縱桁腐蝕情形

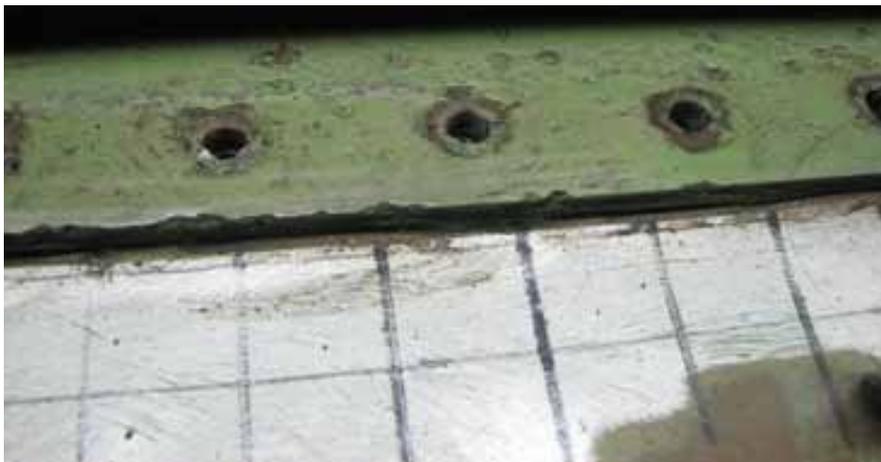
縱桁上緊配螺栓 (Lock Bolt) 之螺帽 (Collar) 拆除後，下方縱桁表面發現深度腐蝕性凹陷，詳圖 1.12-28。

圖 1.12-28 G3 區腐蝕凹陷情形

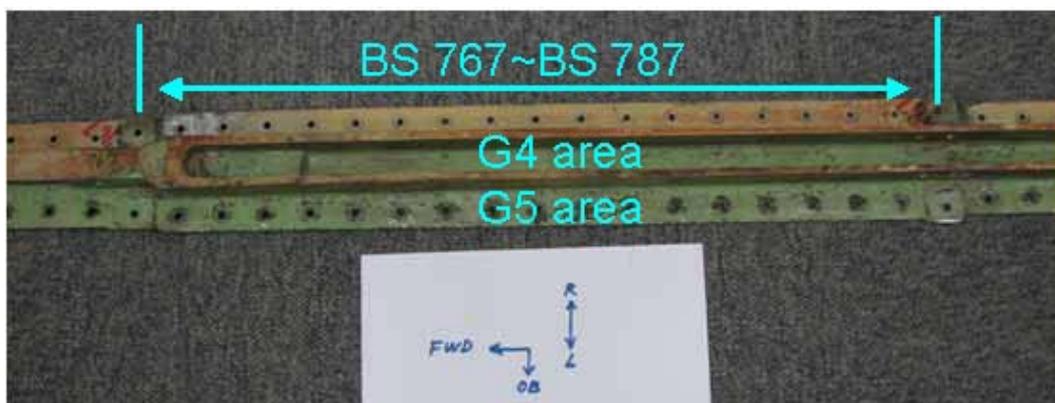
G4 區 (BS 767~BS 787): 縱桁為工型樑，自 BS 767 起為擠製之雙 T 型樑 (以下簡稱雙 T 型樑)，其中央凹槽底部表面輕微腐蝕，詳圖 1.12-29。

G5 區 (BS 767~BS 787): 縱桁左側裙邊表面平均分布深淺不一腐蝕性凹陷, 詳圖 1.12-29。

圖 1.12-29 G4、G5 區縱桁腐蝕情形

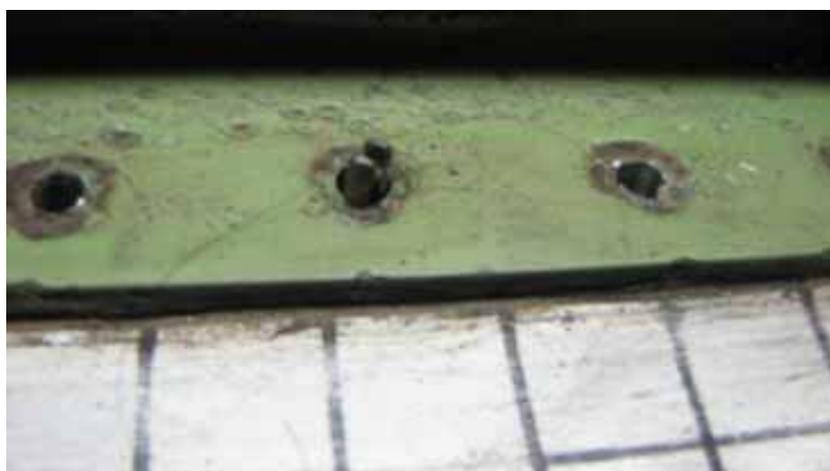
G5 區緊配螺栓之螺帽拆除後, 下方縱桁表面發現深度腐蝕之凹陷, 詳圖 1.12-30。

圖 1.12-30 G5 區腐蝕凹陷情形

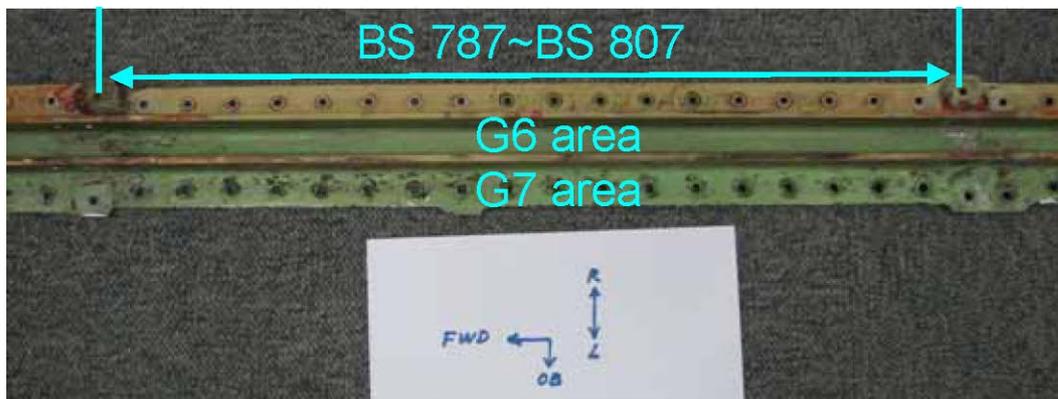
G6 區 (BS 787~BS 807): 為雙 T 型樑, 其中央凹槽底部表面輕微腐蝕, 詳圖 1.12-31。

G7 區 (BS 787~BS 807)：縱桁左側裙邊表面平均分布深淺不一之腐蝕性凹陷，詳圖 1.12-31。

圖 1.12-31 G6、G7 區縱桁腐蝕情形

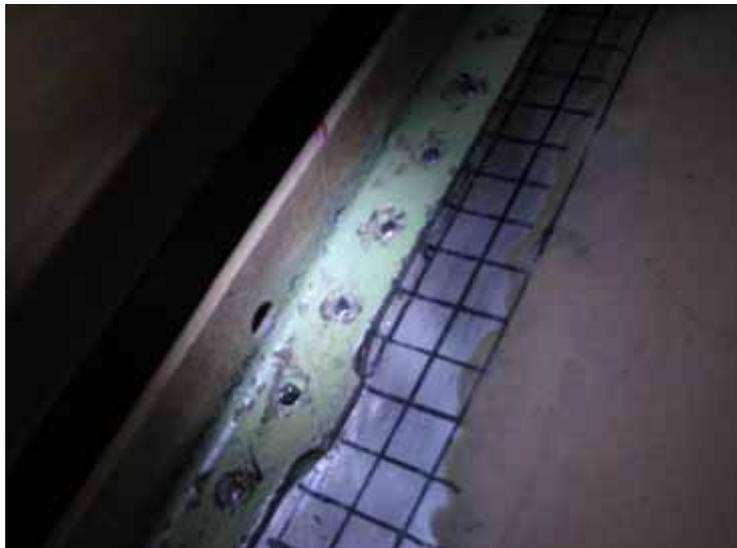
圖 1.12-32 G7 區腐蝕凹陷情形

縱桁上緊配螺栓之螺帽拆除後，下方縱桁表面發現深度腐蝕之凹陷，其腐蝕程度較 G5 區域嚴重，詳圖 1.12-32：

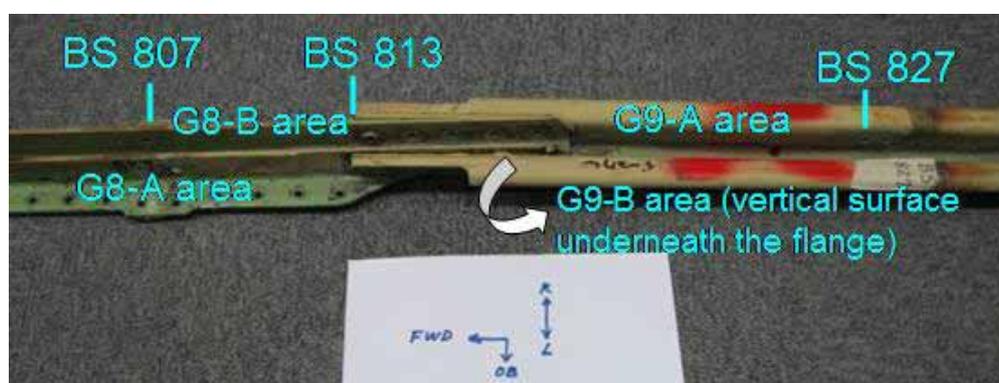
圖 1.12-33 G8-A, G8-B, G9-A, G9-B 區腐蝕情形

G9-A 區 (BS 813~BS 827)：帽型樑中央凹槽底部表面腐蝕，與前面雙 T 型樑之搭接面有輕度腐蝕。帽型樑中央凹槽底部表面腐蝕，尤以鉚釘孔四周較為嚴重，詳圖 1.12-33。

G9-B 區 (BS 813~827)：帽型樑外側垂直面大量灰白色腐蝕生成物堆積，形成層疊腐蝕 (exfoliation) 現象，詳圖 1.12-33。

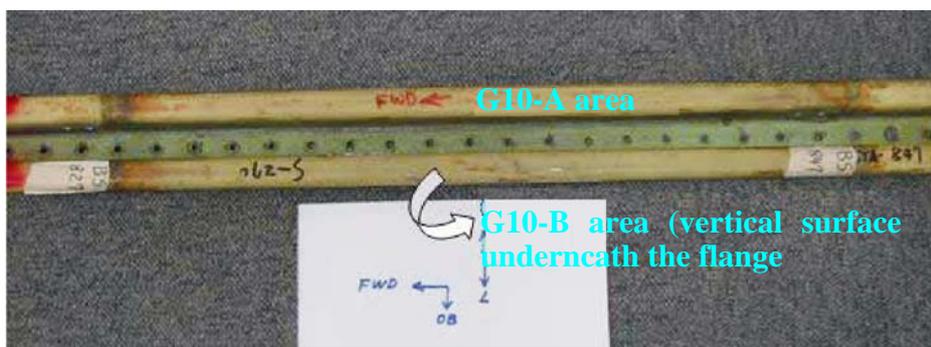
圖 1.12-35 G10-A、G10-B 區腐蝕情形

G10 區 (BS 827~BS 847)：縱桁為帽型樑，詳圖 1.12-35。

G10-A 區：帽型樑中央凹槽底部表面腐蝕，其腐蝕狀況與 G9-A 區相當。

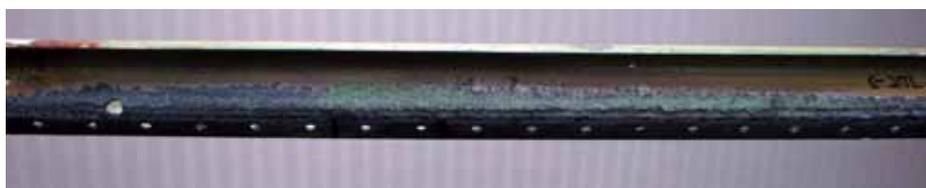
圖 1.12-36 G10-B 區腐蝕情形

G10-B 區：帽型樑外側垂直面大量白色腐蝕生成物堆積。BS 829.5 外側與 BS 844.8 內側排水孔嚴重腐蝕，形成 exfoliation 疊層腐蝕現象，排水孔孔壁崩落，詳圖 1.12-36。

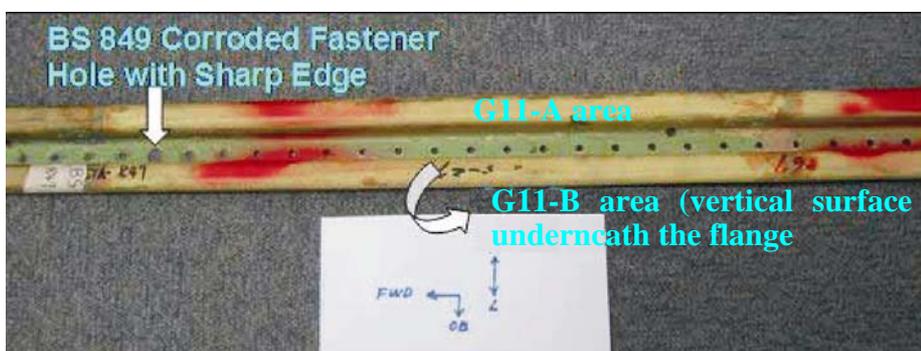
圖 1.12-37 G11-A、G11-B 區腐蝕情形

G11 區 (BS 847~867)：縱桁為帽型樑，詳圖 1.12-37。G11-A 區：帽型樑中央凹槽底部表面腐蝕，其腐蝕狀況與 G10-A 區一致，於 BS 849 一鉚釘孔腐蝕，擴孔邊緣呈尖銳狀。

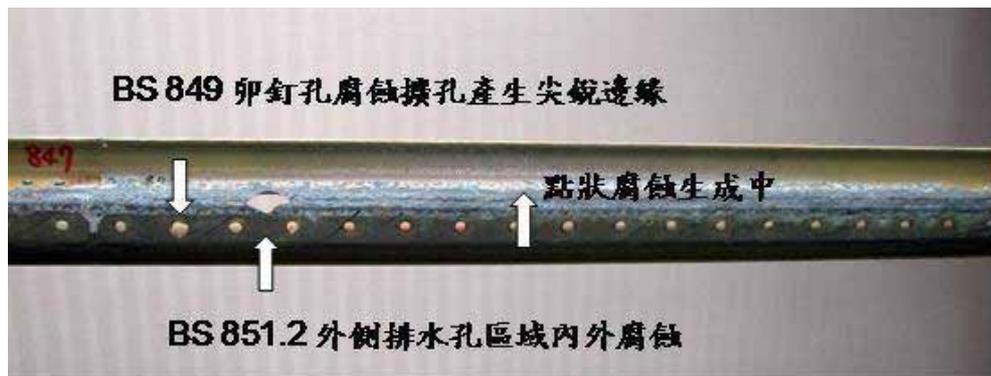
圖 1.12-38 G11-B 區腐蝕情形

G11-B 區：帽型樑外側垂直面大量白色腐蝕生成物堆積。BS 851.2 外側排水孔嚴重腐蝕，形成 exfoliation 疊層腐蝕現象，排水孔孔壁崩落，孔擴至 20mm。BS 847 至 BS 867 帽樑外側表面有點狀腐蝕，詳圖 1.12-38。

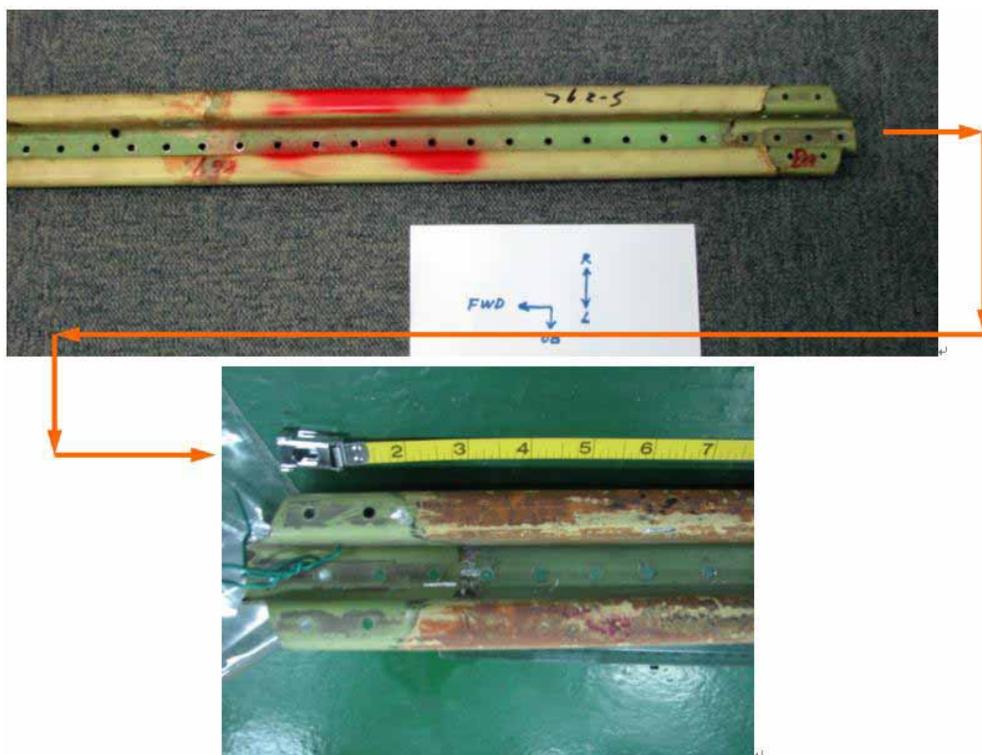
圖 1.12-39 12 區腐蝕情形

G12 區 (BS 867~887)：縱桁為帽型樑，於 BS 880~BS 883 與另一帽型樑搭接，詳圖 1.12-39。

G12-A 區：帽型樑中央凹槽底部表面腐蝕，其腐蝕狀況與 G11-A 區一致。

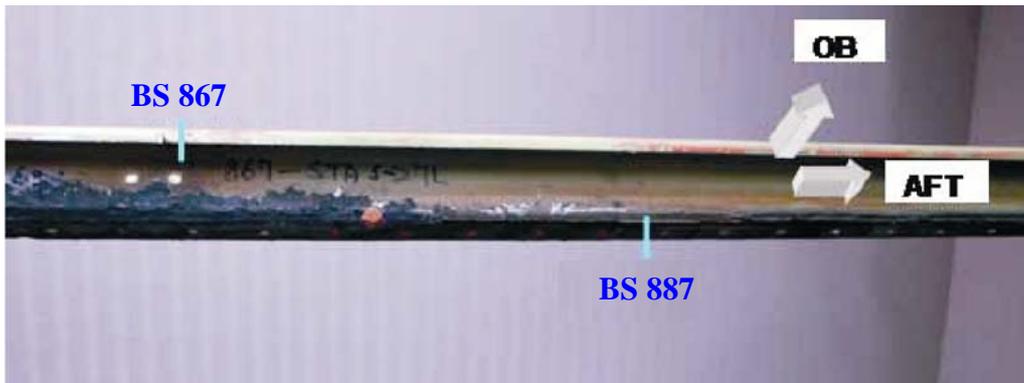
圖 1.12-40 G12-B 區腐蝕情形

G12-B 區：帽樑外方側垂直面大量白色腐蝕生成物堆積，形成 exfoliation 疊層腐蝕現象。腐蝕現象至 BS 871 為止，詳圖 1.12-40。BS 870.5 外側排水孔鏽蝕，排水孔孔壁崩落，詳圖 1.12-41。

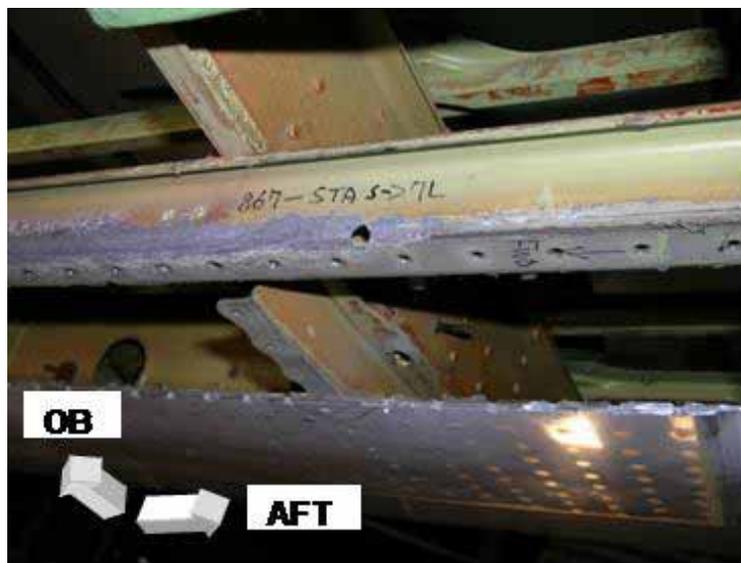
圖 1.12-41 排水孔孔壁崩落

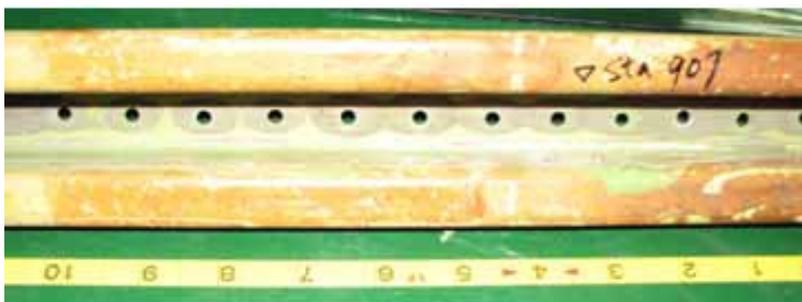
圖 1.12-42 G13 區, BS 907~BS 917 腐蝕情形

G13 區 (BS 907~BS 927)：帽型樑中央凹槽底部表面輕微腐蝕，詳圖 1.12-42 及 1.3-43。

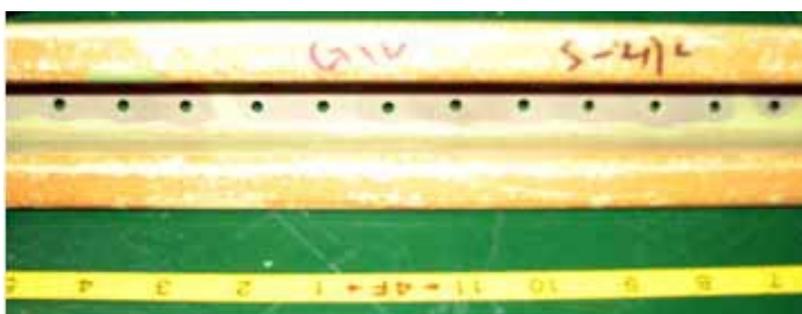
圖 1.12-44 G14 區腐蝕情形

G14 區 (BS 927~BS 947)：帽型樑中央凹槽底部表面輕微腐蝕，詳圖 1.12-44。

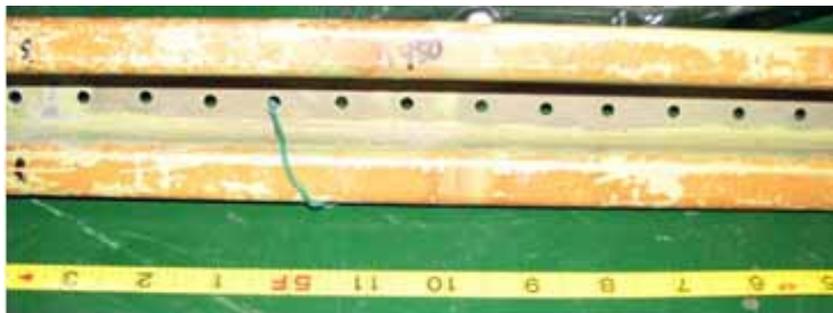
圖 1.12-45 G15 區, BS 947~BS 956 腐蝕情形

G15 區 (BS 947~BS 967): 帽型樑中央凹槽底部表面輕微腐蝕, 詳圖 1.112-45 及 1.12-46。

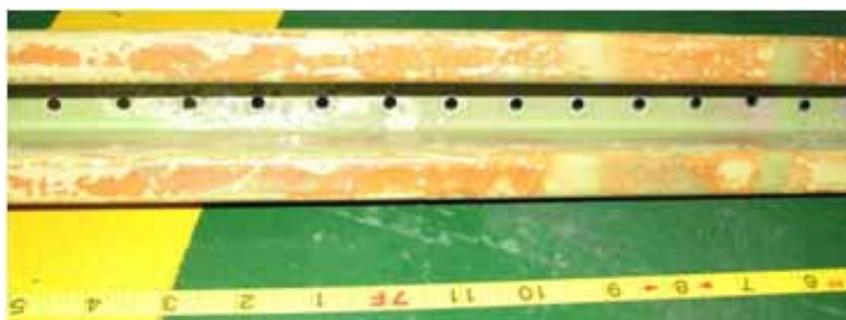
圖 1.12-47 G16 區腐蝕情形

G16 區 (BS 967~ BS 986.5) 帽型樑中央凹槽底部表面輕微腐蝕, 詳圖 1.12-47。

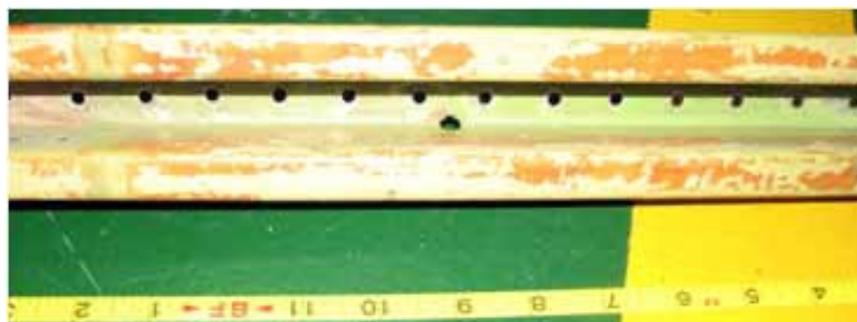
圖 1.12-48 G17 區腐蝕情形

G17 區 (BS 986.5~BS 1006) 帽型樑中央凹槽底部表面輕微腐蝕，詳圖 1.12-48

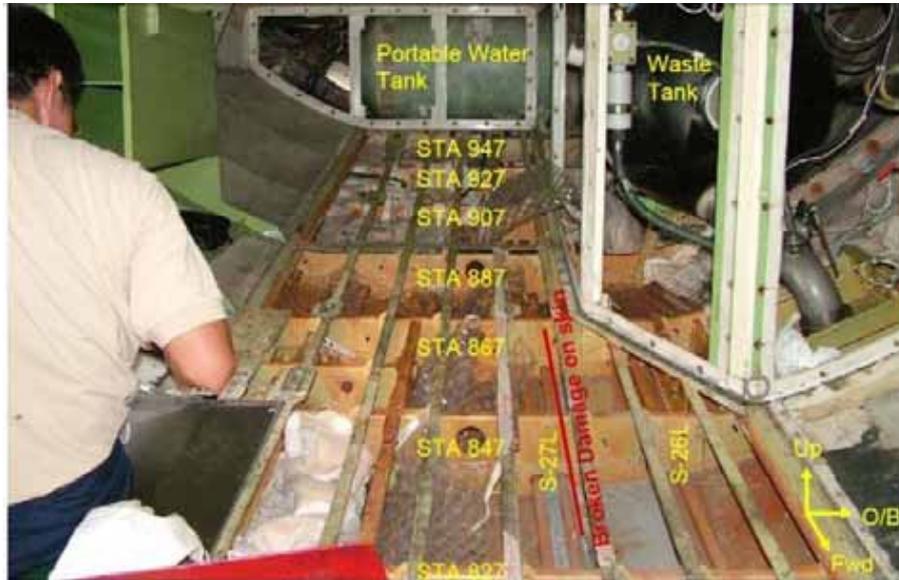
圖 1.12-50 廢水槽出口位置

本會於華航桃園檢修棚廠實地調查發現 BS 867 至 BS 887 之 S-26L 及 S-27L 之肋間片有貫穿性腐蝕，詳圖 1.12-49。廢水櫃出口管位於 BS 867 至 BS 887 之 S-26L 及 S-24L 外側上游，正位於廢水櫃出口管滲漏處下游，詳圖 1.12-50 及 1.12-51

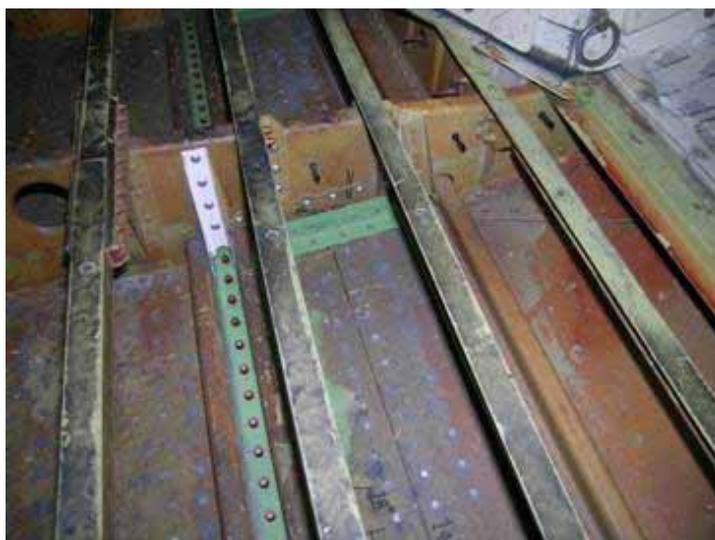
圖 1.12-52 S-26L 與 S-27L 間 BS 847 剪力片

表 1.12-3 之 12 項剪力片的腐蝕，均發生於底部，BS 847 與 BS 867 兩處剪力片腐蝕最嚴重。為執行飛渡作業，12 項發現腐蝕之剪力片均已依 EO 738-53-00-0068 修補更換，詳圖 1.12-52 及圖 1.12-53。

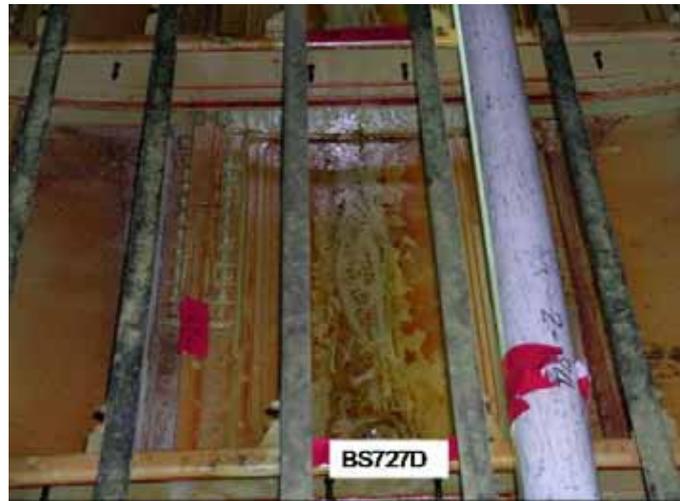
本會於華航桃園檢修棚廠實地調查發現後貨艙底部有凝結水混合防鏽劑之混合物堆積，於凝結水流通路徑上有防鏽劑遭沖刷洗去之痕跡，無腐蝕現象，詳圖 1.12-55。

圖 1.12-55 貨艙底部沖刷痕跡

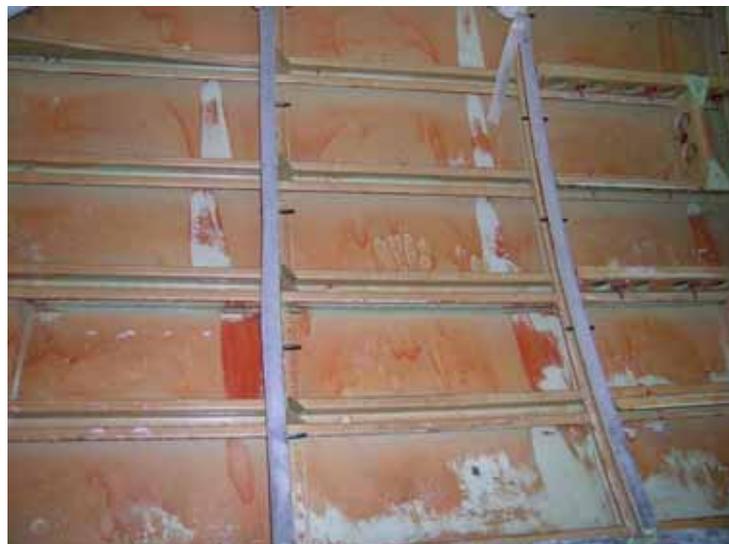
圖 1.12-56 貨艙內部蒙皮結構

本會於華航桃園檢修棚廠實地調查發現後貨艙其他部分蒙皮結構於凝結水流通路徑上有防鏽劑遭沖刷洗去之痕跡，無腐蝕現象，詳圖 1.12-56。

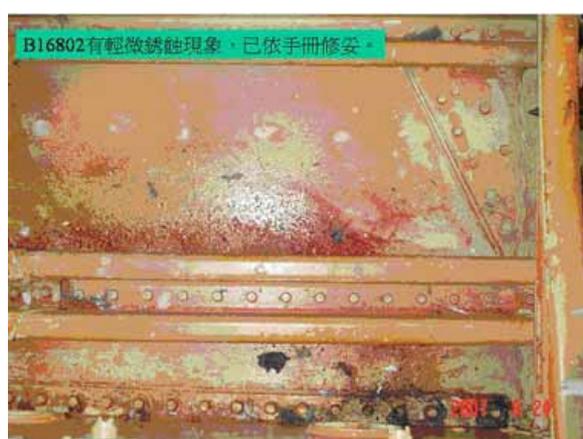
民國 96 年 9 月 22 日至 24 日，華航針對 737-800 機隊共 12 架機執行廢水櫃滲漏之一次性檢查，結果發現其中 3 架機廢水櫃出口管凸緣有裂縫狀況，其中 2 架機廢水櫃出口管有廢水滲漏痕跡，機腹蒙皮有銹蝕現象，詳圖 1.16-1 及 1.16-2，已依維修手冊修妥；經查該 2 架機維修資料，其中 1 架曾於民國 95 年 7 月 1 日執行 AV4 之廢水櫃艙區域檢查，發現廢水櫃艙區有污漬現象，已依維修手冊清潔，另 1 架

圖 1.16-2 飛機編號 B-16802 機腹蒙皮銹蝕

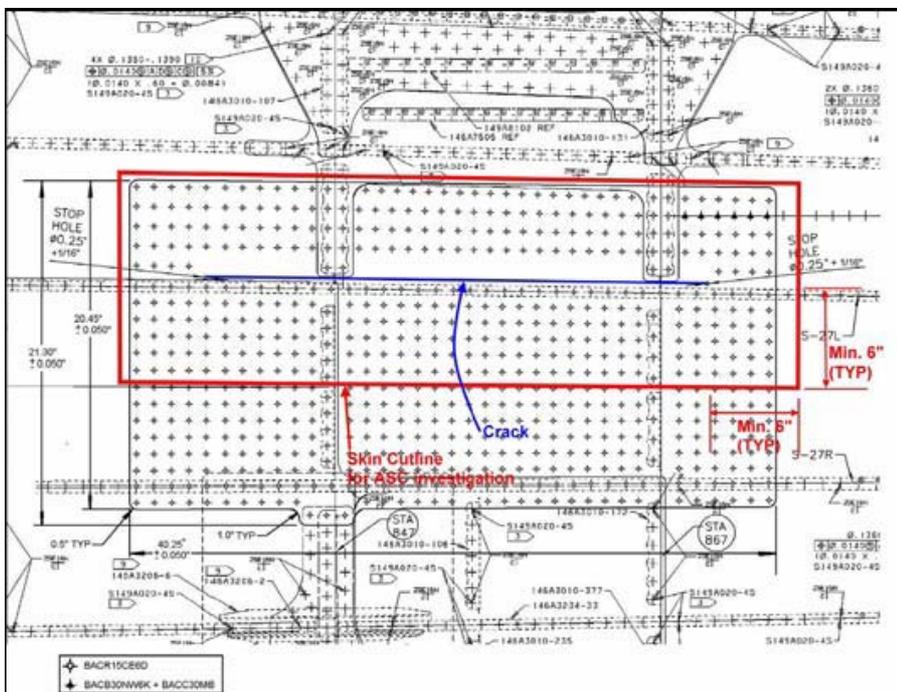
圖 1.16-4 送檢之機腹蒙皮

圖 1.16-3 顯示機腹受損蒙皮與機身之相對位置，裂縫範圍介於 BS 839.2 至 BS 869.7 以及縱桁 S-27L 附近，為執行材料測試，將受損蒙皮作適當裁剪，詳圖 1.16-4。該蒙皮之測試項目包括：外觀目視觀察及照相、受損蒙皮斷裂面掃描式電子顯微鏡（Scanning Electron Microscope，以下簡稱 SEM）觀察、火花放電分光光譜儀（Spark）與能量散射光譜儀（Energy Dispersive System，以下簡稱 EDS）之化學成份分析、材料硬度及導電度測試、金相組織觀察以及離子層析（Ion Chromatography）比對試驗等，以瞭解其破壞模式。

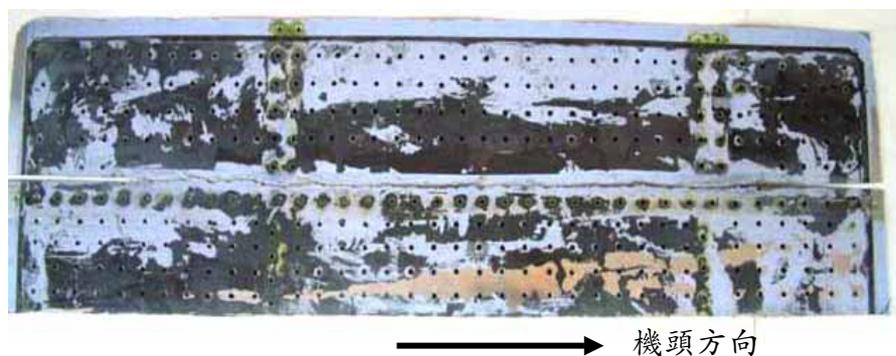
圖 1.16-6 受損蒙皮之外部表面

取樣送檢之蒙皮詳圖 1.16-5 及 1.16-6，檢視受損蒙皮之內表面與外表面，在內表面發現腐蝕生成物，詳圖 1.16-5 灰色區塊（藍圈）。另外檢視受損蒙皮之斷裂面，斷面粗糙且附著腐蝕生成物。將裂縫右側蒙皮裁切成 10 段，巨觀觀察及照相，其中圖 1.16-7 及 1.16-8 分別是編號 1 號蒙皮及 9 號蒙皮之放大照片，其斷裂面呈現凹凸不平，且具有腐蝕之破壞特徵。這些腐蝕生成物已造成鋁合金基材剝離（Exfoliation），可輕易地以外力刮除。其它蒙皮斷裂面亦有同樣之破壞特徵，其放大照片詳附錄四。

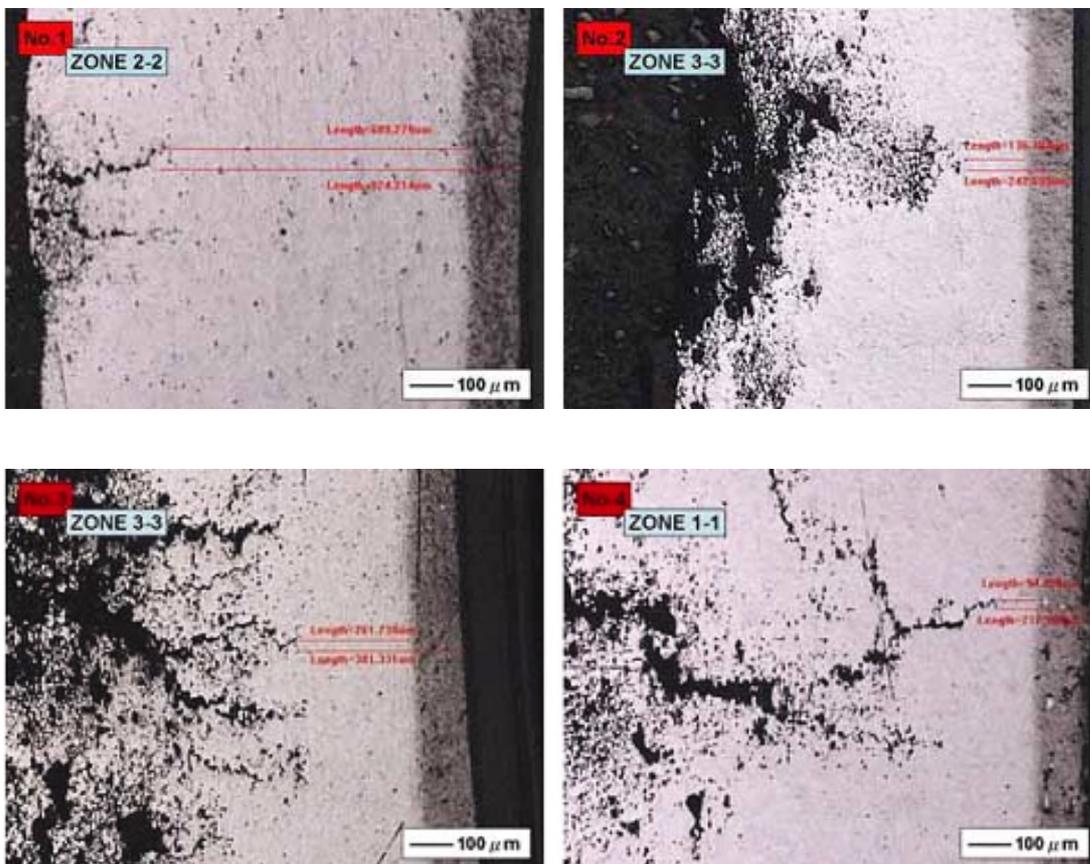
金相試片均發現明顯孔蝕及沿晶裂縫，圖 1.16-16 為金相試片放大照片，有些區域腐蝕破壞情形嚴重，編號 2-3-3 試片⁴、4-1-1 試片及 9-1-1 試片，孔蝕幾乎貫穿蒙皮，量測後發現蒙皮殘餘厚度分別為 0.0054 吋、0.0037 吋及 0.0044 吋（蒙皮厚度規範為 0.063 吋），其它金相照片參閱附錄五。每個金相試片取樣位置及量測之殘餘厚度詳表 1.16-1；圖 1.16-17 為蒙皮斷裂面受腐蝕破壞情形及殘餘厚度示意圖，空白區域表示受腐蝕破壞，灰藍色區域代表蒙皮殘餘厚度。

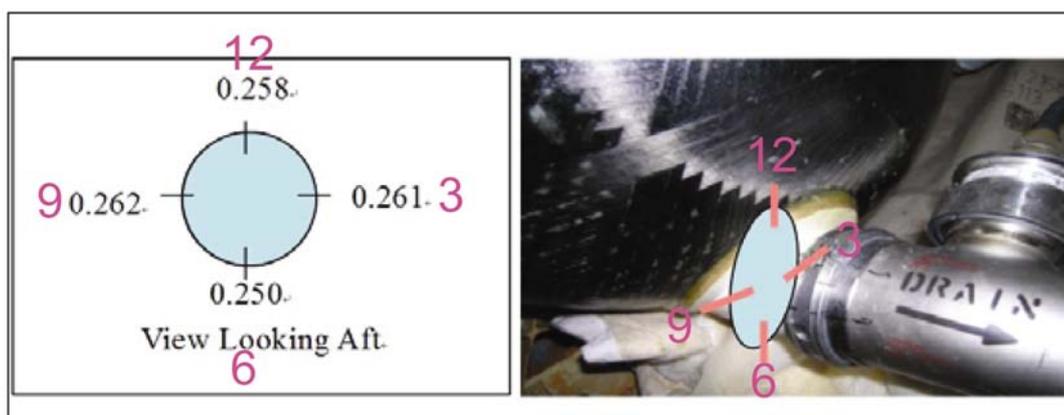
圖 1.18-1 間距量測圖

調查小組會同華航修護工廠針對事故機及另兩架疑似有廢水滲漏之同型機執行廢水櫃管路接頭間距量測，廢水櫃出口管與廢水排放管路接合處由機首向後 3、6、9 及 12 點鐘位置詳圖 1.18-1，發現其中 2 架飛機之廢水櫃出口管接頭間距

大於如圖 1.18-1 所規定之 0.1500 吋，因而再協調華航執行 737-800 全機隊之廢水櫃出口管接頭間距量測，並擴大執行廢水櫃出口所連接管路另一端與球形閥相接處之間隙，量測結果詳表 1.18-1。

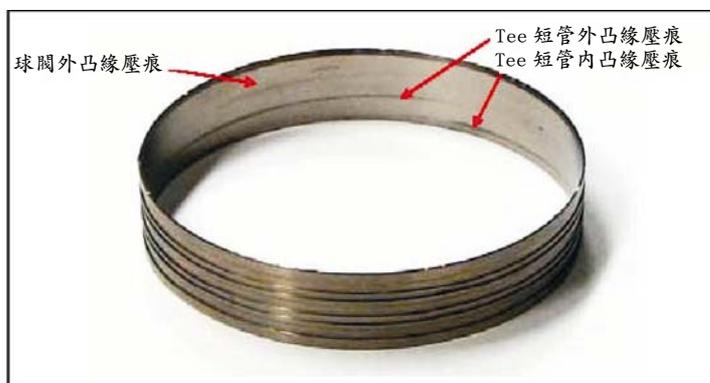
如圖 1.18-3 所示之襯套，為在執行本報告第 1.18.1.1 節，B737-800 機隊廢水櫃出口管接頭間距量測過程中，由飛機編號#7 所取樣之短管與球形閥接頭襯套。本會發現該襯套內側，有襯套與短管及襯套與球形閥兩者凸緣接觸所造成的兩組壓痕，其中襯套與短管接觸所造成壓痕的一組較深而明顯，靠近球形閥一側的壓痕則較輕淡，兩組壓痕分隔約 5 公厘且各自平行。

圖 1.18-3 襯套內側壓迫痕跡

兩組壓痕分布均呈現歪斜的狀態，其中短管外凸緣在襯套上壓出圓弧角約 100 度之壓痕，而短管內凸緣壓出圓弧角約 170 度之壓痕，兩條壓痕分佈於不同方位，襯套拆下時並未記錄安裝位置，無法得知壓痕所在位置之方位角。

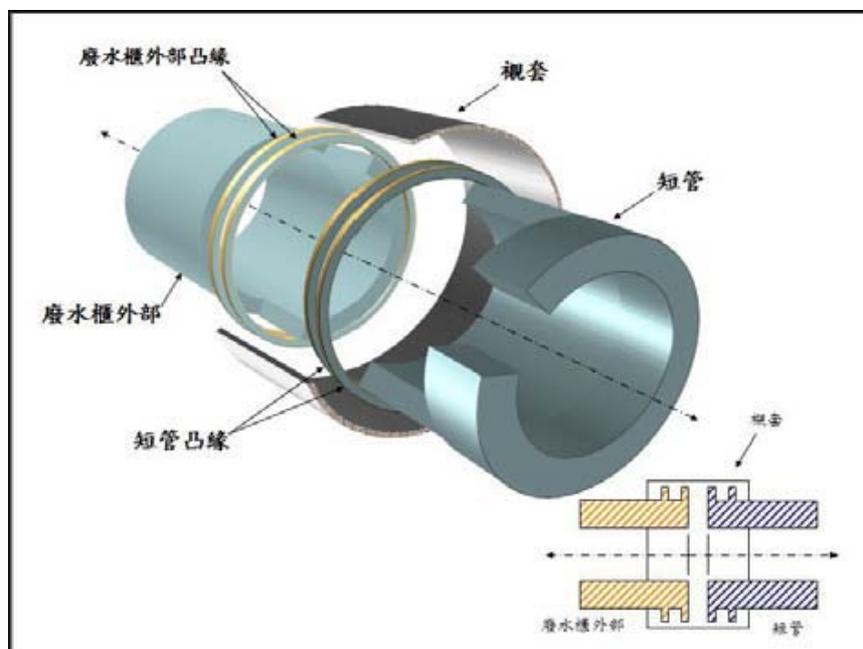
圖 2.3-1 兩管的中心線相互重疊而形成一條中心線

廢水櫃於安裝時，兩管接頭將被限制於襯套 (sleeve) 內，理想的安裝結果是兩管的中心線相互重疊而形成一條中心線 (詳圖 1.3-1)，如果安裝工法或品質因素影響，使兩管中心線未成一線而呈平行雙線時 (詳圖 2.3-2)，管端凸緣與襯套接觸處將產生一徑向之應力，即如原廠檢測報告圖 17 及圖 18 描述向下之應力 (詳圖 2.3-3)，因工具及場地之限制，調查小組未對管路中線之對正進行量測。

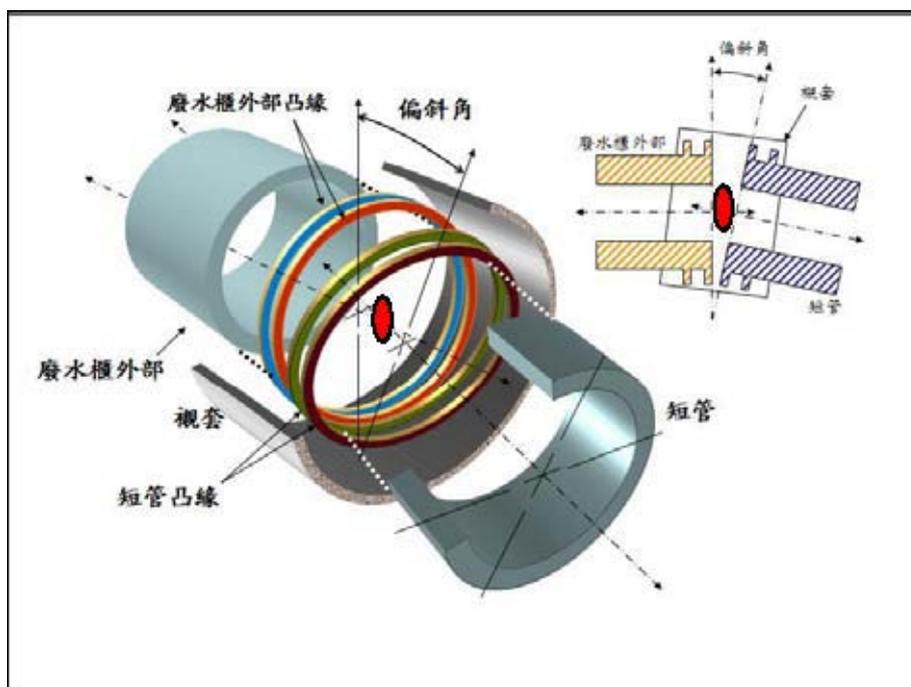
圖 2.3-4 兩管中心延長線未成一線而成一點

2.3-5)，遂發生原廠檢測報告圖 8 描述之模式 1 裂縫（詳圖 2.3-7）；於大間距處產生徑向及軸向之合應力，即如原廠檢測報告圖 21 及圖 22 描述之向後及向下之合應力（詳圖 2.3-6），遂發生原廠檢測報告圖 8 描述之模式 2 裂縫（詳圖 2.3-7）。根據波音公司所提供測試報告（QUALIFICATION TESTING OF HYDRAFLOW 15J02/14F02 SERIES COUPLINGS AND FLANGES TO THE REQUIREMENTS OF BELL-BOEING DRAWING NO. 901-366-582 REV. N/C, JANUARY 29, 1987），管凸緣與套管接合界面之設計經測試可容許兩端中心線在接合面有 3 度角的偏差量，接合界面有中心線偏斜狀況存在是有可能，然只要偏斜角度小於 3 度就不會有應力作用在接合界面兩端。

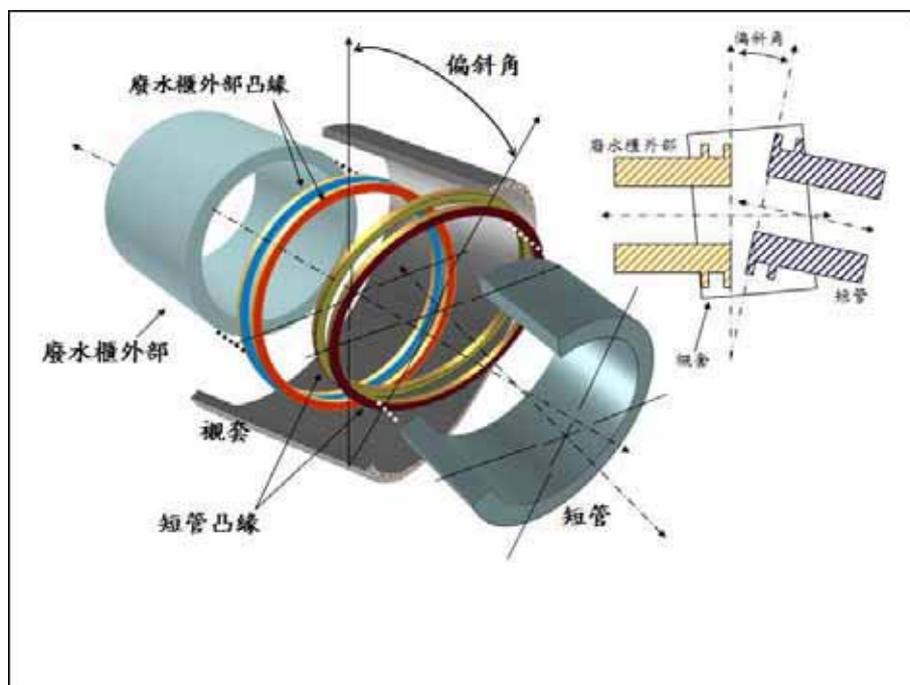
圖 2.3-8 兩管中心線不正及偏斜

廢水櫃於安裝時，如果該兩管不但中心線不正，且中心線亦偏斜（詳圖 2.3-8），則在套管內之兩管凸緣將負載兩種應力之合力。參考 1.6.5 節，表 1.6-4 廢水櫃出口管接頭間距與附錄八廢水櫃原廠報告，3 具廢水櫃出口管前後凸緣受損位置與情形比對其間距，並無一定模式及關係。1.16.4 節原廠報告結論「6.證據顯示管路凸緣曾受管夾組件造成之持續性及錯綜性之應力壓擠」，顯示廢水櫃出口管前後凸緣受損情形係受複雜應力之影響。

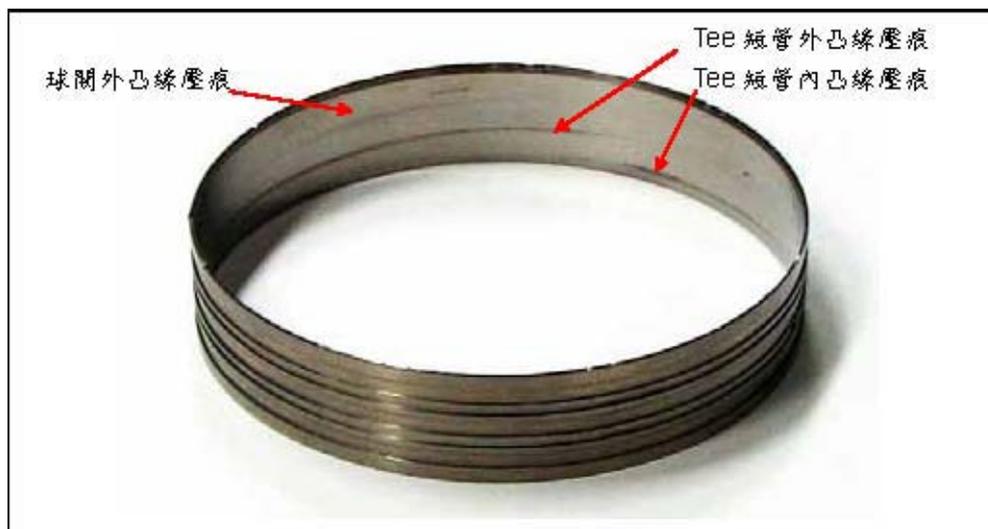
圖 2.3-9 襯套內側之凸緣壓痕

飛機編號#7 球形閥端襯套，內側有短管與球形閥兩組凸緣的壓痕，靠近短管處的一組較深而明顯，靠近球形閥一側的壓痕則較模糊（詳圖 2.3-9）。

廢水櫃出口端襯套因廢水櫃出口為塑膠材質，質地較軟，未能在襯套內徑留下壓痕；球形閥接頭為金屬材質，質地較硬，在襯套內徑留下壓痕，雖非於廢水櫃出口端，但因其所受環境與廢水櫃出口端襯套極為相似，其呈現之情形可為研判廢水櫃出口端情況之參考。

線上而有偏斜角度存在。另觀察短管外凸緣壓痕之起始端點恰與內凸緣壓痕之起始端點相交會，此現象類似 1.16.4 節原廠報告結果「5. 模式 1 及模式 2 之裂縫相互接近顯示凸緣曾受有一支點之彎曲應力」。

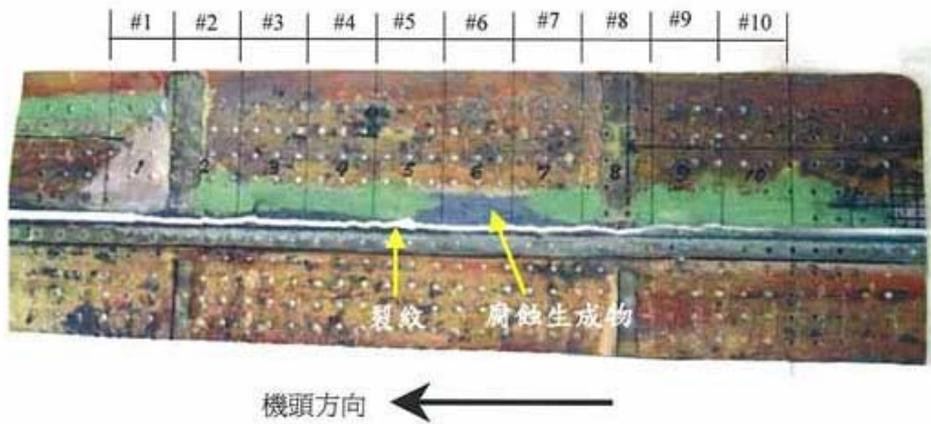
圖 1 與圖 2 分別為華航公司編號 B-16805 波音 737-800 型客機送檢機身蒙皮之內側與外側外觀，箭頭所指為裂紋，此區段內之破斷面粗糙，並有腐蝕生成物附著。除斷面以外，在內側表面亦發現有大面積之腐蝕生成物，如圖 1 灰色區塊。

圖 1、波音 737-800 型客機機身蒙皮裂紋的外觀觀察(內側表面)

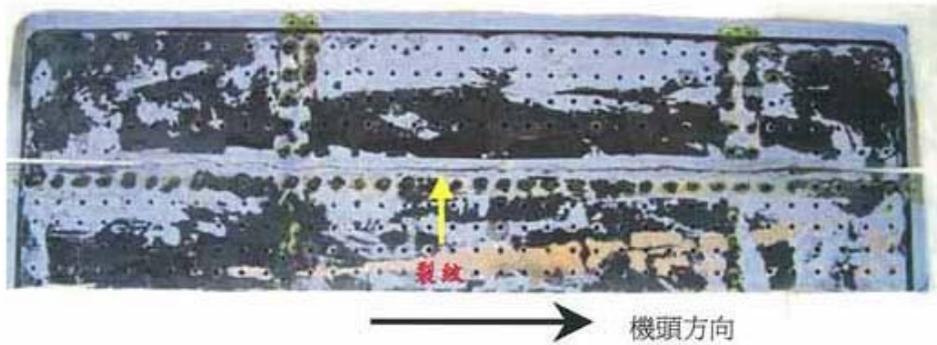
圖 2、波音 737-800 型客機機身蒙皮裂紋的外觀觀察(外側表面)

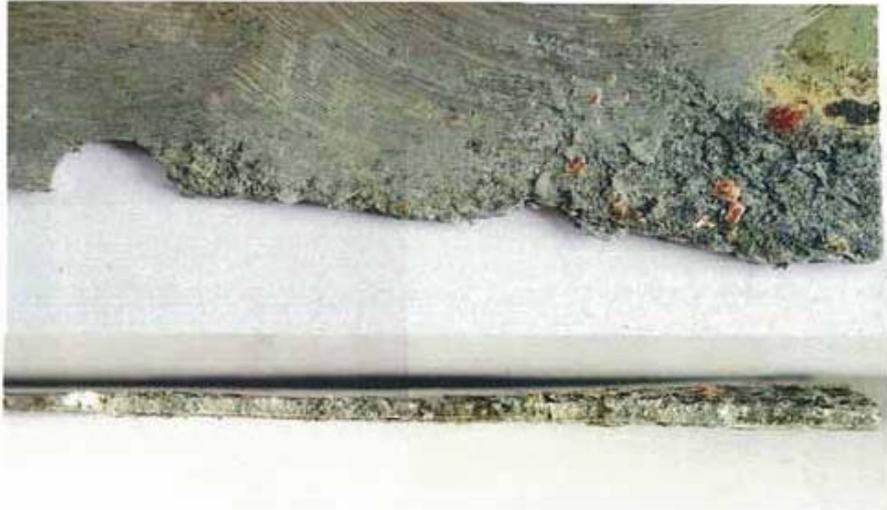
圖 3~圖 12 為將圖 1 內側表面分成 10 段放大觀察之圖片，其相對編號位置標示於圖 1，由這些圖片可以更明顯地發現斷面呈現崎嶇不平並有腐蝕生成物之外觀破壞特徵。這些腐蝕生成物已造成鋁合金基材剝離(Exfoliation)，可輕易地以外力刮下。

圖 3、編號 1 蒙皮試片巨觀觀察(下圖為斷面正視)。
