飛航事故調查報告

ASC-AOR-09-09-001

中華民國 96 年 9 月 20 日
中華航空公司 CI7552 班機
波音 737-800 型機
國籍標誌及登記號碼 B-16805
於日本佐賀機場過境檢查發現
機腹蒙皮 30 吋 (77 公分) 裂縫

行政院飛航安全委員會
AVIATION SAFETY COUNCIL

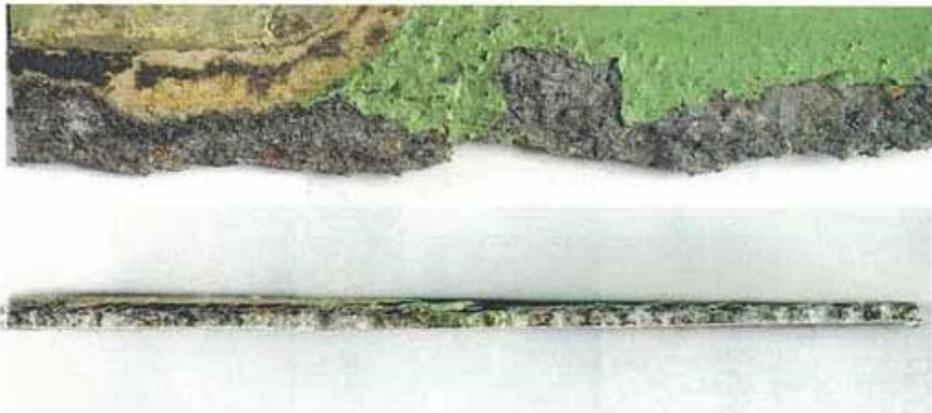
圖 3~圖 12 為將圖 1 內側表面分成 10 段放大觀察之圖片，其相對編號位置標示於圖 1，由這些圖片可以更明顯地發現斷面呈現崎嶇不平並有腐蝕生成物之外觀破壞特徵。這些腐蝕生成物已造成鋁合金基材剝離(Exfoliation)，可輕易地以外力刮下。

圖 4、編號 2 蒙皮試片巨觀觀察(下圖為斷面正視)。

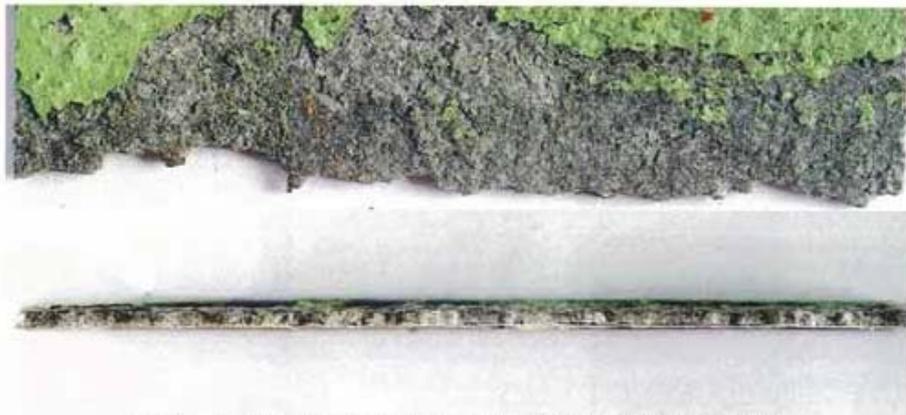
圖 5、編號 3 蒙皮試片巨觀觀察(下圖為斷面正視)。

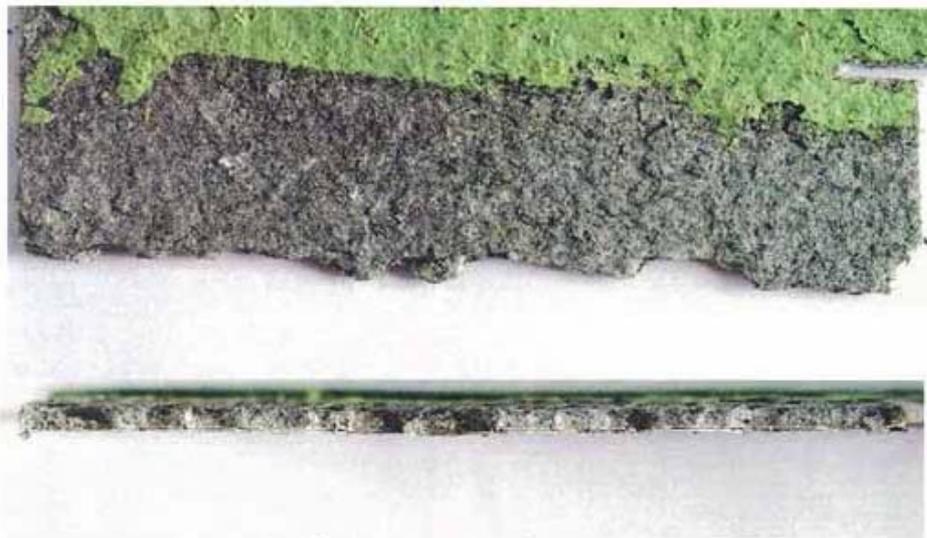
圖 6、編號 4 蒙皮試片巨觀觀察(下圖為斷面正視)。

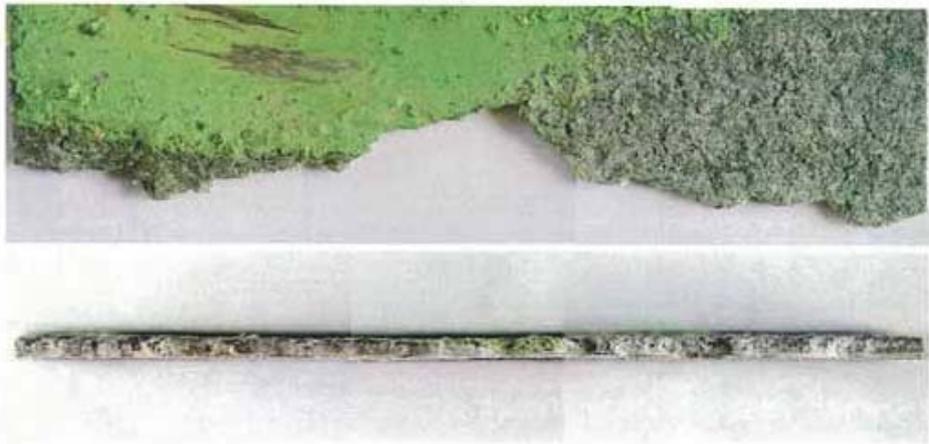
圖 7、編號 5 蒙皮試片巨觀觀察(下圖為斷面正視)。

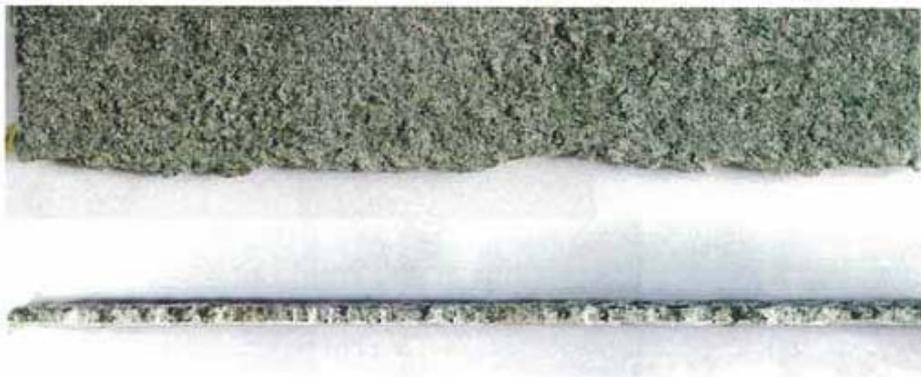
圖 8、編號 6 蒙皮試片巨觀觀察(下圖為斷面正視)。

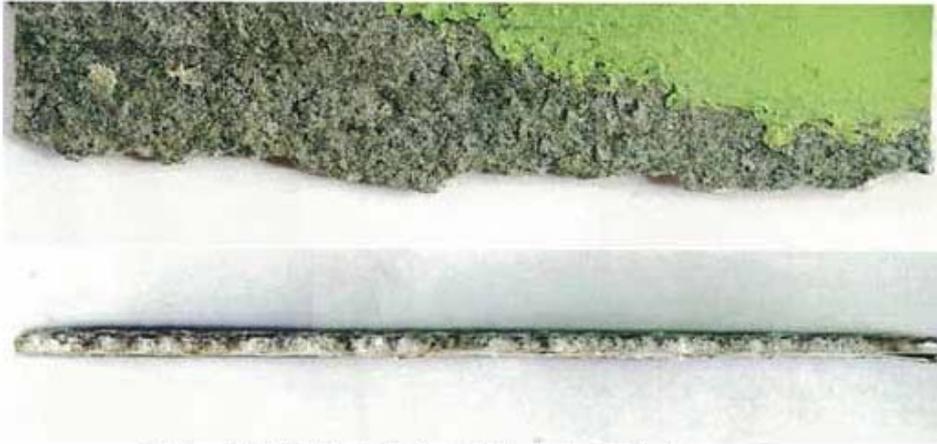
圖 9、編號 7 蒙皮試片巨觀觀察(下圖為斷面正視)。

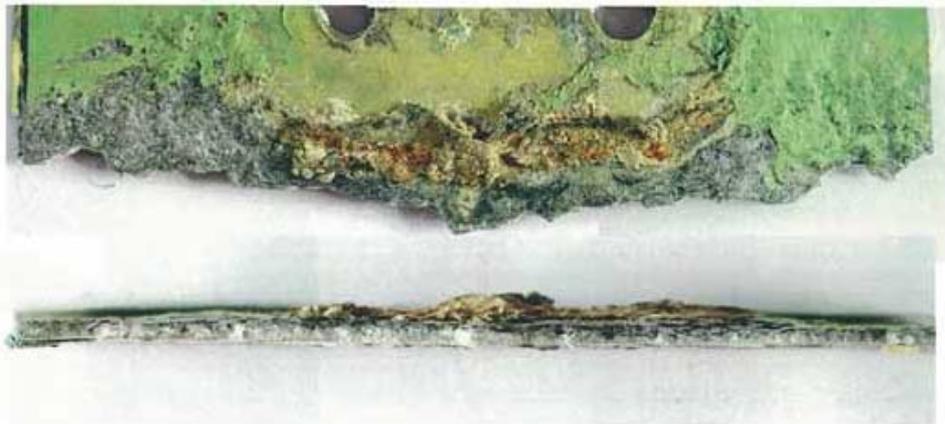
圖 10、編號 8 蒙皮試片巨觀觀察(下圖為斷面正視)。

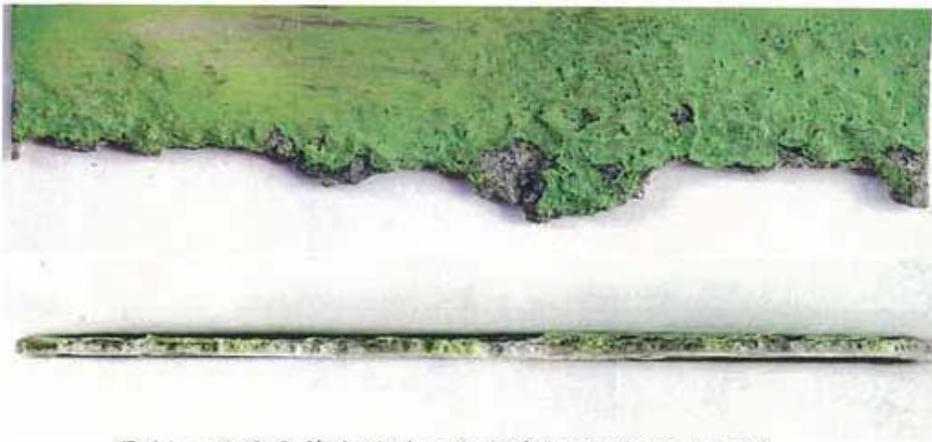
圖 11、編號 9 蒙皮試片巨觀觀察(下圖為斷面正視)。

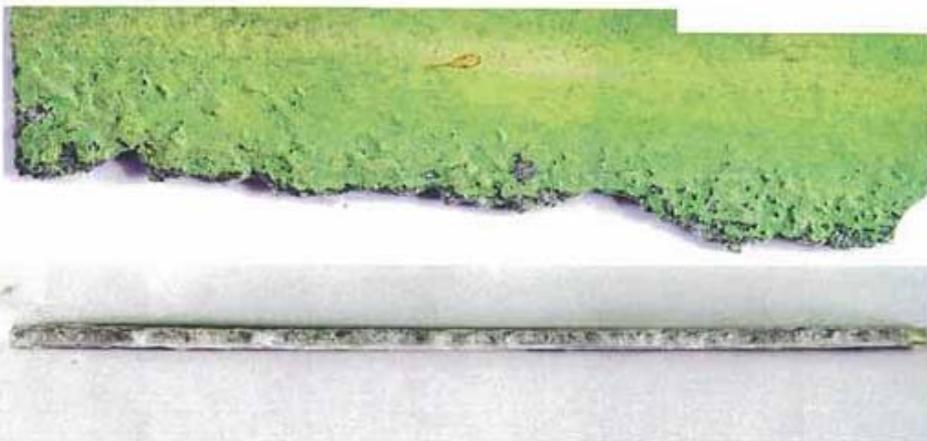
圖 12、編號 10 蒙皮試片巨觀觀察(下圖為斷面正視)。

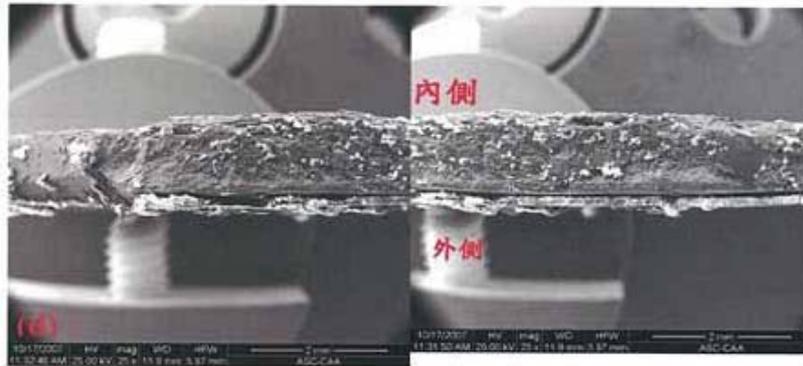
以掃描式電子顯微鏡檢視編號 1 號試片整個斷面如圖 13、圖 14，圖中顯示蒙皮外側表面還存在有較完好的面漆保護，但內側表面則呈現嚴重表面剝離的情形，破斷表面皆已遭非金屬物質覆蓋，無法辨識基材之破壞結構。

圖 13、編號 1 號試片整個破斷面特徵觀察。

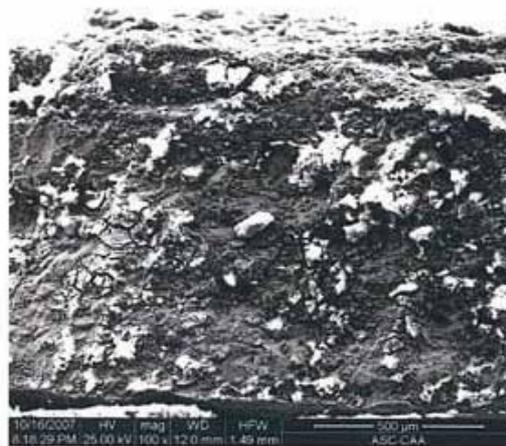
圖 14、編號 1 號試片 SEM 下之破斷面微觀特徵觀察。

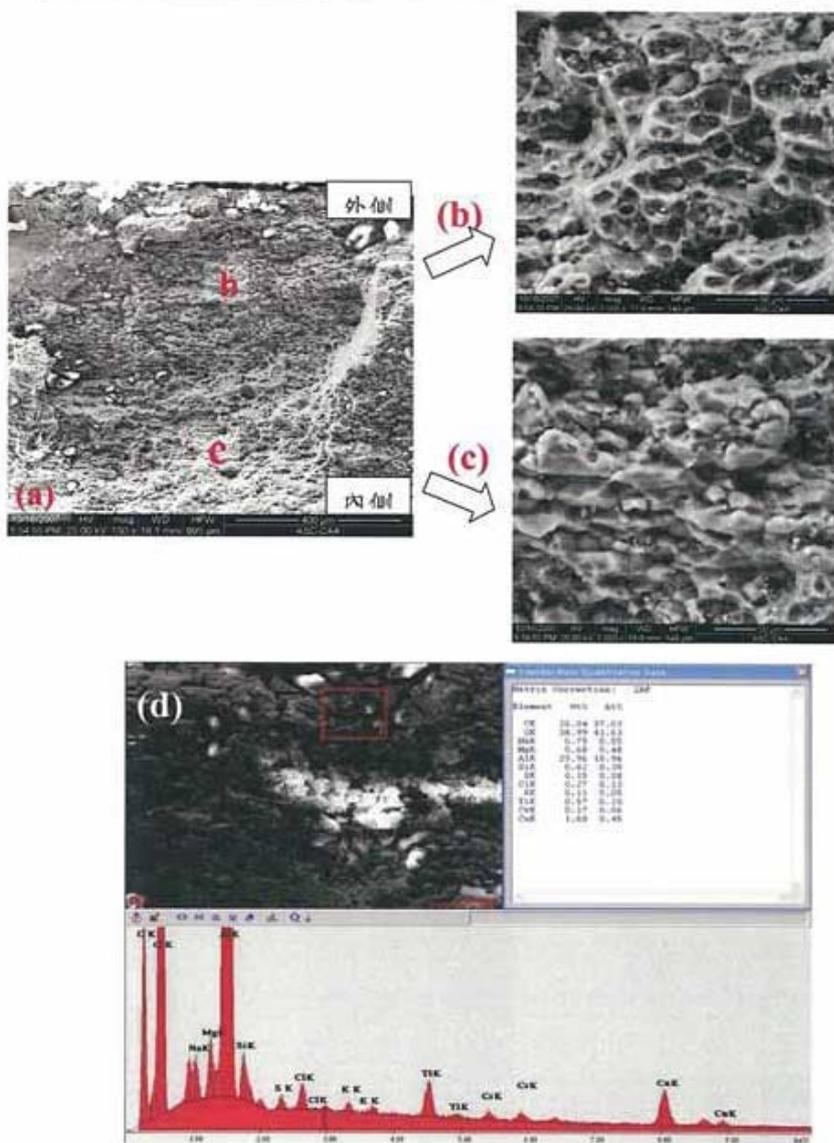
編號 9 號試片斷面之電子顯微鏡觀察結果如圖 15，在蒙皮厚度方向可以清楚區隔為兩個斷面特徵(如圖 15(a))，靠蒙皮內側的斷面顯現的是延晶破裂的模式(如圖 15(b))，而靠蒙皮外側的斷面則顯現強制破裂的模式(如圖 15(c))，前者為主要破斷因素，所佔之面積遠較後者為廣。為了確認延晶破壞以及破斷面表面覆蓋物質與腐蝕之關聯性，以掃描式電子顯微鏡能量散佈光譜(SEM/EDS)分析該等物質之組成，結果如圖 15(d)，顯示除了一般可能來自於外界之污染物質之外，還有少許之氯(Cl)元素，氯是造成鋁合金腐蝕的重要元素，不過考量儀器之精確度以及可能來自大氣環境影響的因素，將另以離子層析儀來檢定其腐蝕物型態。

圖 15、編號 9 號試片 SEM/EDS 下之破斷面微觀特徵觀察。

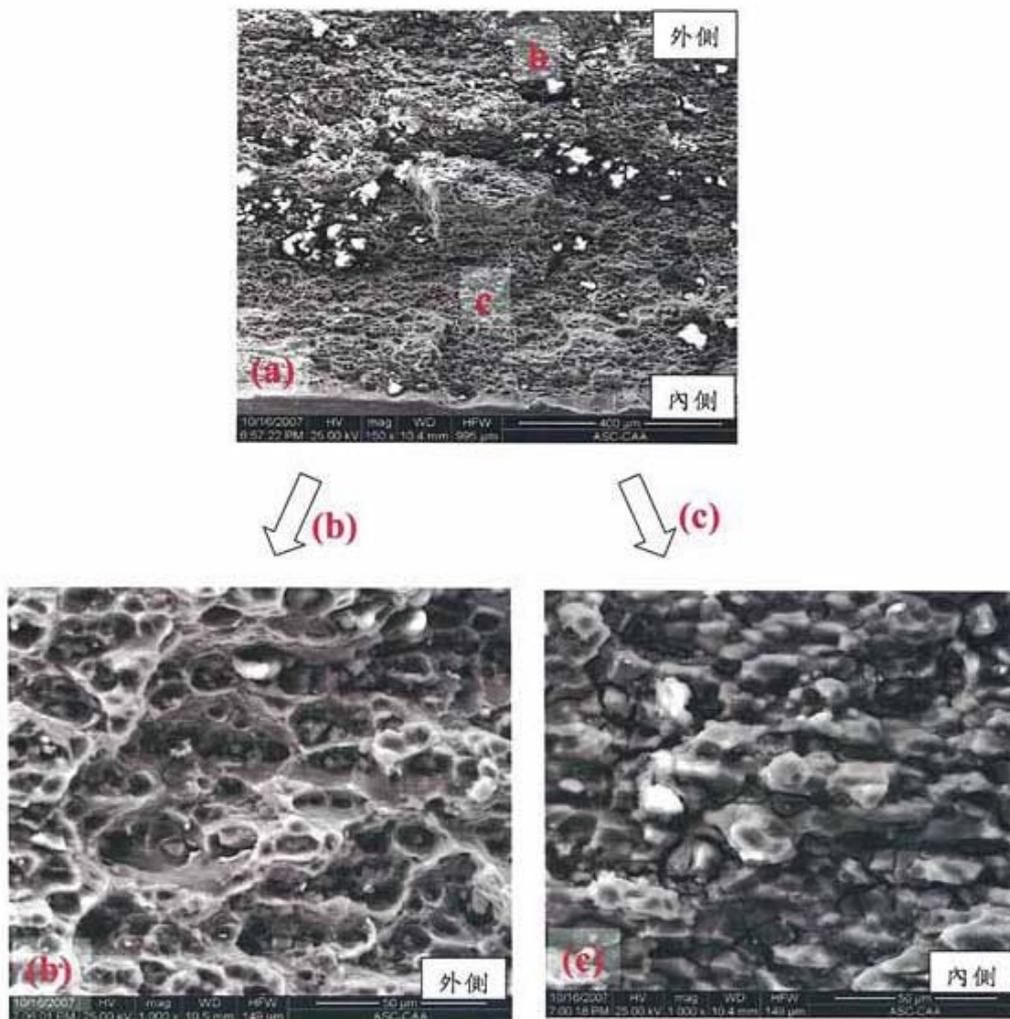
編號 5 號試片斷面之電子顯微鏡觀察結果如圖 16，整個斷面之形貌與前述 9 號試片完全相同。另外再選擇靠蒙皮內側之一處已經剝離之表面來觀察，其破斷特徵如圖 17，顯示同樣為極典型之延晶破壞之模式，顯見這一種破裂模式由蒙皮內側表面往蒙皮厚度方向不斷成長延伸，直到受力面積不足以承受負載後，產生過載破壞(Overload)，並於殘存面積遺留下凹渦特徵(Dimples)，如圖 16 之(b)圖所示。另由

圖 16、編號 5 號試片 SEM 下之破斷面微觀特徵觀察。

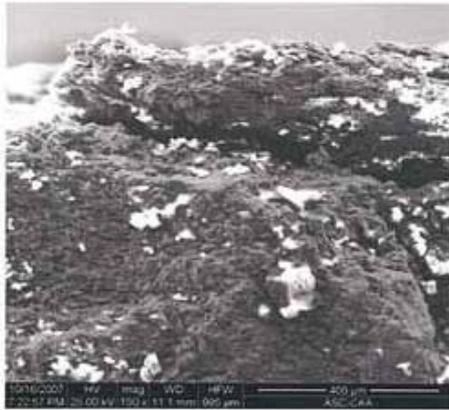
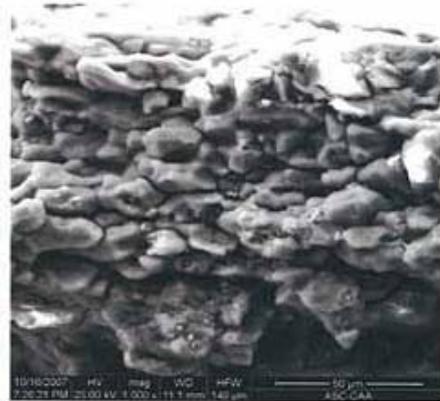
圖 17、編號 5 號試片鄰近內側表面之破斷面微觀特徵觀察。

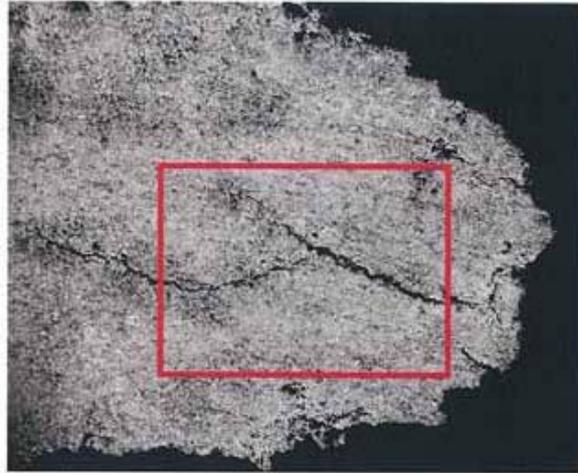
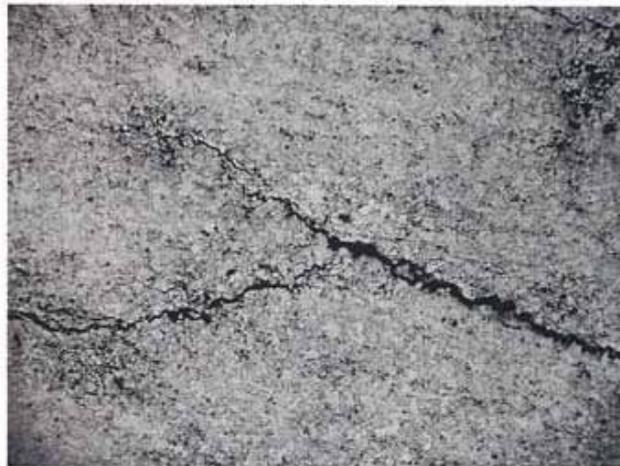
圖 20~圖 22 分別為編號 4 蒙皮裂紋 L 方向和 T 方向的剖面金相觀察，無論從 L 方向或 T 方向觀察均能發現明顯的沿晶裂紋，且其內面外緣的孔蝕從 T 方向觀察更明顯。

圖 20、編號 4 試片 L 方向剖面金相觀察。

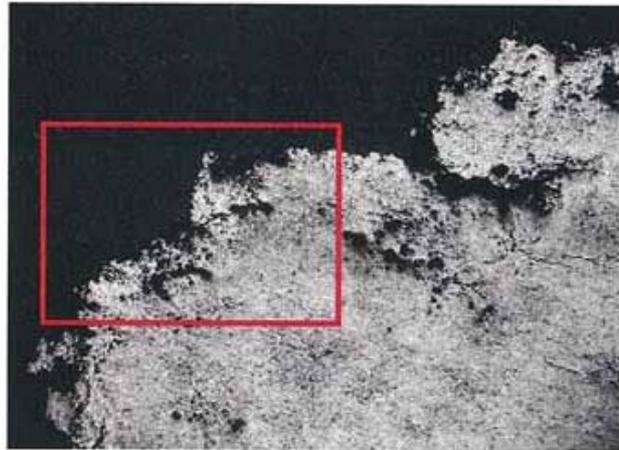
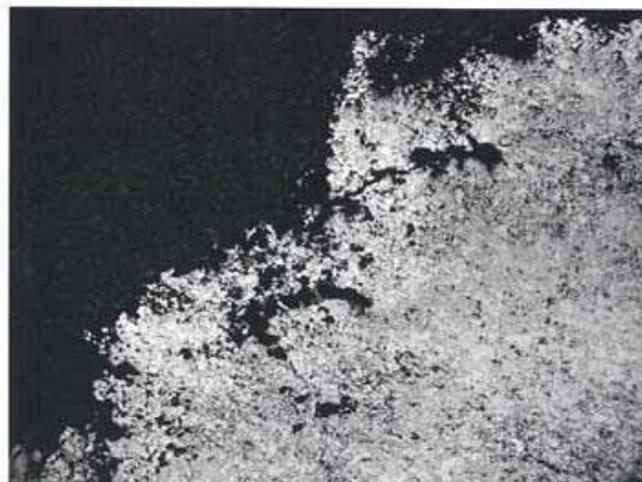
圖 21、編號 4 試片 L 方向另一處剖面金相觀察。

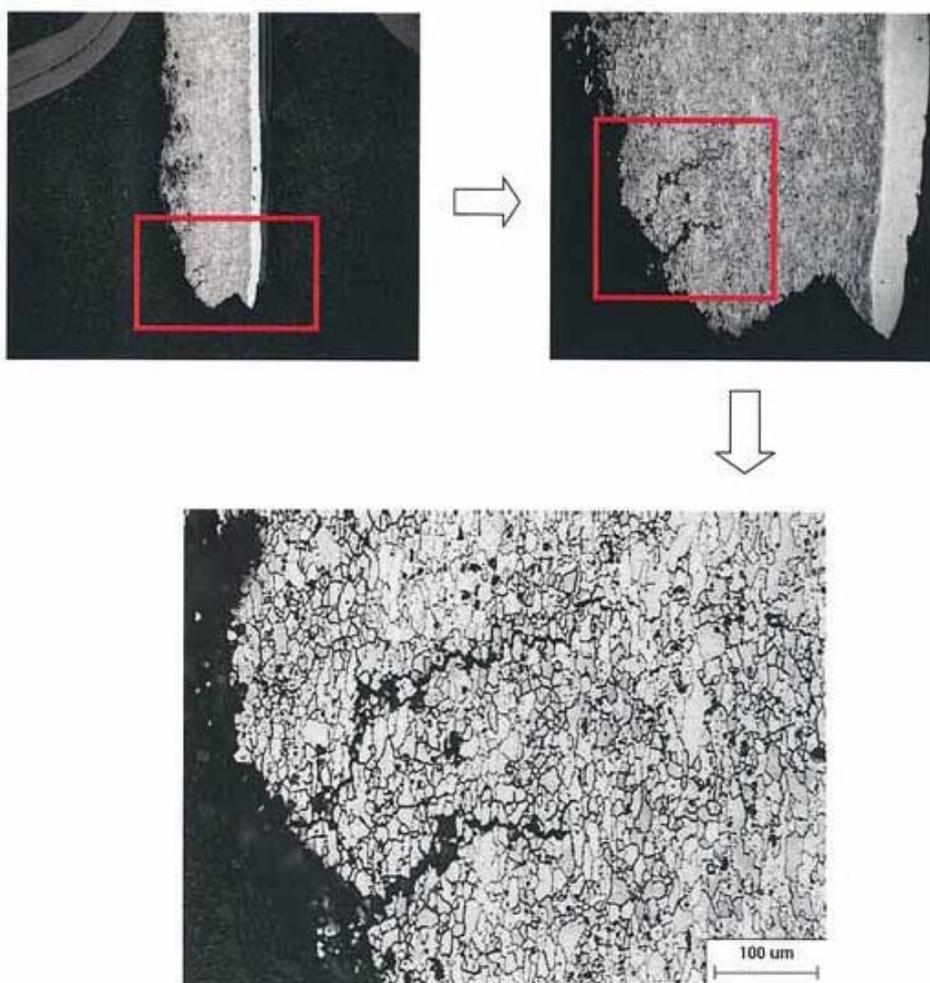
圖 22、編號 4 試片 T 方向剖面金相觀察。

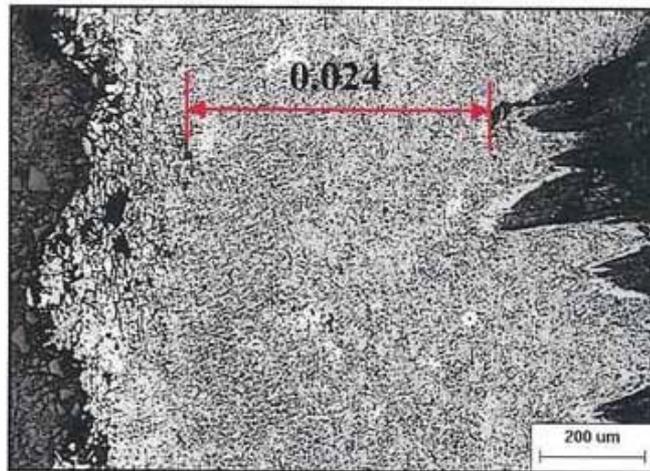
圖 27~圖 30 分別為編號 1、4、7、10 蒙皮裂紋 T 方向的殘存基材厚度量測結果，編號 1 為 0.024 英吋 (604 μm)、編號 4 為 0.019 英吋(494 μm)、編號 7 為 0.023 英吋(584 μm)、編號 10 為 0.024 英吋(615 μm)。(另加鍍鋁層厚度量測值以作為結論之依據)

圖 27、編號 1 試片 T 方向的腐蝕殘餘厚度量測結果。

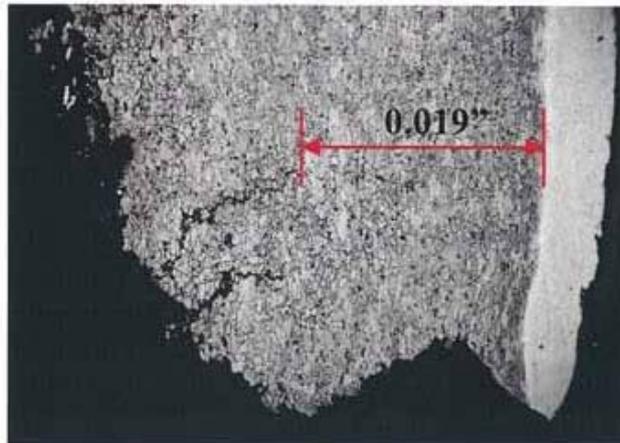
圖 28、編號 4 試片 T 方向的腐蝕殘餘厚度量測結果。

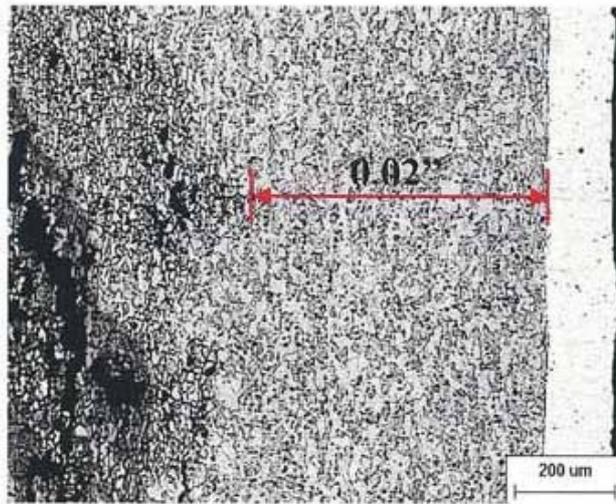
圖 29、編號 7 試片 T 方向的腐蝕殘餘厚度量測結果。

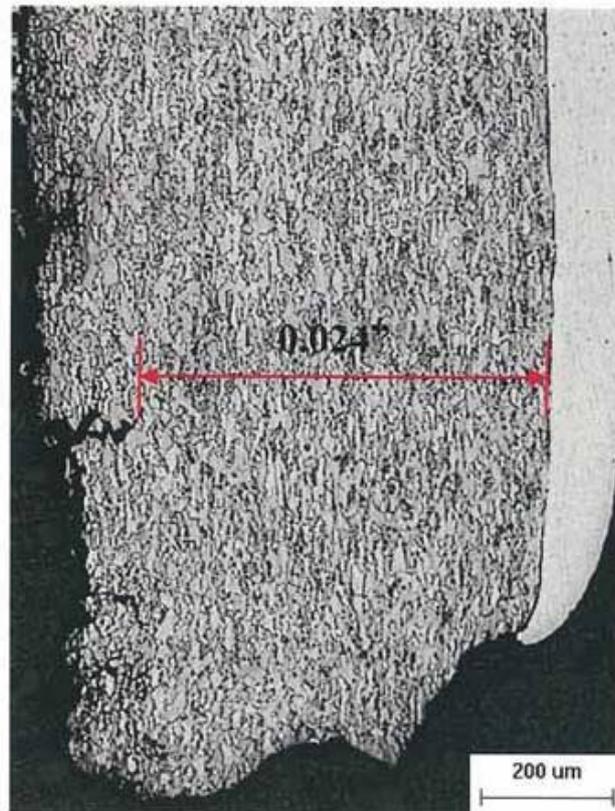
圖 30、編號 10 試片 T 方向的腐蝕殘餘厚度量測結果。

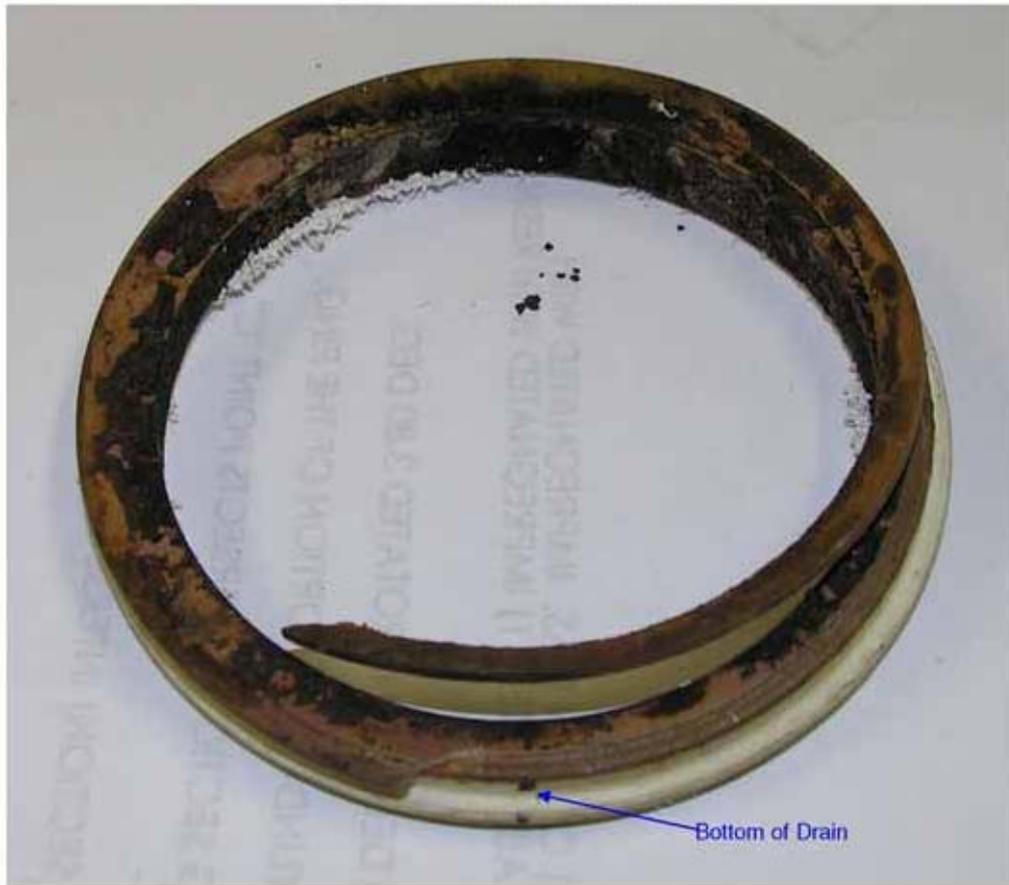
Figure 1 – S/N 09-00-777 after removal

The forward flange is broken in one location, on the bottom of the fitting (figures 1, 2, and 9). The flange is cracked over 200 degrees, from 20 degrees to 220 degrees. The remaining flange is also bent forward at 320 degrees as shown in cross -section DD. One end of crack is still white, near cross-section CC.

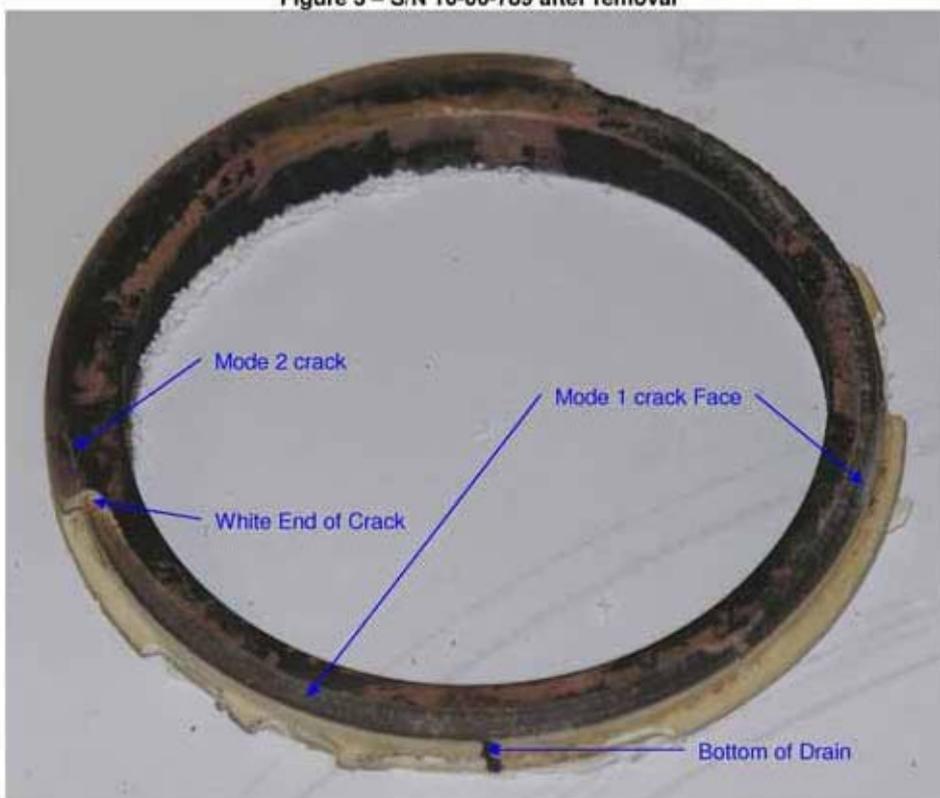
Figure 3 – S/N 10-00-789 after removal

end of the cracked flange is white, as can be seen in figure 3. The mode 1 crack face has one large notch centered at 140 degrees.

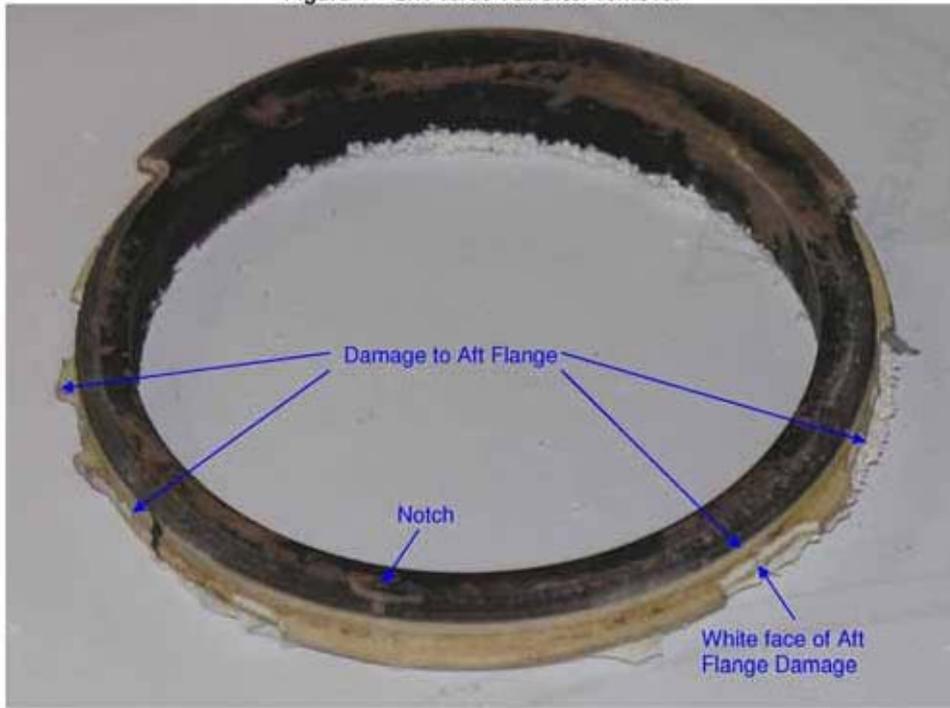
Figure 4 – S/N 10-00-789 after removal

3). The ends of the crack are white in two of the 3 fittings. Notches, as labeled in figures 4 and 5, are seen in the concentric ridges on the crack face in 2 of the 3 drains investigated. Failure crack mode 2 is less common but distinctly different than crack mode 1. Crack mode 2 begins at the forward surface of the fitting and progresses inwards towards the corner of the o-ring groove (figure 8).

The relative smoothness of the mode 1 crack faces in the forward flange, combined with the small concentric ridges or "beach marks", all suggest a fatigue failure mode. The notches in the mode 1 crack faces, as seen in SN 10-00-789 figure 4 and SN 04-02-1226 figure 5, suggest the forward flange cracks contained more than one segment. These segments may have started independently of each other and grown into one large crack, started successively with one cascading into the next, or started simultaneously. Regardless of the timeline of the segments, the complexity of the mode 1 crack line indicates a complex loading situation. The mode 2 cracks in the forward flange are a distinctly different failure method. This failure method occurs in close proximity to the ends of mode 1 cracks, suggesting a pinch or pivot point.

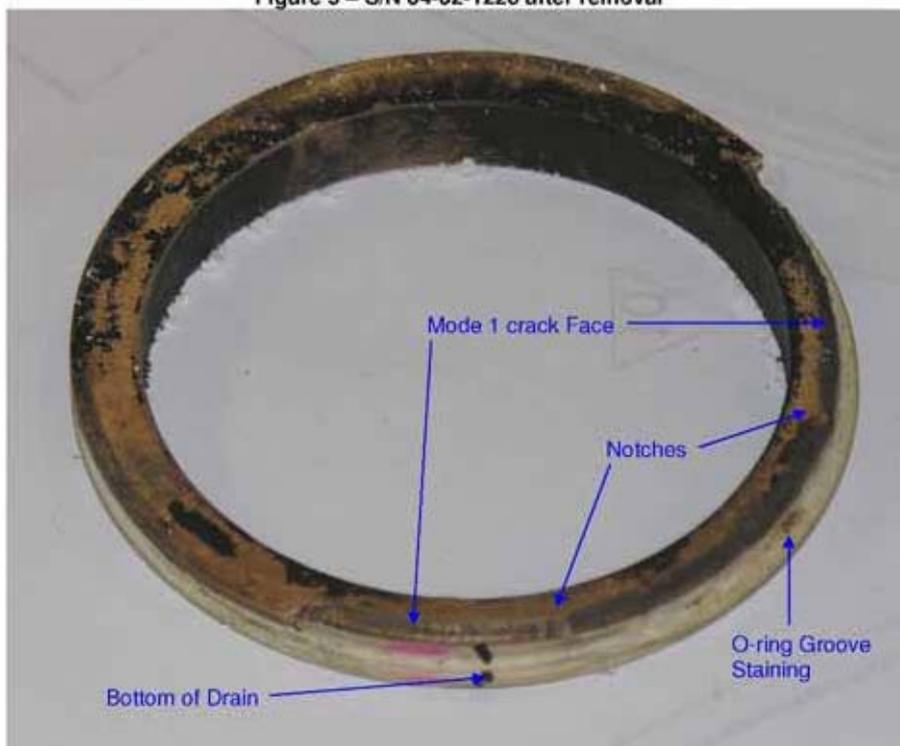
Figure 5 – S/N 04-02-1226 after removal

The o-ring groove is discolored in spots, as shown in figure 5 and figures 9 through 11. The majority of the discoloration is not in the area of forward flange cracking indicated in figure 7.

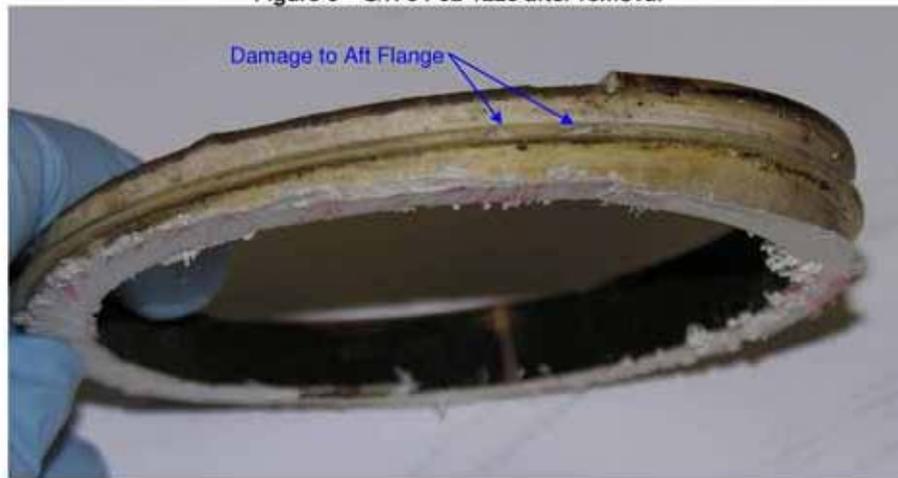
Figure 6 – S/N 04-02-1226 after removal

The aft flange is intact, although there is evidence of damage (figure 6). The aft flange varies in thickness, as seen in the measurements listed above. The edge of the flange is rounded, most noticeably at the top centered at 345 degrees, which corresponds to the smallest measurement 0.063". The aft flange is also noticeably rounded at 270 and at 115 in the area of the forward flange crack.

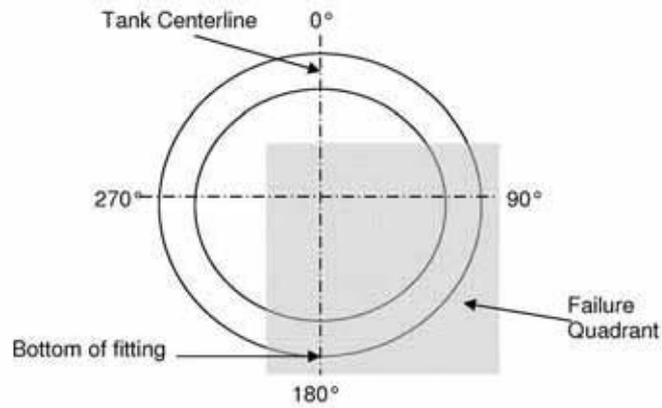
Figure 7 – Common Failure Quadrant

Forward flange is cracked on all three drains, and parts of it are missing in two of the three drains. The cracks occur mostly in the lower outboard quadrant (figure 7) from 70 to 200 degrees. The cracks in the forward flange occur in two different and distinct forms. The most common crack method, from hereon referred to as crack mode 1, is a diagonal crack face beginning at the inside of the o-ring groove and progressing forward and inwards, as shown in figure 8. Failure mode 1 cracks have a dark discolored face, like that of the inside diameter of the fitting. The crack face is relatively smooth and regular, with small concentric ridges (figure

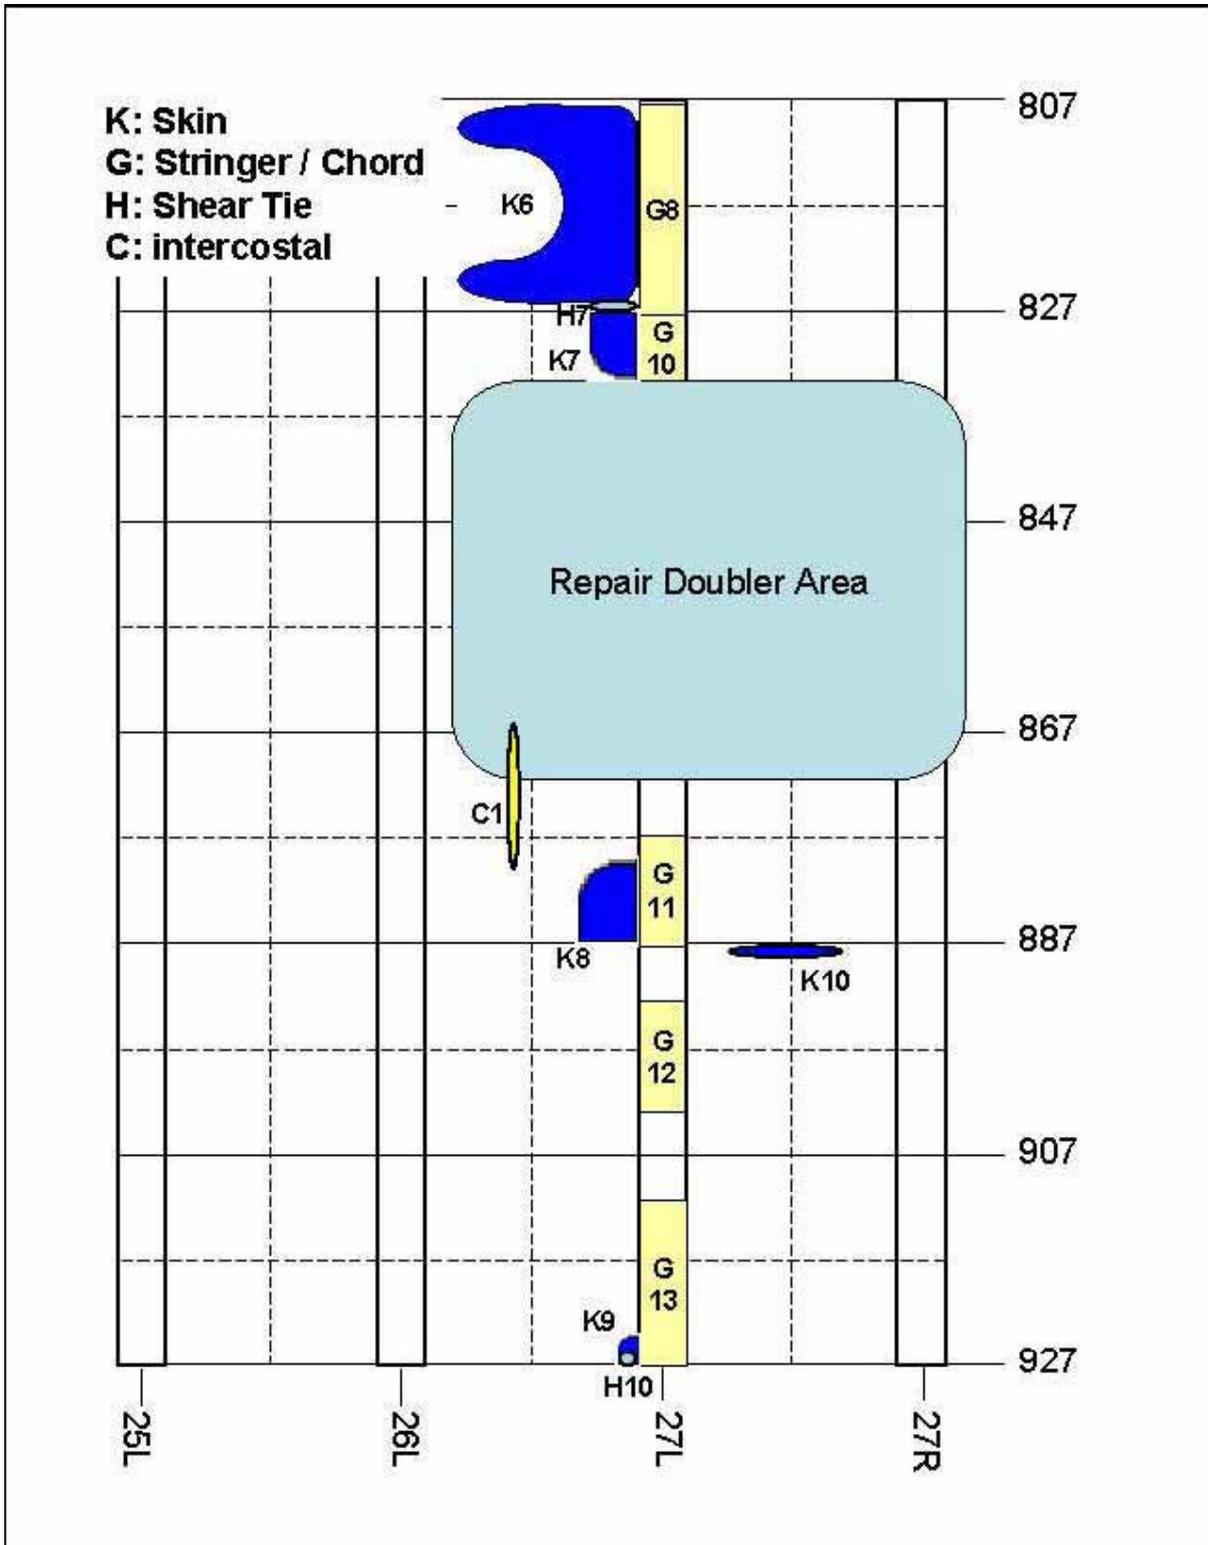
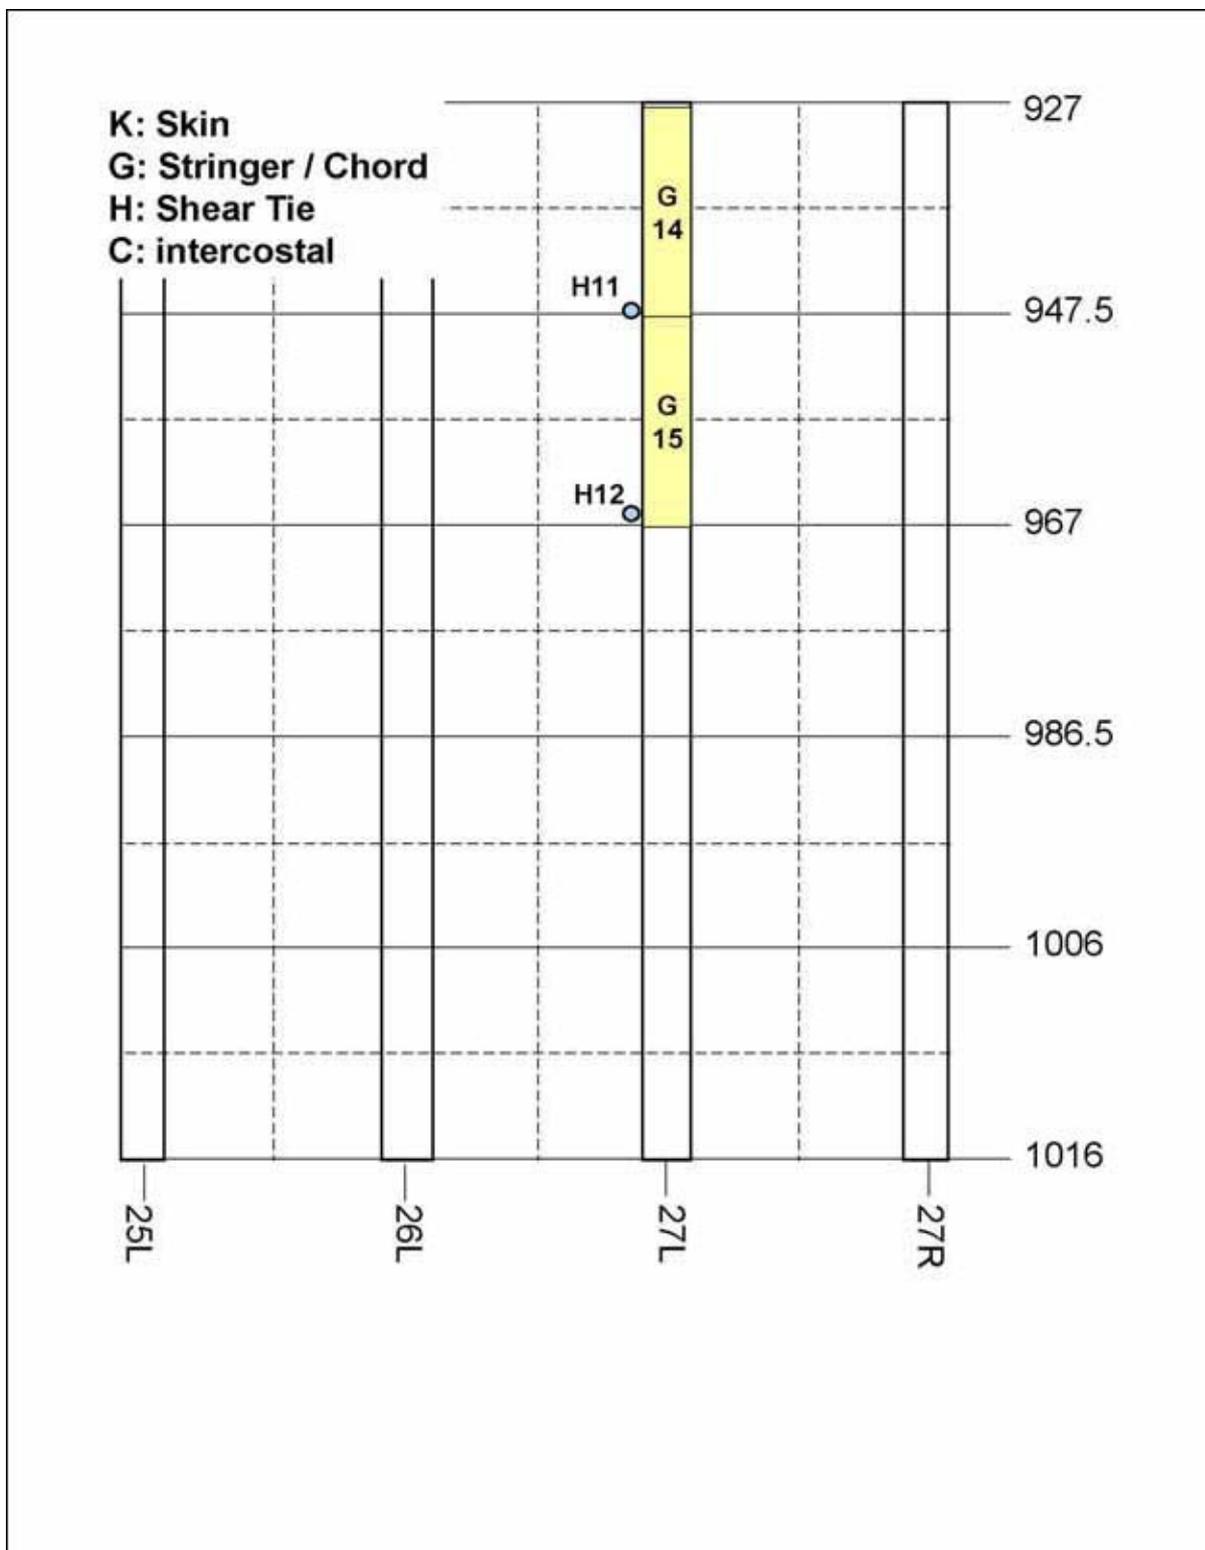
SKIN

ITEM NO.	LOCATION		DIMENSION (INCHES)		MIN. REMAINING THICKNESS (INCHES)
	STA	STRINGER	FWD-AFT DIRECTION	I/B-O/B DIRECTION	
K1	727J - 747	1.5 INCHES O/B OF S-27L	2	1	0.086
K2	727J - 747	1.5 INCHES O/B OF S-27L	9	1	0.060
K3	747 - 767	2 INCHES O/B OF S-27L	20	6	Fwd: 0.053 Aft: 0.055
K4	767 - 787	1 INCHES O/B OF S-27L	20	6	Fwd: 0.054 Aft: 0.055
K5	787 - 807	1 INCHES O/B OF S-27L	20	6	Fwd: 0.057 Aft: 0.040
K6	807 - 827	2 INCHES O/B OF S-27L	20	5	Fwd: 0.051 Aft: 0.042
K7	827 - 847	1.5 INCHES O/B OF S-27L	6	2	0.057
K8	867 - 887	1.5 INCHES O/B OF S-27L	6	2	0.060
K9	907 - 927	1.5 INCHES O/B OF S-27L	2	2	0.057
K10	AT AFT OF 887 FRAME		TBD (尚未開工無法打磨確認)
