# 飛航事故調查報告

ASC-AOR-10-07-001

編號 NA-518

花蓮鳳林馬太鞍溪堤防迫降事故

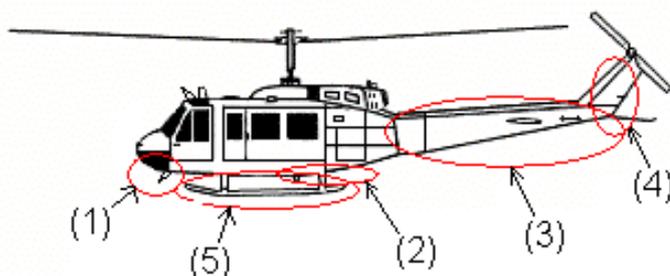
圖 1.12-1 航空器結構損傷區分

航空器結構損傷如圖 1.12-1，概分為 (1) 機鼻下方區域、(2) 機腹、(3) 尾桁、(4) 垂直安定面、(5) 滑橇等五大部分分別敘述。

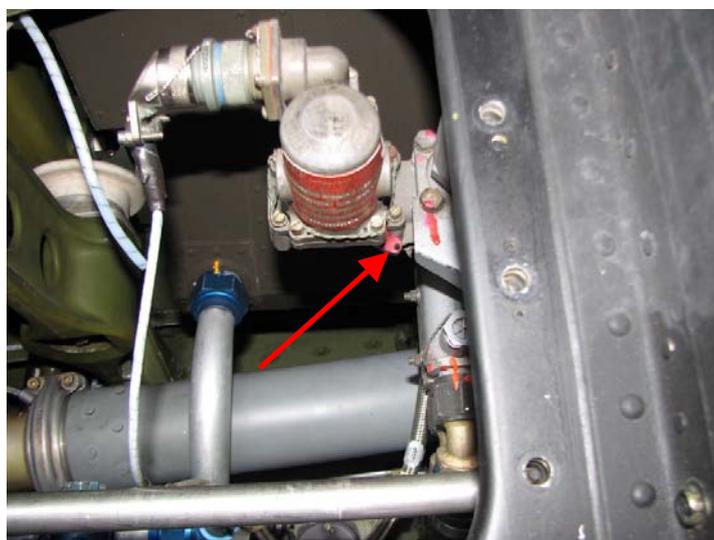
圖 1.16-4 燃油關斷瓣於開啓位置

3. 操作燃油關斷瓣開關，置開關於 ON，耳聞關斷瓣內馬達作動聲響，瓣膜移動至開啓位置 (如圖 1.16-4)，置開關於 OFF，耳聞關斷瓣內馬達作動聲響，瓣膜移動至關閉位置 (如圖 1.16-5)，燃油關斷瓣功能測試結果正常。

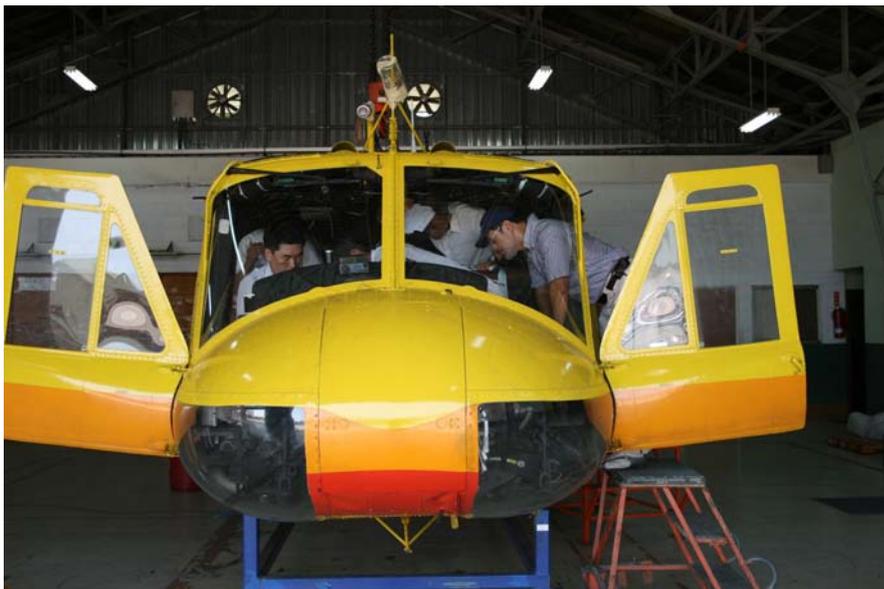
圖 1.16-6 油門桿控制調整之檢查

1.2 油門大俾緩衝減震 (TWIST-GRIP CUSHION) : 5 度

依據技術手冊，限制範圍為  $5 \pm 2$  度，上述調整皆於限制範圍內。

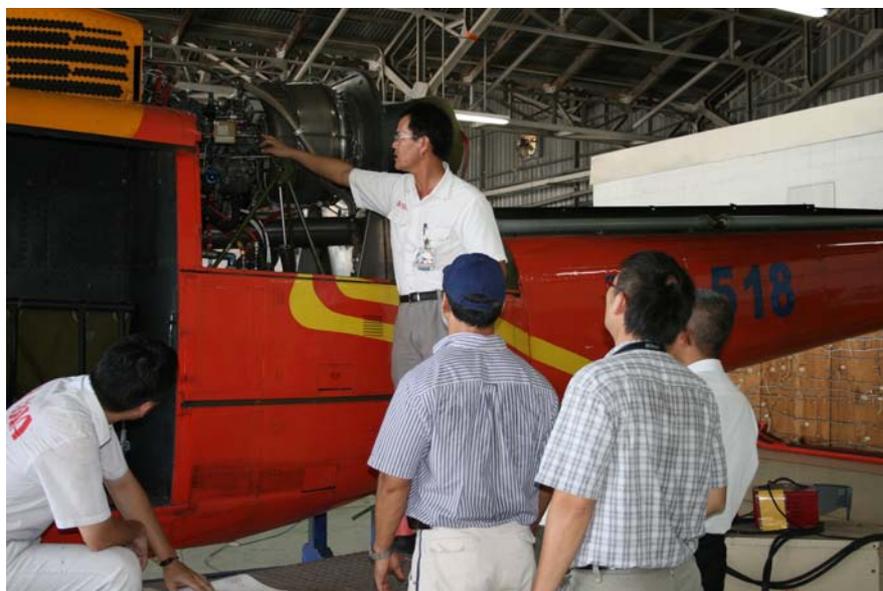
圖 1.16-7 衰降補償控制調整之檢查

- 集體桿全放，線性致動器全開 (COLLECTIVE STICK FULLY DOWN WITH LINEAR ACTUATOR FULLY EXTENDED)：0.010 吋
- 集體桿全收，線性致動器全收 (COLLECTIVE STICK FULLY UP WITH LINEAR ACTUATOR FULLY RETRACTED)：0.006 吋

依據技術手冊，限制行程範圍為 0.01 吋，上述調整皆於限制範圍內。

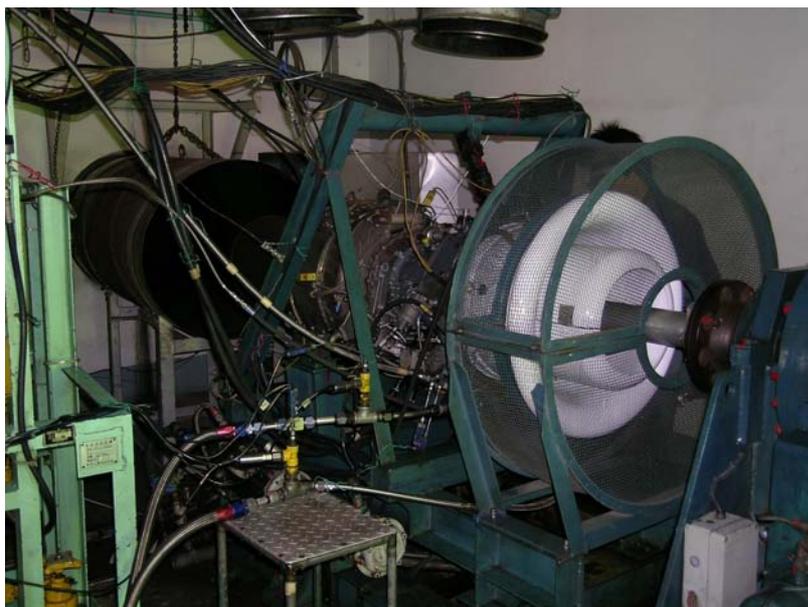
圖 1.16-8 發動機試俾台測試

民國 97 年 7 月 15 日，由飛安會、空勤總隊及亞航代表組成之調查小組，於亞航發動機試俾台進行事故機發動機功能測試 (如圖 1.16-8)。亞航測試結果該發

動機動力輸出無異常，測試紀錄詳附錄 2。直升機製造廠貝爾公司不克參與發動機測試現場，調查小組檢附該發動機測試紀錄寄交貝爾檢視，貝爾函覆該測試未發現該組件可能造成動力喪失之相關異常現象，並提供發動機故障排除流程 13 為後續處置參考（詳附錄 3-1）。

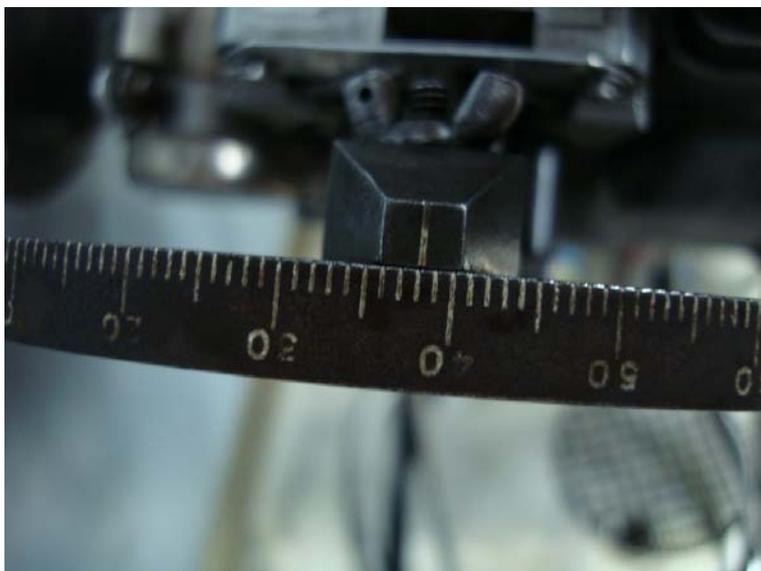
圖 1.16-9 油控器功能測試

民國 98 年 1 月 8 日，飛安會、空勤總隊及亞航代表組成之調查小組，於亞航調速器工場進行事故機油控器（詳圖 1.16-9）及超速調速器（詳圖 1.16-10）功能測試。結果該油控器及超速調速器功能無異常，測試紀錄詳附錄 4 油控器功能測試紀錄，及附錄 5 超速調速器功能測試紀錄。

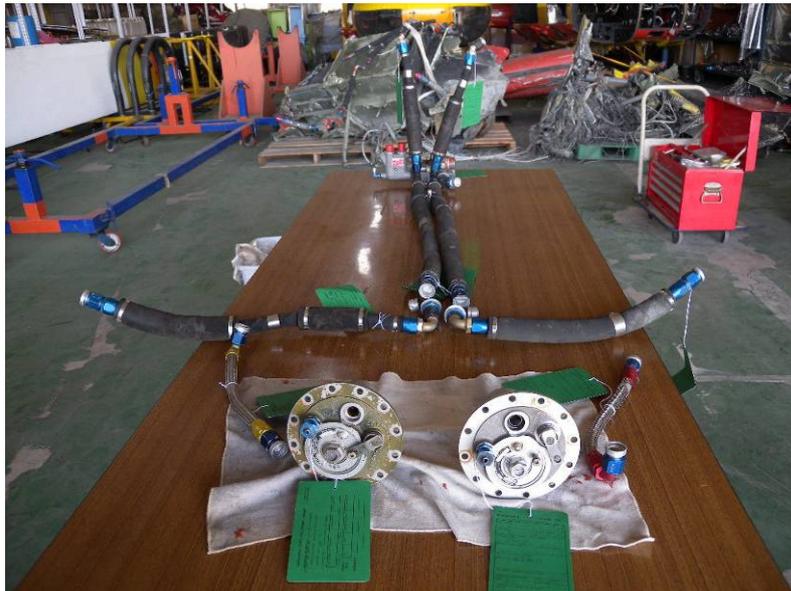
圖 1.16-11 燃油增壓泵及燃油供應管配置圖

民國 98 年 10 月 8 日，飛安會、空勤總隊及亞航代表組成之調查小組於亞航公司直升機棚廠進行事故機燃油系統裝備檢測，燃油加壓系統之加壓泵及管路配置（詳圖 1.16-11），計測試燃油增壓泵 2 具及燃油供應管 8 根（詳圖 1.16-12），燃油管經壓力測試結果均無洩漏，測試記錄詳附錄 6。安裝於右側臥式油箱內之燃油增壓泵（料號 1C64-1，序號 8AD2470，）設定 1000 磅／每小時之燃油流量時，測得壓力值為 7 psig，未達額定之 13.0~25.0 psig 範圍，設定 300 磅／每小時

之燃油流量時，測得壓力值為 11 psig，未達額定之 12.5~25.0 psig 範圍；左側燃油增壓泵（料號 1C64-1，序號 4Ak597），設定 1000 磅／每小時之燃油流量時，測得壓力值為 13 psig，達額定之 13.0~25.0 psig 範圍，設定 300 磅／每小時之燃油流量時，測得壓力值為 14.8 psig，達額定之 12.5~25.0 psig 範圍，測試結果正常，兩具增壓泵測試紀錄詳附錄 7。

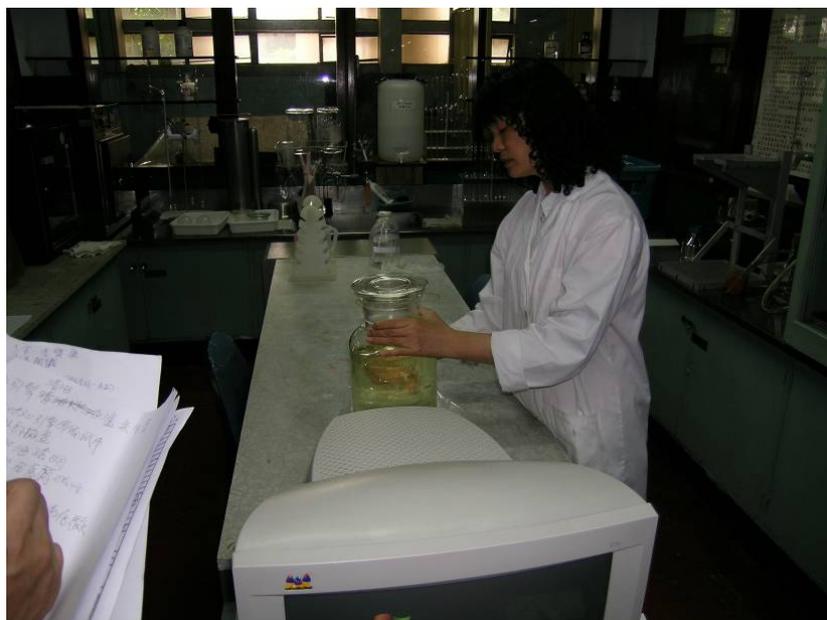
圖 1.16-13 燃油化驗

事故機於事故發生時所使用之燃油經取樣委亞航公司化驗（如圖 1.16-13），化驗結果為合格，化驗記錄詳附錄 8。

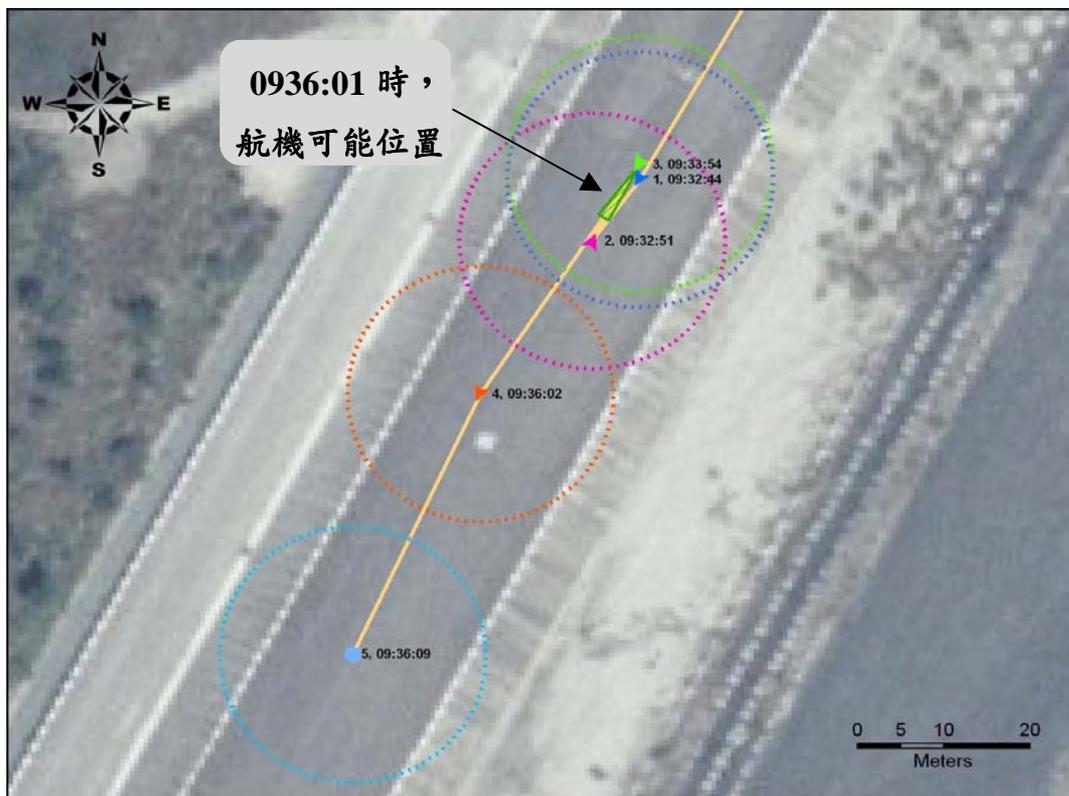
圖 2.1-1 最後 5 筆 GPS 航跡變化圖

<sup>8</sup> GPS 接收機每秒依據速度及航跡角產生一預估位置，並與當下 GPS 位置及軌跡角比較，若水平位置及角度差異在原廠設定範圍內，則該時刻之位置不予記錄，此邏輯不考慮高度變化。因涉及原廠設計機密，該設定範圍無法於報告中公布。
