**ASC-AOR-12-04-001**

**中華民國 99 年 12 月 29 日**

**長榮航空公司 BR 61 班機**

**於巡航時兩套供氣系統失效導致艙壓異常**

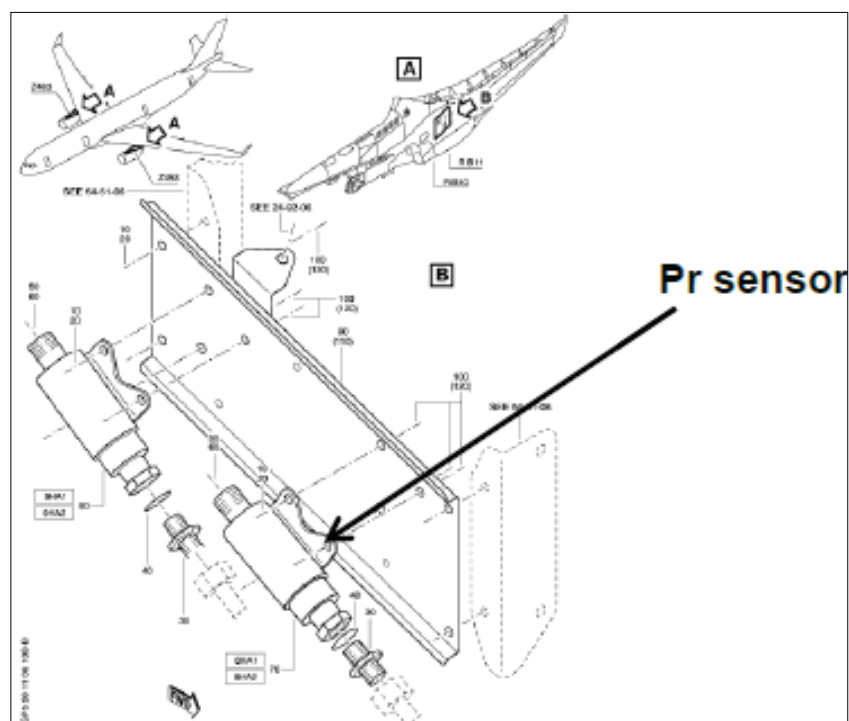
圖 1.6-3 Pr 感測器於 GE 發動機吊艙位置圖

該機裝用 AIRBUS 公司（以下簡稱 AIRBUS）設計製造之 GE 發動機吊艙（PYLON），本事故之故障組件 Pressure Regulated Sensor（壓力調節感測器，以下簡稱 Pr 感測器）詳圖 1.6-2，其於 GE 發動機吊艙中之安裝位置如圖 1.6-3 所示。

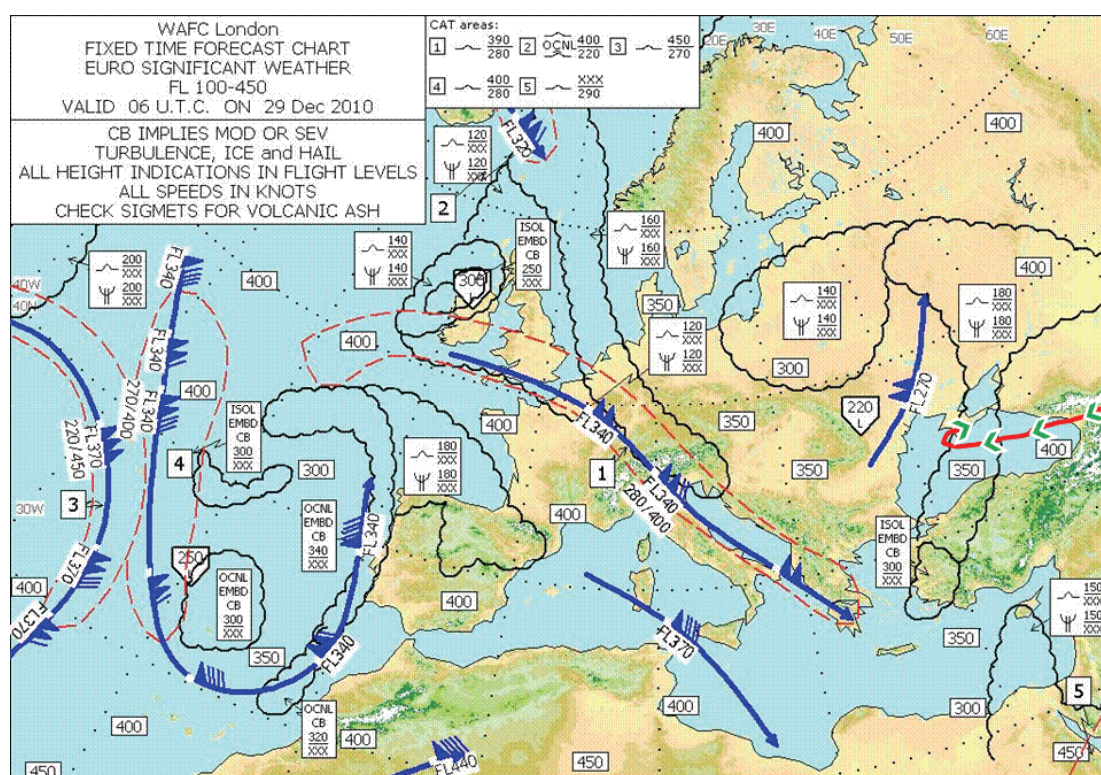
圖 1.7-1 事故當時之顯著危害天氣預測圖

事故當時有一鋒面位於克里米亞半島東南方海面，事故附近區域之雲頂高度約為 30,000 呎；FL400 空層之氣溫約為-65℃、露點溫度約為-69℃，風向約為 240 度、風速約為 60 浬/時。倫敦世界區域預報中心發布之顯著危害天氣預測圖（SIGWX）如圖 1.7-1（紅色線為該機之飛航軌跡），該機於事故附近之航路上無危害天氣。SIP 飛航情報區當天無顯著危害天氣資訊（SIGMET）發布。

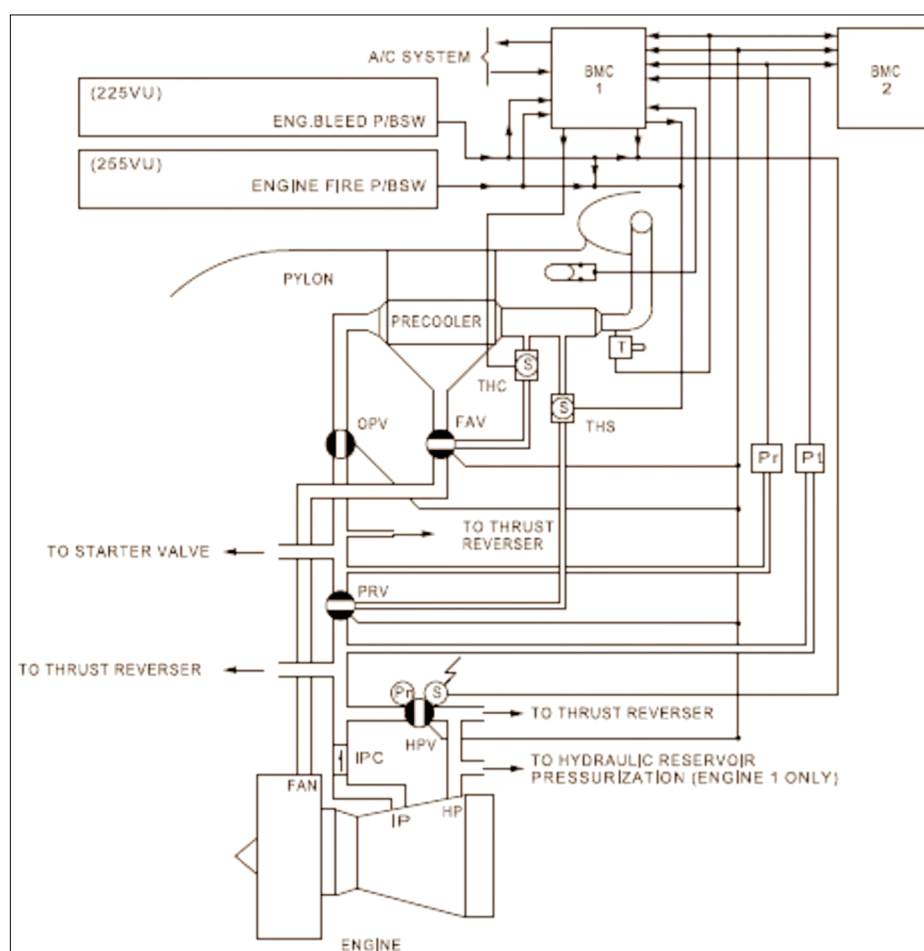
圖 1.18-2 供氣系統概要圖

該 A330 航機供氣系統自動控制功能由兩具供氣監控電腦（Bleed Air Monitoring Computers，BMCs）負責，正常狀況下 1、2 號供氣系統各由 1 具 BMC 負責監控，供氣系統概要詳圖 1.18-2。
