飛航事故調查報告

ASC-AOR-12-03-001

長榮航空公司BR 757班機

於桃園機場落地時短暫偏離跑道

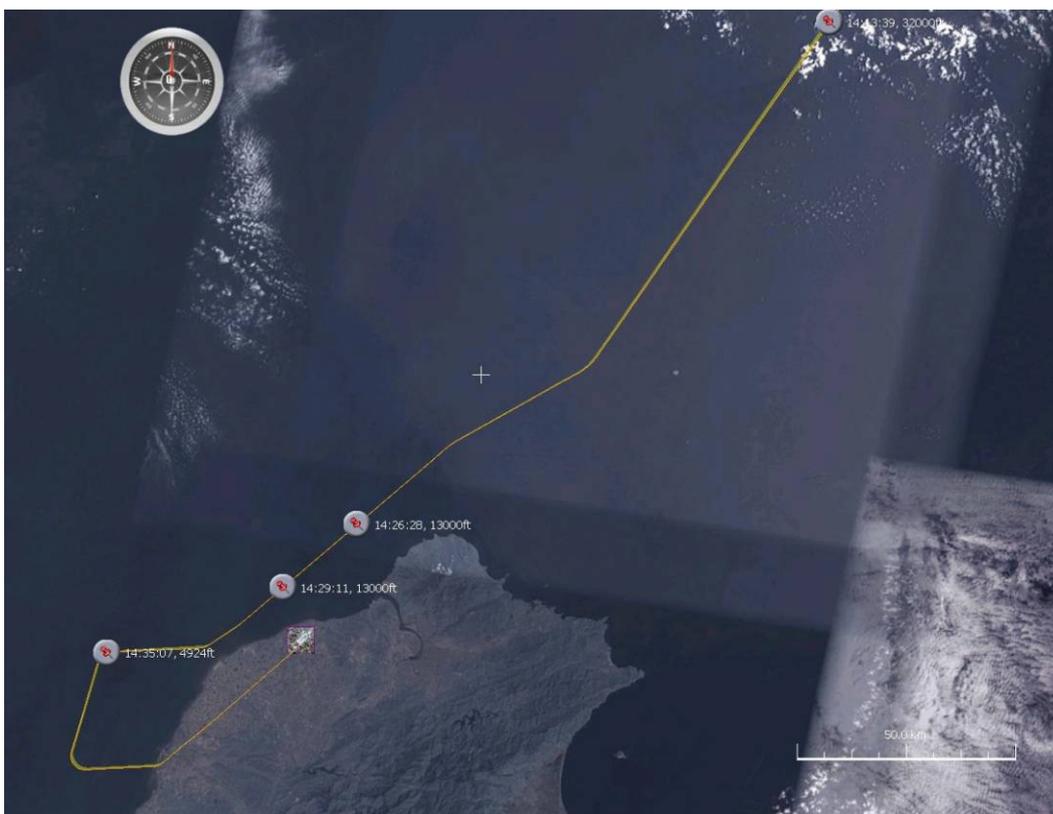
圖 1.1-1 飛航軌跡圖²

該機約於 2200 時與臺北區管中心取得聯繫，獲准開始下降至 32,000 呎。約於 2206 時飛航組員開始執行進場提示，內容為使用跑道狀況、天氣狀況、最後進場定位點（Final Approach Fix, FAF）高度、決定高度（Decision Altitude, DA）及誤失進場（Miss Approach）程序等。約於 2218 時，該機獲許可下降，依據座艙語音紀錄器（Cockpit Voice Recorder, CVR）資料，於下降過程中飛航組員曾討論目視地面情形，覺得可目視部份地面、機場航廈及海岸線，但靠海邊天氣較差，低空有霧濛濛之現象。該機約於 2240 時到達 4,000 呎，並保持該高度開始轉向進場邊（該機至落地前之飛航軌跡如圖 1.1-1）。

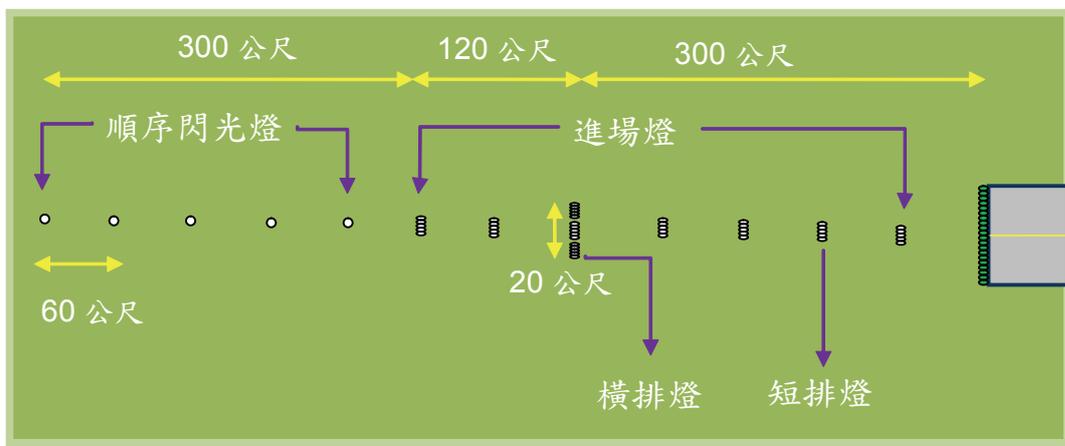
圖 1.10-2 06 跑道進場燈光系統示意圖

桃園機場 06 跑道頭燈計 21 盞，間距 3 公尺，綠色定光燈，無翼排燈；跑道進場燈為美國聯邦航空總署（Federal Aviation Administration, FAA）規範⁸之簡易式高亮度進場燈光系統，配有跑道對正指示燈（Simplified Short Approach Light System with Runway Alignment Indicator Lights, SSALR），長 720 公尺。由跑道頭起沿中心線延長線起，每 60 公尺置 1 組短排燈（5 個白色定光燈，寬 4.3 公尺）共 7 組，其中跑道頭中心線延長線 300 公尺處之短排燈，其左右各加置 1 組橫排燈（5 個白色定光燈）（該排進場燈總寬度 20 公尺，橫排燈與中心線短排燈間距約 3.6 公尺），光亮度可 5 段調控；沿跑道頭起中心線延長線 420 公尺處至 720 公尺處，每 60 公尺置 1 白色順序閃光燈共 5 盞，閃光燈頻率 2 次/秒，光亮度可 3 段調控，06 跑道進場燈光系統示意圖如圖 1.10-2 所示。

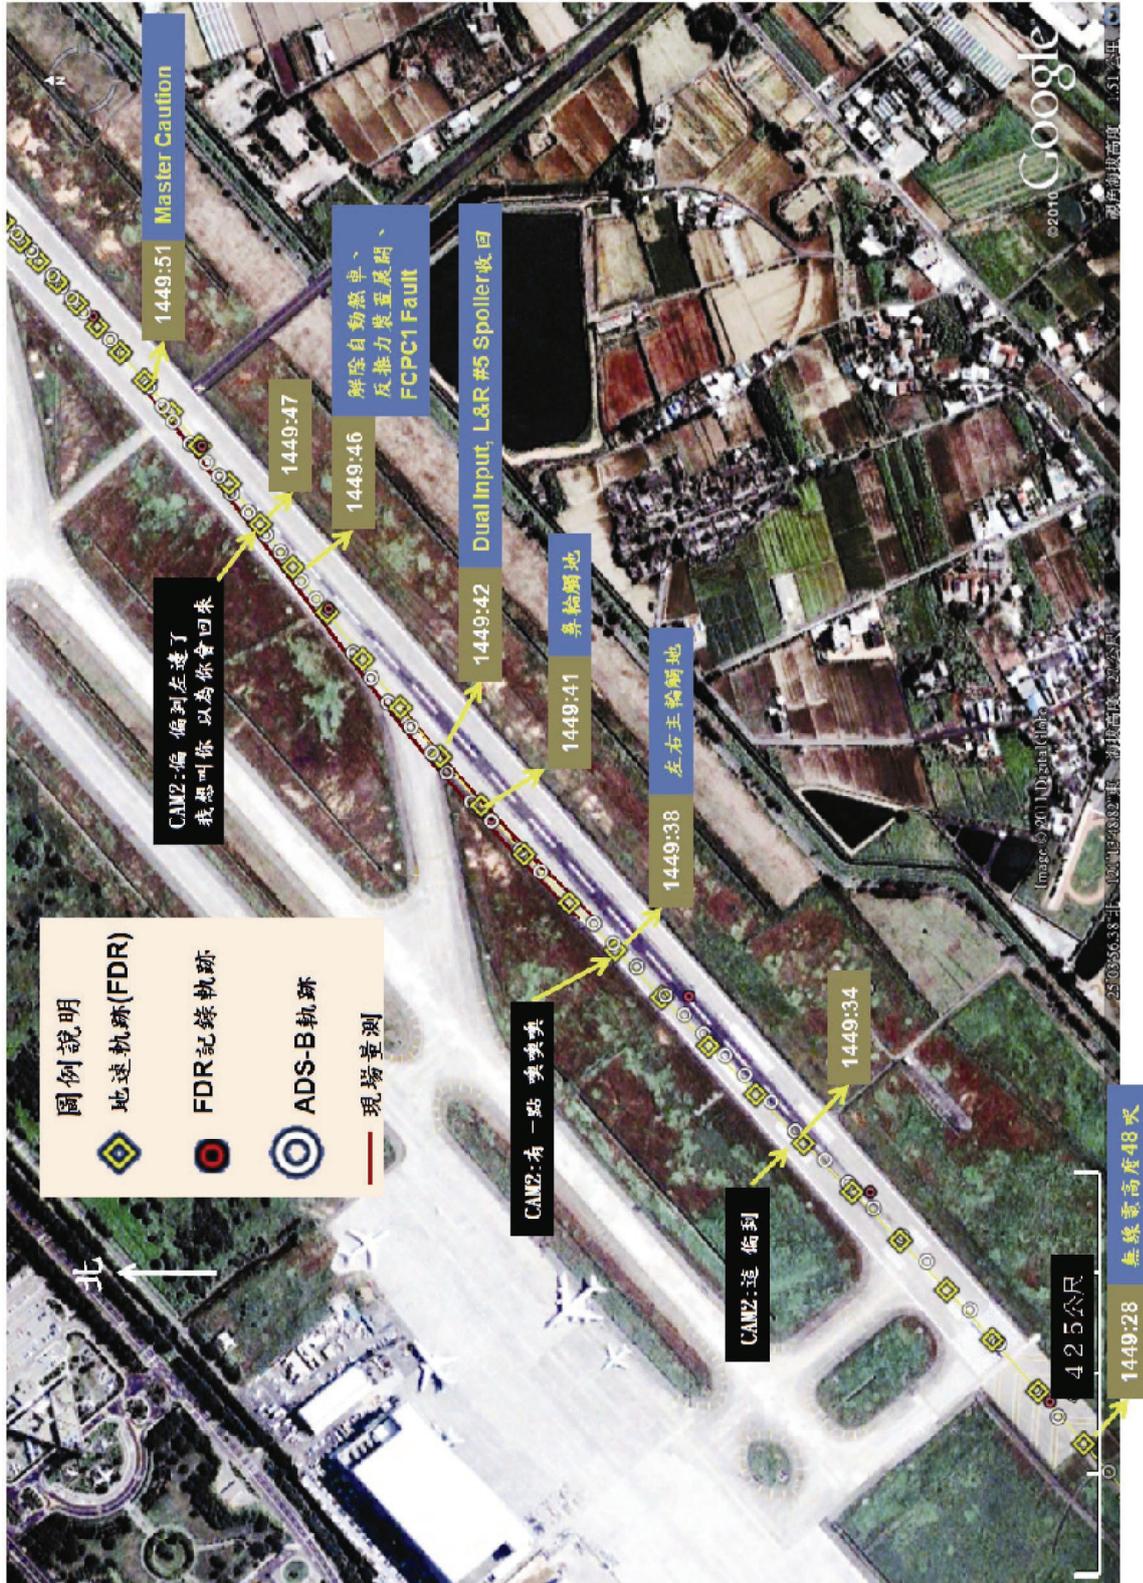
圖 1.11-5 落地軌跡整合圖

落地方式原先就預劃使用手飛落地 (Manual landing)，進場過程航機有些偏左而正駕駛員也有修正，直到低高度約 30、40 呎發現持續偏左，有提醒正駕駛員偏左，感覺正駕駛員有修正，但當時已非常接近著陸。副駕駛員認為當時如用舵修正應可將航機修正回正常落地範圍，但提醒正駕駛員沒多久，飛機已著陸，即便懷疑可能接近跑道邊，但好像也來不及呼叫重飛，當時之時間點很難拿捏，但可確定當時是在靠近跑道邊燈附近落地，滾行時機長也把飛機修正回來，但聽到飛機後側有不正常碰撞聲音，回到跑道中心線上停下來後，正駕駛員懷疑撞到東西，因怕後面飛機進來，立刻告知塔臺跑道上可能有外物恐造成落地航機損傷。之後塔臺問可否滑出跑道，於是檢查輪胎胎壓及溫度均正常，且於落地時並無顛簸現象，於是慢慢經由 S6 滑行道滑出，因不確定飛機及輪胎受損情況是否適合滑行，便要求停機檢查。塔臺同意停於 SP 滑行道並派人檢查跑道，停妥後保持當時外型通知公司派員檢查，之後塔臺指示飛機原地關車等拖車。落地後 ECAM 曾出現「PRIM 1 FAULT」之訊息，但隨後即消失並未影響滑行操作。

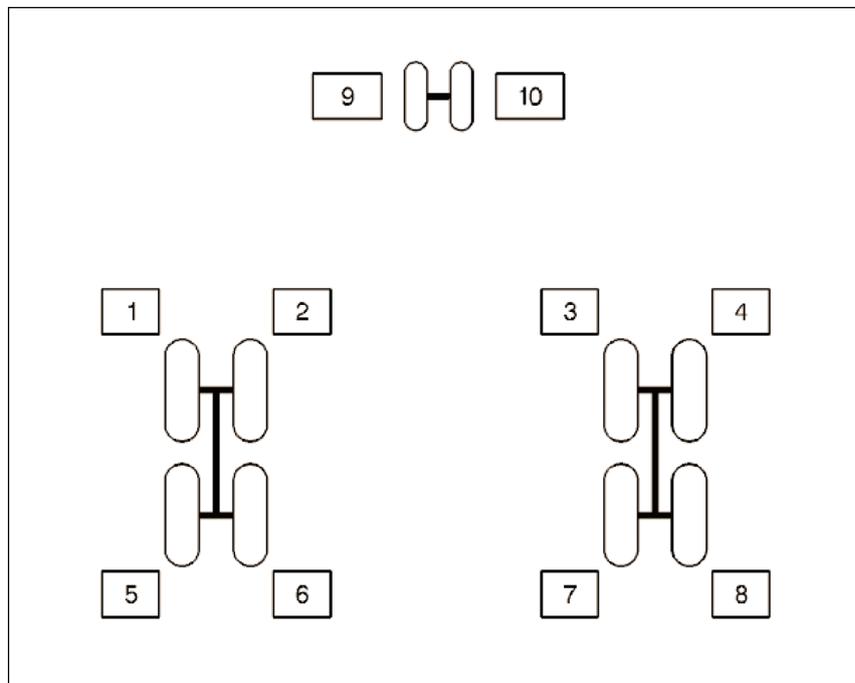
圖 1.12-3 A330 鼻輪與左右主輪編號

- Page0087 Item no.1 : *SUSPECT FOD ON TOUCH DOWN, Action taken: 1. IAW AMM 05-51-24-200-801-A REV.33 INSPECTION FND No.5 MAIN TIRE SIDE CUT & OTHER CONDITION NML 2. REF FLT LOG PAGE 88-1 REPLACED #5 MAIN TIRE/WHEEL ASSY.* (譯:落地時懷疑有外物損傷飛機。採取作為: 根據飛機維護手冊 05-51-24- 200-801-A REV.33 檢查發現 5 號主輪輪邊割傷，其他情況正常。參考 88 頁第一項更換 5 號主輪組件)
- Page0087 Item no.2: *DURING DAILY CHK FND L/H NOSE TIRE WORN-OUT, Action taken: 1. IAW EVA JOB CARD No. 32062X REV.06 REPLACED L/H NOSE TIRE & SVC TIRE PRESSURE TO 190 PSI & PFM AIR LEAK CHK NO AIR LEAKAGE FND & PFM ROTATION CHK NML* (譯: 過夜檢查時發現左鼻輪磨耗。採取作為:根據長榮航空工單號碼 32062X REV.06 更換左鼻輪，胎壓打氣至 190 磅/吋² (PSI)，檢查無漏氣，旋轉檢查正常)

■ 頁碼 0088 Item no.1 : *DURING DAILY CHK FND No.5 MAIN TIRE SIDE-CUT, Action taken: IAW EVA JOBCARD No.:32063X REV.14 REPLACED No.5 MAIN TIRE/WHEEL ASSY & CHK BRAKE ROTATED DISTANCE B IS 3.0 MM & SVC TIRE PRESSURE TO 215 PSI & PFM AIR LEAK CHK NO AIR LEAKAGE FND & PFM RRRTATION CHK NML* (譯:過夜檢查時發現 5 號主輪輪邊割傷。採取作為: 根據長榮航空工單號碼 32063X REV.14 更換 5 號主輪組件, 剎車旋轉距離 B 是 3.0MM, 胎壓打氣至 215 磅/吋² (PSI), 檢查無漏氣, 旋轉檢查正常)

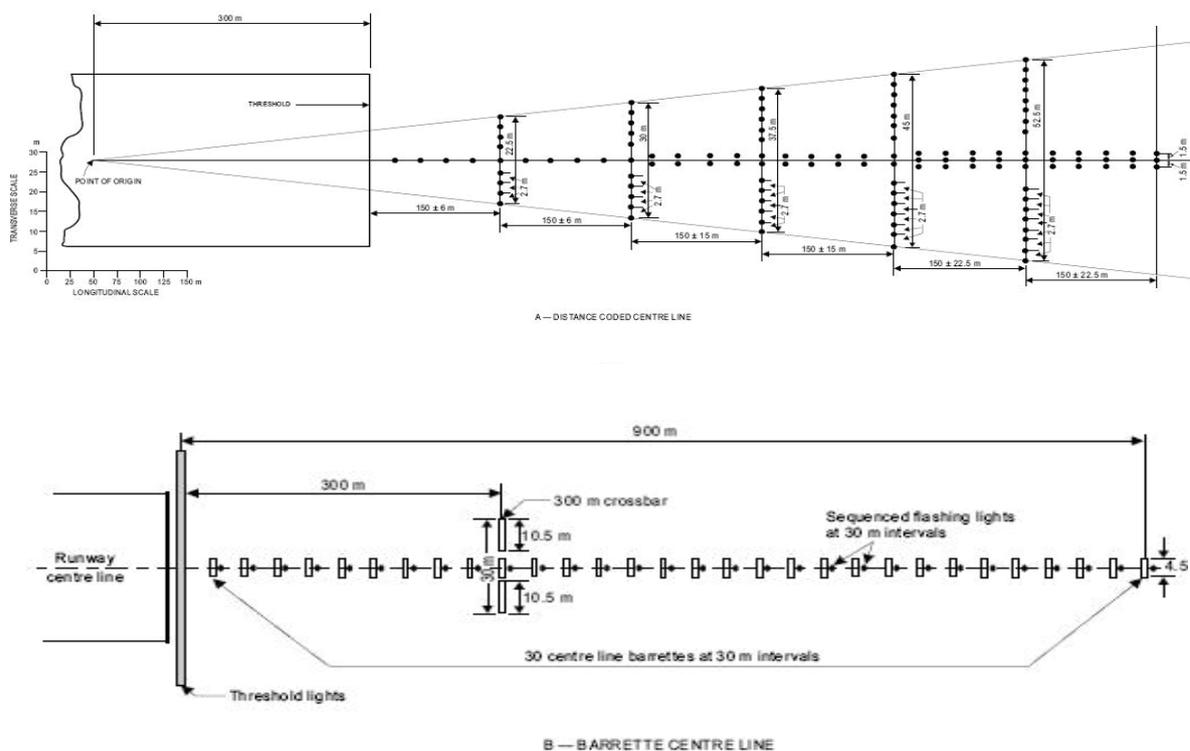
圖 2.4-1 ICAO 第 I 類進場燈光系統

比較上述 2 進場燈光系統，以提供駕駛員進場時之目視參考而言，本會認為：國際民航組織所提供第 I 類進場燈光系統，其長度及配置應較美國聯邦航空總署 SSALR 為佳。桃園機場雖因部份土地取得困難，而需採用美國聯邦航空總署相關規定，限縮進場燈光系統的長度及配置樣式，惟我國國際機場跑道進場燈光系統應符合國際民航標準，依國際民航組織第 14 號附約或「民用機場設計暨運作規範」之標準或建議辦理。
