飛航事故調查報告

ASC-AOR-12-05-001

立榮航空公司執行 BR 806 班機任務

於桃園機場落地時偏離跑道

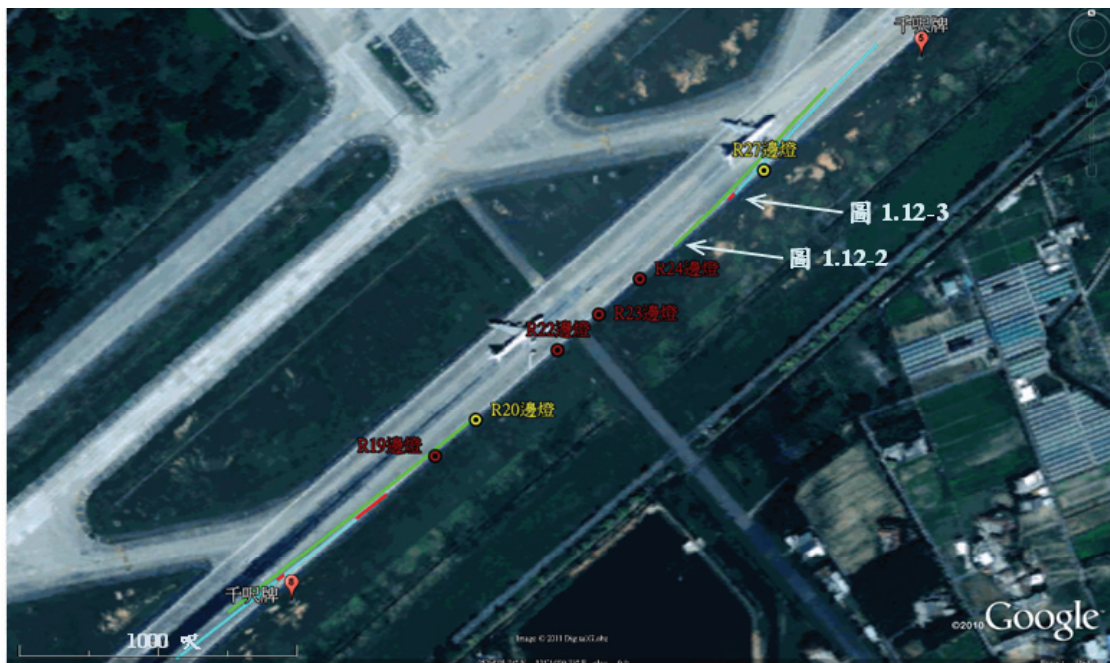
圖 1.12-4 事故現場圖

2036 時¹該機於桃園機場 06 跑道落地，落地滾行時，於距 06 跑道頭約 3,340 呎處右主輪偏出跑道，後於 5,100 呎處返回跑道。該機經由 S6 滑行道脫離跑道，滑回停機位後檢查，發現航機受輕微損傷，人員無傷亡。

地面檢查後發現，航機起落架擋水板變形，1、2、3、4 號主輪刮傷，2 號發動機外部及進氣導片有損傷痕跡，06 跑道右側 4 具跑道邊燈損壞。

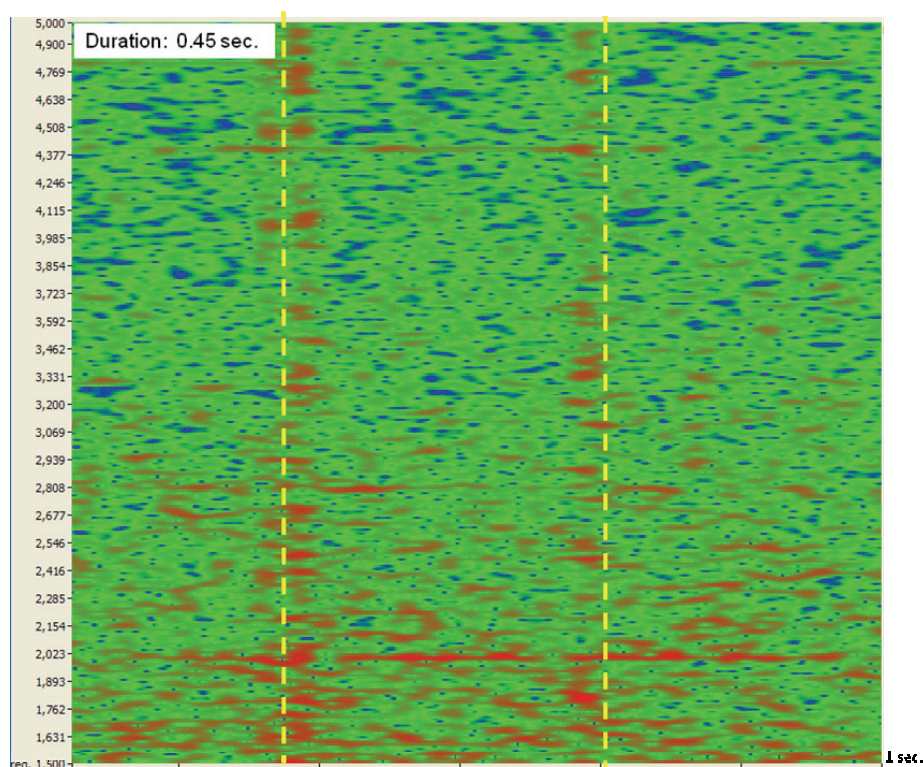
圖 1.16-12 BR806 疑似減速板手柄拉至備動位置之頻譜

7. 地面測試影片中，因人為推油門使減速板手柄自動收回過程中，前 0.188 秒（即第一段寬頻音之 0.122 秒及無特徵音頻之 0.066 秒）為減速板手柄滑回收回位置（retract）動作，後為減速板手柄解除作動（disarm）聲響。
8. 以手動拉起減速板手柄至備動位置的音頻特性為：作動時間約 0.290 秒至 0.7 秒不等，其唯一共有特性為以一長度約 0.140 秒之寬頻音開始（如圖 1.16-11）。圖 1.16-11 與圖 1.16-12 來源皆為駕駛艙區域麥克風，其中圖 1.16-12 BR806 事故航班之背景噪音較為明顯，致該聲響於 3,000 Hz 以下訊號不甚清晰。

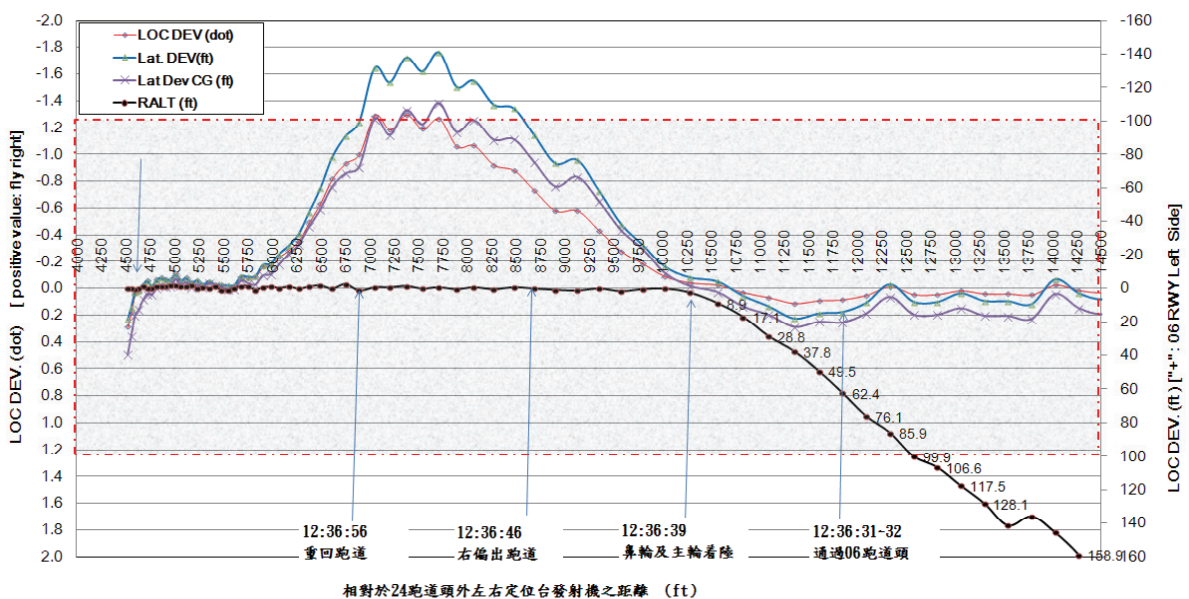
圖 2.2-1 該機 200 呎高度以下至偏出期間之航跡左右偏移量

依 FDR 資料，該機於 2036:33 至 2036:39 時平飄至著陸期間，空速維持於 149+/-5 哩/時。該機主輪於 2036:39 觸地，機首方向為 050，空速為 144 哩/時，地速為 150 哩/時；3 秒後左主輪離地（Weight on wheel 訊號由 Ground Mode 變成 Air Mode）約 2 秒¹⁷，6 秒後右主輪離地約 2 秒¹⁸；此期間航跡前進之方向右偏，機頭持續向左；7 秒後（2036:46 時），航機右主輪偏出跑道，當時之機首方向為 038，地速 117 哩/時；2036:56 時航機重回道面，地速 78 哩/時。總計航機偏出跑道之時間為 10 秒，相關之航跡資料如圖 2.2-2 及 2.2-3。

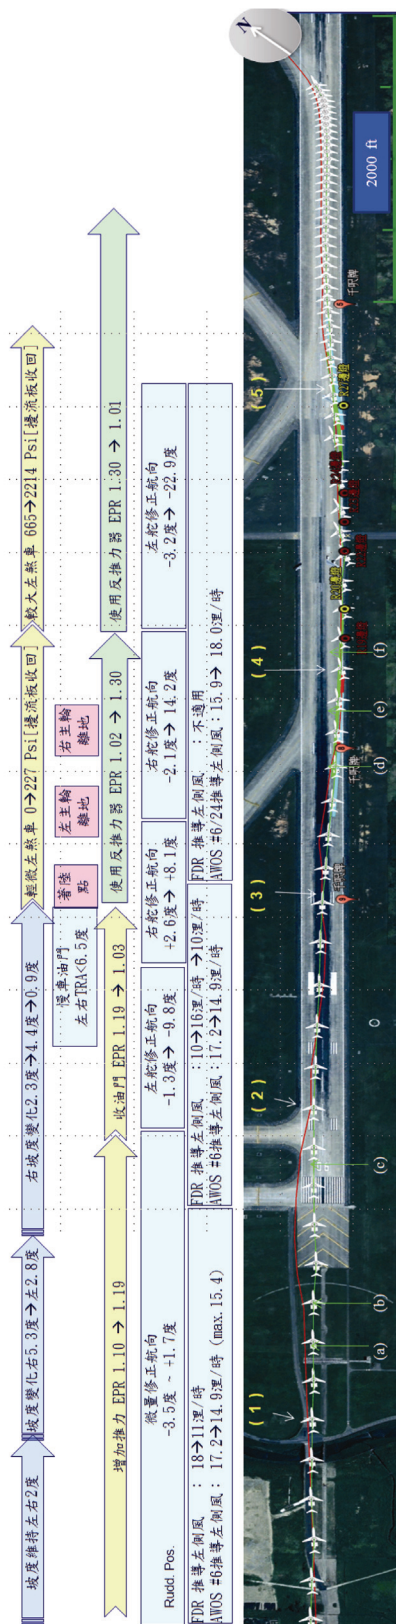
圖 2.2-2 該機最後進場、平飄、落地軌跡分析圖

參考時間	參考時間
(1)	右坡度 5.27度; RA 128.1呎; 空速 144 哩 / 時;
(2)	右坡度 1.41度; RA 37.8呎; 空速 154 哩 / 時; 由仰角轉俯角
(3)	主輪及鼻輪着地; 右坡度 0.88度; 空速 144 哩 / 時
(4)	右主輪右偏出道面 左主輪右偏出道面
(5)	左主輪重回道面 右主輪重回道面

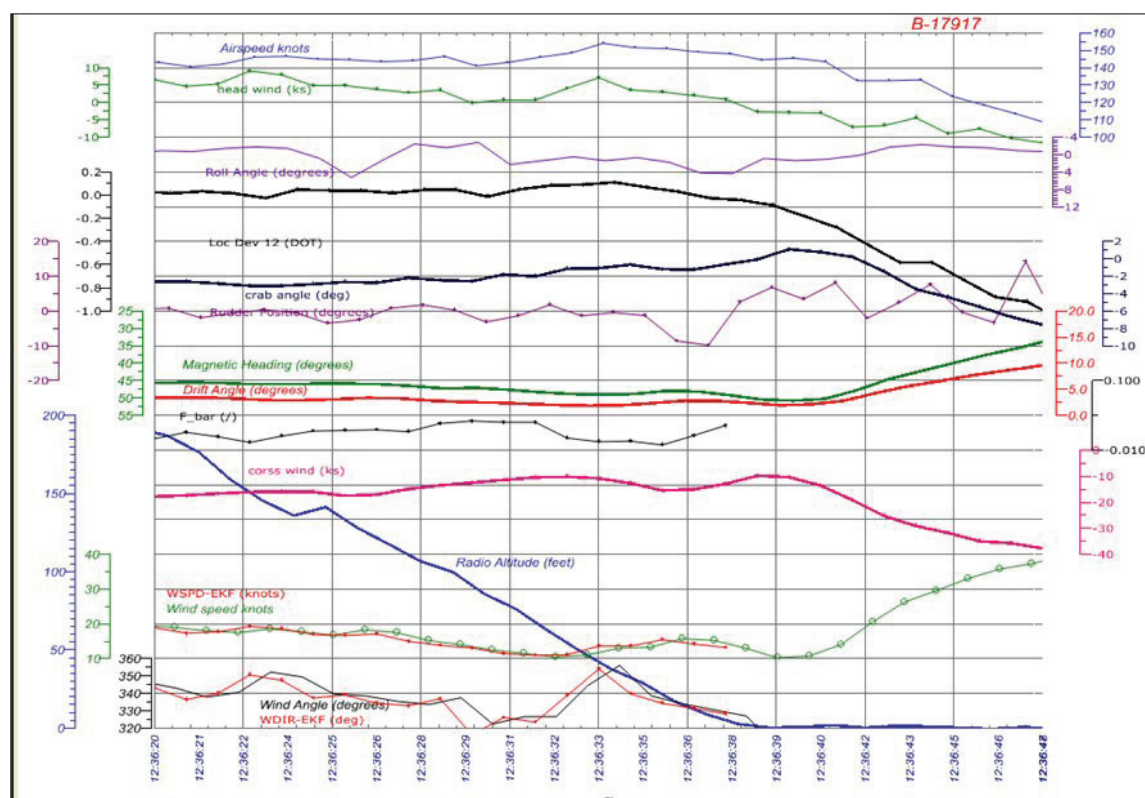
圖 2.3-2 BR806 200 呎高度以下至偏出期間相關參數繪圖

該機無線電高度 50 呎以下至著陸期間，航機坡度均為右坡度且最大為 4.4 度；此期間左側風約 11 增為至 16 浬/時至減為 10 浬/時，由頂風變化 7 浬/時轉為尾風 3 浬/時；此期間方向舵位置約左舵 1.3 度至右舵 6.8 度；航機重心位置由 06 跑道中心延長線左側約 23 呎改為右側約 9 呎，磁航向由 49 度增為 50 度，亦即與 06 跑道磁航向約左偏 3 度。詳圖 2.3-2。

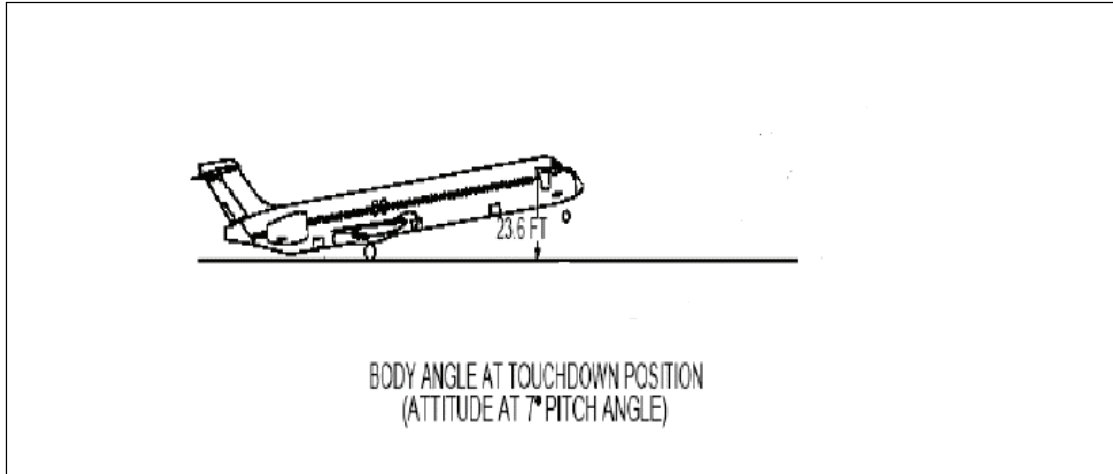
圖 2.3-3 MD-90 落地姿態圖

操控駕駛員於著陸前 4 秒及 2 秒兩次輸入較大的推桿及拉桿的俯仰操控，平飄至著陸期間（36:33 時至 36:39 時），無線電高度 50 呎以下，飛機姿態由 0.88 度仰角轉為 1.05 度俯角，左右主輪及鼻輪同時著陸，導致三輪著陸後並接續發生左右主輪分別短暫離地現象（36:41 時至 36:42 時左主輪離地、36:44 時至 36:45 時右主輪離地）。

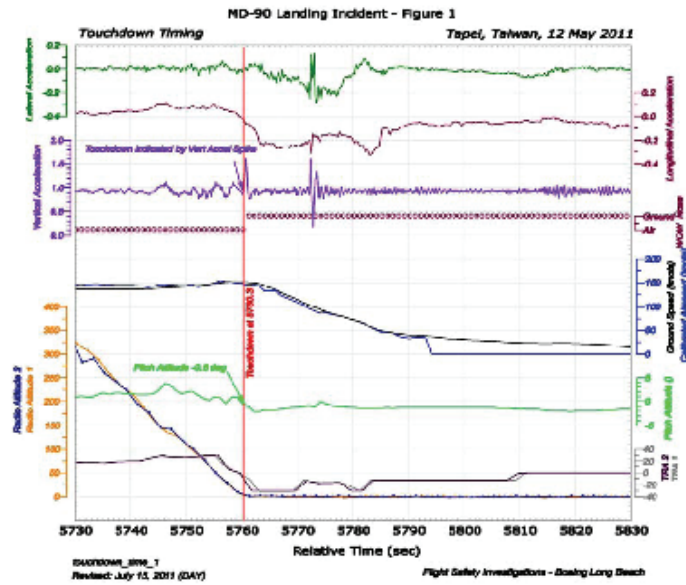
Figure 1 shows the basic parameters used in determining the moment of initial touchdown for the landing. The vertical acceleration spike at the low radio altitude indicates that the airplane touched down at Subframe Reference Time 5760.3 seconds. The Subframe Reference Time is a relative time from the beginning of the analysis file; it does not have any real-world significance. For the remainder of the plots touchdown (SRT=5760.3) is shown as Time=0.

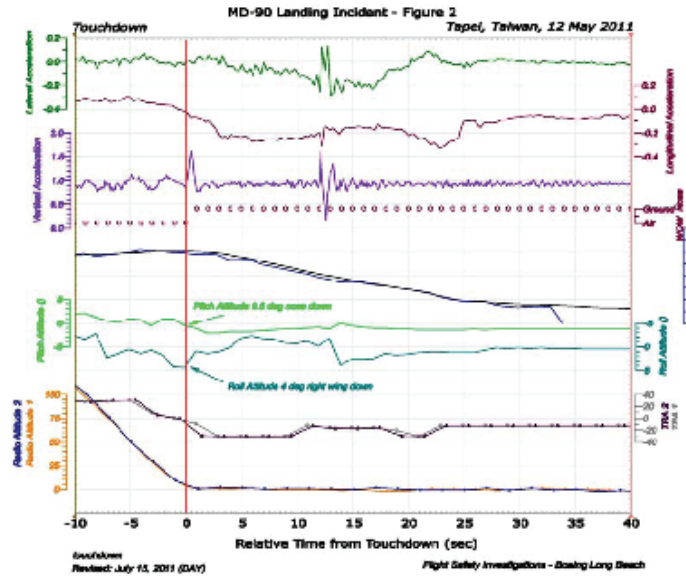
Figure 2 shows selected parameters at the time of touchdown. The airplane touched down in a flat or slightly nose-down pitch attitude, with a right-wing-down roll attitude. Such an orientation results in nearly simultaneous contact runway contact by the nose landing gear (NLG) and the right main landing gear (MLG). Although the radio altitude indicates a small positive value (+2 feet) 1.5 seconds after touchdown, it is not possible to determine, with 100% accuracy, if the airplane actually rebounded ("skipped") off the runway surface. Several factors, including an apparent slight positive bias in the radio altimeter recoding and the persistent nose-down pitch suggest that there probably was no skip or bounce. Throttle resolver angle (TRA) at touchdown is at or very near zero, corresponding to throttle levers at idle. Although the throttle lever positions themselves were not successfully decoded from the binary recording, TRA has a direct correlation and is an acceptable substitute for throttle lever position. Positive TRA corresponds to forward thrust; negative TRA corresponds to reverse thrust.

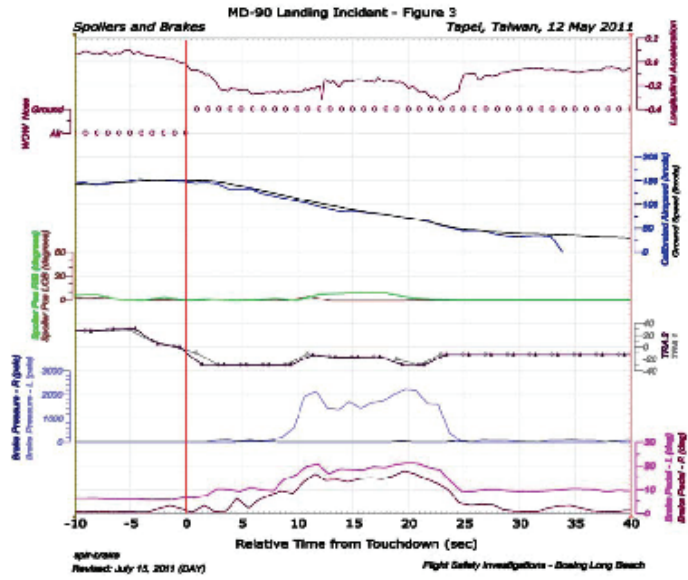
Figure 3 shows the spoiler and braking parameters. Normally on an MD-90, the automatic ground spoiler (AGS) system, if armed, will deploy all spoilers to a deflection of 60 degrees upon MLG wheel spin-up or NLG compression. In this case the right MLG spin-up signal (not recorded) and NLG compression likely occurred less than a second apart due to the flat touchdown pitch attitude. However, the spoilers did not deploy. The minor spoiler deflections seen 10 seconds after touchdown are due to control wheel input, not the ground spoiler system. There is a "knock-down" feature of the AGS that will retract the spoilers when the #2 throttle is advanced in order to prevent a go-around with the spoilers deployed. However, as can be seen in Figure 3, the throttles were at idle at touchdown and in reverse thrust immediately afterward, so the throttle knock-down can be ruled out as a cause for the failure of the spoilers to deploy.

The brake pressure and pedal positions are also shown in Figure 3. The offset between left and right brake pedal position is likely due to a recording anomaly and not from actual asymmetric braking. It appears that the left brake pressure parameter is functioning normally and the right brake pressure parameter is not recording correctly.

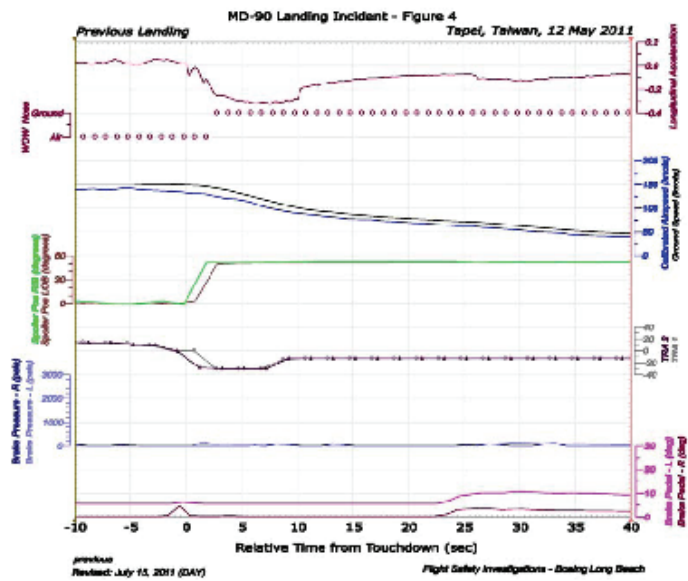
Figure 4 shows the same parameters as Figure 3, but for the previous landing. It can be seen that the spoilers deployed normally. Braking was light.
