行政院飛航安全委員會

事實資料報告

立榮航空公司 B7 642 班機

於台南機場降落於未經指定之跑道

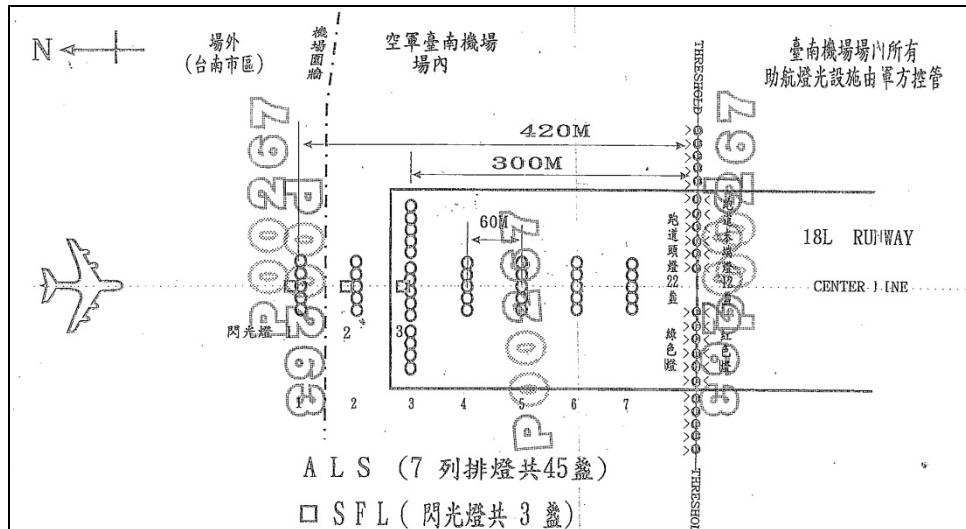
圖 1.10-2 臺南機場 18L 進場燈光圖

依空軍提供臺南機場 18L 進場燈光圖，18L 設置綠色跑道頭燈 22 盞，白色進場燈 5 盞 1 組，每 60 公尺 1 組，其中距跑道頭 300 公尺有 3 組排成 1 列，共 45 盞，另距跑道頭 300 公尺至 420 公尺之進場燈組中心加設 1 盞閃光燈，共 3 盞詳圖 1.10-2 所示。18L 具精確進場滑降指示燈 PAPI。

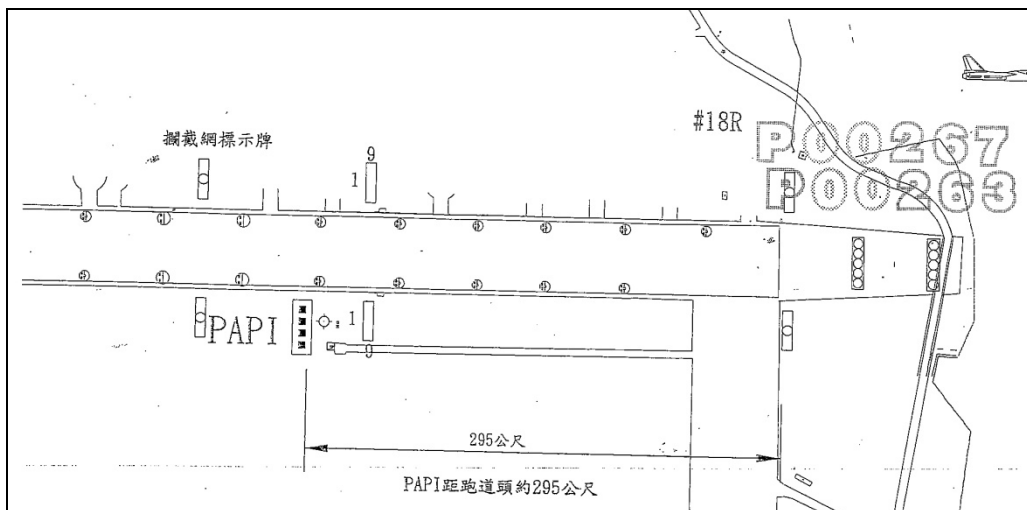
圖 1.10-3 臺南機場 18R 跑道頭前區燈具及跑道邊燈圖

依空軍提供資料，臺南機場 18R 跑道頭前區使用嵌入式燈具 2 組，每組 5 盞綠色定光燈，距跑道頭分別為 60 公尺及 120 公尺，詳圖 1.10-3；目視進場滑降指示燈 PAPI，距 18R 跑道頭 295 公尺及跑道邊燈，間距 60 公尺。

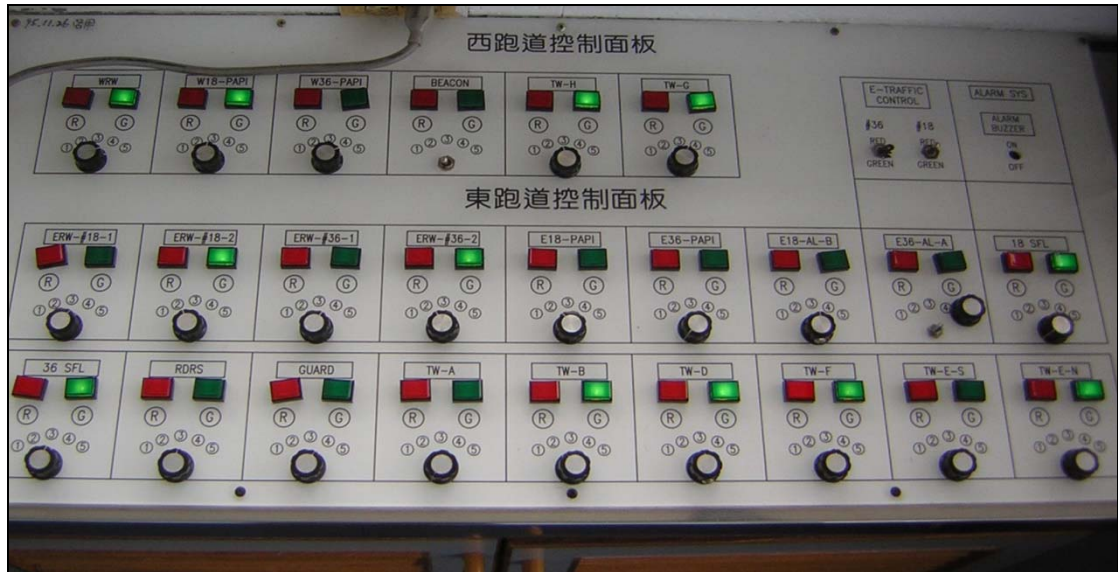
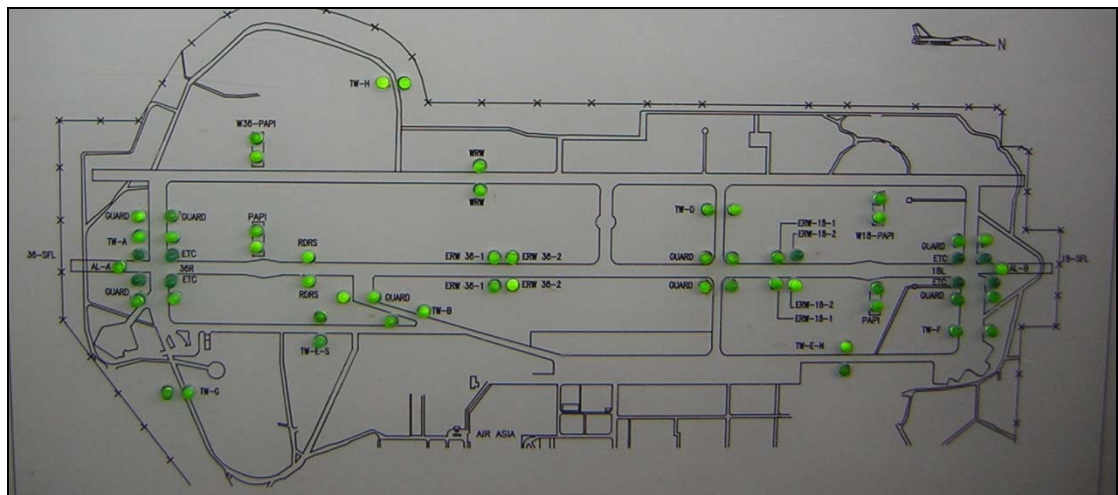
圖 1.10-4 臺南機場跑道燈光控制面板

依飛航管理程序，臺南機場 18L 及 18R 進場燈、目視進場滑降指示燈及跑道邊燈亮度均為 5 段調控。另依空軍提供臺南機場跑道燈光控制面板及助航燈光全區指示面板，詳圖 1.10-4 及 1.10-5，18L 及 18R 進場燈、目視進場滑降指示燈及跑道邊燈之開閉及亮度調控均為獨立控制，且無儲存記錄功能。

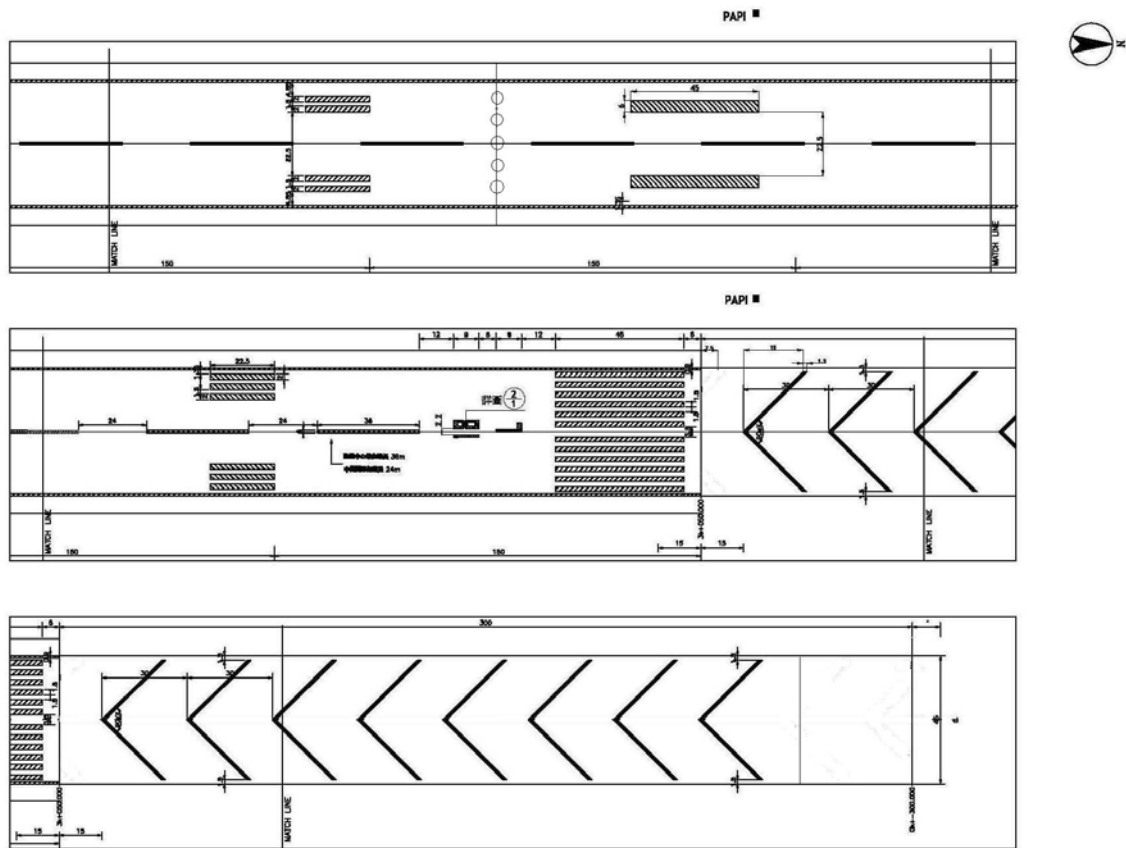
圖 1.10-6 18L 標線圖

18L 著陸點標線距跑道頭 364 公尺，由長 45 公尺，寬 6 公尺，內緣間距 22.5 公尺之 2 條白色標線所組成，詳圖 1.10-6 所示。

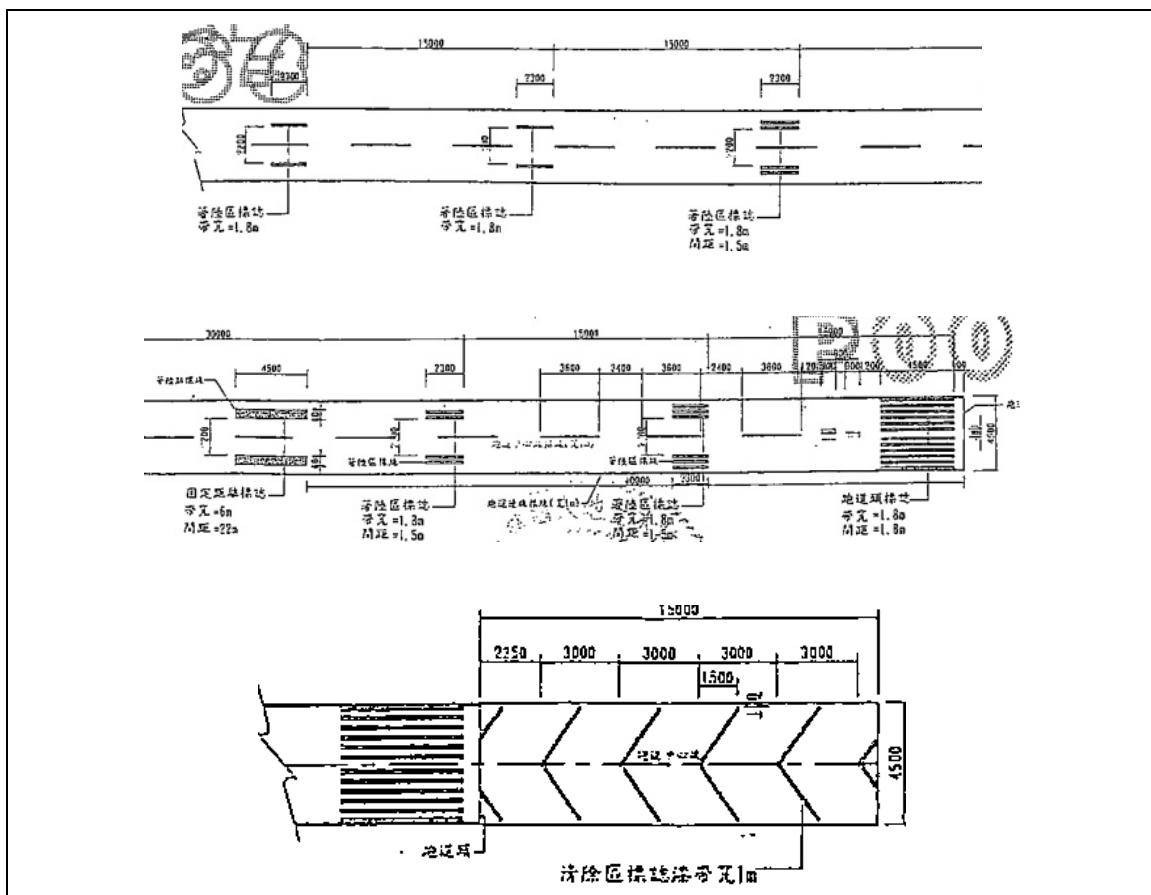
圖 1.10-7 18R 標線圖

18R 著陸點標線由距跑道頭 400 公尺，長 45 公尺，寬 6 公尺，內緣間距 22 公尺之 2 條白色標線所組成，詳圖 1.10-7 所示。

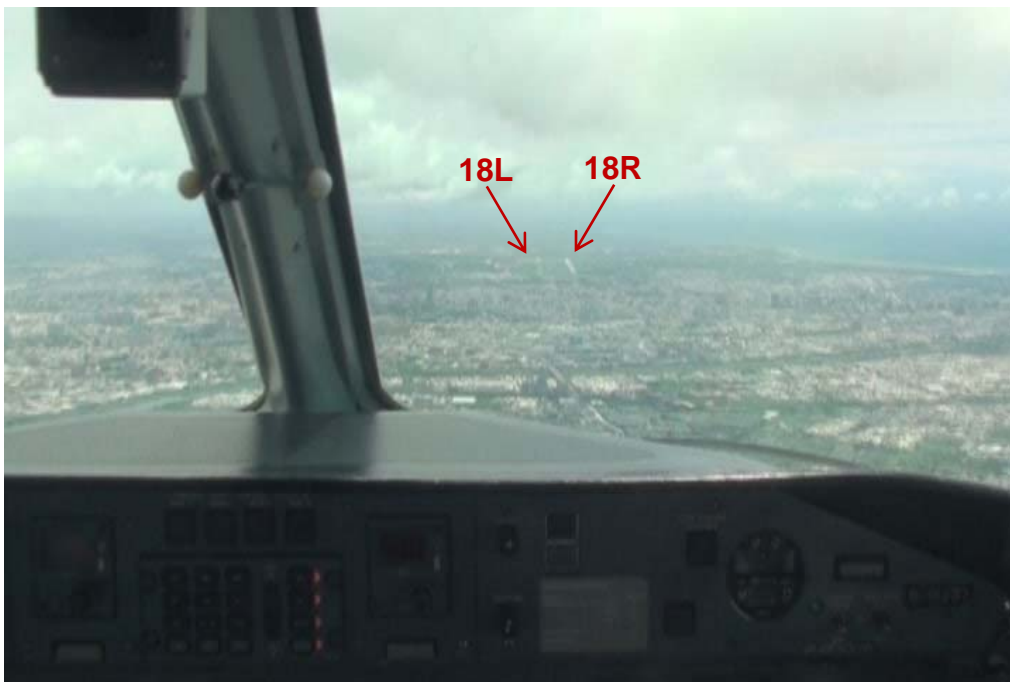
圖 1.16-1 跑道空照圖

- 第二航次B7 646班機通過西港導航臺上空時，指針失效但距離仍指示0.2浬，指針恢復後之距離指示1.7浬，全程距離指示無失效情形。
- 於目視對正跑道情況下，CDI指示無偏移不穩情形。
- 第二航次，距西港導航臺10浬/時，速度由180漸調整至160浬/時。距西港導航臺5浬/時，到達3,000呎，通過182度邊，並開始右轉，通過西港導航臺上空時攔上182度邊。
- 於西港導航臺上空高度3,000呎可目視跑道，比較18L與18R道面情況，18R道面較明亮，18L道面較黑暗。(如圖1.16-1)
- 越過西港導航臺8.5浬（距跑道頭約2浬），航機高度400呎，飛越一運動場，為一可目視之地標。距西港導航臺9.5浬、高度100呎時，進入清除區，跑道頭有一狀似梯形之環場道路。(如圖1.16-2)
- 有關事故航班及上述機上觀察航班之飛航軌跡資料如附錄5。
