# 飛航安全調查委員會

### 事實資料報告

復興航空公司 GE515 班機

報告編號：ASC-AFR-12-09-001

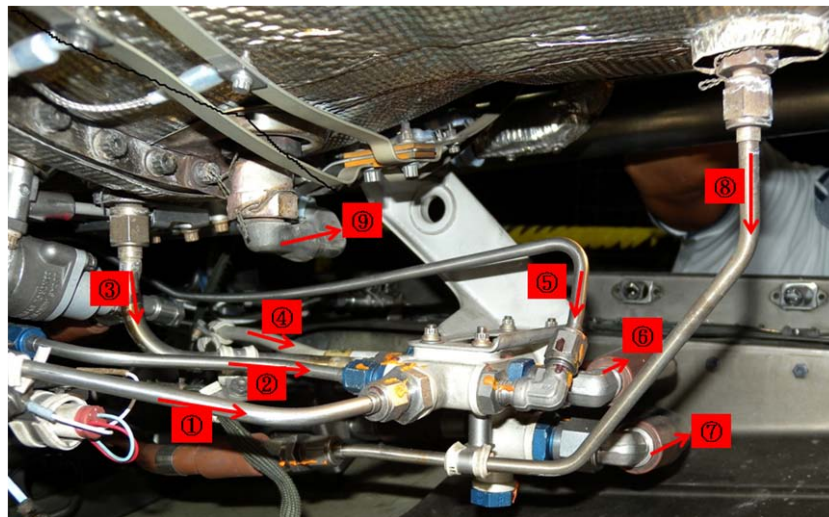
圖 1.14-6 2 號發動機之滲油疏放、回油管路

圖 1.14-6 為該機 2 號發動機漏放歧管與相連接管路照片，事故 1 號發動機與 2 號發動機構型稍有差異，圖中標號②之管路 1 號發動機無須安裝；連接至漏放歧管之燃油管路計 3 根（如圖 1.14-6 標號①、③、⑤），滑油管路則有 1 根（如圖 1.14-6 標號④），洩油在漏放歧管集中後，燃油及滑油再經由漏放管罩分別由標號⑥、⑦之軟管排出機外，⑧ 6,7 號軸承滑油回油管，各管路詳細資料如表 1.14-1。

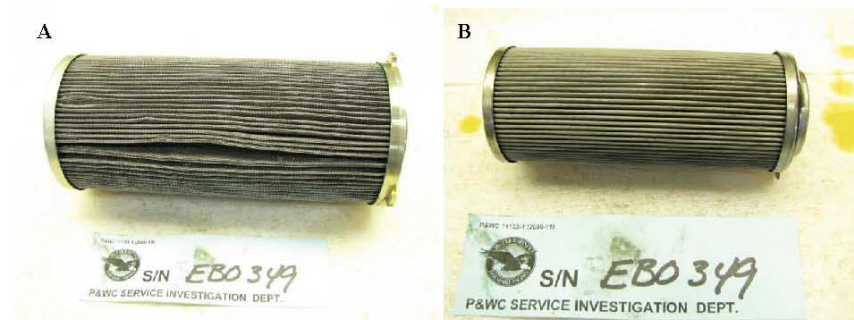
Photo no's 1 A (Main) & B (Scavenge)

- 2.1 The main and scavenge oil filters (photo no's 1 A & B) with the reduction gearbox (RGB) chip detector (photo no's 2 A & C) were clean. The turbomachine (TM) chip detector had collected some metallic slivers (photo no's 2 A & B). The slivers were taken to P&WC Chemical Laboratory for analysis, which they were identified as Stainless Steel (SST) air-seal material. The low (LP) and high pressure (HP) rotors rotated freely. The PT rotor was difficult to rotate. No foreign object damage (FOD) was noted on the leading edge of the LP impeller full vanes.

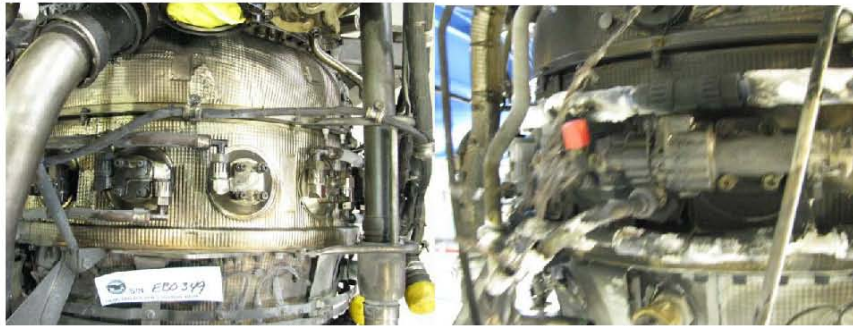
Photo no. 4 (Top view)

- 2.2 Visual inspection of the engine externals located from the rear inlet case (RIC) to the exhaust duct revealed that the primary and secondary fuel manifold hoses, the inter-turbine temperature (ITT or T6) thermocouples and bus-bars insulation, the engine electrical wiring and harnesses, insulation blankets of the gas generator case (GGC) and turbine support case (TSC), fuel manifold adapters and flow divider/dump valve unit, air/oil delivery lines, ignition cables, bleed valve and LP exit ducts displayed areas of wetness, varnishing stains, a film of whitish dust and soot deposits. Various extents of fire damages such as heat-discoloration and degradation and oxidation to the engine externals from being exposed to elevated temperatures, were noted. Refer to photo no's 3 A to D, 4 and 5.

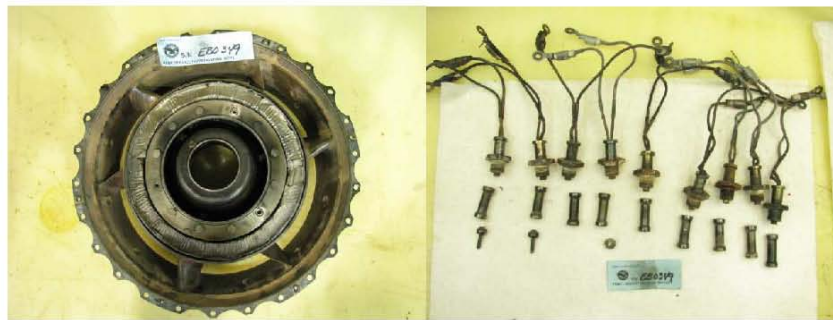
- 2.7 The twelve (12) retention bolts that retained the No. 6 & 7 bearings housing to the ITD with the inter-stage baffle were all in place (photo no. 13 A & 15). The inter-turbine temperature thermocouples (T6) were fractured in which most of them during their removal (photo no. 16).

Photo no. 15  
Photo no. 16  
Views of the No. 6 & 7 bearings housing retained to the ITD (15) and T6's (16).

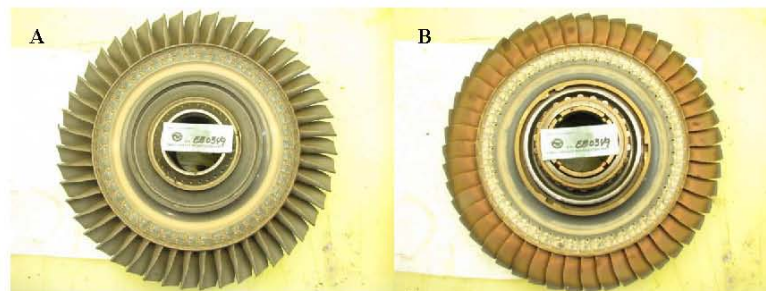
- 2.8 The tip of the low-pressure turbine (LPT) blades had rubbed against several shroud segments (photo no's 14 A, and 17 A to C, arrows). There was no impact damage on the blade L/E's airfoils except for nicking noted at the airfoil T/E's (photo no's 18 A & B). The front and rear faces of the LPT disc did appear intact. The LPT stator vanes were in a satisfactory condition (photo no. 19).

Photo no's 18 A (L/E) & B (T/E)  
LPT disc assembly.

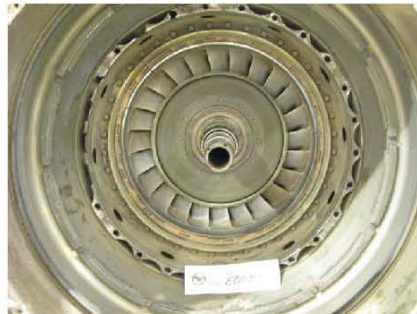
Photo no. 19  
LPT stator assembly.

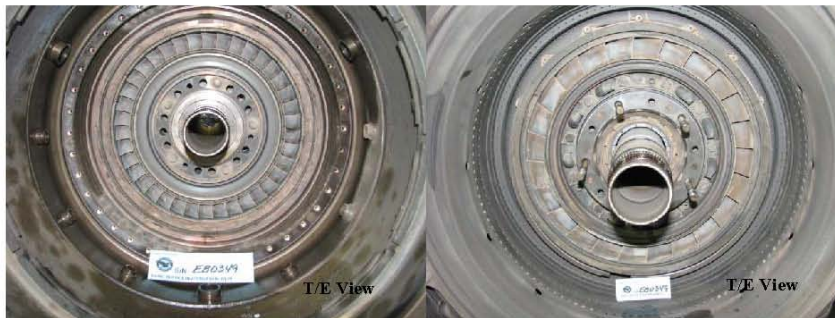
Photo no. 20

- 2.9 The HPT blades (photo no. 20) and stator vanes (photo no. 21) were in a satisfactory condition.

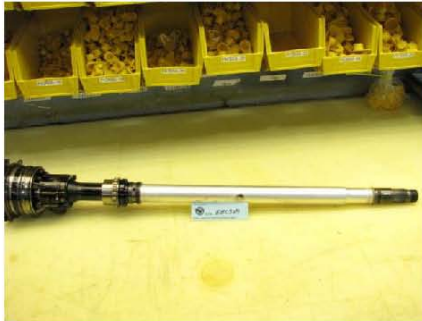
- 2.10 There were no indication of an inter-shaft rubbing on the outside diameter (OD) of the PT shaft (photo no. 22) and the inside diameter (ID) of the HPT disc (photo no. 23). An inter-shaft rubbing was noted on the LP shaft OD (photo no's 24 A & B) and HP impeller ID. There was indication of inter-turbine air-seal rubbing at the PT and LP spools (photo no's 25 A & B).

Photo no. 22 (PT shaft view)

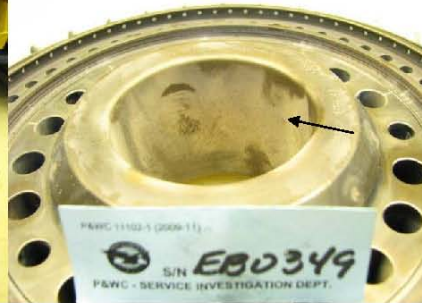
Photo no. 23 (HPT disc ID view)

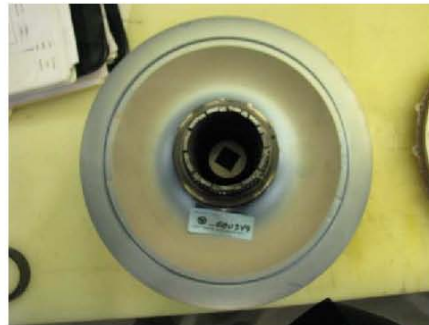
Photo no. 29

- 2.11 The tip of the LP and HP impeller vanes had rubbed against its respective shroud housing (photo no's 26 & 27, A & B). The back-face of the LP impeller had rubbed against the LP diffuser case front wall (photo no's 28 A to D). The HP impeller back-face was clean (photo no. 29).

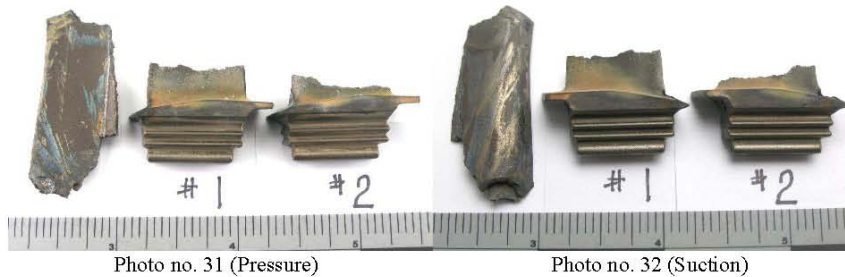
- 3.2 Photo no's 31 and 32 showed aspect views of the pressure and suction sides of PT1 blades #1 & 2 and the airfoil fragment. Blade #1 had fractured through the airfoil approximately 0.270 inches from the platform and blade #2 fractured near the platform at the T/E edge side.

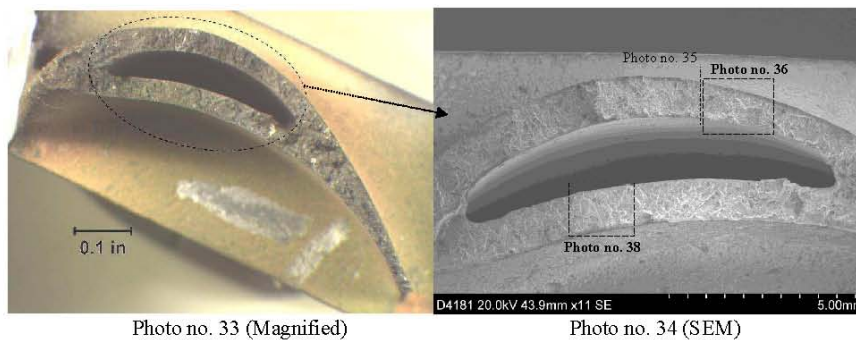
- 3.3 Photo no's 33 and 34 showed magnified and Scanning Electron Microscope (SEM) images of the PT1 blade #1 fracture surface, which displayed a smooth surface at the centre of the airfoil (dotted circle).

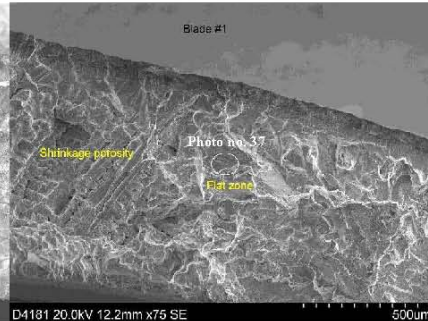
Photo no. 36

- 3.4 SEM image (photo no. 35) of the PT1 blade #1 fracture surface, taken on the convex side, revealed a dendritic solidification pattern with features consistent with shrinkage porosity. SEM image (photo no. 36) of one of the photo no. 34 insert showed shrinkage porosity feature and flat zone (circle).

- 3.5 The higher magnification (photo no. 37) of the flat zone highlighted in photo no. 36 (circle) shows fatigue striations suggesting that the crack initiated from the shrinkage porosity zone. The yellow arrows indicated the fatigue crack propagation direction.

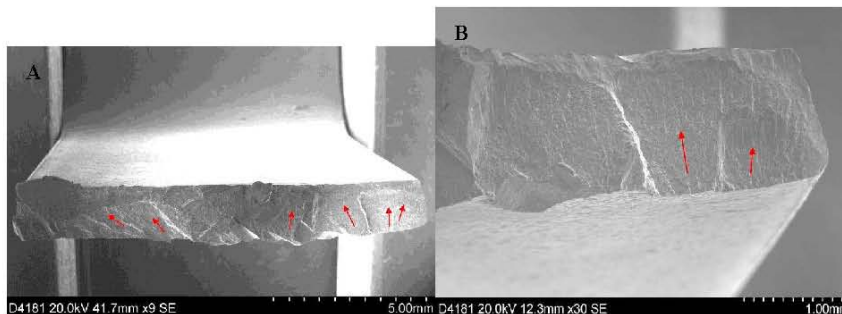
Photo no's 42 A &amp; B

- 3.10 The chemical composition of the PT1 blade material, analysed using the EDS standardless semi-quantitative analysis method, was consistent with the compositional requirements for the major elements of the specs.
- 3.11 SEM image (photo no. 42) of the bracket #1 fracture surface showed a flat surface with river lines and arrest lines typical of fatigue. The red arrows indicated the crack propagation direction. Fatigue features covered almost completely the fracture surface suggesting a low nominal stress suggesting High Cycle fatigue (HCF). Higher magnified view (photo no's 42 A & B) of fatigue origin region (arrows) did not show any mechanical damage.
