飛航事故調查報告

ASC-AOR-13-05-001

復興航空公司GE 515班機

於爬升過程中發生左發動機火警

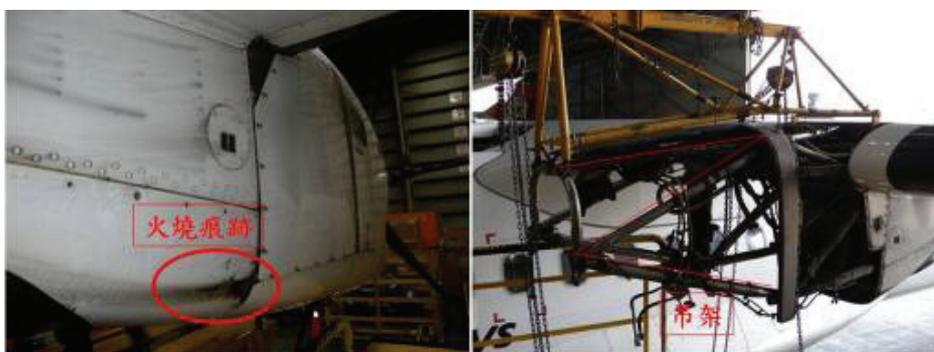
圖 1.14-2 機翼下箱型結構整流罩火燒痕跡及吊架遭受熱損

- 機翼下箱型結構整流罩飛行火燒痕跡及吊架遭受熱損

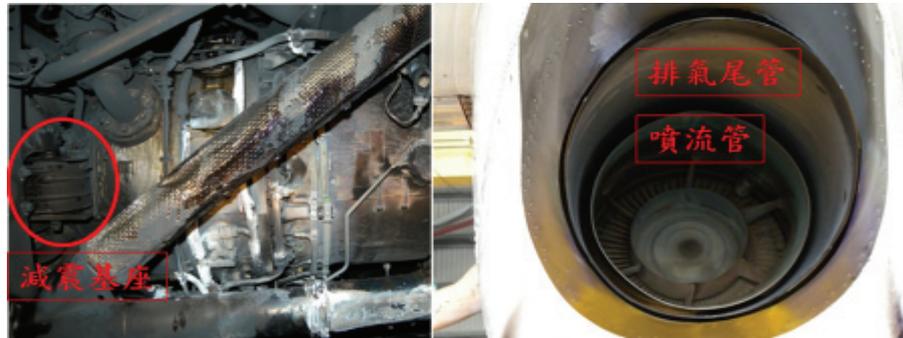
圖 1.14-3 發動機減震基座、排氣尾管及噴流管遭受熱損

- 發動機減震基座、排氣尾管及噴流管遭受熱損

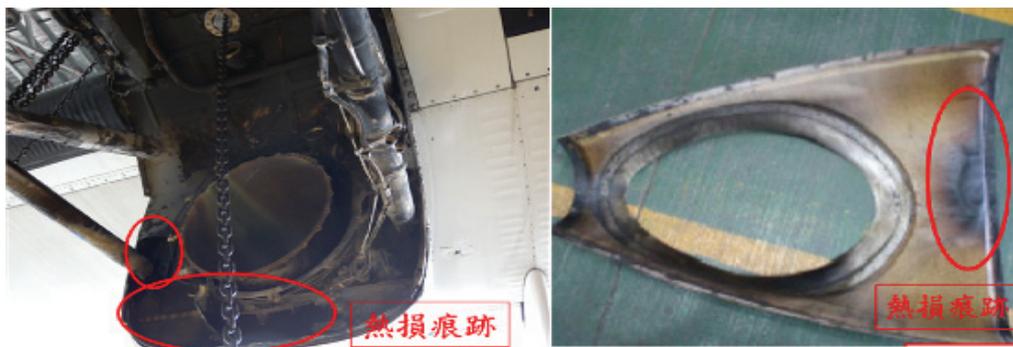
圖 1.14-4 機翼下箱型結構、整流罩遭受熱損

- 機翼下箱型結構、整流罩遭受熱損

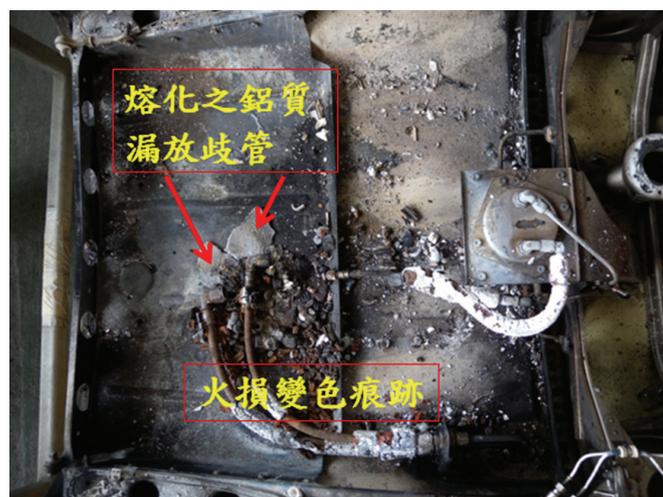
圖 1.14-5 進氣口後段底部整流罩結構火損

- 進氣口後段底部整流罩結構遭受火損

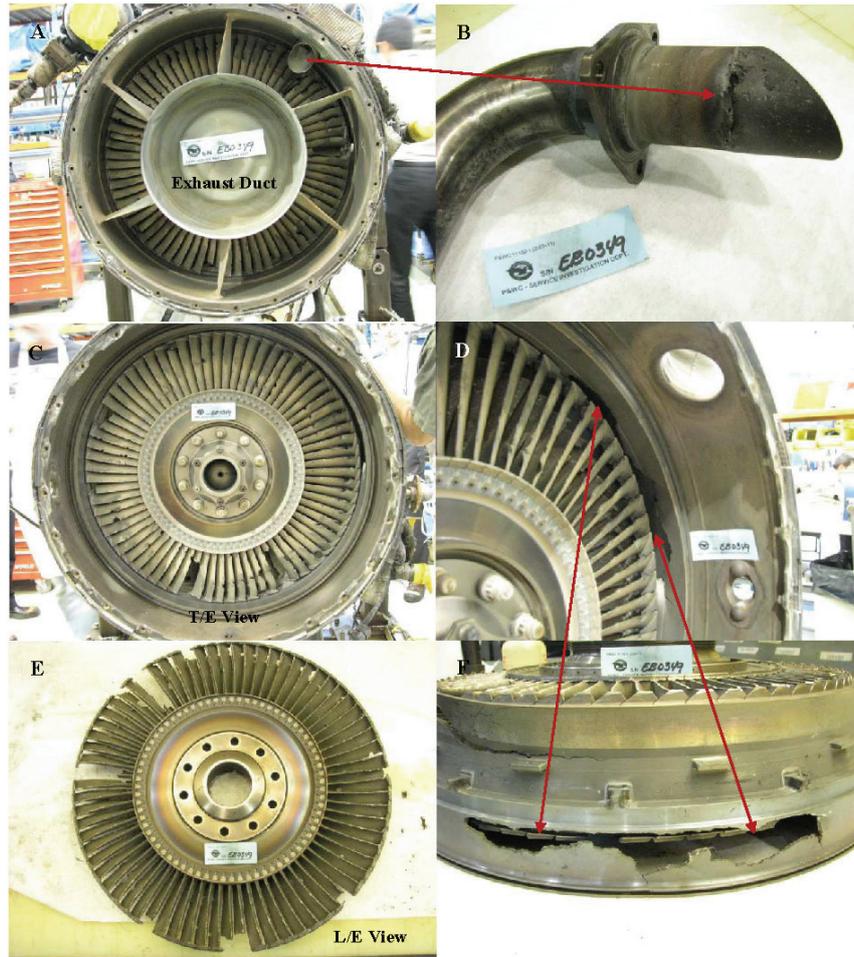
Photo no's 11 A to F

- 2.4 The engine disassembly showed the accessory gearbox (AGB) breather tube assembly at the exhaust duct adjacent to the PT 2 blades was gouged and punctured from debris impacts (photo no's 11 A & B, arrow). The airfoils of the PT2 blades (photo no's 11 A, C & E) and stator vanes showed various extents of fracturing and battering damages from debris impacts. The outer shroud integral to the PT2 stator assembly, located radial to the PT2 blades, was fractured and battered by debris impacts (photo no's 11 D & F, double head arrows).

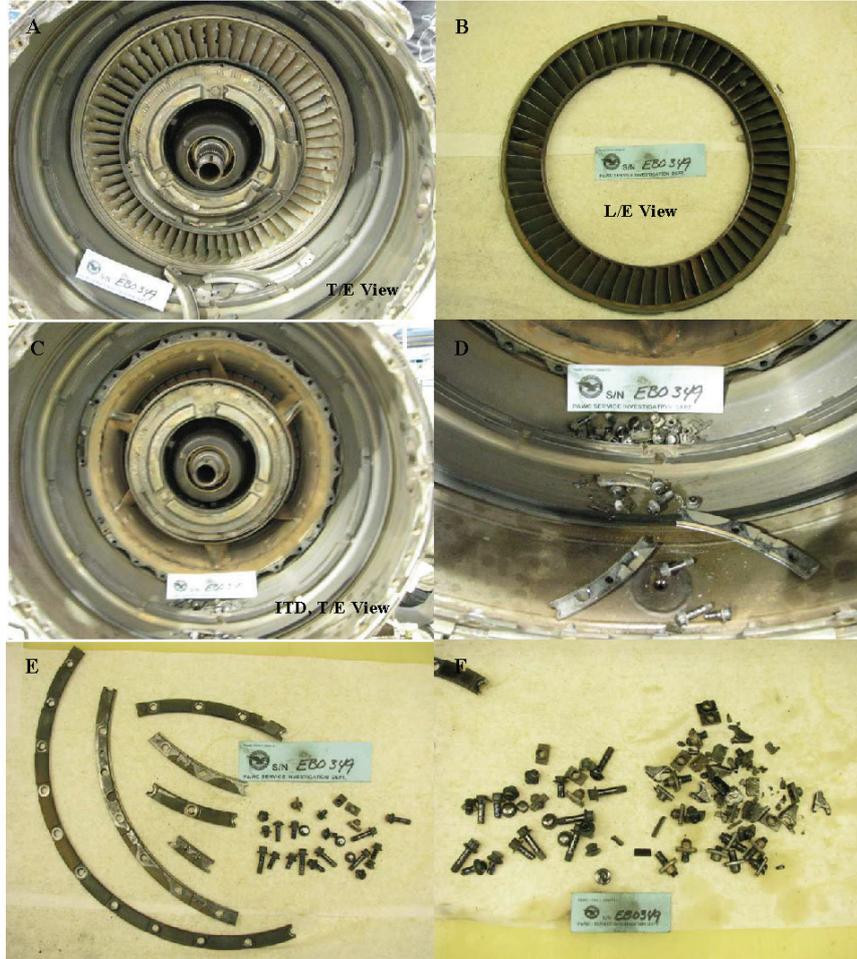
Photo no's 13 A to F

2.6 The PT1 stator assembly and baffle were in place (photo no. 13A). The trailing edge (T/E) of several vanes and outer shroud of the PT1 stator showed impact denting and gouging damages. The interstage turbine baffle of the PT1 stator was battered and fractured (photo no. 13 A). The vane leading edges (L/E) were intact (photo no. 13 B). The anti-rotation lugs at the outer shroud of the PT1 stator assembly were fretted and several of them fractured (photo no. 13 B). The twenty-six (26) retention bolts with the retaining ring that retained the inter-stage turbine duct (ITD) to the LPT housing assembly were fretted, and most of them fractured (photo no's 13 C to F, and 14 A). A section of the bolting flange of the LPT housing assembly showed cracking and fracturing damages (photo no's 14 A & B, parabolic).

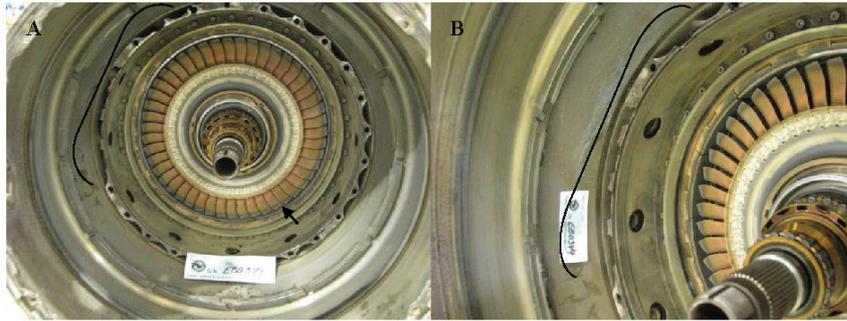
Photo no's 14 A & B
 LPT housing and disc assemblies.

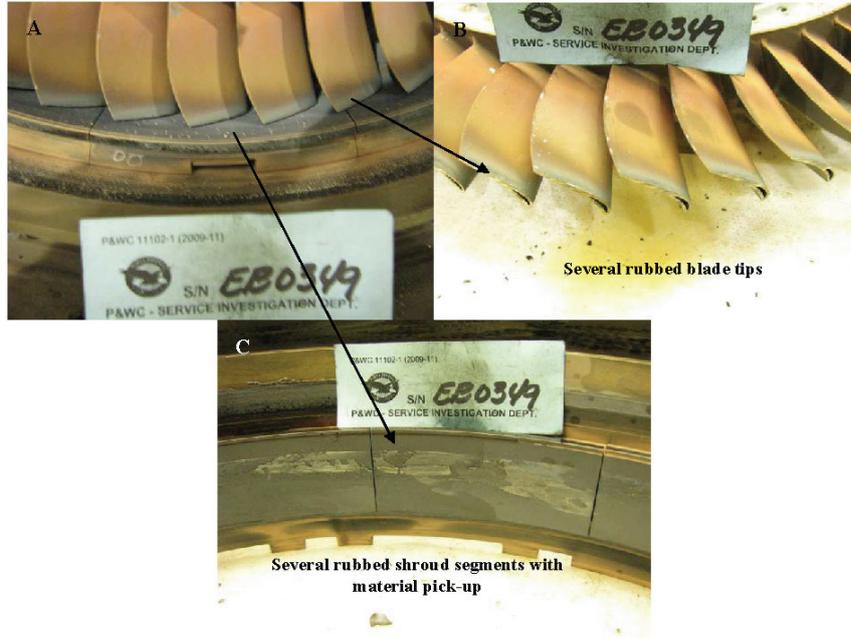
Photo no's 17 A to C

- 2.8 The tip of the low-pressure turbine (LPT) blades had rubbed against several shroud segments (photo no's 14 A, and 17 A to C, arrows). There was no impact damage on the blade L/E's airfoils except for nicking noted at the airfoil T/E's (photo no's 18 A & B). The front and rear faces of the LPT disc did appear intact. The LPT stator vanes were in a satisfactory condition (photo no. 19).

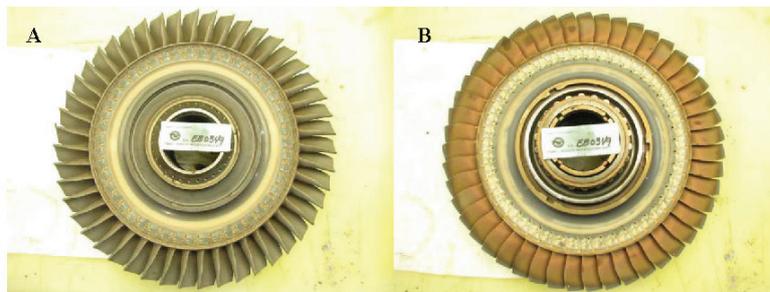
Photo no's 18 A (L/E) & B (T/E)
LPT disc assembly.

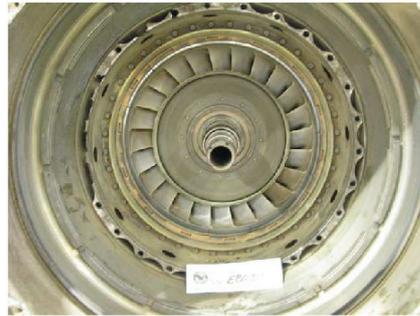
Photo no. 19
LPT stator assembly.

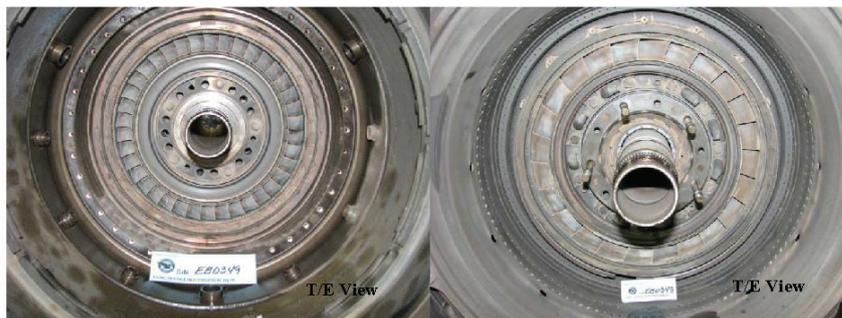
Photo no. 20

2.9 The HPT blades (photo no. 20) and stator vanes (photo no. 21) were in a satisfactory condition.

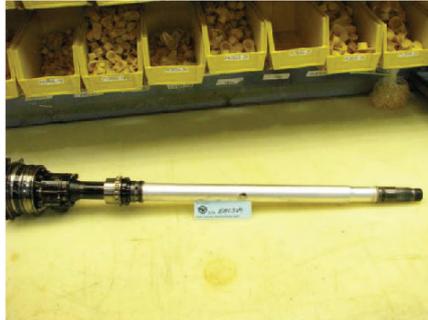
Photo no. 22 (PT shaft view)

2.10 There were no indication of an inter-shaft rubbing on the outside diameter (OD) of the PT shaft (photo no. 22) and the inside diameter (ID) of the HPT disc (photo no. 23). An inter-shaft rubbing was noted on the LP shaft OD (photo no's 24 A & B) and HP impeller ID. There was indication of inter-turbine air-seal rubbing at the PT and LP spools (photo no's 25 A & B).

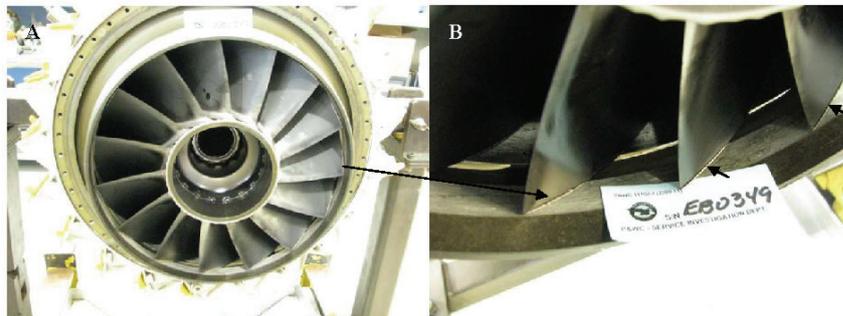
Photo no's 26 A & B

2.11 The tip of the LP and HP impeller vanes had rubbed against its respective shroud housing (photo no's 26 & 27, A & B). The back-face of the LP impeller had rubbed against the LP diffuser case front wall (photo no's 28 A to D). The HP impeller back-face was clean (photo no. 29).

View of the rubbing of the LP impeller vane tips and shroud.

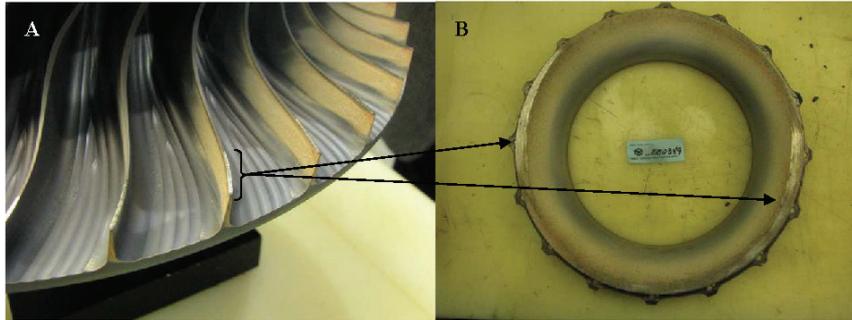
Photo no's 27 A & B
 View of the rubbing of the HP impeller vane tips (exducer) and shroud.

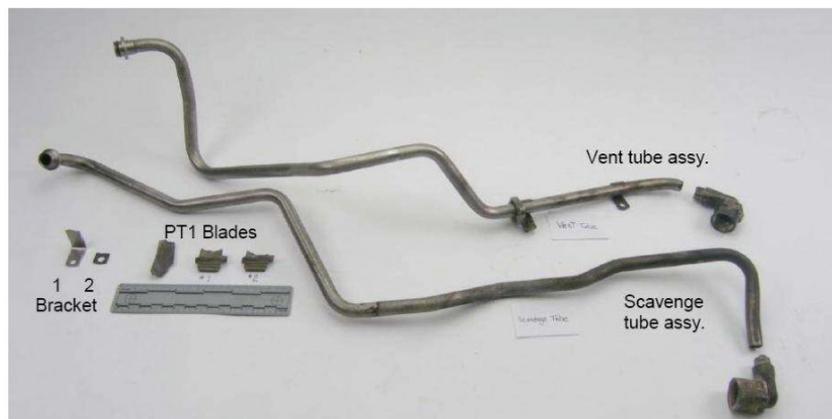
3.1 Photo no. 30 is a general view of the fractured vent and scavenge tube assemblies of the No. 6 & 7 bearings, brackets #1 & #2, PT1 blades #1 & #2 with a blade airfoil fragment in the as received condition.

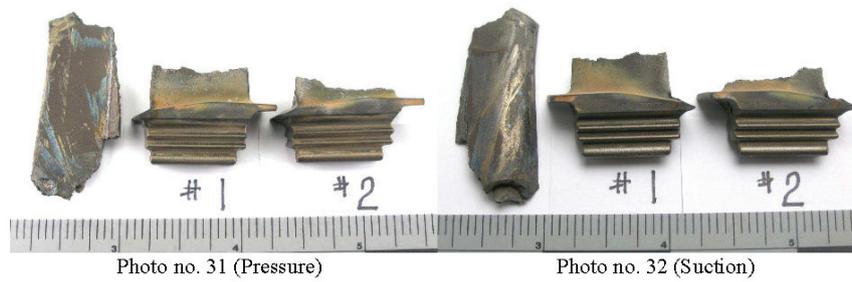
3.2 Photo no's 31 and 32 showed aspect views of the pressure and suction sides of PT1 blades #1 & 2 and the airfoil fragment. Blade #1 had fractured through the airfoil approximately 0.270 inches from the platform and blade #2 fractured near the platform at the T/E edge side.

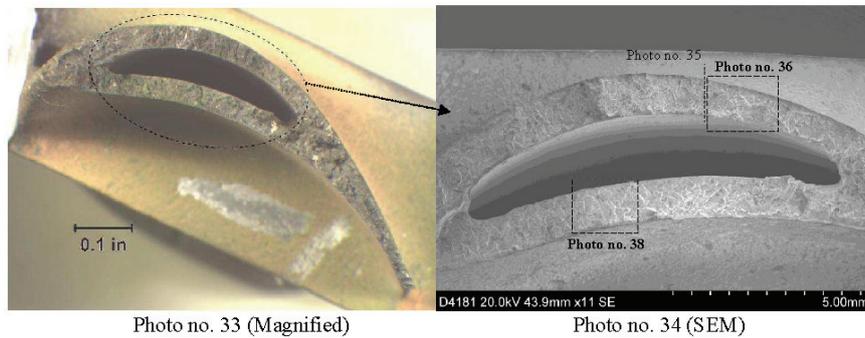
3.3 Photo no's 33 and 34 showed magnified and Scanning Electron Microscope (SEM) images of the PT1 blade #1 fracture surface, which displayed a smooth surface at the centre of the airfoil (dotted circle).

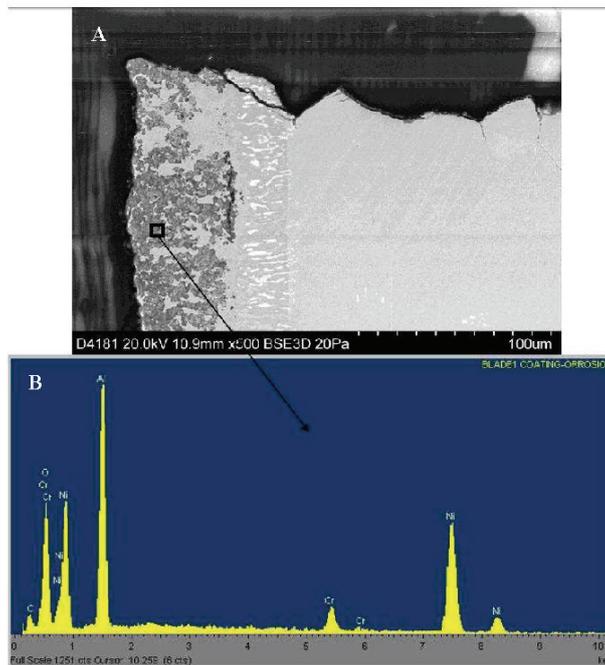
3.8 BSE image through the PT1 blade #1 fracture surface showed corrosion in the top layer of the coating (photo no. 40 A). Energy Dispersive Spectroscopy (EDS) spectrum of the corrosion in the top layer of the coating showed oxygen rich element indicative of oxidation (photo no. 40 B). The average coating thickness was 0.0030 inches and met requirements.

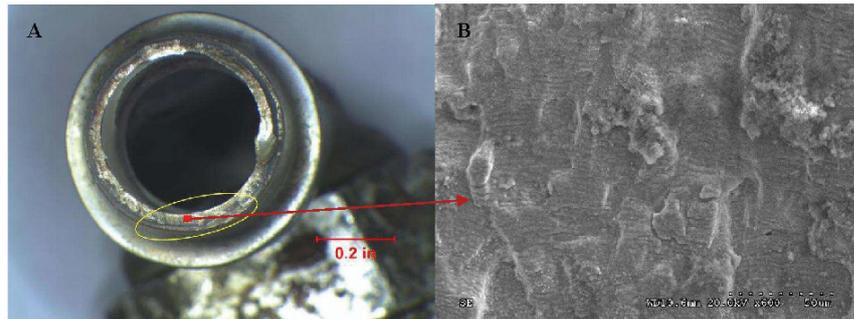
Photo no's 45 A & B

3.14 Magnified view (photo no. 45 A) of the fracture surface of the No. 6 & 7 bearings scavenge tube assembly showed a flat zone indicating of a fatigue mechanism. SEM image (photo no. 45 B) of the fracture surface of the scavenge tube confirmed the presence of fatigue striations.
