# 飛航事故調查報告

ASC-AOR-13-09-003

中華航空公司CI 947航班

遭遇艙壓異常航機緊急下降

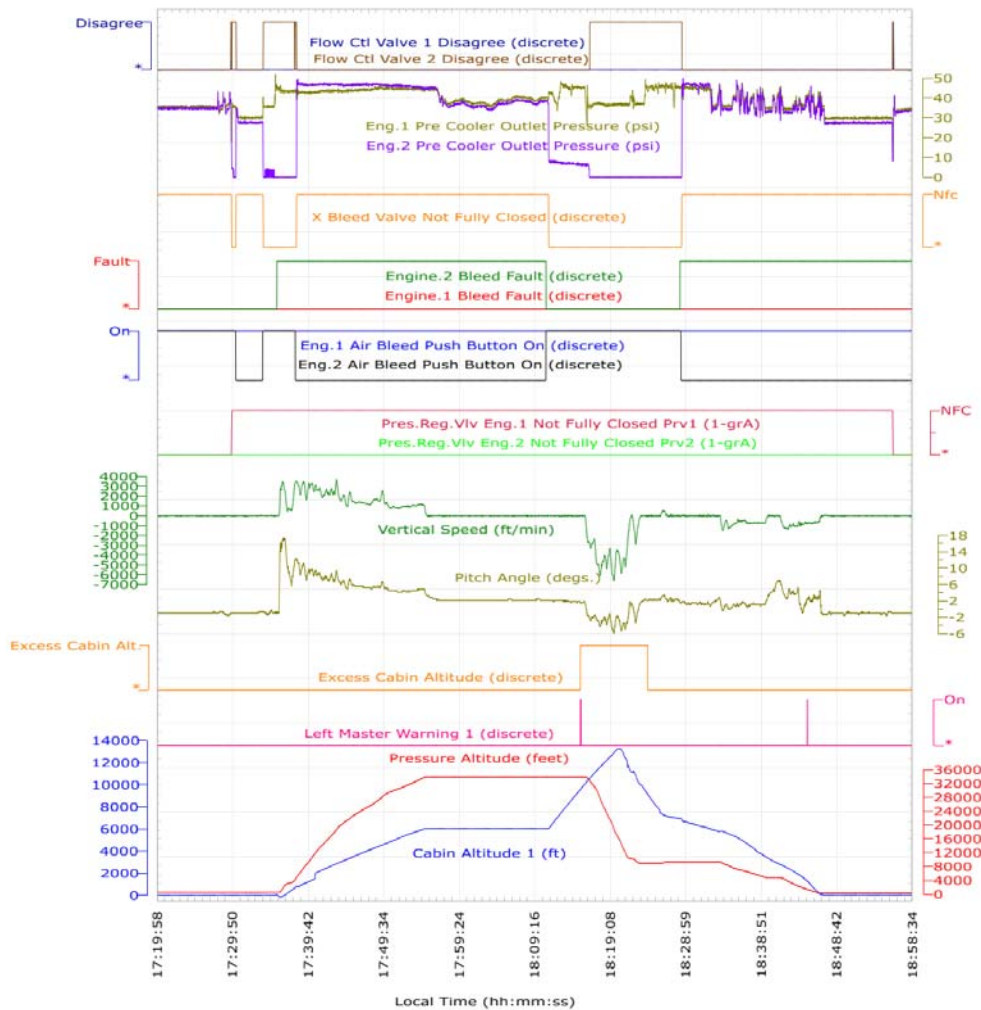
圖 1.11-1 艙壓高度過高階段相關飛航參數圖

- 事故前一航班起飛時，一號及二號發動機供氣系統開關均為 ON 狀態，交叉供氣閥亦為開啟狀態。0526:53 時，交叉供氣閥轉變為關閉；0527:05 時，出現二號發動機供氣系統故障訊息；0527:14 時，二號發動機供氣系統開關轉變為 OFF；0527:45 時，交叉供氣閥轉變為開啟；在 0526:53 時至 0527:45 時期間，大氣高度由 18,024 呎上升至 19,724 呎，艙壓高度由 2,176 呎上升至 3,008 呎。
- 0525:53 至 0526:53，艙壓高度由 1,792 呎上升至 2,176 呎；0527:45 至 0528:45，艙壓高度由 3,008 呎上升至 3,200 呎。

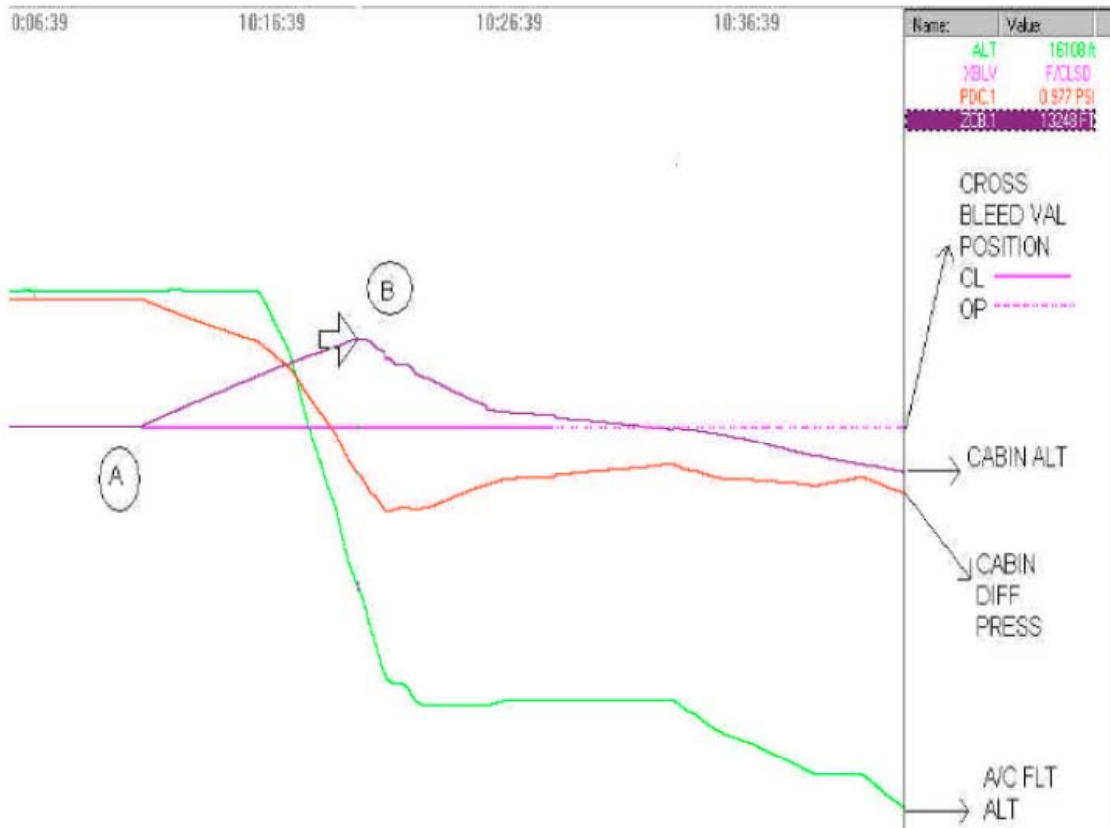
- 10:11 如圖示A.飛機巡航高度34000呎準備下降，**CROSSBLEED VALVE異常關閉**，造成客艙高度開始迅速上升(客艙高度如圖紫線)。
- 10:14 ADVISORY CABIN ALTITUDE警告訊息出現。
- 10:15 CAB PR LO DIFF PR警告訊息出現。
- 10:16 組員依照AOM程序緊急下降(飛機飛行高度如圖綠線)。
- 10:20 如圖示B.飛機客艙高度達到最高值13248呎(14000呎氧氣面罩會自動掉下)
- 10:28 CROSSBLEED VALVE 重新開啟(CROSSBLEED VAL 於地面重複測試功能正常)
