# 飛航事故調查報告

ASC-AOR-13-08-001

中華民國101年9月13日  
長榮航空公司BR 189航班  
A330-300型機  
國籍標誌及登記號碼B-16331  
於松山機場落地時偏出跑道

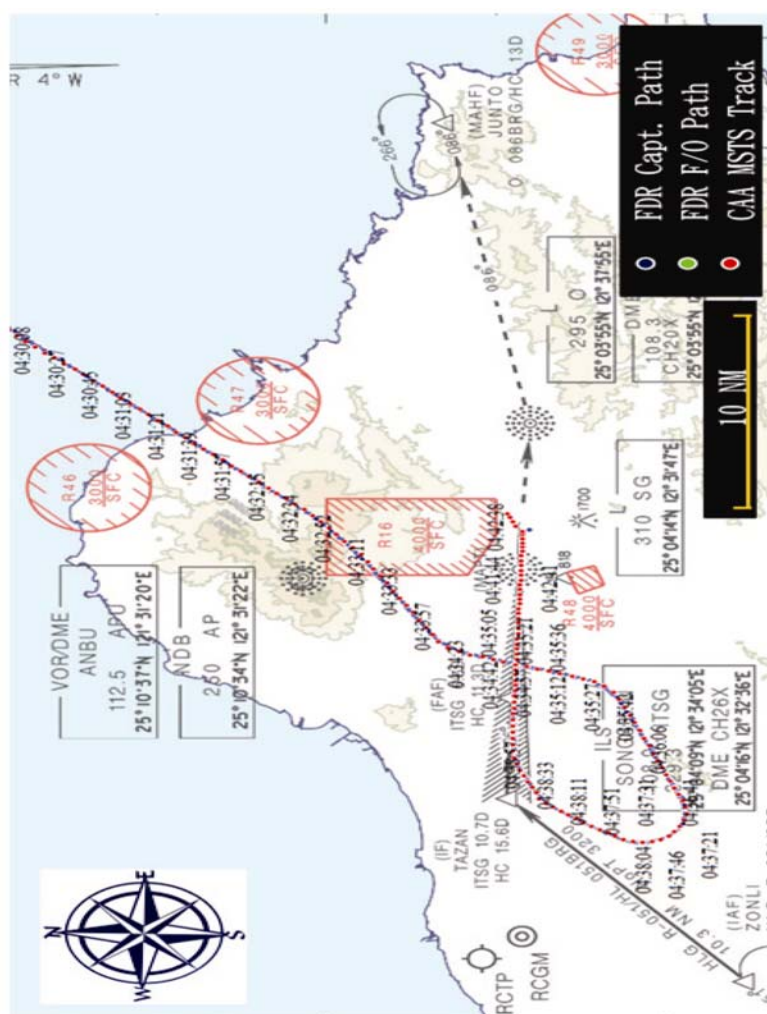
圖 1.1-1 BR189 飛航軌跡及雷達軌跡套疊圖<sup>3</sup>

。滾行過程中於距 10 跑道頭 3,630 呎處右主輪偏出跑道右側，沿跑道邊線外側之草地滾行，於通過 CC 滑行道後，距 10 跑道頭 4,610 呎右主輪始返回跑道，航機偏離跑道邊線之最大距離為 1.8 公尺(約 6 呎)。滾行過程中，飛航組員並未感覺有偏出跑道。於脫離跑道及滑行過程中，塔臺曾詢問航機之狀況及是否可持續滑行，且地面人員通知下機後需至航務組進行酒測，飛航組員始感覺航機落地時可能撞及外物。該機之飛航軌跡如圖 1.1-1、最後進場及落地階段之軌跡如圖 1.1-2。

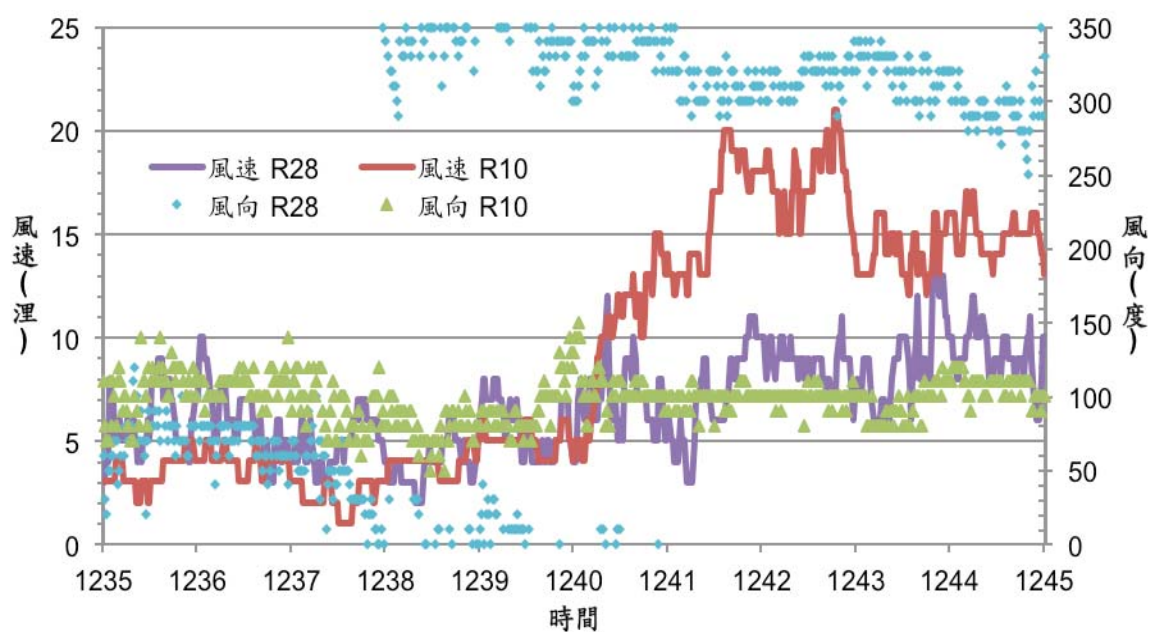
圖 1.7-3 10/28 跑道風向風速

AWOS)之設置地點如圖 1.7-2, 1235 時至 1245 時之 3 秒鐘平均風向風速如圖 1.7-3 所示, 1230 時至 1300 時之 1 分鐘平均跑道視程 (Runway Visual Range, RVR<sup>6</sup>) 及 1 小時累積降雨量資料如圖 1.7-4 所示。

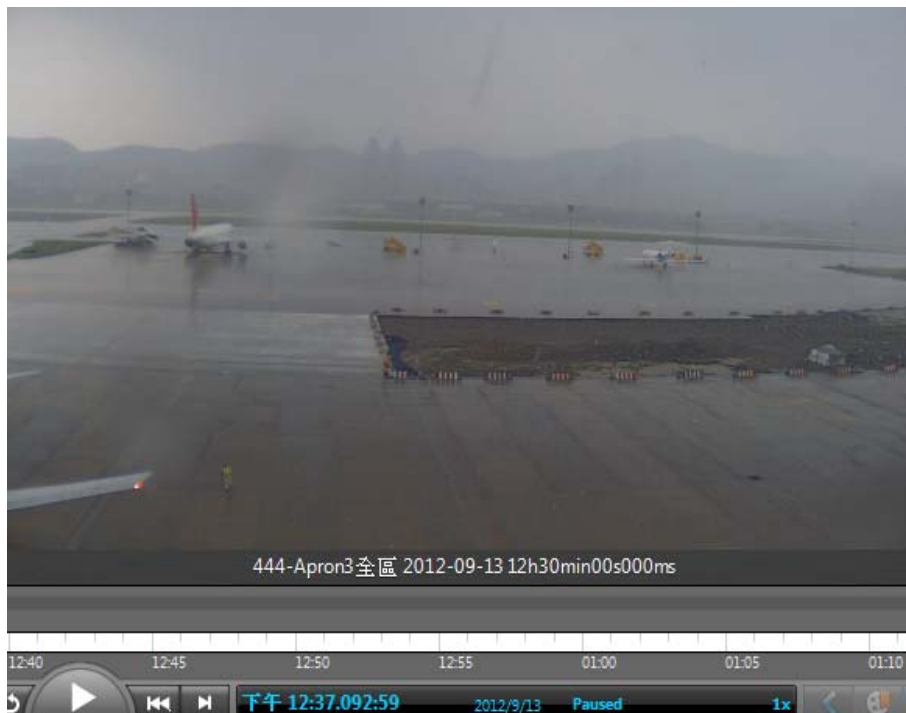
圖 1.10-6 該機落地前 6 分鐘之錄影資料

裝置於機場航廈，位於 CC 滑行道南面之機場錄影機於該機落地前 6 分鐘 (1237) 之錄影資料如圖 1.10-6。落地當時 (1243) 之錄影資料如圖 1.10-7。

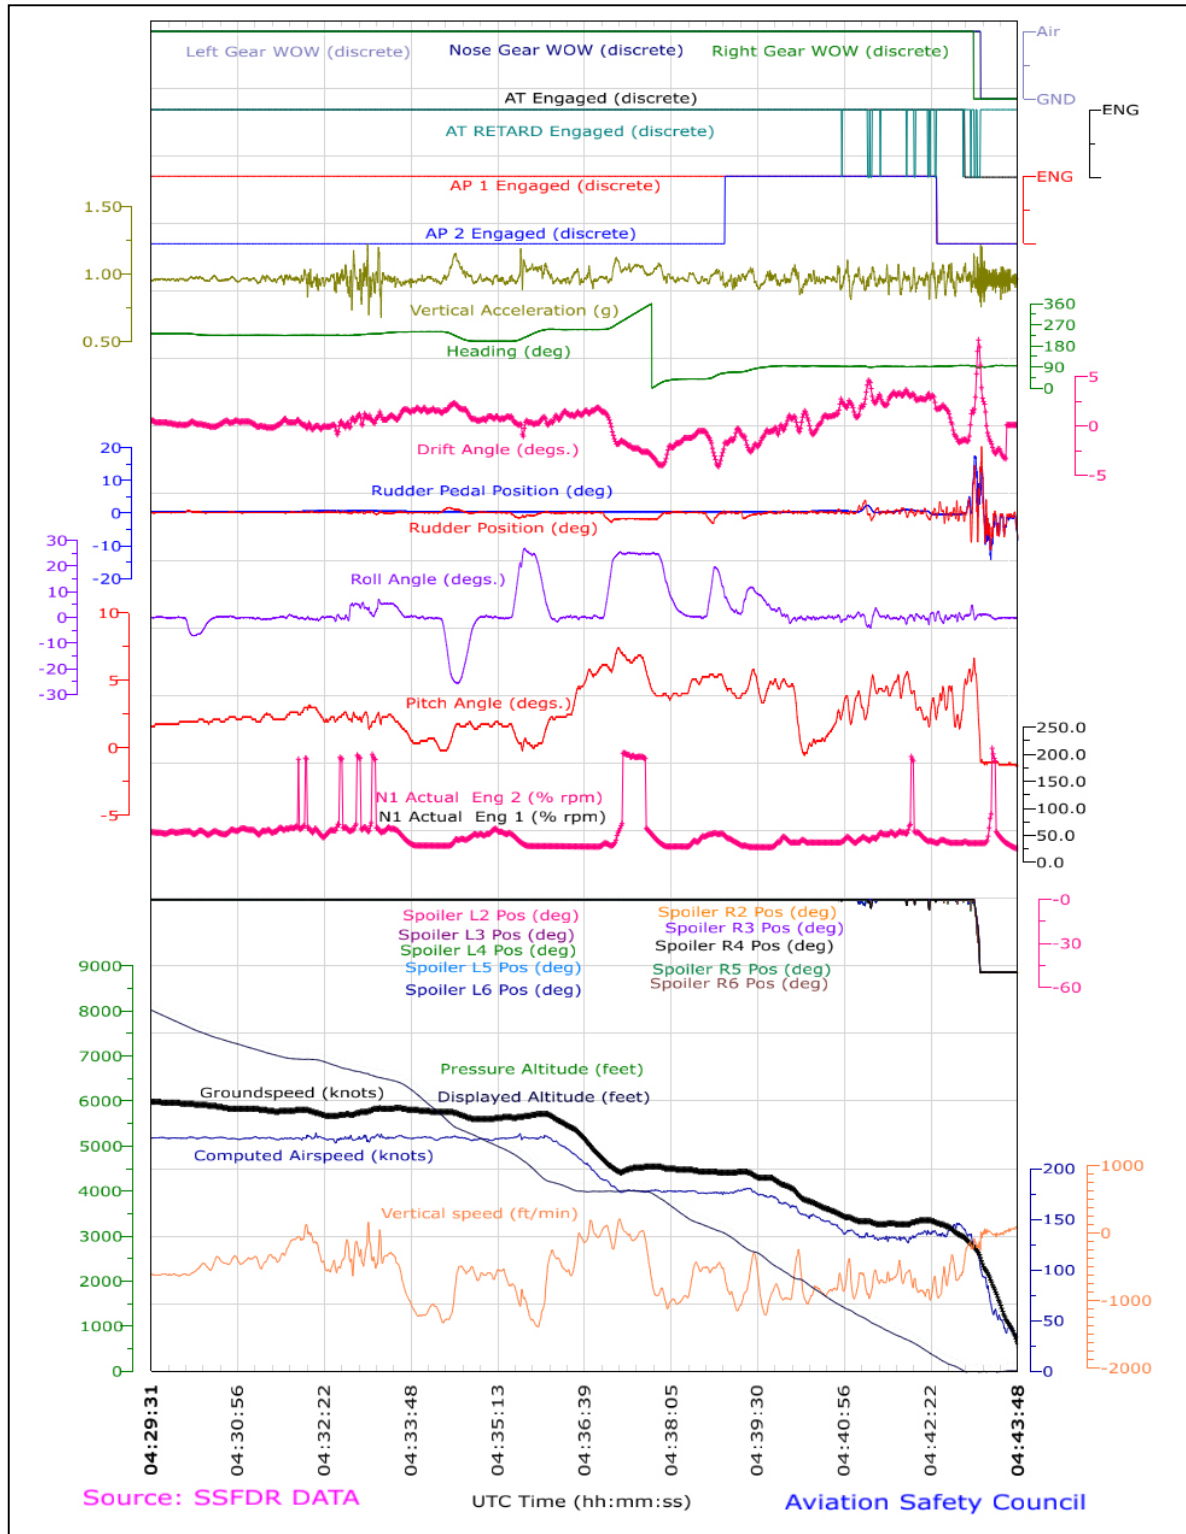
圖 1.11-2 SSFDR 飛航參數繪圖 (最後進場至事故期間)

依據該機固態式飛航資料紀錄器 (Solid-State Flight Data Recorder, 以下簡稱 SSFDR) 及固態式座艙語音紀錄器 (Solid-State Cockpit Voice Recorder, 以下簡稱 SSCVR) 資料，1242:29 時，飛航組員約於高度 500 呎 (無線電高度指示 335 呎) 解除自動駕駛，改以人工方式操作航機，此後正駕駛員駕駛桿之操作幅度開始有較大變化，約 1242:55 時，航機主輪觸地前 11 秒，方向舵開始有向左之短暫操作，此時飛航軌跡大略維持於下滑道中心線上，但航機產生向右之坡度，最大到達約 5 度，於 1242:57 時航機開始向右偏離跑道中心線。飛航組員表示落地前能見度變差，平飄時感覺航機有點飄，且偏跑道中心線右側。1243:06 時，該機主輪觸地，飛航組員敘述觸地時下大雨，觸地前還可目視跑道，觸地後視線很差，約 1 秒後，副駕駛員呼叫「*Going To The Right*」並於 1243:14.5 時接著叫：「*Reverse Reverse Full Reverse*」此時航機鼻輪已觸地 (鼻輪觸地時間為 1243:13)。該機主輪觸地距 10 跑道頭為 2,560 呎，鼻輪觸地距 10 跑道頭為 3,890 呎，飛航組員表示，觸地當時視線很差，很難目視跑道中心線及邊燈，約有 2 至 3 秒幾乎看不到，曾短暫考慮重飛 (Almost Go Around)，因感覺觸地偏跑道中心右側，覺得落在跑道上所以未重飛

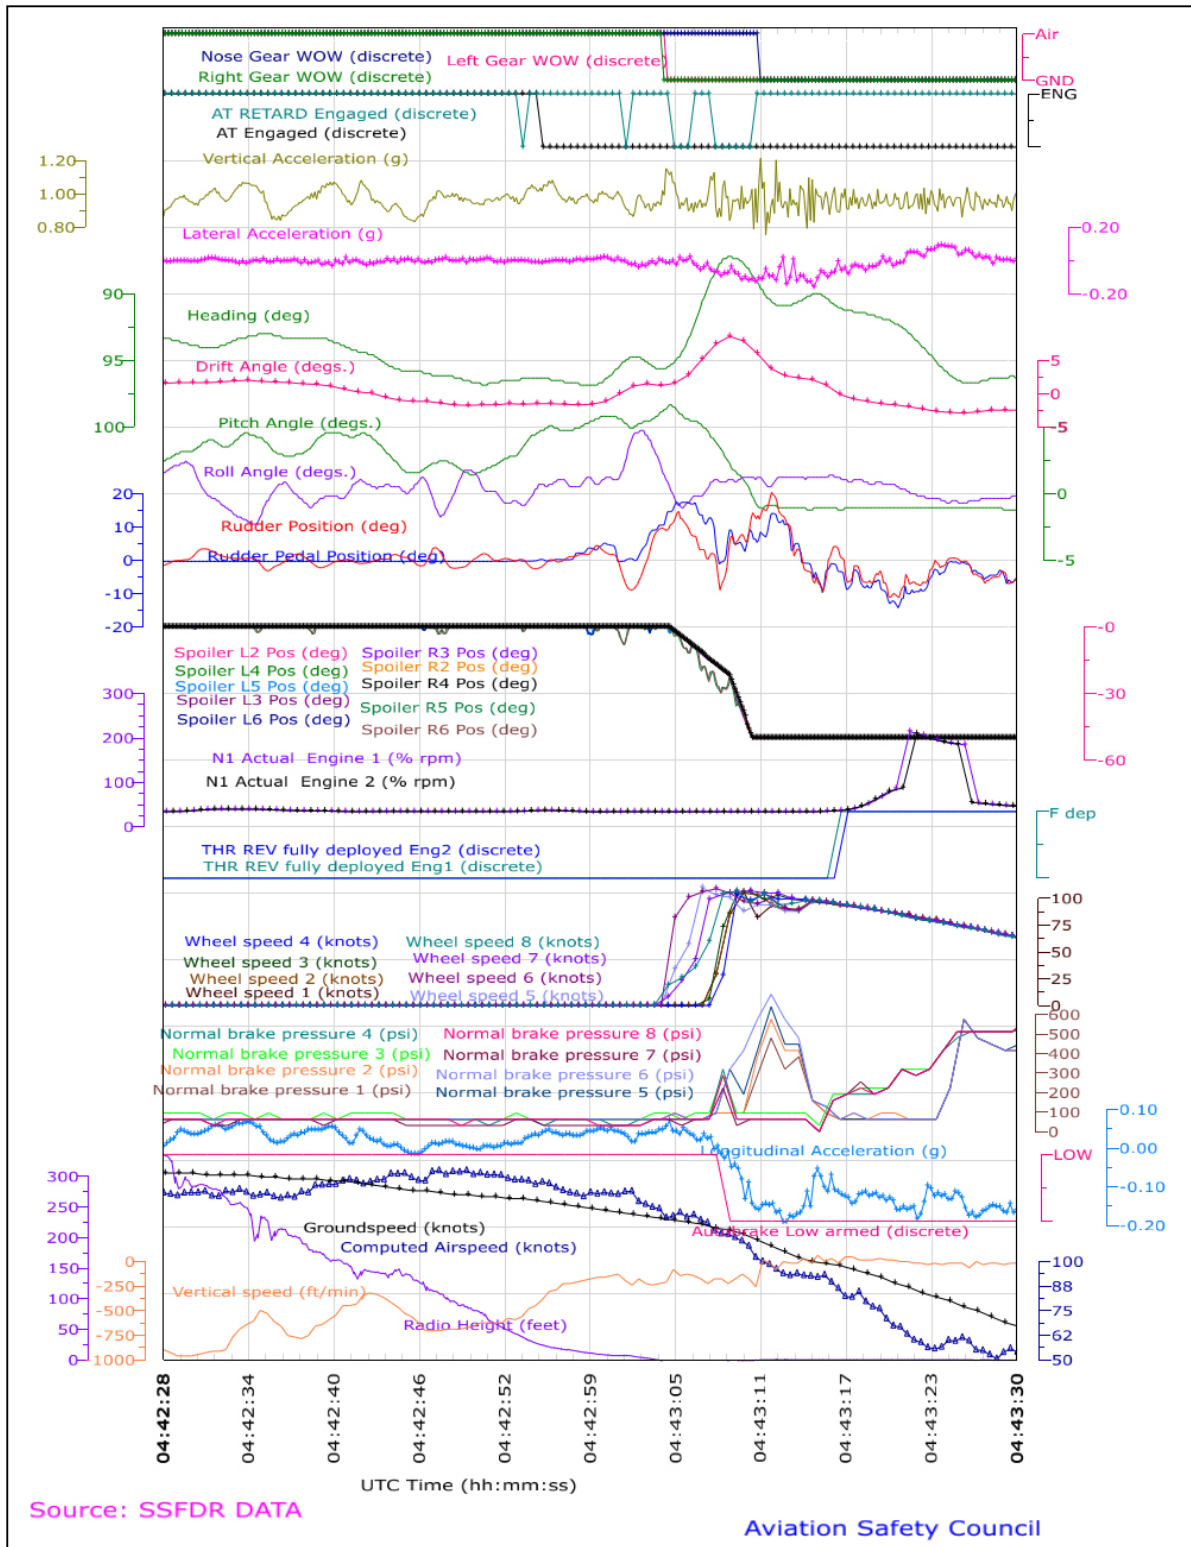
圖 1.11-4 SSFDR 飛航參數繪圖 (煞車及航向操控)

●1243:19 時至 1243:38 時期間（反推力器展開至收回），左右煞車壓力變化為 64PSI / 224PSI  $\rightarrow$  576PSI / 512PSI  $\rightarrow$  352PSI / 416PSI；1243:38 時左右反推力器收回；地速變化為 96 浬/時 $\rightarrow$  49 浬/時。

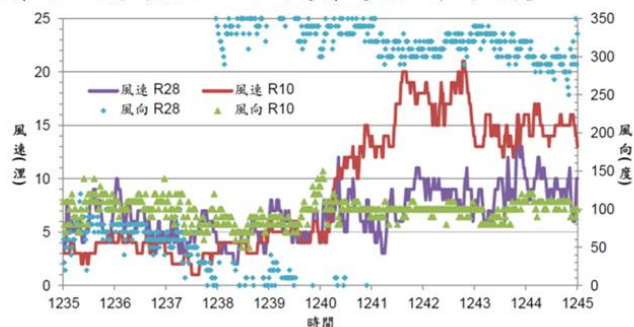
1. 依據調查報告草案第1.10.3 節-鋪面狀況及抗滑章節:” 本次事故發生後，依據首先抵達跑道現場之航務員觀測，當時鋪面為濕「Wet」之狀況”。
2. 依據第一章事實資料 圖1.7-3 10/28 AWOS跑道風向風速如下，於BR189最後進場落地期間，RWY10與RWY28 之風速風向有明顯差距，風向有約230度的差距，而風速有超過15節的改變。

3. 依據調查報告草案第1.7.3節-低空風切警訊章節:”松山機場低空風切預警系統 (Low Level Wind Shear Alert System, LLWAS) 於1230時至1300時之間，10跑道進場曾出現低空風切警示。
4. 依據AWOS的風速與風向判斷，在BR189最後進場階段，應有一”下沉氣流”(downburst)伴隨雷雨而至，而該”下沉氣流”接觸地面位置應在RWY10北邊且較接近RWY10跑道頭，才會造成AWOS資料顯示RWY10(風速約17節, 風向約110度)與RWY28(風速約7節, 風向約320度)有約10節風速以及約210度風向的明顯差距。
