飛航事故調查報告

ASC-AOR-13-11-001

**中華民國102年6月3日
中華航空公司CI 781航班
AIRBUS A330-300型機
國籍標誌及登記號碼B-18317
於胡志明市東北方110哩
遭遇艙壓異常航機緊急下降**

報告日期：民國 102 年 11 月

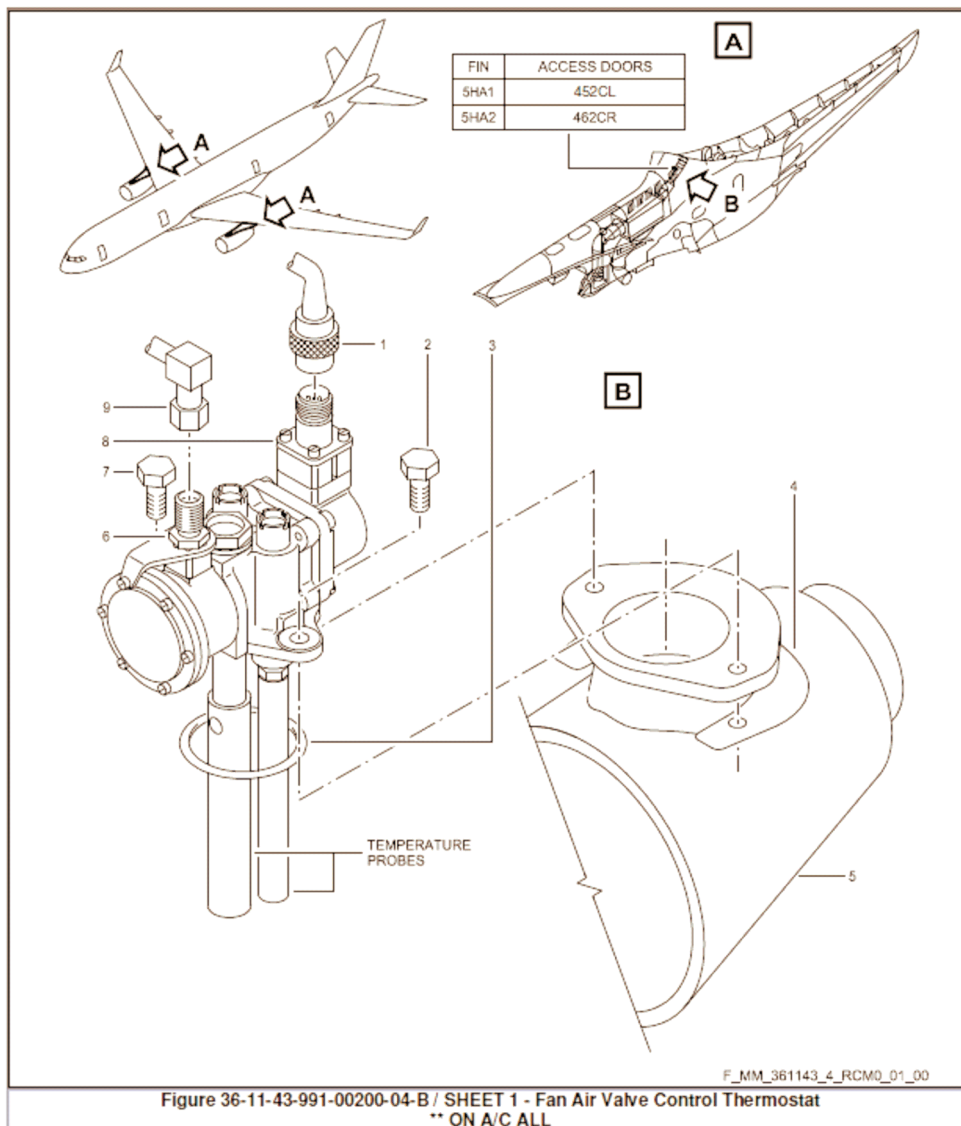
圖 1.6-3 THC 裝置圖

摘錄該機飛航維護紀錄簿，民國 102 年 6 月 3 日於執行 CI781 任務後，登錄「AIR ENG 2 BLEED FAULT」及「AIR ENG 1 BLEED FAULT」缺點，維修人員依據飛機維修手冊 (Aircraft Maintenance Manual, AMM) 36-11-43 更換 2 號及 1 號 THC，於取出 2 號 THC 時，其上之氣封膠圈 (O-RING) 因材質硬化缺損而散失，於取出 1 號 THC 時其上之 O-RING 材質硬化但完整無缺損。民國 102 年 7 月 14 日登錄 FAV SENSE LINE LEAK CHECK 正常。(詳附錄一)

依據 1.16.2 節，LIEBHERR 原廠調查報告及 AAIB Singapore 見證測試報告 3.1.2 及 3.2.2 節內容，顯示 THC SN 01404 之故障現象，並非導致 2 號發動機供氣系統超溫之原因，而係 O-RING 硬化缺損而發生 THC 與發動機供氣系統管路間接頭處漏氣，致使進入 THC 本體之供氣減弱而無法建立驅動 FAV 之壓力，使 FAV 開度變小，冷卻效果不足導致超溫，使 PRV 關閉，引起 2 號發動機供氣系統失效。另依據 DFDR 資料，航機起飛時「Eng.2 Pre Cooler Outlet Temperature」參數由 259°C 上升至最高 304°C，再下降至 257°C，亦證實 2 號發動機供氣系統發生超

- 更新 FAV 測試程序及裝備。
- 更新故障排除手冊（Troubleshooting Manual, TSM）。
- LIEBHERR VSB（Vendor Service Bulletin, VSB）技術通報 398-36-04，防止 THC 內部污染。
- LIEBHERR VSB 398-36-05（詳如附錄二），改進 THC 繫錘（Clapper）導管（Guide），防止黏滯、咬死及較不受老化影響。
- 更新 MPD THC 的濾網清潔/更換時程。

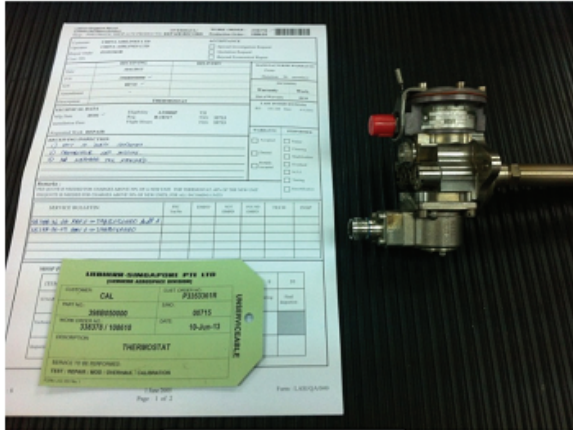
SN 00715 Thermostat

3.2.1 There is no service record of this component in Liebherr database. There were tags not belonging to Liebherr found on the component. China Airlines will have to check their records to where this component had been serviced.

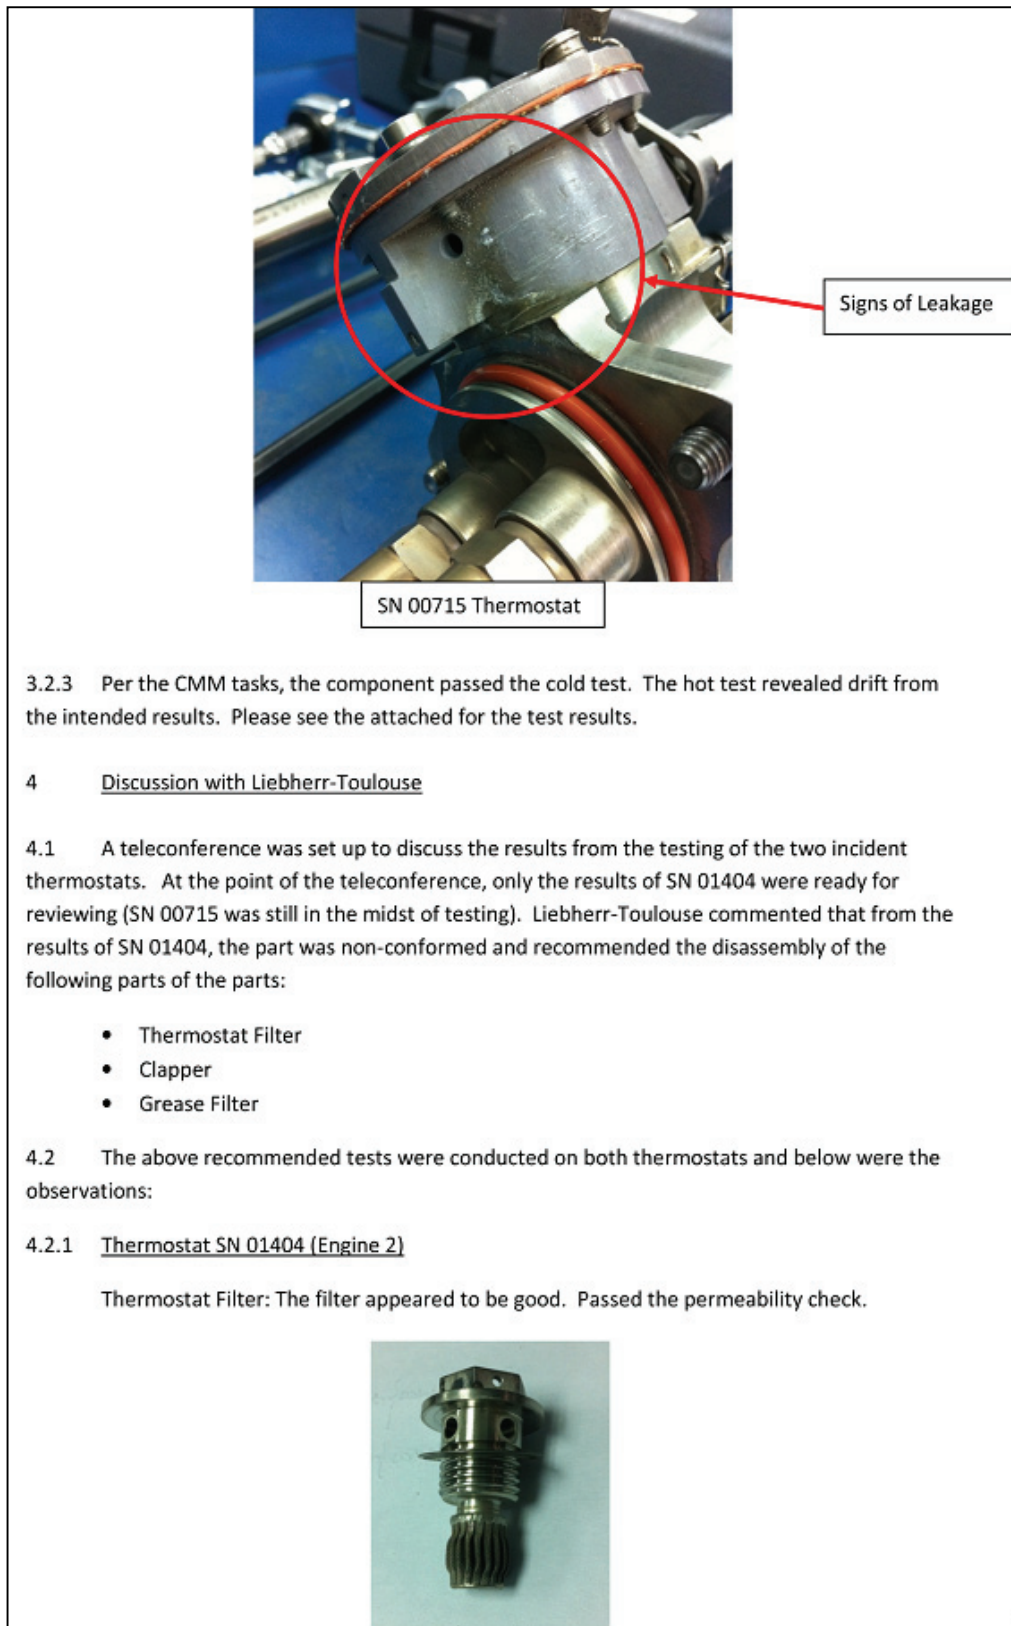
3.2.3 Per the CMM tasks, the component passed the cold test. The hot test revealed drift from the intended results. Please see the attached for the test results.
