# 飛航安全調查委員會

## 飛航事故 事實資料報告

復興航空公司 GE 5111 航班

松山機場起飛爬升時駕駛艙出現高溫氣體

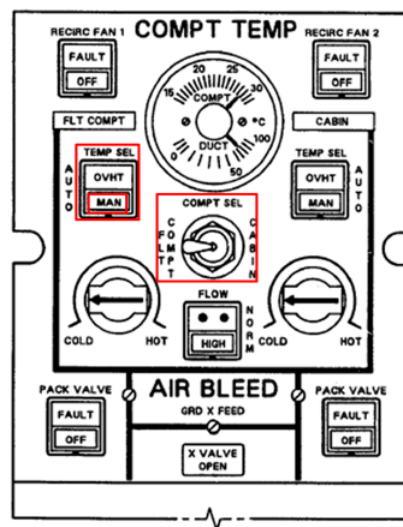
圖 1.6-3 駕駛艙溫度控制面板開關

入熱氣，或者關閉閥門阻隔熱氣進入；飛航組員可藉由選擇位於溫度控制面板之溫度顯示選擇開關至「FLT COMP」或「CABIN」(如圖 1.6-3，中央紅框處)，以檢視駕駛艙或客艙及空調導管 (Duct temperature) 之溫度。

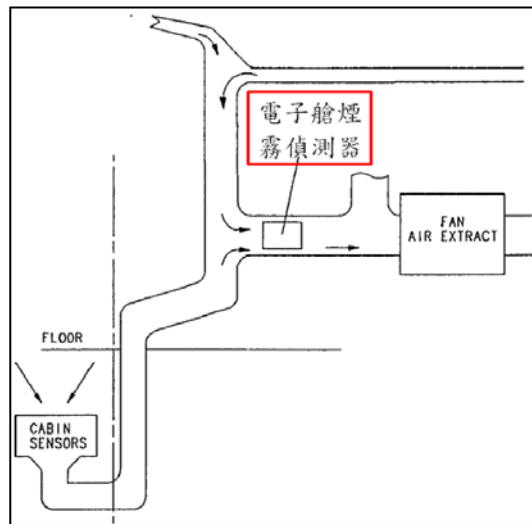
圖 1.6-4 電子艙煙霧偵測器位置

該型機電子艙煙霧偵測器位於電子艙散熱通風管道內（如圖 1.6-4），電子艙附近之風扇提供散熱空氣以降低各電子裝備之操作溫度，抽取駕駛艙與前客艙周遭空氣後，完成散熱後之空氣，經由管路導引至位於電子艙內之航電裝備架、斷路器面板及儀表板等，再由位於通風管道內風扇抽取，經由煙霧偵測器及通風閥門排放至機外。
