飛航事故調查報告

ASC-AOR-14-03-001

復興航空公司GE 5111航班

松山機場起飛爬升時駕駛艙出現高溫氣體

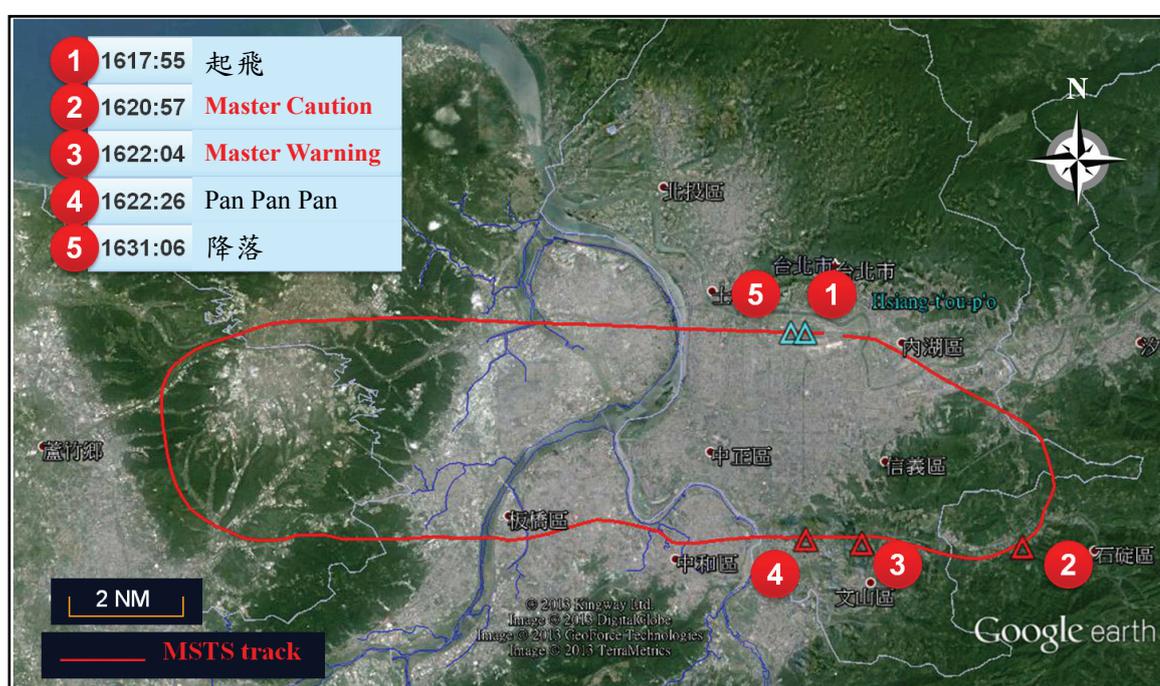
圖 1.1-1 飛航軌跡圖

駕駛艙主警示聲響出現後，副駕駛員持續與航管進行該機返航相關之通話。經臺北近場臺確認該機返航之意圖後，指示航向 270 度，高度保持 4,000 呎，以雷達引導至松山機場 ILS 10 號跑道之最後進場航道，當時航機高度約 5,100 呎。1621:44 時，客艙組員以機內通話告知飛航組員，客艙吹出之空氣為暖空氣，正駕駛員告知空調系統故障，並指示客艙組員廣播告知航機將返回松山機場。

開啟電子艙排氣通風閥 (AVIONICS VENT EXHAUST MODE...OVBD)、以及選擇高空調供氣壓力 (AIR FLOW...HIGH) 等步驟。飛航組員表示，當電子艙排氣通風閥開啟後，駕駛艙之霧氣及警示燈全部消失，溫度也恢復至可接受之程度，飛航組員因而決定不繼續執行電子艙煙霧處置程序後續之步驟，但因為駕駛艙出現高溫與霧狀氣體之原因不明，所以告知航管狀況解除，仍請求返場落地。該機於 1631 時落地，正常滑回停機坪，人機均安。

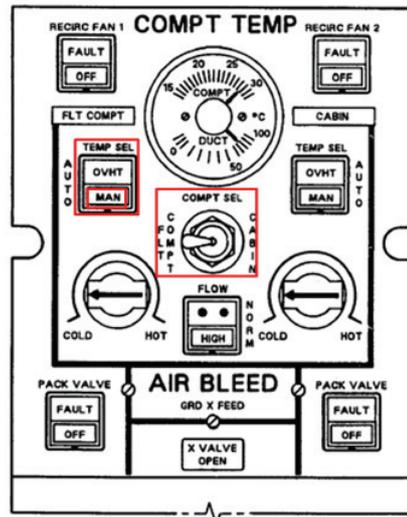
圖 1.6-3 駕駛艙溫度控制面板開關

飛航組員對駕駛艙及客艙空調溫度控制方式有自動及手動兩種方式，當自動溫度控制失效時，飛航組員可將駕駛艙內之溫度控制面板「TEMP SEL」按鈕開關按下，「MAN」燈亮起（如圖 1.6-3），以手動方式調整空調溫度，並藉由調整面板上之溫控選擇鈕，打開調節閥門引入熱氣，或者關閉閥門阻隔熱氣進入；飛航組員可藉由選擇位於溫度控制面板之溫度顯示選擇開關至「FLT COMP」或「CABIN」（如圖 1.6-3，中央紅框處），以檢視駕駛艙或客艙及空調導管（duct temperature）之溫度。

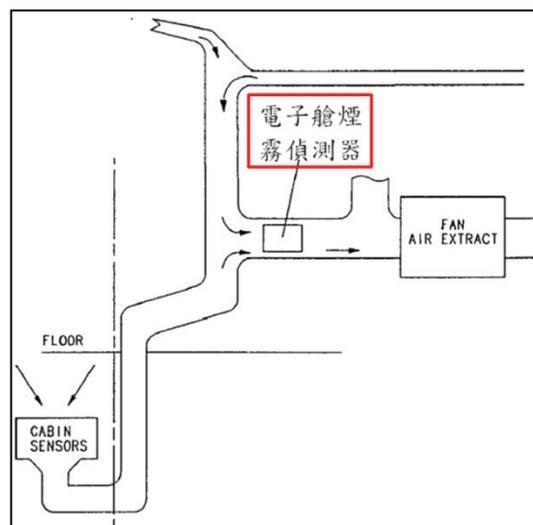
圖 1.6-4 電子艙煙霧偵測器位置

該型機電子艙煙霧偵測器位於電子艙散熱通風管道內（如圖 1.6-4），電子艙附近之風扇提供散熱空氣以降低各電子裝備之操作溫度，抽取駕駛艙與前客艙周遭空氣後，完成散熱後之空氣，經由管路導引至位於電子艙內之航電裝備架、斷路器面板及儀表板等，再由位於通風管道內風扇抽取，經由煙霧偵測器及通風閥門排放至機外。

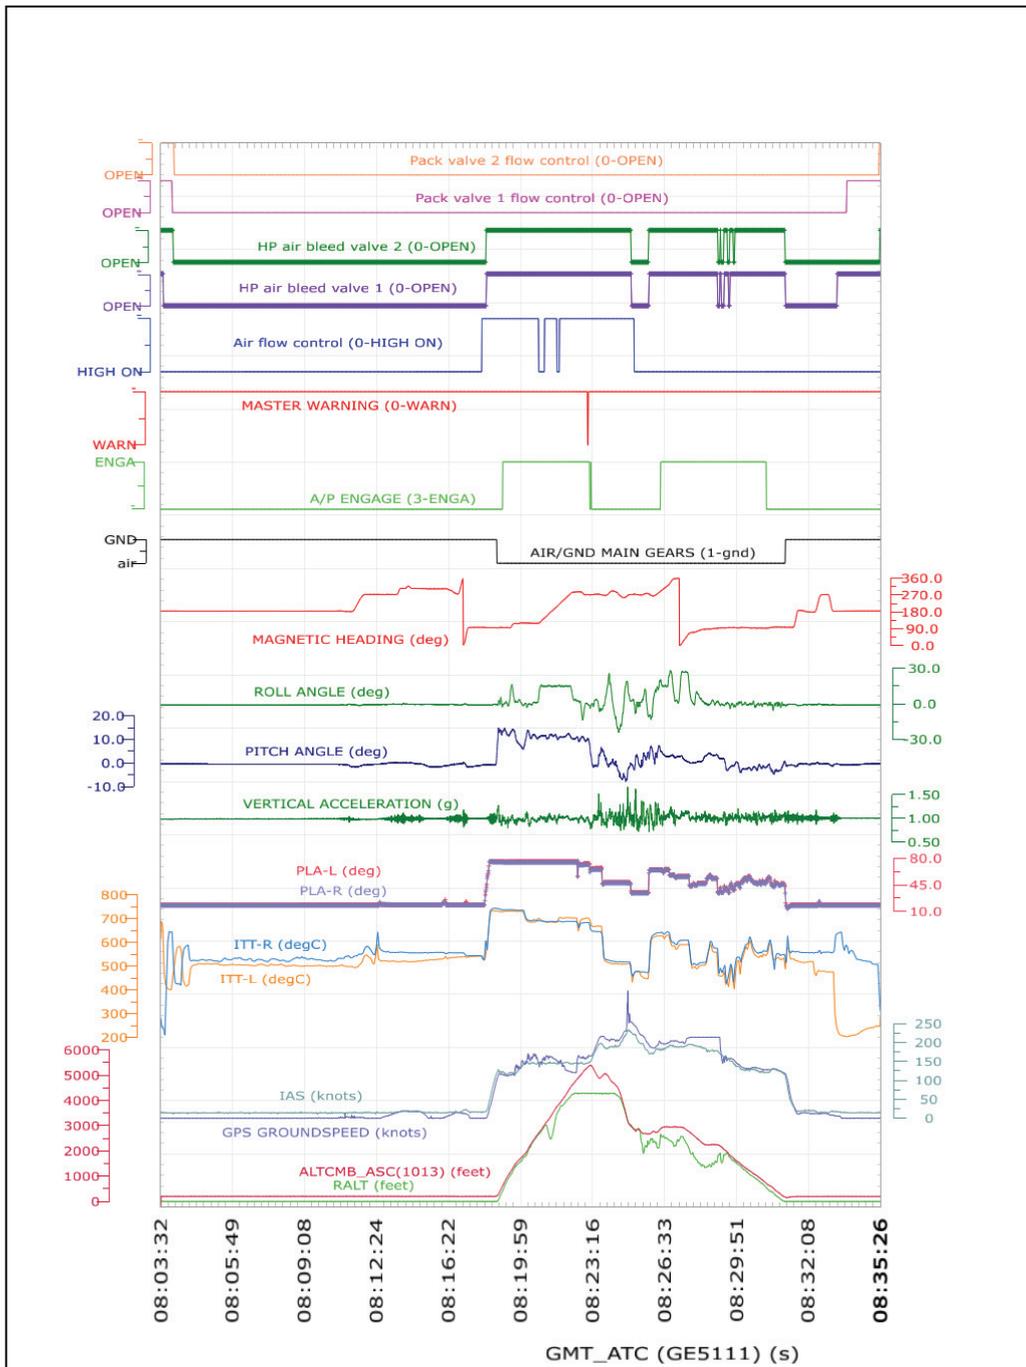
圖 1.11-1 SSFDR 飛航參數圖 (完整航班)

2,880 呎；0830:14 時，解除自動駕駛。主警告發生期間空調相關參數解讀資料如附件 2，飛航參數變化情形，詳圖 1.11-1 及圖 1.11-2。SSFDR 解讀後，以 ATC UTC 時間為參考依據。
