飛航事故調查報告

ASC-AOR-17-06-001

**中華民國105年4月17日
中華航空公司CI025班機
BOEING 737-800型機
國籍標誌及登記號碼B-18609
於關島西北方約150海浬上空艙壓異常返航**

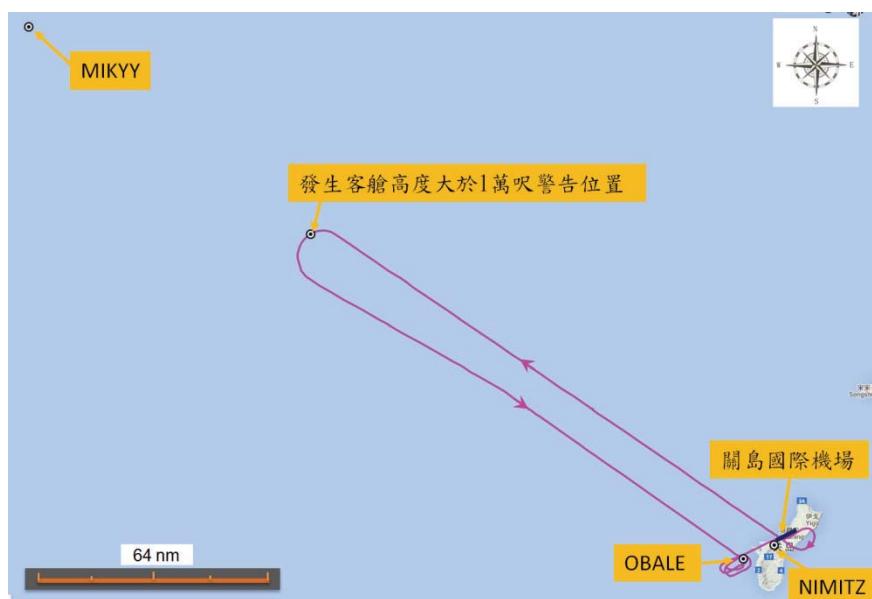
圖 1.1-2 事故機飛航軌跡

1441 時，飛航組員確認艙壓高度已低於 10,000 呎後，先後取下氧氣面罩，該機於關島近場臺許可下持續下降至 6,000 呎高度，後續於 OBALE 初始進場點附近待命航線盤旋消耗燃油後，於 1525 時安降關島 06R 跑道，人員無傷亡，航機無受損。維修人員檢查後發現，該機外流閥（out flow valve, OFV）無法固定於打開或關閉位置，可隨意活動。該機飛航軌跡與事故發生相關位置，如圖 1.1-2 所示。

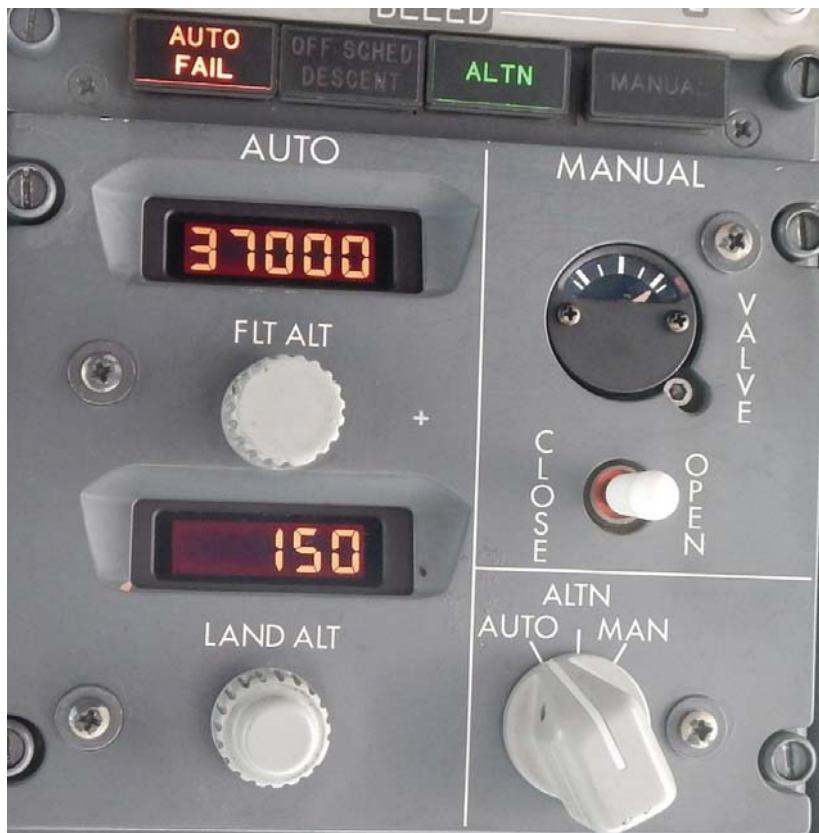
圖 1.6-2 艙壓控制模組

依據華航飛機維修手冊 (aircraft maintaince manual, AMM)，飛機壓力控制系統包含 3 個次系統，分別為：CPCS、艙壓釋壓系統、艙壓指示及警告系統；CPCS 功能為操作 OFV 開口大小，以達控制機艙內部排出空氣之速率，以維持機艙壓力高度，防止飛機飛航時組員及乘客發生缺氧狀況及安全且舒適之艙壓環境；CPCS 主要元件包含：1 具位於駕駛艙之 CPCM (如圖 1.6-2)、2 具位於電子艙之艙壓控制器 (cabin pressure controller, CPC) 及 1 具位於後方機腹之 OFV。
