國家運輸安全調查委員會

重大運輸事故 事實資料報告

遠東航空股份有限公司 FE3060 班機

於臺中清泉崗機場落地時短暫偏出跑道

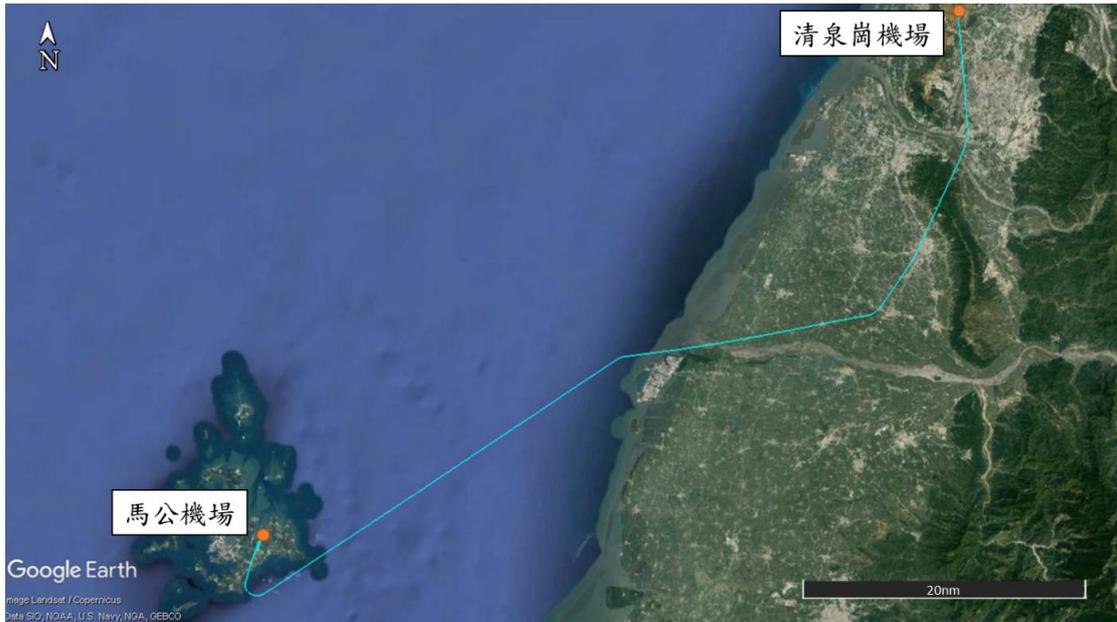
圖 1.1-1 事故機全程飛航軌跡圖

PM 於訪談時表示距跑道頭約 1 哩時，目視航機落地燈照到跑道道面有反光，且可看到水波紋，表示跑道有積水。PF 表示航機觸地剎那，瞬間向左偏，立刻放下鼻輪修正，但航機仍然向左偏出跑道，修正回跑道後，將航機停止於距跑道頭約 7,000 呎處並通知塔臺航機可能因出跑道受損，建議派員至現場檢視。經地面人員確認航機除右主輪轂有草外無其他損傷後，始將航機滑回停機位置。該機自馬公機場起飛至臺中機場全程飛航軌跡如圖 1.1-1，落地期間偏出跑道之軌跡如圖 1.1-2。

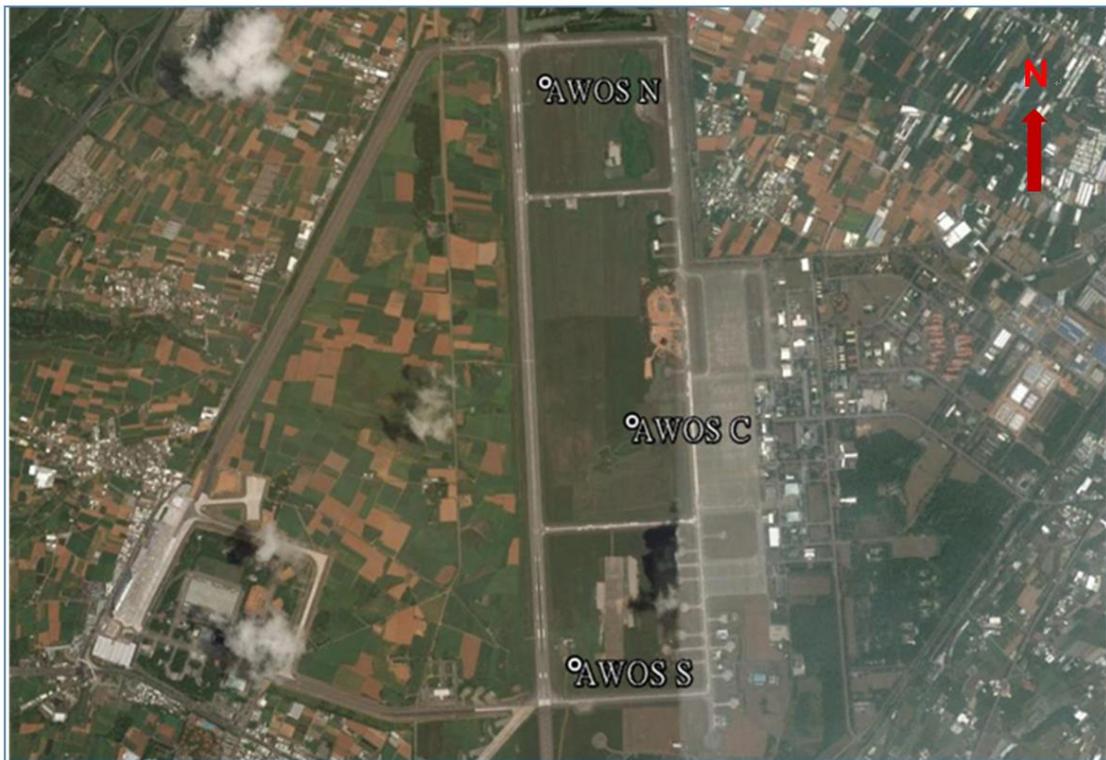
圖 1.7-3 AWOS 設置地點

臺中機場地面自動氣象觀測系統 (automated weather observation system, AWOS) 設置於跑道兩端及中段附近 (設置地點如圖 1.7-3)，提供天氣中心及塔臺即時之天氣資訊顯示，相關天氣紀錄如圖 1.7-4 至圖 1.7-6 所示。自 2118:00 時 (該機無線電高度為 200 呎) 至 2118:29 時 (該機左偏後返回跑道)，AWOS S 風向為 030-070 度，風速 3-11 浬/時；AWOS C 風向為 040-060 度，風速 5-8 浬/時；事故前 6 分鐘 AWOS S 之跑道視程大於 2,000 公尺，累積降水量 0.4 毫米 (降雨強度為中度)。

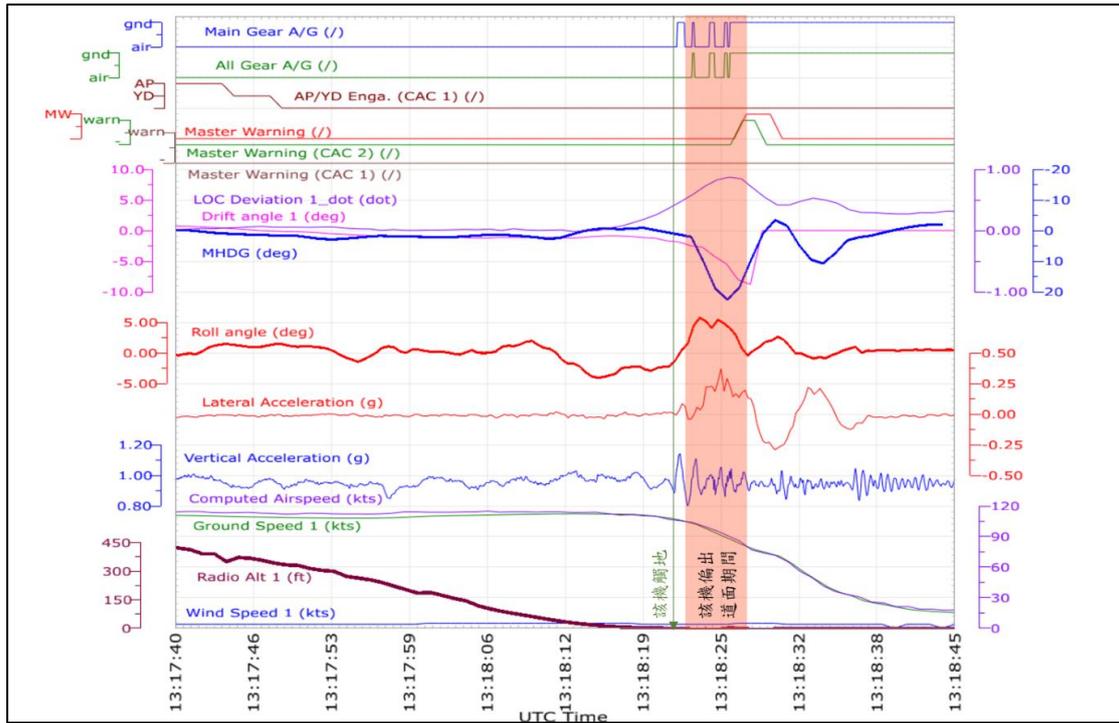
圖 1.11-1 落地階段之飛航資料繪圖 (1)

7. 2118:26 時，該機左主輪於距跑道頭約 2,640 呎，距跑道邊線外側最遠約 15 呎，空速 96 浬/時，地速 92 浬/時，磁航向 19 度。
8. 2118:28 時，該機左主輪於距跑道頭約 2,880 呎返回跑道，空速 86 浬/時，地速 81 浬/時，磁航向 19 度，此時主警告「master warning」及「master warning (CAC2)」參數作動並持續 3 秒，儀表板上的發動機警告顯示 (engine warning display, EWD) 頁面亦出現「ENG 2 FLAME OUT IN FLIGHT」程序，並於 1 秒鐘後轉變為「ENG 2 FLAME OUT ON GROUND」的程序。
9. 2118:36 時，該機於距跑道頭約 3,640 呎，跑道中心線左側約 50 呎處滑行，地速 35 浬/時，磁航向 8 度，EWD 顯示程序轉變為「AFTER LANDING」程序並持續至該機停止滑行。
10. 2119:21 時，該機停止於距跑道頭約 4,530 呎，跑道中心線左側約 60 呎處，左右發動機仍維持正常運轉。
11. 2136:07 時，該機以自身動力再度開始滑行進入滑行道，約 2146 時停止於臺中航空站停機坪，約 2148 時 FDR 停止記錄。
12. 圖 1.11-1 及圖 1.11-2 為事故機落地階段之飛航資料繪圖，圖 1.11-3 為事故機起飛至落地飛航軌跡圖。
