# 國家運輸安全調查委員會

## 事實資料報告

國籍標誌及登記號碼 NA-103

執行模擬尾旋翼失效程序時墜毀

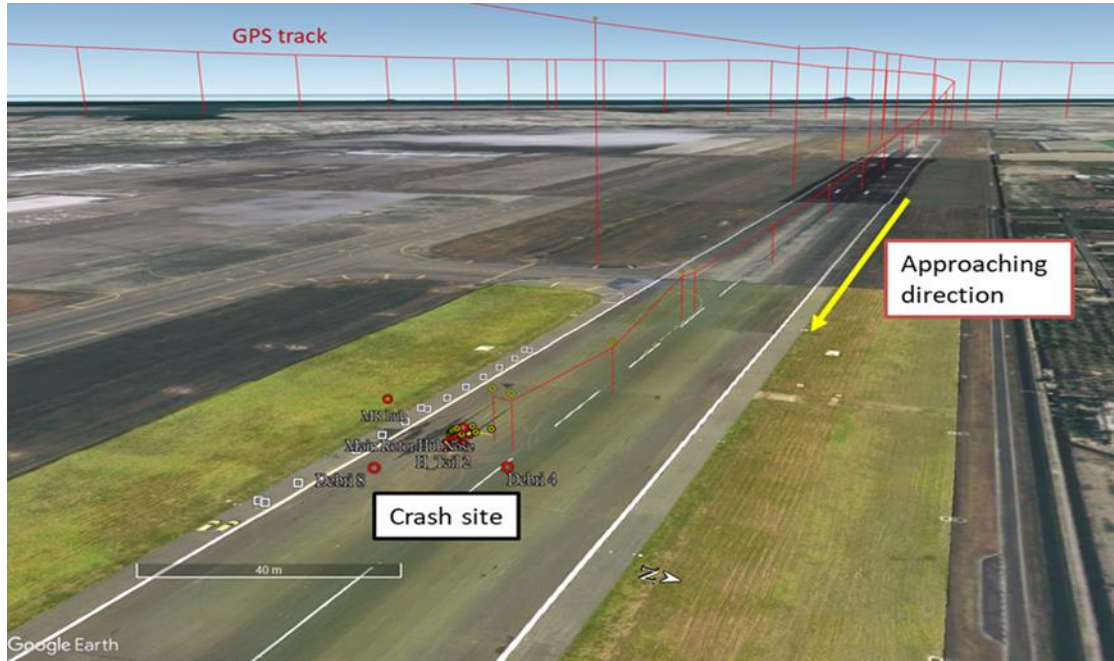
圖 1.1-2 事故前飛航軌跡

50 呎，繼續沿跑道穩定飛航並下降至距道面約 20 呎，速度約為 60 浬/時；1530 時，該機開始建立右偏角度，於 1530:15 時到達約 30 度之右偏角（機頭向右）並沿跑道前行，前進姿態穩定，速度減少至約 28 浬/時。至 1530:48 時前，該機保持約 20 度至 40 度之右偏角、保持距地約 20 呎之高度沿跑道方向前行，速度開始繼續減少至約 16 浬/時。1530:54 時航機右偏角度加大至約 40 度，呈滯空狀態，速度已遞減至 0，至 1530:59 時，航機開始快速右偏，約於 1531:01 時主旋翼打地，並冒出大量白煙。1531:06 時，白煙向南飄散，航機側翻於跑道上，機身左側向下，主旋翼全毀，機首方向約為 260 度。該機於進入跑道後之飛航軌跡，如圖 1.1-2，停止於跑道上之姿態，如圖 1.1-3。

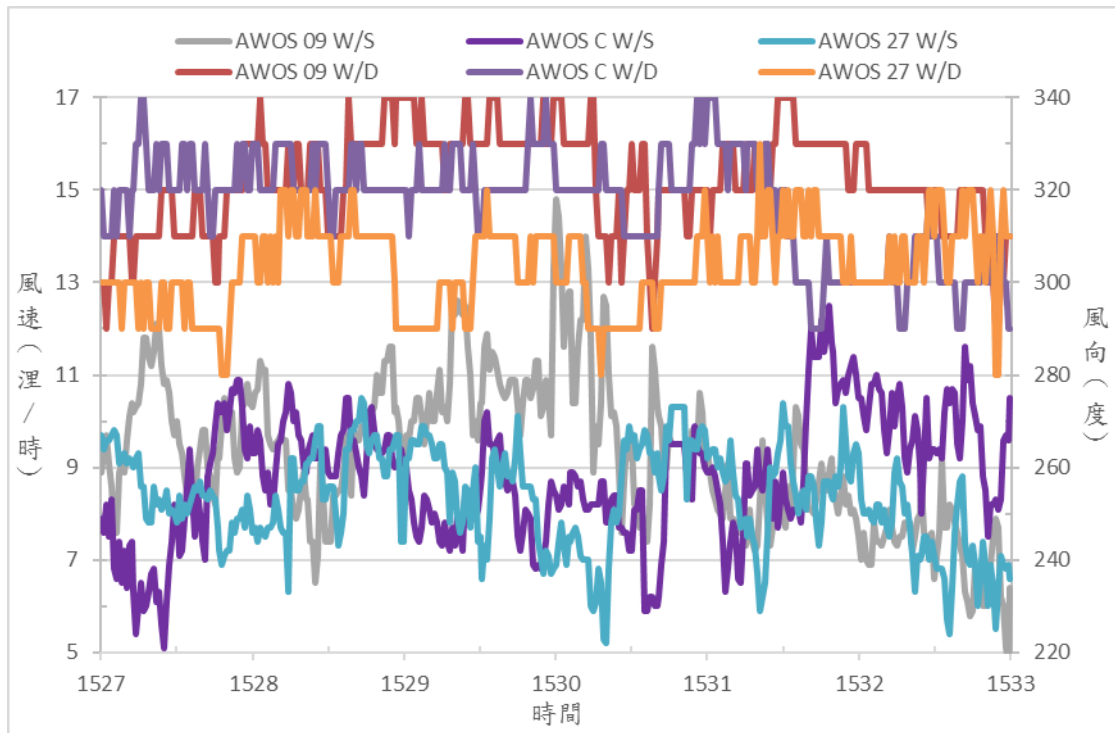
圖 1.7-2 高雄機場 AWOS 瞬時風向風速

高雄機場地面自動氣象觀測系統（automated weather observation system, AWOS）設置於跑道兩端及中段附近，如圖 1.7-1。1527 時至 1533 時之每秒瞬時風向風速，如圖 1.7-2，09 跑道頭風向為 290 至 340 度，風速 7 至 15 浬/時；跑道中段風向為 310 至 340 度，風速 6 至 10 浬/時，如圖 1.7-3；27 跑道頭風向為 280 至 320 度，風速 5 至 10 浬/時，如圖 1.7-4。

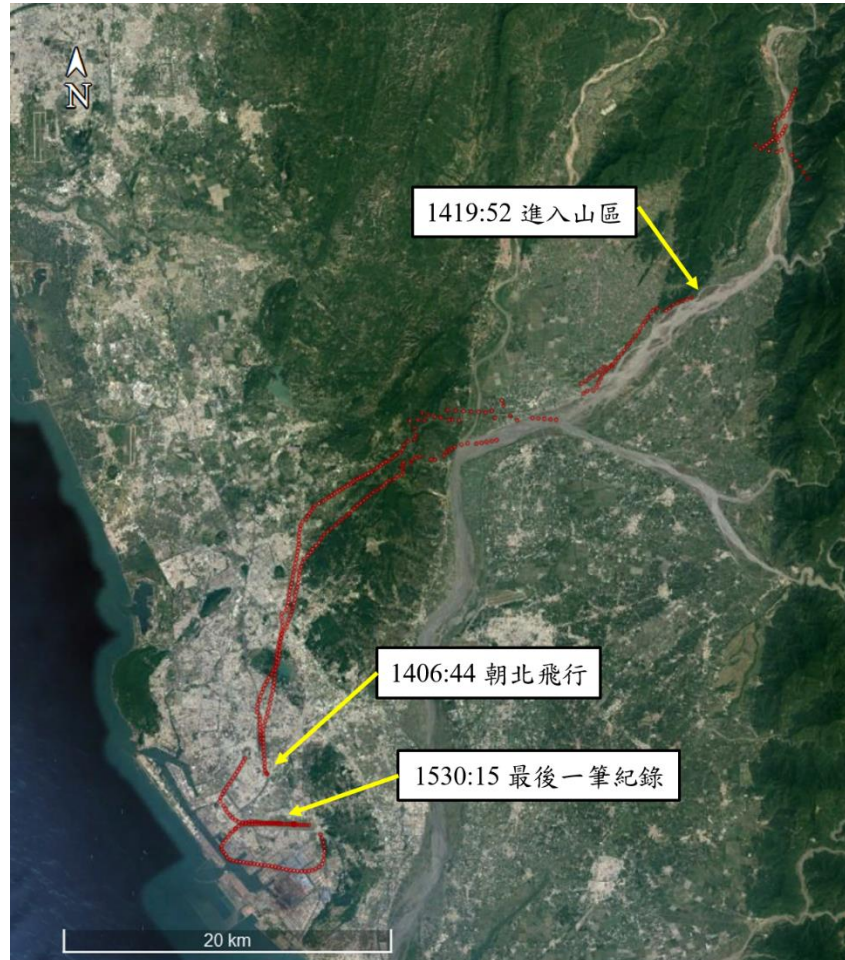
圖 1.11-1 雷達軌跡與衛星影像套疊圖

依據該 MSTS 資料，自 1406:44 時開始至 1530:15 時止。當日下午事故機由高雄機場起飛後向北飛行，於 1408:45 時通過澄清湖朝北飛行，於 1416:23 時經里港大橋後朝東北方荖濃溪上游處飛行，受地形遮蔽影響，MSTS 資料未涵蓋部分山區飛行期間。該機於 1510:51 時經里港交流道朝西南方飛行，於 1518:28 時通過澄清湖朝南飛行，該機於 1522:24 時第 1 次進入 09 跑道頭；於 1529:23 時第 2 次進入 09 跑道頭；1530:15 時為最後一筆紀錄，位於高雄機場 C 滑行道停止線東北方約 120 公尺處。

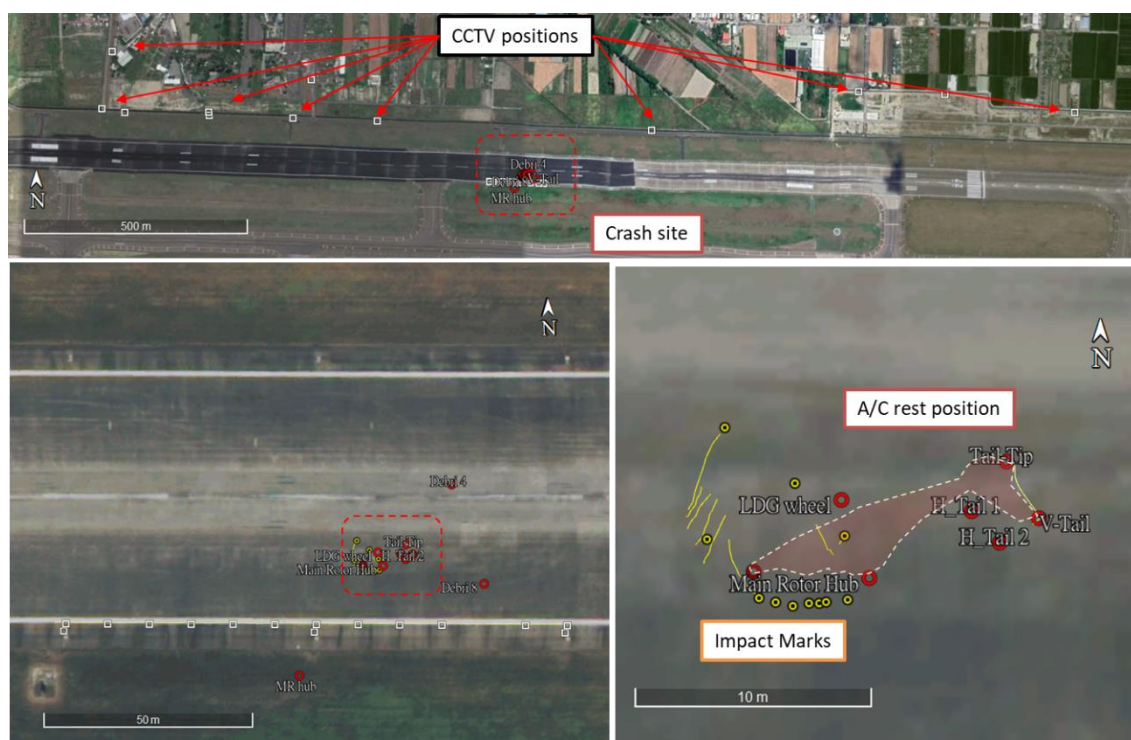
圖 1.12-13 現場測量結果及 CCTV 位置

本次事故現場量測使用高精度衛星測量儀以及遙控無人機，以跑道邊線、距離標識及跑道邊燈特徵為量測參考基準，量測資料包括事故機主旋翼與跑道接觸之刮痕、主輪、主旋翼、機鼻、尾旋翼、水平尾翼以及跑道北側圍牆各 CCTV 安裝位置如圖 1.12-13。

相關測量成果搭配該機 GPS 軌跡，並與遙控無人機拍攝及後製之 1 公分解析度正射影像套疊如圖 1.12-14 所示。根據現場測量結果，該機於 09 跑道進場後因機身傾轉，導致主旋翼接觸跑道產生多處刮痕，刮痕區域離 09 跑道頭約 4,960 呎，離跑道中心線右側約 35 呎，該機停止位置離 09 跑道頭距離約 4,980 呎，離跑道中心線右側約 46 呎，機鼻參考方向為 253 度。
