# 國家運輸安全調查委員會

## 重大運輸事故 調查報告

華信航空股份有限公司 AE7931 班機

於下降過程客艙短暫失壓

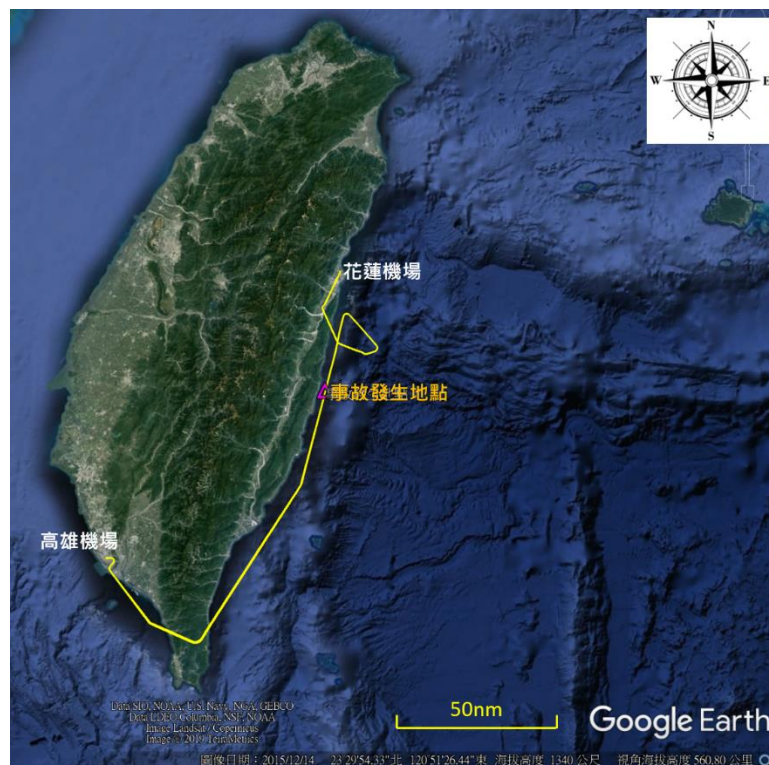
圖 1.1-1 事故航班飛航軌跡

1514 時，飛航組員向臺北近場臺管制員請求雷達引導，執行花蓮機場 03 跑道儀器降落系統(instrument landing system, ILS)進場，於 1528 時降落花蓮機場，人機均安。事故航班飛航軌跡如圖 1.1-1。

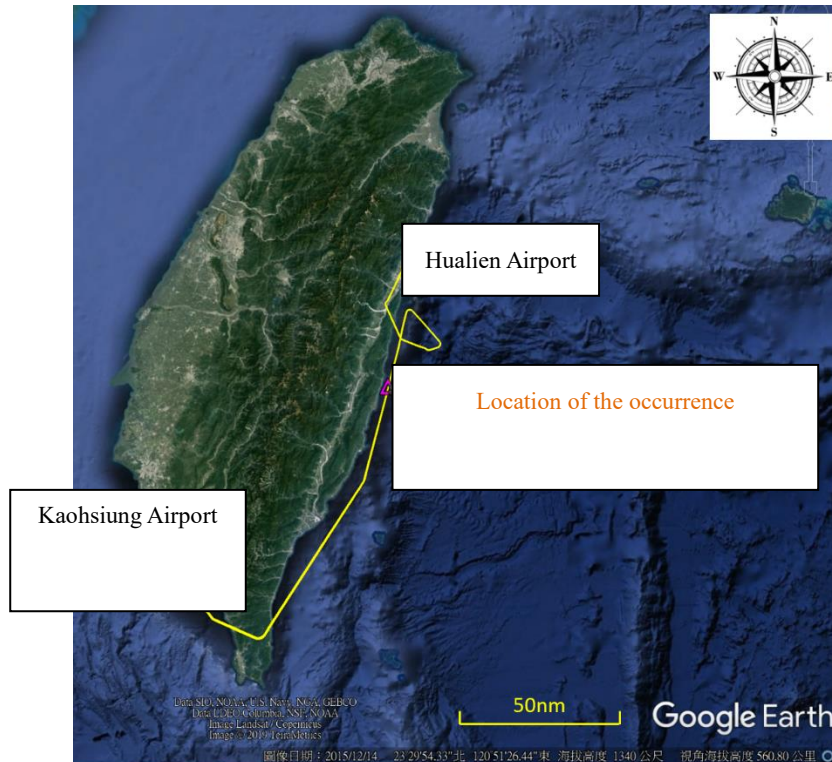
Figure 1.1-1 Flight Path of the Occurrence Aircraft

At 15:14, the flight crew requested radar vectors for the runway 03 instrument landing system (ILS) approach from Taipei Approach. At 15:28, the aircraft landed at Hualien Airport without further event. The flight path of the occurrence aircraft is shown in Figure 1.1-1.

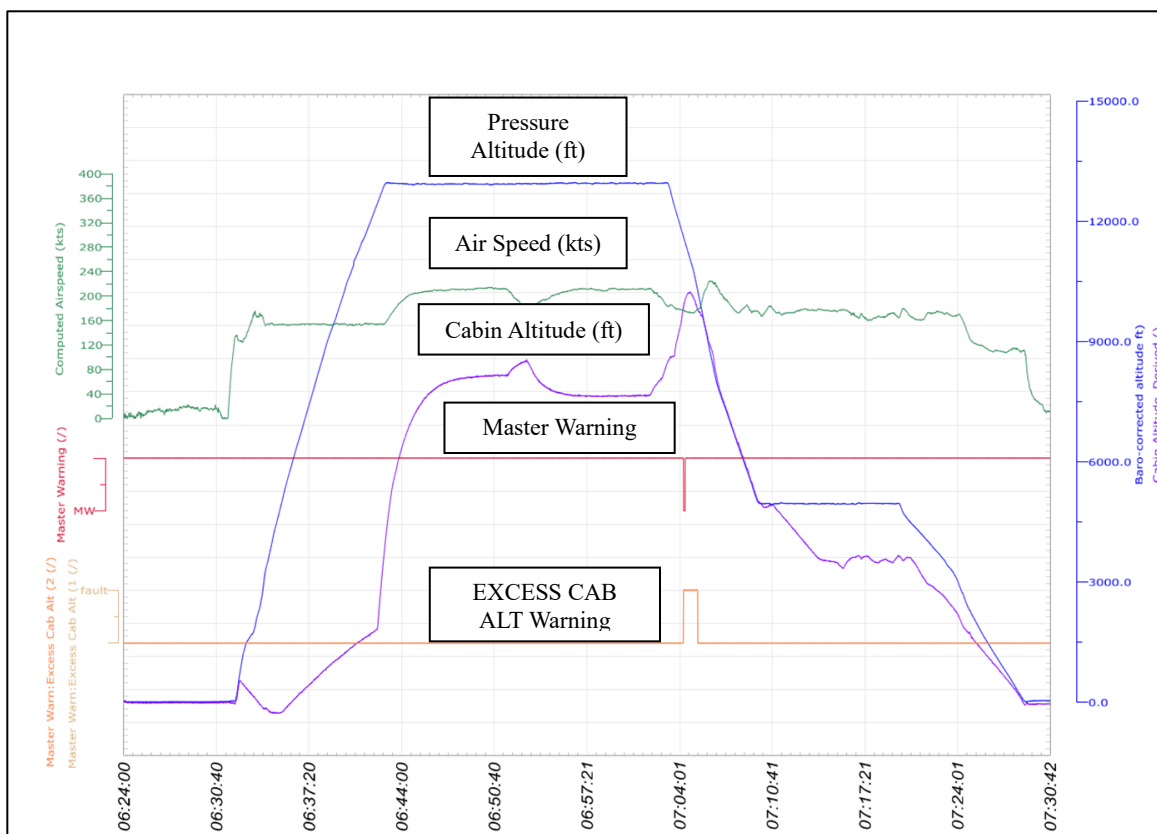
Figure 1.11-1 Flight Data Plot of the Occurrence Aircraft

5. At 15:04:45 Taipei Local Time, the pressure altitude of the aircraft was 11,090ft and the cabin altitude peaked at 10,241ft.
6. At 15:05:19 Taipei Local Time, the pressure altitude of the aircraft was 10,284ft. The EXCESS CAB ALT warning was cancelled when the cabin altitude became 9,833ft.
7. The aircraft landed at Hualien Airport at 15:28:50 Taipei Local Time.
8. At 15:34 Taipei Local Time, FDR stopped recording.

The flight path of the occurrence aircraft is shown in Figure 1.1-1. Figure 1.11-1 depicts the data plot of the recorded parameters for the aircraft.
