# **Aviation Occurrence Report Volume I**

**IN-FLIGHT BREAKUP OVER THE TAIWAN STRAIT**

**CHINA AIRLINES FLIGHT CI611**

**BOEING 747-200, B-18255**

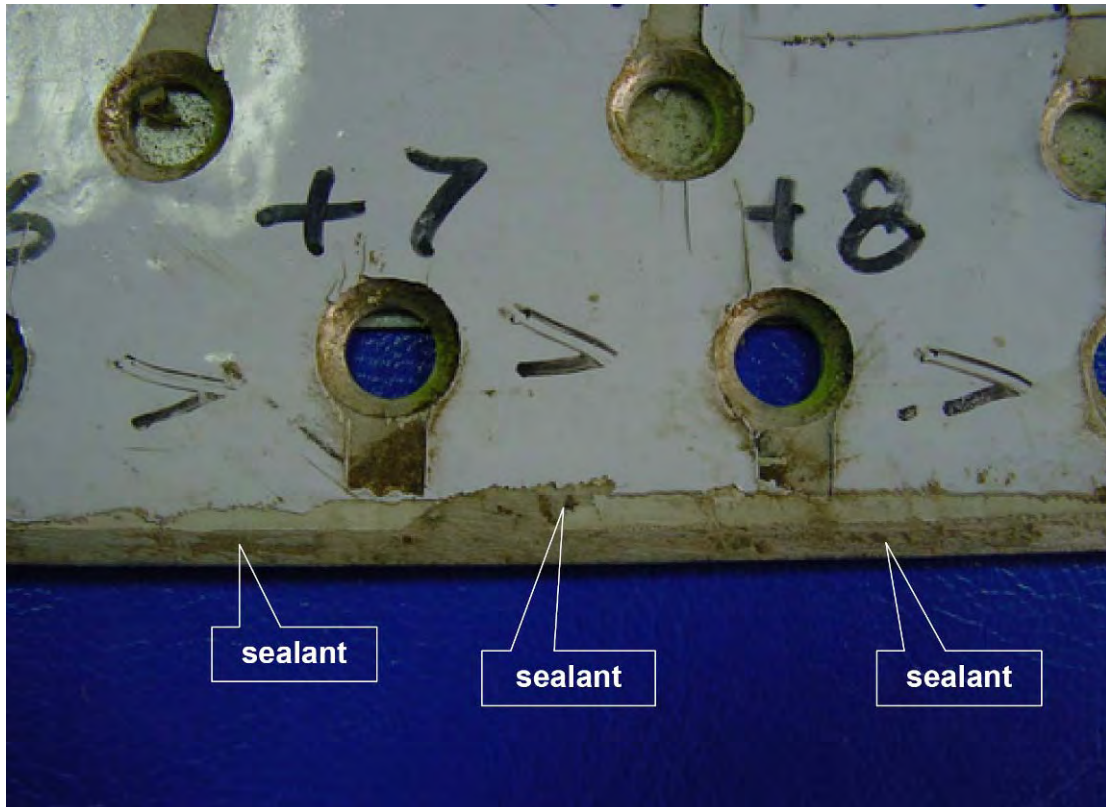
Figure 1.6-11 Paint removed from the doubler edge with sealant remaining

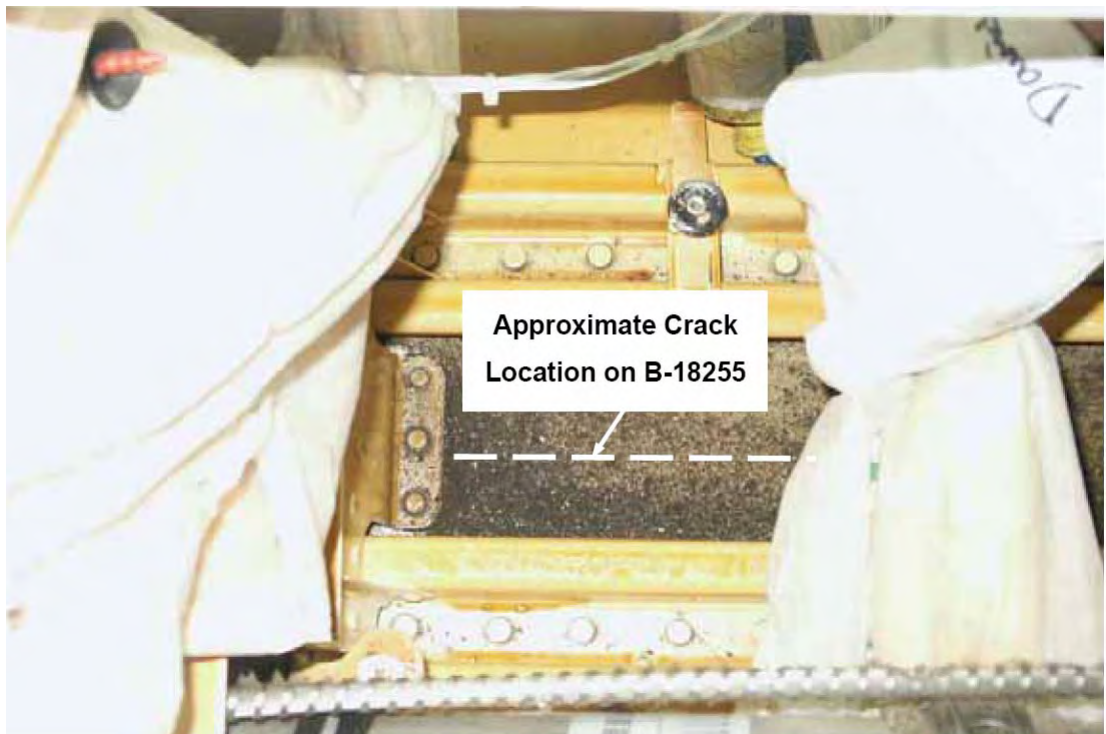
Figure 1.6-12 shows a B747-200 freighter bilge after cleaning. Figure 1.6-13 shows the bilge before corrosion inhibit compound and dust was removed from a B747-400 freighter. The stain on the lower lobe skin cover part of the paint. The bilge was covered with dirt and residue on two adjacent insulation blankets in the bulk cargo lower lobe bay.

Figure 1.6-13 A B747-400 aircraft bilge area without removing CIC and dust

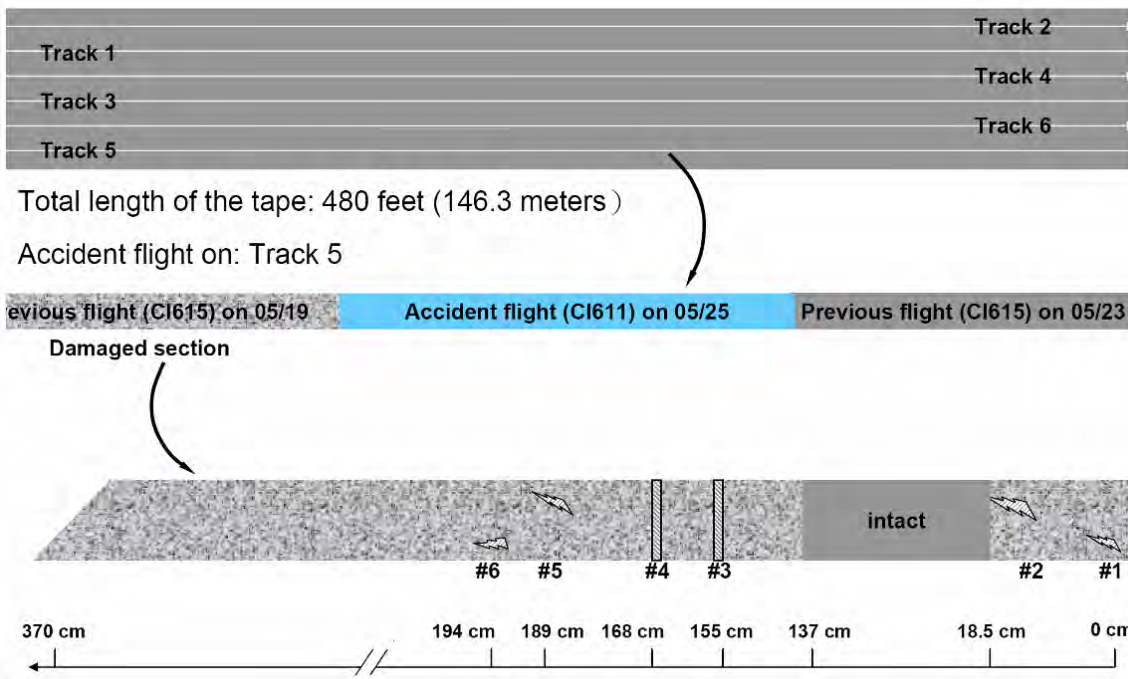
Upon arrival, the FDR enclosure was open immediately and the magnetic tape was found damaged. Pictures of the damaged FDR tape are shown in Figures 1.11-3 and 1.11-4. There are six crinkle marks on the tape.

Figure 1.11-4 Sketch of damaged tape locations and conditions

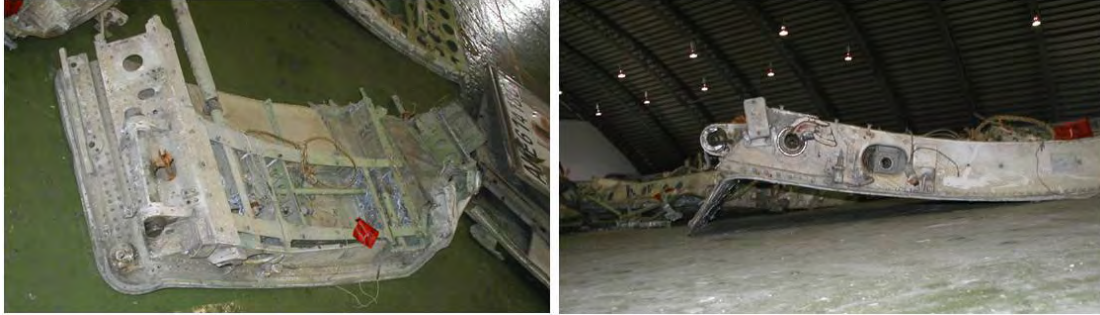
Figure 1.12-5      Item 2019

The lower aft portion of the door (item 2019 in Figure 1.12-5), including the aft pair of latches, was found separately. The lower portion of the door skin was bent

outboard approximately in 45 degrees. Examination of the hinge, latches, and the other mechanisms was consistent with the aft cargo door being closed at the time of the aircraft breakup.

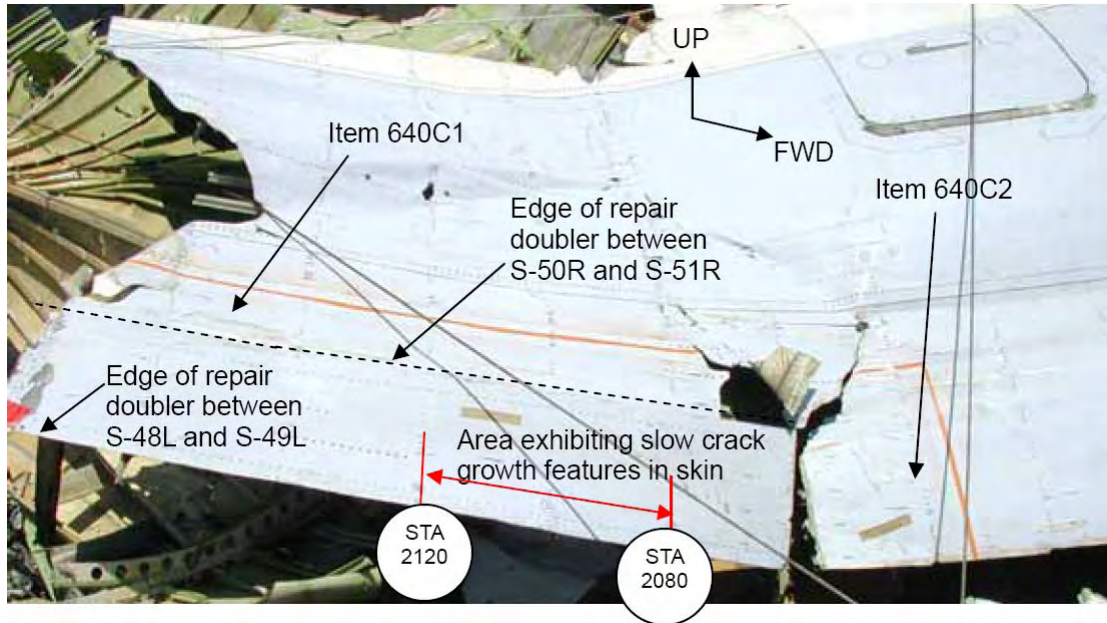
Figure 1.12-6 Item 640

Also included in item 640 is the bulk cargo door. The segment was recovered with the door closed and latched. The lower portion of the bulk cargo door seal protruded through the space between the door and the sill.

The forward portion of item 640 includes the aft portion of the aft cargo door cut out frame. There are deformations at the lower latch fitting attachment location.

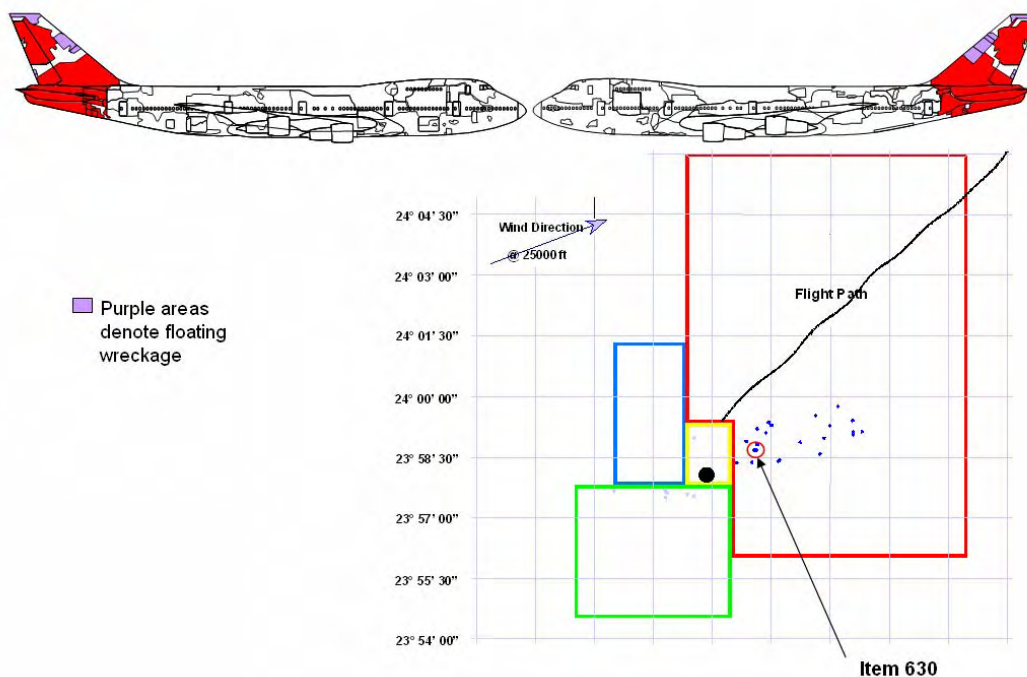
The section 48 and empennage structure (the aft pressure bulkhead and all structure aft) was found in the red zone (Figure 1.12-8). The horizontal stabilizer, the majority of the skin/stringer/bulkhead structure, and the lower third of the vertical fin were found attached with very little damage (Item 630, Figure 1.12-9).

Figure 1.12-8 Section 48 and empennage structure found in the red zone

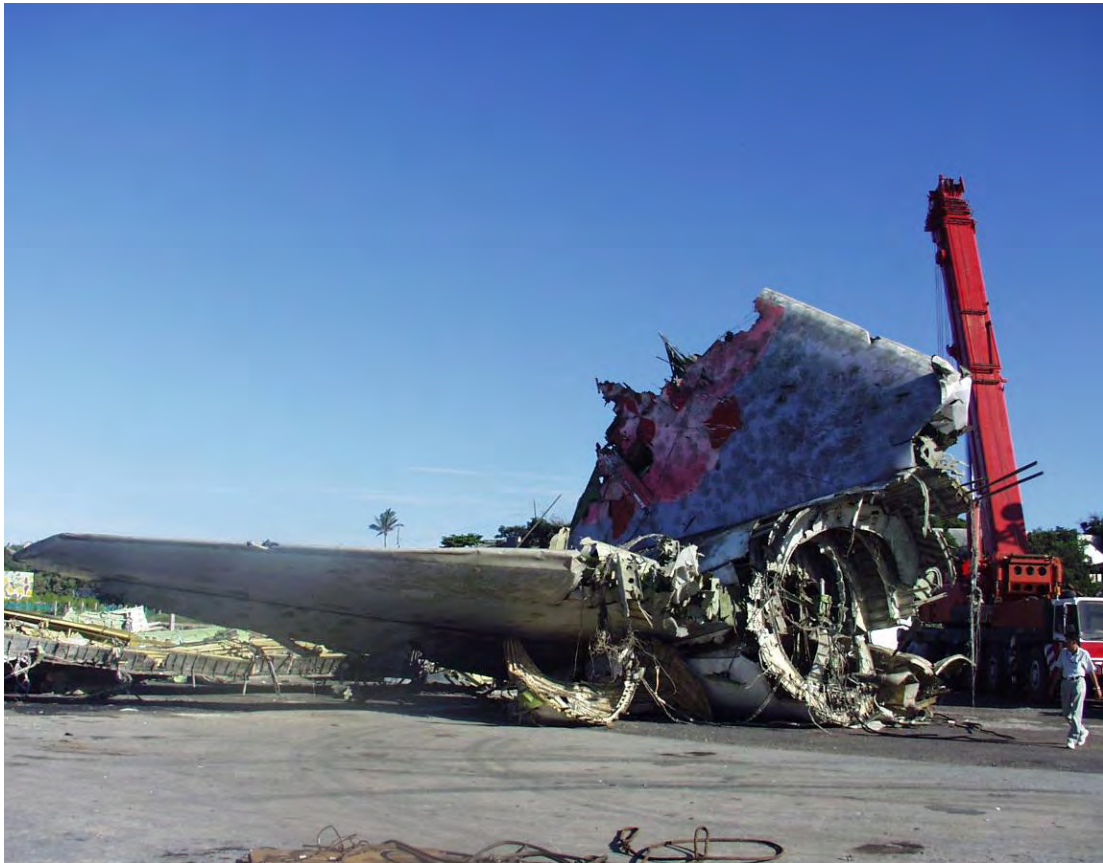
Figure 1.12-9 Item 630

The right horizontal stabilizer (RHS) is considerably more damaged than the left horizontal stabilizer (LHS). The inboard portion of the RHS leading edge is deformed upwards. At the root of the RHS, the inboard 10 feet showed considerable impact damage along with upwards deformation of the compromised structure. A portion of seat support was found inside a puncture common to the lower surface of the LHS. A small segment of fuselage stringer was also found imbedded in the RHS elevator (Figure 1.12-10 left-down). A small fastener and shim from a stowage bin assembly were found inside a puncture common to the RHS leading edge (Figure 1.12-10 right).

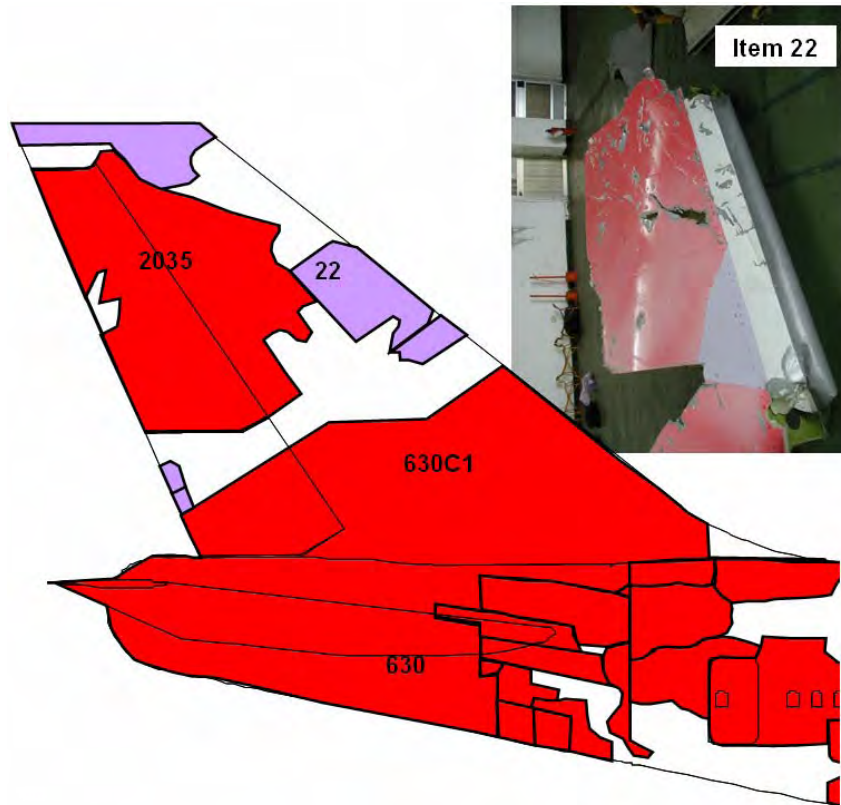
Figure 1.12-11 Vertical fin and item 22

Some fin structure, including leading edge structure and the fin cap (items 22, 23, and 960) were recovered as floating debris. A large upper portion of the fin and rudder was found separate from item 630.

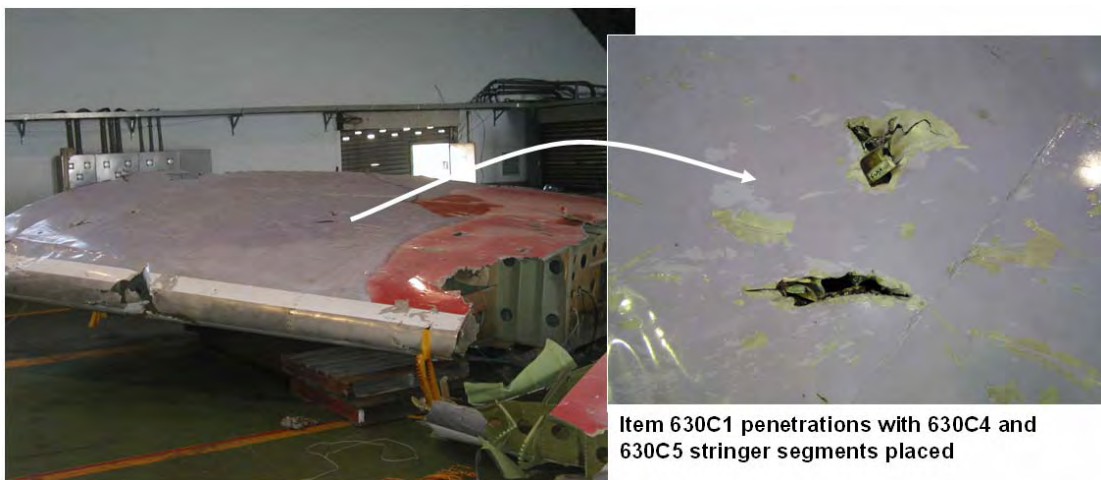
Figure 1.12-12 Item 630C1

The lower portion of the fin (item 630C1), the upper portion of the fin (item 2035), and several of the floating pieces (item 22) show similar evidence of impact damage on the right side.

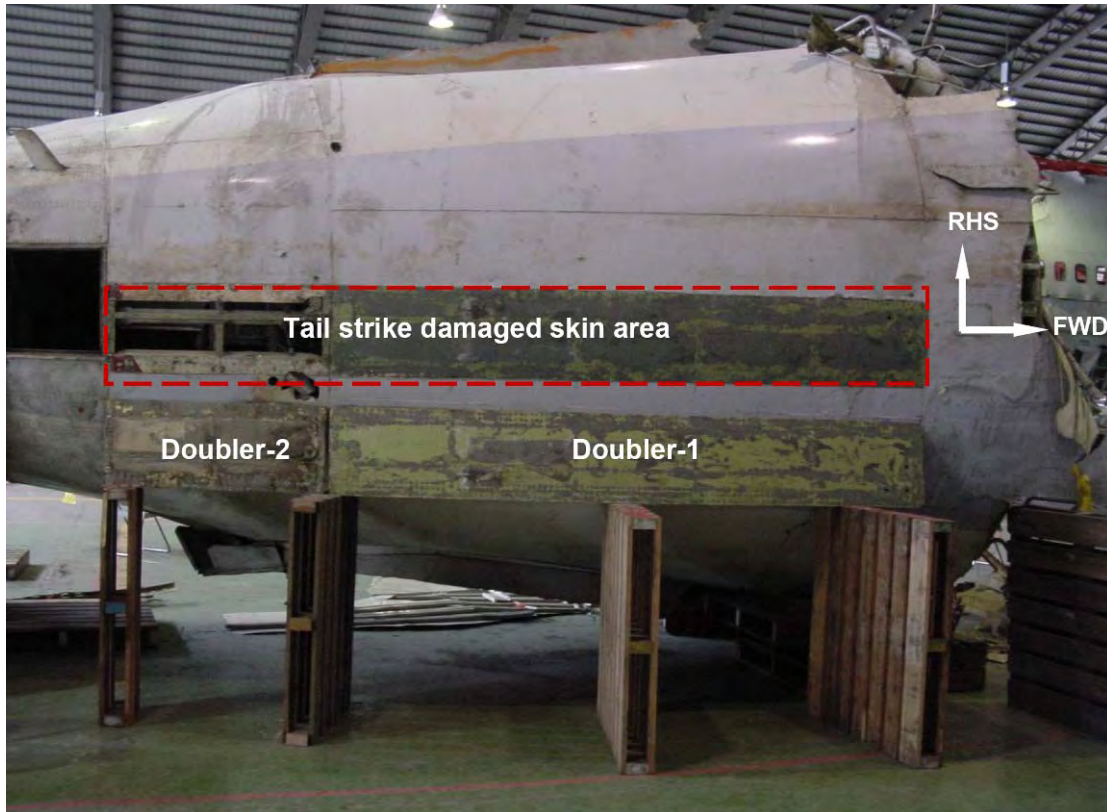
Figure 1.12-13 Doublers in section 48

The belly area of item 630 between STA 2484 to STA 2658 was examined, and two adjacent doublers were removed during wreckage examination as shown in Figure 1.12-13.

The B-18255 Aircraft Log Book stated the belly skin area between STA 2578 to STA 2638 had serious abrasion damage. Examination of the skin underneath the two doublers revealed that, skin underneath Doubler-1<sup>18</sup> (STA 2484 to 2598) had damage consisting of fore to aft (longitudinal) scratching with the most severe scratching at the locations of skin stiffening members. The damaged area had not been cut out or removed (trimmed), however, blending was found over much of the repair surface. Skin beneath the Doubler-2 (STA 2598 to STA 2658) was cut out as shown in Figure 1.12-13.

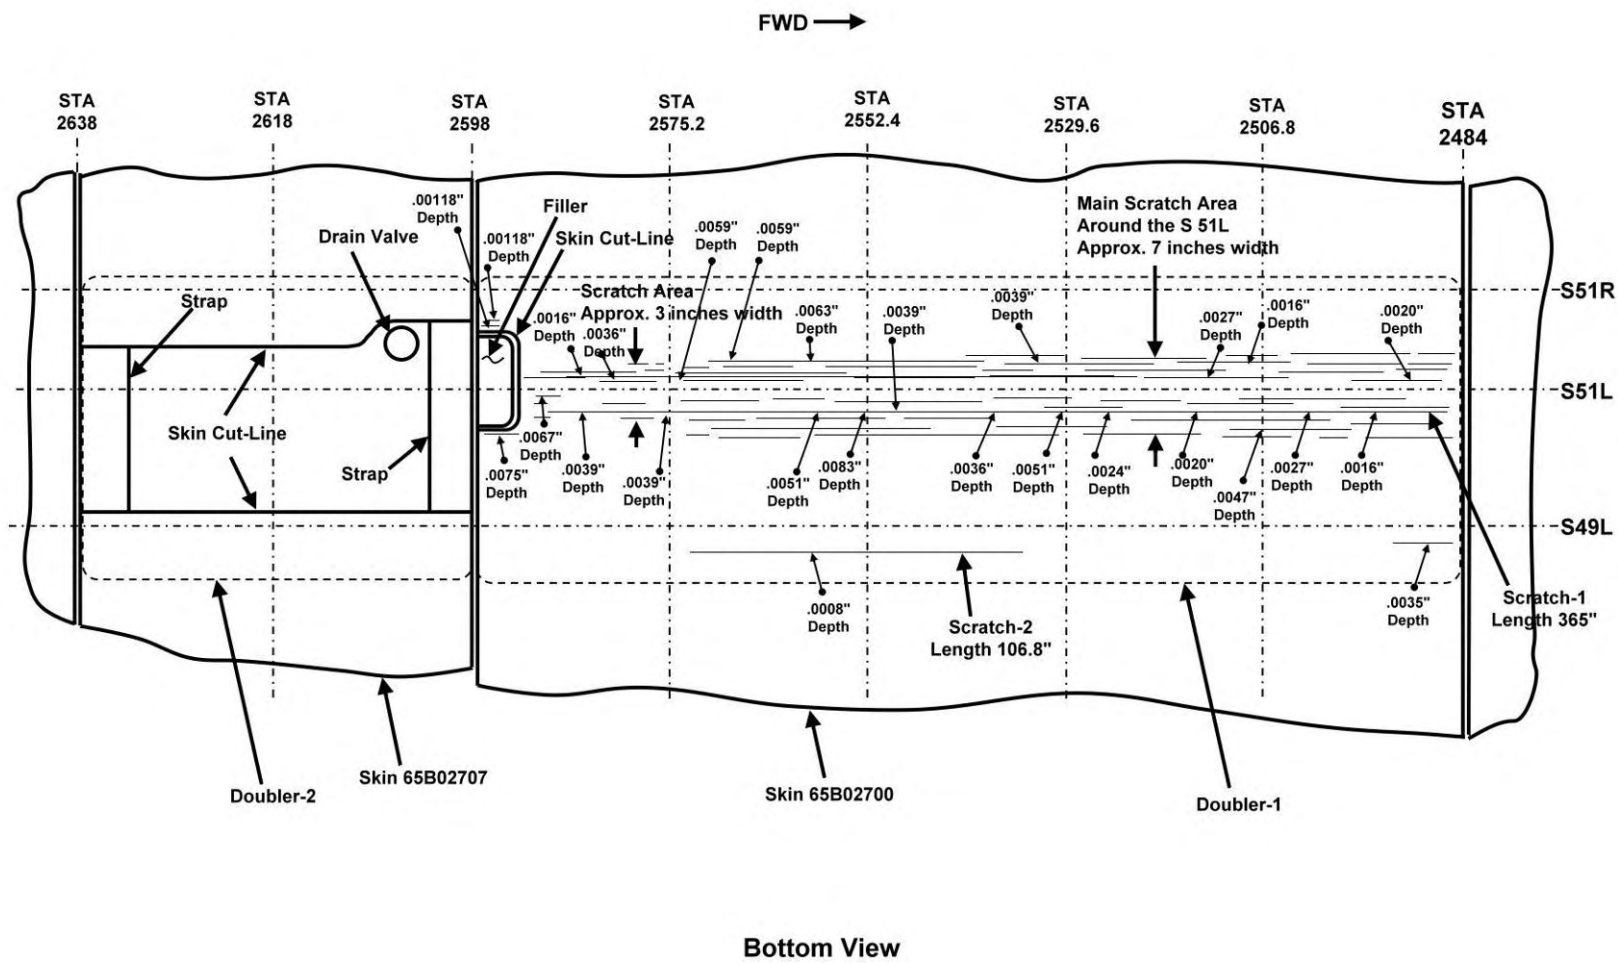
Figure 1.12-14 The schematic diagram of the doublers in Section 48

and starts from STA 2535 with the length of 42 inches. No evidence of crack was identified in this region. There are dents at STA 2567 and STA 2610, which was the result of wreckage handling.

It was noted that the former topcoat, enamel and primer (original painting before the skin repair) remained on the skin covered by Dubler-2.

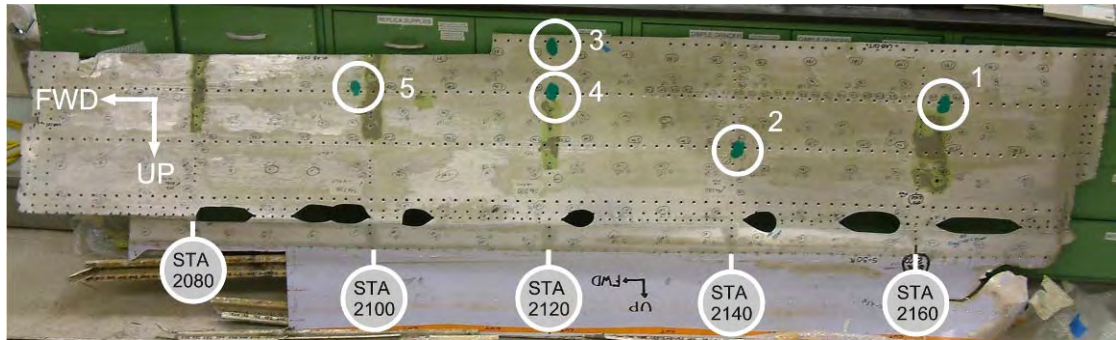
Five locations exhibiting major scratches on the repair faying surface of the skin as shown in Figure 1.16-4, were chosen for the examination of the scratch geometry and depth. The maximum scratch depth measured in each location is shown in Table 1.16-1.

Figure 1.16-4 Locations chosen for scratch depth measurement

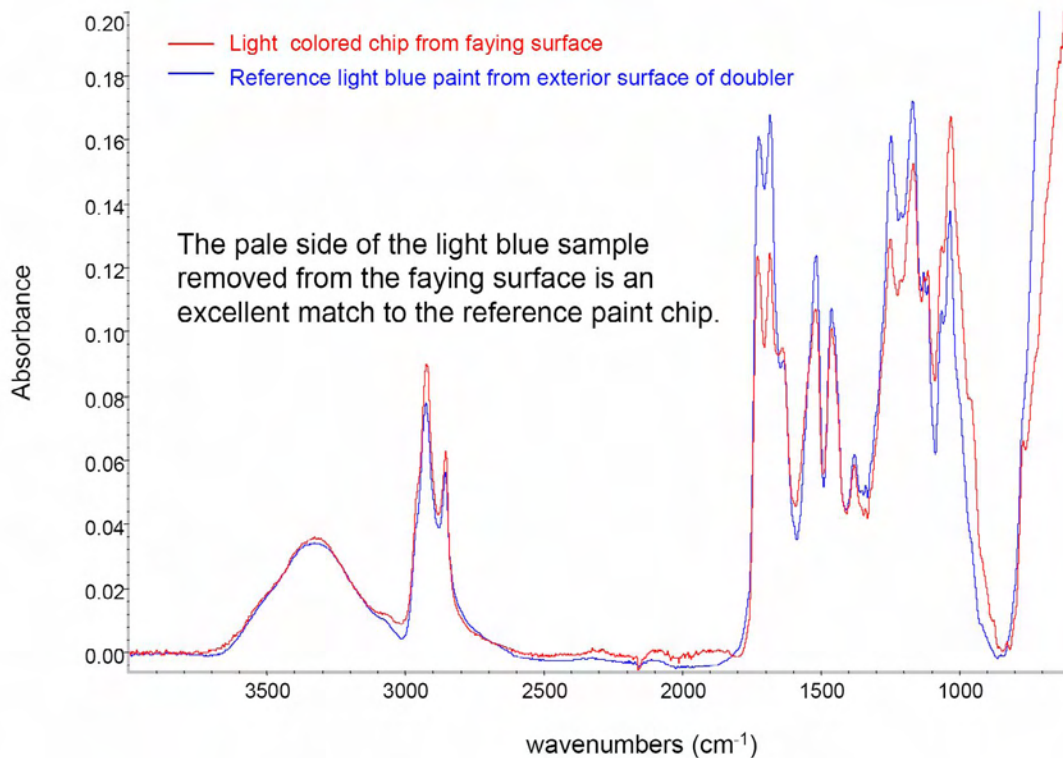
A light colored deposit was noted on the overhanging portion of the faying surface of the doubler above the fracture surface at S-49L as shown in Figure 1.16-6. Low power optical examination of this area revealed that this light colored deposit had a similar appearance to the light blue exterior paint applied to the doubler. Organic analysis utilizing Fourier Transform Infrared

Figure 1.16-7 FT-IR analysis result

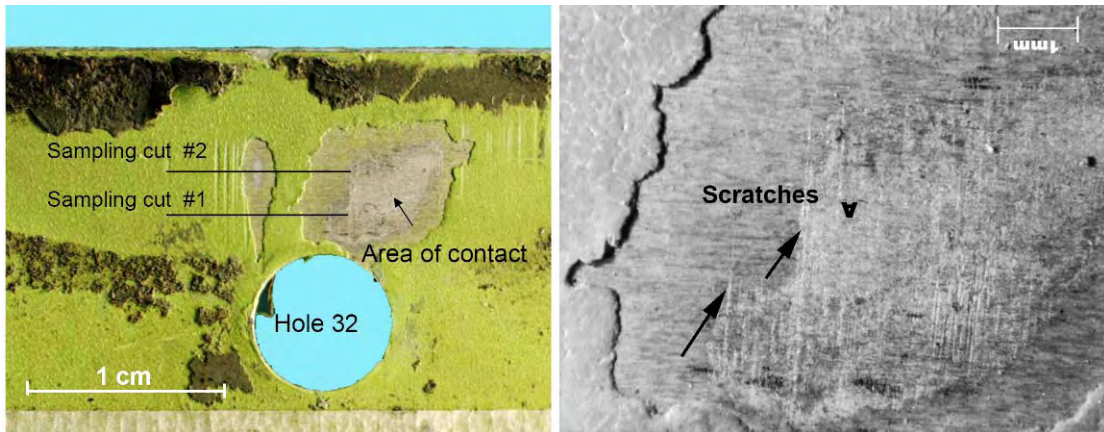
- The fretting marks observed from STA 2061 (hole +16) to STA 2132 (hole 49) are associated with most of the rivet locations. The most significant fretting damage was present between holes 8 and 43.
- The fretting marks near hole 32 and an optically magnified photograph of the area of contact is shown in Figure 1.16-9. It shows that the area of contact exhibits many colors and some hoop-wise scratches (marked by arrows).
- Two cross-section locations were chosen to characterize the area of contact. Figures 1.16-10 and Figure 1.16-11 show the metallographic photographs through the area marked by data sampling cut #1 and data sampling cut #2 respectively. It is observed that there was some material superimposed over the grooves of the scratches.

Figure 1.16-9 Area of contact near hole 32 showing the different colors (left) and scratches present (right)

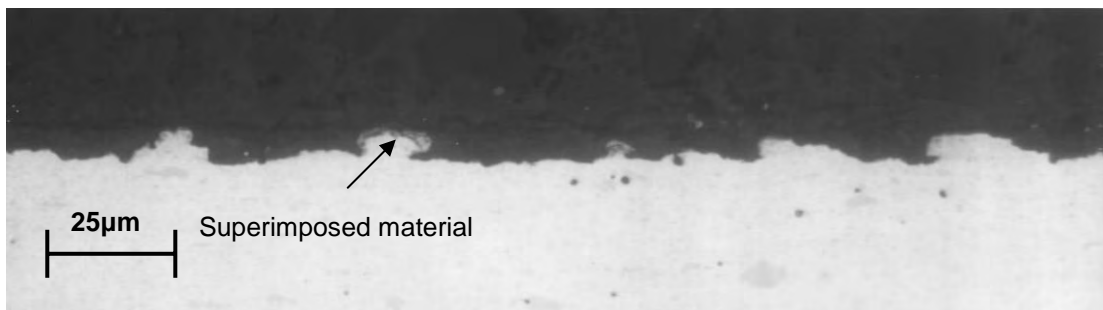
Figure 1.16-10 Metallographic photograph of the profiles marked by data sampling cut #1 in Figure 1.16-9

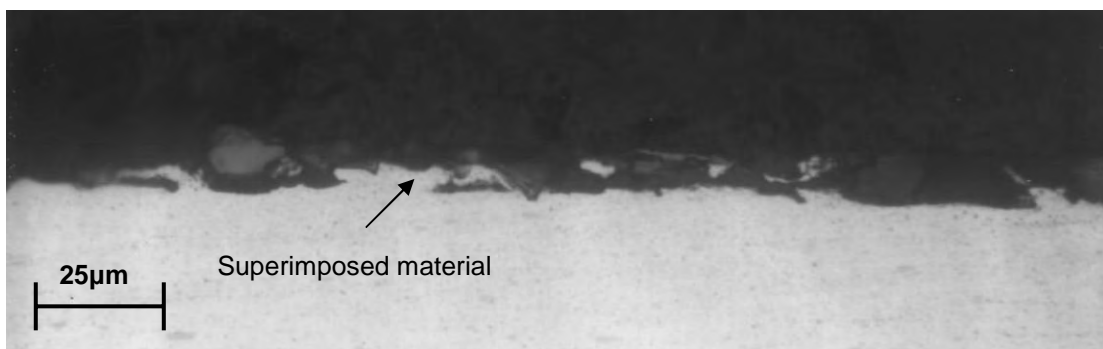
Figure 1.16-11 Metallographic photograph of the profiles marked by data sampling cut #2 in Figure 1.16-9

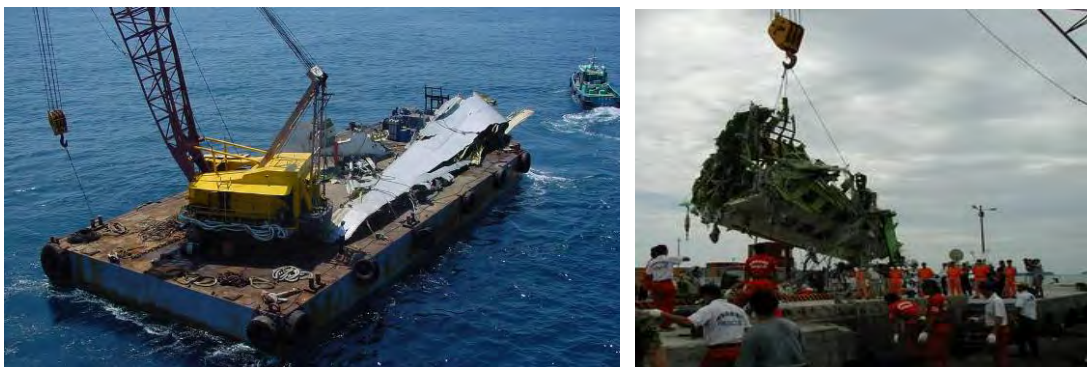
Figure 1.18-1 The Asia Pacific barge (left); the Coast Guard's dock (right)

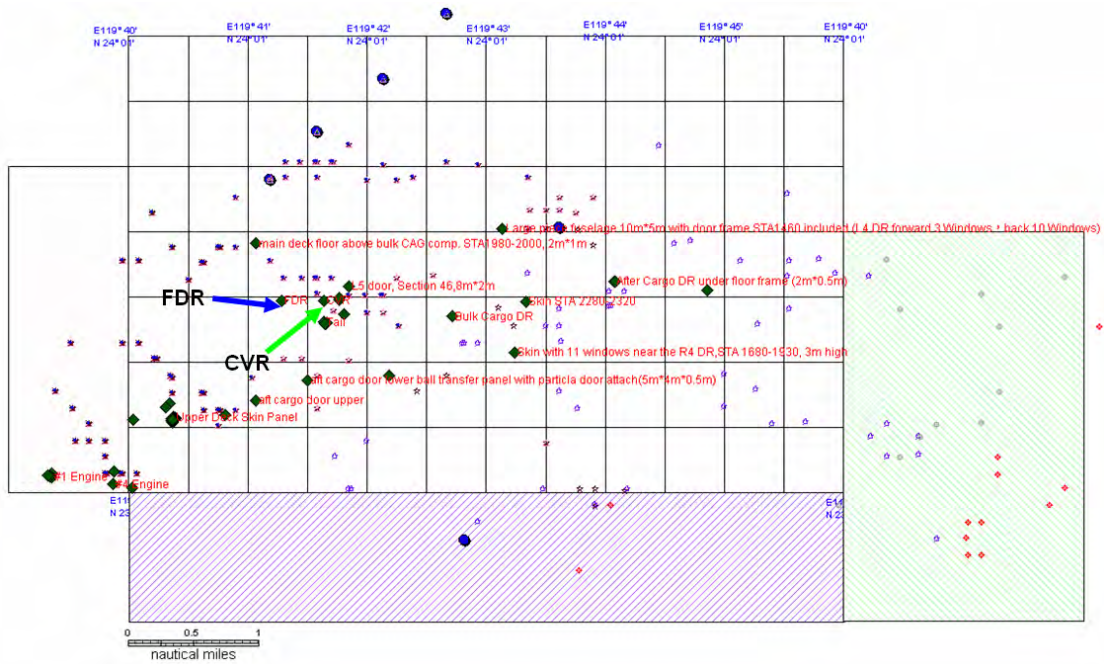
The Distance between the two recorders was about 610 meters. Relative positions of the two recorders, as well as the wreckage distribution are shown in Figure 1.18-3.

Figure 1.18-3 Relative position of the two recorders and the wreckage

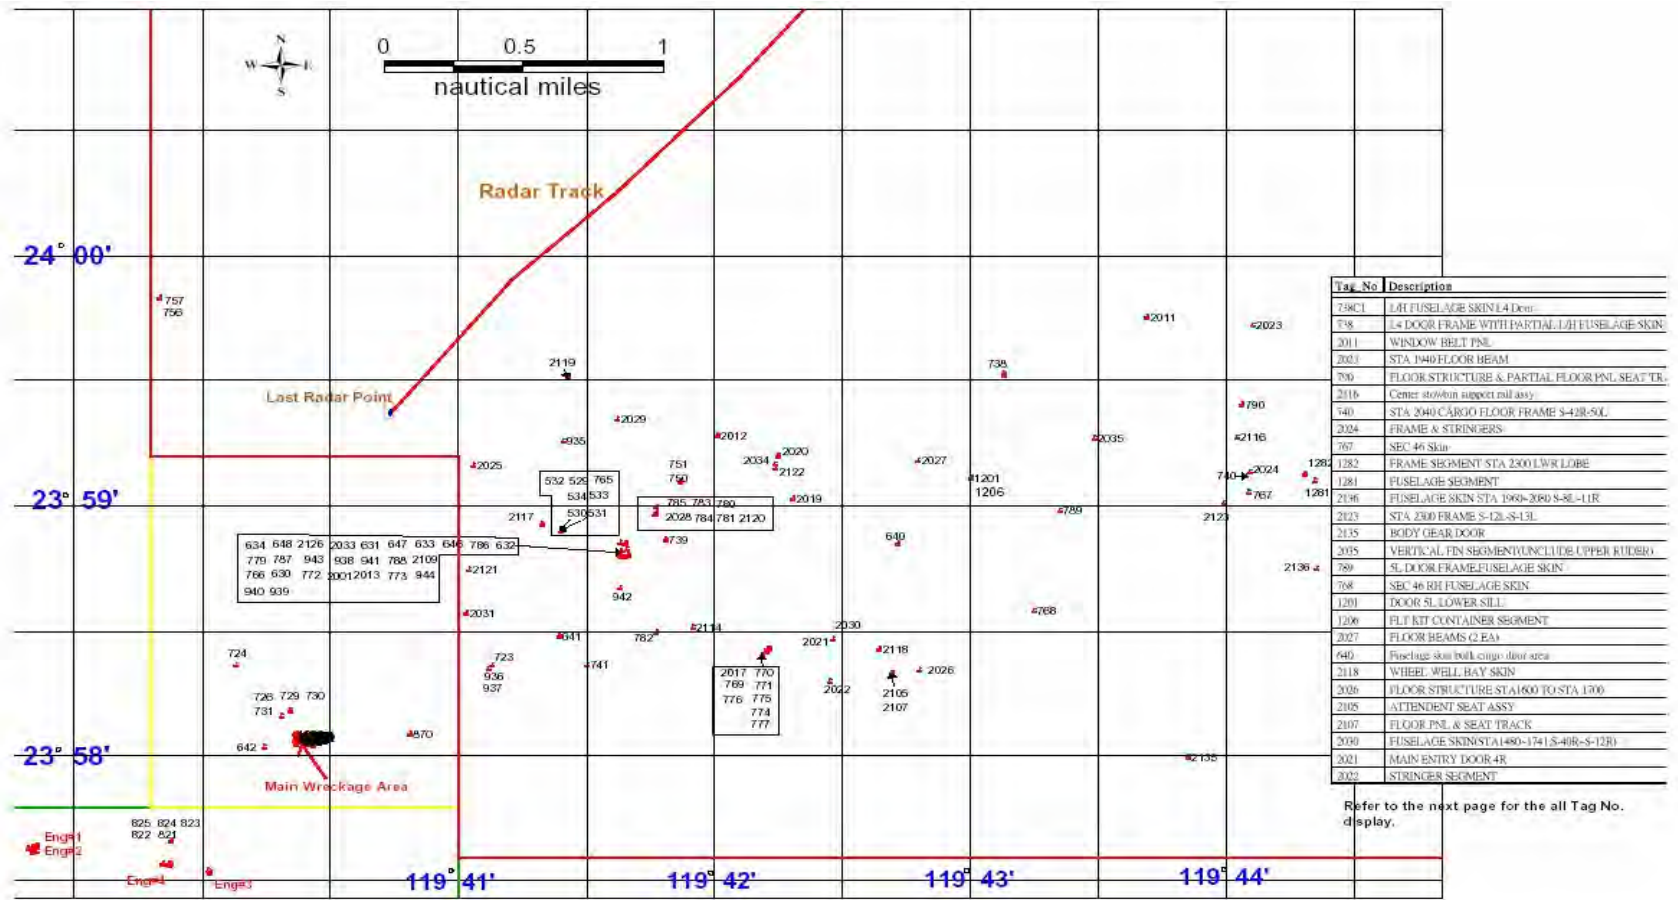
investigation lasted nearly 5 months, recovered approximately 1,500 pieces, and 175 bodies. After combining all the survey sources and the wreckage recovery locations, the wreckage map is shown in Figure 1.18-4. There are still 50 bodies and a major portion of the Section 46 uncovered.

Figure 1.18-4 The wreckage distribution map

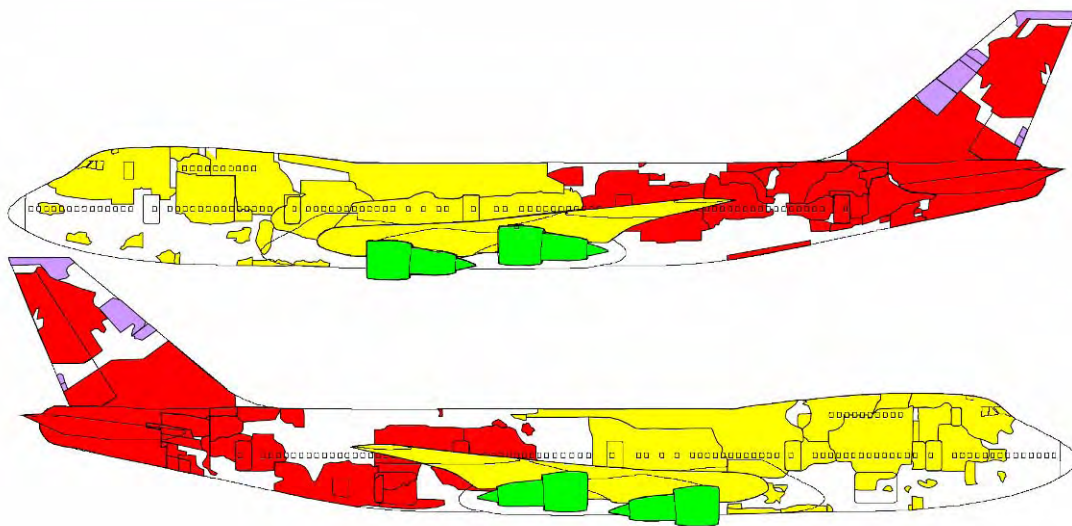
Figure 1.19-1 Relative location of the recovered wreckage pieces

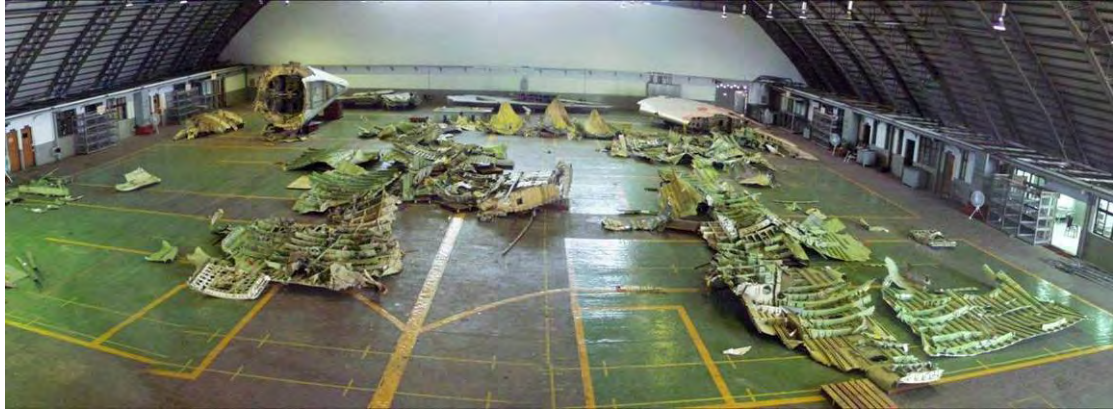
Figure 1.19-2 2D hardware reconstruction at TAFB Hanger #2

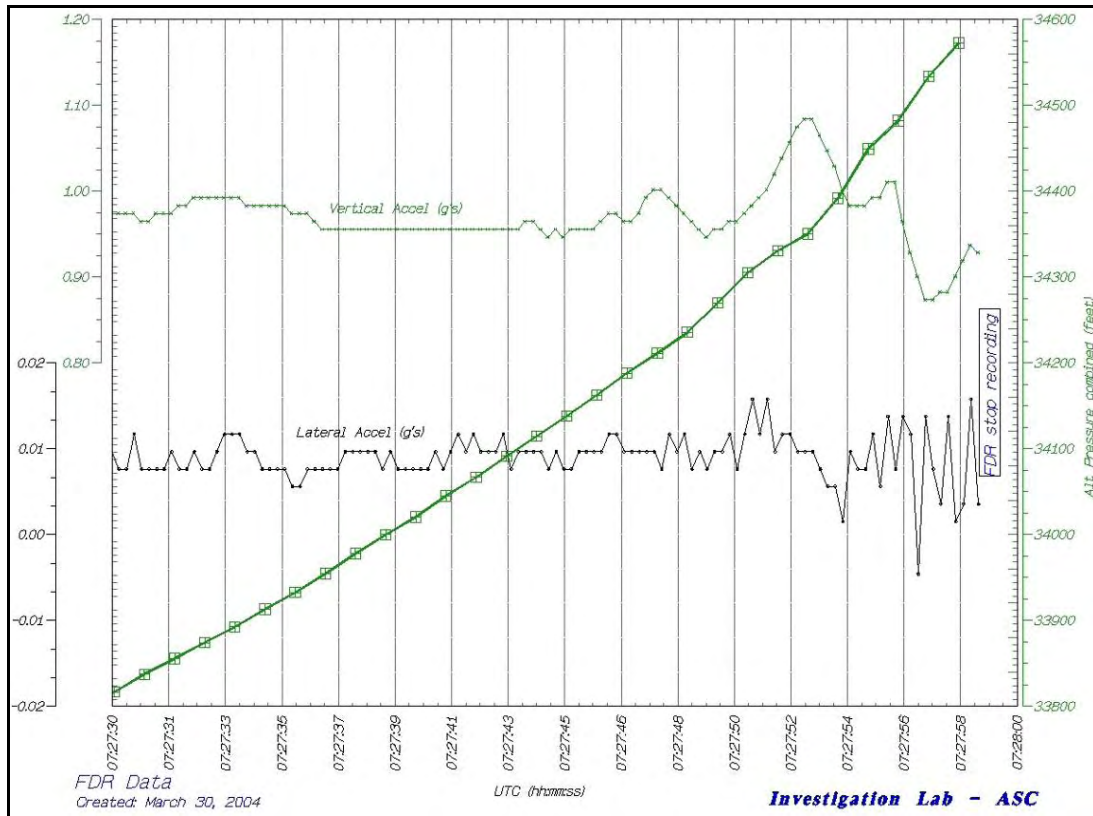
By carefully examining the acceleration data from the FDR, one can observe that 10 seconds prior to the loss of power of the flight recorders, there was a slow increase in both the vertical acceleration and lateral acceleration, as shown in Figure 2.1-1. By comparing the lateral acceleration parameter of the previous two flights of B-18255, before approaching its cruising altitude of 35,000 ft, similar oscillatory behaviors were found, as shown in Figure 2.1-2. Comparison was also made of the vertical acceleration parameter of CI611 and the two previous flights. A more pronounced increase in magnitude of the vertical acceleration was observed. These data led to the consideration that a preliminary breakup of the fuselage structure might have been in progress before the power loss of the FDR.

Figure 2.1-1 CI611 vertical and lateral acceleration data (last 30 seconds)

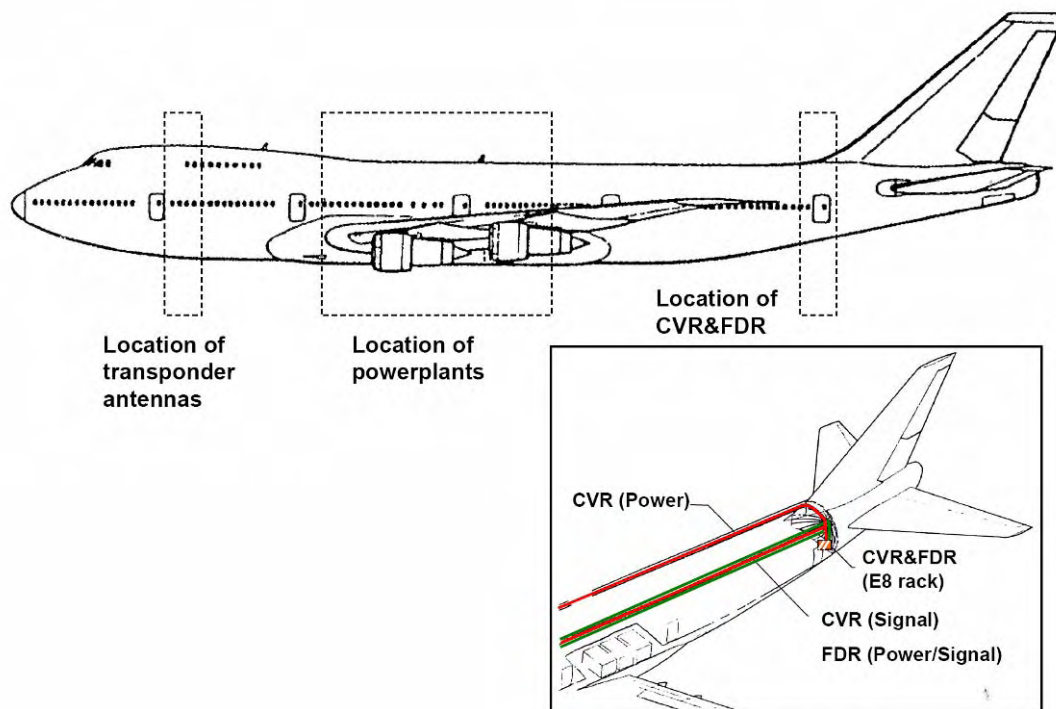
In addition, both recorders were located in the aft portion of the aircraft (above ceiling near to door 5L) and both transponder antennas were installed behind door 1 (Figure 2.2-1). The power of the CVR and FDR was interrupted simultaneously at 1527:59. However, the radar transponder continued to transmit for about 15 seconds longer. Therefore, the breakup should occur between the power plants and the recorders.

The Aviation Safety Council concludes that the loss of power to the CVR and FDR was the result of damage to electrical wires in the aft-pressurized fuselage area as the aircraft began to breakup. The forward portion of the aircraft continued to have power to the Mode-C transponder system for about an additional 15 seconds, before power to the transponder was interrupted.

Figure 2.2-1 Locations of flight recorders, transponder antennas, and power plants

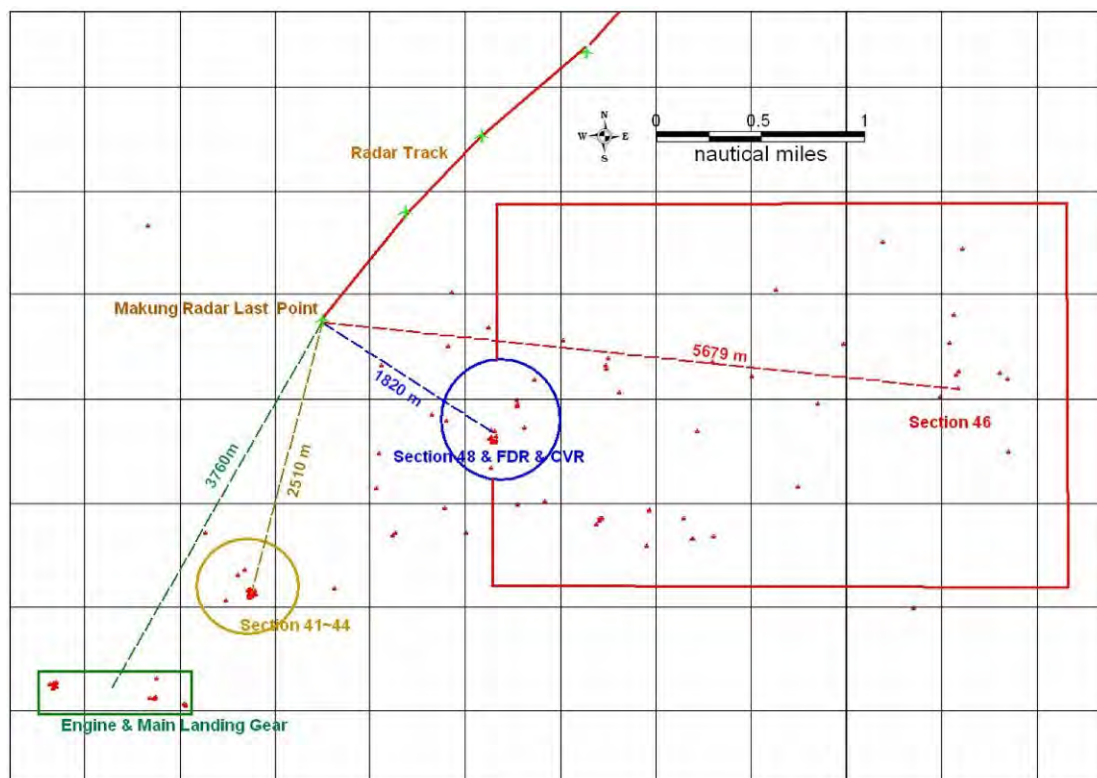
Figure 2.2-3 shows the relative locations of the CI611 wreckage. The wreckage distribution pattern matches the four groups of aircraft wreckage detected by PSR.

The wreckage distribution data show that the distance between the tail (section 48 with lower portion of fin) and forward portion of fuselage (section 41-44) was 1.5 nautical miles. The distance between the tail and most eastbound wreckage (section 46), which was recovered under water, was 3 nautical miles.

Figure 2.2-3 Relative location of the wreckage

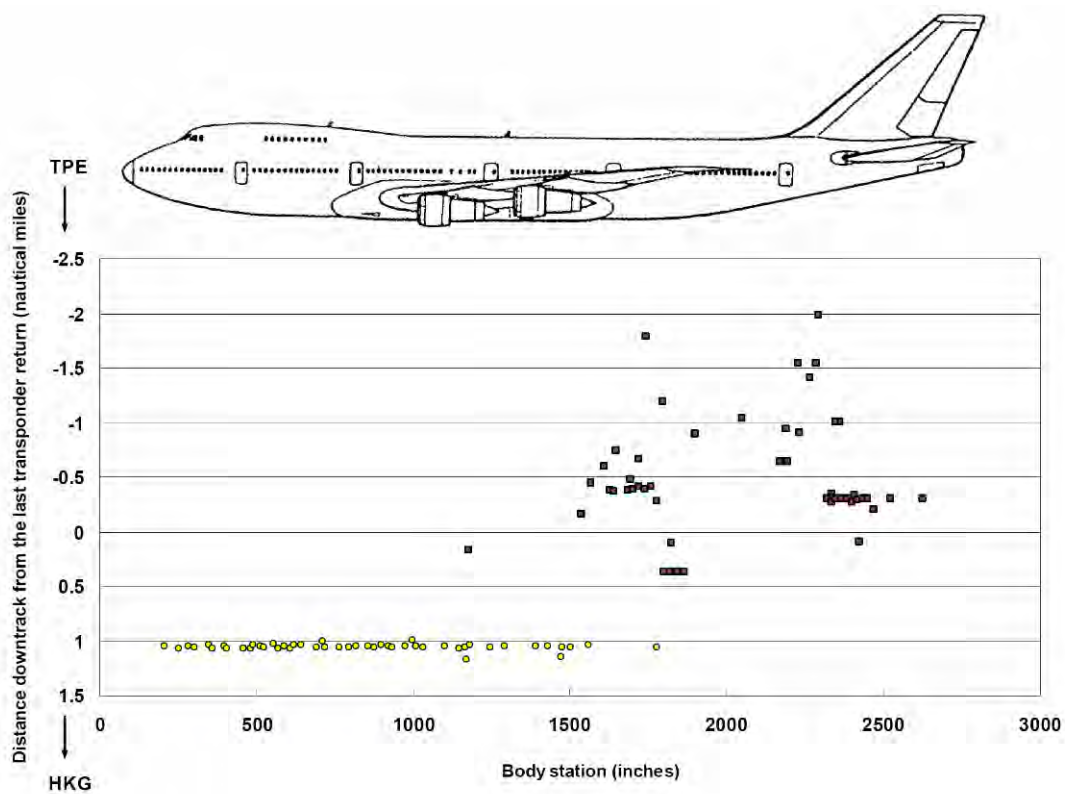
Hong Kong, which is shown in Figure 2.2-4. One can readily see that the wreckage pieces from the cockpit, engines, wings, all landing gears, and sections 41, 42, and 44 are distributed along a very concentrated segment while section 46, 48, and the tail empennage are spread widely.

The figure also shows a step jump from the forward portion of the aircraft to the aft sections. It shows that the fuselage section 46/48 structure aft of the aft wheel well bulkhead at STA 1480 was separated from the rest of the aircraft.

Figure 2.2-4 Wreckage distributions along the flight path

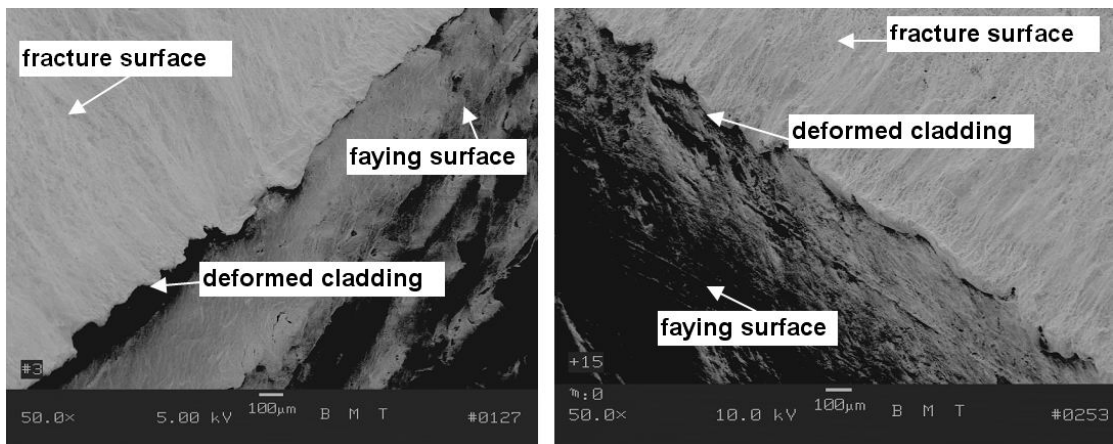
Cyclic rubbing of the fracture surface and associated compressive deformation of the cladding was observed along the faying surface shown in Figure 2.2-10 providing additional evidence of pre-existing crack. The cladding displayed compressive deformation due to cyclic crack closure as far forward as hole +17 and as far aft as hole 62. The remaining fracture aft of hole 62 displayed “necking”, which is typical of continuous tensile loading to ultimate tensile separation (Figure 2.2-11).

Figure 2.2-10 SEM photographs of the cladding near hole 3 (left) and +15 (right)

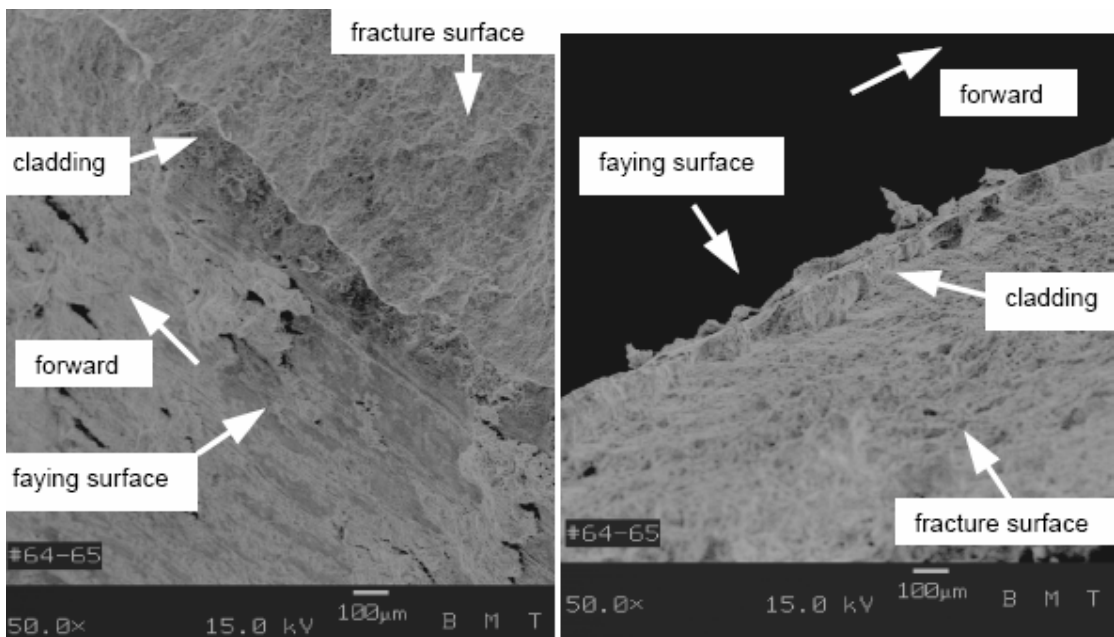
Figure 2.2-11 SEM photographs of the cladding between hole 64 and 65
