# **Aviation Occurrence Report Volume I**

**IN-FLIGHT BREAKUP OVER THE TAIWAN STRAIT**

**CHINA AIRLINES FLIGHT CI611**

**BOEING 747-200, B-18255**

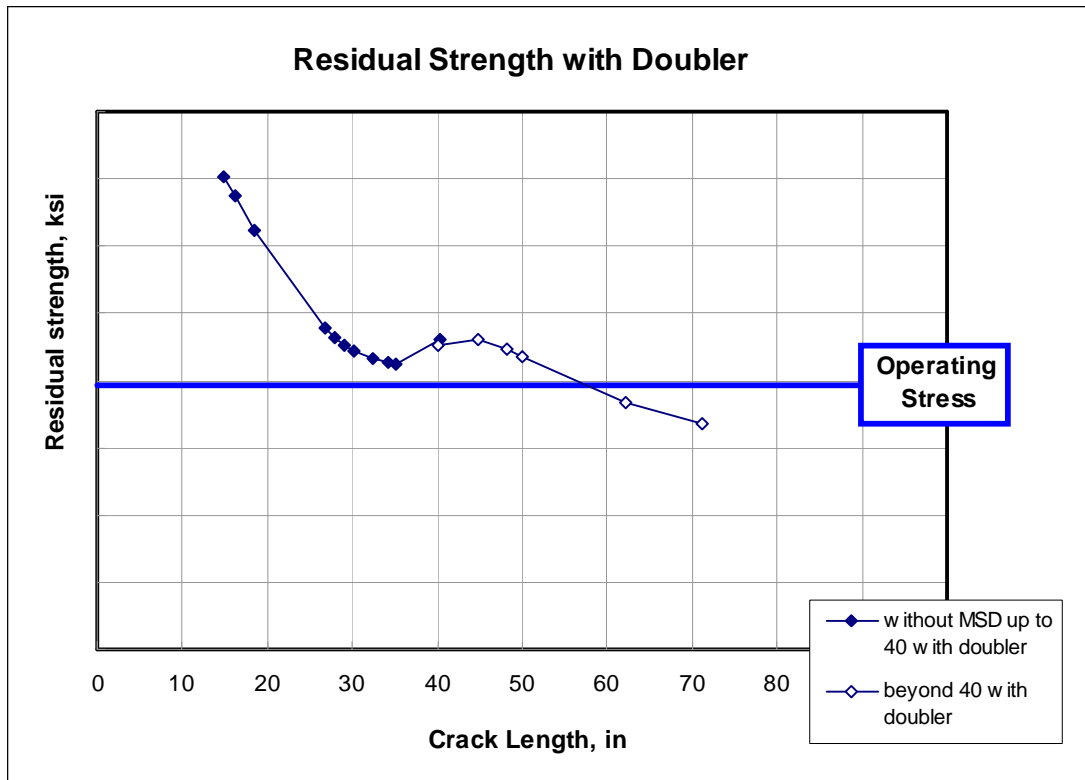
From the residual strength analysis discussed in section 2.5, when the crack was over 58 inches, the residual strength of the skin assembly would go below the operating stress (Figure 2.2-13), therefore caused the skin assembly beyond the capability limit under the application of normal operational loads.

Figure 2.2-13 Residual strength of cracking

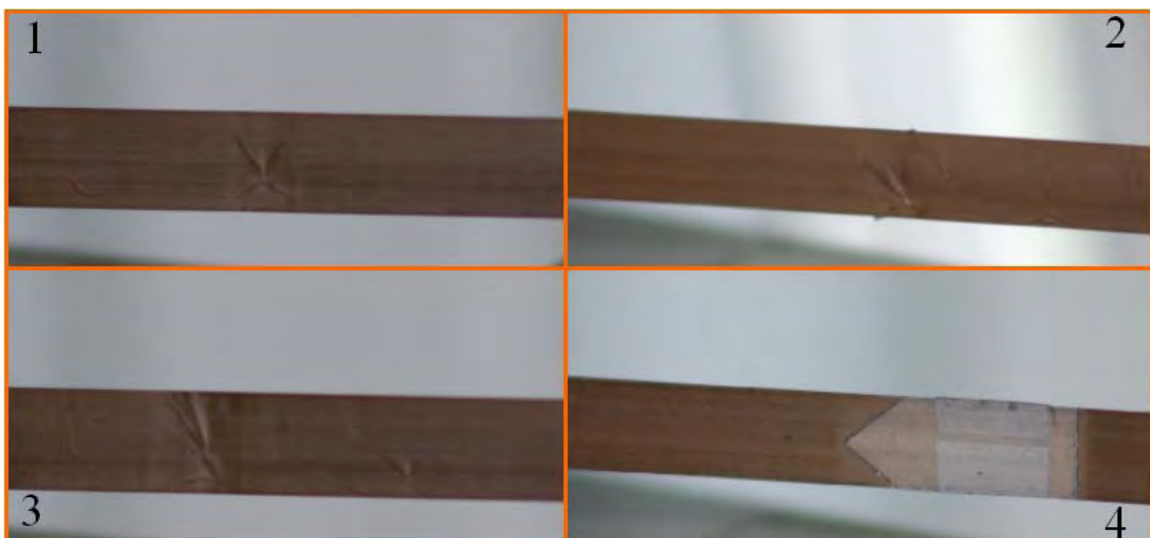
Eight unidentified sounds were attributed to the tape damage and one with no signal was attributed to the tape splicing. Figure 2.6-1 frame #1 to #3 shows the typical tape damage and frame #4 shows the spliced area. Several sounds were identified as possible sounds from a toggle switch, or other switches. Because of high noise background, sounds from switches are difficult to be identified, such as momentary switch, switch movements, keyboard entries on the INS panel, switch on the audio selector panel, etc. Some unidentified sounds are likely the sound of crew motions but they might not be directly related to any operational action. Table 2.6-2 lists the unidentified sounds and their associated possible events.

Figure 2.6-1 Damaged and spliced tape areas

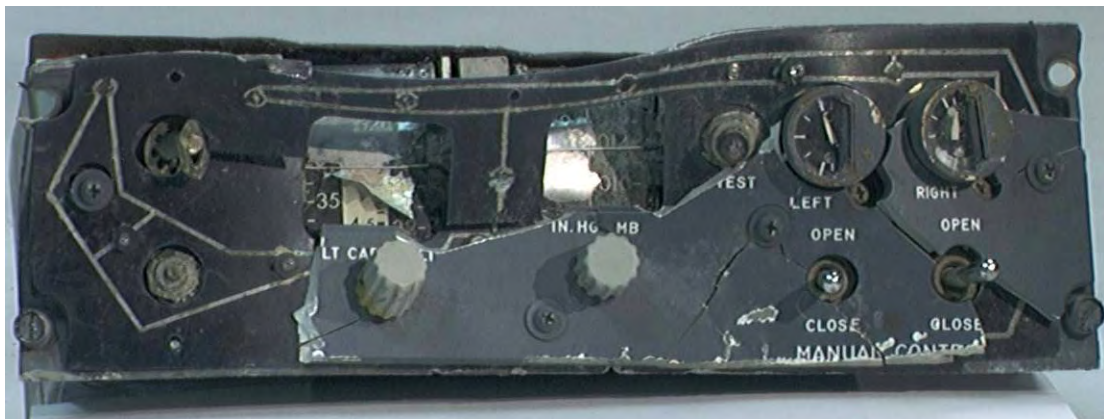
Based on the examination, the Cabin Pressure Control Selector Panel (shown in Figure 2.7-1) is deformed, delaminated and fractured. The examination and test results show that the mode switch was in the “MAN” (manual) position.

Figure 2.7-1 Cabin pressure control selector panel

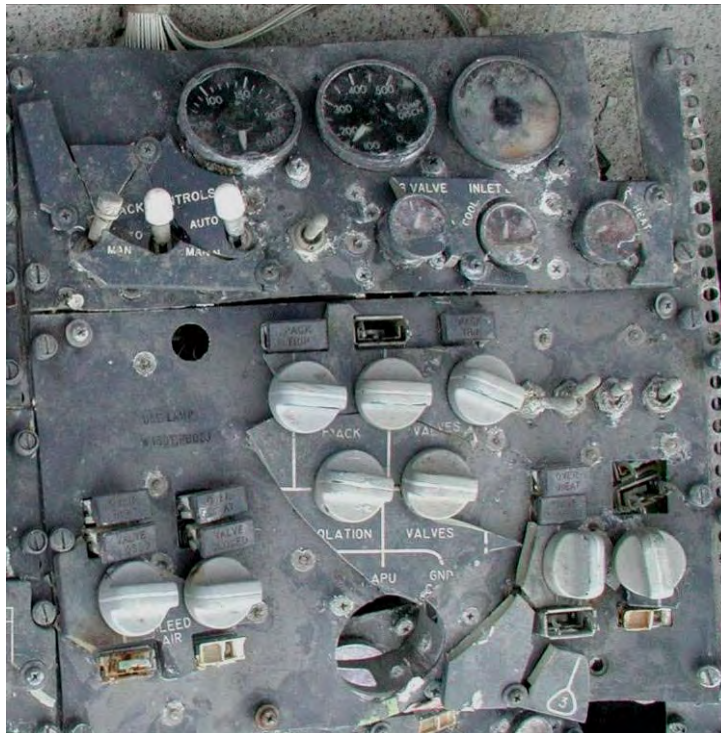
Figure 2.7-2 Air conditioning panel

Examination and test results of the air conditioning panel revealed that two of the three air conditioning “pack” valve selectors were found in the “Closed” position and another one was found in the near closed position. The normal operating procedures for CAL B747-200 specify that at least two pack valves be in the “open” position after engine start, and CM3 shall check the setting after takeoff and during climb. Also, CM3 is required to verify two packs “Open” after takeoff and during the initial climb. The CVR transcript reveals that CM3 verbally confirmed that two packs were “Open.”

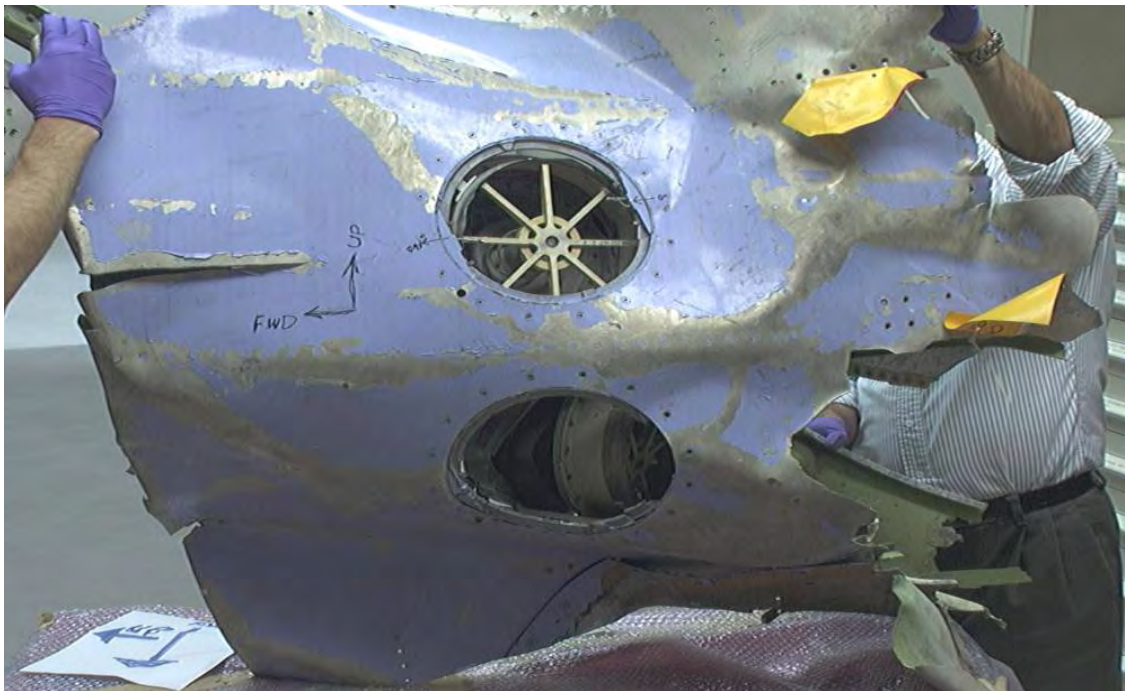
Two cabin pressurization relief valves are installed to relieve excessive pressure in the cabin. Both valves were recovered as shown in Figure 2.7-3. All flapper (blowout) doors (upper and lower for both valves) and some hinge pins are missing. The Lower Pressure Relief Valve was no longer attached to the structure. The structure between the upper and lower valves was buckled outward.

Figure 2.7-3 Pressure relief valves.

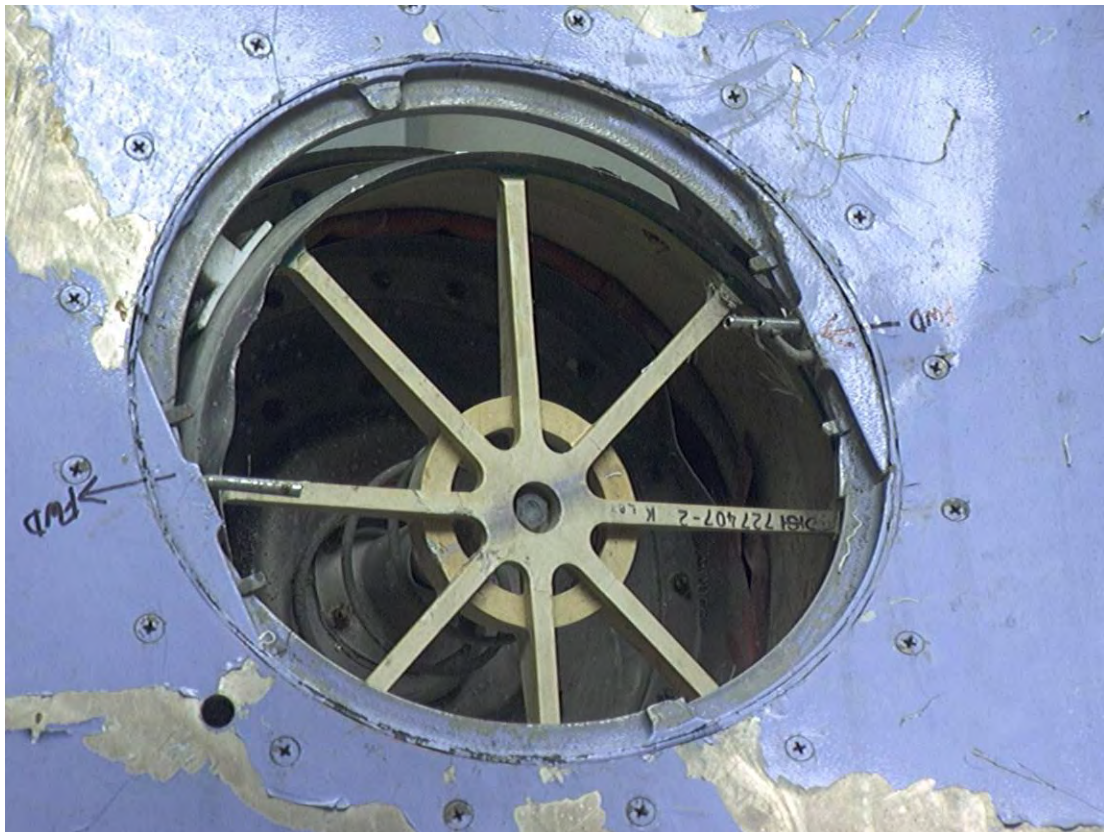
The visual inspection result shows the Upper Pressure Relief valve (Figure 2.7-5) has been deformed inward, the blowout doors are missing, the gate web fractured, FWD upper hinge pin is bent, lower hinge pin missing, AFT lower hinge pin is bent and all hinge pins are moveable.

Figure 2.7-5 Upper pressure relief valve

The wreckage examination results show that the upper pressure relief valves had been deformed inward, the flapper doors were missing and the three out of four existing shear pins were bent-in, but moveable. It could be that outside-in forces crushed the relief valve and damaged the flapper doors and the web gate. Those three pins of item 275 were still attached to the shear pins and are parallel to the relief valves housings (aircraft fuselage skin) that might indicate the valve doors was open before the water impact. However, based on the test results, the Safety Council could not conclude whether the door was open prior to the water impact.

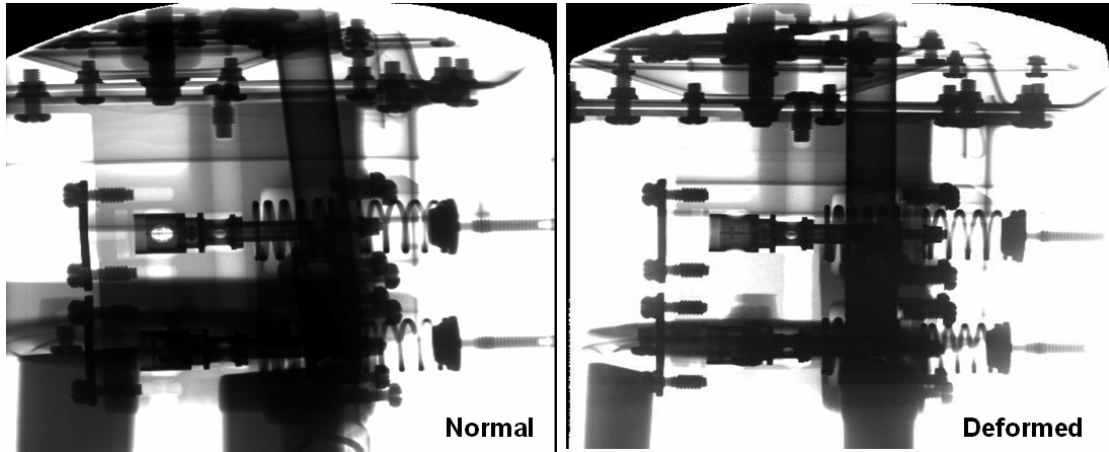
X-Ray on the upper relief valve control switch was conducted. The results show that the control sensor assemblies were deformed from their original setting as shown in Figure 2.7-6.

Figure 2.7-6 X-ray check results

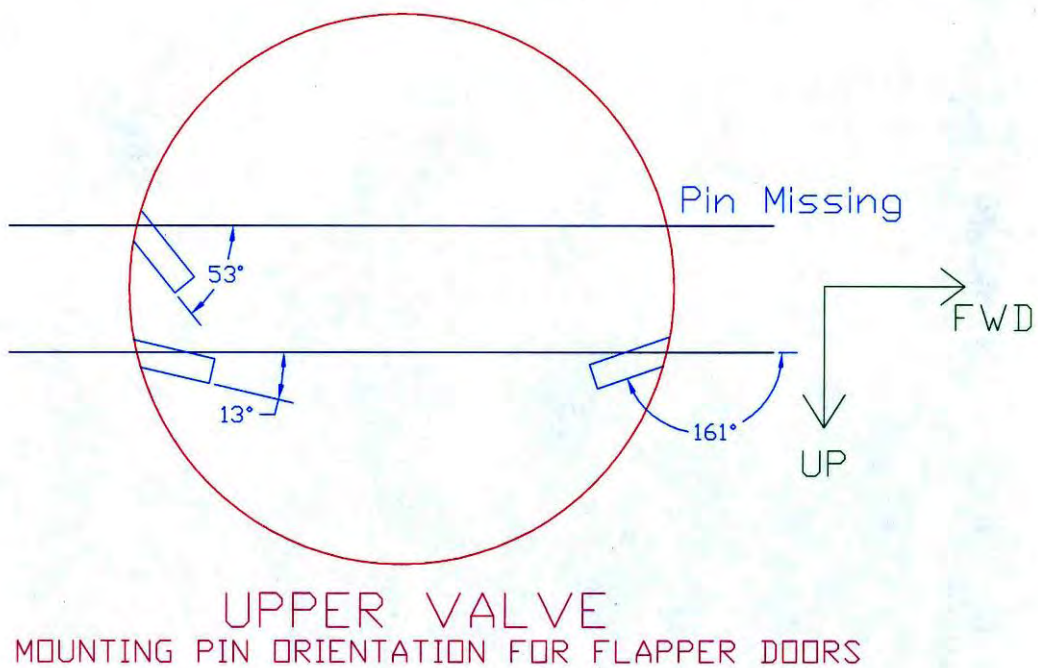
The measurement of pin angles was performed using a flat reference plane (outer skin of aircraft); using two imaginary reference lines running between the centerlines of the pin mounting holes (upper fwd to upper aft) & (lower fwd to lower aft). All angular measurements were based from these two imaginary lines as shown in Figure 2.7-7. Results of the measurements are:

Upper aft pin was approximate  $13^\circ$ ; Upper fwd pin was approximate  $161^\circ$ ; Lower aft pin was approximate  $53^\circ$

Figure 2.7-7 Upper flapper doors pins measurement results

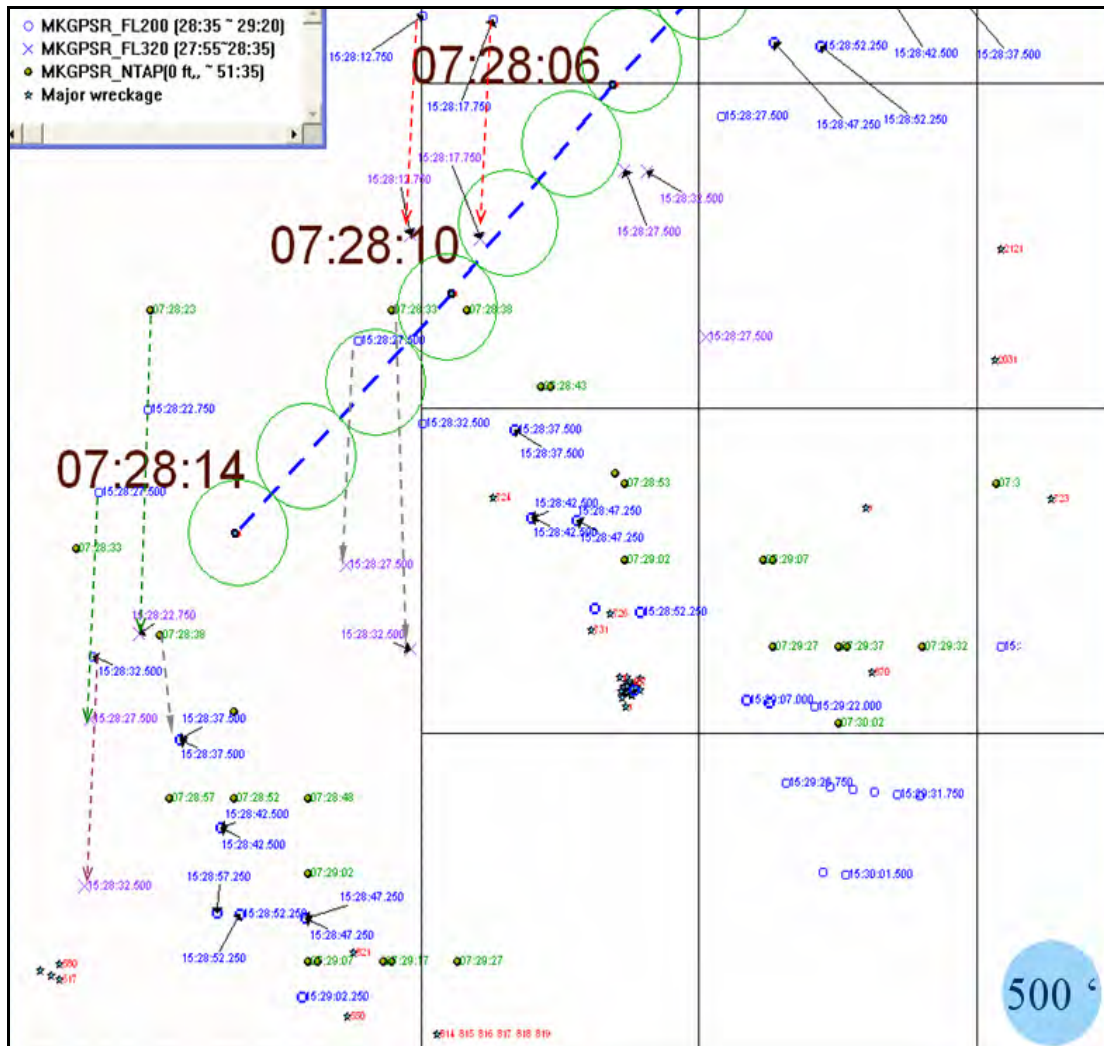
Figure 2.9-2 SSR track, PSR returns with altitude correction (yellow, green zones)

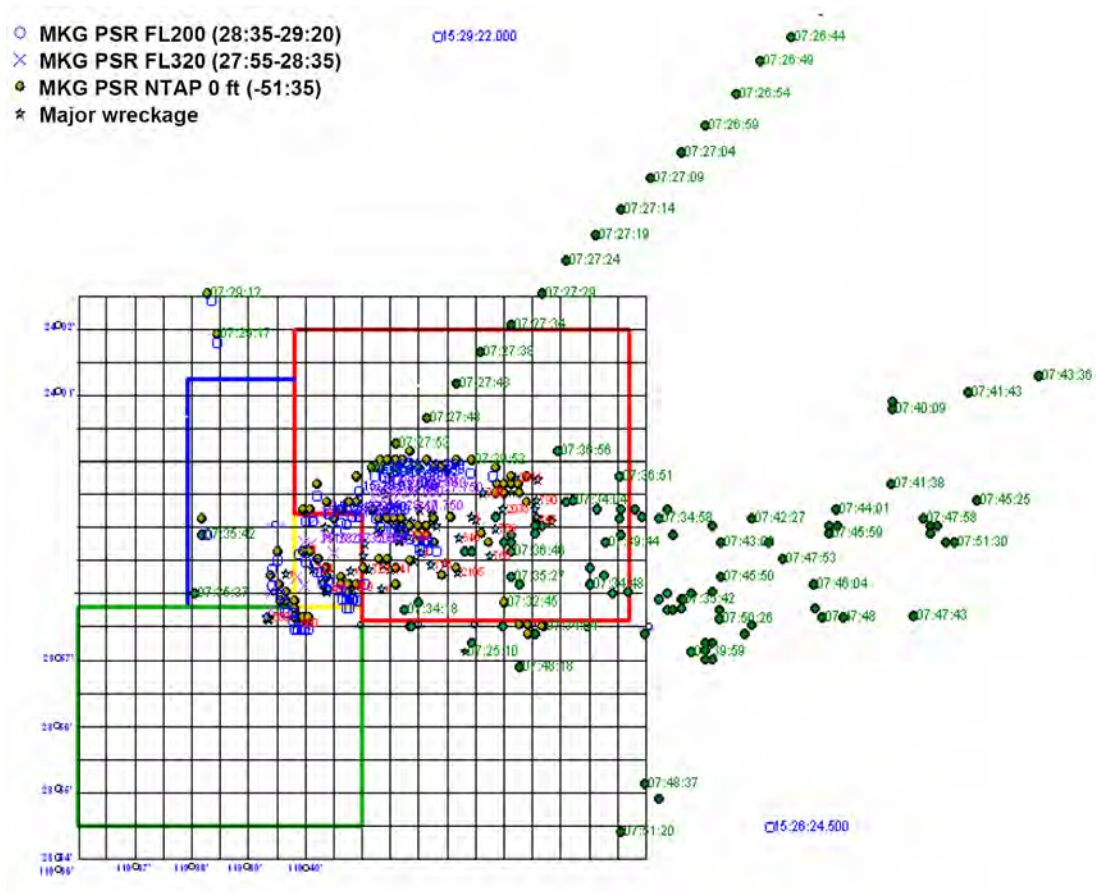
Before correction, there were no relevant PSR returns within 1,500 ft of the recovered positions of engines #1, #2, and the main wreckage field. Figure 2.9-3 shows the superposition of the PSR returns, SSR track from 1526:39 to 1528:14, and positions of major wreckage.

Figure 2.9-3 SSR track, PSR returns and position of major wreckage

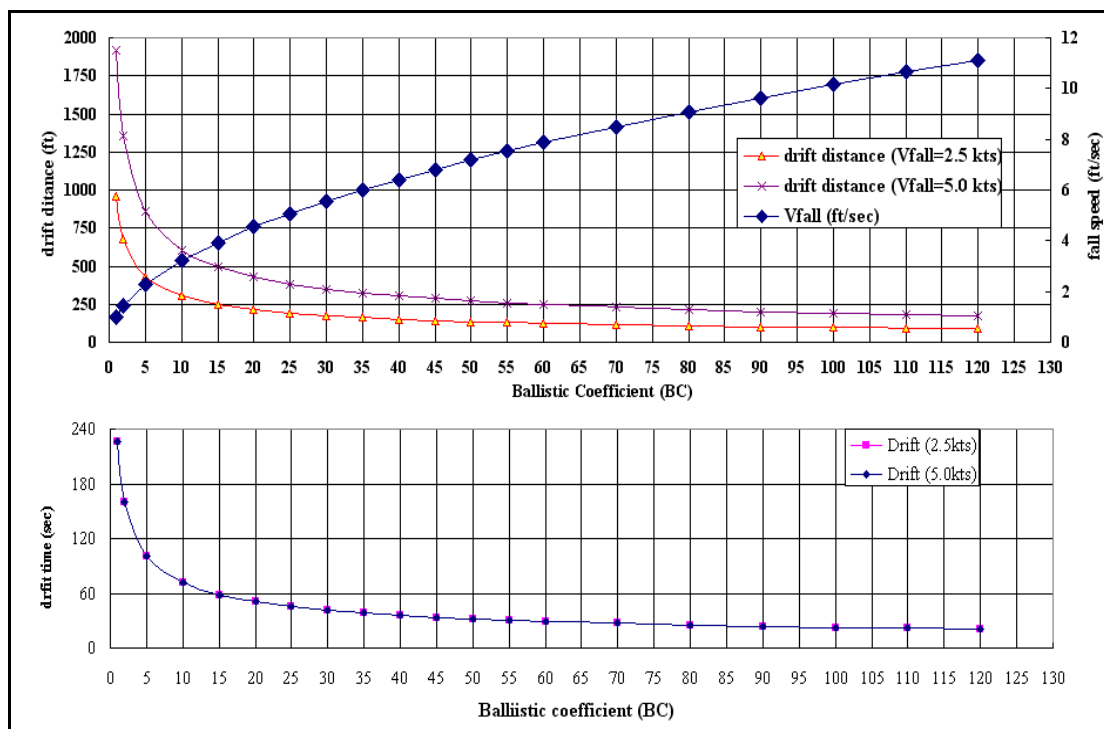
The estimated drift effect of ocean current does not take into account the effect of buoyancy<sup>49</sup>. Ocean depth at the accident site is about 230 ft. The ocean current at the time of the accident was predicted by NCOR to be 2.5 knots to 5.0 knots, northern direction. It is desirable to determine the drift effect of the current on wreckage locations. Figures 2.9-4 shows the relationships of drift distance and different ballistic coefficients (BC). The drift effect of ocean currents on heavy wreckage position (BC greater than 10) is less than 500 ft; 1,000 ft to 2,000 ft for the lighter wreckage (BC less than 10).

Figure 2.9-4 Comparison of drifting distance on the wreckage of different ballistic coefficients

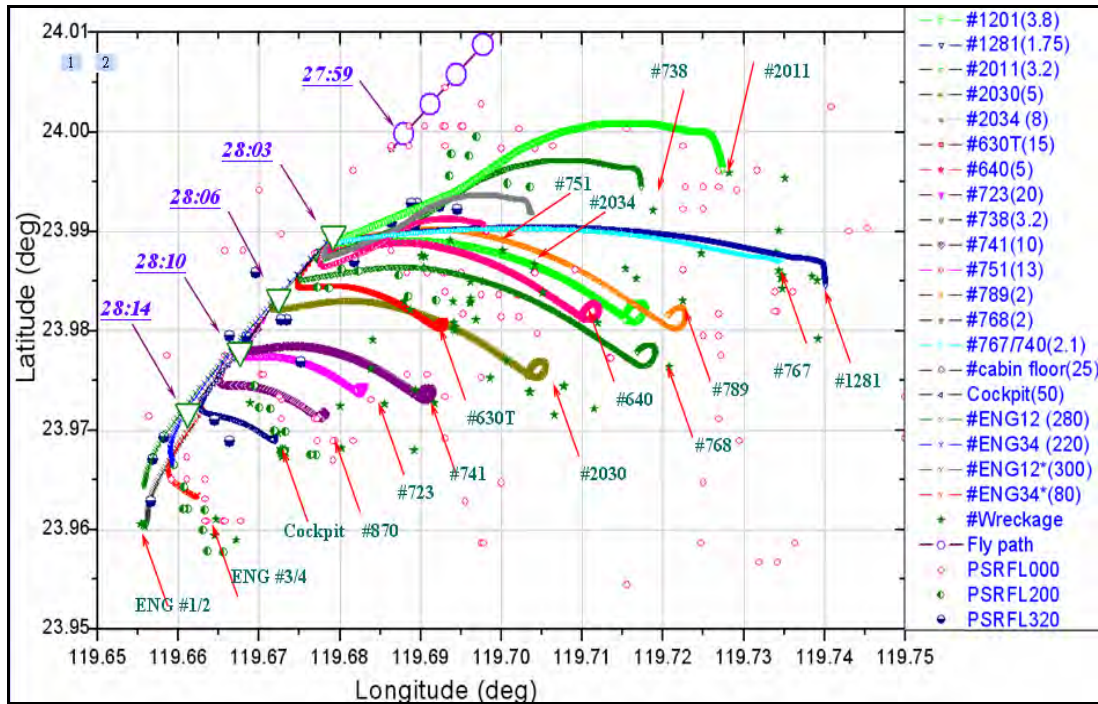
Figure 2.9-5 Two-Dimensional plot of ballistic trajectories

The ballistic analysis indicated that initial breakup of CI611 may have occurred more than 4 seconds after the ending of the FDR recording for all or some of the segments. Larger segments may have separated into smaller segments after the initial breakup. It should be re-emphasized that partial lift and buoyancy effects were not taken into account in the analysis.

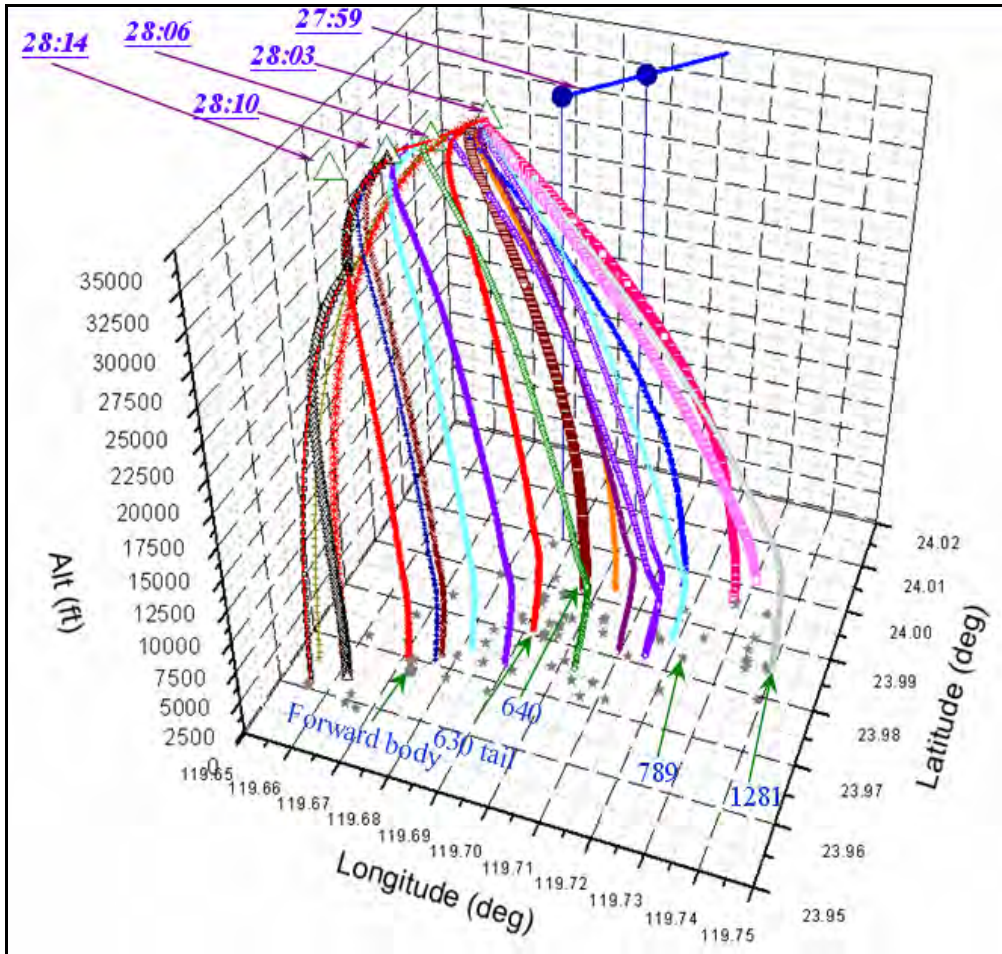
Figure 2.9-6 Three-Dimensional plot of ballistic trajectories

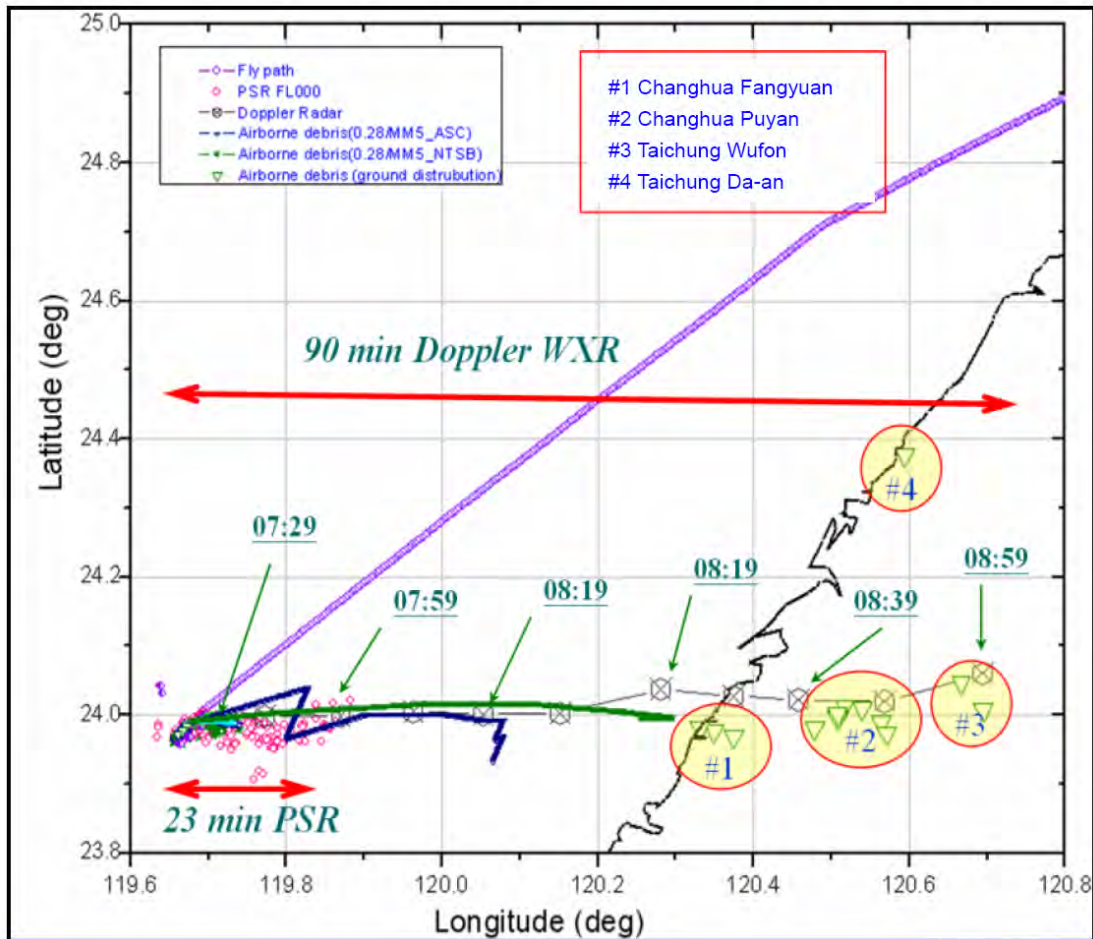
All the ballistic trajectories were consistent with the salvaged wreckage positions. The average distance error is less than 1,000 ft. Figure 2.9-7 (denoted as blue and green) shows the superposition of ballistic trajectories, SSR track, PSR returns, Doppler weather radar trajectory, and airborne debris distribution. Two

trajectories using different wind profiles with the same breakup initial condition (BC assumed to be 0.28). These trajectories indicated that airborne debris initiated descent at the altitude about 35,000 ft. Doppler radar trajectories and the recovered location of those light pieces of debris match with the computed ballistic trajectory.

Figure 2.9-7 2D ballistic trajectories, SSR, PSR returns, and airborne debris
