# **Aviation Occurrence Report Volume II**

ASC-AOR-05-02-001

**IN-FLIGHT BREAKUP OVER THE TAIWAN STRAIT**

**CHINA AIRLINES FLIGHT CI611**

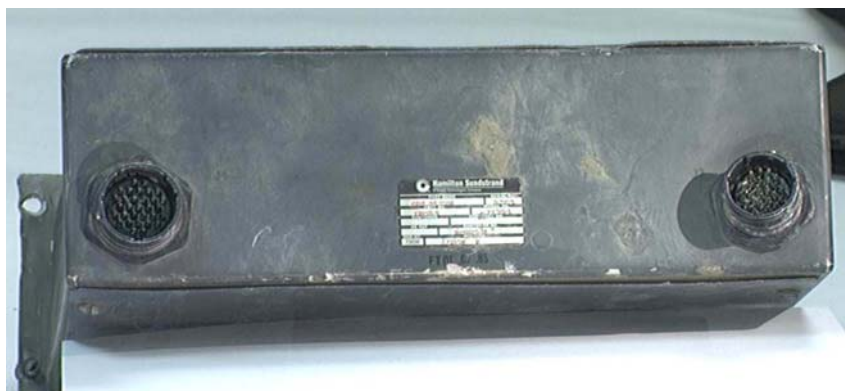
**Figure 8:** Flight Engineer's Cabin Pressure Control Selector Panel - (back view)

- J3 connector (right) misaligned due to deformation of rear chassis. Both connector (J3 and J4) pins are intact.
- Both connectors show contamination around multiple connector pins.

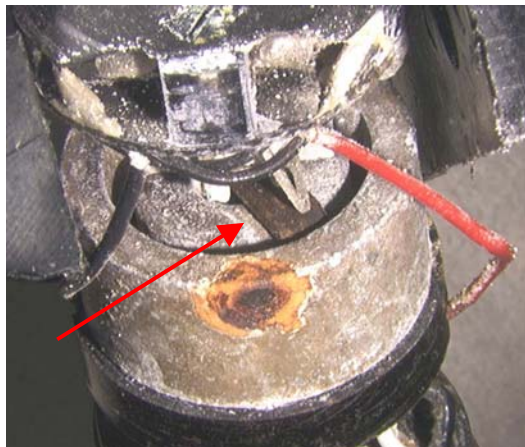
**Figure 17: LEFT, OUTFLOW VALVES**  
Position Indicator witness mark

**Figure 18: LEFT, OUTFLOW VALVES**  
Position Indicator showing witness mark after moving armature.

- Moving armature/needle, mounting tab corresponds to a witness mark on underlying base. This position corresponds to needle positioned at approximately 25% open. The armature was moved from its location in Figure 17 to display the “witness” pattern underneath the movable armature, shown in Figure 18.

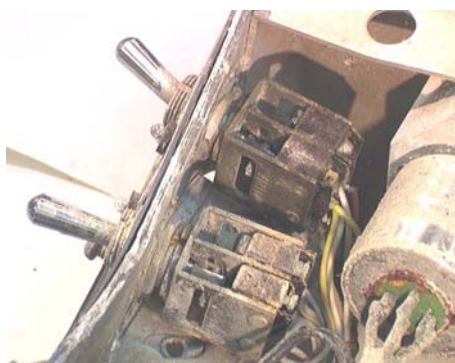
**Figure 22: Outflow Valves, MANUAL CONTROL, OPEN & CLOSE** toggle switches as viewed from underneath.

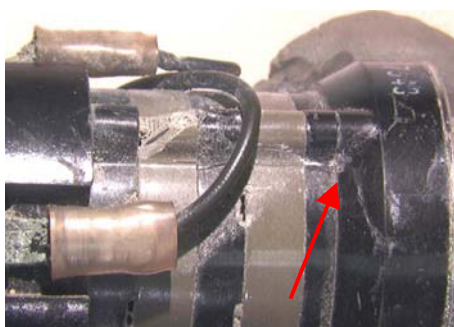
**Figure 34:** Bleed Air Switch #1.

- Minor cracking of housing is apparent.
- Crack detail.
- No continuity could be attained.
- All external wiring appears intact.

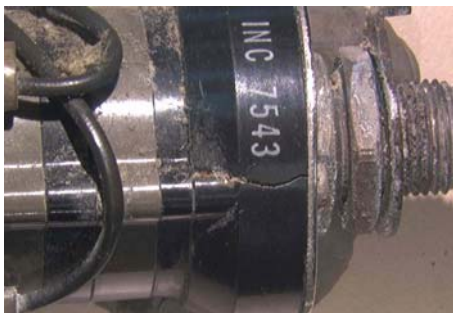
Figure 36: **BLEED AIR** switch 2.

- Minor cracking of housing apparent.
- Detail of cracks.
- No continuity could be attained.
- All external wiring appears intact.
- Knob in OFF position
- Corrosion on all metallic parts

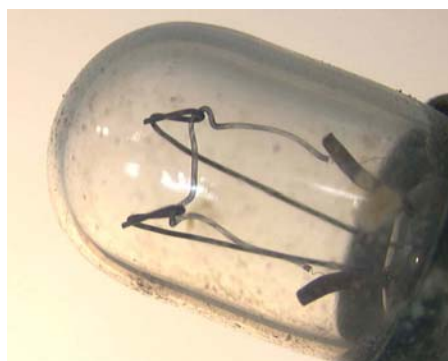
**Figure 41:** PRESS RELIEF light, lower right lamp.  
 • Filament appears to be intact.  
 • Legend plate missing, (Ref. Figure 37, red arrow for lamp location).

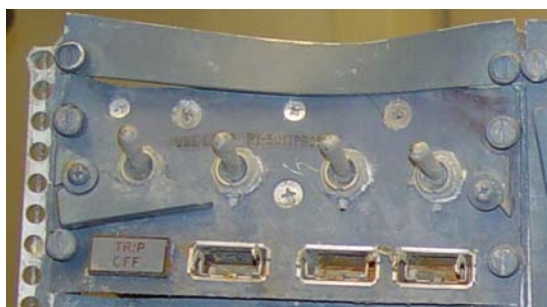
**Figure 52:** Galley Power control panel M179

- Light plate is missing.
- All switch toggles are in up position.
- **TRIP OFF** indicator lights, numbers 2, 3 & 4 legend plates, bulbs and retaining assemblies are missing.

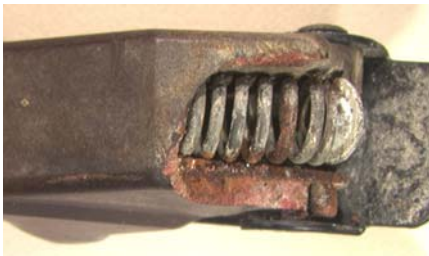
Figure 61: Top view of switch guard damage.

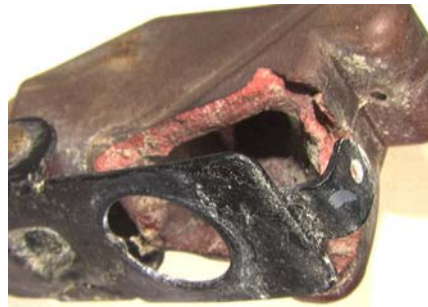
Figure 62: Bottom view of switch guard damage.

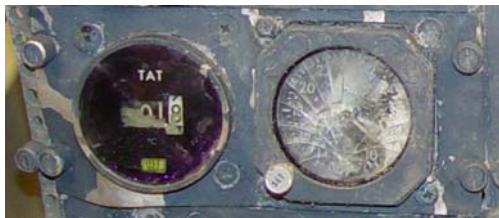
**Figure 65:** Clock Panel, module M184

- Clock glass is fractured.
- Hands set at approximately 0825, partially obscured by broken glass.
- **TAT** partially obscured by discoloration.
  - Reads 1.8 deg. C and **OFF**
- After removal from Flight Engineer's Panel, slight impact damage to top rear of case was noted.

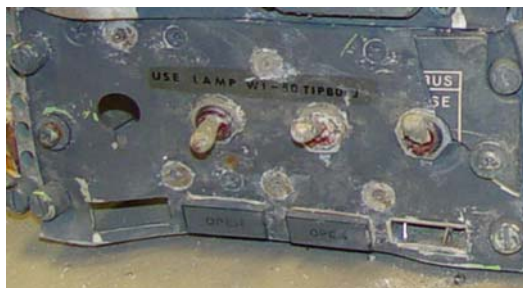
**Figure 67:** DC BUS ISOLATION panel, module M557

- Light plate is missing.
- All three switches' toggles are in up (**CLOSE**) position.  
    **BUS 3** and **BUS ESS** toggles are bent upward.
- **ESS BUS**, & **OPEN** indicators legend plates, bulbs and retaining assemblies are missing.

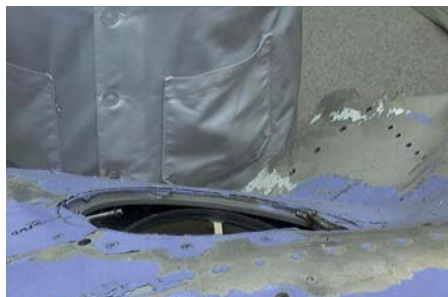
**Figure 77:** Upper pressure relief valve, (center of picture) distorted exterior skin.

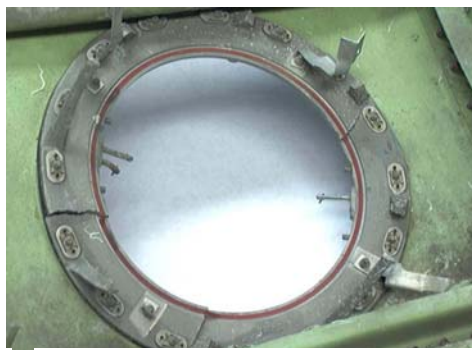
**Figure 91:** Interior view of opening with valve removed (looking inside to outside).

- Forward/lower hinge pin missing.

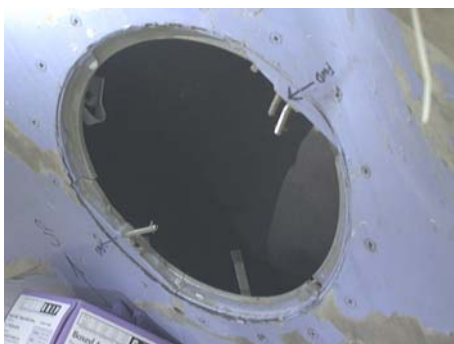
**Figure 92:** Upper Pressure Relief Valve, pins in approximately "door closed" position.

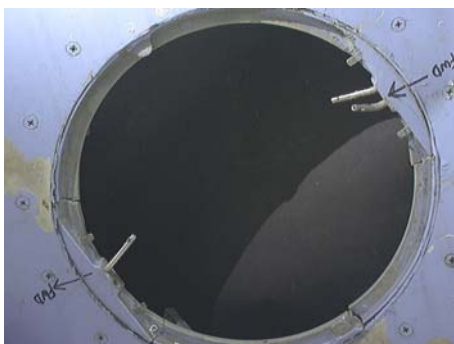
**Figure 94:** Upper Pressure Relief Valve, pins in approximately "door fully open" position.

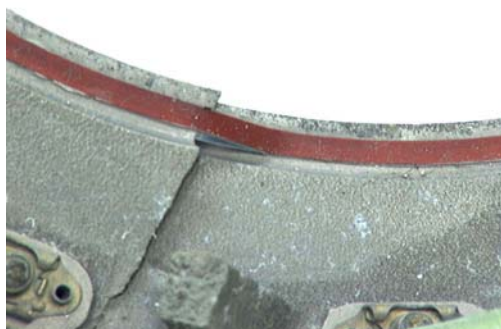
**Figure 99:** Another cut on the seal.

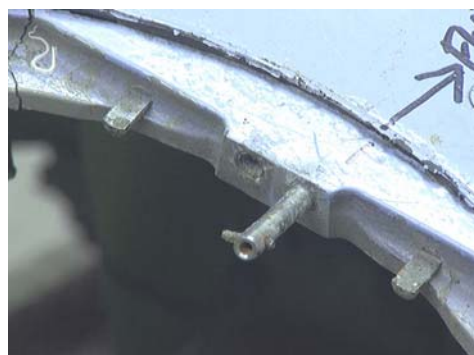
**Figure 102:** Forward stops and hinge pins, (looking from outside to inside).  
 • Forward/upper hinge pin can rotate freely.  
 • Stop pins look normal and unbent.

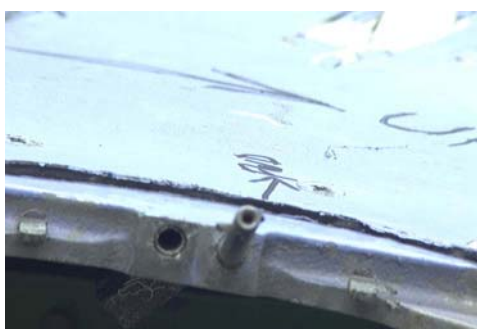
**Figure 103:** Forward/upper hinge pin, physically rotated by hand so that bent portion was oriented outboard.

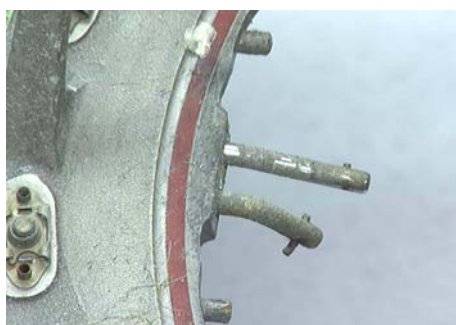
**Figure 106:** Aft hinge & stop pins (looking from inside to outside).

- Aft/lower stop pin appears to have a rust mark and can rotate.

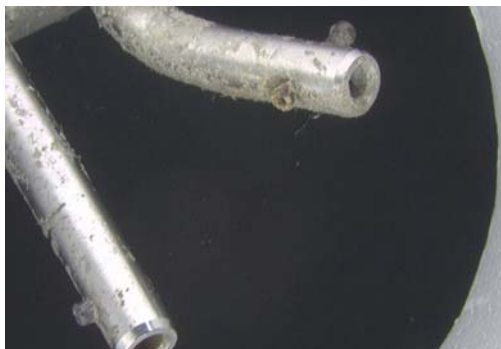
Figure 110: Aft hinge pins, upper & lower. Aft/lower pin is rotated to non-closed door position.

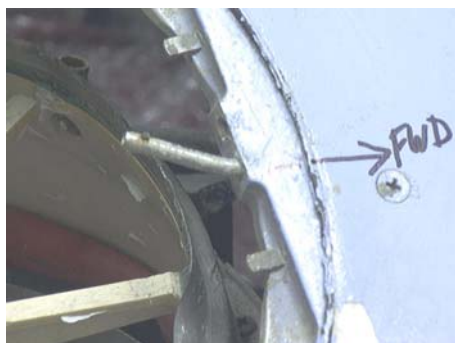
Figure 113: Forward/upper hinge pin, upper door (forward/lower hinge pin is missing).

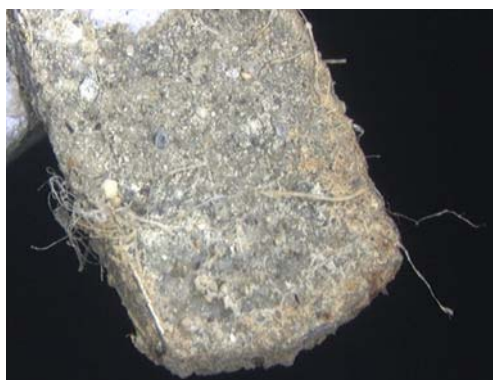
**Figure 126:** Aft/upper stop pin, close-up of figure #125.

- Paint is chipped.

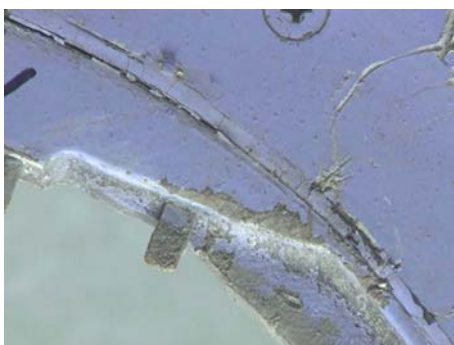
**Figure 135:** Overview of aft/lower stop pin, exterior view.

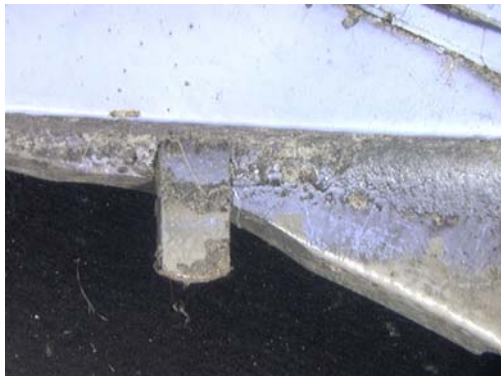
**Figure 136:** Aft/lower stop pin.  
 • Overall, pin is relatively straight.

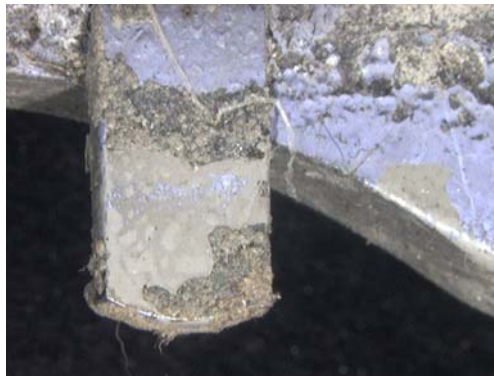
**Figure 137:** Aft/lower stop pin, close-up of figure #136.  
 • Paint is chipped.

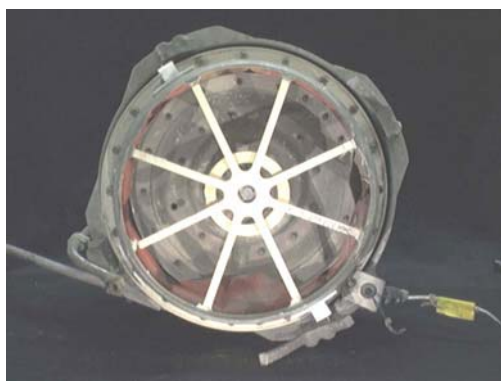
**Figure 138:** Overview of valve face.  
 • Knife-edge has some rolled over areas and some bent edges.  
 • In general, reasonably round.  
 • 2 gate spacers, HS P/N 727407-30 are missing, remaining 2 spacers on top and bottom as shown.

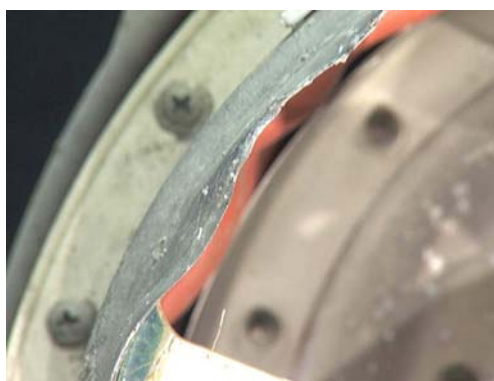
**Figure 139:** Close-up of knife-edge damage.

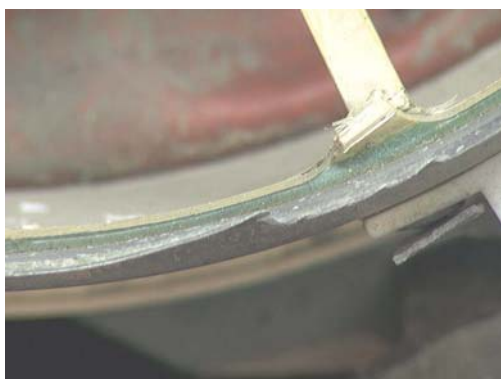
**Figure 140:** Close-up of knife-edge damage.

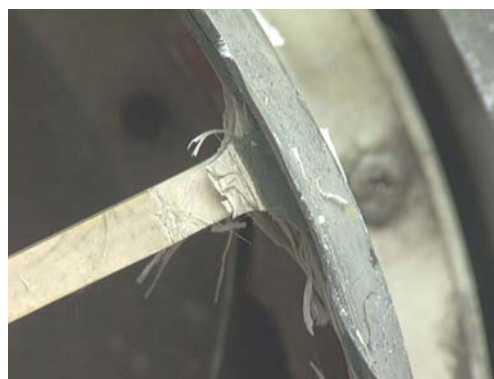
**Figure 141:** Close-up of knife-edge damage.

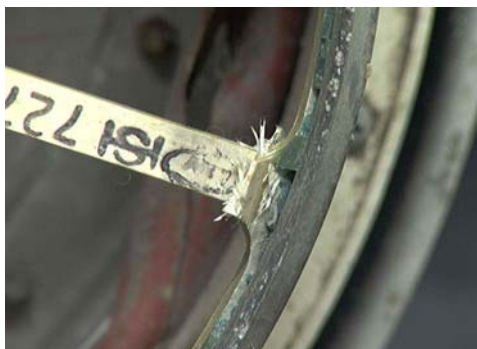
**Figure 142:** Overview, close-up of typical web fracture.

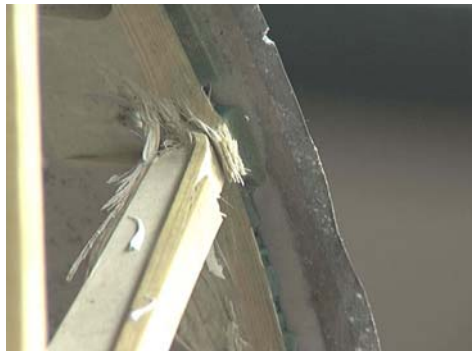
**Figure 143:** Close-up of web, representative of web fractures at gate ID.

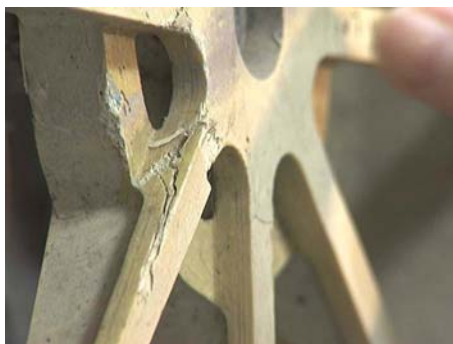
**Figure 144:** Worst of the center web cracks. 2 of 8 appear to be intact, remaining exhibit various degrees of cracking.

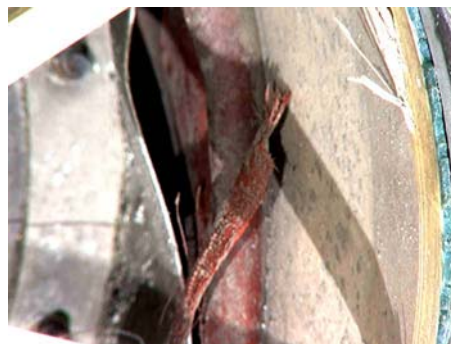
**Figure 145:** Diaphragm, 75 % of outer circumference is torn/split.

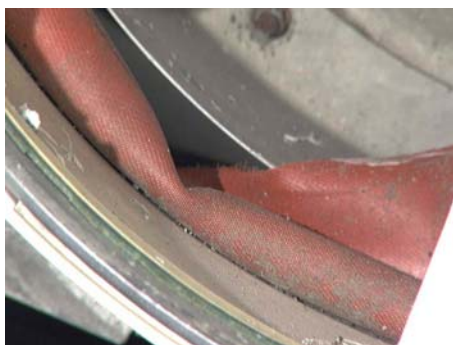
**Figure 146:** Diaphragm, showing typical tear.

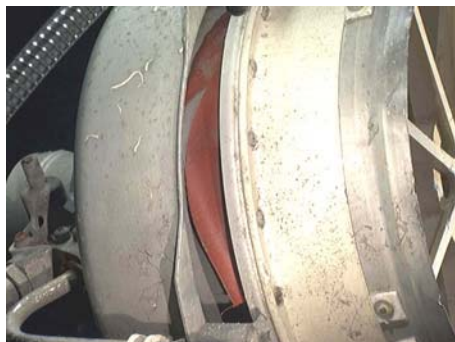
**Figure 148:** Diaphragm, circumferential tear.

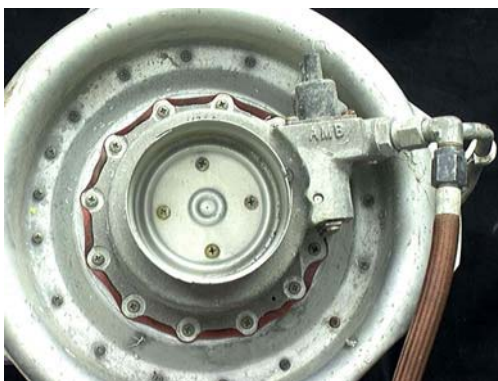
**Figure 156:** Overview of control and filter assemblies.

- The filter (HS P/N 715942-1), cover (HS P/N 727423-1) and spring (HS P/N 727430-1) – are all missing.
- Control orifice shown in bottom of filter housing looks clean.
- Exterior of sensors exhibit light deposits of contamination.

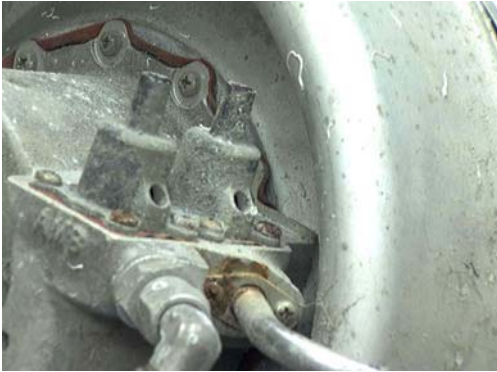
**Figure 157:** Exterior view of sensors, showing some apparent corrosion on the integral ambient sense tube.

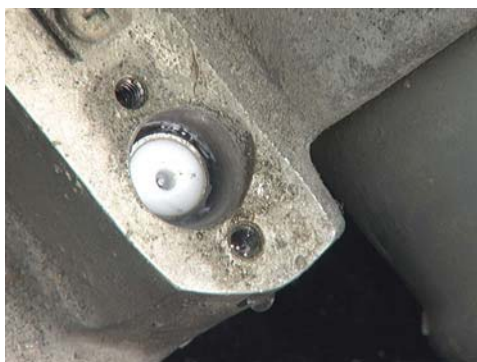
**Figure 169:** Shows water in plug area.

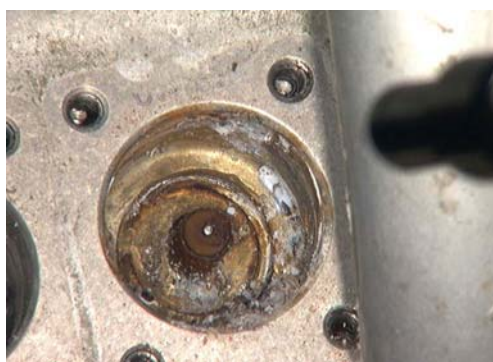
**Figure 170:** Integral ambient sensor poppet housing bore.

- Poppet was free.

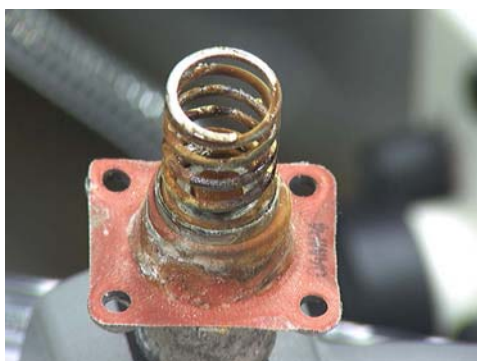
**Figure 171:** Integral ambient sensor spring & diaphragm.

- Heavy hardened corrosion on spring and diaphragm in localized areas.
- Corrosion on spring seat almost all the way around.

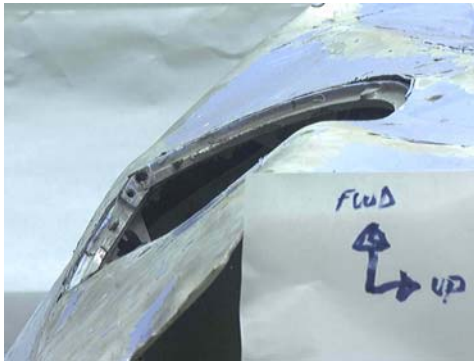
**Figure 183:** Skin distortion at valve mounting location.

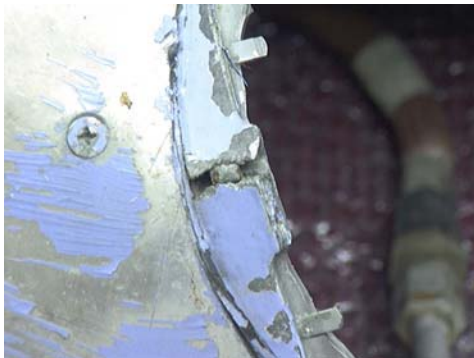
**Figure 184:** Exterior opening, close-up of fracture of valve housing at forward/upper hinge pin.

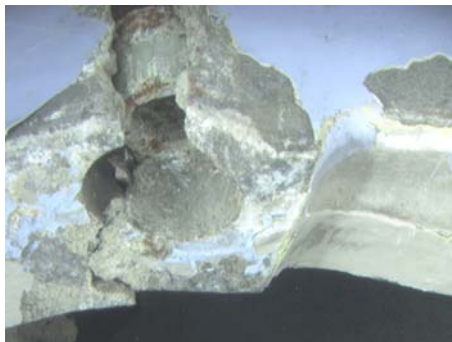
**Figure 186:** Forward/upper hinge pin bushing hole.

- Housing is cracked and contains partial bushing.

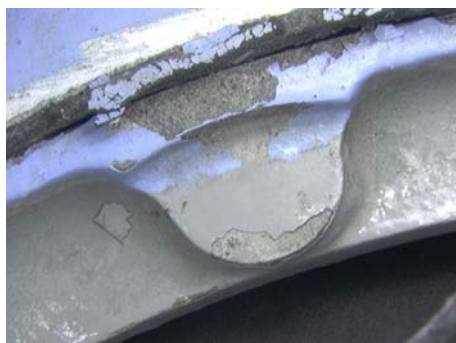
Figure 191: Upper stop pad; paint chipped.

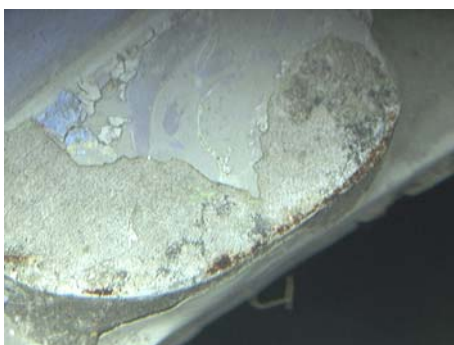
**Figure 202:** Close-up of figure #200, paint chipped.

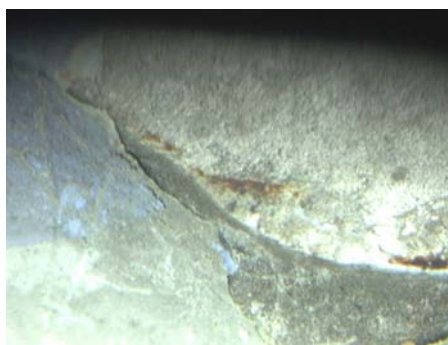
**Figure 203:** Close-up of figures #200 and #202, slight dent on pad, paint chipped.

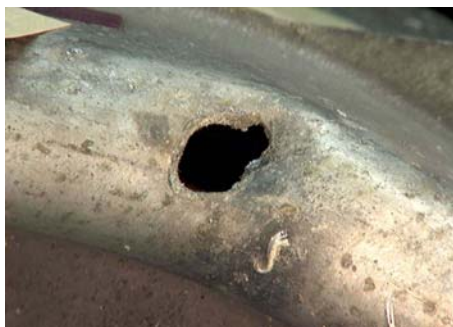
**Figure 209:** Hole penetrating support housing, HS P/N 727405-1.

- Hole is approximately 0.365 inch x 0.560 inch.

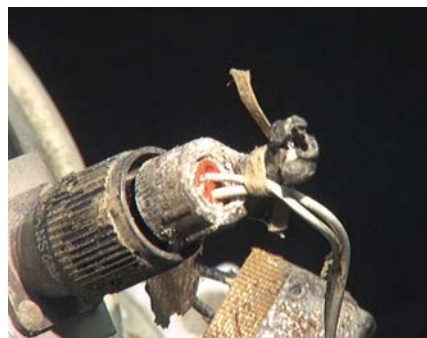
**Figure 210:** Electrical switch connector interface appears to be intact.

- Wires are intact exiting plug.
- Strain relief on backshell is broken.

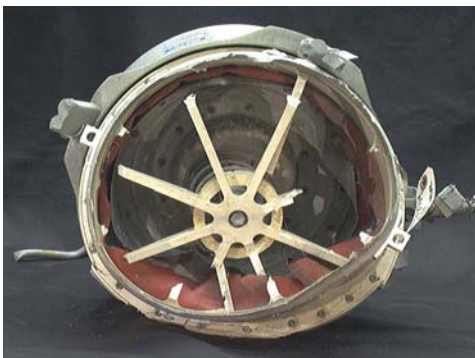
Figure 215: Overview of removed valve.

- Gate adapter is out of round.
- Web members have rotated approximately 45° in relation to case.
- Approximately 50% of edges were curled & torn.
- Light salt deposits.
- At attachment to gate HS P/N 727407-11, 50% of sealant is cracked.
- All 8 rivets (attaching gate to gate adapter) are intact.
- 2 of 4 spacers HS P/N 727407-30, are broken off at flanges.
- HS P/N 727407-11, gate – all 8 of center body webs are broken (7 of 8 at the inside diameter [ID] of the gate).

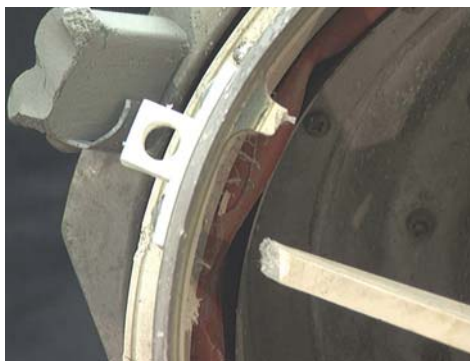
Figure 217: Broken web detail.

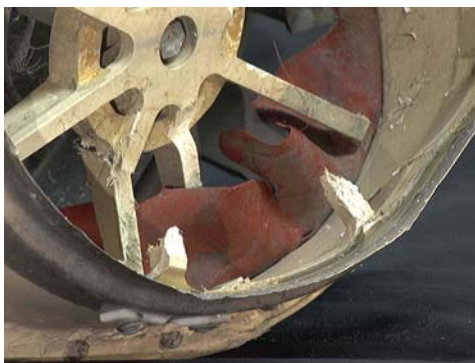
[Figure 220](#): Detail of more broken webs.

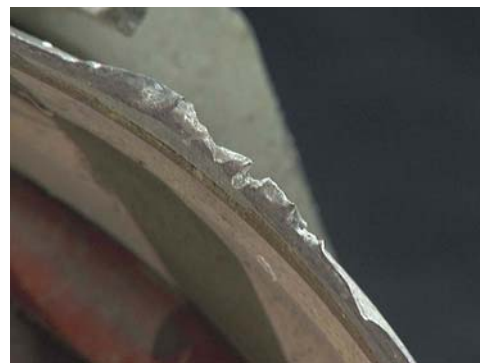
[Figure 221](#): Knife-edge close-up of damage.

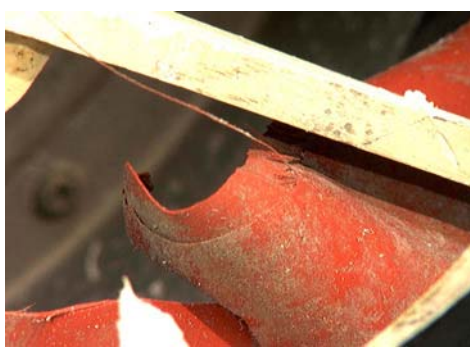
Figure 227: Outer diaphragm HS P/N 727403-1, torn location.

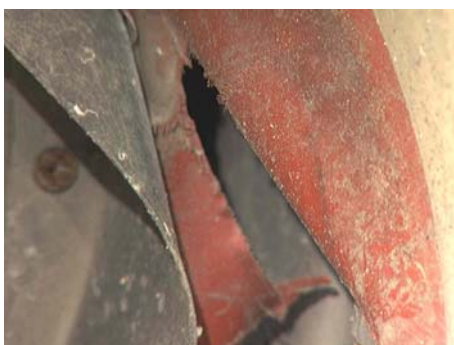
Figure 228: Outer diaphragm, approximately 60% of circumference is torn.

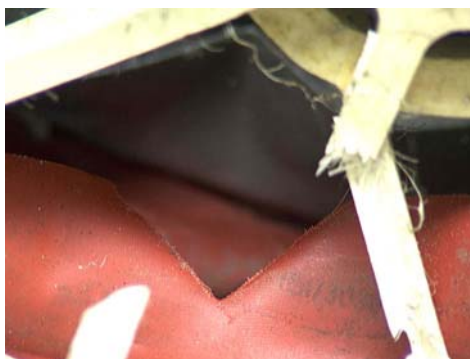
Figure 229: Outer diaphragm, torn location.

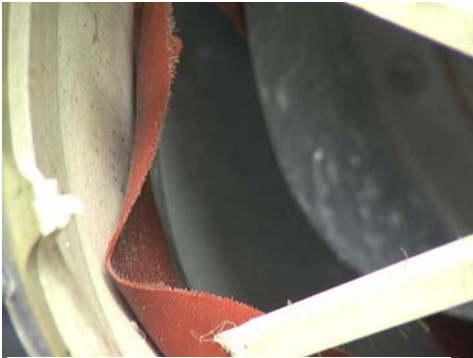
Figure 230: Outer diaphragm damage.

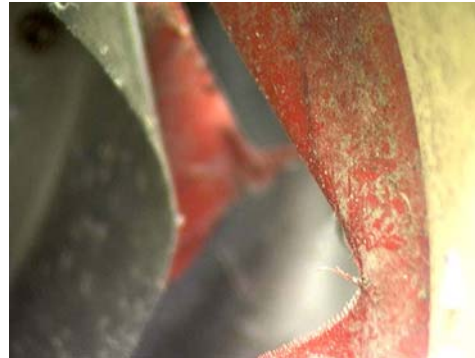
Figure 231: Outer diaphragm damage.

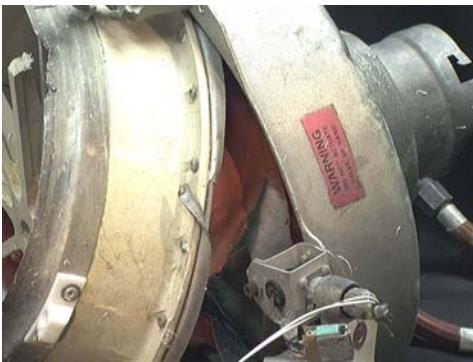
Figure 232: Side view of gate assembly & valve cover, showing the approximate 30° angle between gate assembly & valve cover.

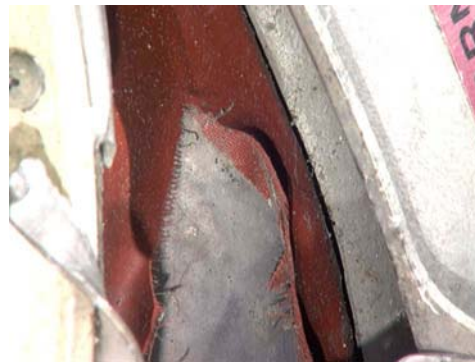
Figure 233: Outer diaphragm, close-up of tear origin.

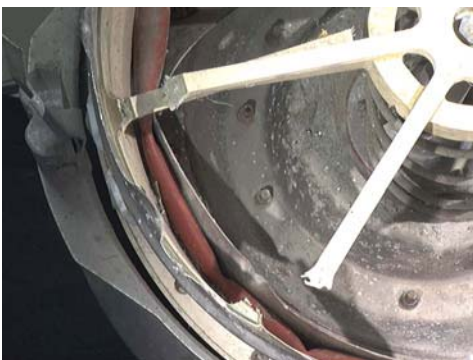
Figure 234: Outer diaphragm, intact (not torn) portion.

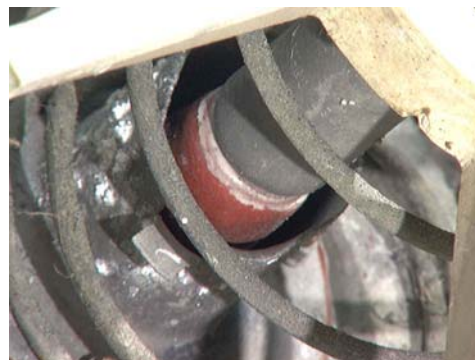
Figure 235: Center diaphragm, HS P/N 727401-1 appears to be intact and the bond portion can be seen; looks normal.

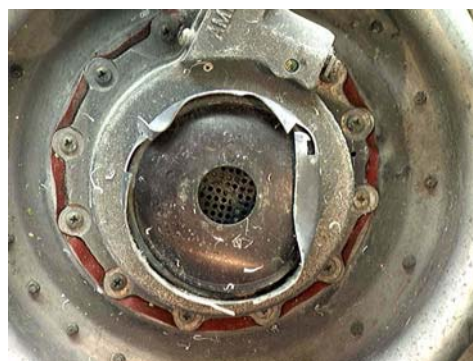
**Figure 239:** Overall of control, filter end.

- Filter cover HS P/N 727423-1 & spring HS P/N 727430-1 are missing.
- Filter housing HS P/N 727426-1 is bent over holding filter in place.

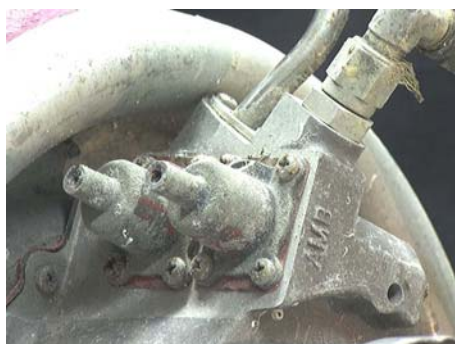
**Figure 240:** Control assembly area (sense housing area), overview.

- Intact, some surface accumulation.
- Nothing looks out of place.
- Integral ambient sensing tube attachment looks normal.
- Remote tube attachment looks normal.

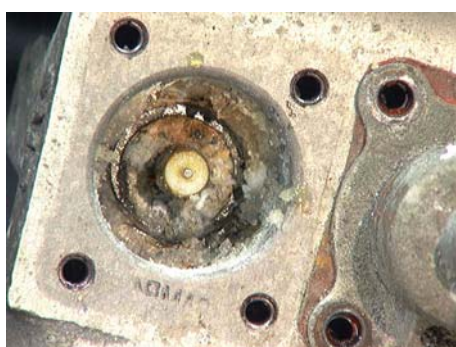
**Figure 251:** Close-up of salt deposits inside housing bore.

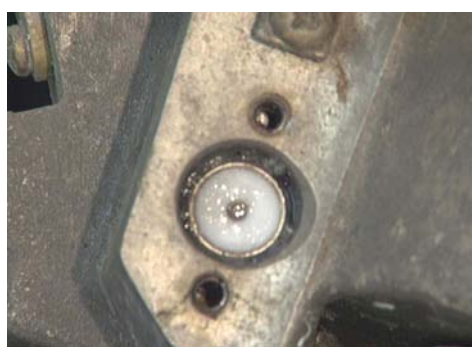
**Figure 252:** Remote ambient sensor, opposite end of poppet and guide.

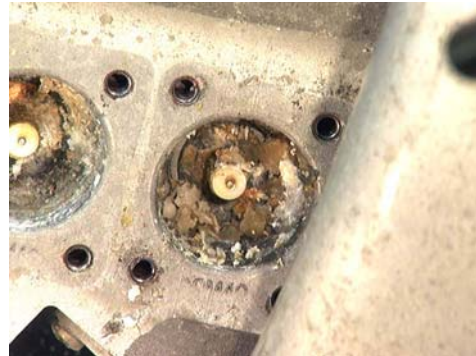
**Figure 254:** Integral sensor housing bore.

- Heavy deposits.
- Poppet appears to be frozen.
- Salt deposits on end of poppet.

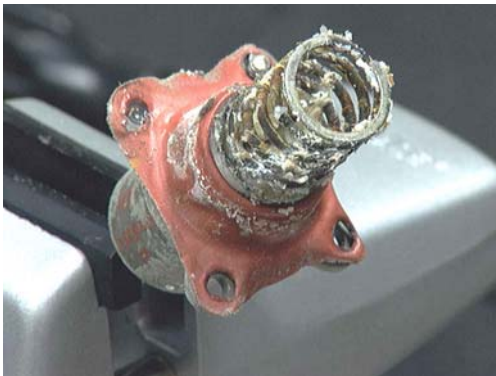
**Figure 255:** Integral sensor spring and diaphragm.

- Heavy salt deposits.
- Diaphragm intact.
- Spring has heavy salt deposits and possibly salt corrosion.

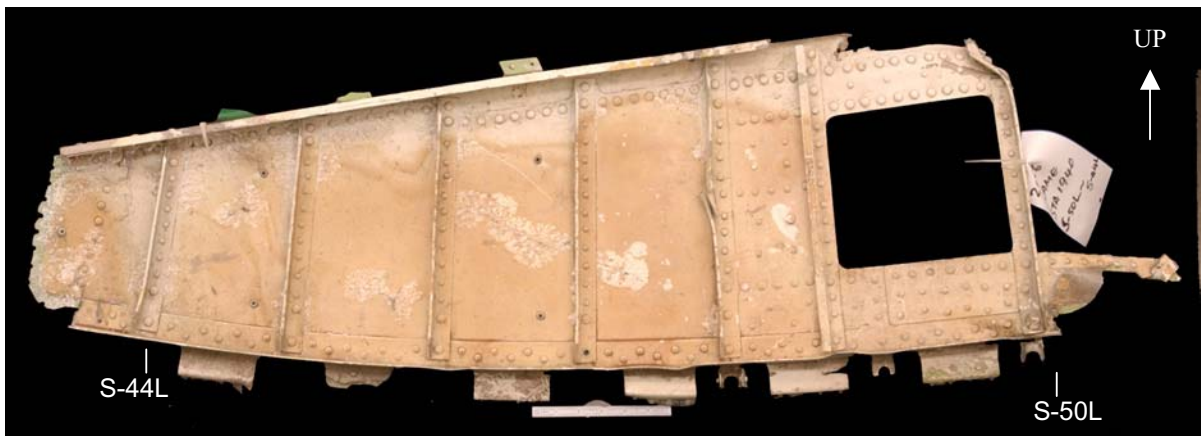
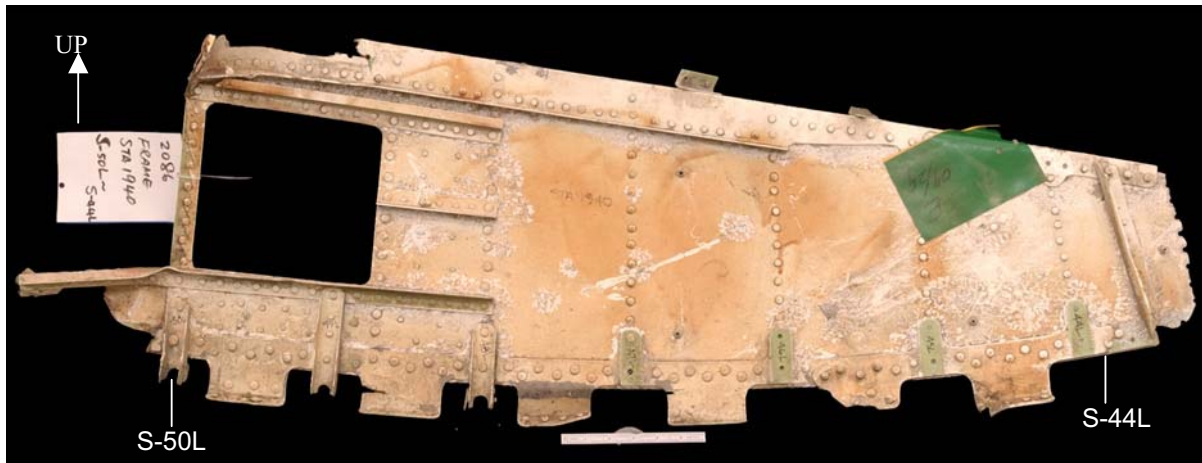
The as-received condition of this frame segment is shown in Figures 89 and 90. This frame segment contained two repairs of shear tie locations and one repair to the web. The shear ties were repaired between S-50L and S-49L with the use of a doubler (see Figure 91) and between S-46L and S-44L with the use of a replacement shear tie/doubler combination (see Figure 92). The web was repaired with the use of a doubler placed on the aft side under the cut-out between S-50L and S-49L (see Figure 93).

Figure 89. As received condition of the STA 1940 frame segment submitted for examination. The aft surface is shown in this view.

Figure 90.  
As received condition of STA 1940 frame segment submitted for examination.  
The forward surface is shown in this view.
