**Aviation Safety Council  
Taiwan**

**Far Eastern Air Transport Flight EF306,  
Boeing 757-200 / Thai Airways  
International Public Company Ltd  
Flight TG659, Boeing 777-300**

**A TCAS Event in Narrow Collision  
Avoidance at an Altitude of 34,000 Ft.  
and 99 NM South of Jeju Island, Korea**

**Final Report**

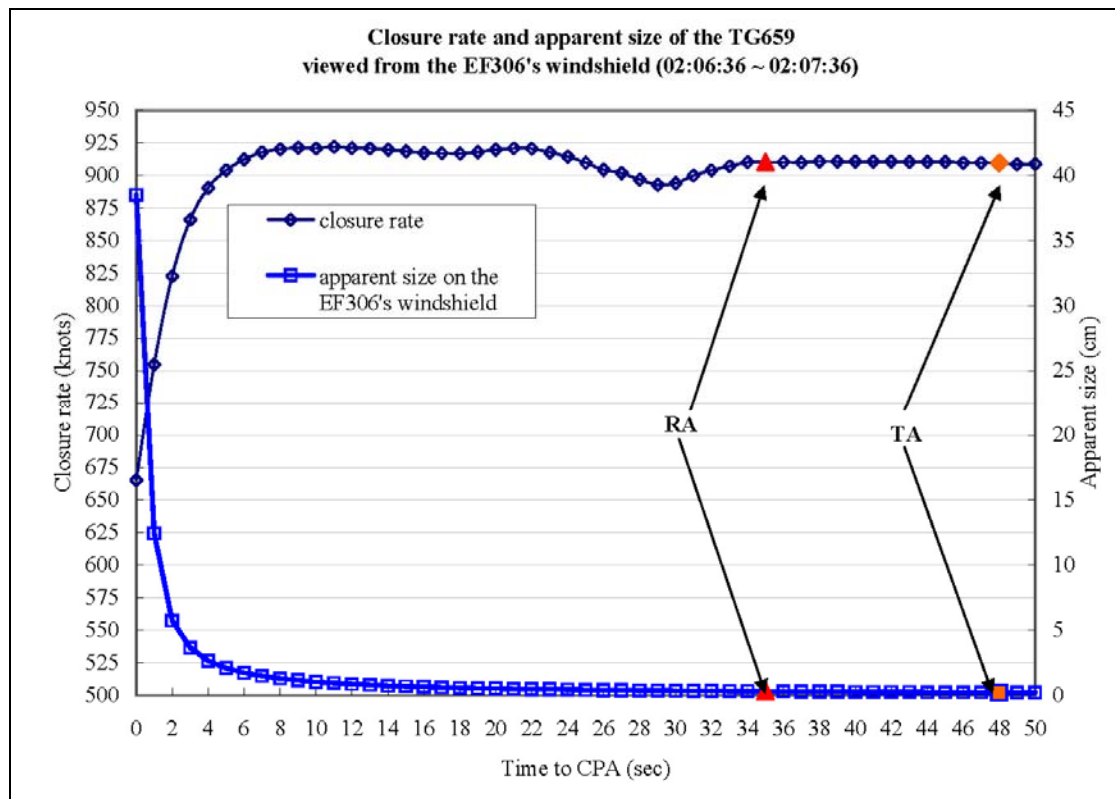
Figure 2.2-1 The apparent size of TG659 from EF306 cockpit

The apparent size of an aircraft varies in the form of an exponential function while the two aircraft are approaching; a more detail description is in Attachment 9. The closure rate and apparent size of the TG659 views from EF306 cockpit with respect to the time to CPA<sup>25</sup> is shown in Figure 2.2-1. Based on the results of Figure 2.2-1, the apparent size of TG659 at the time of 02:07:01(RA warning issued) was about 0.3 centimeter and almost the same at the time of 02:07:07(the time of max. negative g). This means that the PF's visual contact dose not agree with the data of Figure 2.2-1.

The FAA's AC90-48C also indicates: Based upon the "see and avoid principle" it takes approximate 12.5 seconds to initiate the traffic avoidance maneuver after visual contact with threatening approaching traffic. The EF306 RA announced 36 seconds prior to the CPA in this event. The threatening traffic was 9 NM ahead. If the EF306 initiated the avoidance maneuver 12.5 seconds later, there were still about 24 seconds prior to the CPA; the apparent size of TG659 based on Figure 2.2-1 is about 0.4 centimeter. This again means that the abrupt TCAS avoidance maneuver was not necessary. Page 6-8, TCAS/ACAS II (Change7) Pilot's Guide (Appendix 8) emphasizes when RA is announced, the PF shall look inside the aircraft to determine the commanded vertical speed required and change the pitch of the aircraft on the attitude indicator to the computed target attitude which will yield the commanded vertical speed. The PM shall continue to scan the outside of the aircraft for traffic, to back up the PF to insure the required performance and notify ATC when practical. Page 7-20, FCOM also indicated that visual avoidance maneuvers could mislead the flight crews into making abrupt input to the aircraft.

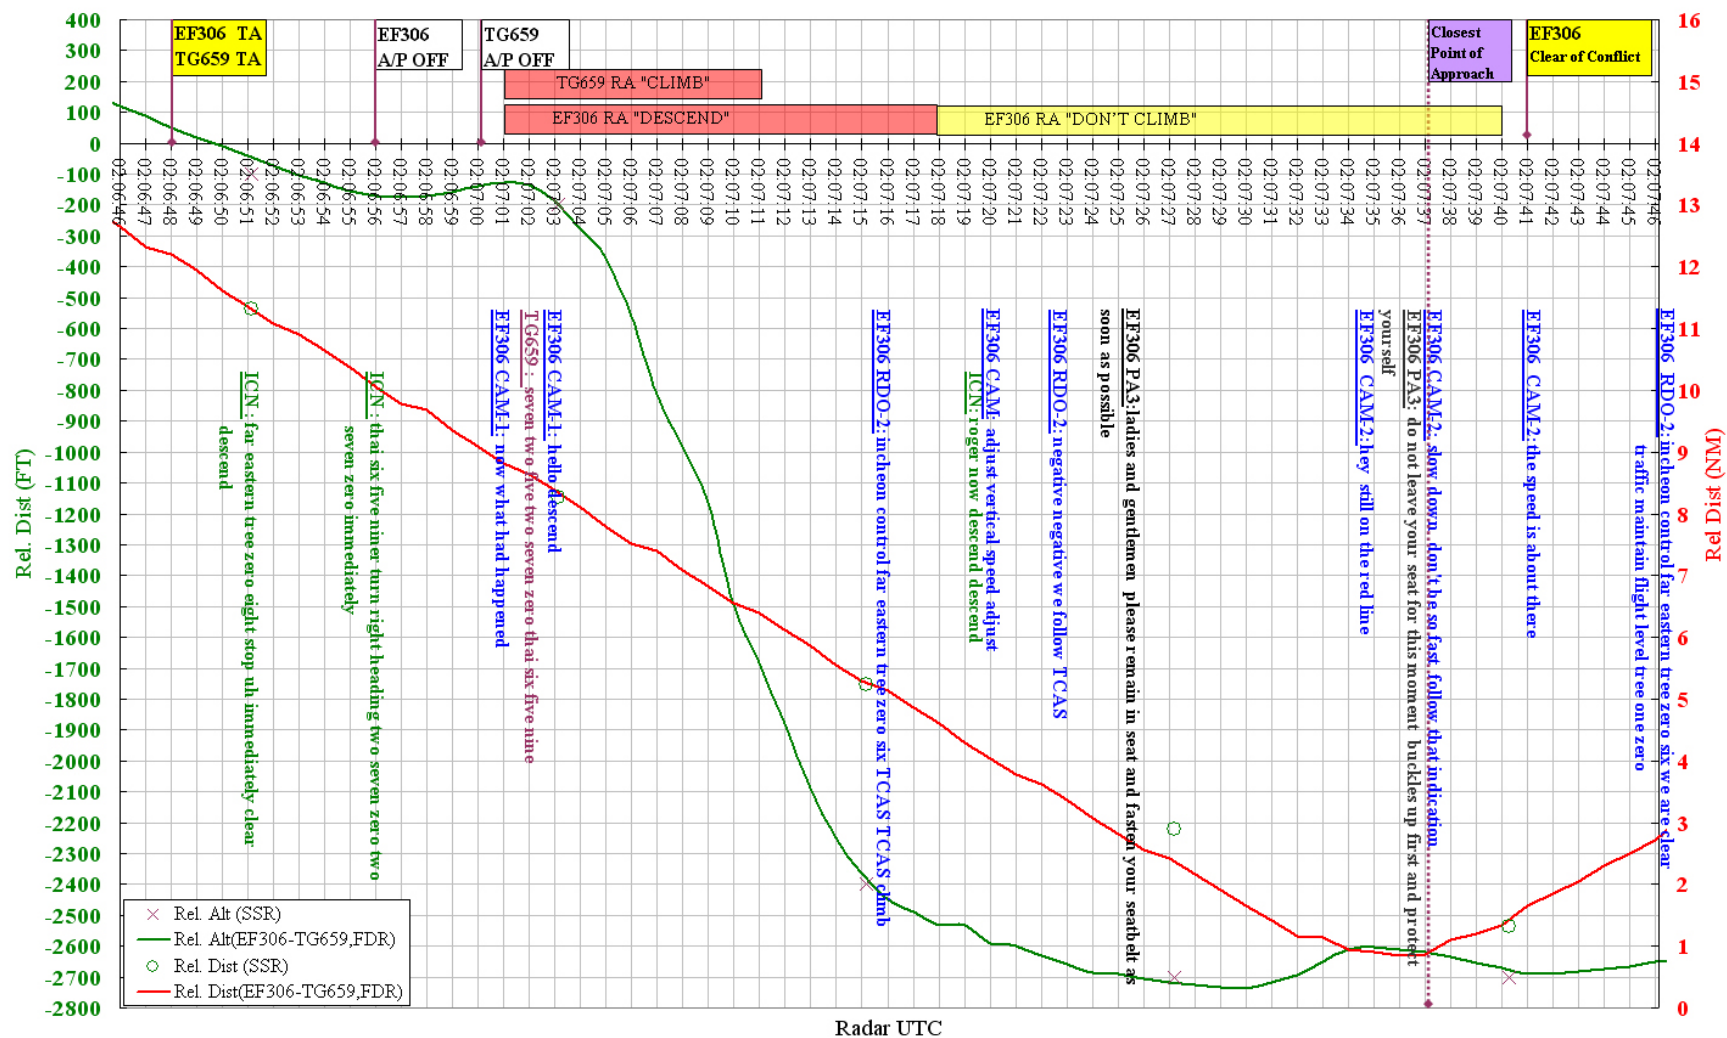
Figure 2.4-2 The variation of vertical speed, relevant CVR transcripts, relative distance and altitude during the TCAS activation

Figure 2.4-2 includes the vertical speed, relative distance and relative altitude variation during the TCAS activation with relevant CVR transcripts. Table 2.4-1 lists those parameters, plotted in Figure 2.4-2, and described the derivative parameters with relative distance and bearing angle.

The flight crew performed an excessive descent rate during the first 8 seconds. That kind of maneuver induced a negative G-force and resulted in occupants' injury. At 02:07:08, the vertical separation was -983 ft. If the two aircraft fully followed the TCAS RA instructions and performed with the recommended vertical speed of RA (i.e. vertical speed between 0 ft/min and 1500 ft/min), there would be no collision hazard.

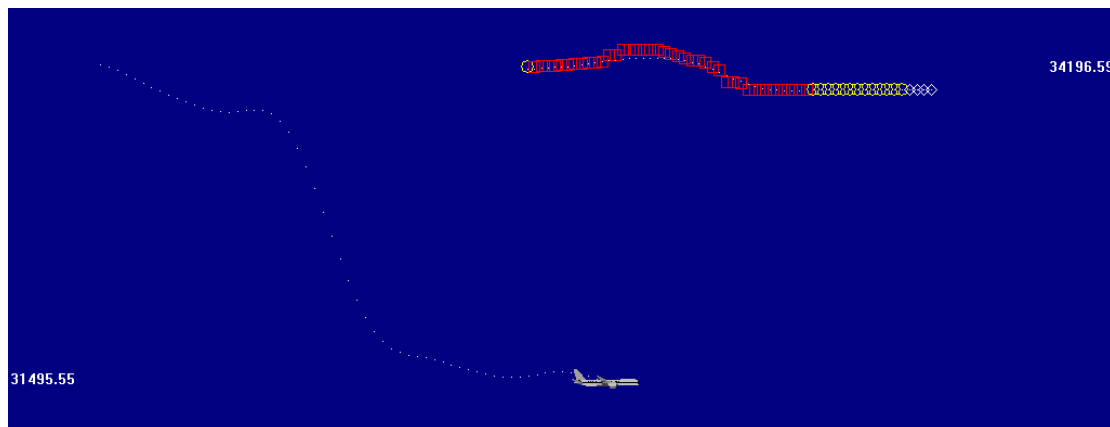
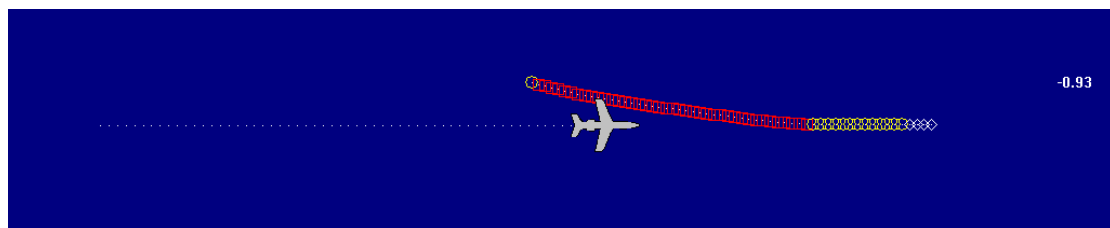
- The Traffic Advisory occurred at time 02:06:48,
- The Descend RA “Descend, Descend” occurred at time 02:07:01,
- The Reduce Descend RA “Adjust Vertical Speed, Adjust” occurred at time 02:07:13,
- The RA Removed “Clear of Conflict” occurred at time 02:07:41,
- The closest relative range was 0.877 nm at time 02:07:36 and the altitude separation was approximately 2,600 ft.

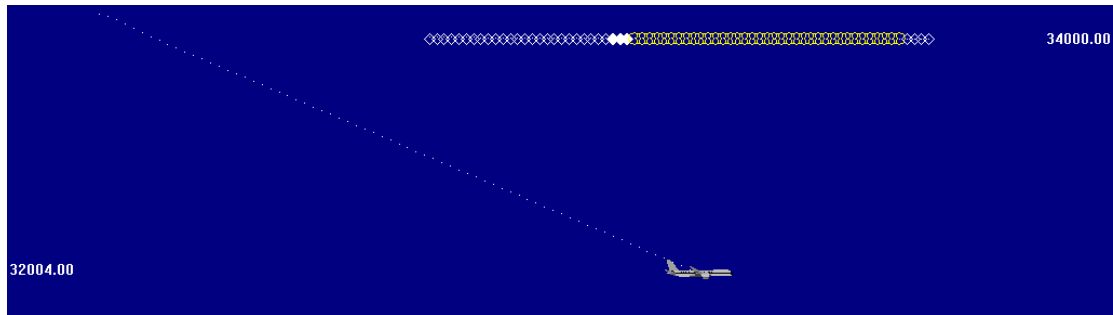
Figure 2.6-3 Side view of Scenario 2 on TSIM

- The Traffic Advisory occurred at time 02:06:48, but thereafter, there was no more TCAS warning.
- The closest relative range was 0.263 nm at time 02:07:36 and the altitude separation was approximately 1,450 ft.

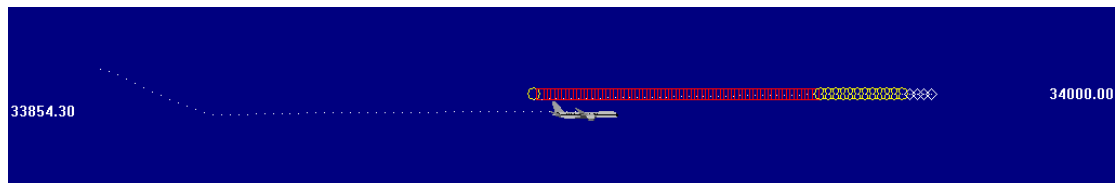
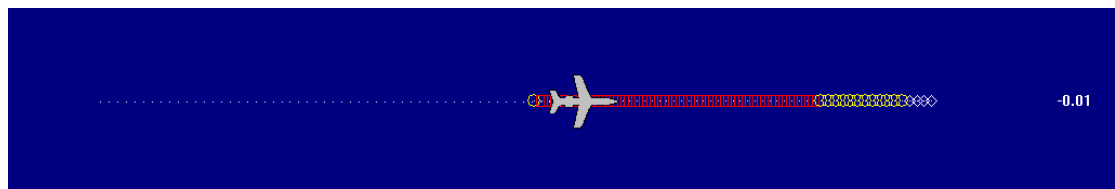
- The Descend RA “Descend, Descend” occurred at time 02:07:00
- The Increase Descend RA “Increase Descent, Increase Descent” occurred at time 02:07:29.
- The RA Removed “Clear of Conflict” occurred at time 02:07:38
- The closest relative range was 0.116 nm at time of 02:07:35 and the altitude separation was approximately 150 ft.

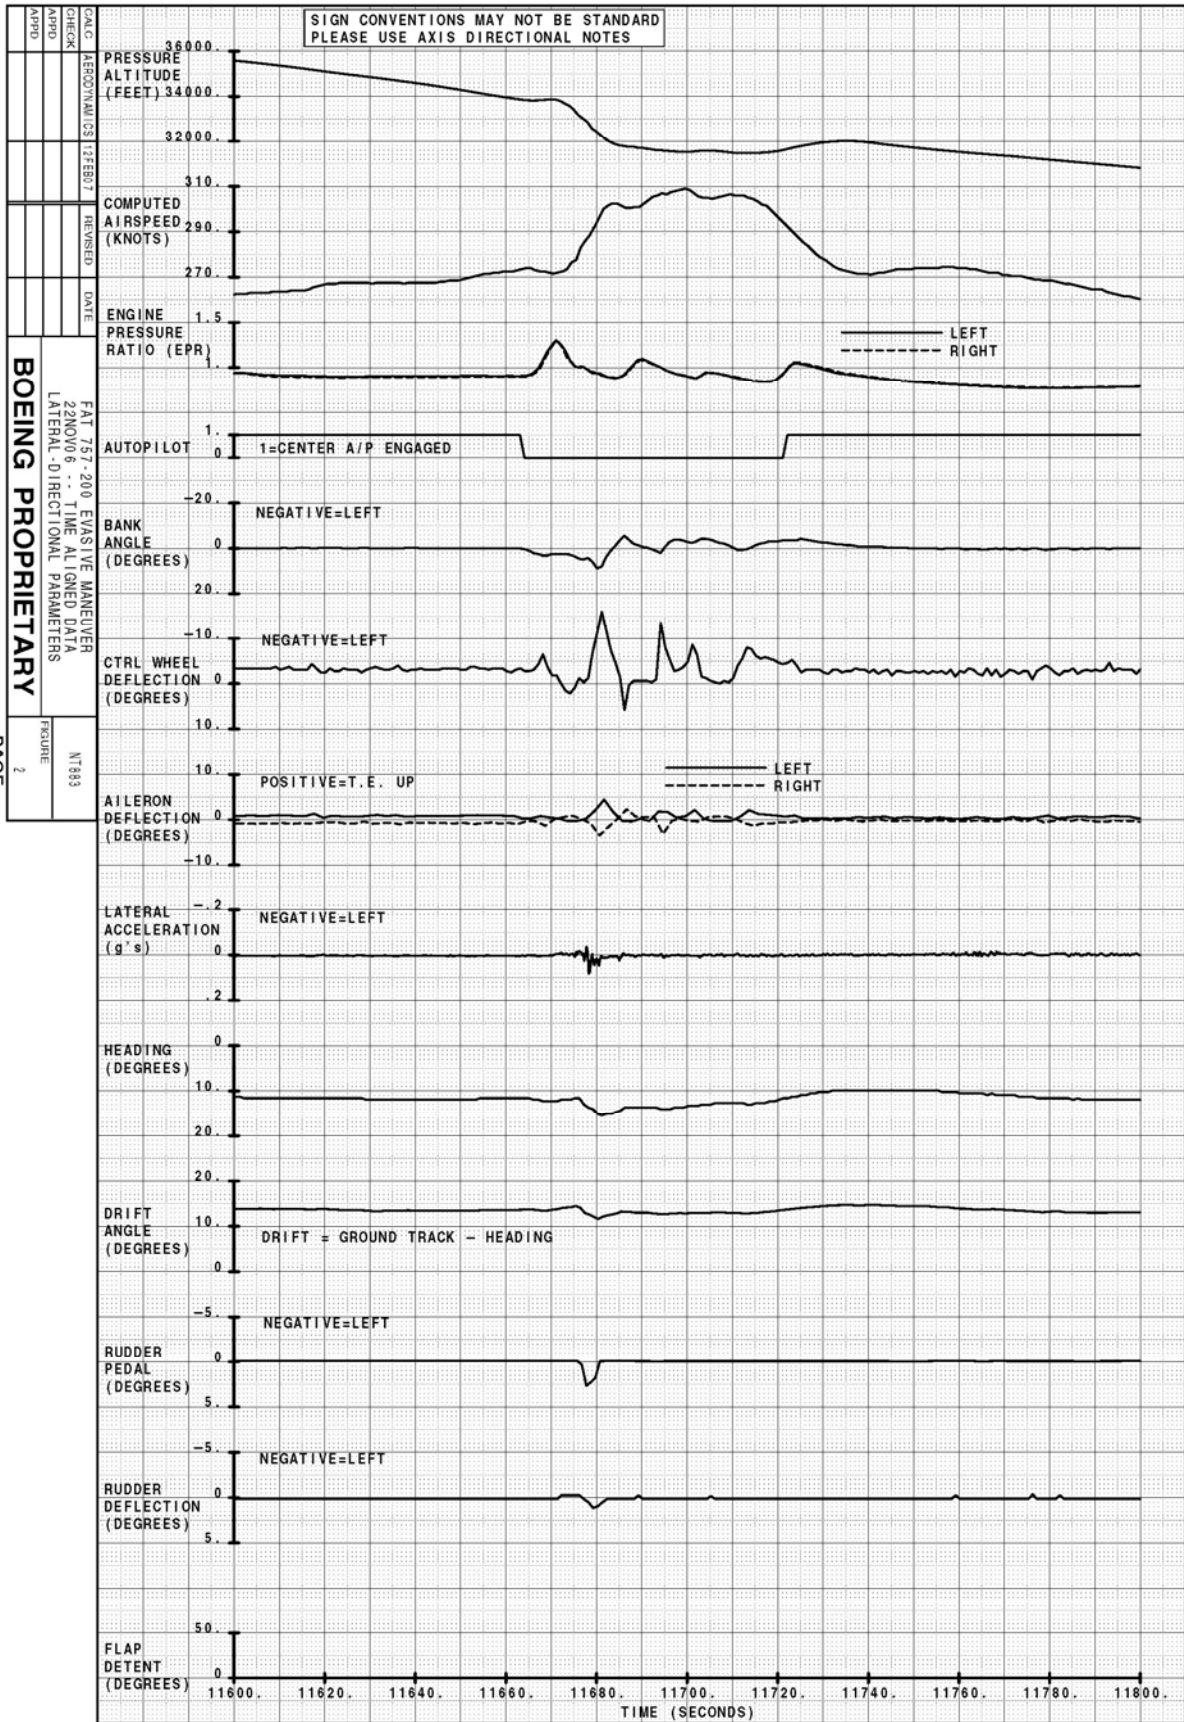
Figure 2: Lateral-Directional parameters vs. time

Although not confirmed by a pilot report, the FDR data suggests that the crew was aware of traffic in the area, from either a TCAS Traffic Advisory (not recorded in the FDR data) or visually, and responded to the traffic by discontinuing the normal descent and entering a shallow climb. Then the crew received a TCAS Resolution Advisory to descend at 1500 ft/min, which was opposite of their original maneuvering. The push over to comply with the resolution advisory resulted in the airplane reaching a normal load factor of approximately -1.0 g's and a descent rate of 15000 ft/min. The recovery from this rapid descent involved maneuvering that resulted in normal factors between 0 and 2.5 g's.

Boeing recommends in the Reference (c) 757 QRH, that for a TCAS Resolution Advisory that the pitch and thrust be smoothly adjusted to satisfy the RA command. Based on analysis of the FDR data only, the rapid descent maneuver performed in this event greatly exceeded the recommended procedure.
