# Aviation Occurrence Report

ASC-AOR-16-01-002

**TransAsia Airways Flight GE222**

**Impacted Terrain and Collided  
with a Residential Area**

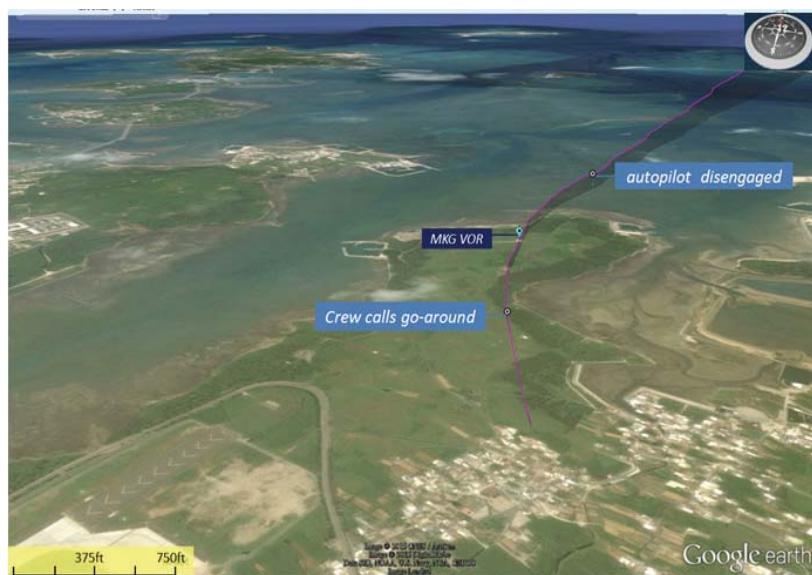
Figure 1.1-1 Final approach track

At 1906:11, both pilots called "*go around*" at 72 feet and both engine power levers were advanced. Two seconds later, the aircraft hit the foliage 850 meters northeast of the runway 20 threshold. The aircraft sustained significant damage and consequently collided with a residential area. Due to the high impact forces and post-impact fire, the aircraft was totally destroyed.

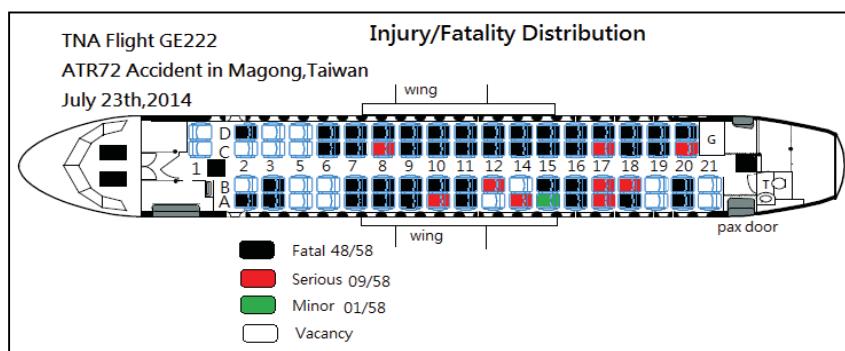
Figure 1.2-1 Injury and fatality distribution

Figure 1.2-1 shows the injury and fatality distribution via seat location. The passenger seating positions were based on the airline seating plan and interviews with the surviving passengers.

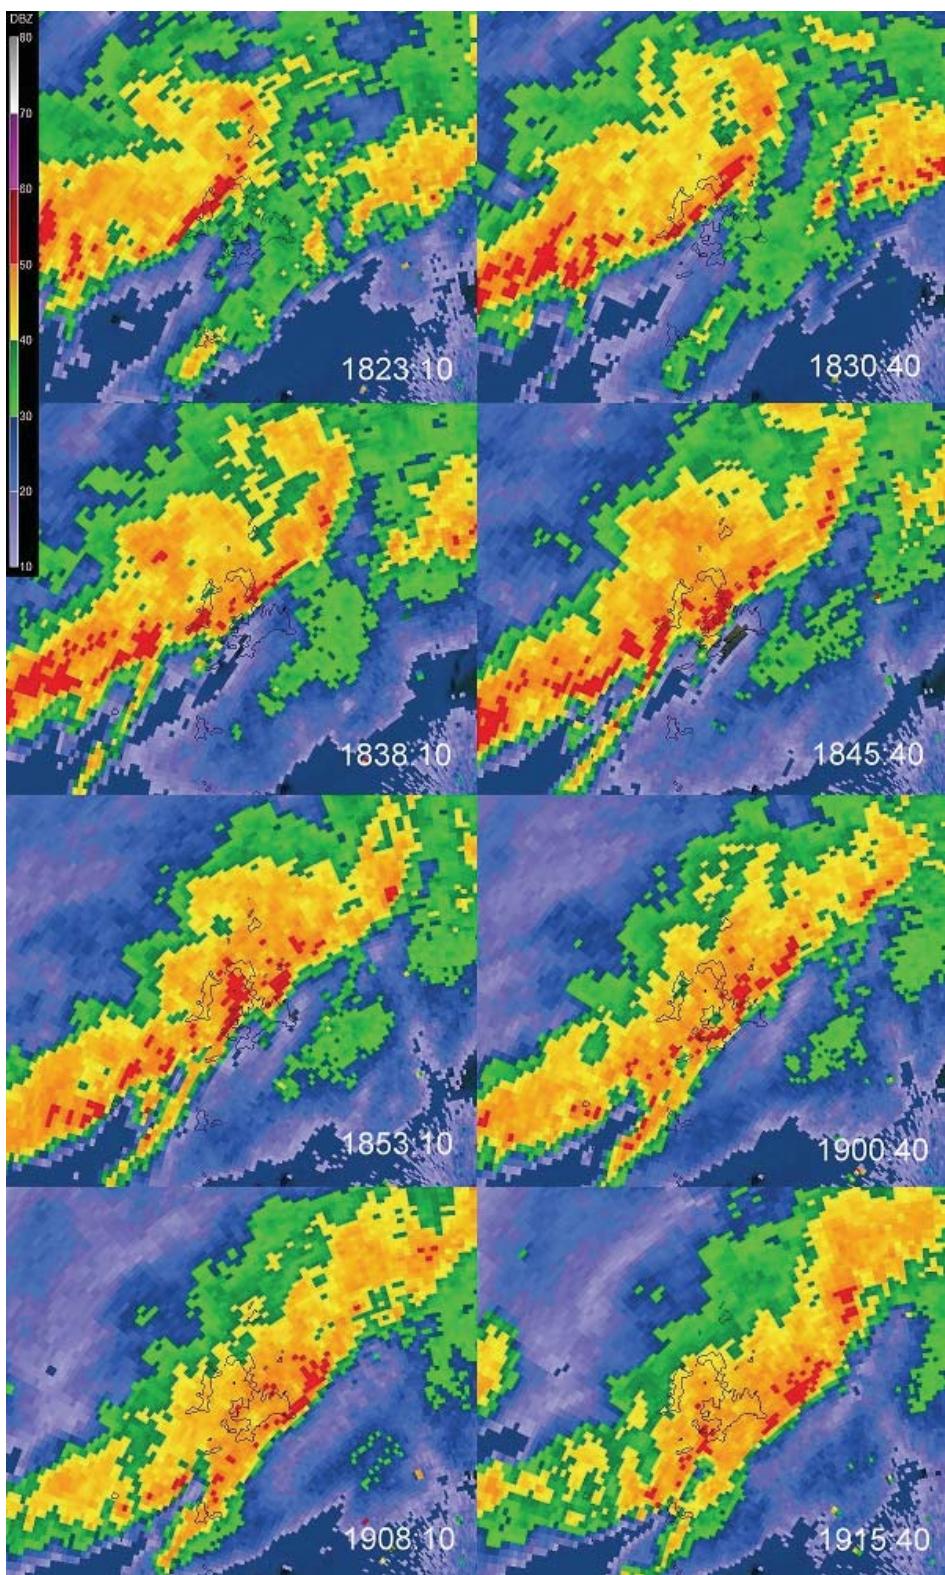
Figure 1.7-10 Chiku weather radar images before and after the occurrence

Chiku weather radar was located approximately 35 nm to the southeast of the occurrence site. A scan was completed every 7.5 minutes. With the scan taken at 0.5° elevation, the airspace between about 1,100 and 4,700 feet above mean sea level above

the occurrence site was captured. The images from Chiku's radar between 1823:10 and 1915:40 are depicted in Figure 1.7-10.

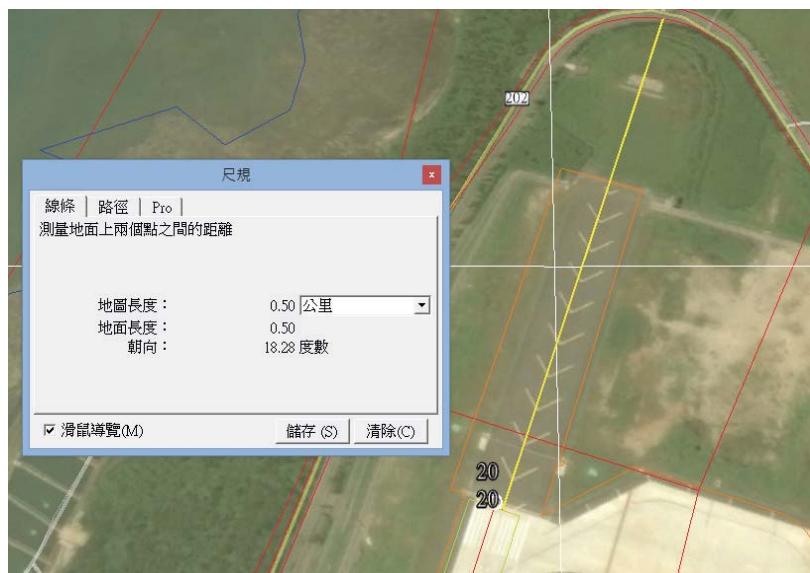
Figure 1.10-3 Available distance measured from Runway 20  
(image from Google Earth)

There was no approach lighting system for runway 20. According to ICAO Annex 14 section 5.3.4 and the CAA Civil Aerodrome Design and Operations Specifications section 5.3.4, where physically practicable, a simple approach lighting system shall be provided to serve a non-precision approach runway. A simple approach lighting system shall consist of a row of lights on the extended center line of the runway extending, where possible, over a distance of not less than 420 meters from the threshold.

Measurement of the extended center line for runway 20 indicated that about 500 meters was available for an approach lighting system within the airport area, as shown in Figure 1.10-3.

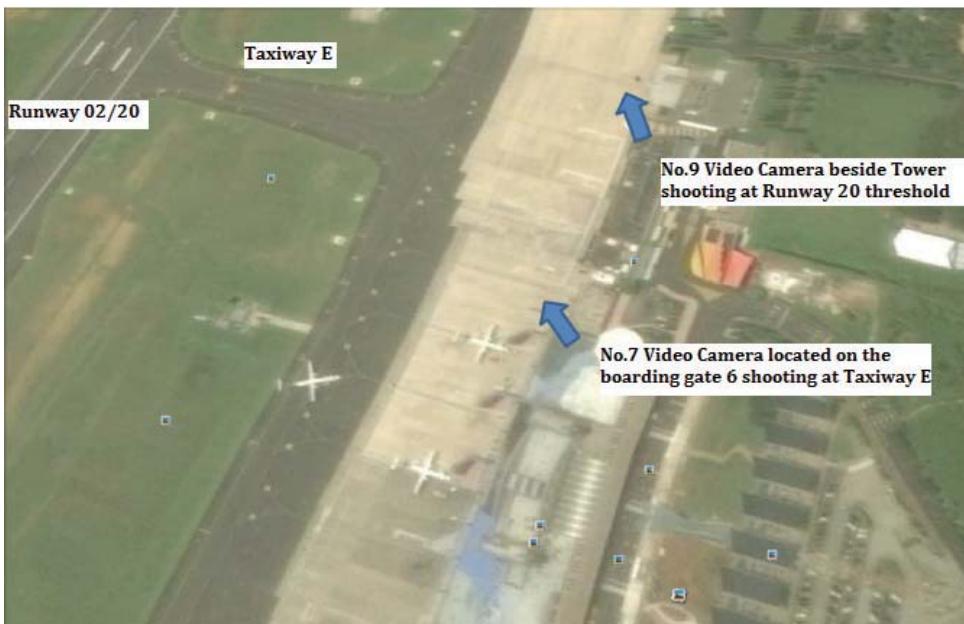
Figure 1.10-5 The location of airport CCTV No.7 & No.9

airport surveillance cameras. The camera locations and filming directions are shown in Figure 1.10-5. The camera footage encompassing the time period between 1830 and 1930 on the day of the occurrence was examined. Relevant images extracted from No.7 and No.9 cameras are presented in Appendix 2. A summary of the information obtained from the video footage is presented in Table 1.10-1.

Time	Observations
1830-1858	Raining, runway edge lights and control tower visible.
1858-1903	Storm suddenly intensifies accompanied by continuous lightning, runway edge lights not visible.
1903-1910	Very poor visibility, no objects could be recognized from camera.
1913-1930	Airport rescue firefighting vehicles were dispatched. Storm conditions improved and some runway edge lights were visible.

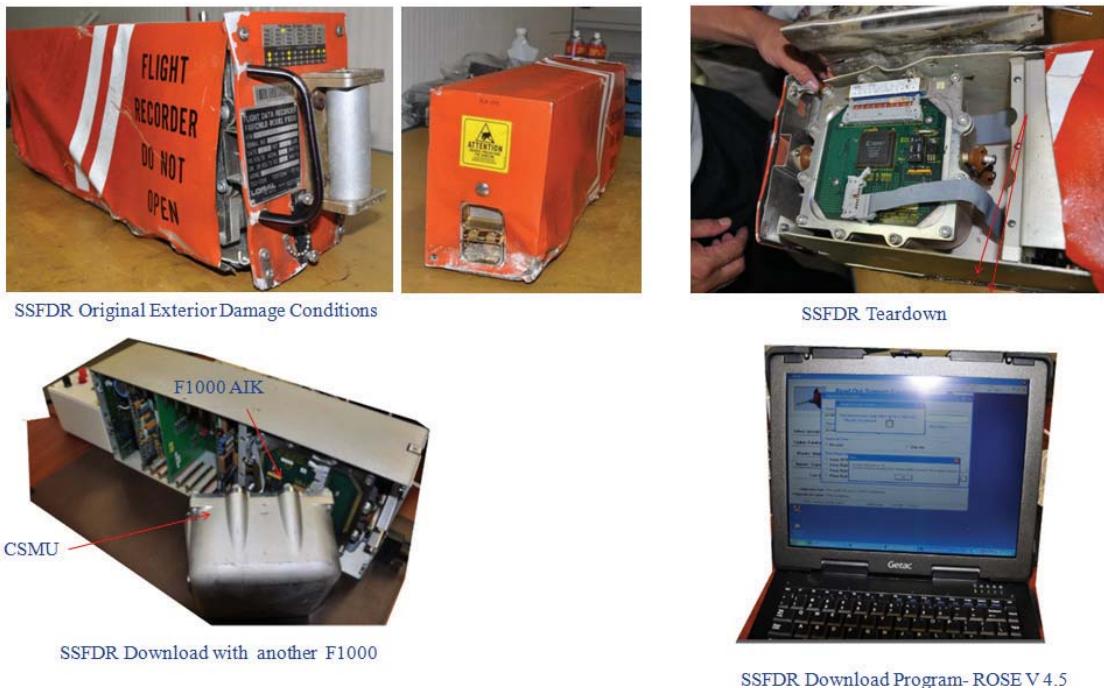
Figure 1.11-2 FDR exterior view, teardown and download process

There was no evidence of heat or fire damage on the exterior of the FDR. The FDR casing had sustained some impact damage and two CSMU support units were broken. The CSMU was not damaged and all applicable data was recovered. Figures 1.11-2 shows the FDR exterior view, teardown and download process.

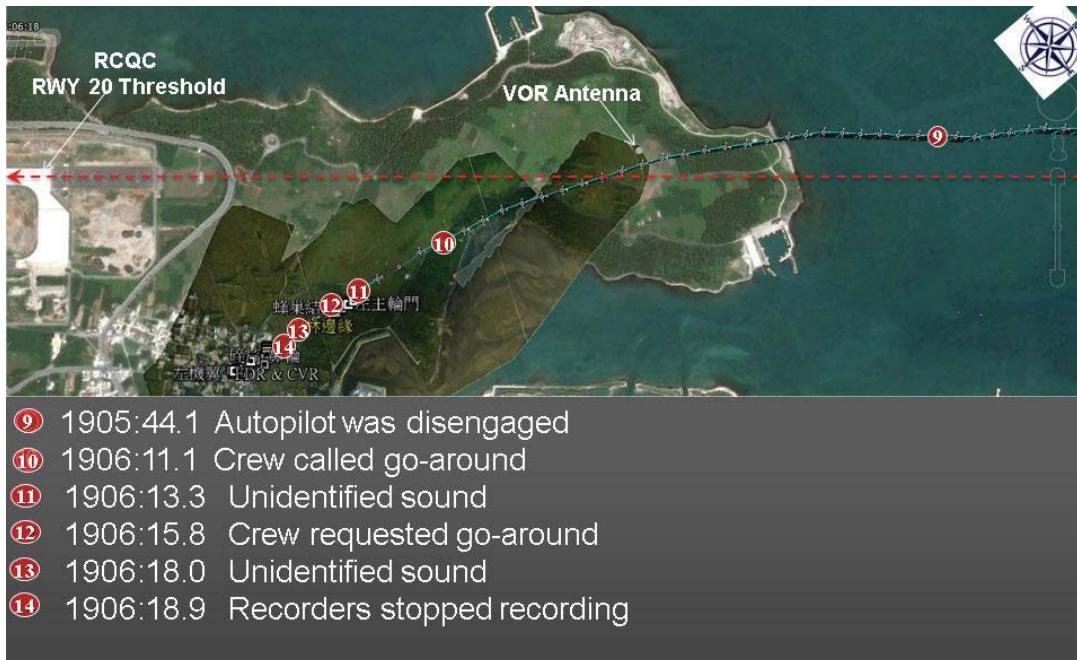
Figure 1.11-9 Superimposed GE222 flight path with satellite imagery for the last 40 seconds.

The occurrence aircraft's position was recorded by the FDR every 4 seconds. The recorded position parameters included GPS latitude and GPS longitude at a sampling rate 1/4 Hz. By applying double-integration<sup>40</sup> of the acceleration data recorded by the FDR, the position of the aircraft at every second was calculated, which enabled a reconstruction of the occurrence flight path. At 1906:18.9, the aircraft's last recorded position was N23°35'08.2", E119°38'21.1". Figure 1.11-8 displays key points along the occurrence flight path with the radar track superimposed with the Magong runway 20 VOR chart. Figure 1.11-9 presents the occurrence aircraft's trajectory during the last 40 seconds overlaid on a satellite image of the area.

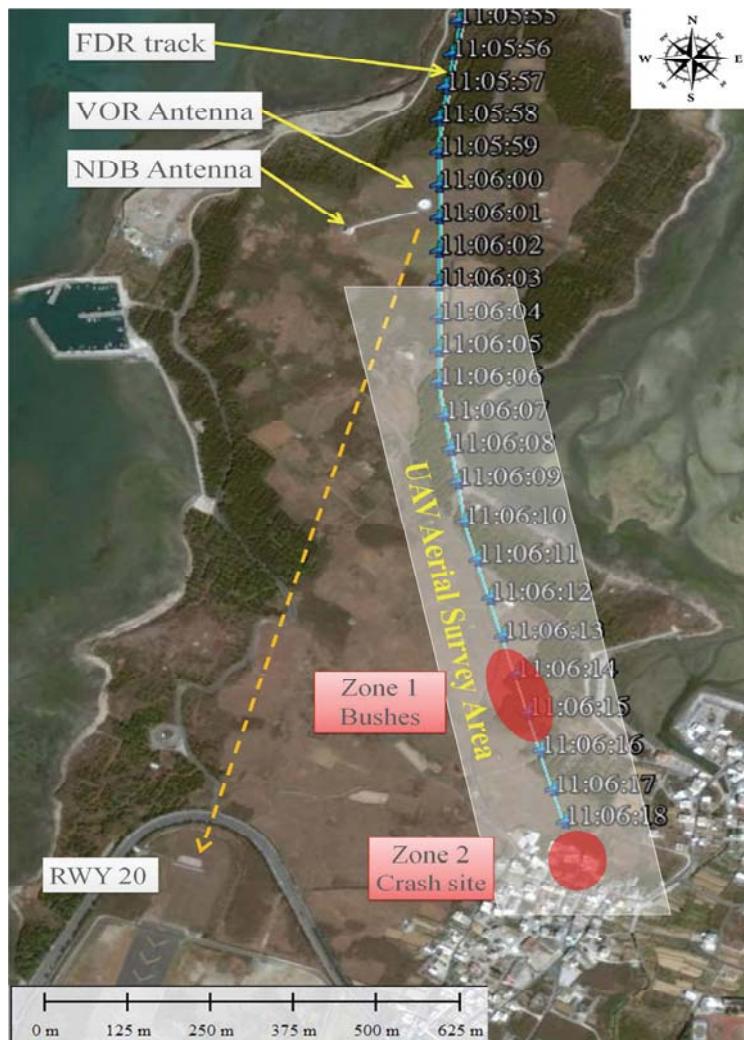
Figure 1.12-2 Superimposed GE222 flight path with time marks and wreckage zones

The UAV aerial survey generated a geo-reference map and 3D terrain model (DSM<sup>43</sup>) of the occurrence area. Figure 1.12-2 shows the UAV area of operations superimposed on the occurrence flight path with timings and wreckage zones.

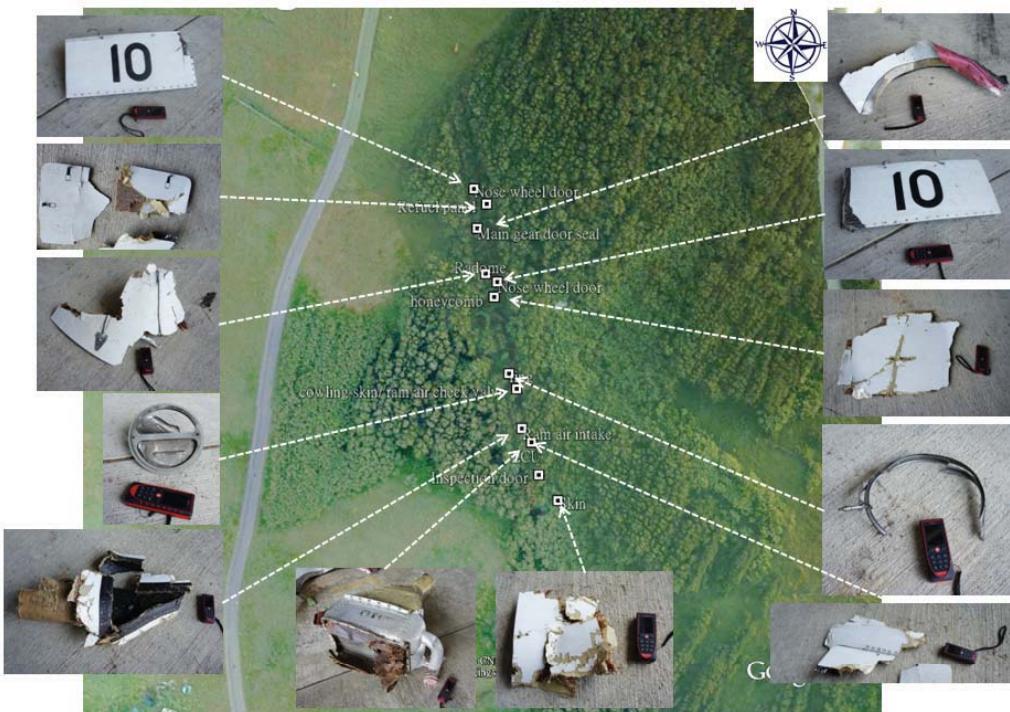
Figure 1.12-6 Superimposed aircraft wreckage distribution and component photos

Some aircraft wreckage was found along the swathe through the foliage. Those pieces of wreckage were identified as: nose landing gear aft doors, radome, left-hand heat exchanger, ram air inlet, ram air check valve, left-hand main landing gear door, belly fairing inspection doors, and belly fairing panels. The superimposed aircraft wreckage distribution and identified components on the UAV's orthogonal image<sup>45</sup> is shown in figure 1.12-6.

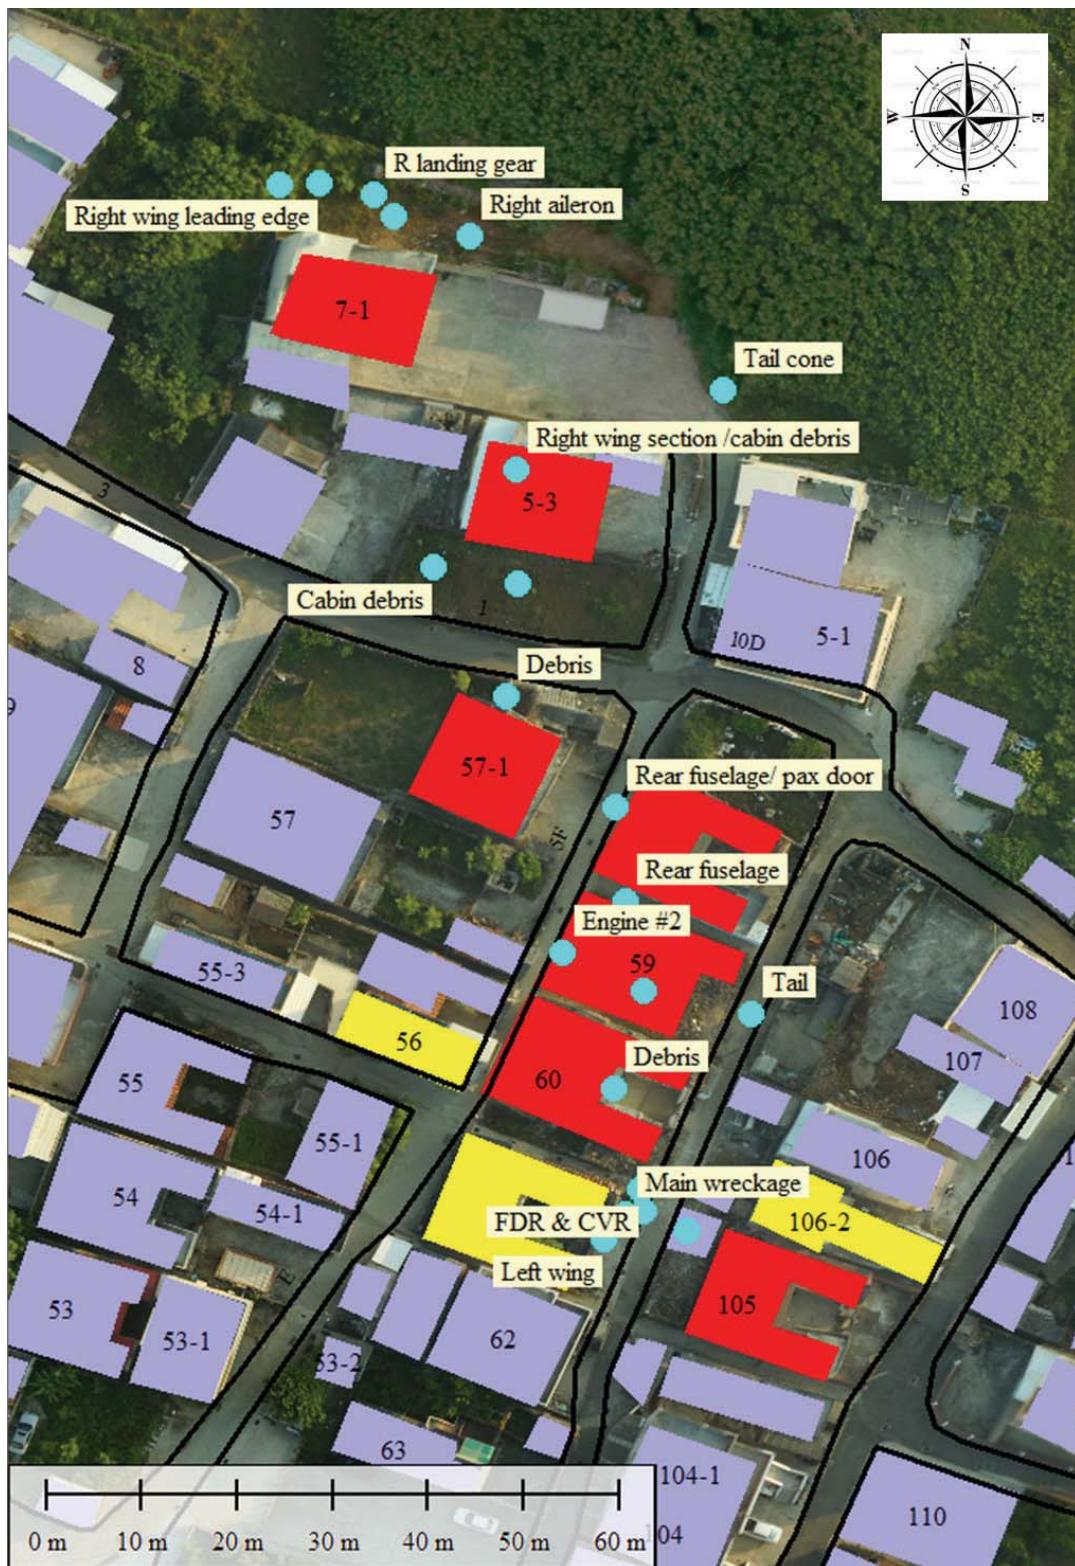
Figure 1.12-7 Wreckages distribution overlaid on Xixi village street map

Zone 2 was located in a residential area of Xixi village. The trajectory of the aircraft was from north to south. The aircraft collided with multiple buildings and broke apart into several major sections. The main wreckage site, which included the cockpit, forward fuselage, left wing, and no.1 engine came to rest in a street in the south of Zone 2. The distance between the main wreckage site and the first building collision was about 120 meters. Figure 1.12-7 depicts the aircraft wreckage distribution overlaid on a Xixi village street map. The red area indicates extensive damage to housing; the yellow area indicates houses with minor damage; and the light blue area indicates undamaged houses. In addition, smaller items of debris such as passenger seats, window frames, baggage, and fuselage skin were scattered throughout Zone 2 over an area of approximately 80 meters by 120 meters. The aircraft main wreckage distribution and damaged buildings are shown in Figure 1.12-8.

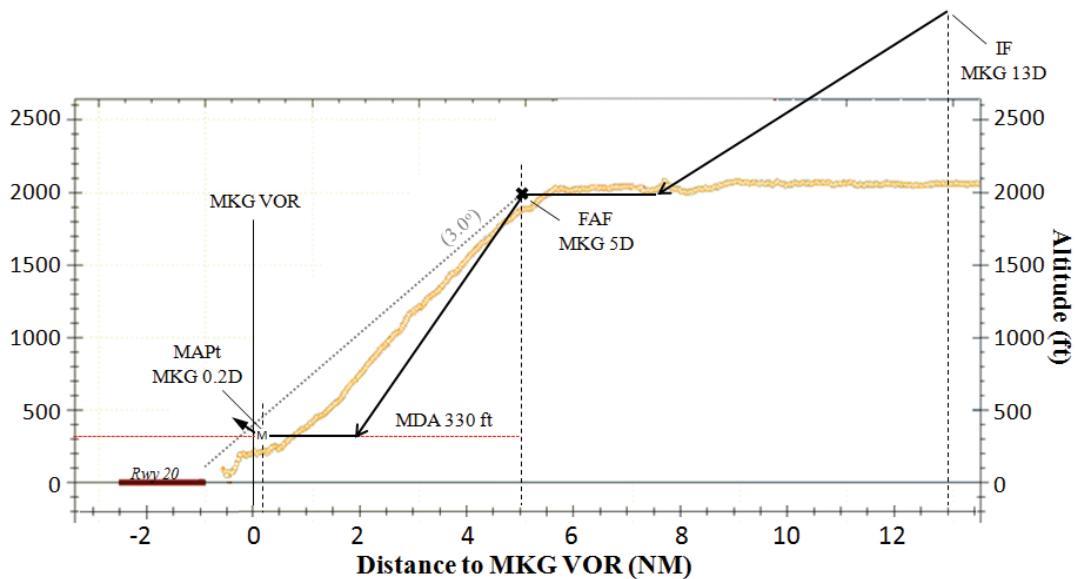
Figure 2.2-1 GE222 approach profile

When the aircraft was maintaining an altitude of 2,000 feet inbound for approach, the first officer obtained permission from the captain to preset the next altitude to 400 feet (1859:15). The aircraft then started to descend (1902:50) with a selected vertical speed of -700 feet/min. Based on weather data and the sound of the windshield wipers increasing in speed on the CVR (1903:36.1), the aircraft probably penetrated heavy thunderstorm rain around then. Three seconds after the “500 feet auto call-out” was announced, the selected altitude was reset to 300 feet while the aircraft was descending through 450 feet (1905:12.4). When the aircraft had descended to 344 feet, the selected altitude was reset to 200 feet and the aircraft kept descending (1905:25.7). The sequence of flight crew actions regarding the decision to continue the approach below the MDA is shown in Table 2.2-2. The GE222 approach profile is shown in Figure 2.2-1.

There was no discussion by the crew on whether the required visual references had been obtained before the captain as the pilot flying (PF) continued to descend the aircraft below the MDA. The first officer, in his capacity as the pilot monitoring (PM) did not object or intervene but rather coordinated with the captain's decision to descend below the MDA in contravention of standard operating procedures (SOPs).

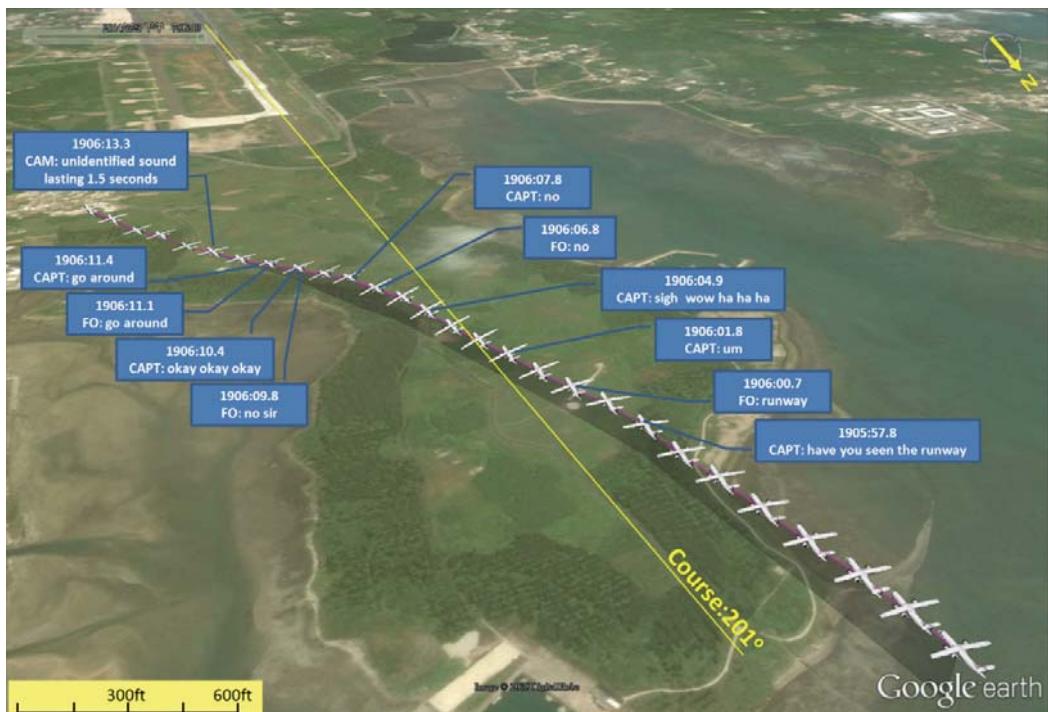
Figure 2.2-2 Aircraft track and altitude deviations as flight crew attempted to visually locate the runway.

2.2-4 and Figure 2.2-2) indicated that the aircraft's heading changed from 207° to 188° as a result of the bank angle changing from approximately wings level to 19° left and then decreasing to 4° left, which was consistent with the aircraft commencing a left turn away from the required approach course. The aircraft also commenced a descent from previously maintained altitude of 200 feet. The aircraft pitch angle decreased from 0.4° nose up to 9° nose down then returned to 5.4° nose down which produced a reduction altitude from 179 feet to 72 feet.

The combination of the captain's left control wheel input and strong right crosswind (32 to 34 kts from 252°) had turned the aircraft to the left, which consequently resulted in the aircraft's deviating from the required instrument approach course. In addition, the combination of the captain's forward control column input and the possible effects of moderate turbulence pitched the aircraft nose down with a subsequent loss of altitude below the previously maintained altitude of 200 feet.

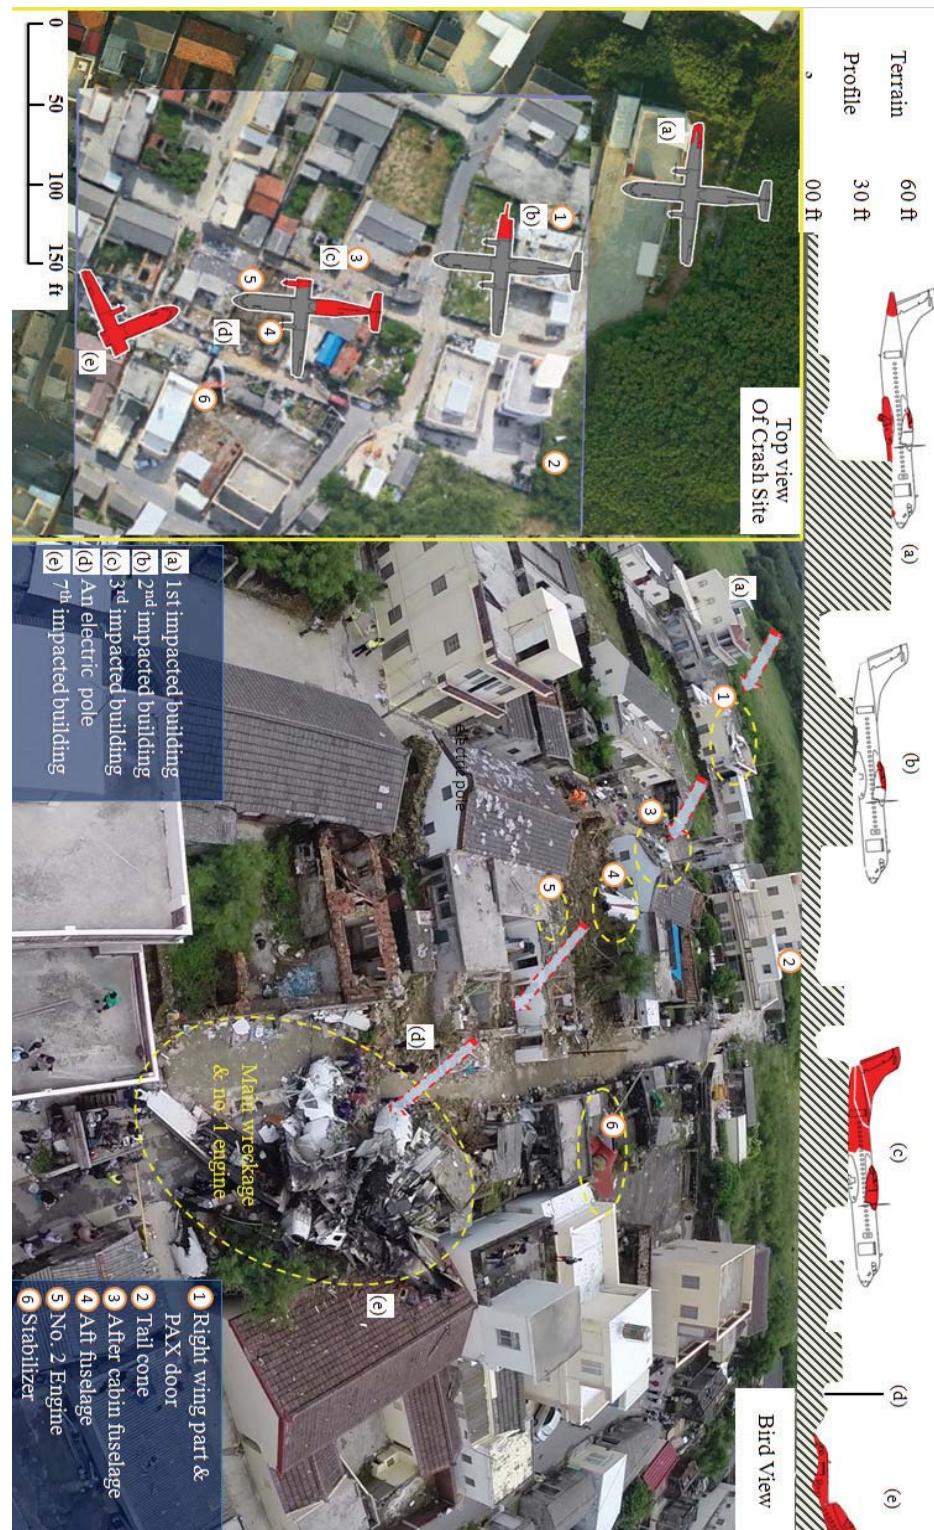
Figure 2.2-3 Aerial image of occurrence site superimposed with the main wreckage and final flight trajectory

The aircraft's right wing also collided with the northern wall of the first impacted building. After the first impact, the aircraft's direction of movement was altered to about 170 degrees and it then collided with several other buildings before it finally came to rest. Figure 2.2-3 shows an aerial image of occurrence site superimposed with the main wreckage and final flight trajectory.

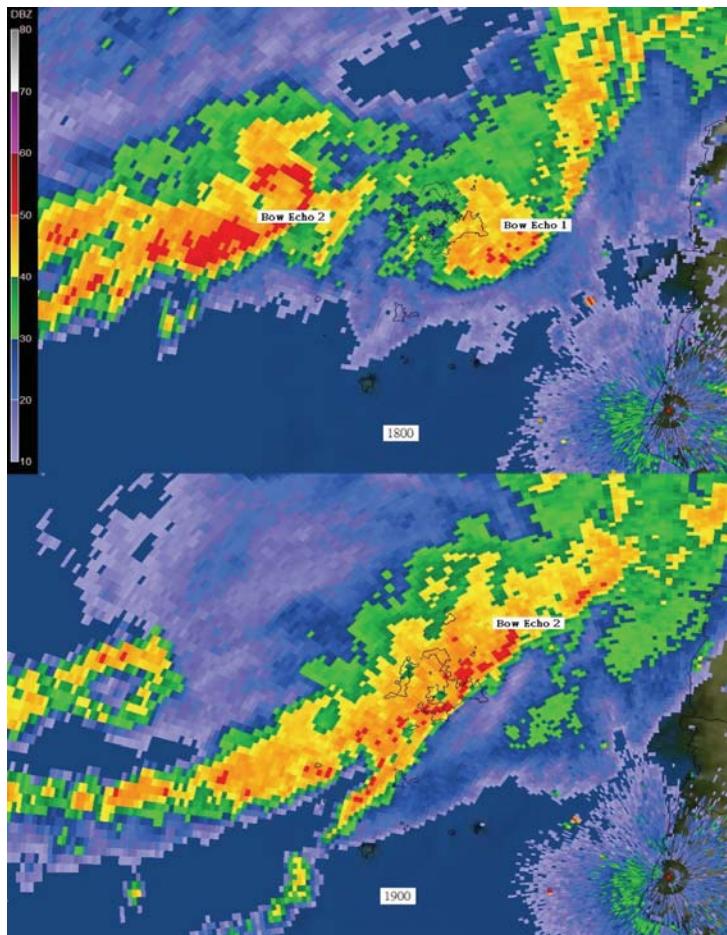
Figure 2.8-1 Rainband activity at Magong before the occurrence.

Magong Airport was affected by the outer rainbands of Typhoon Matmo at the time of the occurrence. The automated weather observation system (AWOS) and radar data showed that these rainbands were similar to squall lines. The radar images (see Figure 2.8-1) indicated that two waves of rainband passed through Magong Airport before and during the occurrence. The first bow echo affected Magong Airport from 1738 to 1803; the second echo was from 1901 to 1945. These bow echoes may cause significant changes in wind speed and wind direction with associated heavy rain showers.

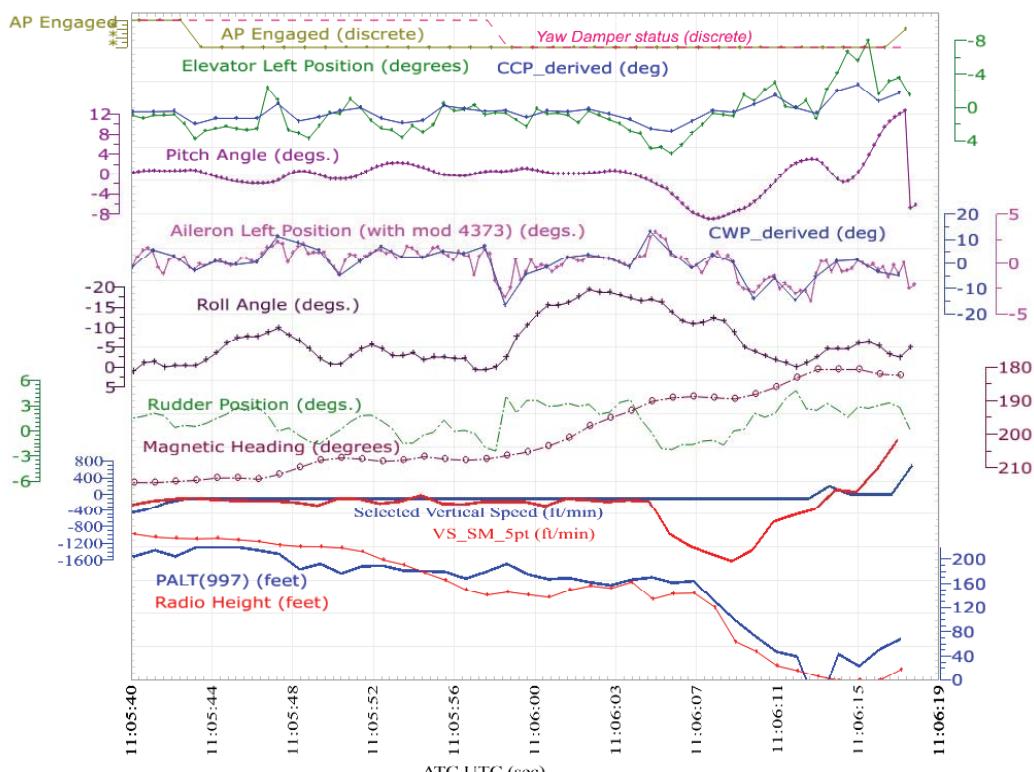
Figure 2.9-1 Relevant FDR and derived parameters

Based on the FDR data and the technical information provided by the ATR, the vertical speed, control column position, and control wheel position of the occurrence flight after the autopilot was disengaged were calculated. Relevant FDR parameters and the three derived parameters are depicted in Figure 2.9-1. Derived vertical speed is denoted as “VS\_SM\_5PT”, derived control column position and control wheel position are denoted as “CCP\_derived” and “CWP\_derived”, respectively.

The occurrence aircraft’s increased rate of descent from 150 ft/min to 1,600 ft/min between 1906:05 and 1906:10 was the result of an elevator control input by the captain. The nose down pitch angle of the aircraft was a maximum of 9 degrees. While descending, the aircraft turned to the left as a result of left aileron input. That is, the aircraft behavior was consistent with the control surface inputs.

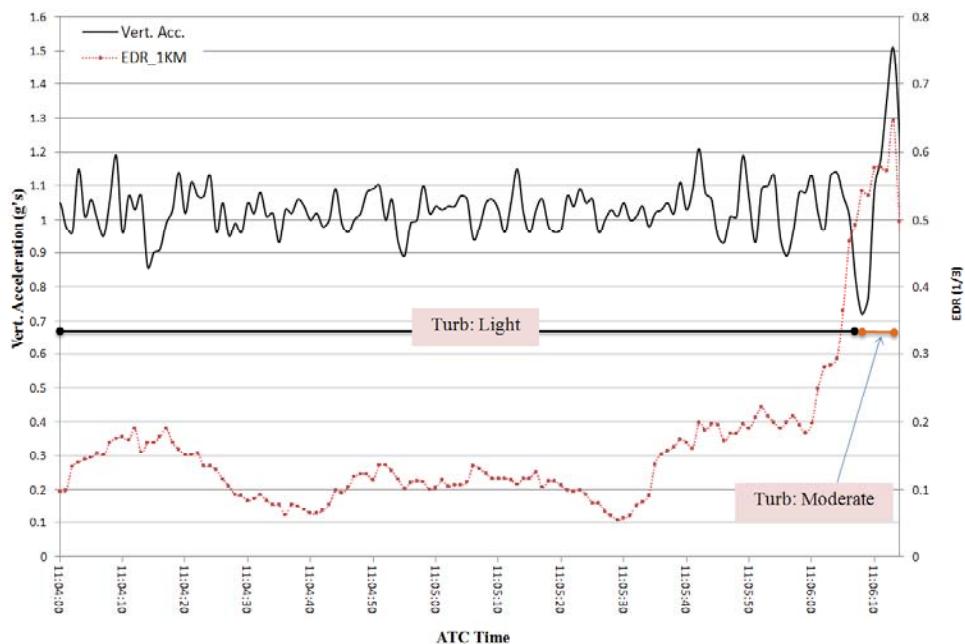
Figure 2.9-2 GE 222 vertical acceleration and calculated EDR (last two minutes)

Stated in the ICAO Annex 3, the EDR is an aircraft-independent measure of turbulence. The relationship between the EDR value and the perception of turbulence is a function of aircraft type, and the mass, altitude, configuration and airspeed of the aircraft. The EDR values of the occurrence flight were calculated and shown in Figure 2.9-2. Similar to the vertical acceleration, the EDR values were less than 0.2 most of the time during the last two minutes of the flight. About 1906:00, the EDR value started to increase and reached the maximum of 0.65 just before the aircraft contacted with the trees.

Compare with the FDR data, between 1906:00 and the end of the flight, the occurrence aircraft had large amount of pitch and roll angle changes. The increased vertical acceleration and EDR values probably are cause by the combination of the turbulence and the aircraft maneuver. Based on the values, the turbulence strength of the occurrence flight during the last 2 minutes could be classified as “light to moderate” level.

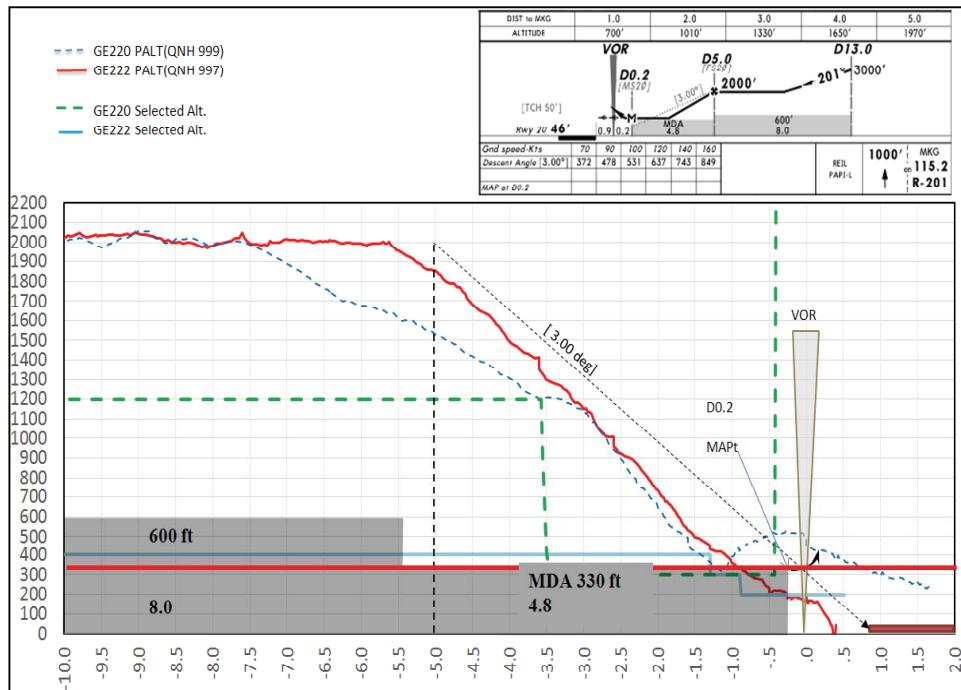
Figure 2.11-1 GE222 and GE220 flight profiles

The parameters and threshold values setting of the TNA FOQA program were in accordance with the manufacturer’s suggestions. Based on the airline’s FOQA system, on the day of occurrence, flight GE 220 triggered three red events: altitude below 500 feet - heading deviation greater than 20 degrees, GPWS warning triggered 24 seconds and level off below 1,400 feet above field elevation (AFE) exceeded 10 seconds. The occurrence flight GE222 triggered two red events: excessive bank angle on final approach below 100 feet AFE, and high rate of descent on approach between 500 and 50 Feet AFE. See Figure 2.11-1 for GE222 and GE220 flight profiles.

However, the traditional FOQA program was not configured to be able to readily identify, without further analysis, those events that were indicative of non-compliance with SOPs including violations of approach procedures, such as descent below minimum safe altitudes. No current FOQA system can readily integrate all the required data sources needed to identify some violations of SOPs.

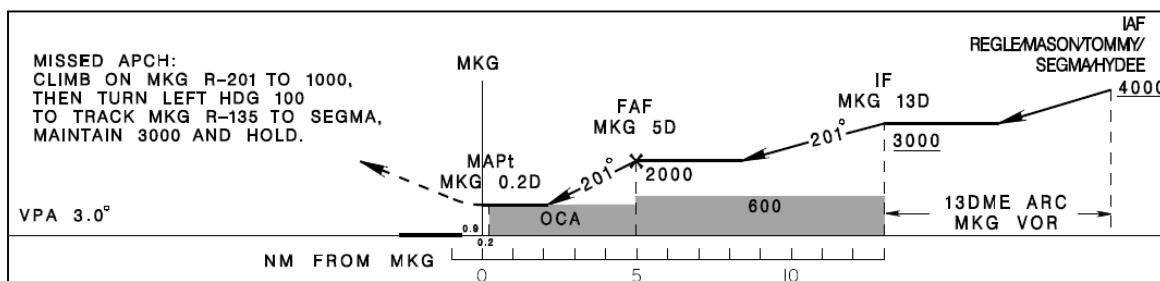
Figure 2.12-2 Magong MAPt location and runway 20 VOR approach procedure

According to the AIP, the distance from the runway 20 VOR missed approach point (MAPt) to the runway 20 threshold is 1.1 nautical miles (2,037.2 meters) (see Figure 2.12-2). The distance is longer than the published visibility landing minima of 1,600 meter.

The CAA used the PANS\_OPS Designer software to calculate the OCA for the runway 20 VOR approach. The CAA advised that the calculations indicated if the MAPt was located at the threshold, the OCA would be 394 feet. If the MAPt was at 1.1 nm from the threshold, the OCA could be lowered to 328 feet. The investigation team asked the CAA to re-calculate the OCA for the runway 20 VOR approach by moving the MAPt to different locations toward the threshold. The results indicated that moving the MAPt to 0.8 nm (1,460 meters) from the threshold, the OCA was 328 feet.

With the same OCA, if the MAPt was set closer to the runway threshold, it would have increased the likelihood of crews being able to visually identify the runway in the future.
