## **Aviation Occurrence Report**

**ASC-AOR-09-09-001, Publication Date: Sep, 2009**

**A 30 in (77 cm) cracked through fuselage skin was found during transit check**

**BOEING 737-800**

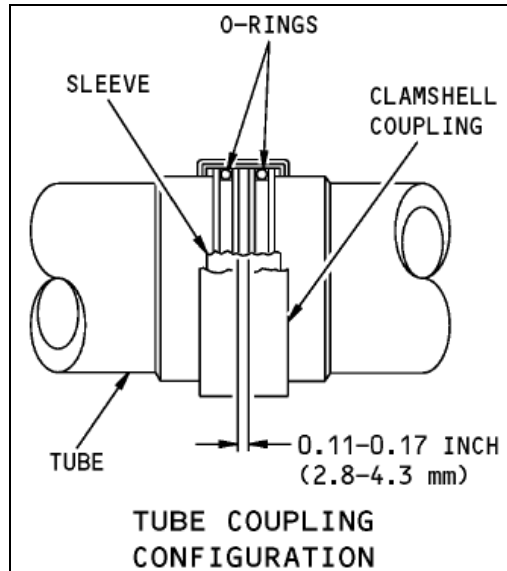
Figure 1.6-4 Tube Coupling Specification on Waste Line

Boeing's reply stated that the gap dimension of the coupling tube can be referred to AMM 38-32-00 page 403, Figure 401(B) (as shown in Figure 1.6-4). The specification on the flange distance of the connecting tubes of waste line system is from 0.11 in to 0.17 in.

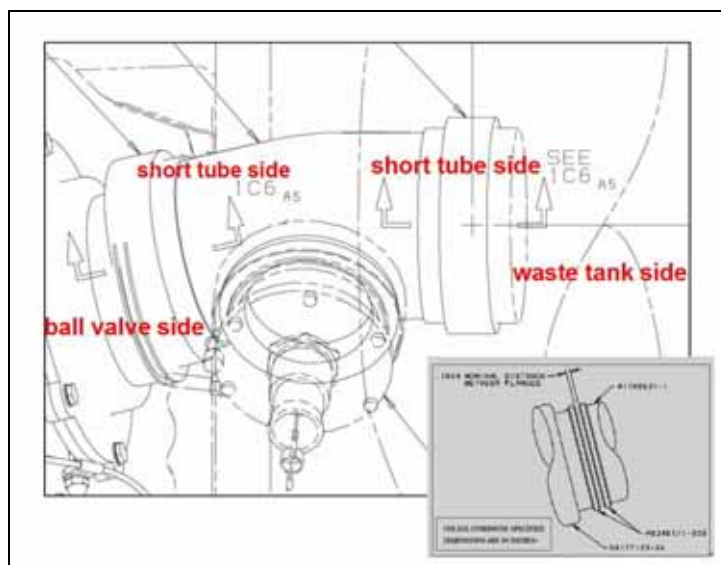
## Figure 1.6-5 Nominal Distance Between Flanges

According to Boeing 737-X type drawing number 417A8630 (Status Date 10-08-04), the nominal distance of the tube coupling between waste tank outlet and drain tube is 0.1500 (as shown in Figure 1.6-5). The distance was not specified or explained in 738 AMM.

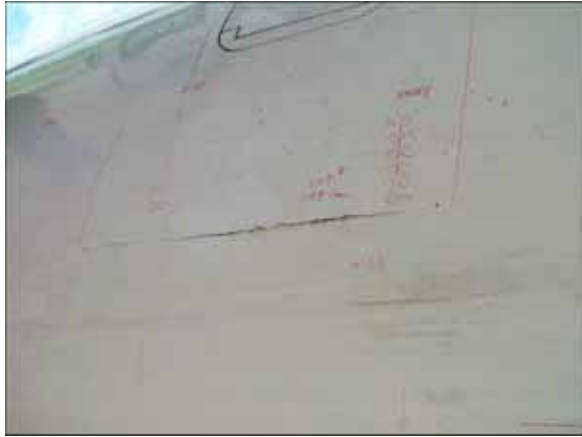
Figure 1.12-1 (A) Cracked Skin External View

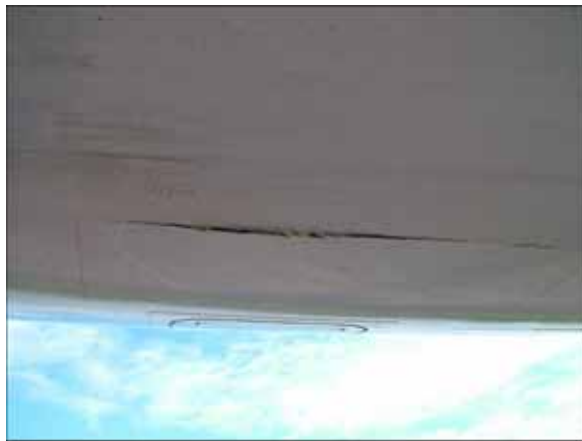
Figure 1.12-1 (B) Location of Crack

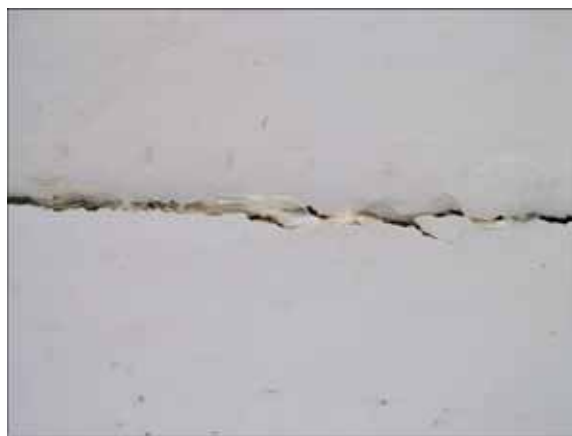
Figure 1.12-1 (C) Detail Cracked Skin External View

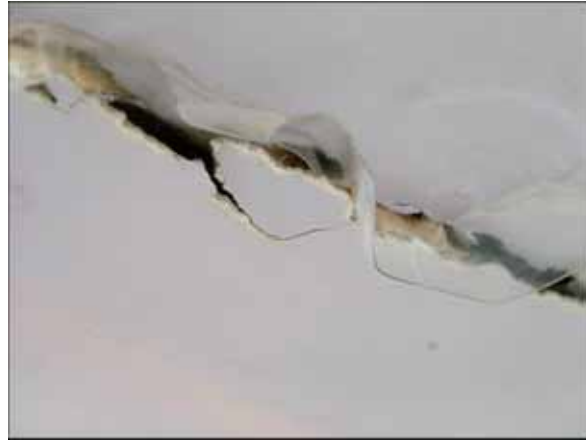
Figure 1.12-1 (D) Detail Cracked Skin External View

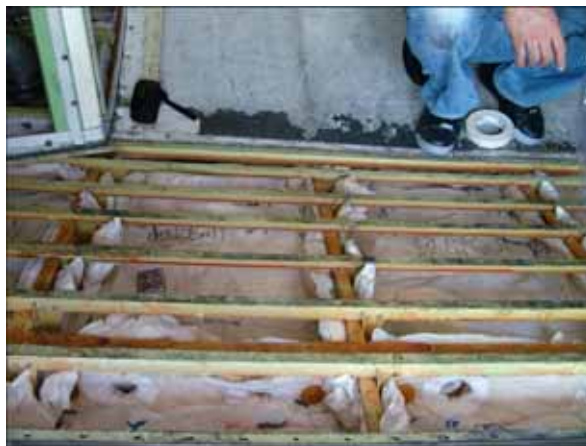
Figure 1.12-2 (A) Floor panel Open Up Inspection for Skin Damage

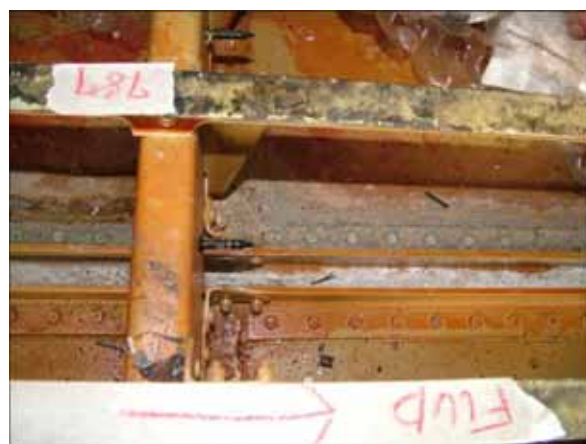
Figure 1.12-2 (B) Corrosion forward of Sta. 78

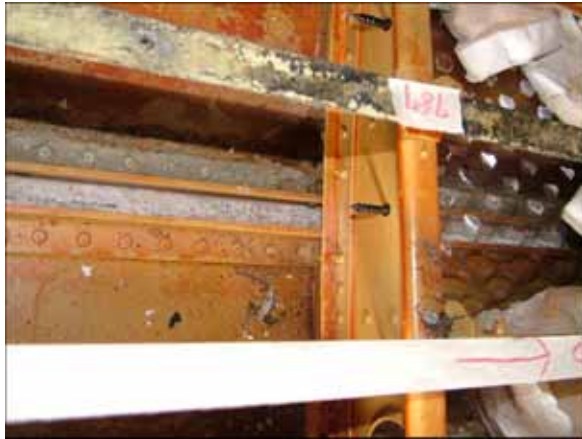
Figure 1.12-2 (C) Corrosion aft of Sta. 787

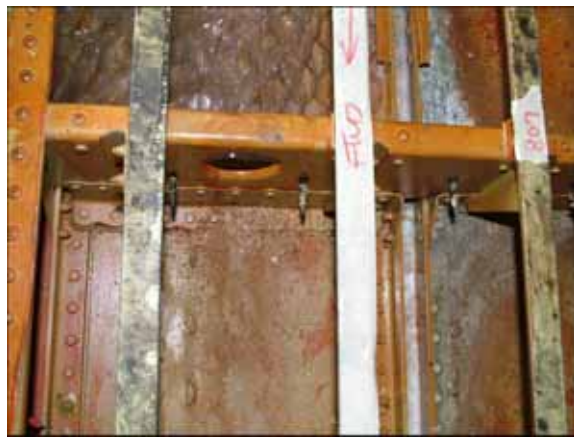
Figure 1.12-2 (D) Corrosion forward of Sta. 807

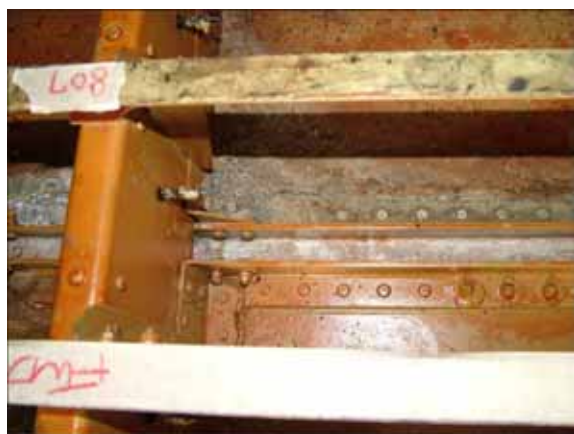
Figure 1.12-2 (E) Corrosion forward of Sta. 807 Close up View

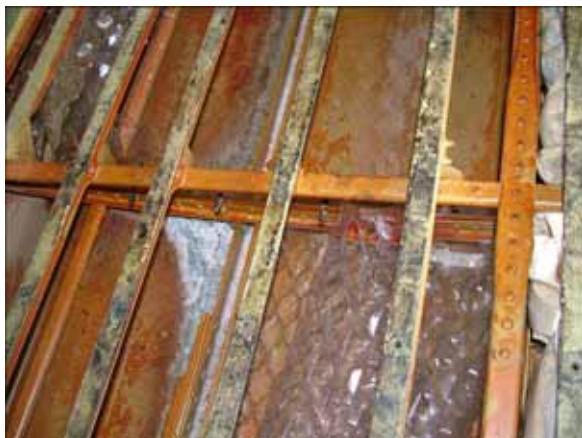
Figure 1.12-2 (F) Corrosion aft of Sta. 807

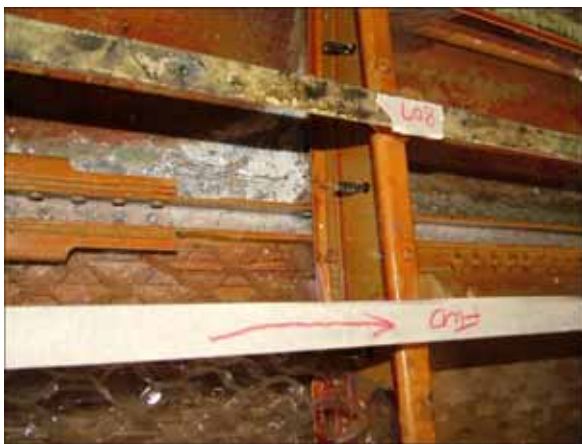
Figure 1.12-2 (G) Skin Corrosion aft of Sta. 807

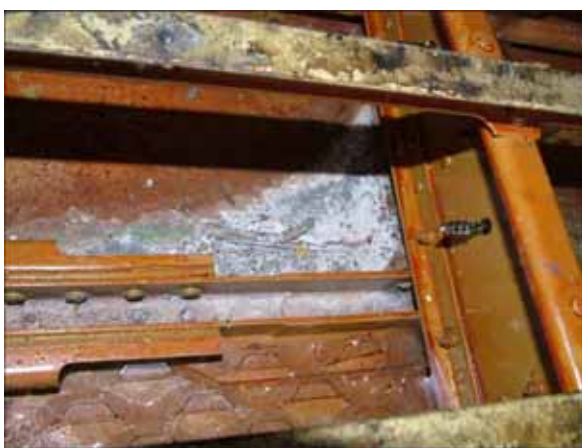
Figure 1.12-2 (H) Skin Corrosion aft of Sta. 807 Close up View

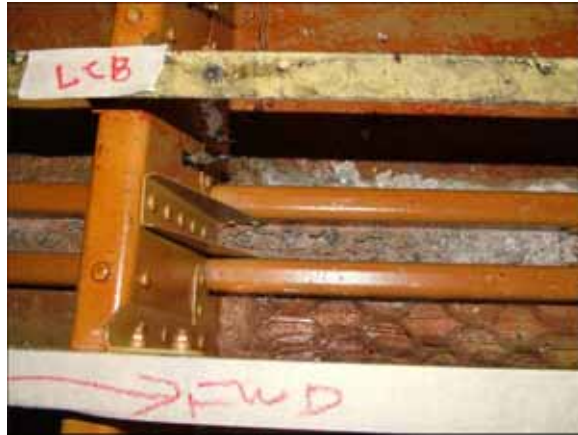
Figure 1.12-2 (I) Corrosion forward of Sta. 827

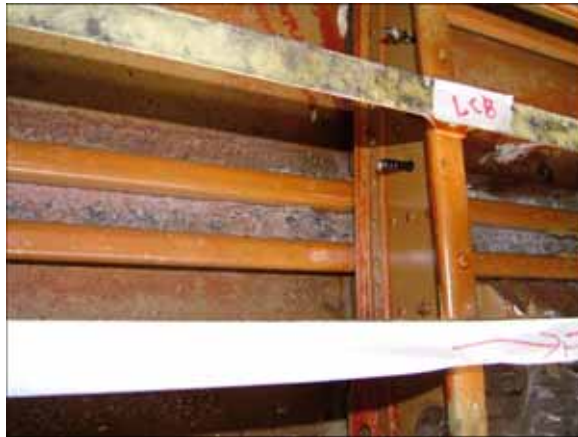
Figure 1.12-2(J) Corrosion aft of Sta. 827

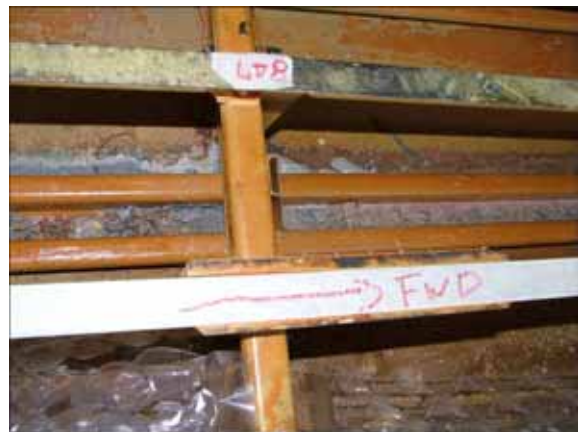
Figure 1.12-2 (K) Corrosion at Sta. 847

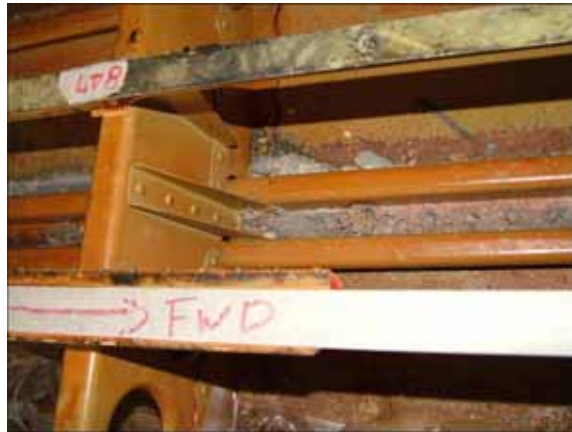
Figure 1.12-2 (L) Corrosion forward of Sta. 847

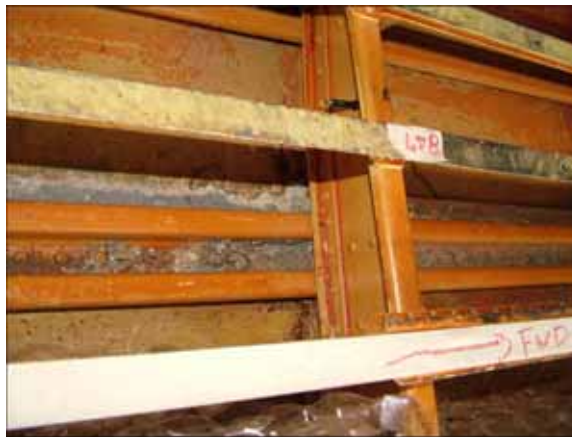
Figure 1.12-2 (M) Corrosion aft of Sta. 847

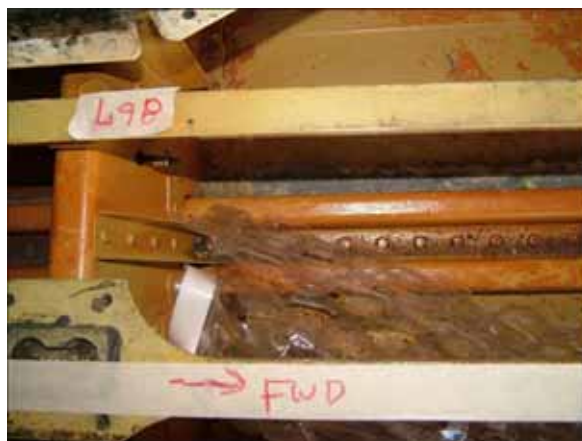
Figure 1.12-2 (O) Corrosion forward of Sta. 867

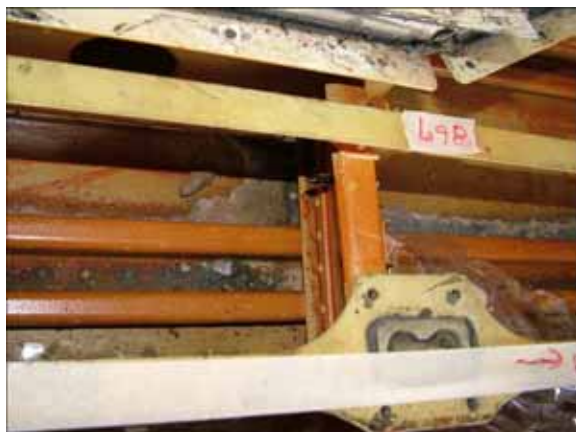
Figure 1.12-2 (P) Corrosion aft of Sta. 867

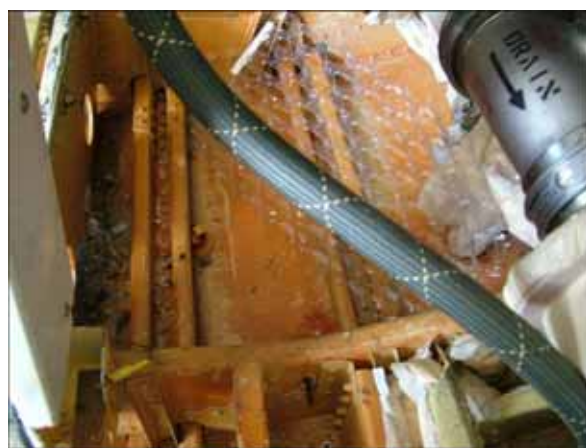
The photograph of damage on the exterior of airplane are shown in Figure 1.12-1 (A) ~ (D), whilst the interior view for damaged structure at the crack site and typical structure corrosion are shown in Figure 1.12-2 (A) ~ (S). From these photographs, in addition to the location of the crack, the extension of structure corrosion inside the cargo bilge area was observed. The corrosion was mostly located on the fuselage belly skin left side of the stringer S-27L, on the channel of the S-27L stringer, and at the lower side of the intercostals which was beneath the waste tank outlet coupler later found leaked.

Figure 1.12-2 (Q) Relative Position of the Leaking Waste Tank Outlet and the Corroded Intercostal

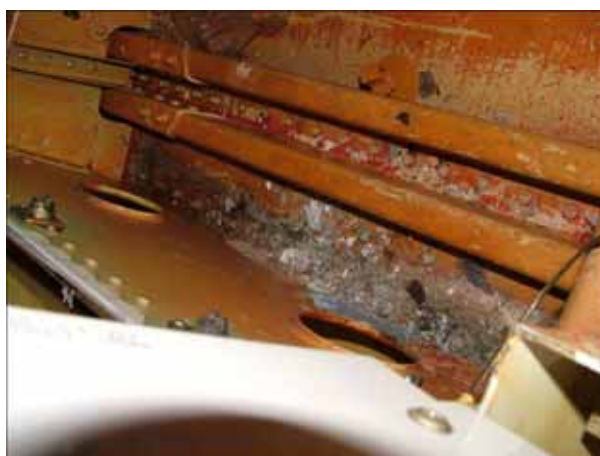
Figure 1.12-2 (R) The Corroded Intercostal

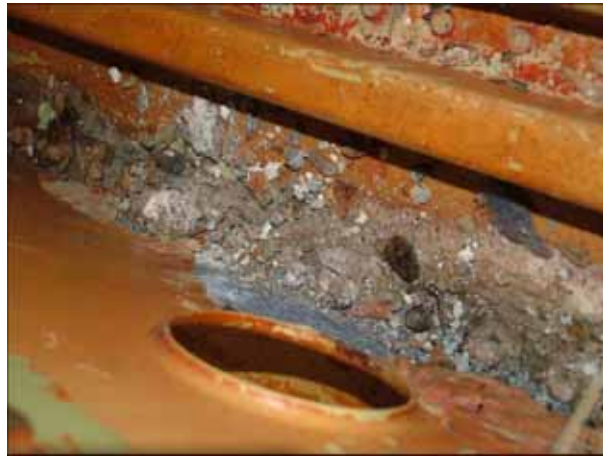
Figure 1.12-2 (S) The Corroded Intercostal Close up View

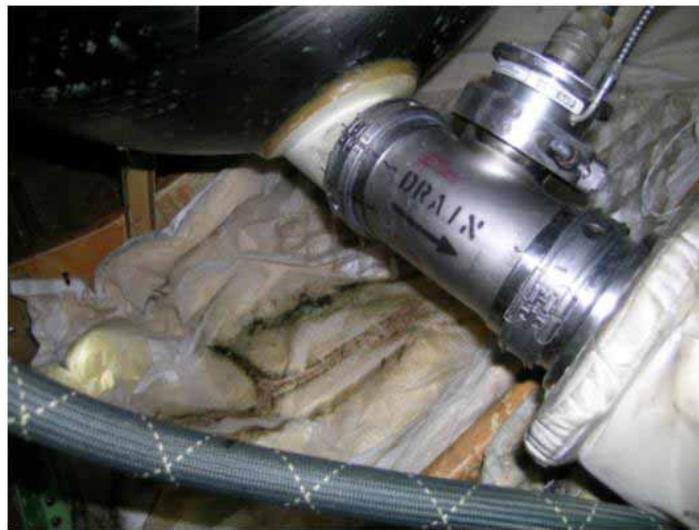
During ASC's investigation in CAL's maintenance depot, contamination mark from leaked waste tank was found over the insulation blanket located beneath the waste tank outlet, which was up stream to the skin crack in the aft cargo compartment. The most up stream point of the contamination mark was right below the coupler ring of the waste tank with the metal short tube; the contamination mark appeared as a 20 in long pattern of liquid flow, which traveled down stream to the lower edge of the insulation blanket, leaving several green-yellowish, black, and dry traces on the top surface of the insulation skin. After removal of the contaminated insulation blanket, same trace of leaking was also found on the belly skin. See figure 1.12-5 ~ 1.12-7 for detail.

Figure 1.12-5 Trace of Contamination from Leaked Waste Water

From figure 1.12-5 the contamination mark on the insulation blanket indicates that the waste tank fluid leaked from the connector for plastic outlet piece of the waste tank and the metal tube is suspected.

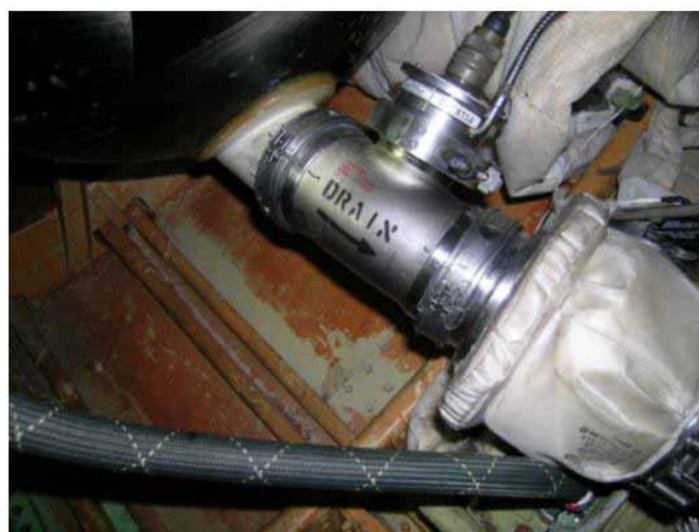
Figure 1.12-6 Structure Members underneath the Insulation Blanket

After removal of the contaminated insulation blanket, as shown in figure 1.12-6, it was found that the leaking waste tank fluid had penetrated the layers of the insulation blanket and reached the belly skin leaving a visible trace. (See figure 1.12-7)

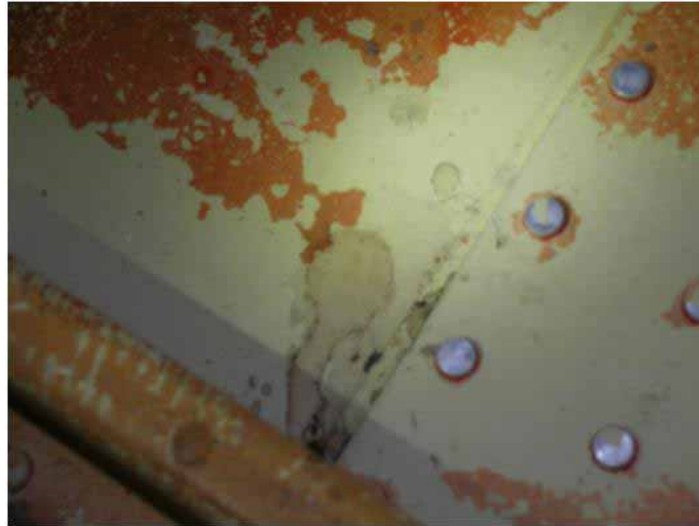
Figure 1.12-7 Leakage Trace over The Skin Panel

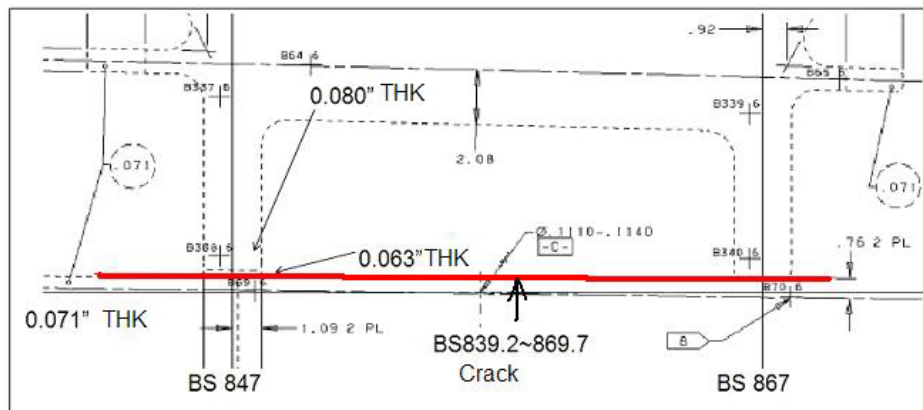
Figure 1.12-10 Skin Panel at BS847 and BS867

(1) Skin thickness outboard of BS847 S-27L changed with two steps, first from 0.071" reduced to 0.063", within very short distance from 0.063" increased to 0.080".

(3) In between BS847 and BS867, outboard of S-27L, the skin thickness is 0.063”, the skin crack is located. Also in the 0.063” thin area of the (1) and (2) area, there is no so called tear strap<sup>2</sup> exists.

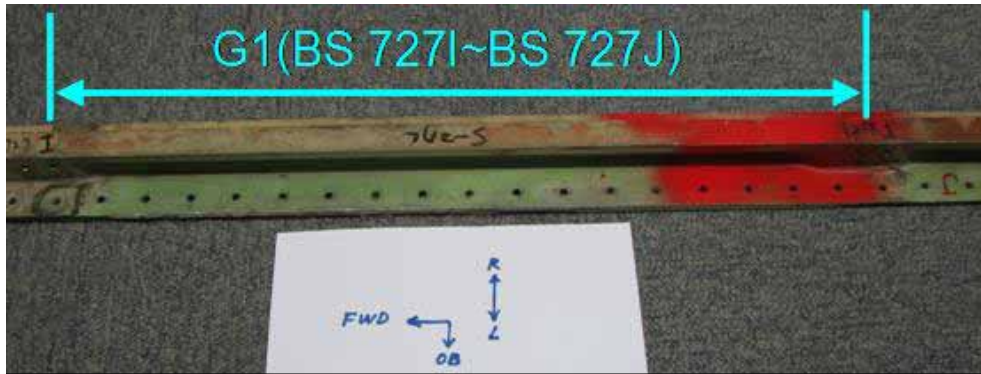
Figure 1.12-25 Stringer Corrosion Area G1

G1 area (BS727I ~ BS727J): Stringer in this area is fabricated with extruded I type beam, evenly distributed light surface corrosion was observed on the left side flange upper surface, see figure 1.12-25. For the purpose of non-revenue ferry flight, the corrosion was removed and protective top coat was applied for temporary repair.

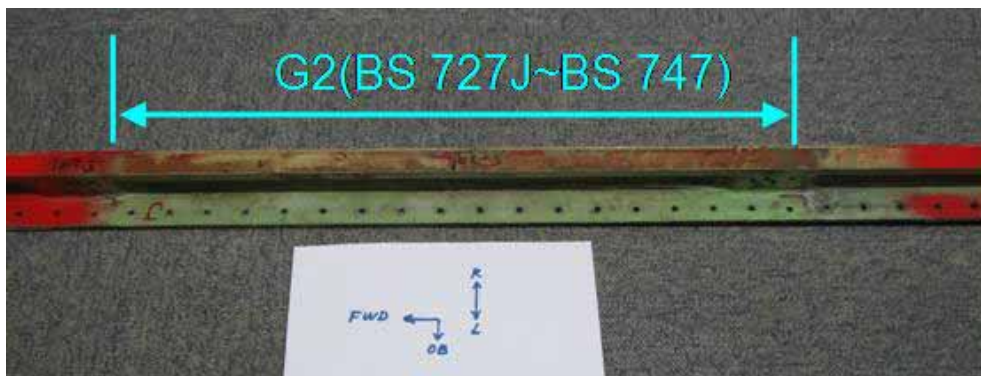
Figure 1.12-26 Stringer Corrosion Area G2

G2 area (BS727J ~ BS747): Stringer in this area is extruded I beam, evenly distributed light surface corrosion was observed on the left side flange upper surface, see figure 1.12-26. For the purpose of non-revenue ferry flight, the corrosion was removed and protective top coat was applied for temporary repair.

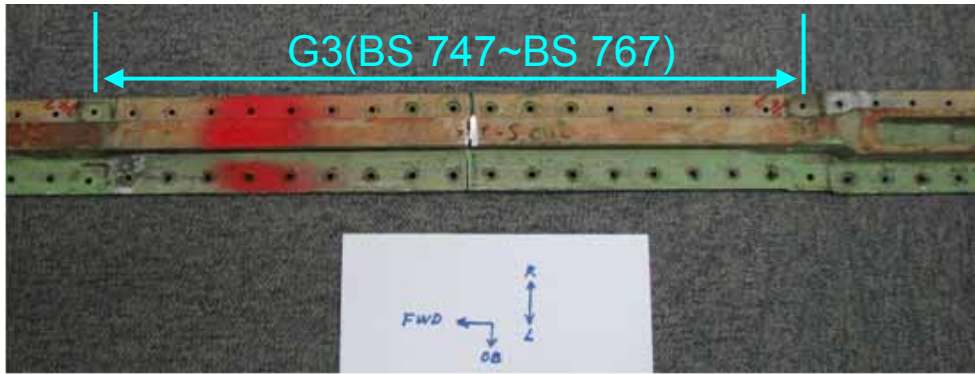
Figure 1.12-27 Stringer Corrosion Area G3

G3 area (BS747~ BS767): Stringer in this area is extruded I beam, medium surface corrosion with various depths was observed all over the left side flange upper surface, revealing dimples of material loss. See figure 1.12-27.

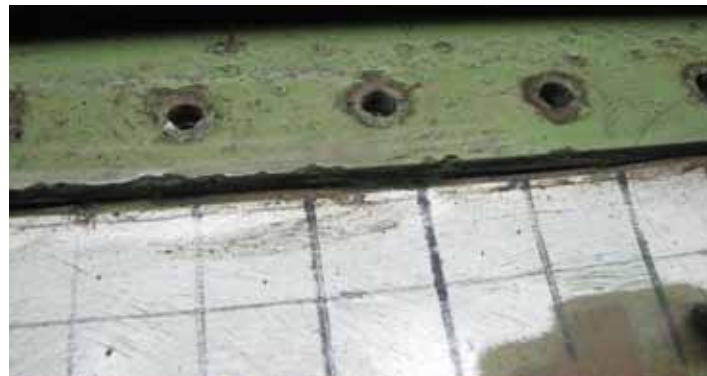
Figure 1.12-28 Deep Corrosion Found in G3 Area

After removal of the collars of the fasteners (Lock Bolt), deep corrosion craters were found underneath the collar, see figure 1.12-28.

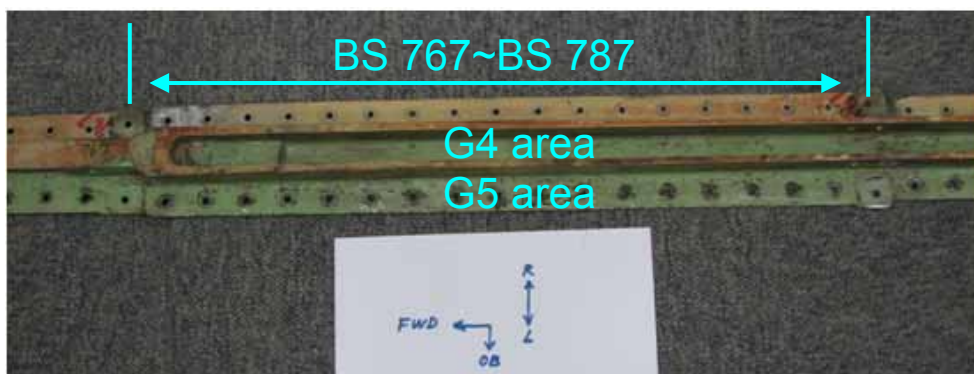
Figure 1.12-29 Stringer Corrosion in G4, G5 Area

G4 area (BS 767~BS 787)Stringer in this area is extruded I beam, however after BS767 the I beam was altered into extruded double T beam shape. The valley area in the center was corroded lightly on the upper surface, see figure 1.12-29.

G5 area (BS767~BS787): Corrosion pits with various depths were found on the left side flange upper surface, see figure 1.12-29.

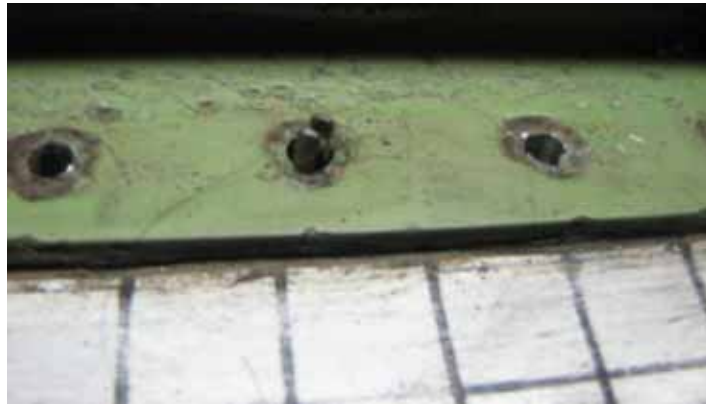
Figure 1.12-30 Deep Corrosion in G5 Area

After removal of the collars of the fasteners in G5 area, deep corrosion craters were found on the stringer underneath the collar, see figure 1.12-30.

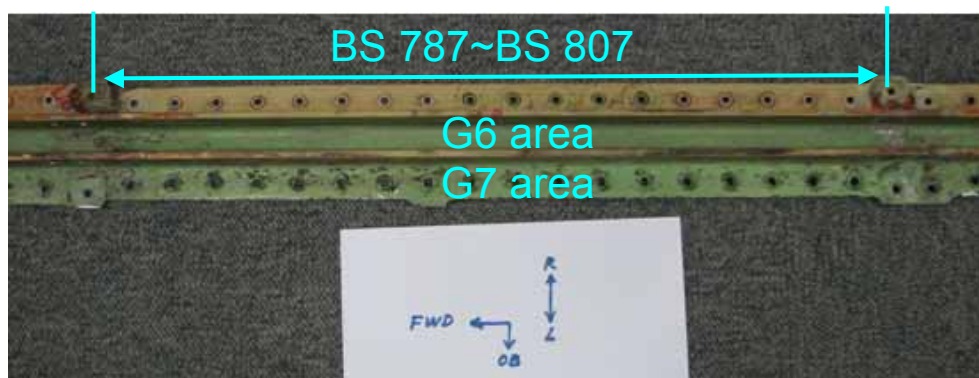
Figure 1.12-31 Corrosion Site G6, G7

G6 area (BS787 ~ BS807): Double T shape beam, light surface corrosion was found on the bottom between the two vertical legs. See figure 1.12-31.

G7 area (BS787 ~ BS807): Corrosion pits with various depths were found on the left side flange upper surface of the stringer, see figure 1.12-31.

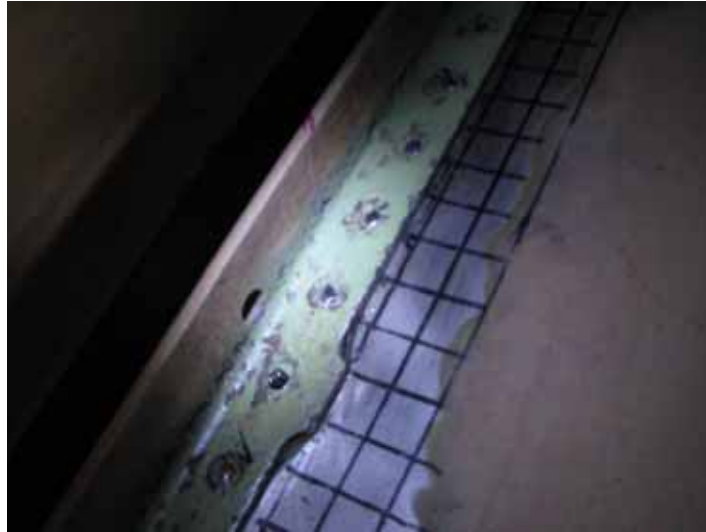
Figure 1.12-32 Deep Corrosion in G7 Area

After removal of the collar and the close fit bolt, more severe corrosion damage craters than those found in G5 area were observed on the stringer surface. See figure 1.12-32.

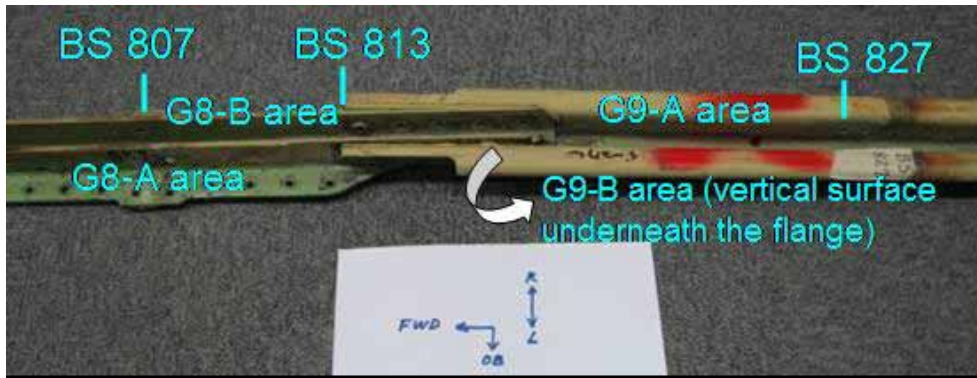
Figure 1.12-33 Corrosion Sites G8-A, G8-B, G9-A, G9-B

- G8-A area (BS807 ~ BS817): Corrosion pits with various depths were found on the left side flange upper surface of the stringer. After removal of the collar and the close fit bolt, deep corrosion craters similar to those in G7 were observed on the stringer surface. See figure 1.12-33.
- G8-B area (BS807 ~ BS817): Light surface corrosion was found on the bottom between the two vertical legs. See figure 1.12-33.

- G9-A area (BS813 ~ BS827): Bottom channel at centerline of stringer showed signs of surface corrosion. Corrosion was also found on the mating surface with the double T beam. The corrosion found on the bottom of channel, especially around the fastener holes, are severe, see figure 1.12-33.
- G9-B area (BS813 ~ BS827): Graydish corrosion deposits was found on the outboard side vertical web, showing signs of exfoliation corrosion. See figure 1.12-34.

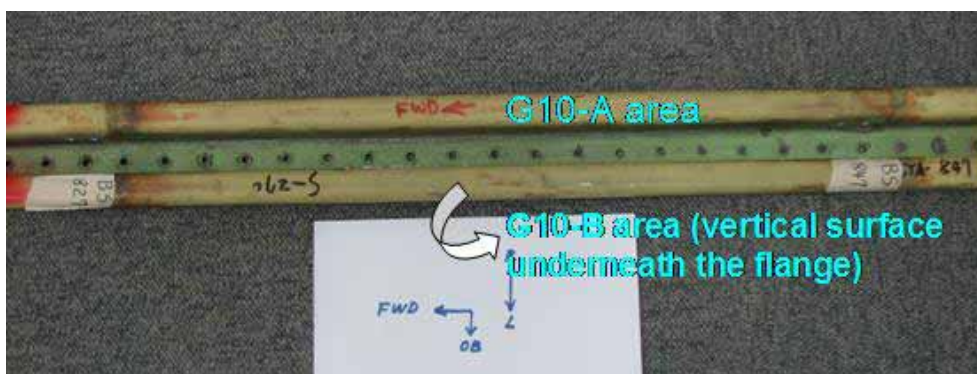
Figure 1.12-35 Corrosion Area G10-A, G10-B

G10 area (BS827 ~ BS847): Hat section stringer, see figure 1.12-35.

- G10-A area: Bottom channel at centerline of stringer showed signs of surface corrosion similar to G9-A area.
- G10-B area: Graydish corrosion deposits was found on the outboard side vertical web, drain holes at BS 829.5 outboard side and BS844.8 inboard side were found heavily corroded showing signs of exfoliation corrosion, stringer wall around the drain holes were consumed by the corrosion. See figure 1.12-36.

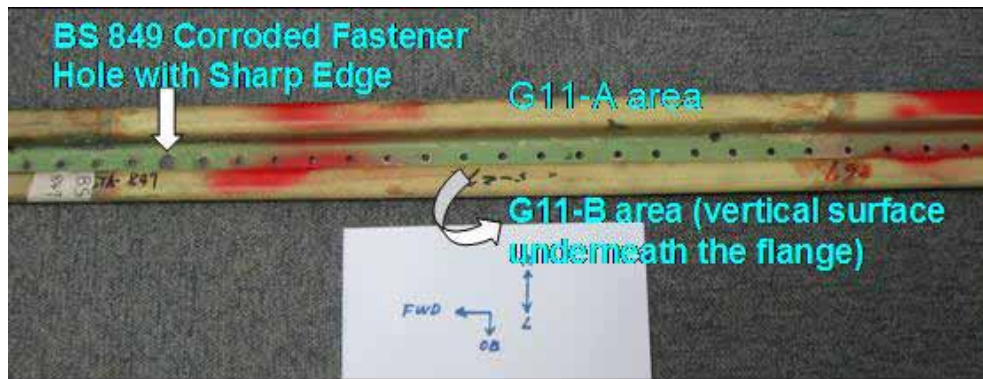
Figure 1.12-37 Corrosion Area G11-A \ G11-B

G11 area (BS847 ~ BS867): Hat section stringer, see figure 1.12-37.

- G11-A area: Bottom channel at centerline of stringer showed signs of surface corrosion similar to G10-A area. One rivet hole at BS849 was corroded that the hole was enlarged with irregular sharp edges.

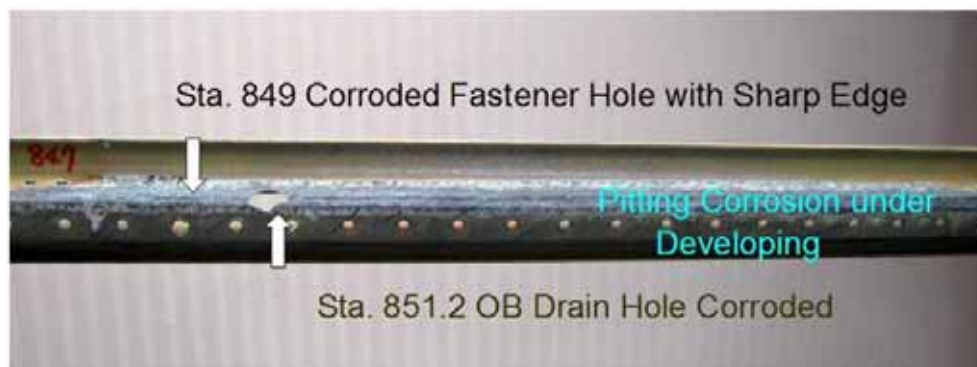
Figure 1.12-38 Corrosion Area G11-B

- G11-B area: Graydish corrosion deposits was found on the outboard side vertical web, a drain hole at BS 851.2 outboard side was found heavily corroded showing signs of exfoliation corrosion, stringer wall around the drain holes were consumed by the corrosion to enlarge the hole to 20mm in diameter. In addition, areas of pitting corrosion were found on the outboard side surface from BS847 ~ BS867 of the stringer. See figure 1.12-38.

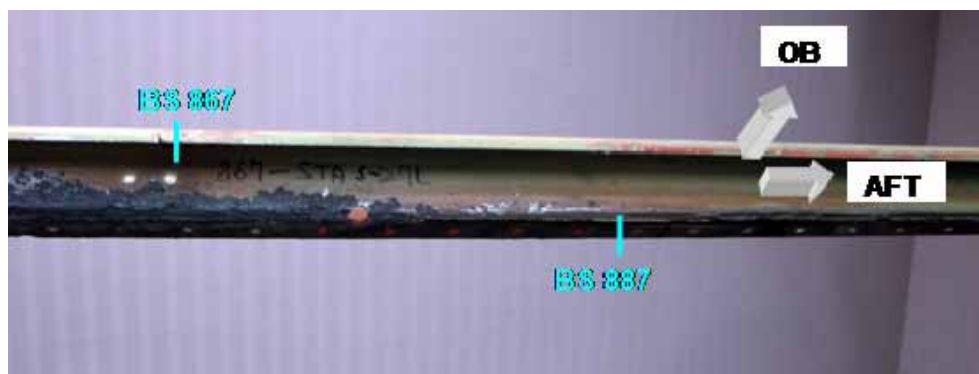
Figure 1.12-40 Corrosion Area G12-B

- G12-A area: Bottom channel at centerline of stringer showed signs of surface corrosion similar to G11-A area.
- G12-B area: Graydish corrosion deposits was found on the outboard side vertical web, showing signs of exfoliation corrosion till BS871. See figure 1.12-40. The drain hole located at outboard side BS870.5 suffer heavy corrosion that the hole was enlarged with material loss, see figure 1.12-41.

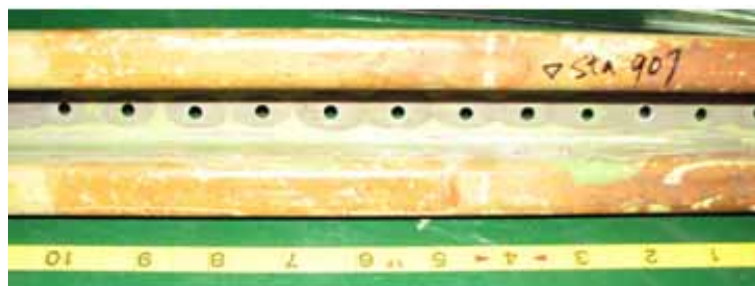
Figure 1.12-42 BS 907~BS 917 Corrosion with G13 Area

G13 area (BS907 ~ BS927): Bottom channel at centerline of stringer showed signs of light surface corrosion. See figure 1.12-42 and 1.12-43.

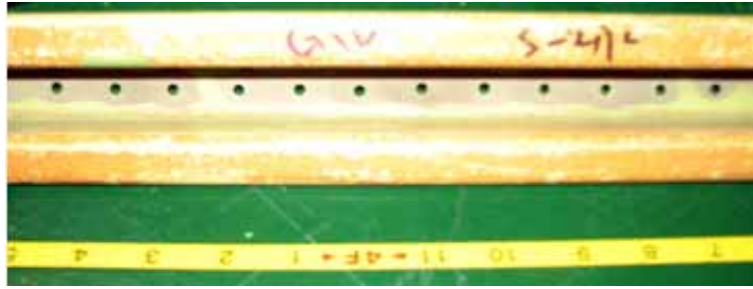
Figure 1.12-44 Corrosion Area G14

G14 area (BS927 ~ BS947): Bottom channel at centerline of stringer showed signs of light surface corrosion. See figure 1.12-44.

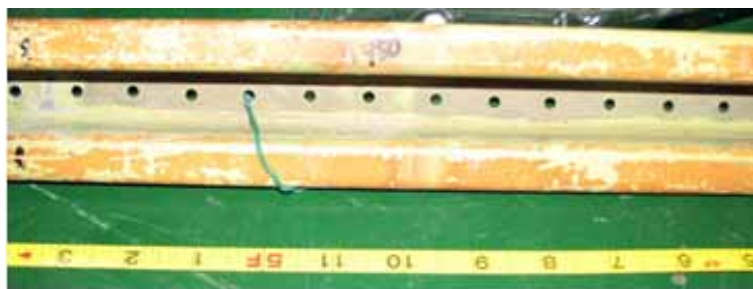
Figure 1.12-45 BS 947~BS 956 Corrosion with G15 Area

G15 area (BS947 ~ BS967): Bottom channel at centerline of stringer showed signs of light surface corrosion. See figure 1.12-45 and 1.12-46.

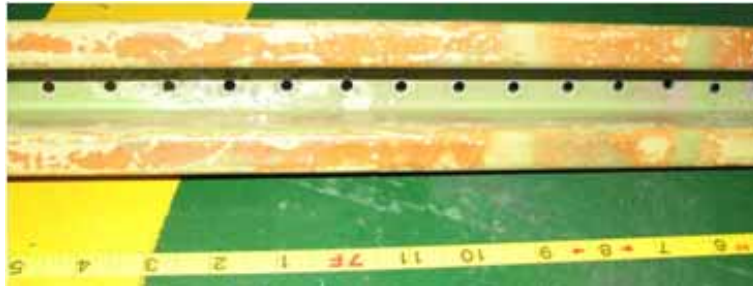
Figure 1.12-47 Corrosion Area G16

G16 area (BS967 ~ BS986.5): Bottom channel at centerline of stringer showed signs of light surface corrosion. See figure 1.12-47.

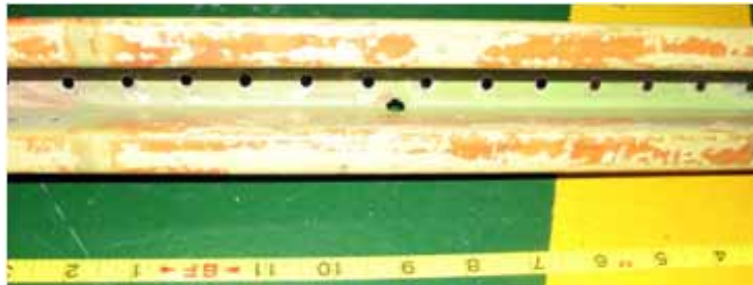
Figure 1.12-48 Corrosion Area G17

G17 area (BS986.5 ~ BS1006): Bottom channel at centerline of stringer showed signs of light surface corrosion. See figure 1.12-48.

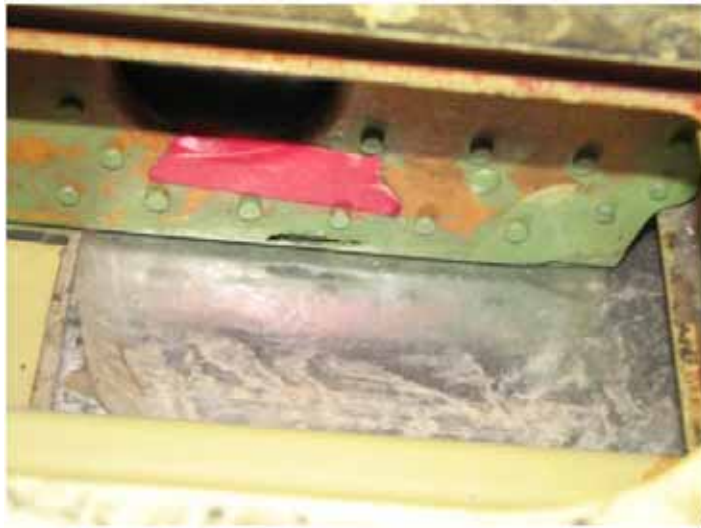
Figure 1.12-49 Corroded Intercostal with Material Lost Through Hole

During investigation, the intercostals between BS867 ~ BS887, S-26L and S-27L, was found damaged with corrosion, and such heavy corrosion has resulted in a through hole, see figure 1.12-49. The outlet port of the waste water tank located upstream of outboard side of BS867 ~BS887 S-26L and S-24L, whilst the damaged intercostals was exactly at down stream of the leaking point of the waste tank outlet, see figure 1.12-50 and 1.12-51.

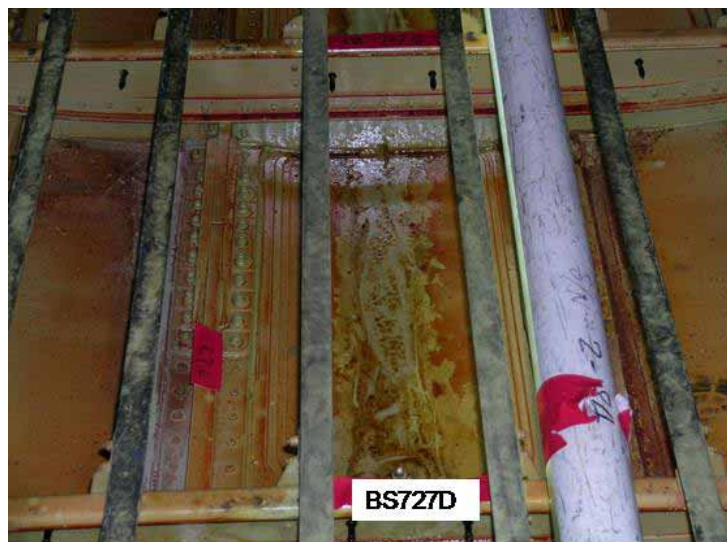
Figure 1.12-55 CPC on The Belly Skin

During the site investigation of cargo compartment in operator's home maintenance depot, mixture of the condensate water and the corrosion inhibiting compound (CPC) was found on the bottom of the aft cargo compartment. In addition, the CPC film was observed had being washed away at the bottom skin drain path of condensate water, however no corrosion was found at this area. See figure 1.12-55.

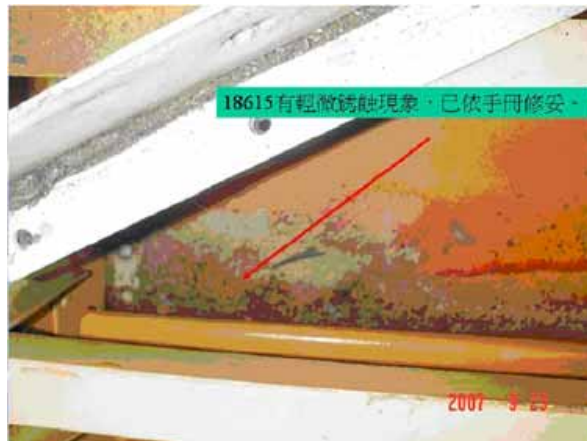
Figure1.16-1 Corrosion on aircraft B-18615

CAL performed a one time leakage inspection on the 737-800 fleet from Sep. 22 to Sep. 24, 2007. Twelve airplanes were inspected. Three airplanes were found to have cracks on waste tank outlet flanges Two out of those three aircrafts had waste water leakage and corrosion was found on the belly skin as shown in Fig.1.16-1 and Fig. 1.16-2. The corrosion was fixed in accordance with the manual. From the maintenance records, one of those two aircrafts had dirty in the region which was found during the latest inspection of waste tank compartment (AV4, Jul. 1, 2006) before the occurrence. The dirty was cleaned in accordance with the manual. CAL sold the other aircraft to a foreign airlines and no maintenance information available. These 3 waste tanks were removed and were sent back to the manufacturer (EDO Fiber Science) for inspection and overhaul. Manufacturer's test report is shown in Appendix 7.

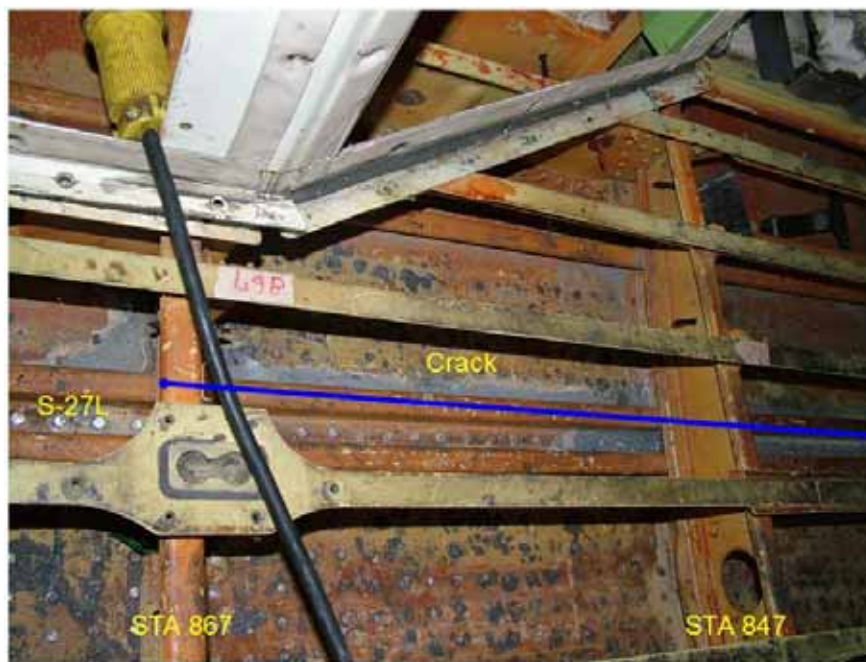
Figure 1.16-3 Location of crack adjacent to the S-27L stringer

Refer to figure 1.16-3, it shows the location of damaged skin, the crack had grown from BS839.2 and reached to BS869.7. Following the direction of crack, it passed adjacent to S-27L. For the purpose of material test, the damaged skin was segmented properly as shown in figure 1.16-4. Following examinations and tests were macro observation and photographic documentation, Scanning Electron Microscope (SEM) examination on fracture surface, chemical analysis by Chemical Analysis Energy Dispersive X-Ray Spectroscopy (EDS) and SPARK analysis, hardness and conductivity testing, metallographic examination, corrosive tests by Ion Chromatography (IC) method, to determine the root cause of failure.

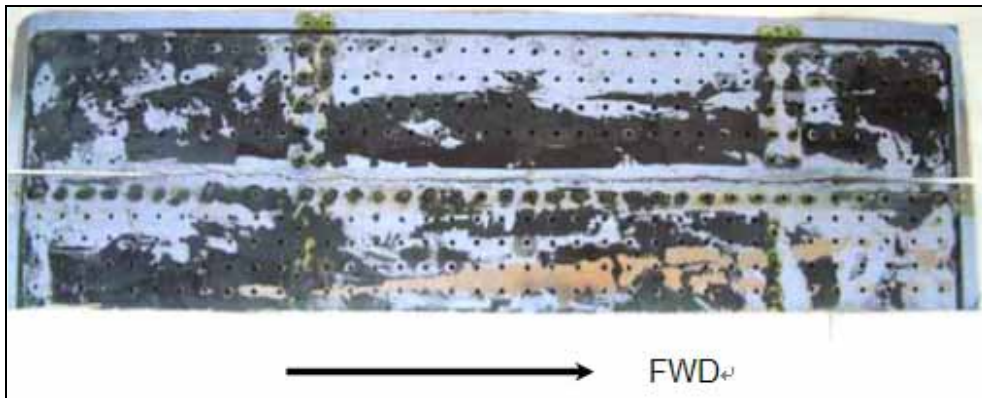
Figure 1.16-6 Exterior surface of the damaged skin

The damaged overall view of the interior and exterior surface of the damaged skin (sampling) was shown in figure 1.16-5 and 1.16-6. The interior surface of the sampling (indicated by circle in Figure 1.16-5) was covered with corrosion products, and the fracture surface was rugged and rough with corrosion products. The sampling was segmented to ten sections for macro observation and photographic documentation. Figure 1.16-7 shows the macro observation of fracture surface of item 1, and figure 1.16-8 for item 9. The fracture surface obviously revealed rougher and showed the corrosion features. This is a key feature of exfoliation corrosion. See Appendix 4 for the photographs of other items.

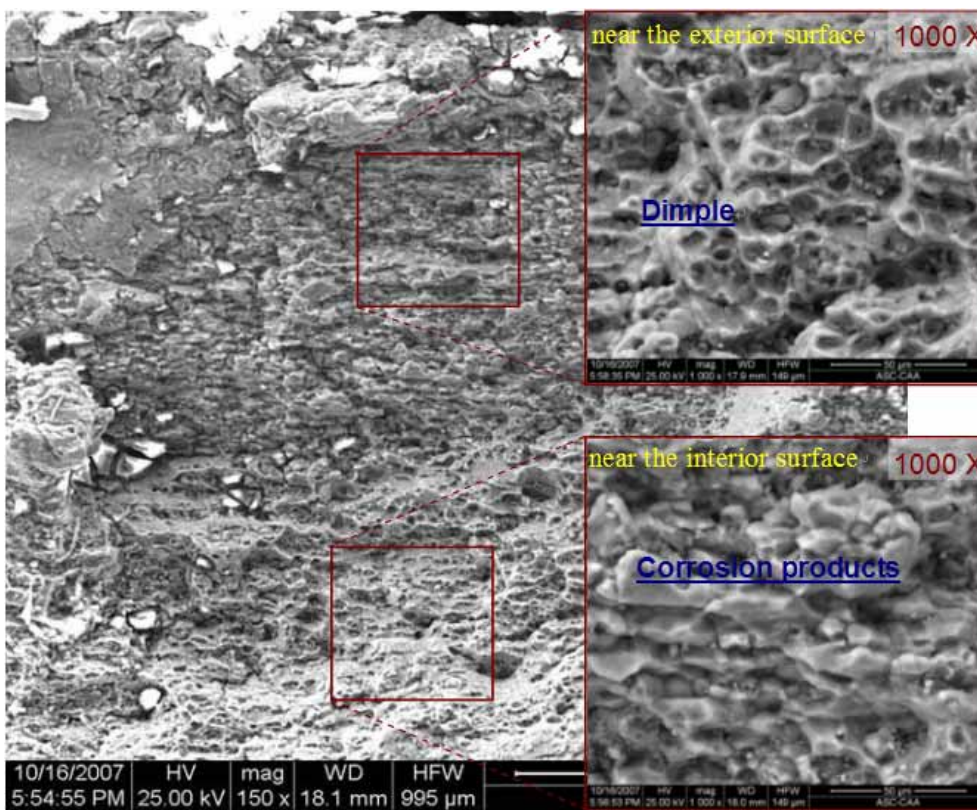
Figure 1.16-10 Fracture surface of item 9

The fracture surface of item 1 examined by Scanning Electron Microscope (SEM) was shown in figure 1.16-9. The topcoat was present up to the exterior surface of the skin, but the interior surface of the skin revealed in severe exfoliation condition. The fracture surface of item 9 was examined by Scanning Electron Microscope (SEM) shown in figure 1.16-10, the fracture surface near the interior surface of the skin revealed intergranular failure mode. Moreover, the fracture surface near the exterior surface of the skin revealed overload failure mode (dimple).

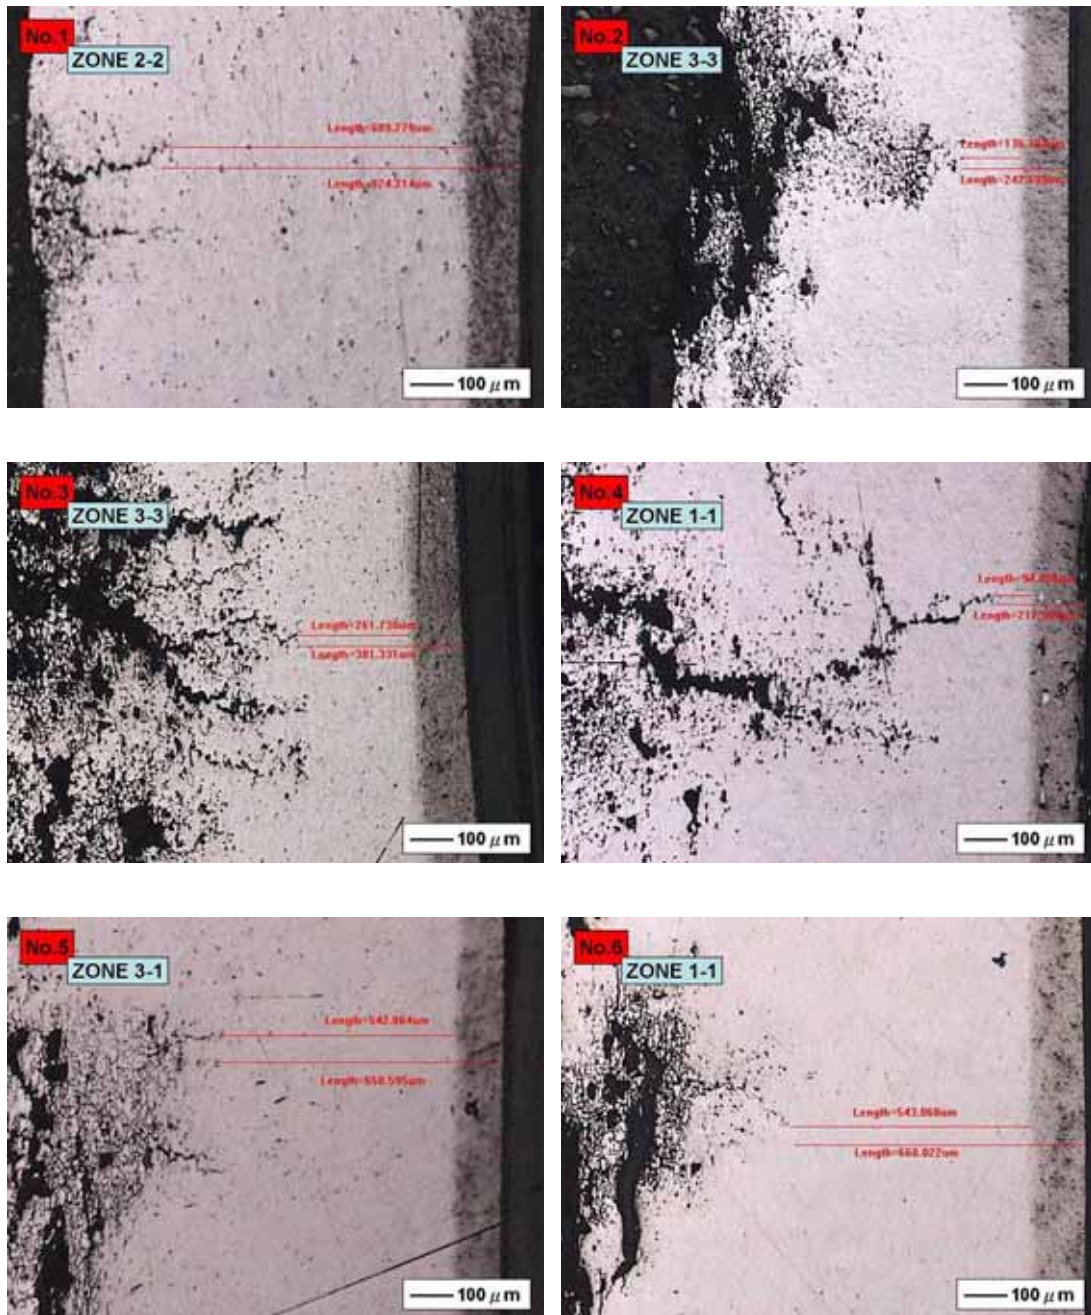
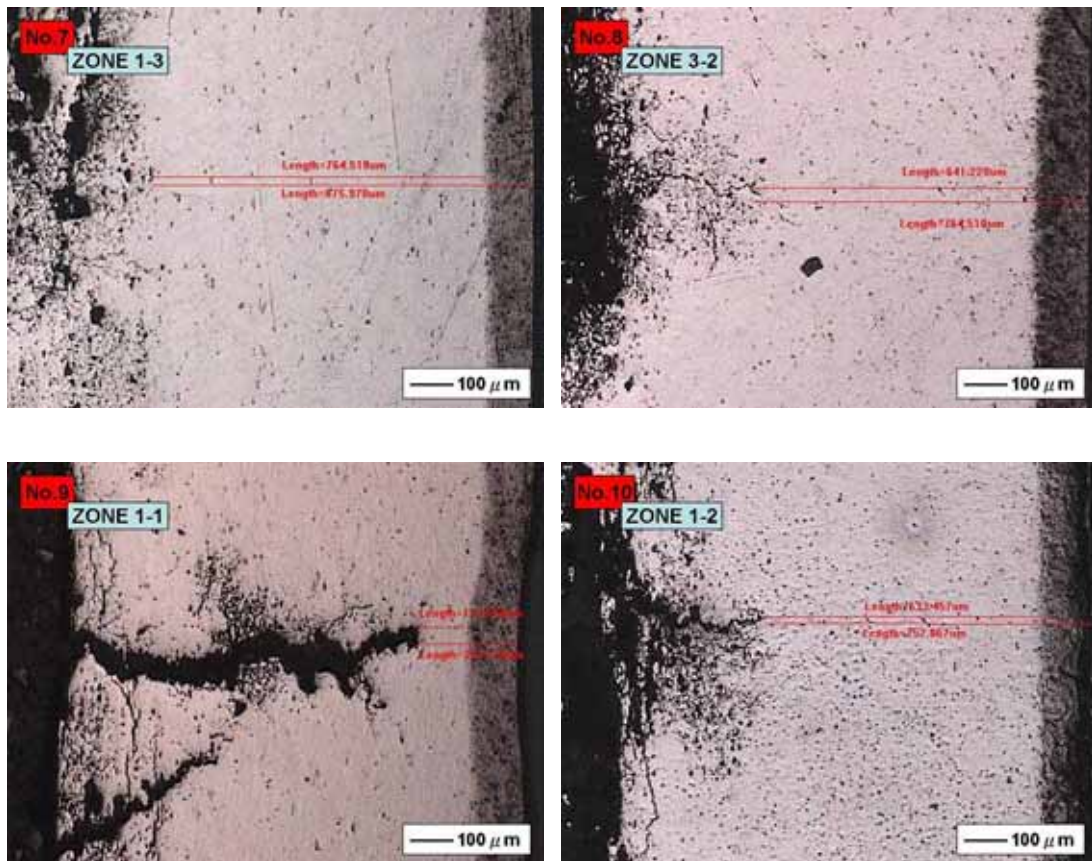
Figure 1.16-16 Metallographic photographs

The pittings and intergranular fractures are found clearly in all inspection items. Figure 1.16-16 shows the metallographic photographs, severe corrosions are found in some inspection items, even some pitting almost passes through the skin, like item 2-3-3<sup>4</sup>, item 4-1-1 and item 9-1-1, and the effective thicknesses of these items are 0.0054 in, 0.0037 in and 0.0044 in (the standard is 0.063 in
