## **Aviation Occurrence Report**

**ASC-AOR-09-09-001, Publication Date: Sep, 2009**

**A 30 in (77 cm) cracked through fuselage skin was found during transit check**

**BOEING 737-800**

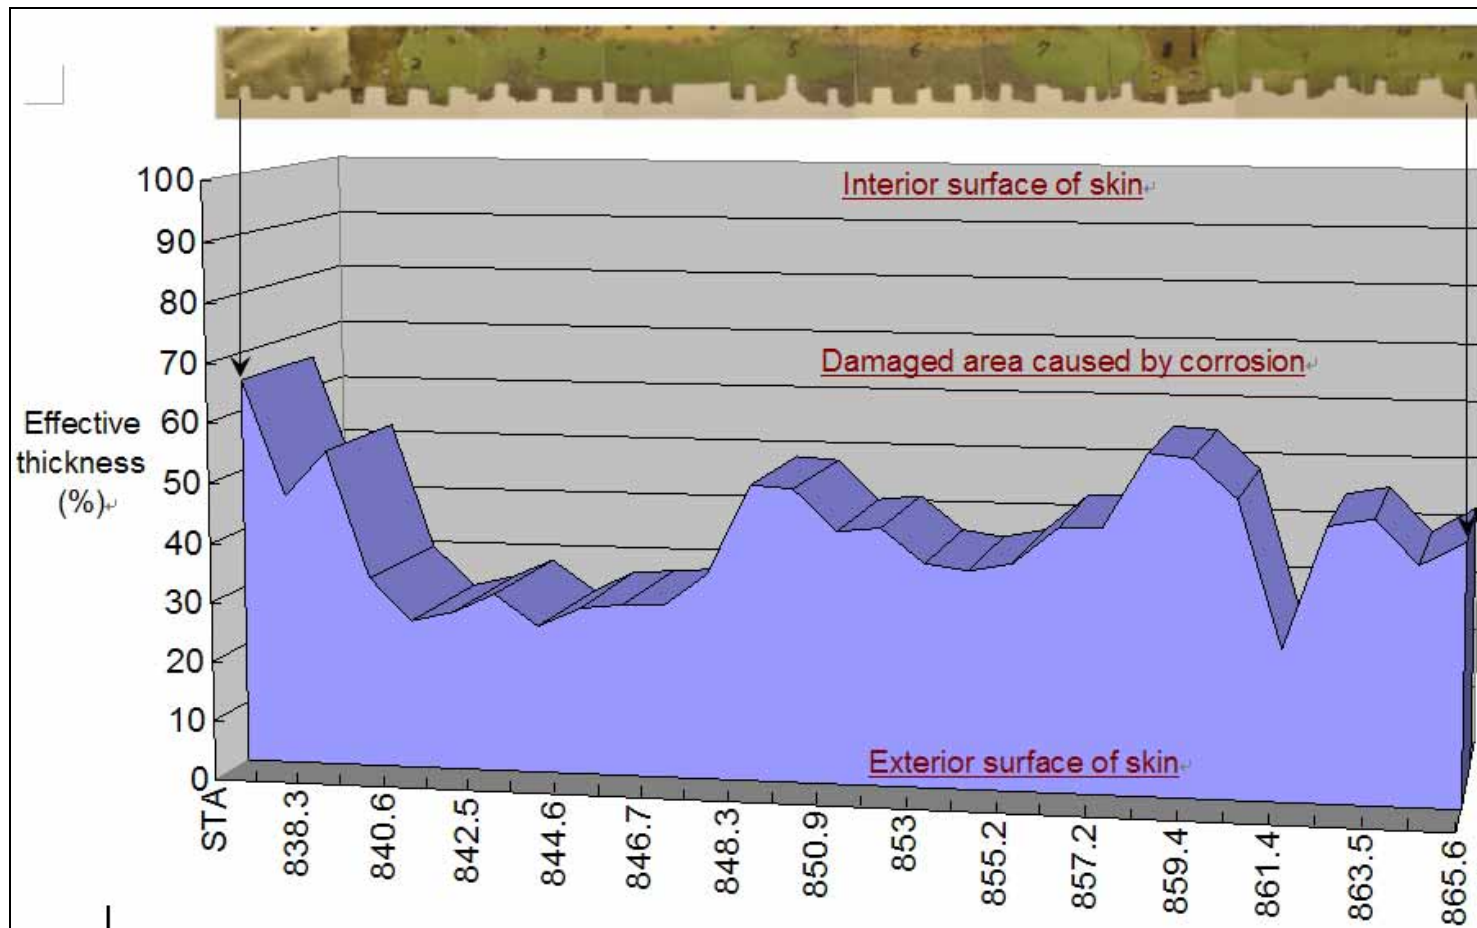
Figure 1.16-17 Effective thickness of the skin

referred to Boeing Drawing). The metallographic photographs of other inspection items are documented as in Appendix 5. Table 1.16-1 is the sampling positions and the effective thicknesses of each inspection items. Figure 1.16-17 illustrates the corrosive condition of the damaged skin, blank area represents some damage caused by corrosion, and the remainder represents the effective thickness of the skin.

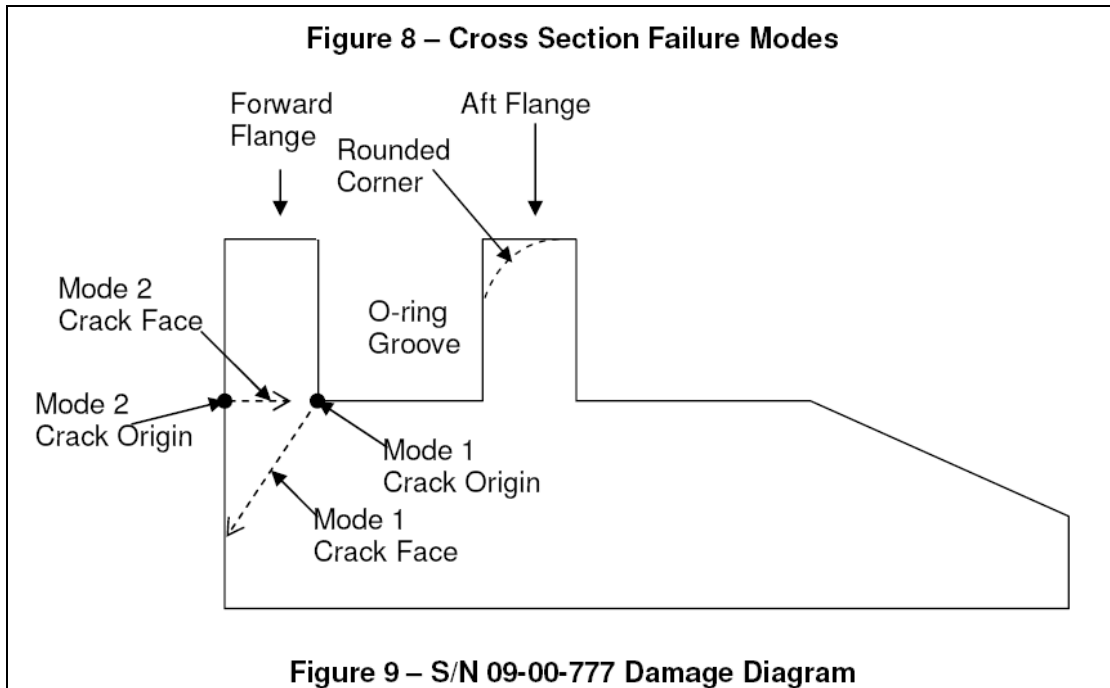
Figure 1.16-18 Cross sections of failure modes

3. The complexity of the mode 1 crack line indicates a complex loading situation. The mode 2 cracks in the forward flange are a distinctly different failure method. This failure method occurs in close proximity to the ends of mode 1 cracks, suggesting a pinch or pivot point. (Figure 1.16-18)

4. The two crack modes seen in the physical examination and shown in figure 8 of Appendix 8 are very similar to the crack behavior suggested by the finite element analysis. (Figure 1.16-18)

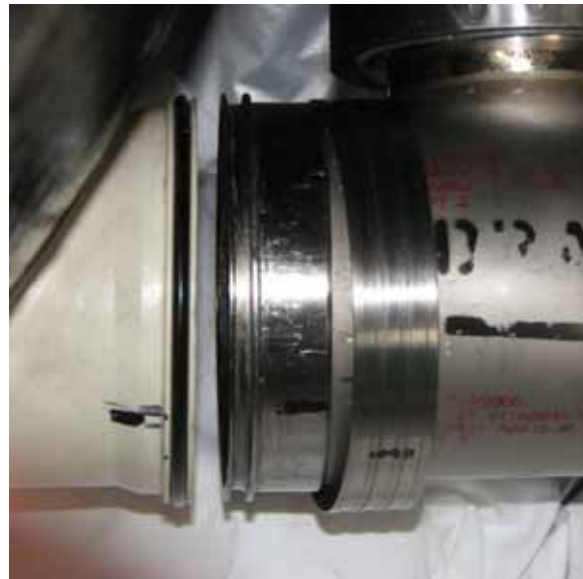
The measurements of airplane number #1 shown in Table 1.18-1 were the gap dimension after the replacement of a serviceable waste tank. The waste tanks of airplane number #1, #2 and #3 were removed and were all sent back to the manufacturer for repair. According to manufacturer's report, cracks were found on outlet flanges and were all located on 3-6 o'clock position. During the process of gap measurement, cracks were also found on outlet flanges of airplane number #4, #5, #7 and #10. The cracked waste tanks were all

Figure 1.18-2 Photo of Waste Tank Outlet and Coupling Short Tube

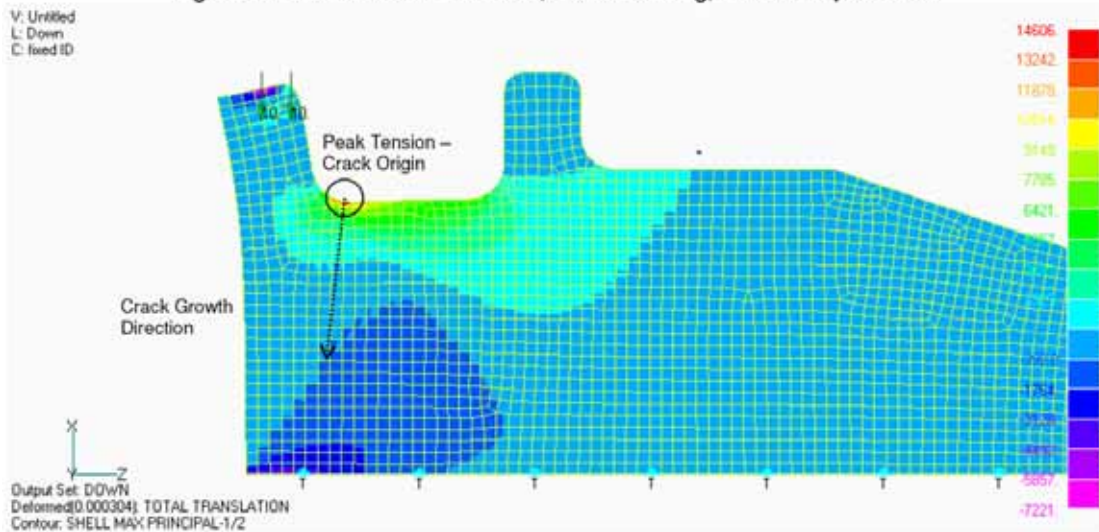
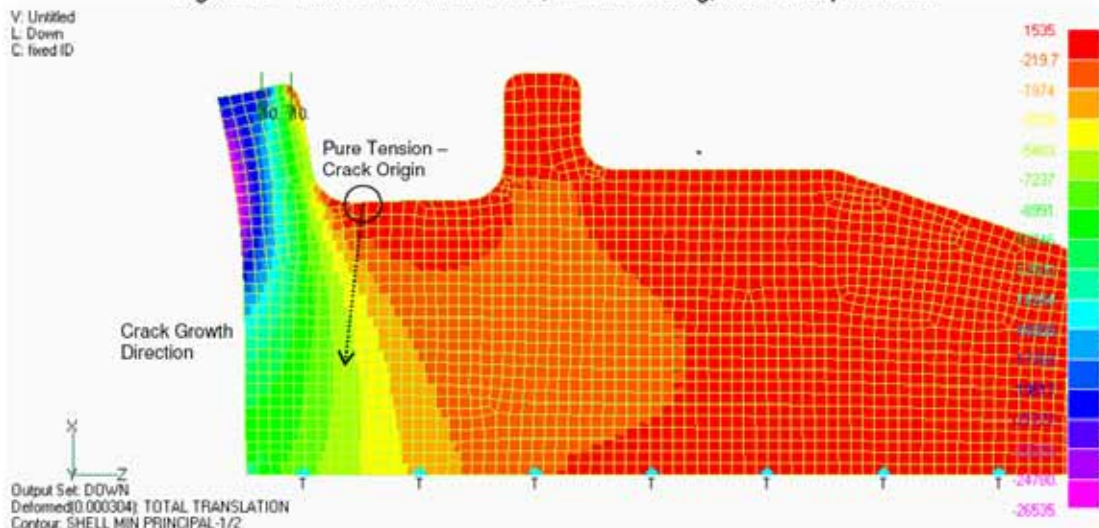
Figure 2.3-3 Mode of Down Loading on Front Flange

During installation, the coupling of waste tank outlet and its adjacent short tube are confined within a sleeve. An ideal installation is that the centerline of waste tank outlet overlaps that of the adjacent short tube and becoming a single centerline (refer to Figure 2.3-1). Poor workmanship or installation quality causes two parallel centerlines instead of a single one (refer to Figure 2.3-2). It will result in stress along radial direction on the contact points of sleeve and two adjacent tubing flanges. The same situations were showed in Figures 17

and 18 (refer to Figure 2.3-3) of the manufacturer's test report. Because of the restrictions on tools and space, ASC did not measure the matchness of centerlines.

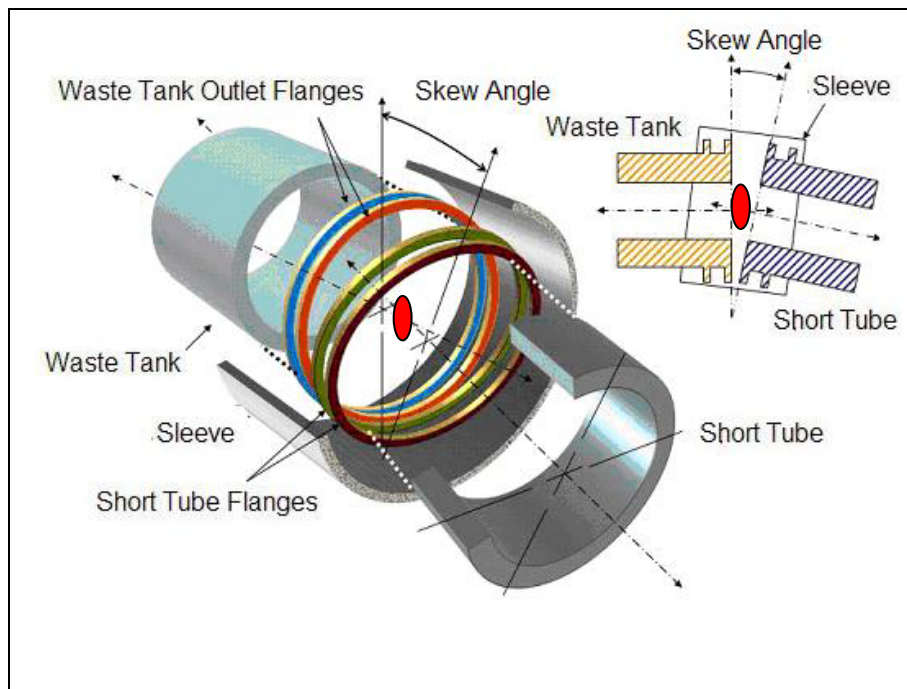
Figure 2.3-4 Non-overlapped Centerlines Intersect at One Point

Instead of overlapped centerlines, if the extended centerlines of both sides intersect at one point (refer to Figure 2.3-4) during installation, the end faces of flanges will be changed from parallel to skewed plane. This results in different gap distance between two adjacent tubing flanges and the skewed plane causes the compression of sleeve on the flange. Combined stress will be produced from axial and radial directions at the location with small gap distance. The same situations were showed in Figures 19 and 20 (refer to Figure 2.3-5) of the manufacturer’s test report. The combined stress causes mode 1 crack (refer to Figure 2.3-7) as shown in Figure 8 of the manufacturer’s test report. While for the location with large gap distance, combined stress will

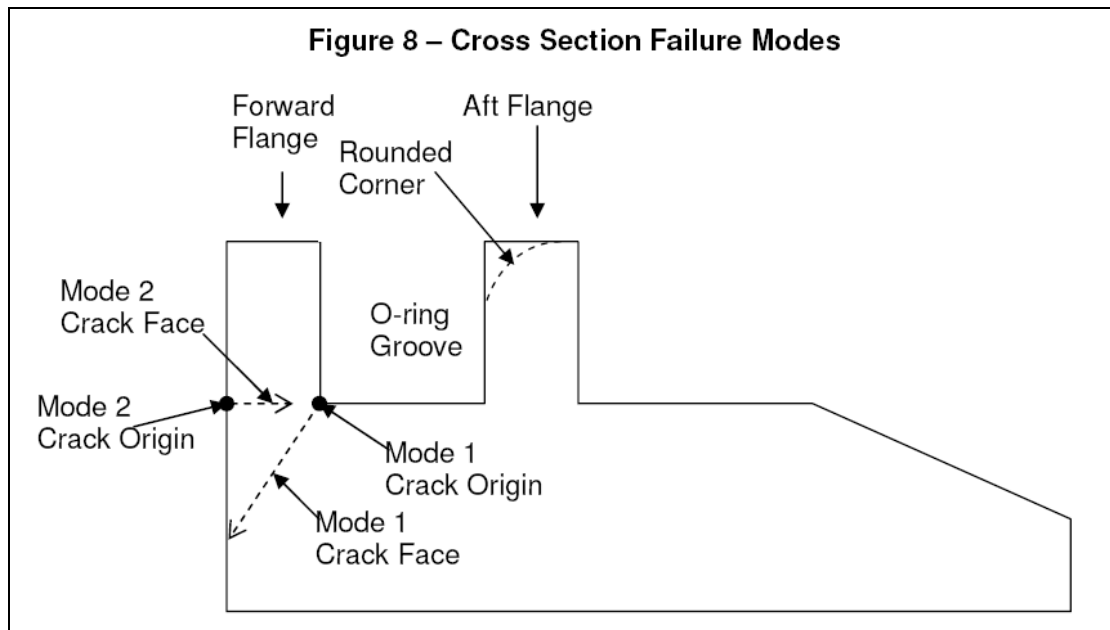
Figure 2.3-7 Flange Failure Modes

The two crack modes seen in the physical examination and shown in figure 8 are very similar to the crack behavior suggested by the finite element analysis. The mode 1 crack suggests either a forward or forward plus down combined loading. The mode 2 cracks suggest the opposite, either a pure aft loading, or an aft plus down combined loading. These comparisons are confirmed by the direction of forward flange movement; the forward flange moves forward for a mode 1 crack (figure 1) and aft for a mode 2 crack (figure 2). None of the cracks suggest a pure down loading, as the finite element analysis suggests this type of crack face would not have a radius from the o-ring groove because the origin point would be well inside the groove, and some radius can be felt on all 3 drains. Furthermore, the close proximity of mode 1 and mode 2 cracks suggest the drain flange is under a bending loading with pivot points.

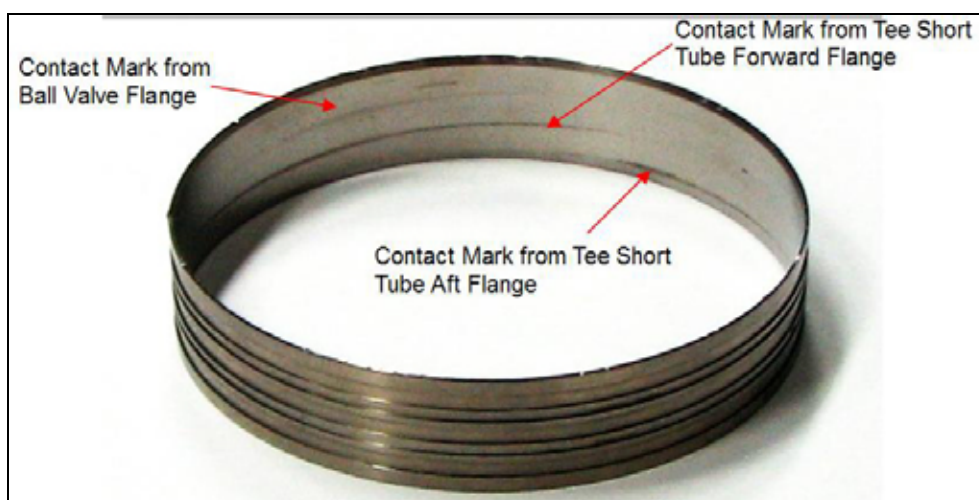
Figure 2.3-9 Trace of Contact Marks on the Inner Race of the Sleeve

Observation over the sleeve coupling the short tube and ball valve of the #7 airplane, on the inner race of the sleeve, the pair from the short tube is clear whilst the other one from the ball valve seemed blurred. (See figure 1.6-8).

The material of waste tank outlet port is nylon, relatively softer than the CRS sleeve, leaves no contacting mark on the inner ream of the coupling sleeve to be an evidence of abnormal contacting (Riding Condition) of the outlet flange; however whilst on the opposite side the ball valve flange, which was made from metal which is relatively harder, mostly did leave contacting marks in suggesting the misalignment condition in coupling the waste system components was not unusual. As the installation environment for the ball valve side is extremely similar to the waste tank outlet side, it is worthwhile be considered as a good reference to relaise the misalignment that could happed on the waste tank outlet port side.

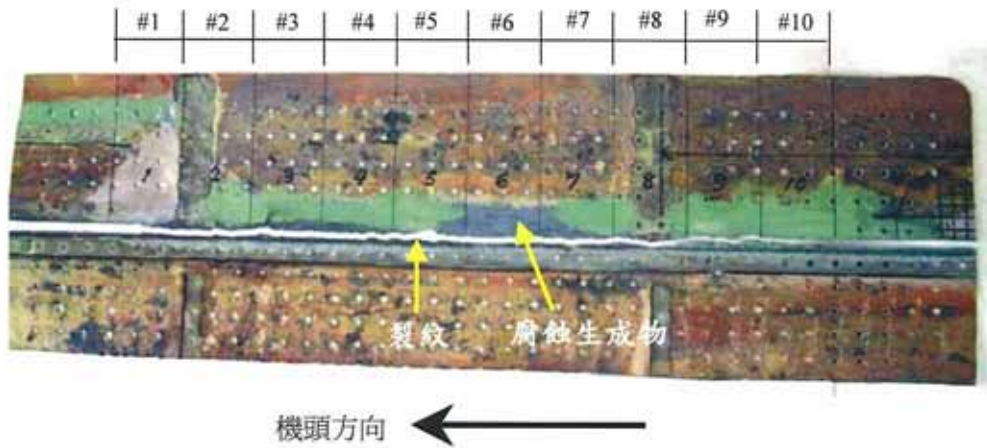
1. 送檢中華航空公司編號 B-16805 客機蒙皮，材質為 2024-T3 Clad 鋁合金，符合華航公司所提供之藍圖需求。
2. 腐蝕為造成蒙皮裂紋的主要機制，其型態屬於剝離(Exfoliation)腐蝕。腐蝕由無鍍鋁層的內側蒙皮表面開始，逐漸往蒙皮外側擴展，最後因有效截面積不足，無法承受外載力量而出現過載破壞裂紋。
3. 由蒙皮腐蝕粉末所淬取的溶液中，發現主要為醋酸根離子及氯離子。此兩者中，又以氯離子造成的腐蝕危害最大，為主要關鍵。
4. 離子層析結果發現，飛安會檢送的廢水系統清洗液與由蒙皮腐蝕粉末所淬取的溶液，兩者的陰離子成份相同。

圖 1、波音 737-800 型客機機身蒙皮裂紋的外觀觀察(內側表面)

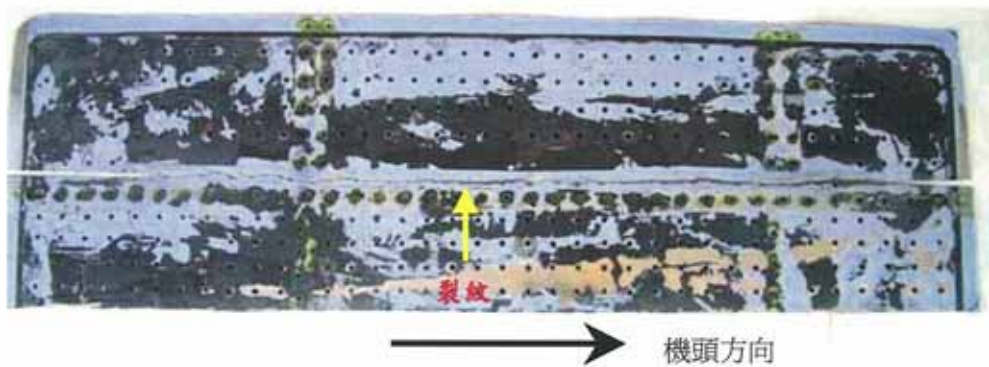
圖 2、波音 737-800 型客機機身蒙皮裂紋的外觀觀察(外側表面)

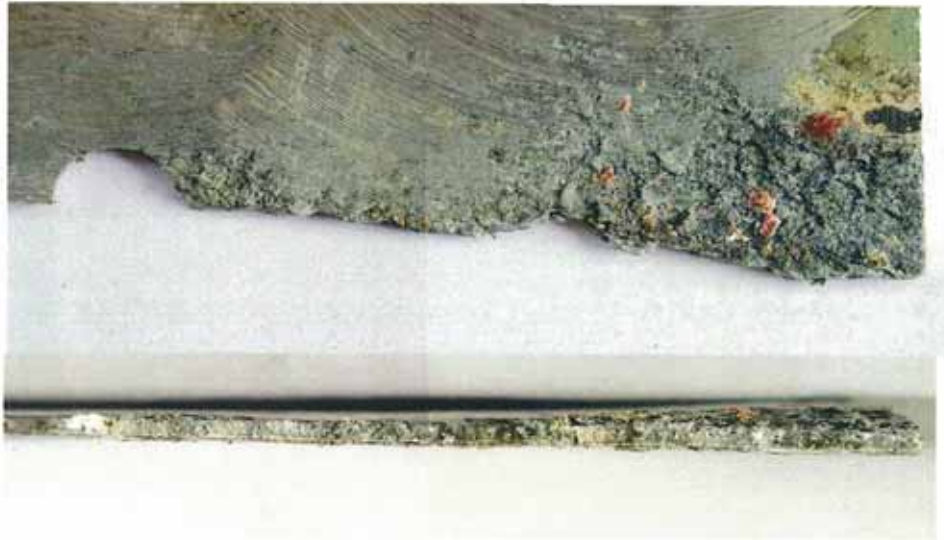
圖 3、編號 1 蒙皮試片巨觀觀察(下圖為斷面正視)。

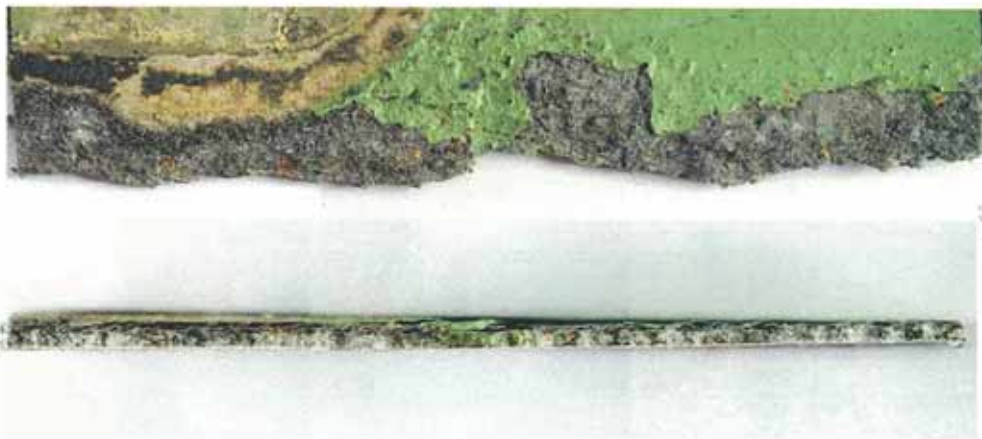
圖 4、編號 2 蒙皮試片巨觀觀察(下圖為斷面正視)。

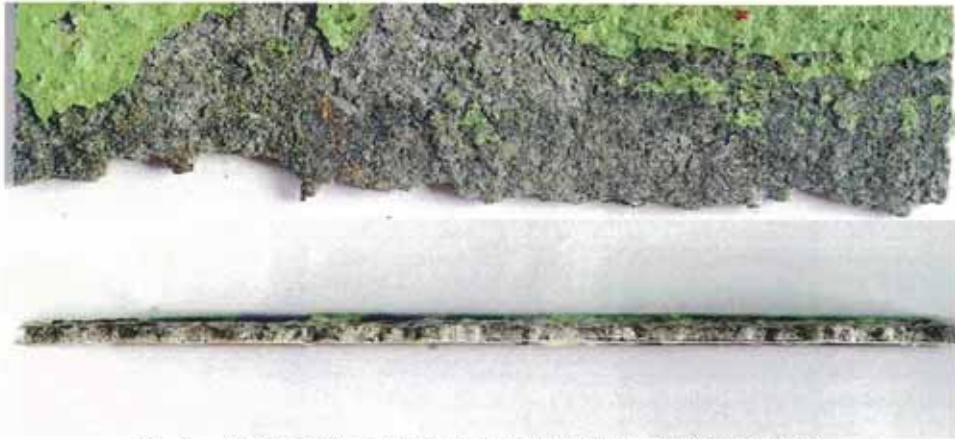
圖 5、編號 3 蒙皮試片巨觀觀察(下圖為斷面正視)。

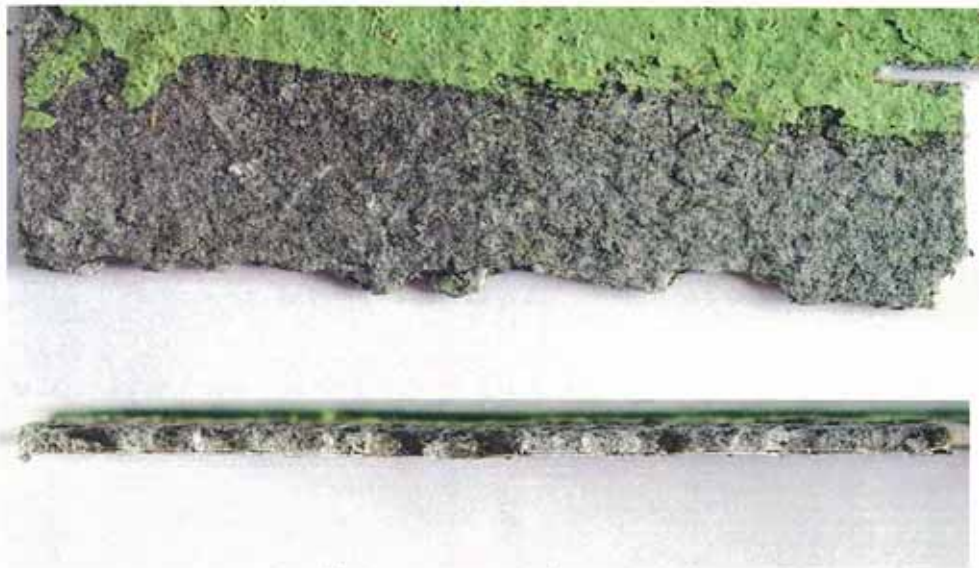
Figure 2.1-1 shows the metallographic photograph of item 4 (100X), the right side represents the pure aluminum cladding, the thickness of the cladding near the fracture surface becomes thinner, and the nipple feature is revealed obviously. The deformation of the aluminum cladding near the fracture surface

圖 6、編號 4 蒙皮試片巨觀觀察(下圖為斷面正視)。

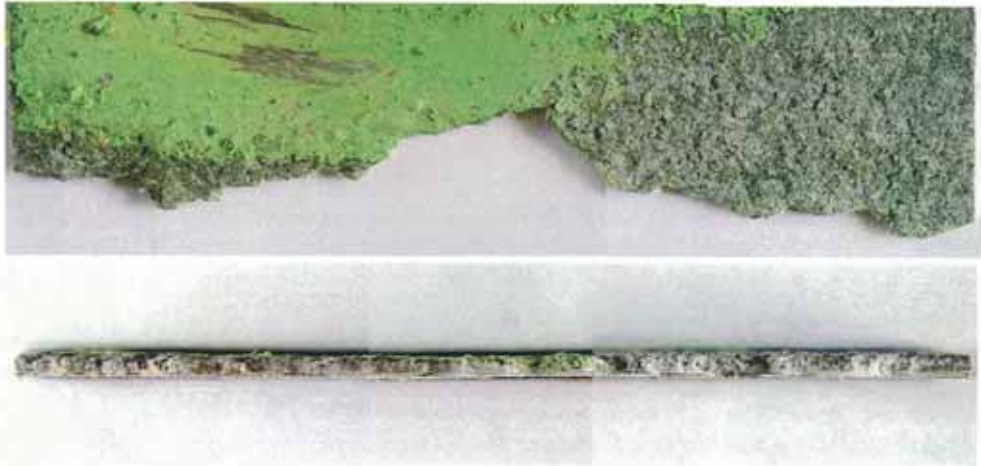
圖 7、編號 5 蒙皮試片巨觀觀察(下圖為斷面正視)。

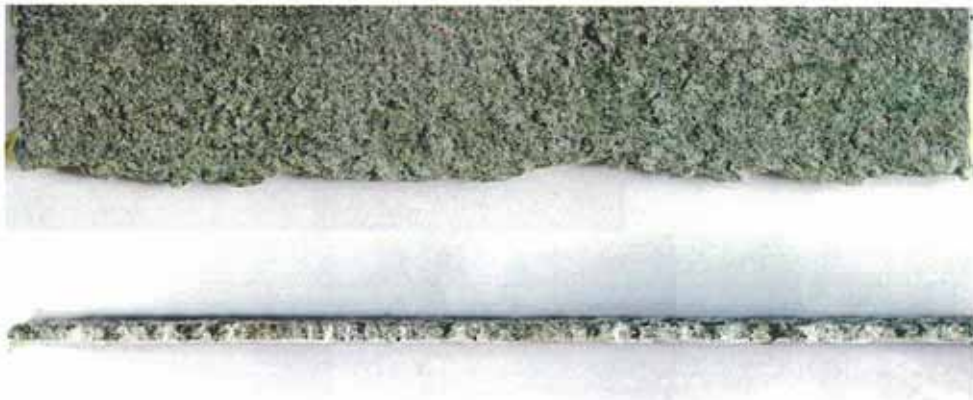
圖 8、編號 6 蒙皮試片巨觀觀察(下圖為斷面正視)。

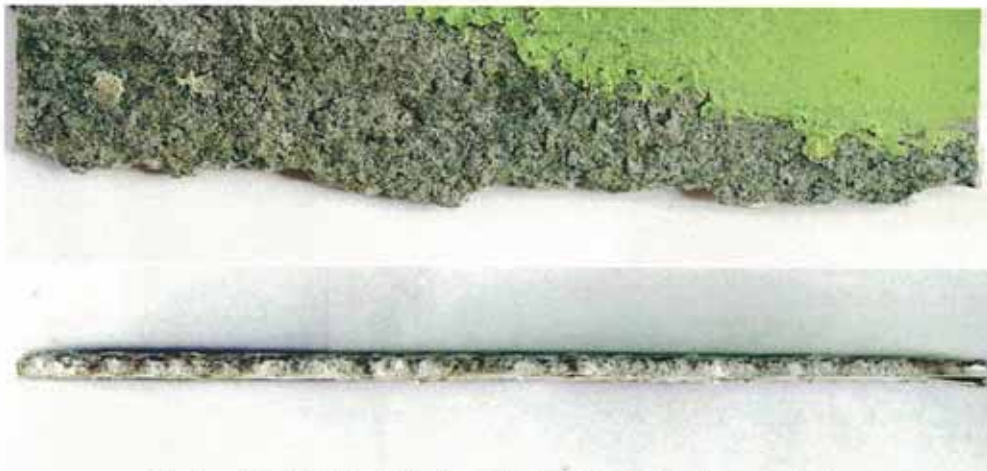
圖 9、編號 7 蒙皮試片巨觀觀察(下圖為斷面正視)。

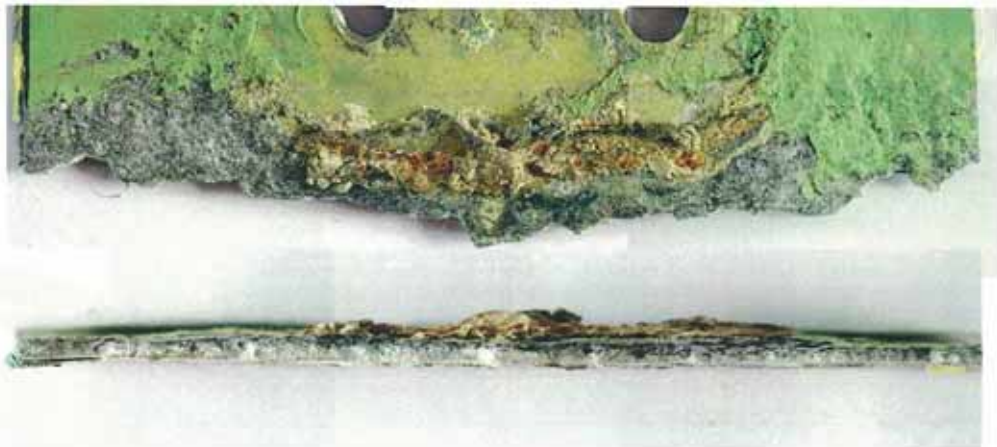
圖 10、編號 8 蒙皮試片巨觀觀察(下圖為斷面正視)。

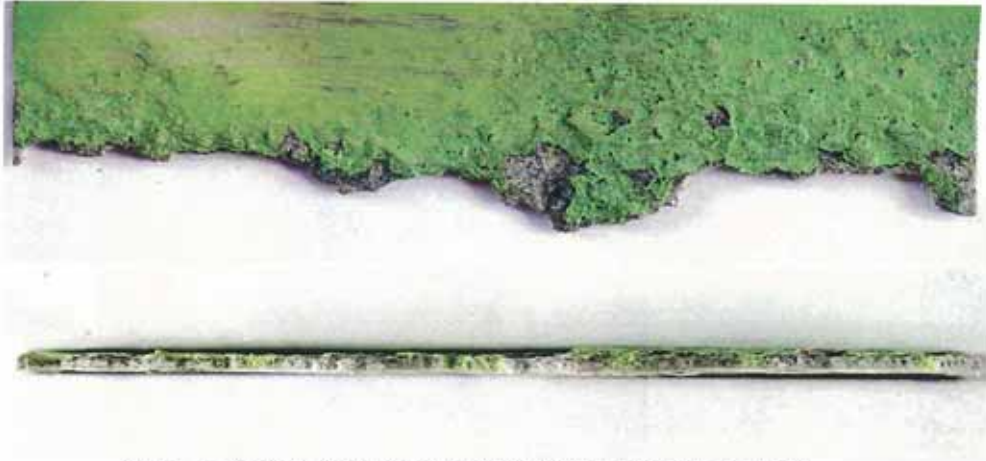
圖 11、編號 9 蒙皮試片巨觀觀察(下圖為斷面正視)。

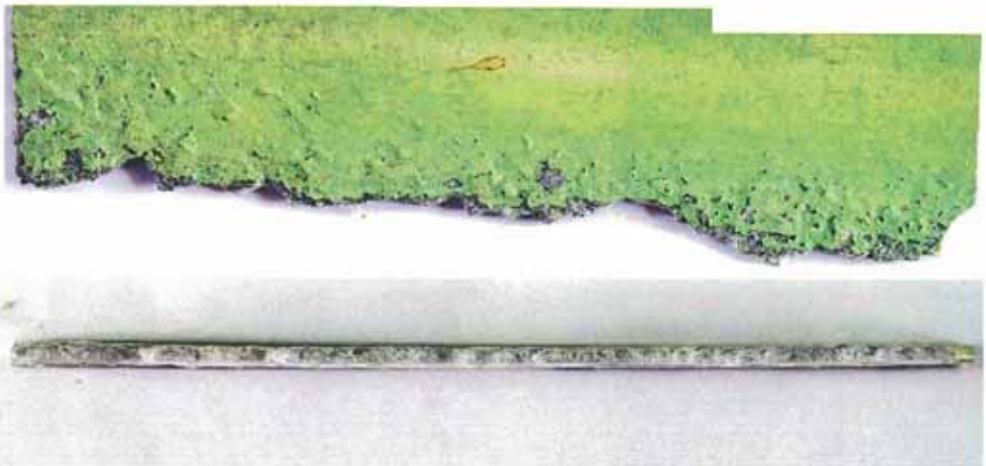
圖 12、編號 10 蒙皮試片巨觀觀察(下圖為斷面正視)。

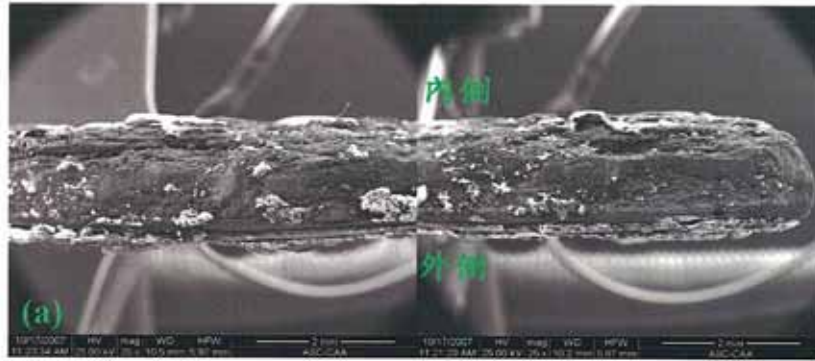
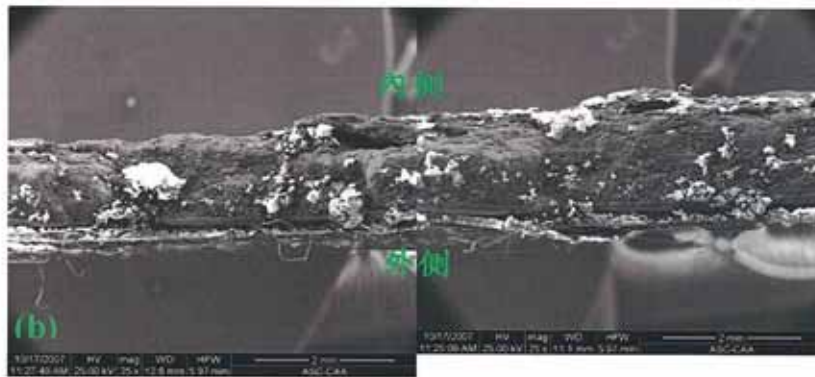
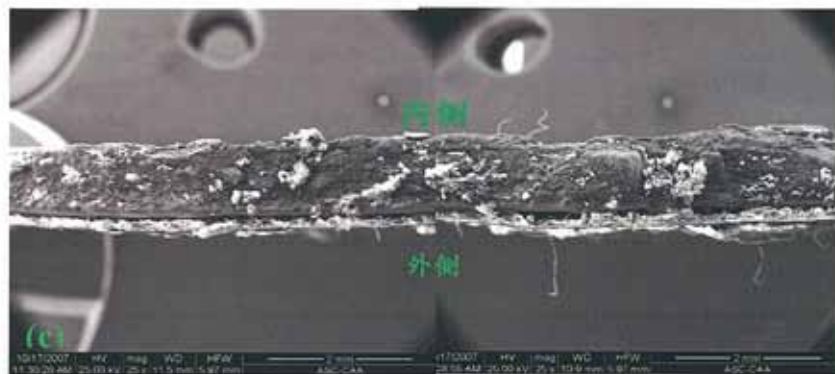
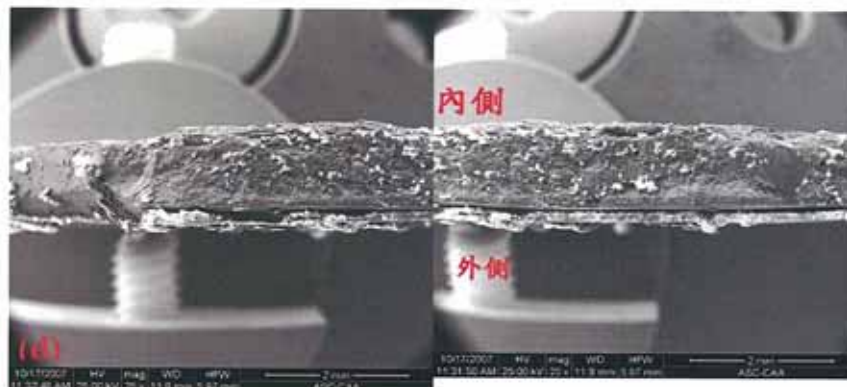
圖 13、編號 1 號試片整個破断面特徵觀察。

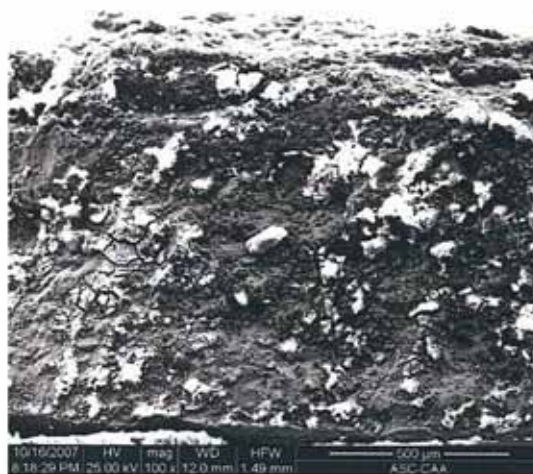
圖 14、編號 1 號試片 SEM 下之破断面微觀特徵觀察。

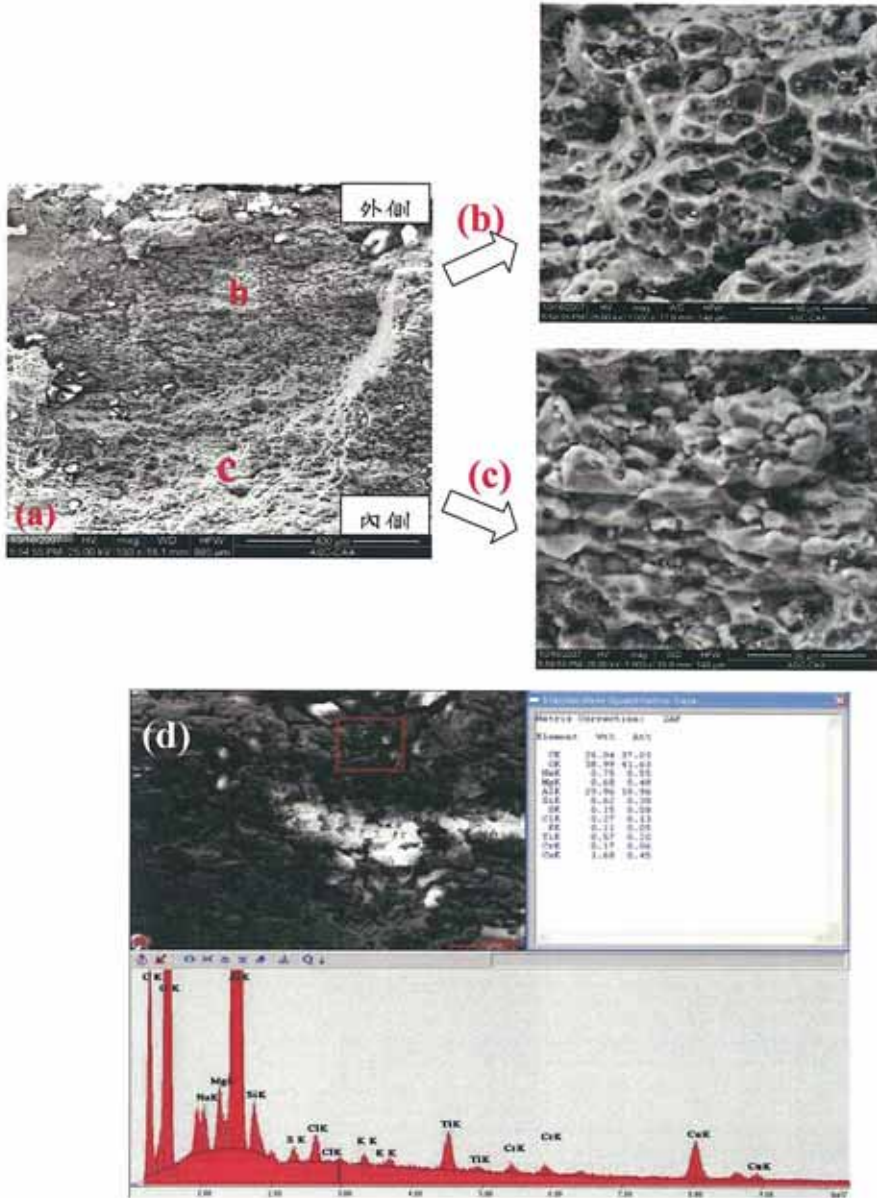
圖 15、編號 9 號試片 SEM/EDS 下之破斷面微觀特徵觀察。

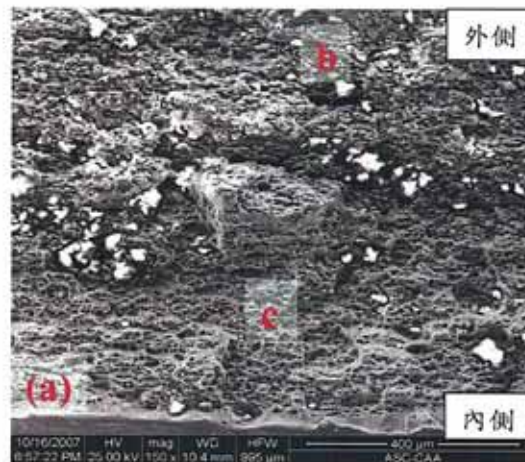
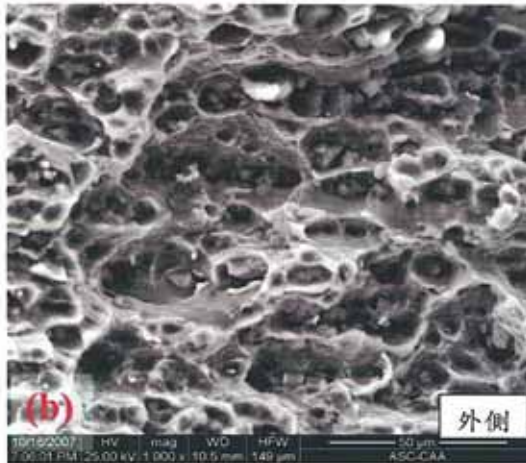
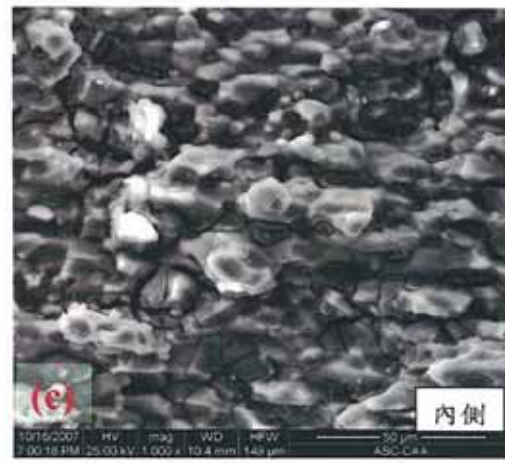
圖 16、編號 5 號試片 SEM 下之破斷面微觀特徵觀察。

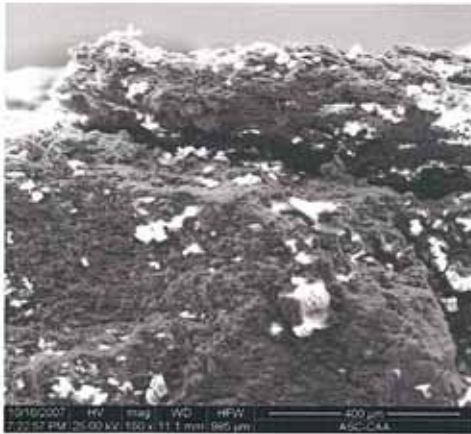
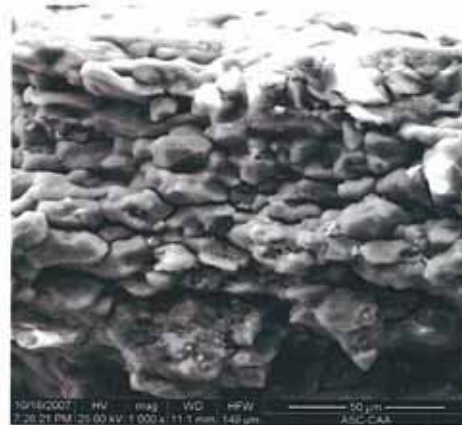
圖 17、編號 5 號試片鄰近內側表面之破斷面微觀特徵觀察。

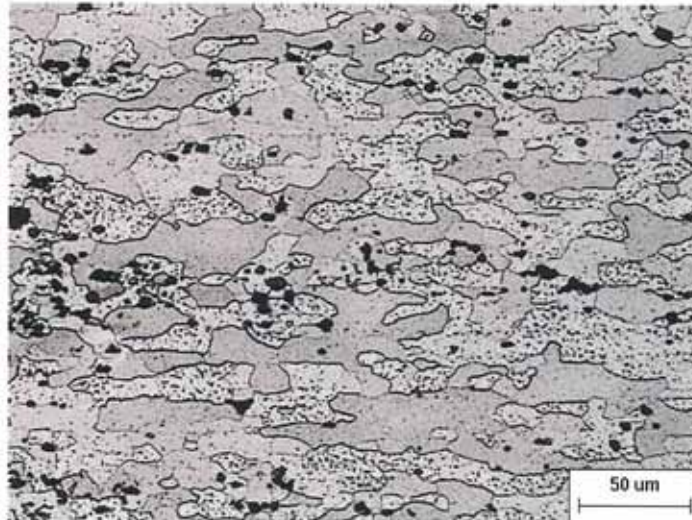
圖 18、機身蒙皮 L 方向的金相觀察。

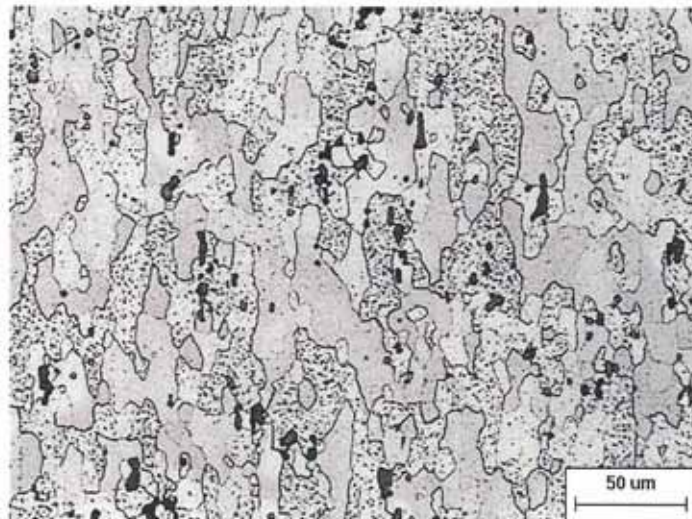
圖 19、機身蒙皮 T 方向的金相觀察。

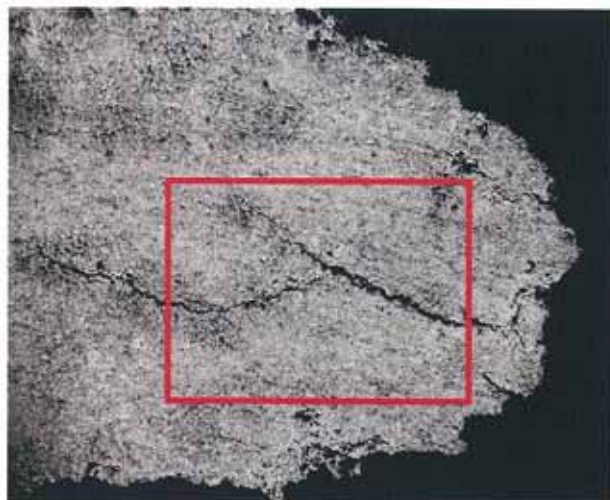
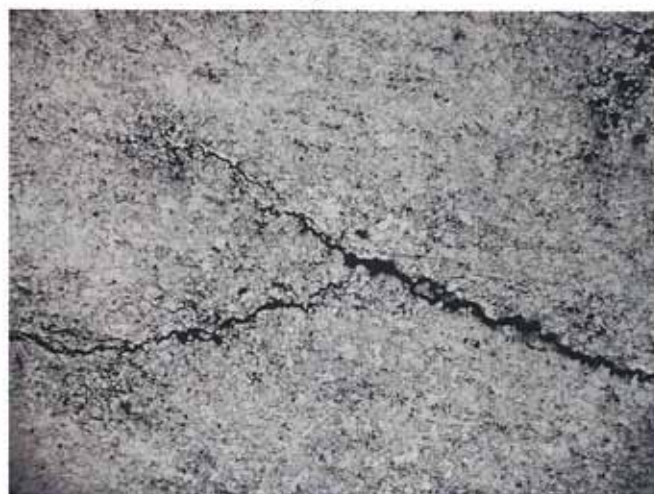
圖 20、編號 4 試片 L 方向剖面金相觀察。

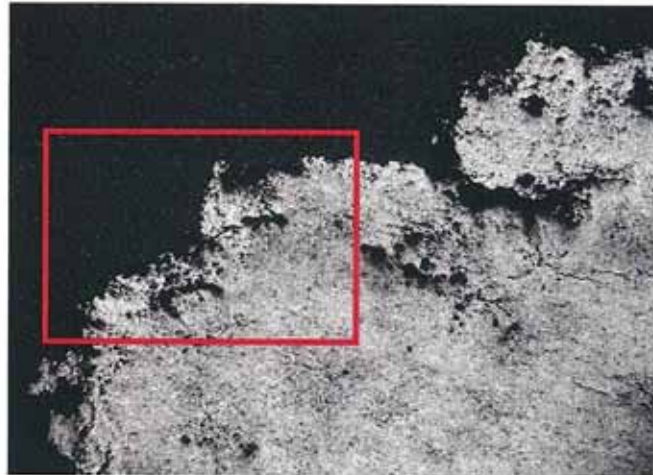
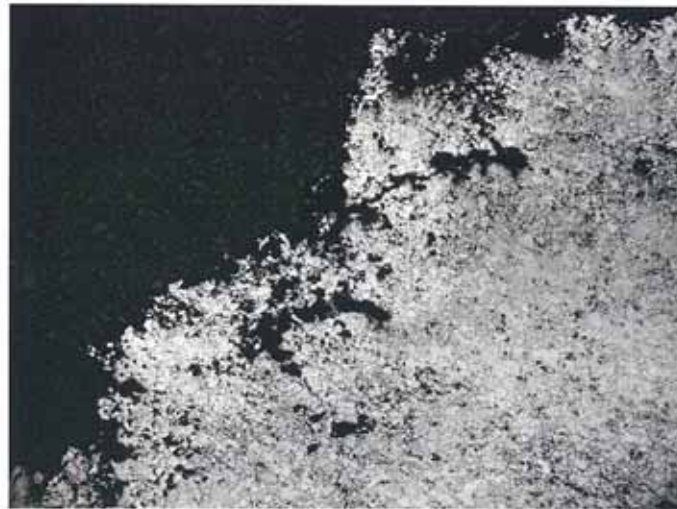
圖 21、編號 4 試片 L 方向另一處剖面金相觀察。

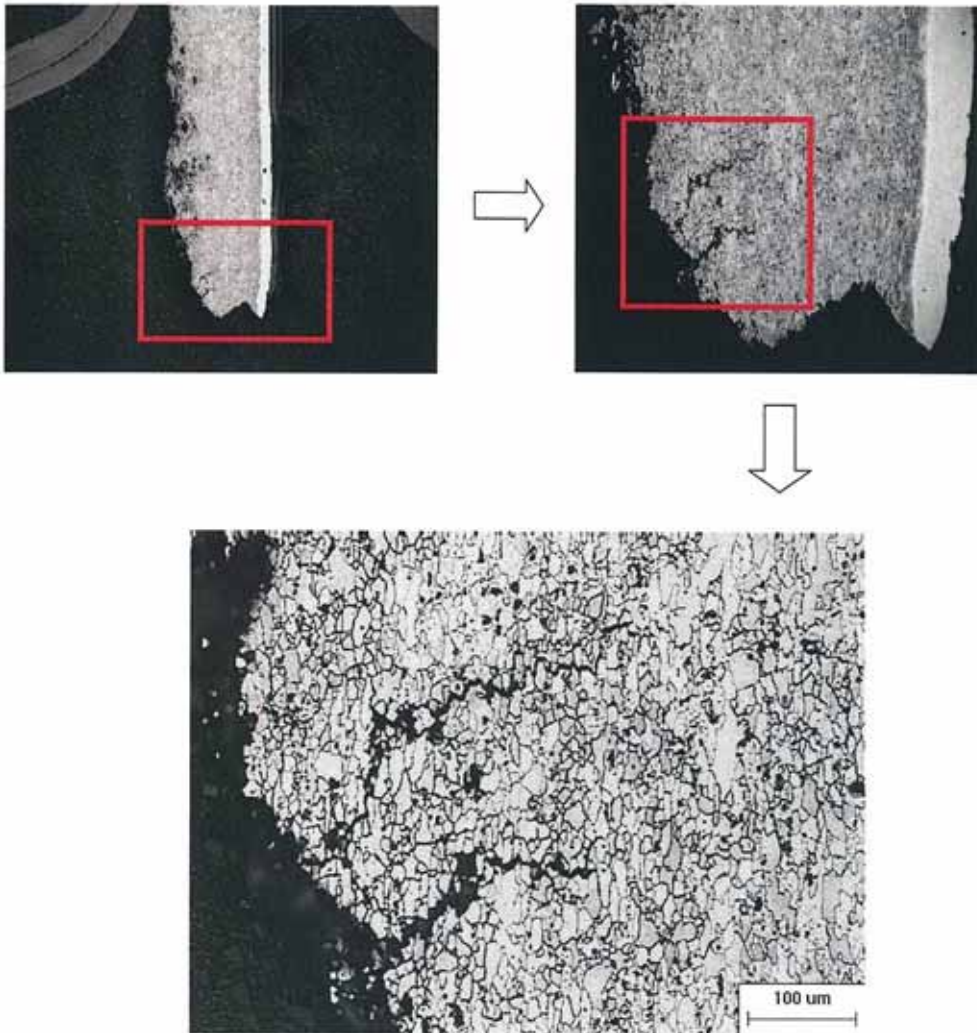
圖 22、編號 4 試片 T 方向剖面金相觀察。

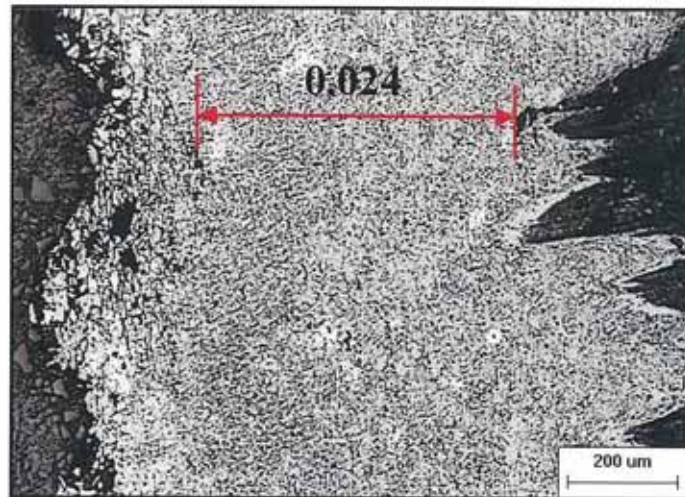
圖 27、編號 1 試片 T 方向的腐蝕殘餘厚度量測結果。

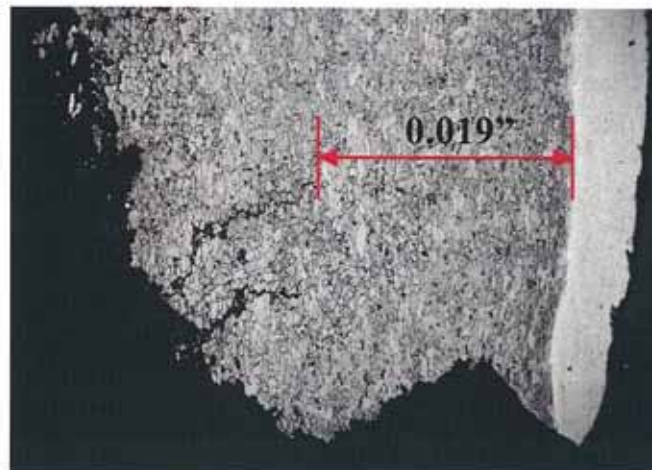
圖 28、編號 4 試片 T 方向的腐蝕殘餘厚度量測結果。

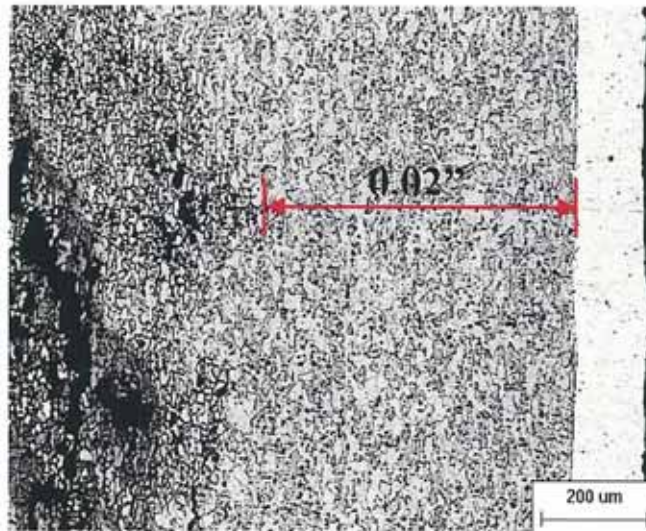
圖 29、編號 7 試片 T 方向的腐蝕殘餘厚度量測結果。

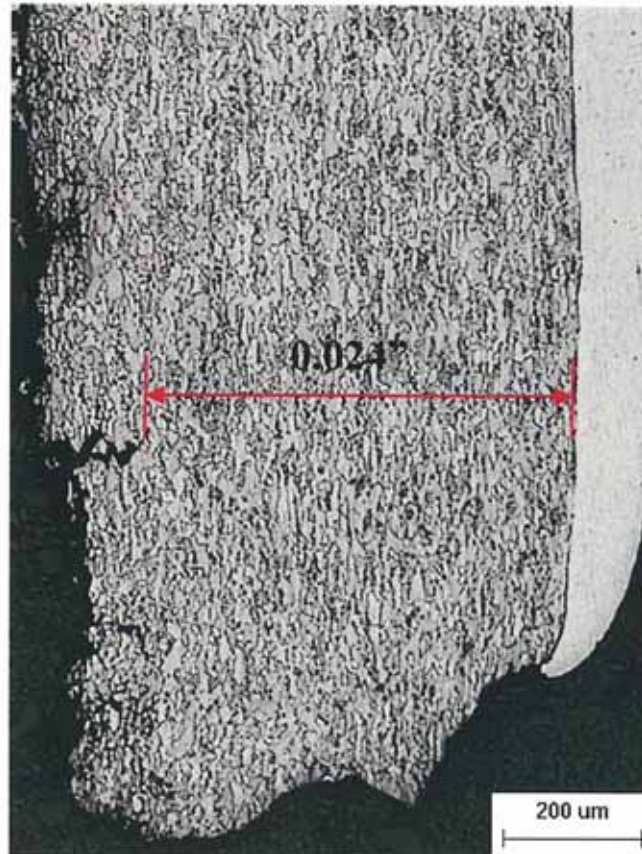
圖 30、編號 10 試片 T 方向的腐蝕殘餘厚度量測結果。

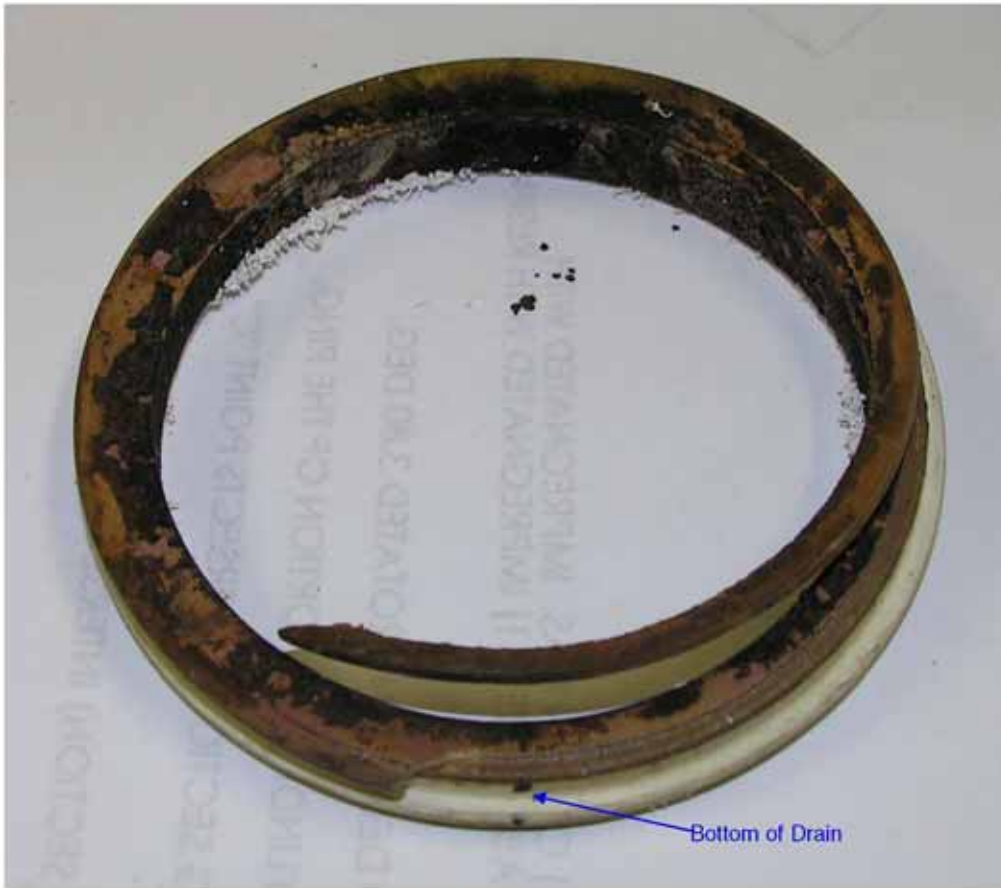
Figure 1 – S/N 09-00-777 after removal

The forward flange is broken in one location, on the bottom of the fitting (figures 1, 2, and 9). The flange is cracked over 200 degrees, from 20 degrees to 220 degrees. The remaining flange is also bent forward at 320 degrees as shown in cross -section DD. One end of crack is still white, near cross-section CC.

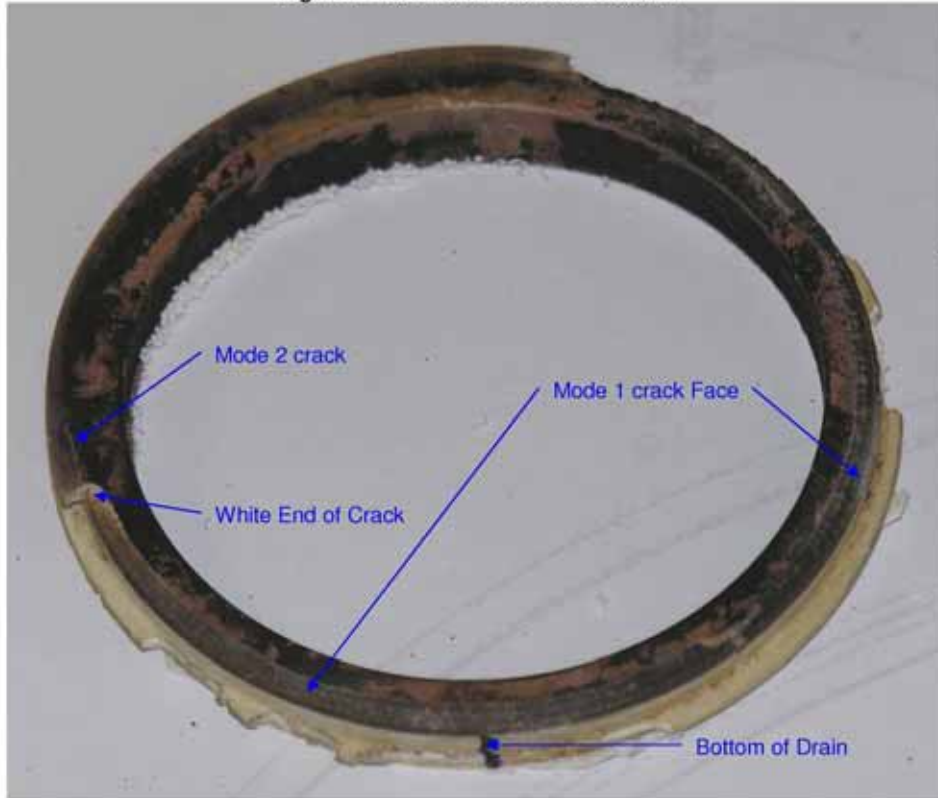
Figure 3 – S/N 10-00-789 after removal

3). The ends of the crack are white in two of the 3 fittings. Notches, as labeled in figures 4 and 5, are seen in the concentric ridges on the crack face in 2 of the 3 drains investigated. Failure crack mode 2 is less common but distinctly different than crack mode 1. Crack mode 2 begins at the forward surface of the fitting and progresses inwards towards the corner of the o-ring groove (figure 8).

end of the cracked flange is white, as can be seen in figure 3. The mode 1 crack face has one large notch centered at 140 degrees.
