## **Aviation Occurrence Report**

**ASC-AOR-09-09-001, Publication Date: Sep, 2009**

**A 30 in (77 cm) cracked through fuselage skin was found during transit check**

**BOEING 737-800**

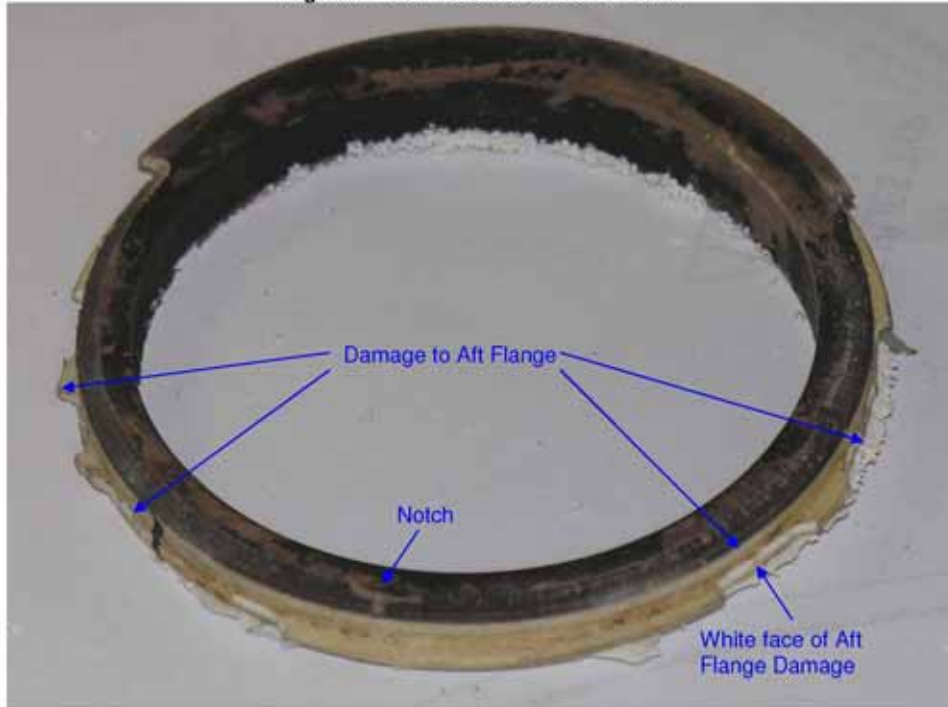
Figure 4 – S/N 10-00-789 after removal

3). The ends of the crack are white in two of the 3 fittings. Notches, as labeled in figures 4 and 5, are seen in the concentric ridges on the crack face in 2 of the 3 drains investigated. Failure crack mode 2 is less common but distinctly different than crack mode 1. Crack mode 2 begins at the forward surface of the fitting and progresses inwards towards the corner of the o-ring groove (figure 8).

The damage to the aft flange could be due to removal of the clamp attached to the drain, especially the jagged damage seen on SN 10-00-789 in figure 4. Removing the drain clamp after time in service has been shown to be difficult in the past, and damage to the aft flange is likely if the procedure is not done with care. Furthermore, the clear, flexible adhesive substance on the outside of drain fitting SN 10-00-789 could be evidence of an attempt to repair the leaking fitting after installation into the aircraft. This possible repair method is not standard EFS procedure or per the CMM, which would entail replacement of the entire drain fitting.

The relative smoothness of the mode 1 crack faces in the forward flange, combined with the small concentric ridges or "beach marks", all suggest a fatigue failure mode. The notches in the mode 1 crack faces, as seen in SN 10-00-789 figure 4 and SN 04-02-1226 figure 5, suggest the forward flange cracks contained more than one segment. These segments may have started independently of each other and grown into one large crack, started successively with one cascading into the next, or started simultaneously. Regardless of the timeline of the segments, the complexity of the mode 1 crack line indicates a complex loading situation. The mode 2 cracks in the forward flange are a distinctly different failure method. This failure method occurs in close proximity to the ends of mode 1 cracks, suggesting a pinch or pivot point.

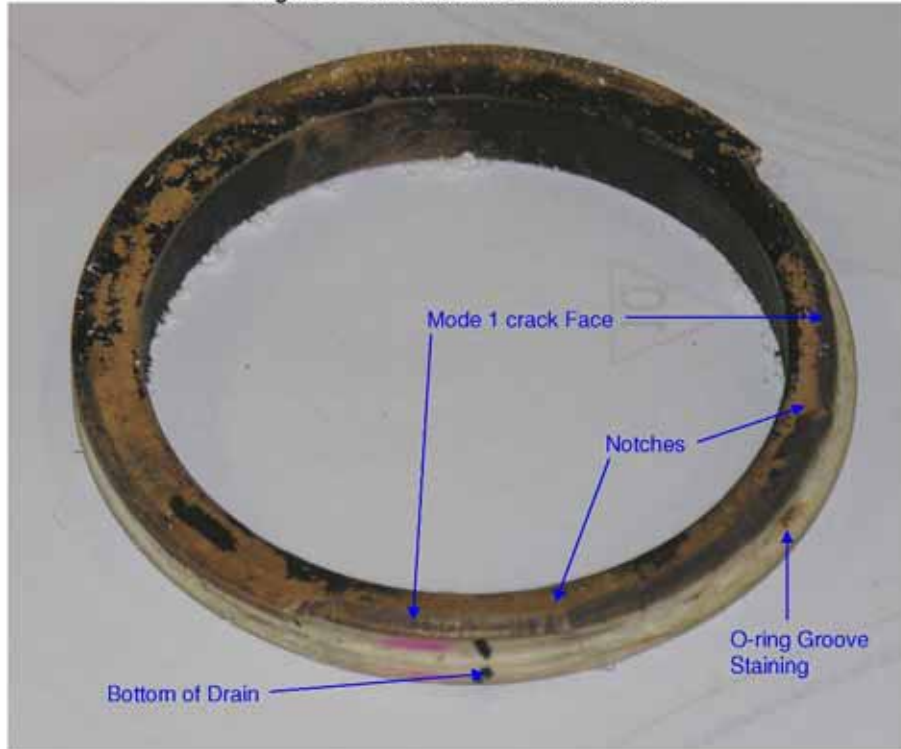
Figure 5 – S/N 04-02-1226 after removal

The o-ring groove is discolored in spots, as shown in figure 5 and figures 9 through 11. The majority of the discoloration is not in the area of forward flange cracking indicated in figure 7.

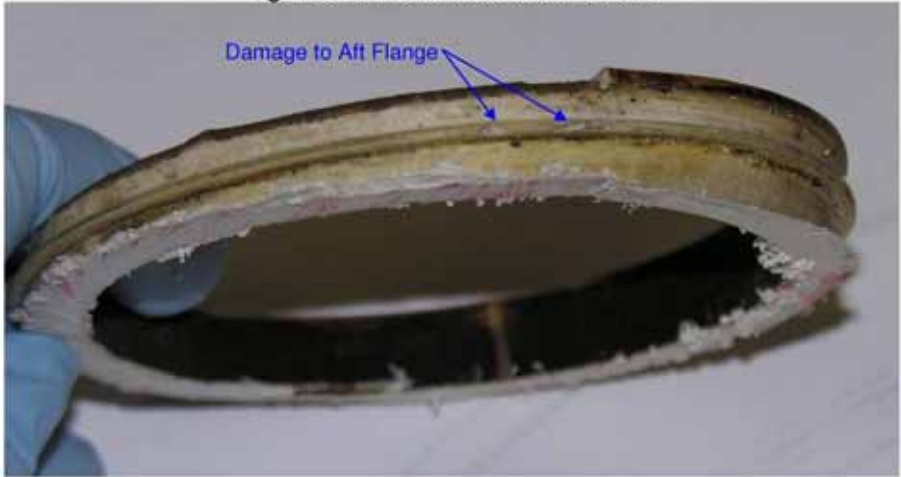
Figure 6 – S/N 04-02-1226 after removal

The aft flange is intact, although there is evidence of damage (figure 6). The aft flange varies in thickness, as seen in the measurements listed above. The edge of the flange is rounded, most noticeably at the top centered at 345 degrees, which corresponds to the smallest measurement 0.063". The aft flange is also noticeably rounded at 270 and at 115 in the area of the forward flange crack.

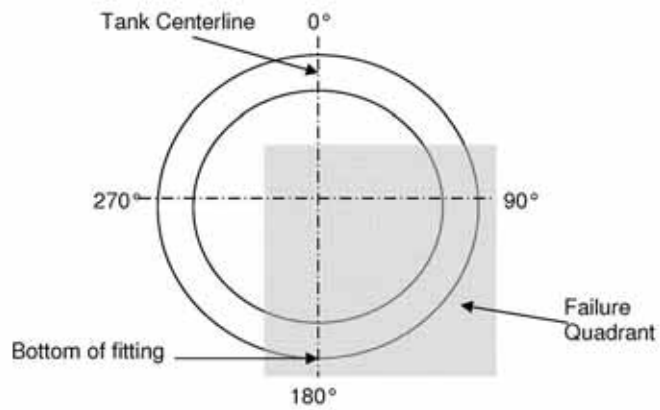
Figure 7 – Common Failure Quadrant

Forward flange is cracked on all three drains, and parts of it are missing in two of the three drains. The cracks occur mostly in the lower outboard quadrant (figure 7) from 70 to 200 degrees. The cracks in the forward flange occur in two different and distinct forms. The most common crack method, from hereon referred to as crack mode 1, is a diagonal crack face beginning at the inside of the o-ring groove and progressing forward and inwards, as shown in figure 8. Failure mode 1 cracks have a dark discolored face, like that of the inside diameter of the fitting. The crack face is relatively smooth and regular, with small concentric ridges (figure

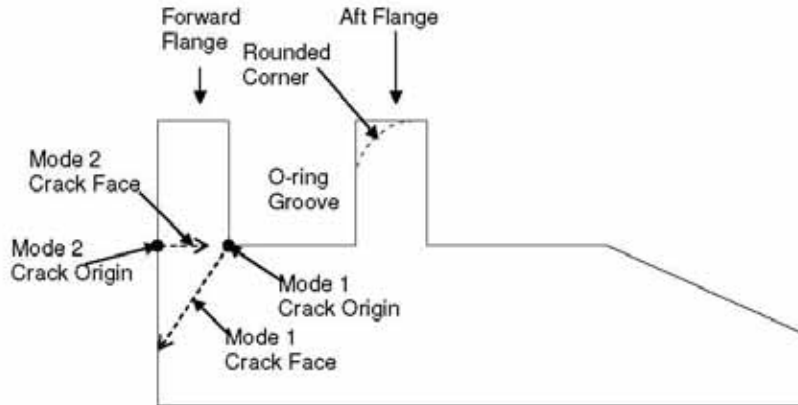
Figure 8 – Cross Section Failure Modes

The two crack modes seen in the physical examination and shown in figure 8 are very similar to the crack behavior suggested by the finite element analysis. The mode 1 crack suggests either a forward or forward plus down combined loading. The mode 2 cracks suggest the opposite, either a pure aft loading, or an aft plus down combined loading. These comparisons are confirmed by the direction of forward flange movement; the forward flange moves forward for a mode 1 crack (figure 1) and aft for a mode 2 crack (figure 2). None of the cracks suggest a pure down loading, as the finite element analysis suggests this type of crack face would not have a radius from the o-ring groove because the origin point would be well inside the groove, and some radius can be felt on all 3 drains. Furthermore, the close proximity of mode 1 and mode 2 cracks suggest the drain flange is under a bending loading with pivot points.

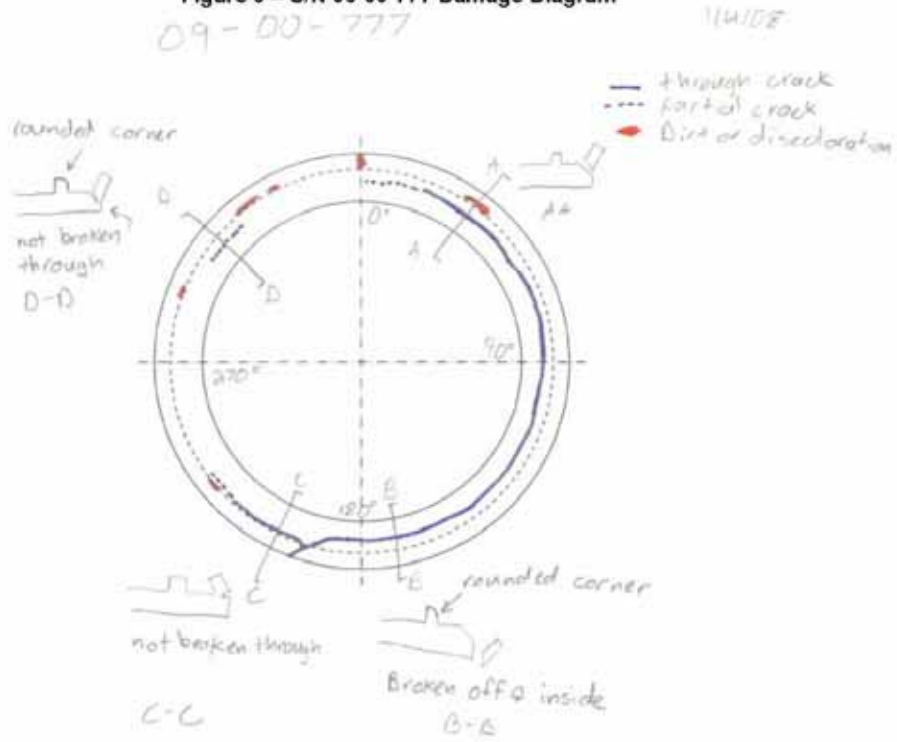
Figure 9 – S/N 09-00-777 Damage Diagram

Figure 9 is a diagram of the damage to the S/N 09-00-777 fitting. Cross sections of the fitting were drawn at various locations around the circumference to highlight features of interest.

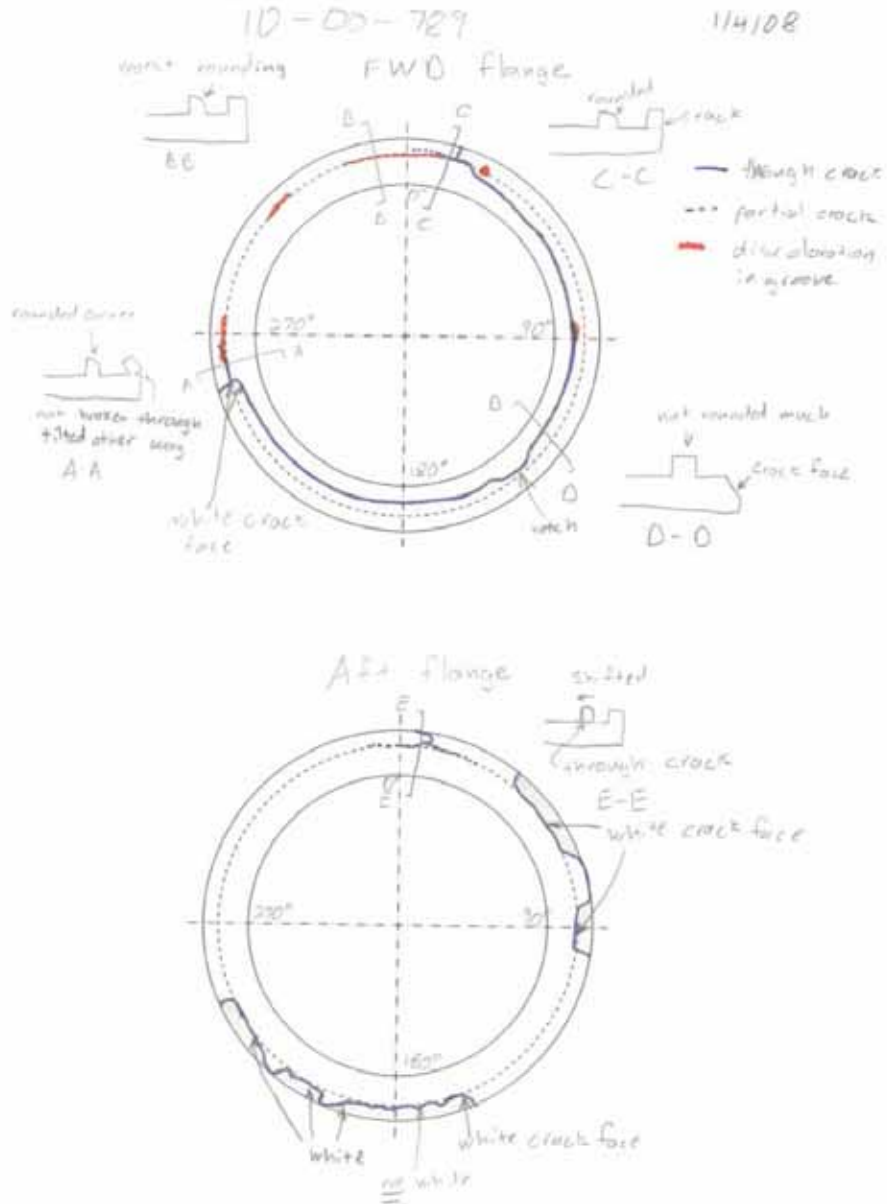
Figure 10 - S/N 10-00-789 Damage Diagram

Figure 10 is a diagram of the damage to the S/N 10-00-789 fitting. Cross sections of the fitting were drawn at various locations around the circumference to highlight features of interest.

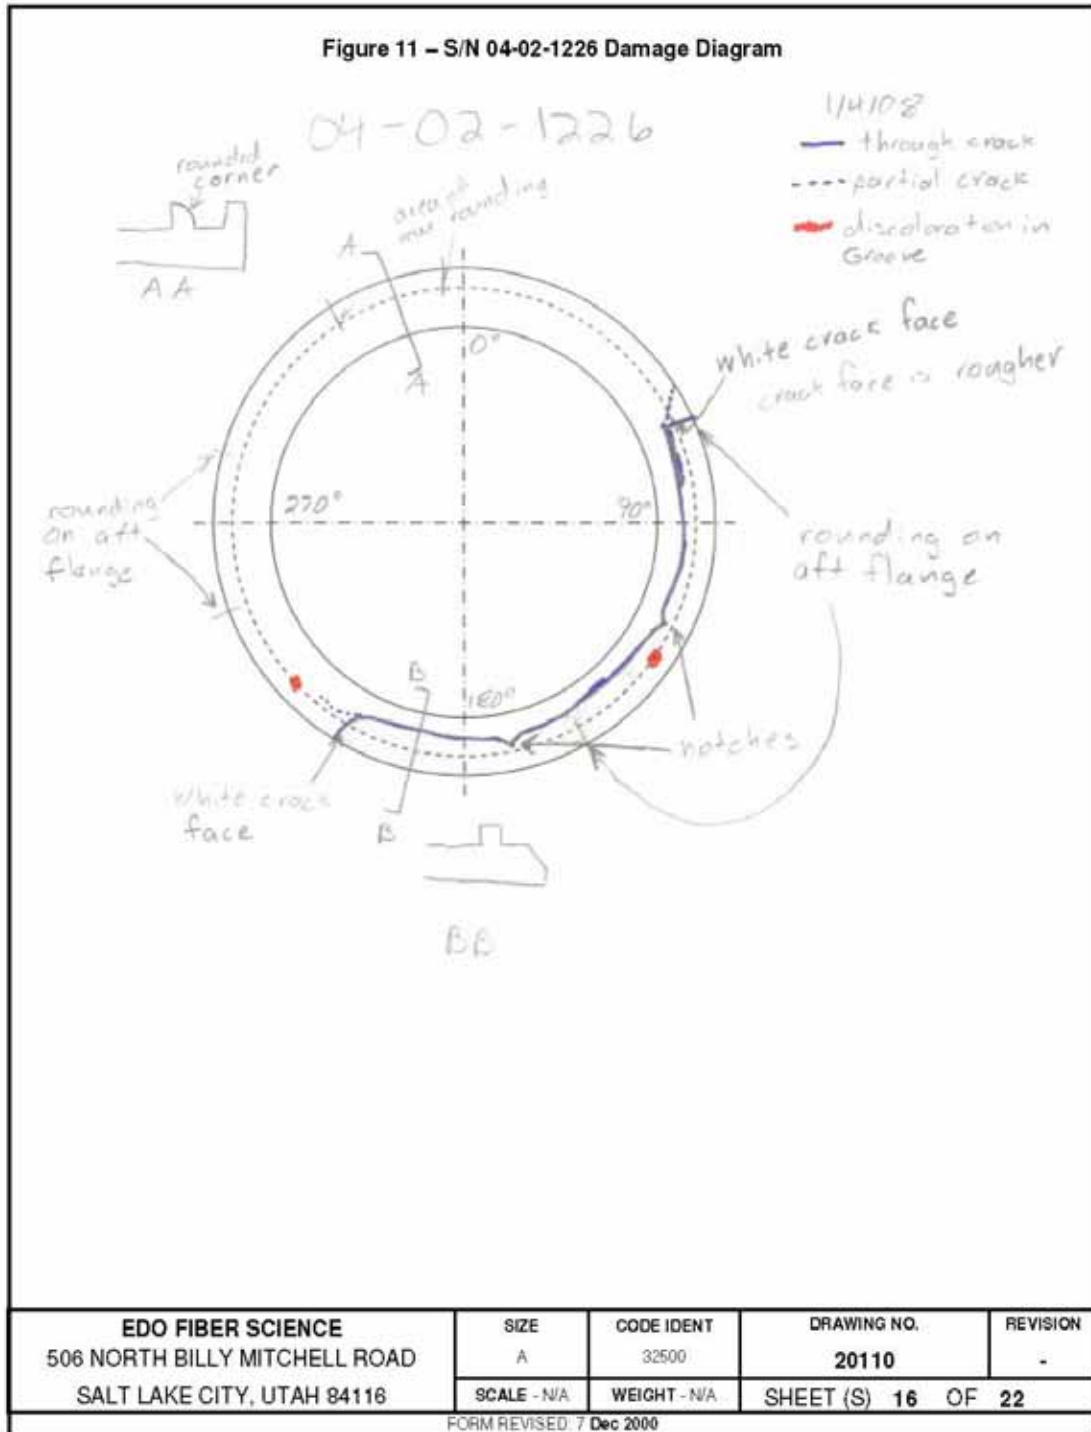
Figure 11 - S/N 04-02-1226 Damage Diagram

Figure 11 is a diagram of the damage to the S/N 04-02-1226 fitting. Cross sections of the fitting were drawn at various locations around the circumference to highlight features of interest.

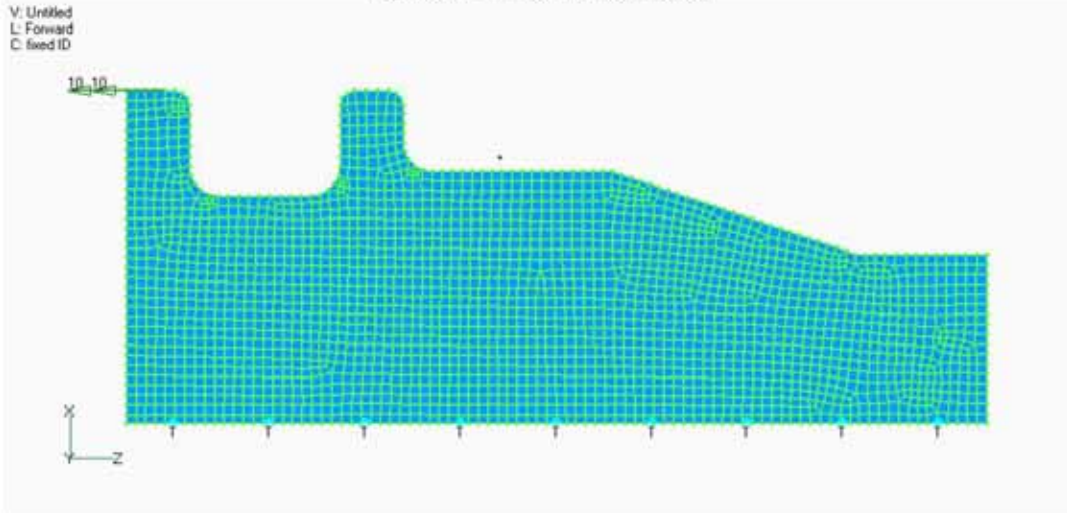
Figure 12 – Finite Element Model

The objective of the finite element analysis was to analyze the distribution and gradients of stresses in the cross section of the drain fitting. The drain fitting cross section was meshed with plane strain plate elements, as shown in Figure 12. The trends obtained from the finite element analysis helped to understand how the cross section of the drain flange behaved due to its geometry. The actual magnitude of stresses will scale linearly with the assumed thickness of the plane strain elements, with the material properties, and with the magnitude of the load

The plane strain elements were constrained on the inside diameter to simulate the inherent stability of a circular fitting, as represented by the blue triangles on the cross section in figure 12. Three load cases of forward, aft, and down, were analyzed, both individually and in combination. The load cases are illustrated by the green arrows in figures 13 through 20. These three load cases were judged to be the most likely methods by which the forward flange could be loaded.

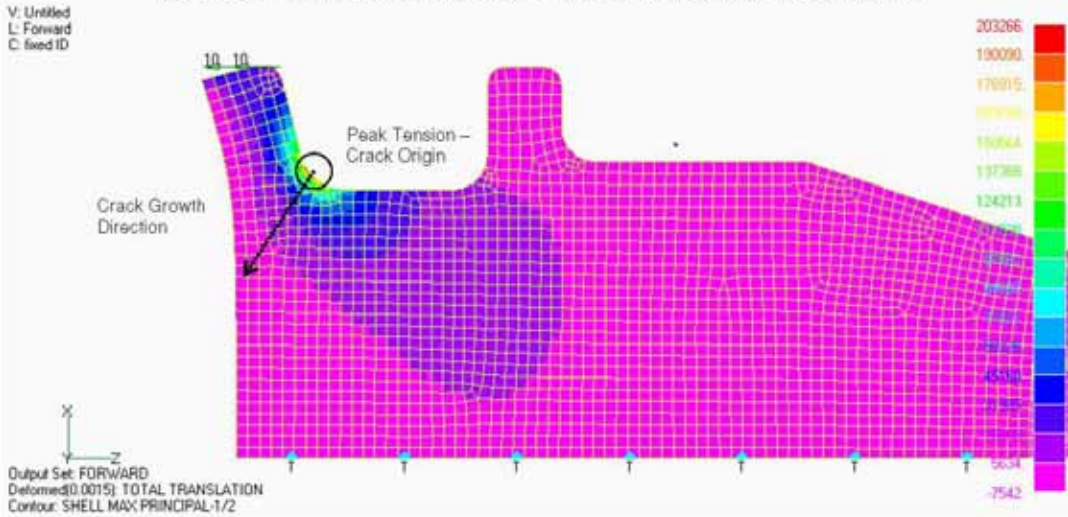
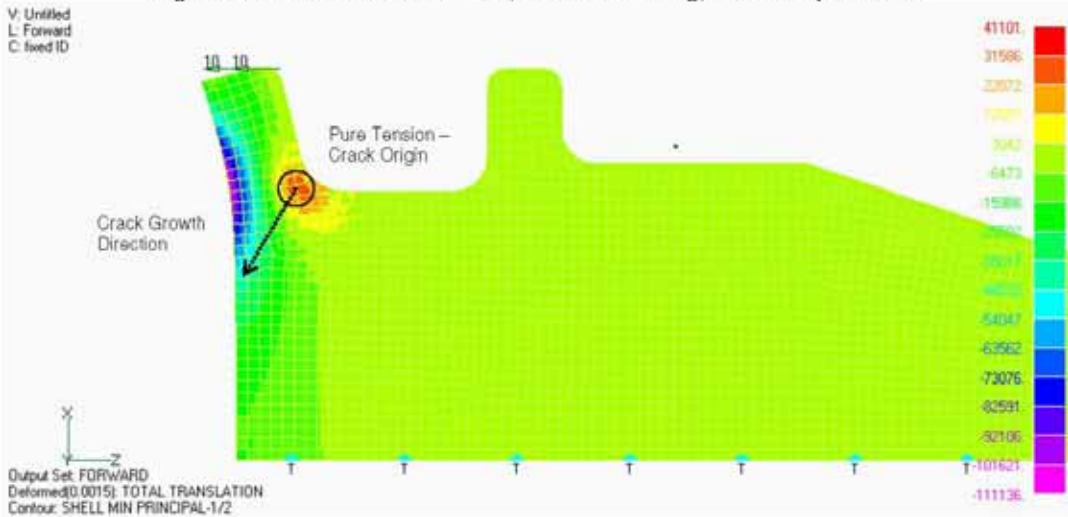
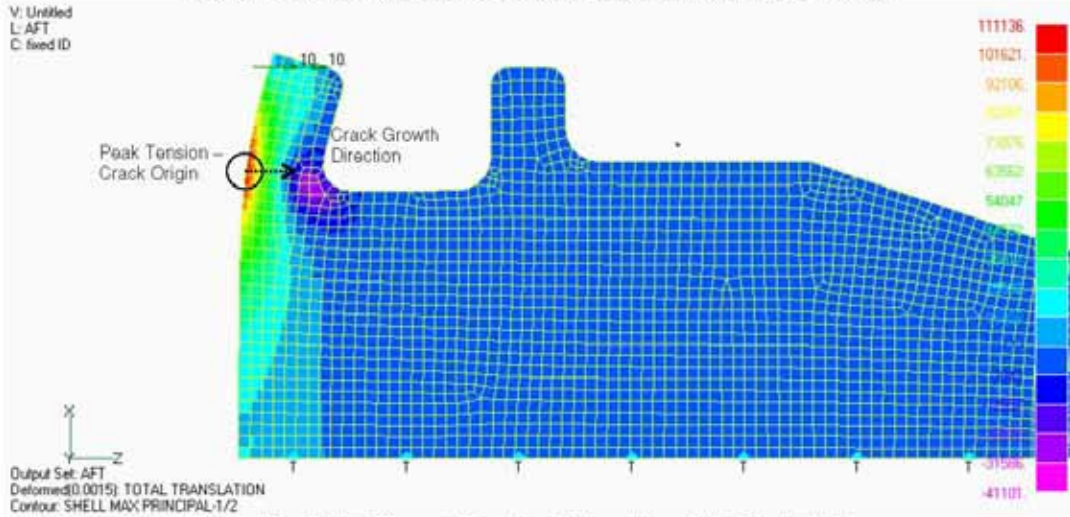
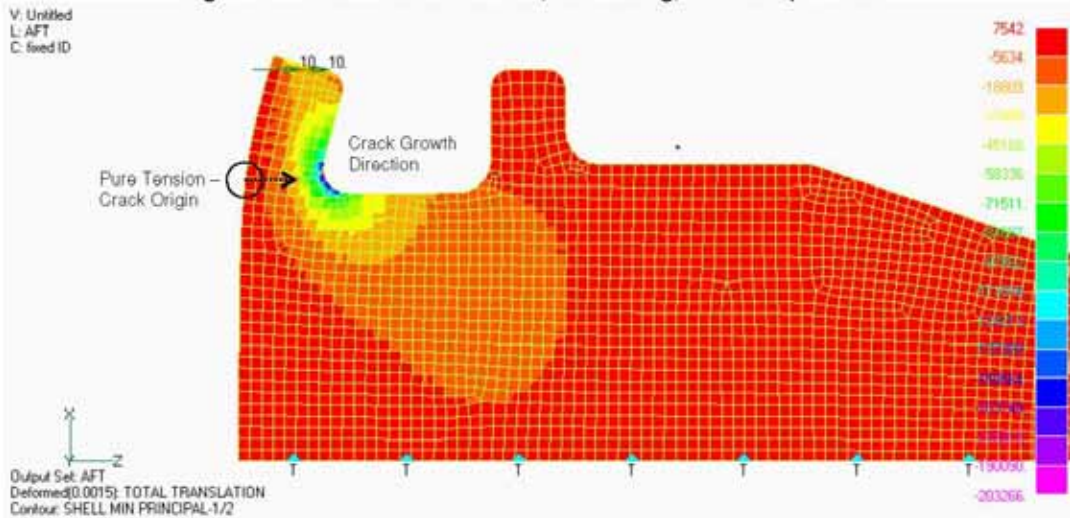
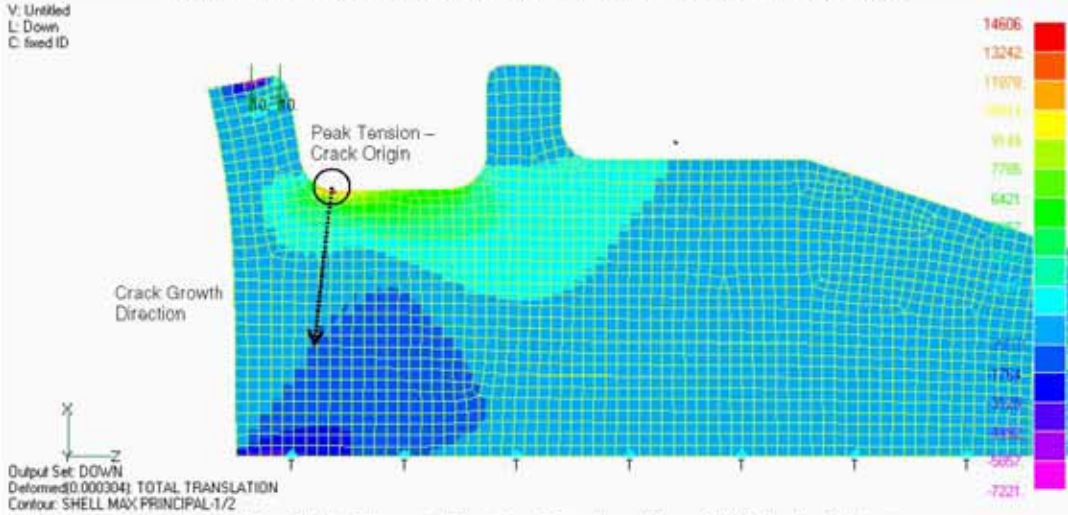
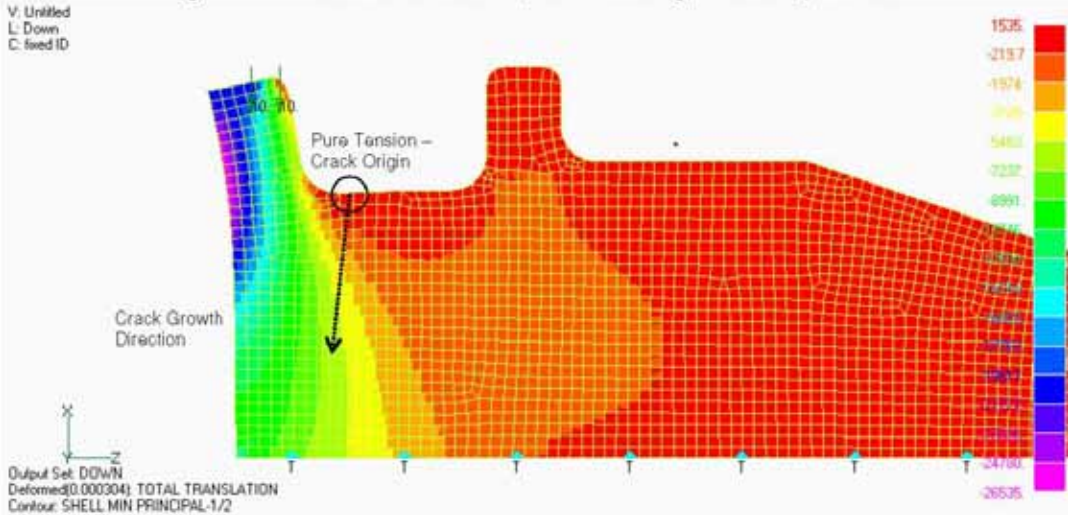
Figures 13 though 20 show the maximum and minimum principal stresses from all the load cases analyzed. The most likely crack origin under any loading is at a position of pure tensile stress, as any compressive stress will tend to close a crack rather than open it. Furthermore, cracks are also more likely to occur in locations of rapidly changing stresses and geometry, such as at a corner or radius. Once a crack has started, they grow away from their origin along a line of approximately equal stress; if stress is higher on one side of the progressing crack than the other it will bend away from the high stress in order to equalize stress. On figures 13 through 20 the position of the maximum tensile stress is circled and labeled as the crack origin. The dotted arrow in each figure illustrates the most likely direction for the crack to grow from its origin.

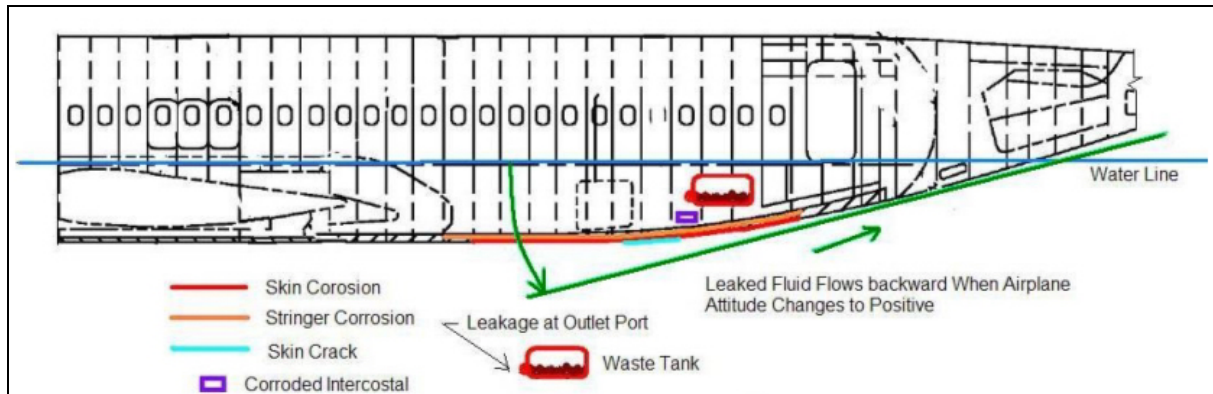
Figure 2.2-A The Leaked Fluid Moved to Aft Due to Airplane Pitch Change

6. During flight while the attitude of airplane changed with increasing pitch angle, the leaked fluid then flowed along the S-27L toward higher water line portion of the belly area (at this time at relative lower level), causing the inner side corrosion of S-27L of fuselage section 47 and skin corrosion outboard of S-27L in fuselage section 47. See figure 2.2-A.

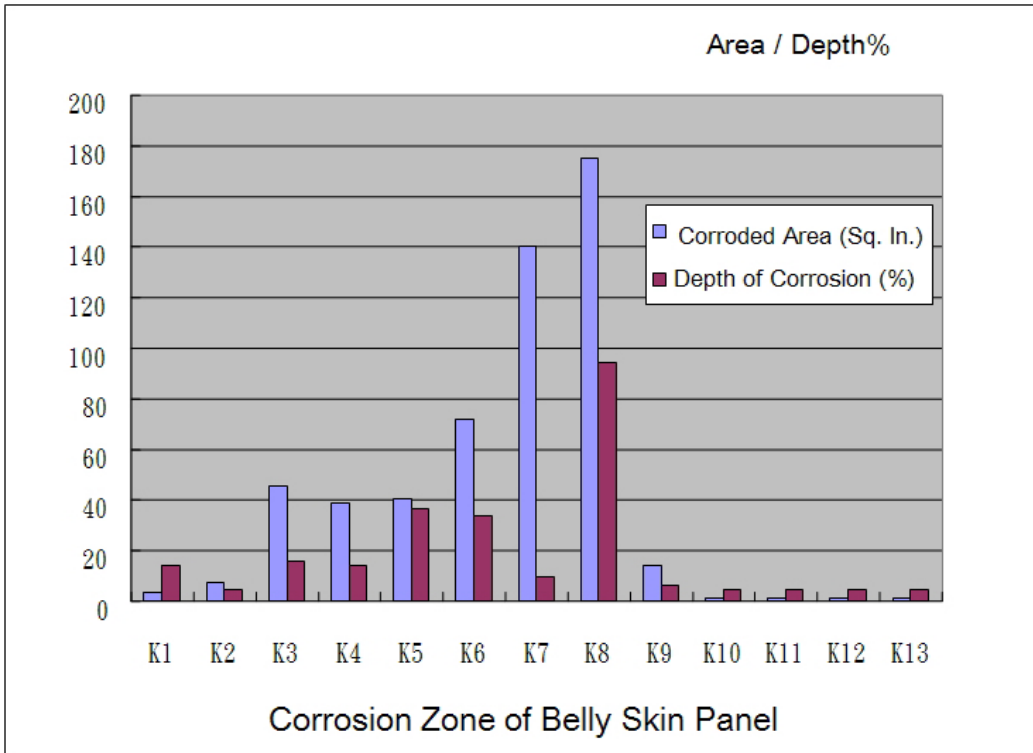
Figure 2.2-B Corrosion Servity and Distribution of the Skin

7. The severity of corrosion can be compared from Chart 1.12-1 that those corrosion sites (K3 ~ K8) distributed in five frame spaces in front of K8 (BS847 ~ BS872) are relatively heavy in size and depth. This indicates at most of the time the leaked fluid stayed here, see figure 2.2-B<sup>10</sup>. The depth information of corrosion was provided by China Airline measured from corrosion blend out during temporary repair, as the crack skin with K8 area was not reworked by corrosion blend out, the residual skin thickness was alternately checked by the microscope observation to be 0.0037 inch thick as indicated in paragraph 1.16.2, compared to the original skin thickness 0.063 in, the corrosion had consumed 94% of the skin in the thickness.

made the leaked fluid moving rearward to areas was higher on ground but now relative lower during flight, resulted in minor corrosion sites such as K9, K10, K11, K12, and K13 respectively. In certain occasions with pitch down attitude of the airplane during flight, the fluid was moved further forward to cause the K1 and K2 area corrosion that relatively not as severe as those in the major corrosion sites.

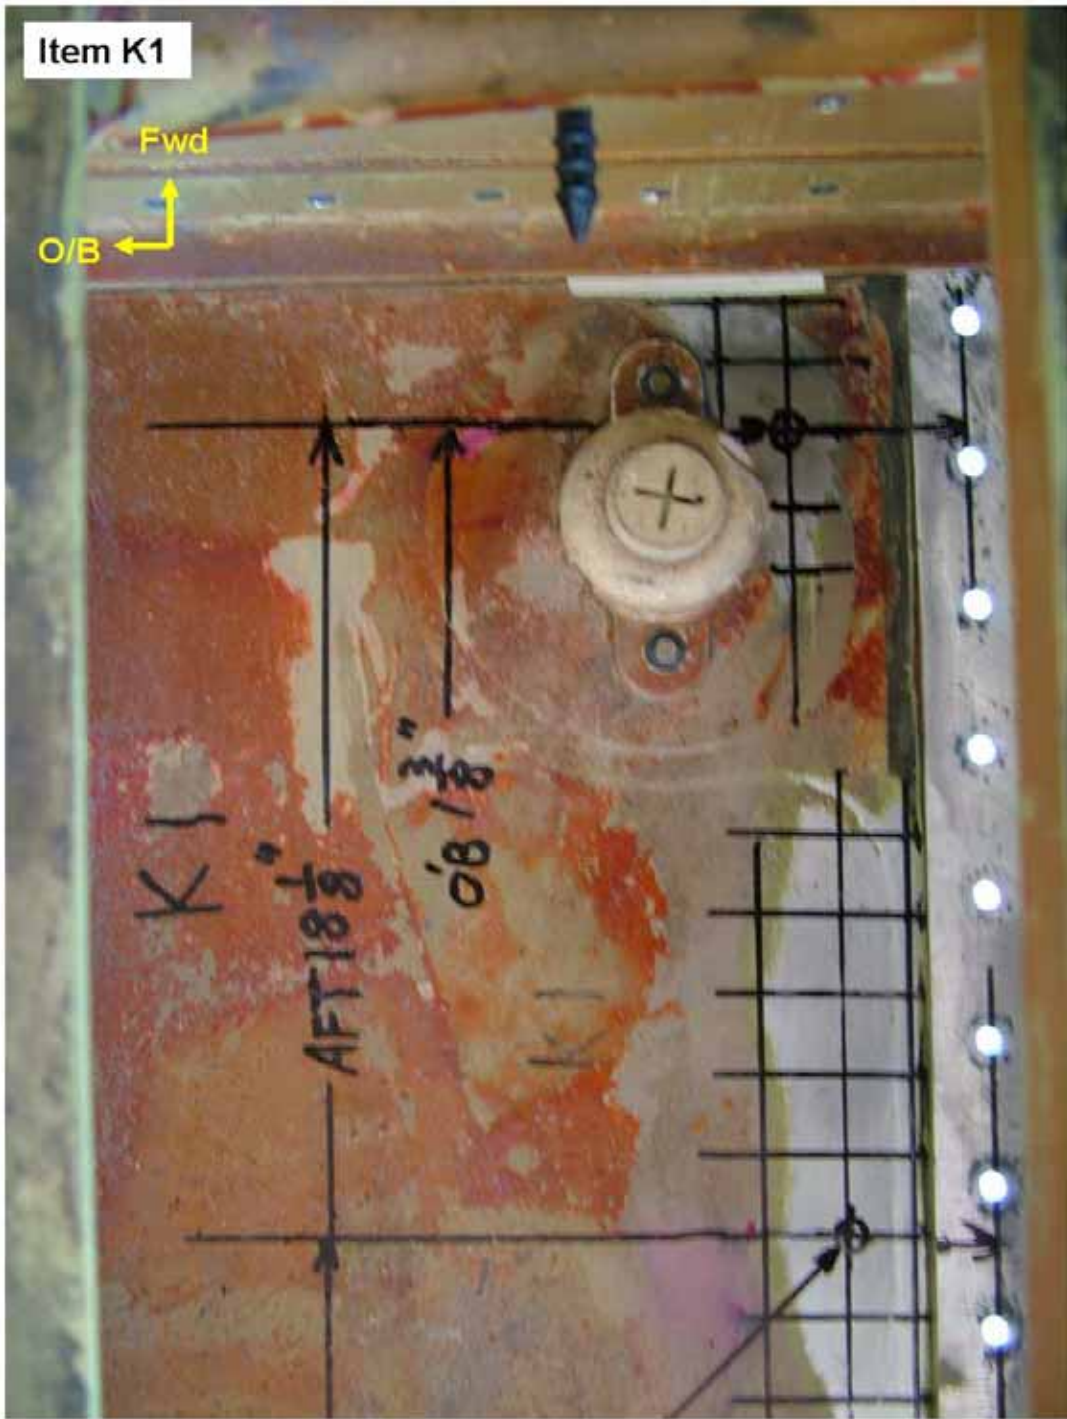
Item K1

ITEM NO.	LOCATION		DIMENSION (INCHES)		MIN. REMAINING THICKNESS (INCHES)
	STA	STRINGER	FWD-AFT DIRECTION	I/B-O/B DIRECTION	
<b>K1</b>	727J - 747	1.5 INCHES O/B OF S-27L	2	1	<b>0.086</b>
<b>K2</b>	727J - 747	1.5 INCHES O/B OF S-27L	9	1	<b>0.060</b>
<b>K3</b>	747 - 767	2 INCHES O/B OF S-27L	20	6	Fwd: <b>0.053</b> Aft: <b>0.055</b>
<b>K4</b>	767 - 787	1 INCHES O/B OF S-27L	20	6	Fwd: <b>0.054</b> Aft: <b>0.055</b>
<b>K5</b>	787 - 807	1 INCHES O/B OF S-27L	20	6	Fwd: <b>0.057</b> Aft: <b>0.040</b>
<b>K6</b>	807 - 827	2 INCHES O/B OF S-27L	20	5	Fwd: <b>0.051</b> Aft: <b>0.042</b>
<b>K7</b>	827 - 847	1.5 INCHES O/B OF S-27L	6	2	<b>0.057</b>
<b>K8</b>	867 - 887	1.5 INCHES O/B OF S-27L	6	2	<b>0.060</b>
<b>K9</b>	907 - 927	1.5 INCHES O/B OF S-27L	2	2	<b>0.057</b>
<b>K10</b>	AT AFT OF 887 FRAME		TBD (尚未開工無法打磨確認)
