# Aviation Occurrence Report

ASC-AOR-10-08-002

Emergency descent due to temporary  
Interruption in the bleed air system  
Supply During Initial Descent

Cathay Pacific Airways Flight CX521  
AIRBUS A330-300, B-HLH  
September 14, 2008

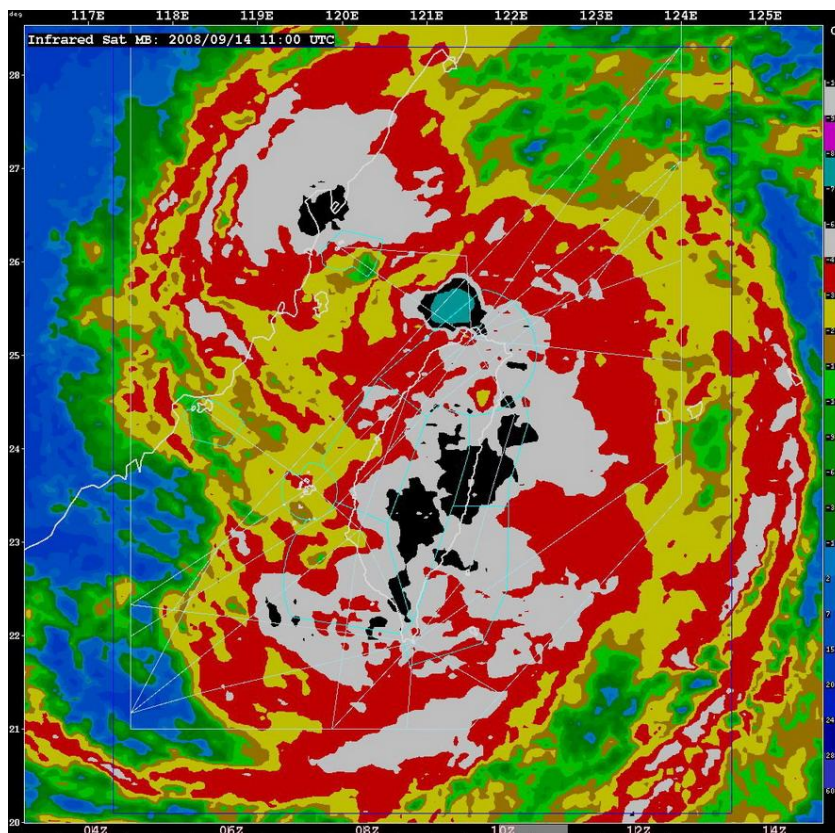
Figure 1.7-1 The infrared satellite image at 1900

According to the Typhoon Warnings issued by Taipei Aeronautical Meteorological Center, Typhoon “Sinlaku” became weaker and was centered at approximately 13 NM north of Taipei International Airport at 1700-2000. The forecast track was moving from NNE turning to NE and radius of the storm was 60 NM. Figure 1.7-1 is the infrared satellite image at 1900.

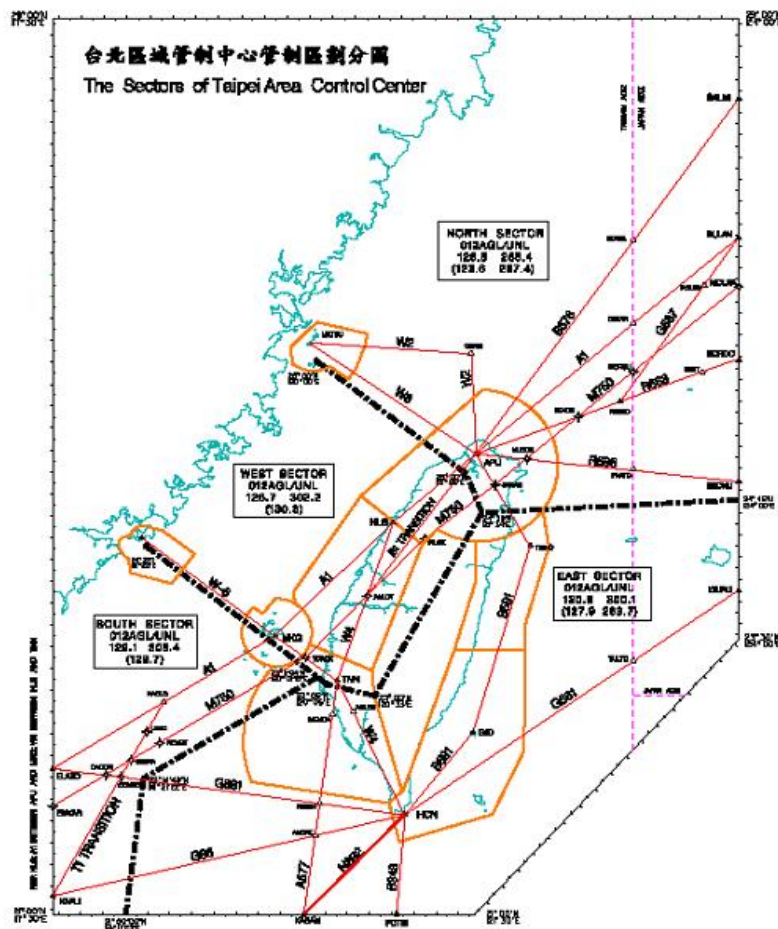
Figure 1.18-1 The sectorization of Taipei Area Control Center and Taipei Approach

Figure 1.18-1 is the sectorization of TACC and Taipei Approach.

From the radar display records of TACC and Taipei Approach, TACC proceeded to handoff CX521 by radar automation systems at 1907:05. TACC and Taipei Approach completed radar handoff at 1907:26 and the distance from ANBU VOR to CX521 was around 71 NM at an altitude of 10,000 feet. TACC instructed CX521 to contact Taipei Approach at 1907:38.

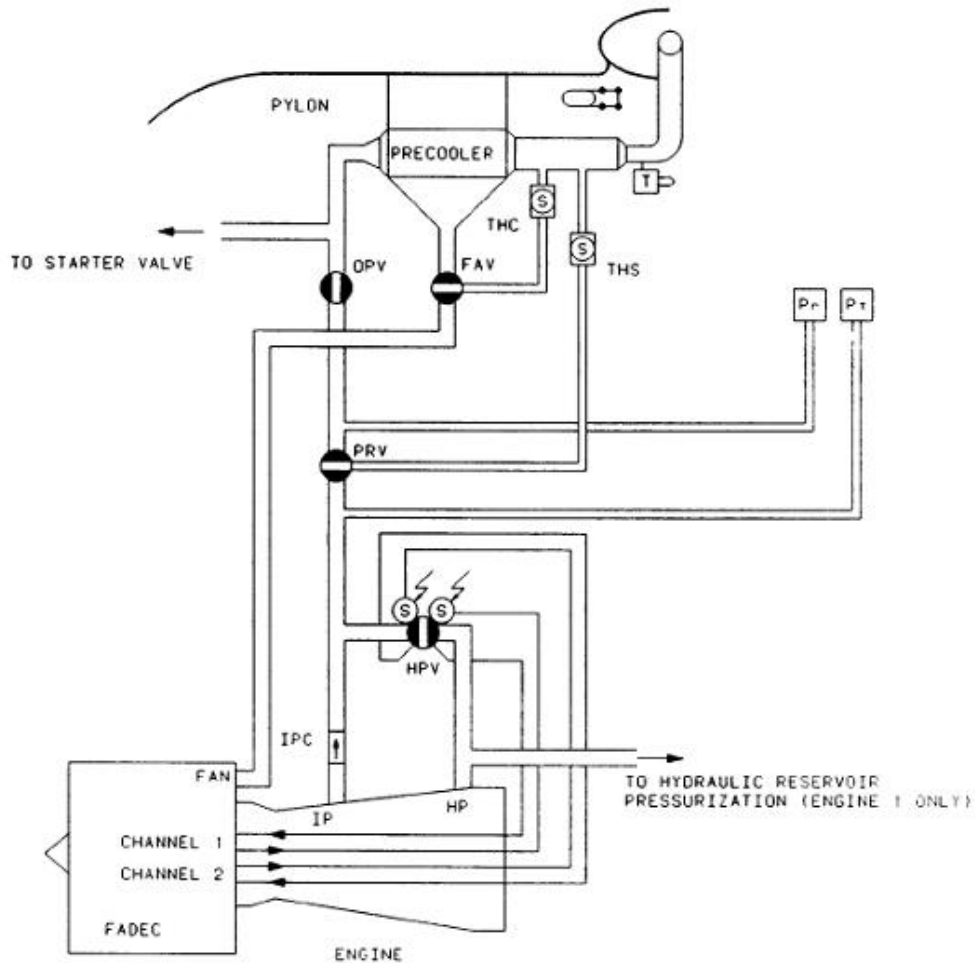
Figure 1.18-2 A330 FCOM pneumatic system description 1.36.10

Refer to Maintenance Manual, 36-00-00 PNEUMATIC – GENERAL –DESCRIPTION AND OPERATION, A. *Pneumatic Air Sources, The aircraft engines; the APU or a ground air source can supply compressed air to the pneumatic system. The distribution system supplies the compressed air from the different sources to the user systems.* (Schematic referred to Figure 1.18-2)

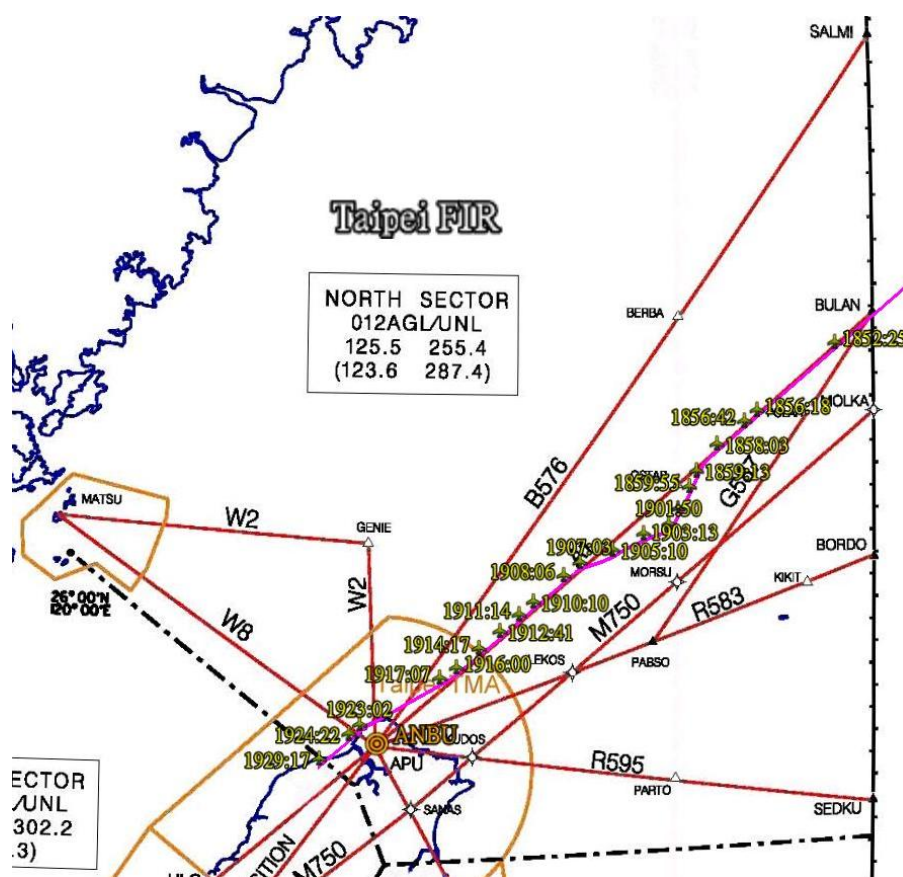
Figure 2.8-1 Diagram of the track of CX521 and the area of TACC North Sector and Taipei Approach

The following table 2.8-1 and figure 2.8-1 are the sequence of event based on the CVR, FDR, radar, ATC radio and hot line recording records.
