**SMOKE CAME OUT OF THE DADO PANEL IN
REAR CABIN DURING PASSENGERS
DISEMBARKING**

**EVA AIRWAYS FLIGHT BR67
BOEING 747-400, B-16410
BANGKOK SUVARNABHUMI INTERNATIONAL
AIRPORT FEBRUARY 23, 2008**

Final Report

Report Number: ASC-AFR-09-05-002

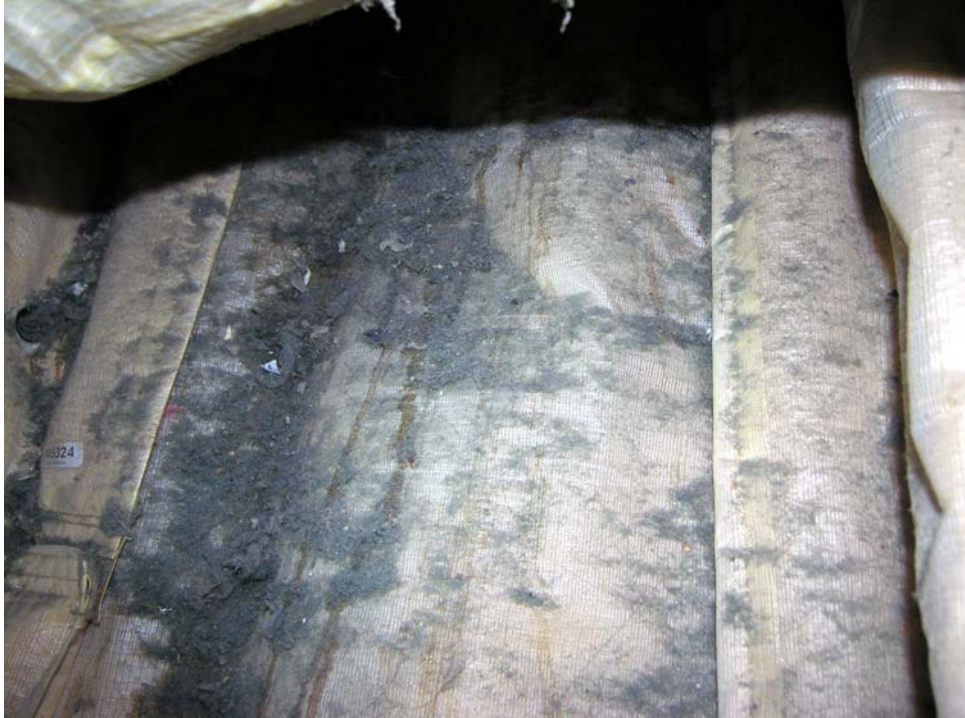
Fig. 1.12-13 Dust and Traces of Contamination on Insulation Blanket

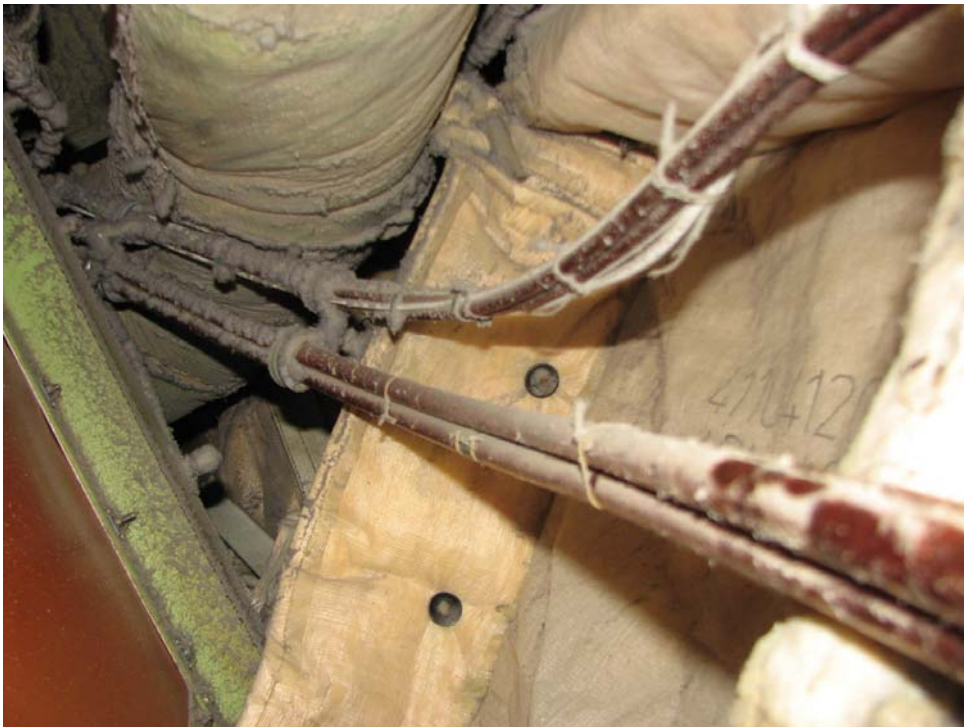
Fig. 1.12-14 Dust on Other System Components

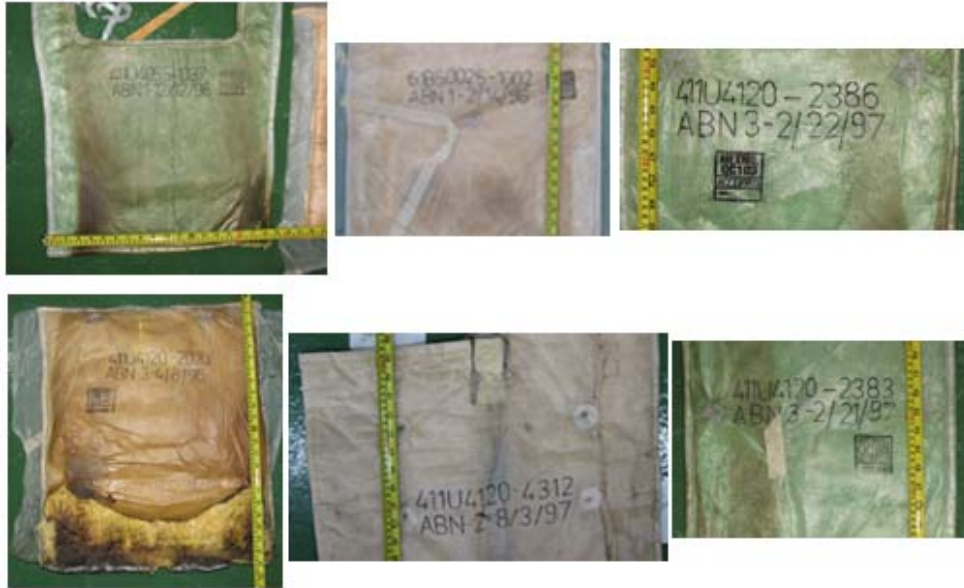
The distinguishable information such as parts number and date of referred blue print of the replaced insulation blankets (refer to Fig. 1.14-5) due to fire damage were listed as follows.

Fig. 1.14-5 Distinguishable Samples of Damaged Insulation Blankets

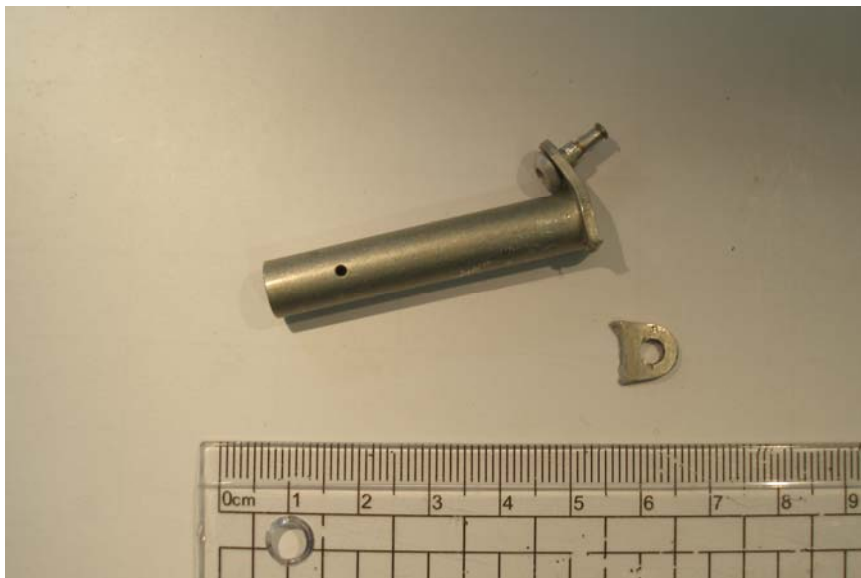
Refer to figure 1.16-1, it shows the APU power cable standoff. Following examinations and tests were macro observation and photographic documentation, chemical analysis, microstructure inspection, micro-hardness tests, and Scanning Electron Microscope (SEM) examination on fracture surface to determine the root cause of failure. The following sections summarized the results of the examinations and tests.

Fig. 1.16-1 the APU power cable standoff
