Aviation Safety Council

Aircraft Incident Report

Number: ASC/AIR-2000/01

Occurrence: Runway excursion after landing

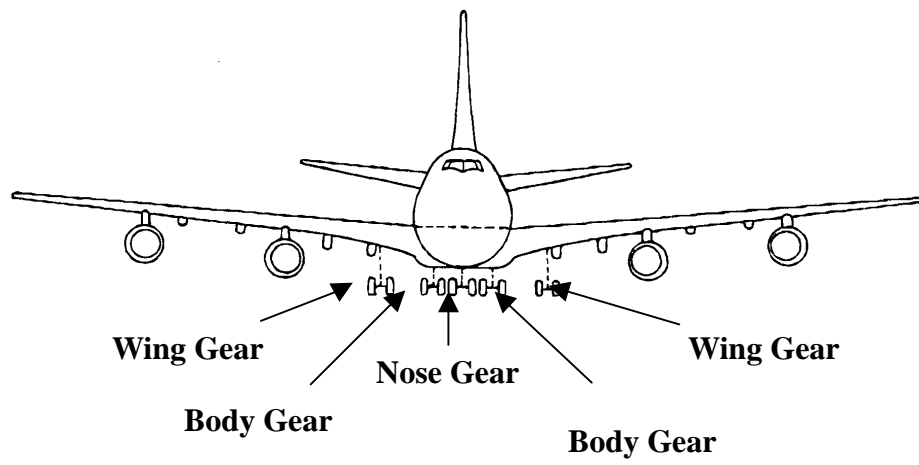
Fig. 1-5 Aircraft Outlook and Gear Locations

A 26ft x 10ft lower fuselage skin immediately adjacent to the left body gear, including the hydraulic lines, were damaged (Fig. 1-1). Some parts of the nose gear assembly and both nose tires were damaged (Fig. 1-2). The axles of the front and rear trucks of the left body gear were snapped (Fig. 1-3 & 1-4). Scrubbed marks were found at the bottom of #1 engine cowling. Please refer to Fig. 1-5 & 1-6 for the outlook of the aircraft and gear locations.

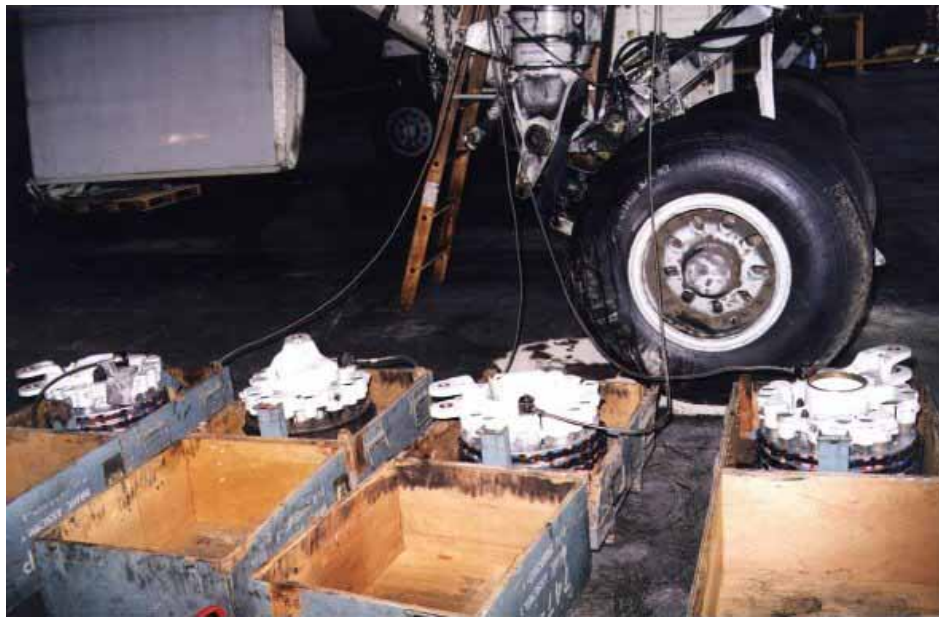
Fig. 1-27 Soft High Pressure Tubes Connected to Useable Parts

The test was conducted in accordance with Boeing Maintenance Manual AMM 32-41-00 (p.501). The damaged hydraulic lines to #5, 6 and 7 wheels were temporarily connected via soft high pressure hoses to the brakes' serviceable parts, while those to #8 wheel were externally connected to a pressure gauge (Fig. 1-27). The aircraft's electrical power system was then turned on to pressurize, and the gauge indicated 3000PSI when braking paddles were applied (Fig. 1-28). All wheel braking functioned normally. The brakes for #6, 7 and 8 wheels also functioned normally when tested with manual hydraulic pumps. The brakes for #5 wheel were not tested due to damage upon impact.

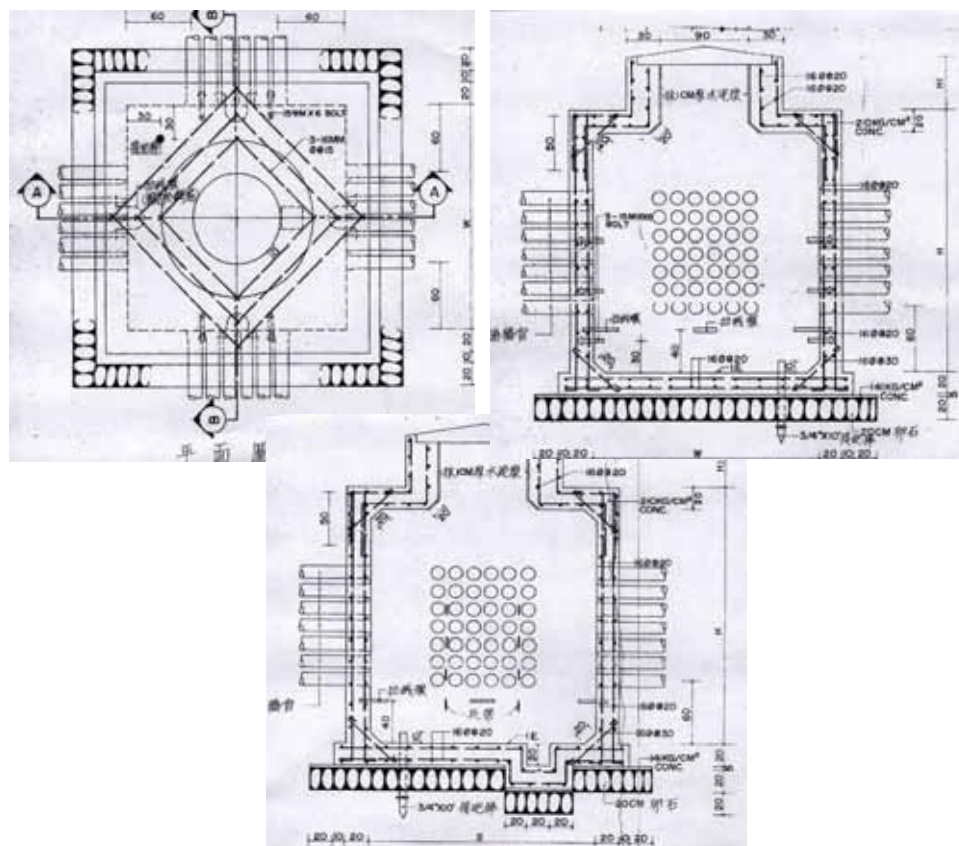
Fig. 1-31 Manhole Design

Parallel to the runway, the manhole's base is a 2.4 x 2.4 square structure without bevel. The hole is covered, 1.5 meters in diameter, and 35 centimeters in height, while the base is approximately 29 centimeters above the ground. Thus, the height of the manhole is 69 centimeters in total (Fig. 1-31).

“Within the non-instrument and instrument landing runway strips, structures should be buried at least 30 centimeters under the ground surface as much as possible to ensure uniform strength along the entire runway strip. If it becomes necessary to locate a structure such as manhole above ground surface, the structure can be constructed in accordance with Fig. 2-13. The structure surrounding should be protected by concrete, with a 30 centimeter tapering leading to top of the structure.”

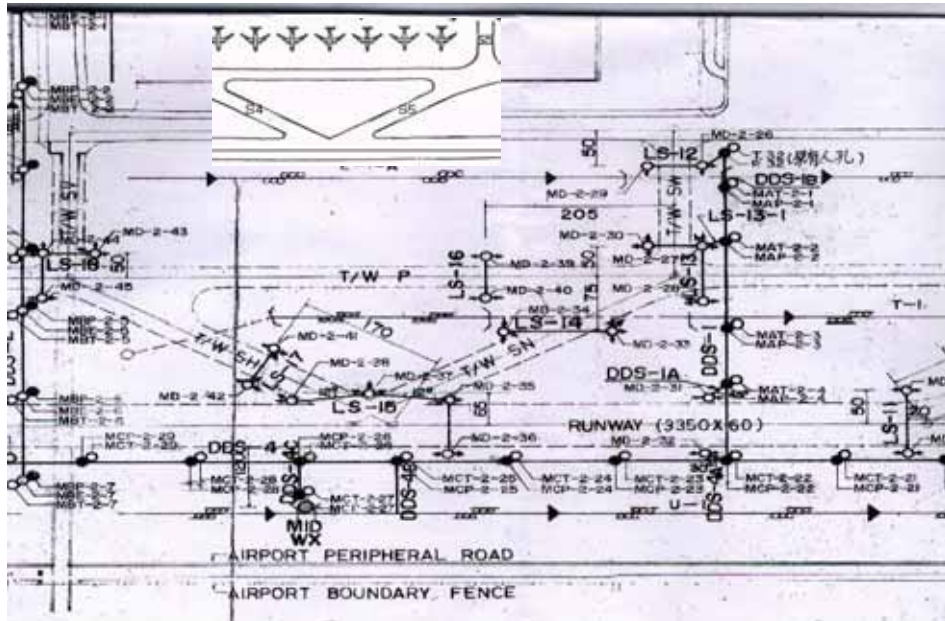
Fig. 1-32 Manhole Locations

As part of the navigation lighting system, the protruding concrete manhole (Fig. 1-30) struck by DT2's nose gear is located 11 meters to the side of the runway between Runway 06 and Taxiway S5.

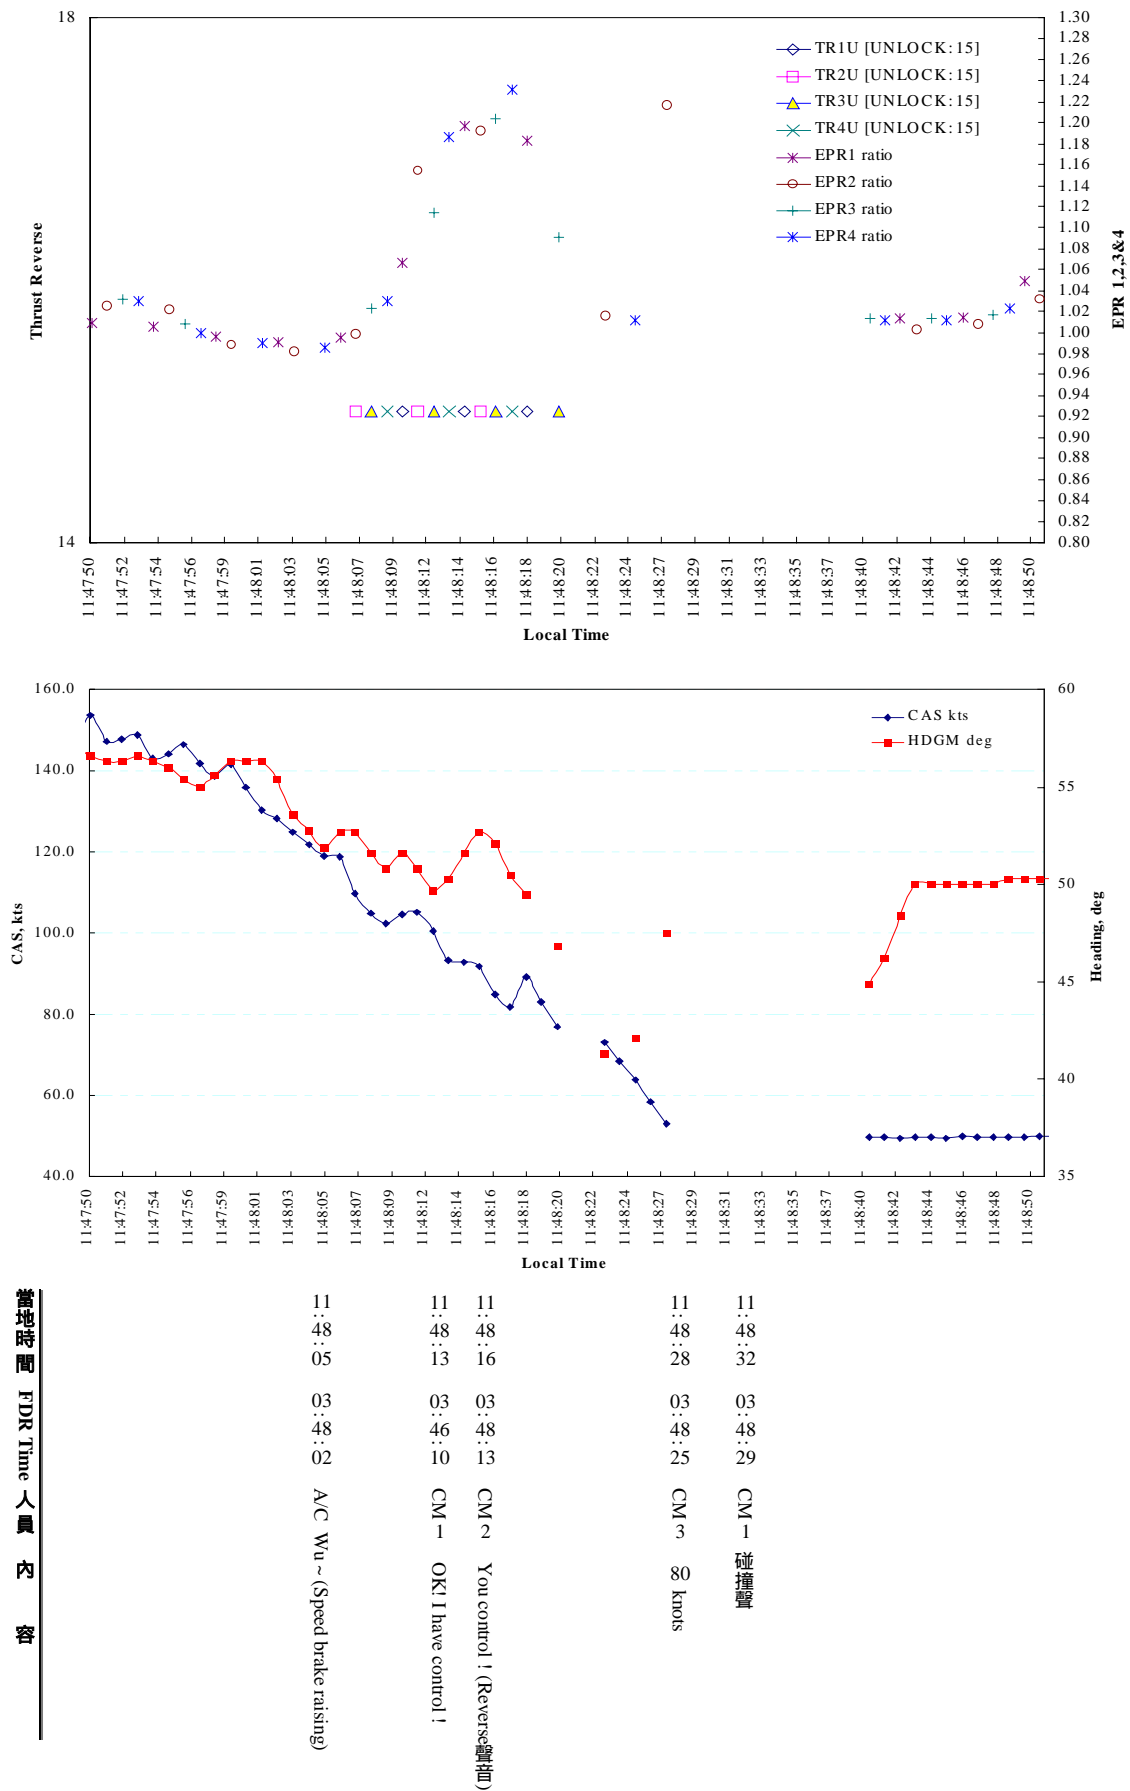
Fig. 2-1 CVR and FDR records.

The flight data recorder indicated that the path of the DT2 during its landing roll was approximately 052 degrees, but shifted to 047 degrees 16 seconds after touchdown (for a duration of approximately four seconds). Two seconds thereafter, the path shifted rapidly to 041 degrees, and information on the flight data recorder disappeared in these two seconds. The shift in direction during this period, verified by the uneven dark nosewheel tracks and the bodywheel tracks indicated that the pilot-in-command had started using the tiller to steer the aircraft toward Taxiway S5. Before the drastic change in the aircraft direction, the FDR recorded the air speed as 76.8 Kts, and the reverse

thrust was not stowed. The relevant records are shown in Fig. 2-1.

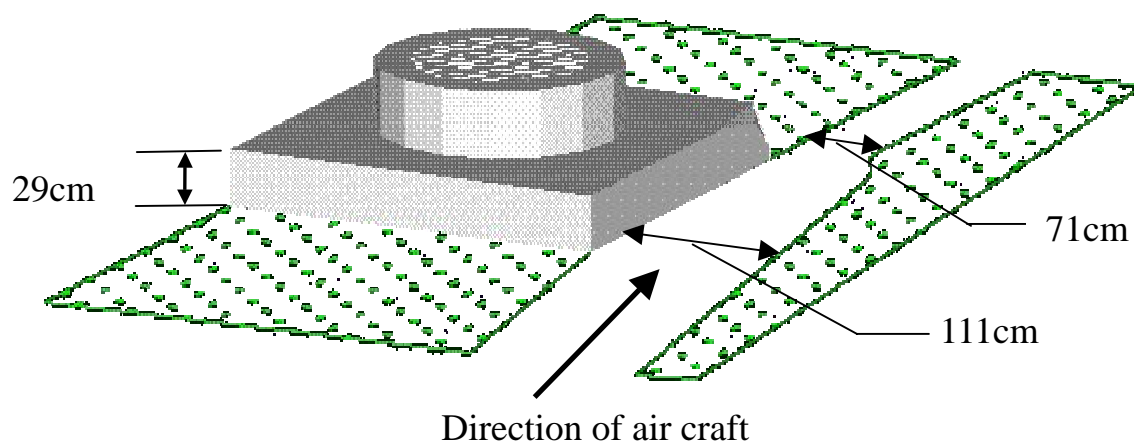
Fig. 2-2 Tracks on the grass area.

The data measured on site were as follows (Fig. 2-2):

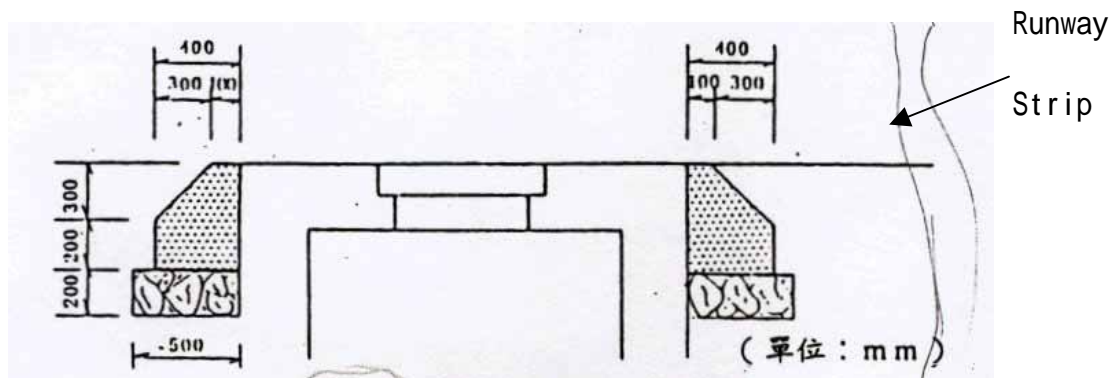
Fig. 2-13 Design of the manhole protective structure.

The essence of the guideline is that when a aircraft runs over a soft ground surface, the aircraft wheel will still be protected by the tapered surface when it sags to the safety limit of 30 centimeters; as such, the tire will not break off or rupture due to forceful collision.

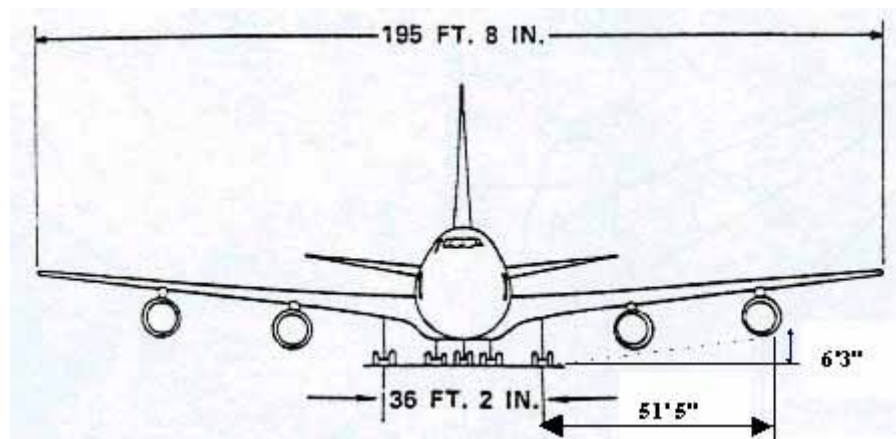
Fig. 2-15 Physical dimension of the Boeing 747SP.

The cowl of #1 engine of China Airlines B18253 came into contact with the grass surface after the aircraft ran off the runway. Thus from the physical appearance of the aircraft (Fig. 2-15) and assuming that the left wing gear ran into a grass area with the same slope, the angle of elevation of the runway's inner strip exceeded 6.9 degrees, that is, the grass areas ran over by the left and right wing gear had a difference in elevation of 134 centimeters. The traverse slope exceeded 12.1%, which does not comply with the above guideline.

Analyzing the breakage of the left body gear, and assuming that the left wing gear ran into a grass area with a different slope, the angle of elevation of the runway's inner strip exceeded 5.13 degrees based on calculation using the aircraft's centerline. The traverse slope exceeded 8.99%, which does not comply with the above guideline.

Therefore, due to safety concerns, the traverse slopes of the runway strips at the CKS airport should be appropriately modified.
