# 國家運輸安全調查委員會

## 事實資料報告

中華航空公司 CI202 班機

於松山機場落地時三套主飛控電腦失效

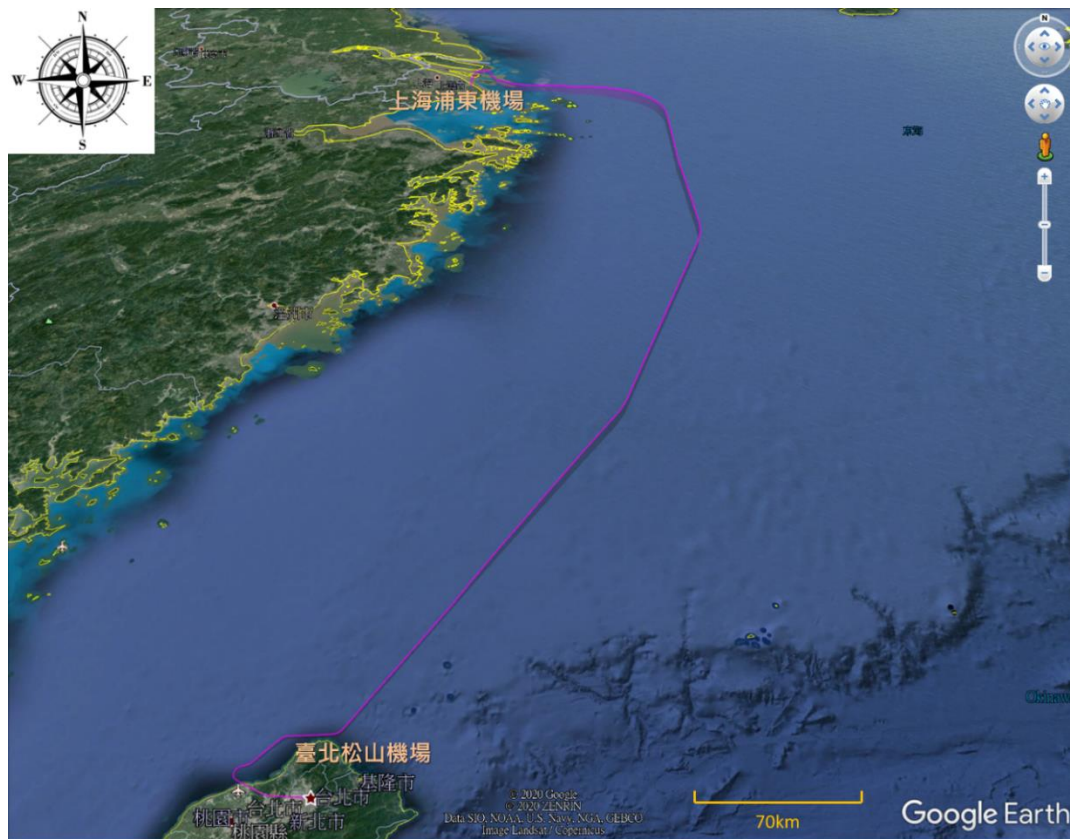
圖 1.1-1 事故機之飛航軌跡

(1747:04.6)，操控駕駛員叫出「*manual brake*」，並將煞車踏板踩到底（煞車液壓壓力值為 448 psi<sup>3</sup>，縱向加速率 longitudinal acceleration 數值約-0.1g）。1747:07 秒，監控駕駛員叫出「*reverse no green*」，約 1 秒後，PF 叫出「趕快幫我踩，幫我踩」（此時地速為 124 哩/時），從此兩人同時將人工方式煞車踩到底，但煞車液壓壓力約為 128psi~192psi，縱向加速率數值為-0.167g's。直至 1747:36 飛機完全煞停於跑道末端為止，在此期間煞車液壓壓力及縱向加速率數值有數次上下不規則波動，煞車液壓壓力值最小為 64 psi，最大為 2,560 psi，縱向加速率數值最小量為-0.05g's，最大量為-0.47g's。飛機自浦東機場至台北松山機場全程飛航軌跡如圖 1.1-1

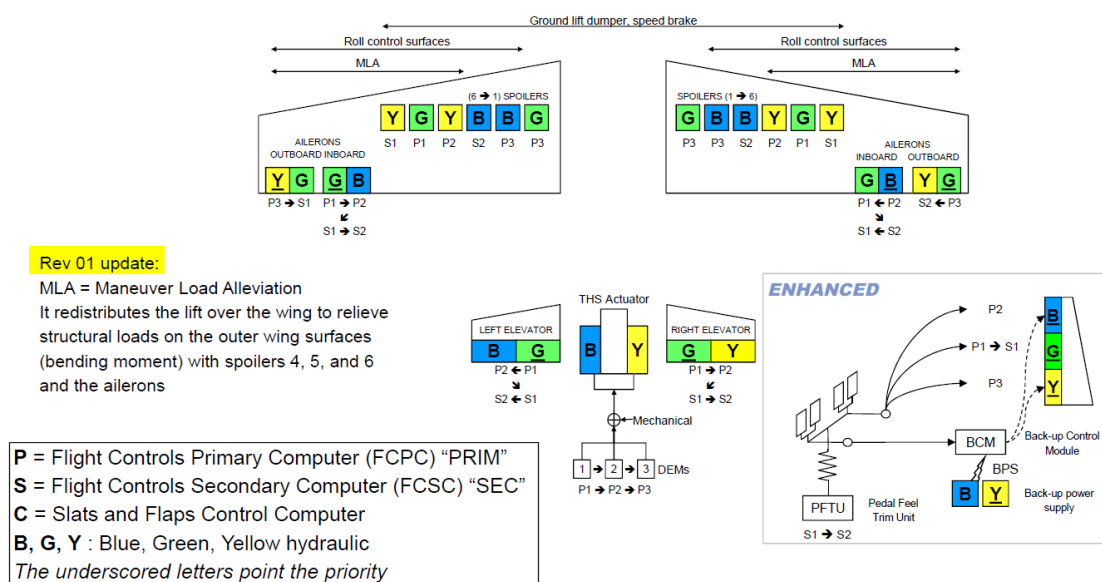
圖 1.6-9 FCPC 與飛行伺服控制系統示意圖

如圖 1.6-9 所示，每個 FCPC 最多可以控制八個伺服迴路，同時；每個 PRIM 在常態邏輯下都可以提供對飛機的完整控制。若主飛控電腦（PRIM 1）檢測發覺本身故障時，便將轉移控制權到下一套飛控電腦（PRIM 2）。若 PRIM 2 檢測發覺本身故障時，便將轉移控制權到第三套飛控電腦（PRIM 3）。

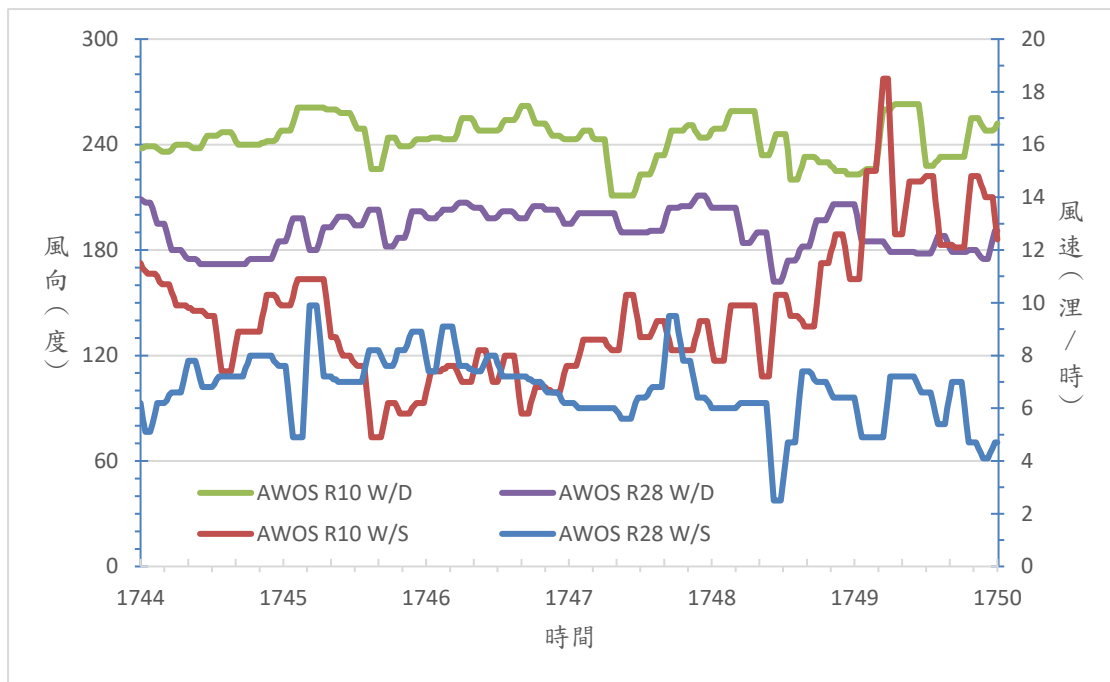
圖 1.7-4 AWOS 風向風速

松山機場地面自動氣象觀測系統 (automated weather observation system, AWOS) 與 LLWAS 風向風速計之設置地點如圖 1.7-3，1744 時至 1750 時 AWOS 之即時風向風速如圖 1.7-4 所示，A 自 1746:36 時 (該機無線電高度約 200 呎) 至 1747:36 時 (該機停止)，AWOS R10 風向為 210-260 度，風速 6-10 浬/時；AWOS R28 風向為 190-210 度，風速 6-7 浬/時。LLWAS 相關風向風速計之紀錄資料詳附錄 1。

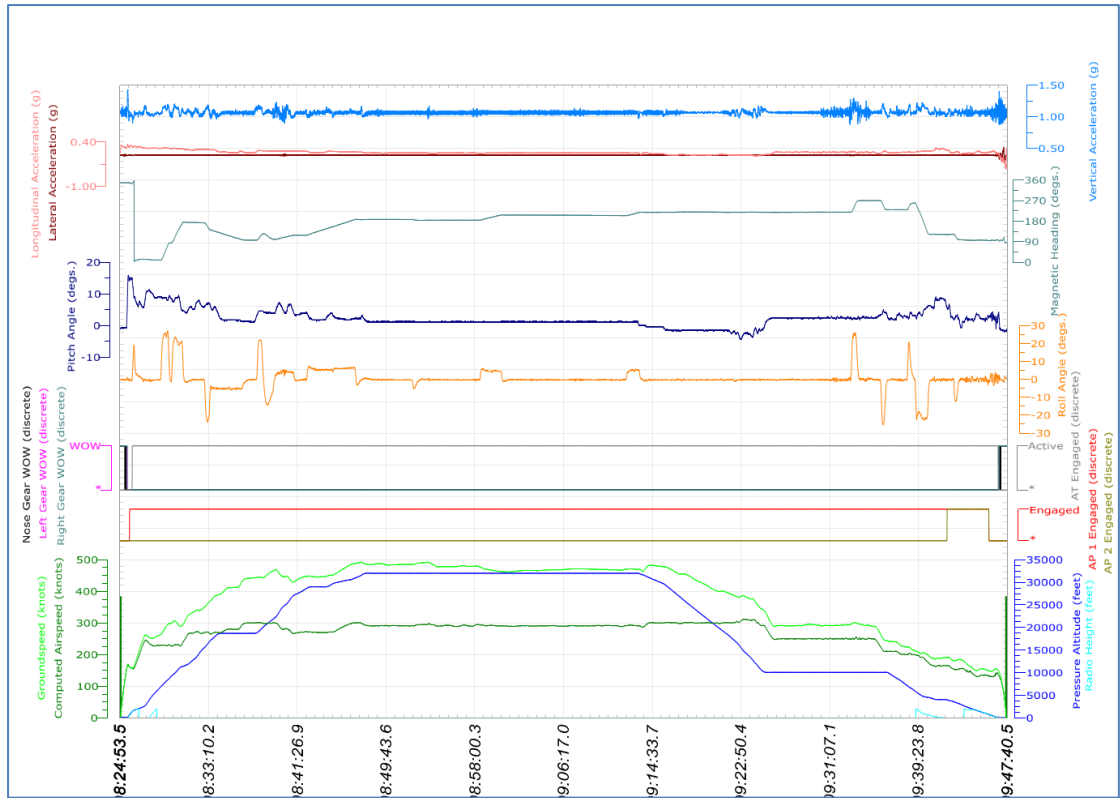
圖 1.11-1 事故航班基本參數圖 (完整航班)

有關該機與事故過程相關飛航參數如圖 1.11-1 至圖 1.11-4，顯示時間均為 UTC 時間；事故發生階段之軌跡與有關參數及 CVR 抄件套疊如圖 1.11-5。

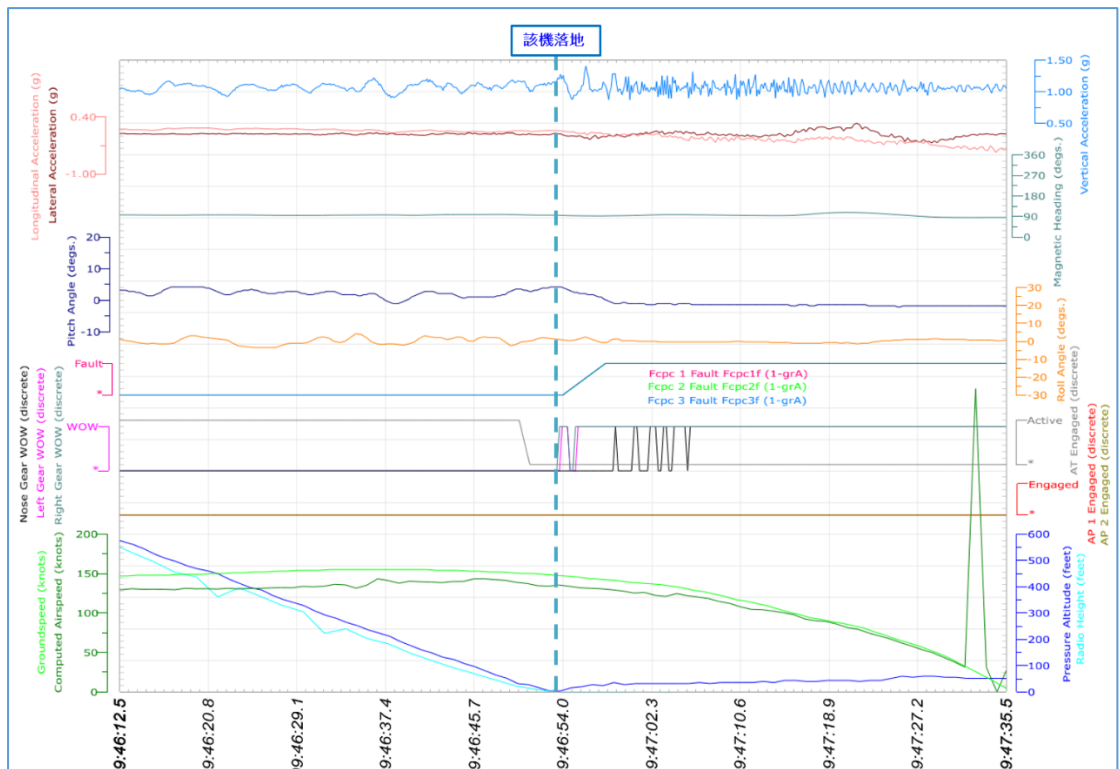
圖 1.11-2 落地階段基本參數圖 (RA 200 呎以下)

11. 臺北時間 1746:57 時，地速 144 浬/時，中度自動煞車備動解除，自動煞車故障狀態出現並持續至 1747:36 時止。
12. 臺北時間 1746:58 時，地速 142 浬/時，三套主飛控電腦故障狀態出現；第 1、2、4 號擾流板可用狀態解除，此後全部 12 項擾流板角度持續記錄在收起位置，或收起位置與 22 度之間，並以每 4 秒循環變化。

航機落地至停止過程中，部分地面擾流板觸地後展開又立刻收回，反推力裝置全程未作動。
