Elit'Avia Malta Limited Flight EAU52P

Bombardier BD-700-1A10

Abnormal Runway Contact during Landing

**Aviation Occurrence Investigation Factual
Report**

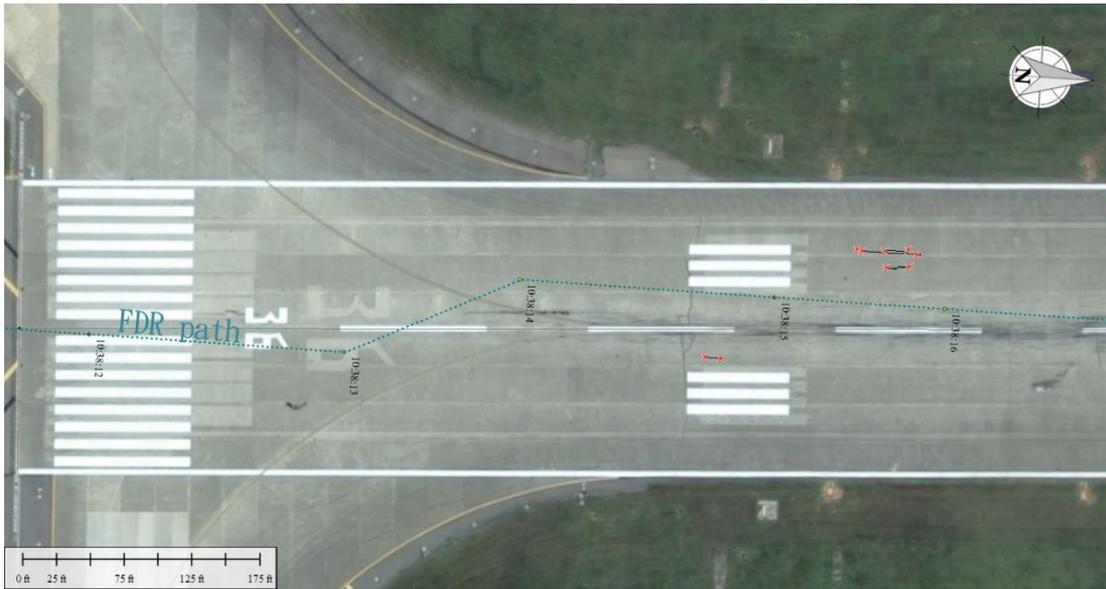
Figure 1.12-1 Superimposed site survey item and FDR flight path

The investigation team arrived at RCMQ Airport around 1515 hours on the occurrence day, and then searched for significant wing contact marks on the runway 36 surface around 1537 hours. The team utilized global positioning system (GPS) equipment and a camera to conduct a ground survey of the occurrence site. The team found the first (right) wing mark (R1) at about 503 feet from the runway threshold, then the three parallel (left) wing marks (L1 to L3) were found about 636 feet from the runway threshold.

No.	Survey item	Distance from runway 36 threshold (ft)	Length (ft)
1	First wing mark(R1)	503~515	12
2	Second wing mark(L1)	636~652	15
3	Third wing mark(L2)	618~658	42
4	Fourth wing mark(L3)	633~650	17
