Taiwan Transportation Safety Board

Major Transportation Occurrence Final Report

China Airlines Flight CI202

The aircraft experienced multiple system failures

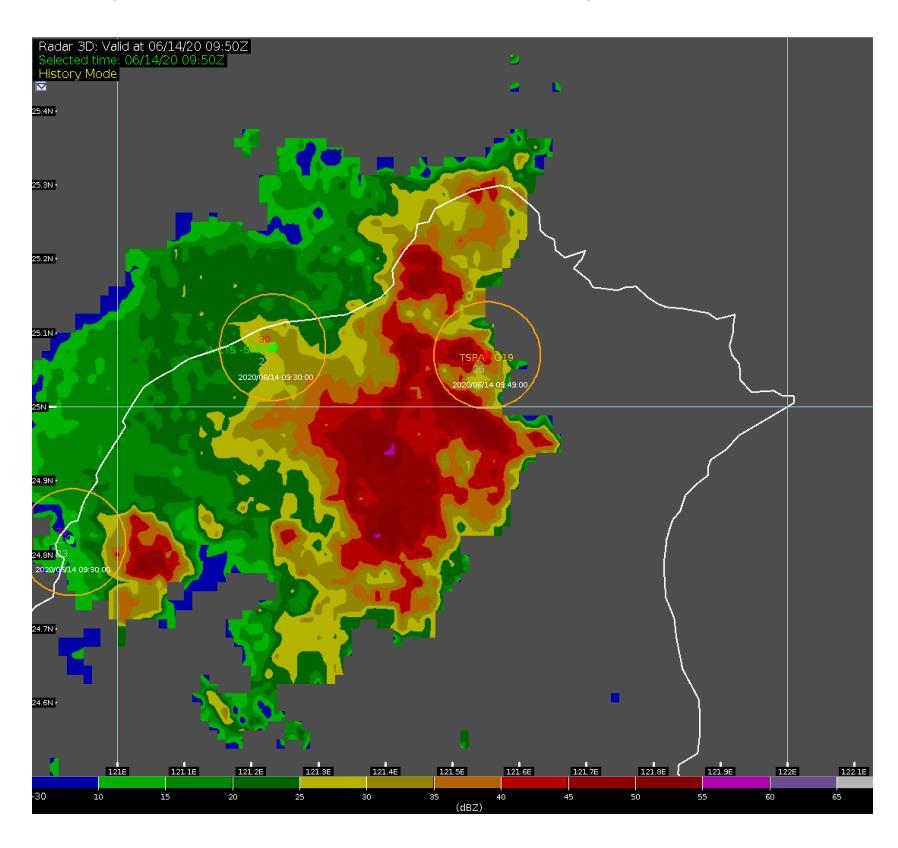
Figure 1.7-2 North Taiwan weather radar image at 1750 hours

The Asian surface analysis chart at 1400 hours on the day of the occurrence showed a low-pressure of 1004 hPa located on the northern Hainan Island and moved west-northwest at a speed of 15 knots. Taiwan was affected by high pressure system, southerly winds and land-sea winds were prevailed, and the northern Taiwan was prone to afternoon thunderstorm. According to the infrared satellite image (figure 1.7-1) and the Doppler weather radar image (figure 1.7-2) at 1750 hours, the convective cloud systems were located in northern and central Taiwan, and the radar echo intensity over Songshan Airport was about 40 to 45 dBZ.

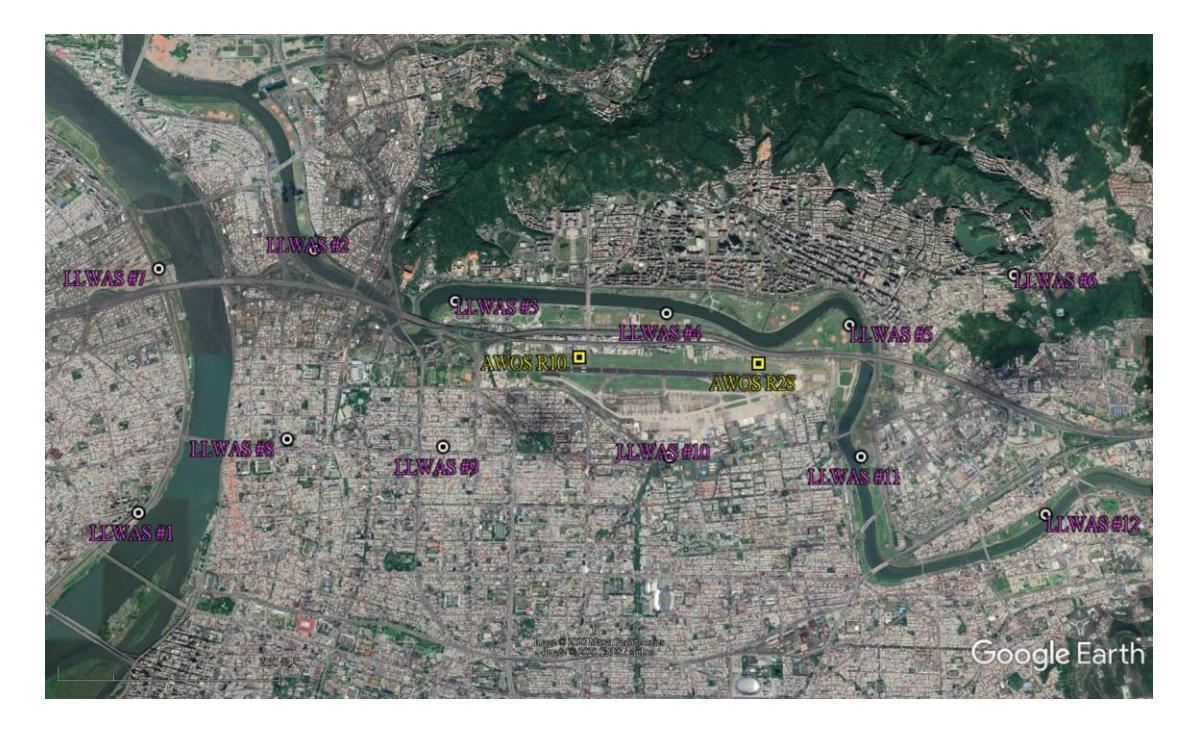
Figure 1.7-3 The anemometer locations of the AWOS and LLWAS

The anemometer locations of the automated weather observation system (AWOS) and LLWAS of Songshan Airport are shown in Figure 1.7-3. The AWOS wind information from 1744 to 1750 hours are shown in Figure 1.7-4. From 1746:36 hours (the radio height of the aircraft was 200 feet) to 1747:36 hours (the aircraft stopped), the wind variations were 210-260 degrees and 6-10 knots for AWOS R10, the wind variations were 190-210 degrees and 6-7 knots for AWOS R28. The related LLWAS wind information is detailed in Appendix 1.

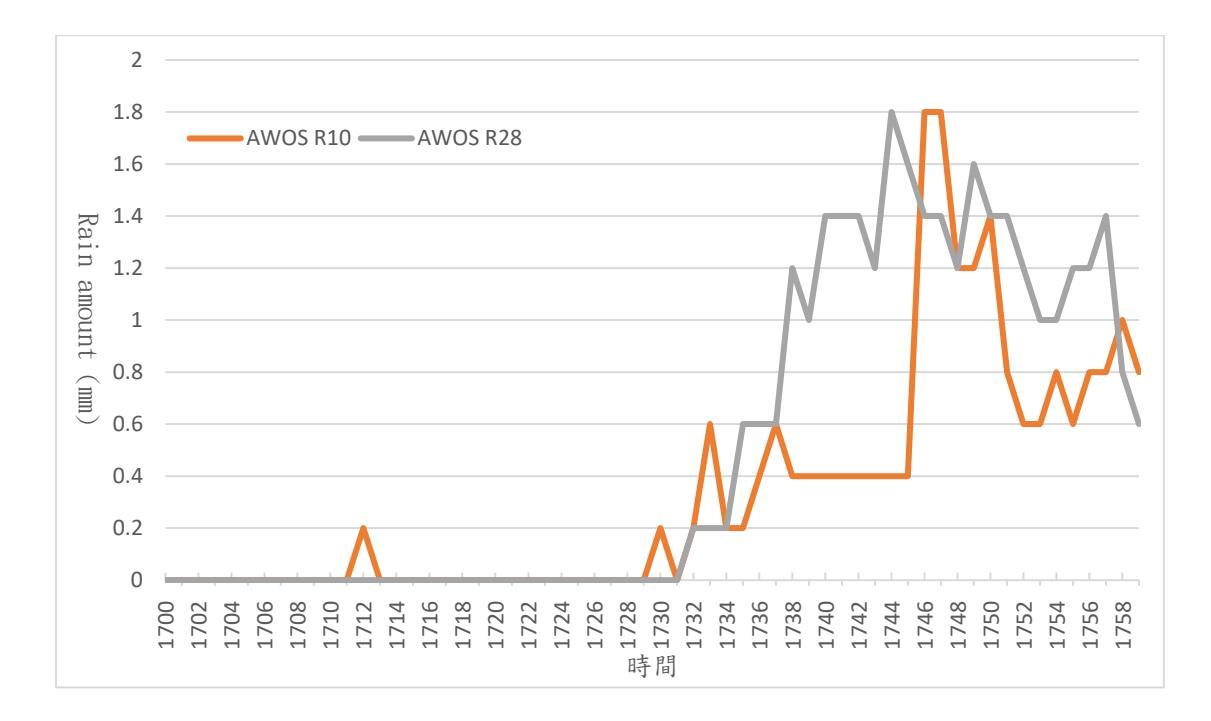
Figure 1.7-5 The rain amount of AWOS

Six minutes before the occurrence, the cumulative precipitation of AWOS R10 was 5.2 mm (heavy rain), and the cumulative precipitation of AWOS R28 was 8.8 mm (heavy rain), as shown in Figure 1.7-5.

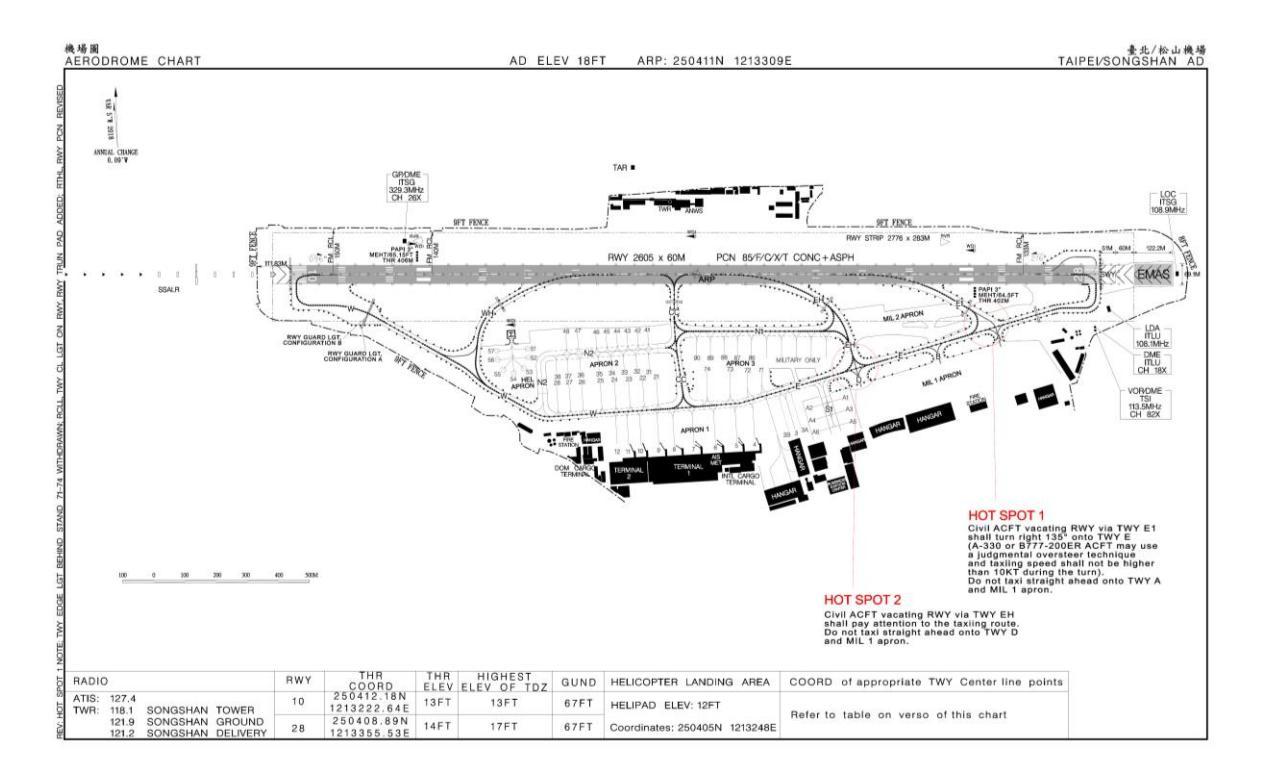
Figure 1.10-1 Taipei/Songshan aerodrome chart

According to "Aeronautical Information Publication of Taipei Flight Information Region," Taipei/Songshan Airport is located 4.8km northeast of Taipei City with 18 feet elevation. A single runway is deployed and designated as RWY 10/28 with declared dimensions of 2,650 meters long, 60 meters wide. The runway pavement has a bituminous surface course overlaying on the plain concrete base with pavement classification number (PCN) as PCN 83/F/C/X/T. The aerodrome chart shows in Figure 1.10-1.
