國家運輸安全調查委員會

調查報告

中華航空公司 CI922 班機

爬升階段 1 號發動機起火

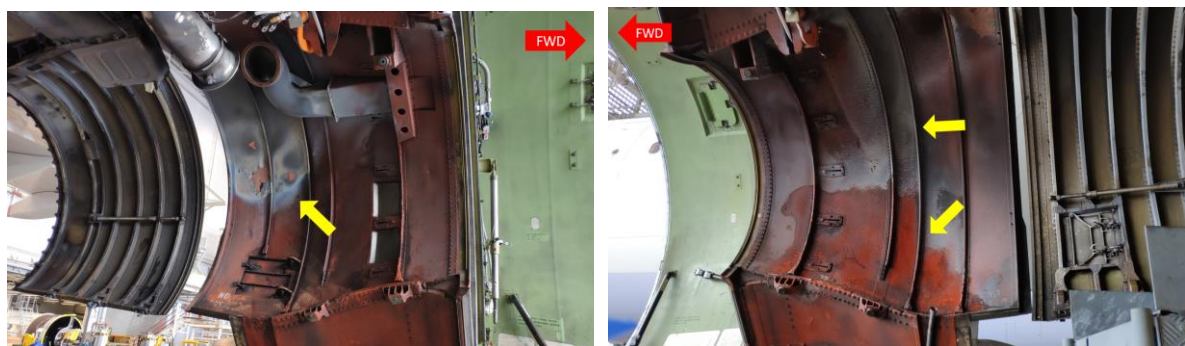
圖 1.14-1 左右側發動其整流罩內部狀況

事故發動機（1 號）左側中央整流罩上半部有炭色燻黑物質附著，如圖 1.14-1 左，右側中央整流罩上半部有炭色燻黑物質附著，下半部有油漬痕跡遺留，如圖 1.14-1 右。

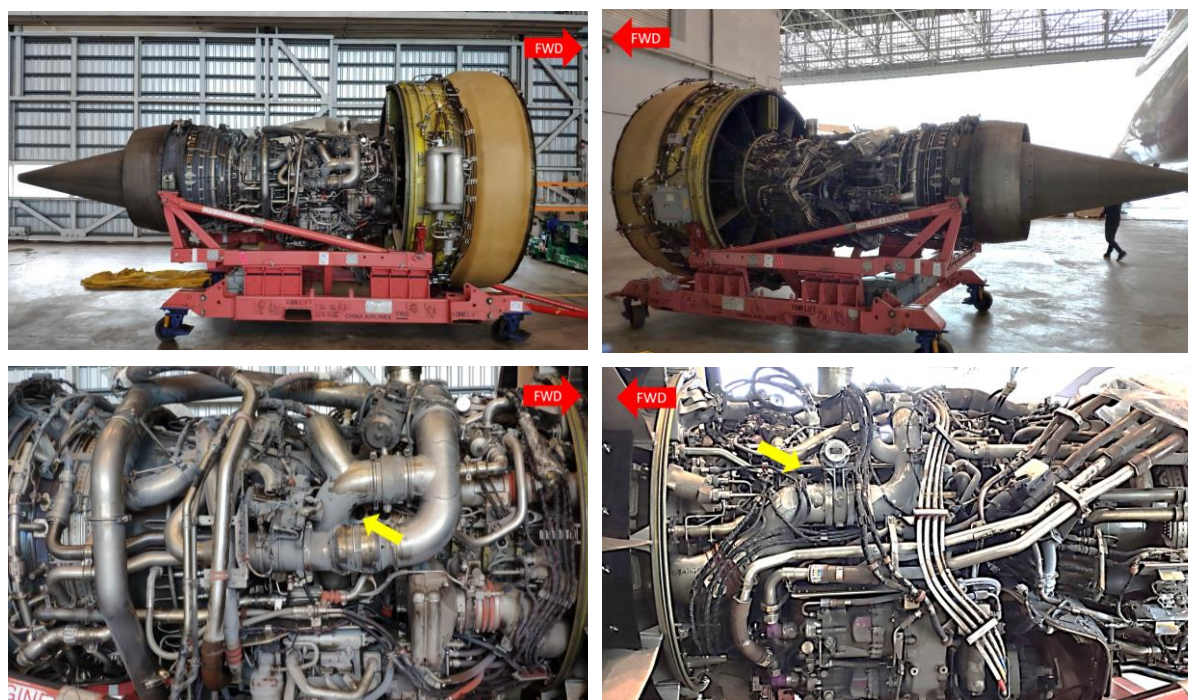
圖 1.14-2 發動機左右側外觀狀況

於壓縮器段之組件及管路外部有明顯碳色粉末附著及高溫侵蝕痕跡，如圖 1.14-2。

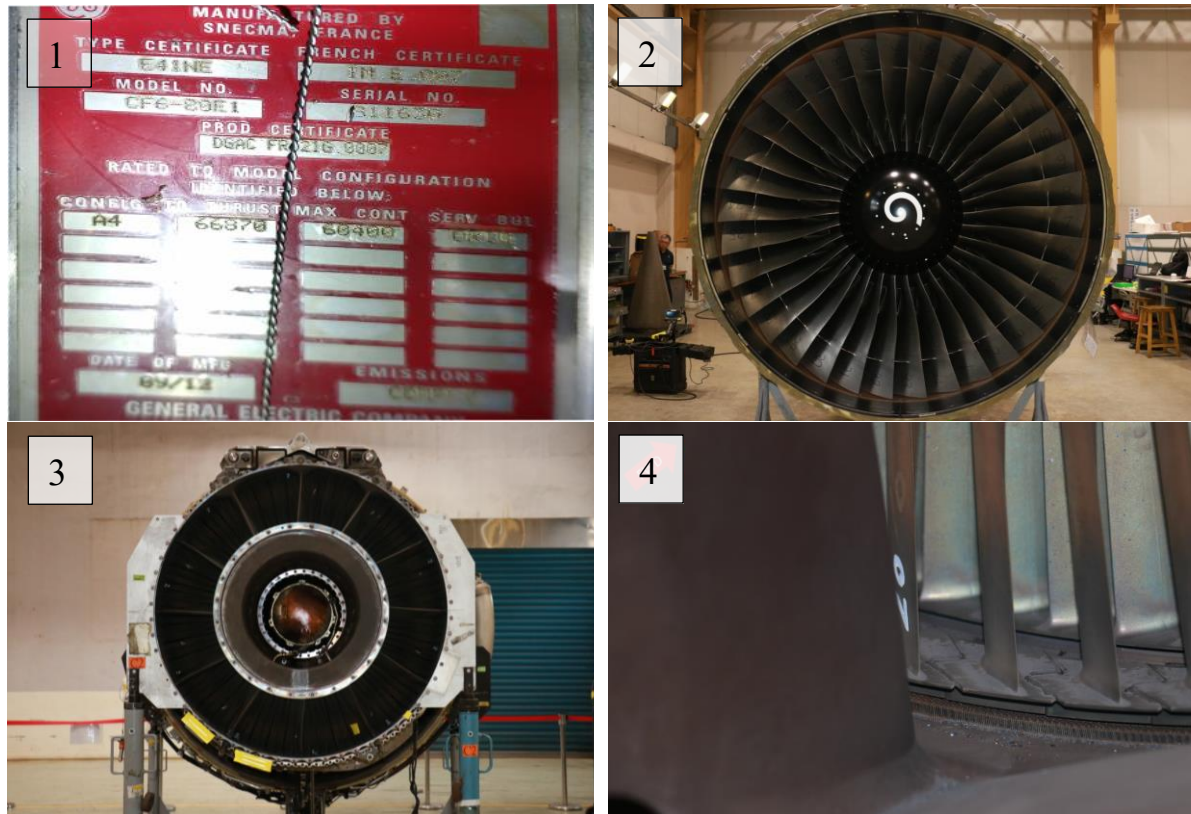
圖 1.16-1 發動機進、排氣口目視檢查

第一級風扇壓縮器葉片表面、葉尖及前後緣外觀完整無擊傷，排氣尾管內側底部有金屬屑殘留，詳圖 1.16.1-2~4。

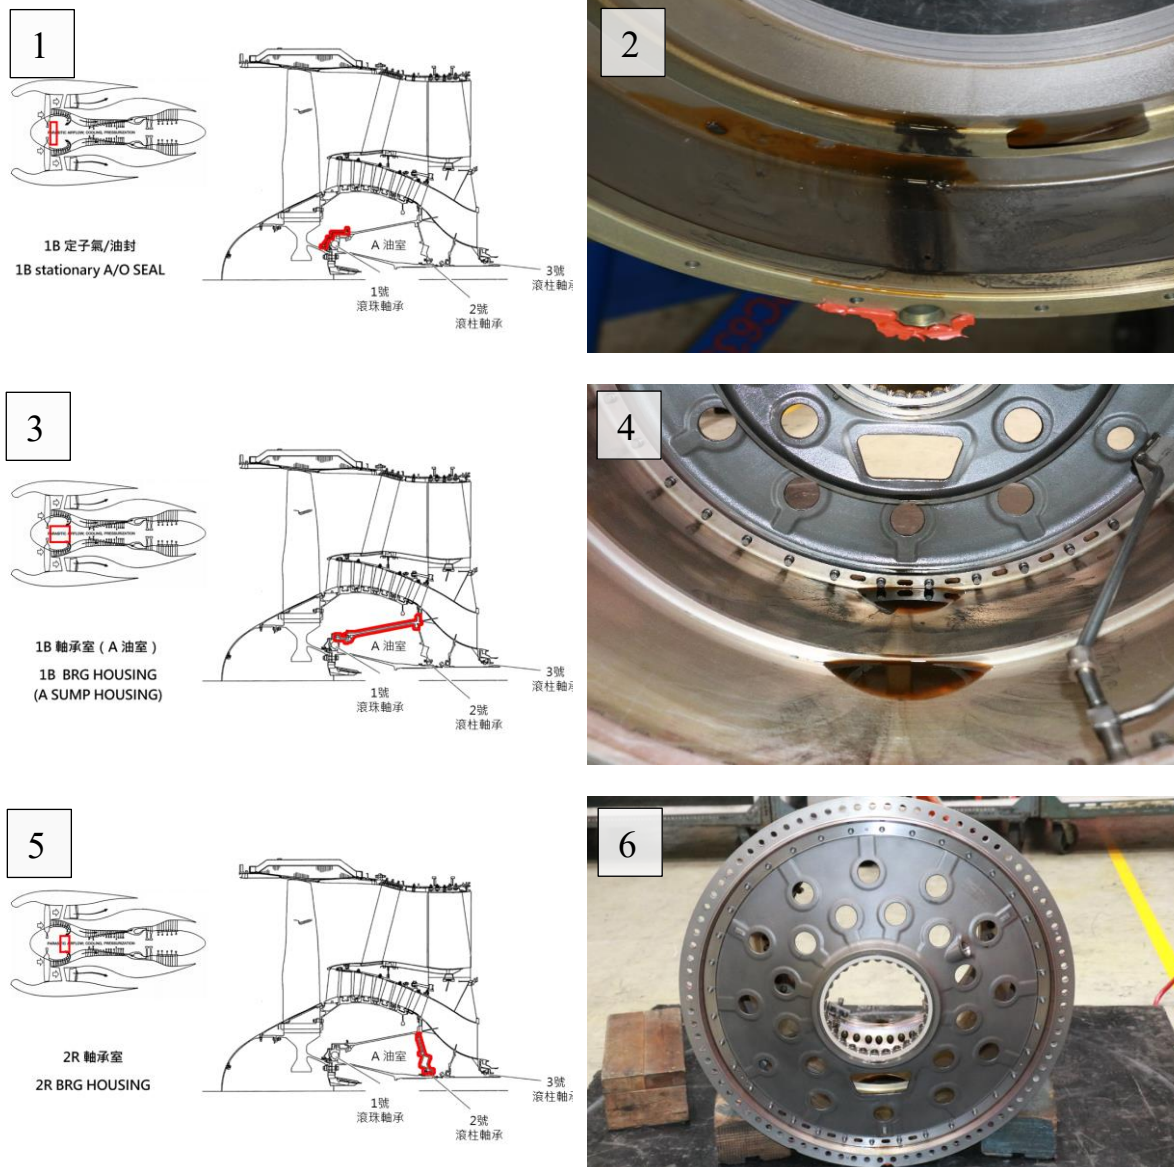
圖 1.16-2 風扇模組拆卸及目視檢查

1B 定子氣/油封、1 及 2 號軸承室底部有含金屬屑油漬殘留； 2 號滾柱軸承目視狀況良好，詳圖 1.16-2-1~6。

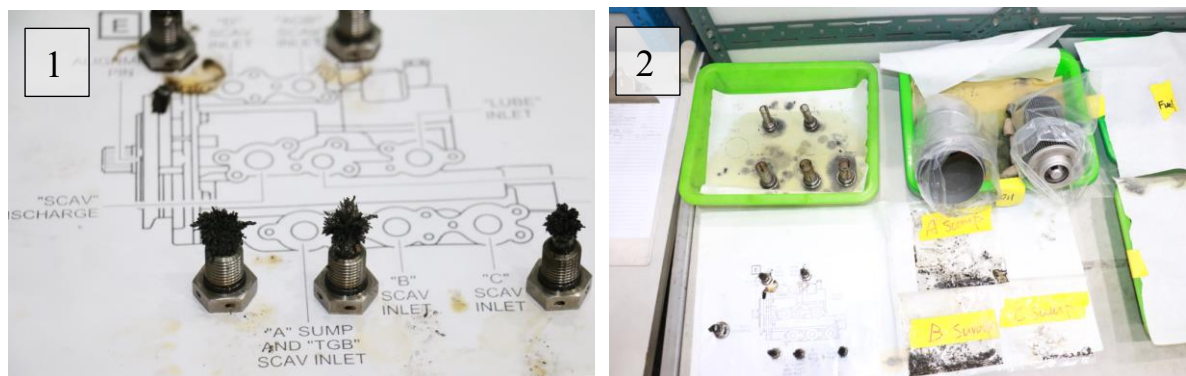
圖 1.16-4 磁性金屬屑偵測器檢查

自事故發動機參數出現異常，歷經約 2 分多鐘之 N2 振動，於所有回油濾磁性金屬屑偵測器上發現大量磁性反應金屬屑吸附，詳圖 1.16-4-1~2。

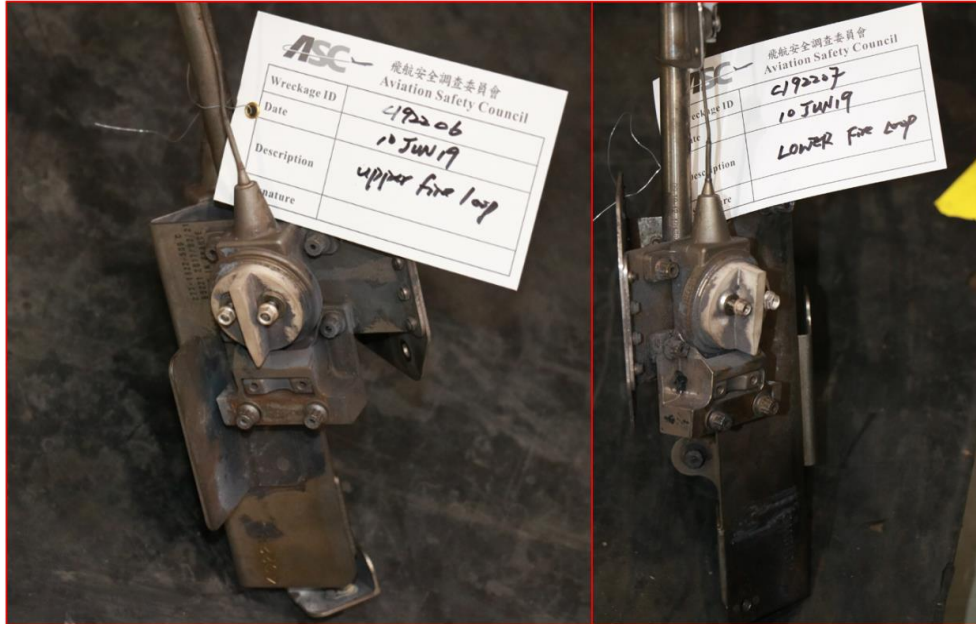
圖 1.16-6 火警偵測組件

火警偵測器終端模組金屬有受熱變色及炭色燻黑物質附著情形，詳圖 1.16-6。

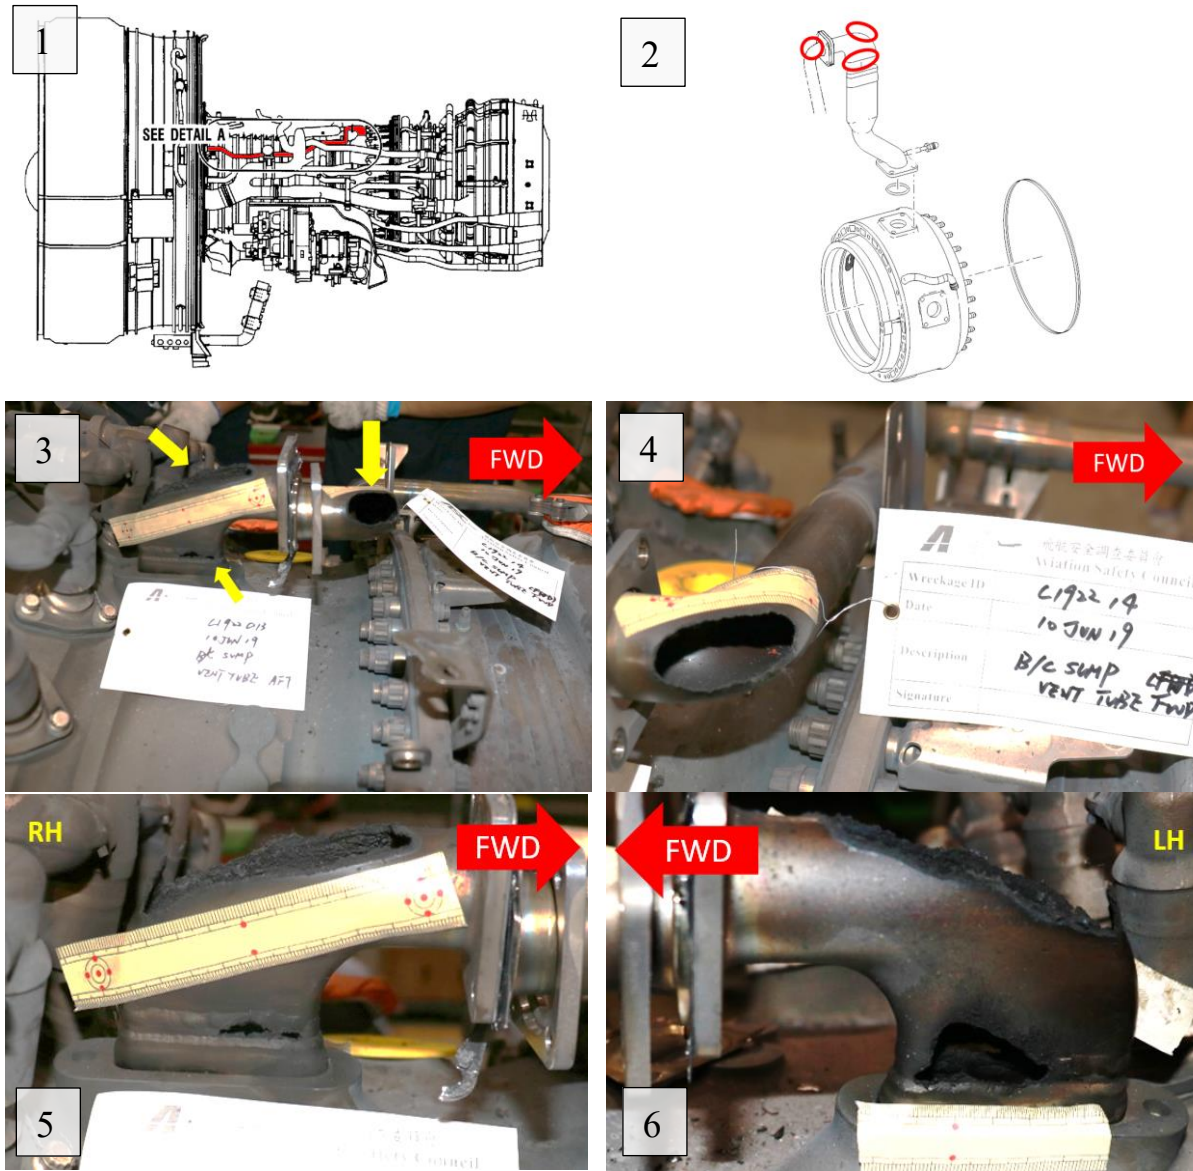
圖 1.16-8 B/C 油室前通氣管燒穿

B/C 油室前通氣管壁 3 點鐘位置燒穿約 2*1 吋，詳圖 1.16-8-3~4。後管壁上端約 12 點鐘位置燒穿約 3*1 吋，後管壁左側燒穿約 1.5*0.8 吋，後管壁右側燒穿約 1.2*0.2 吋，詳圖 1.16-8-5~6。

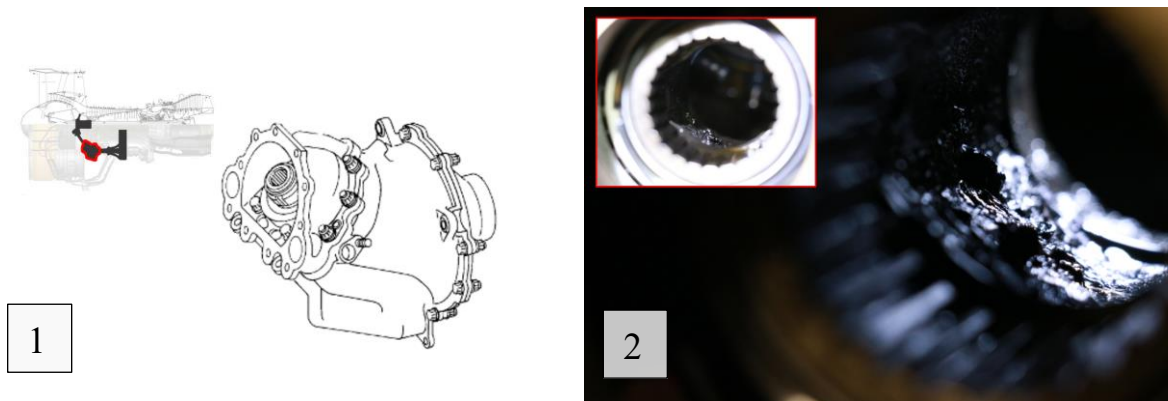
圖 1.16-12 TGB 內部淤積油泥

傳動齒輪箱 (transfer gearbox, TGB) 內部有金屬屑油泥淤積，詳圖 1.16-12。

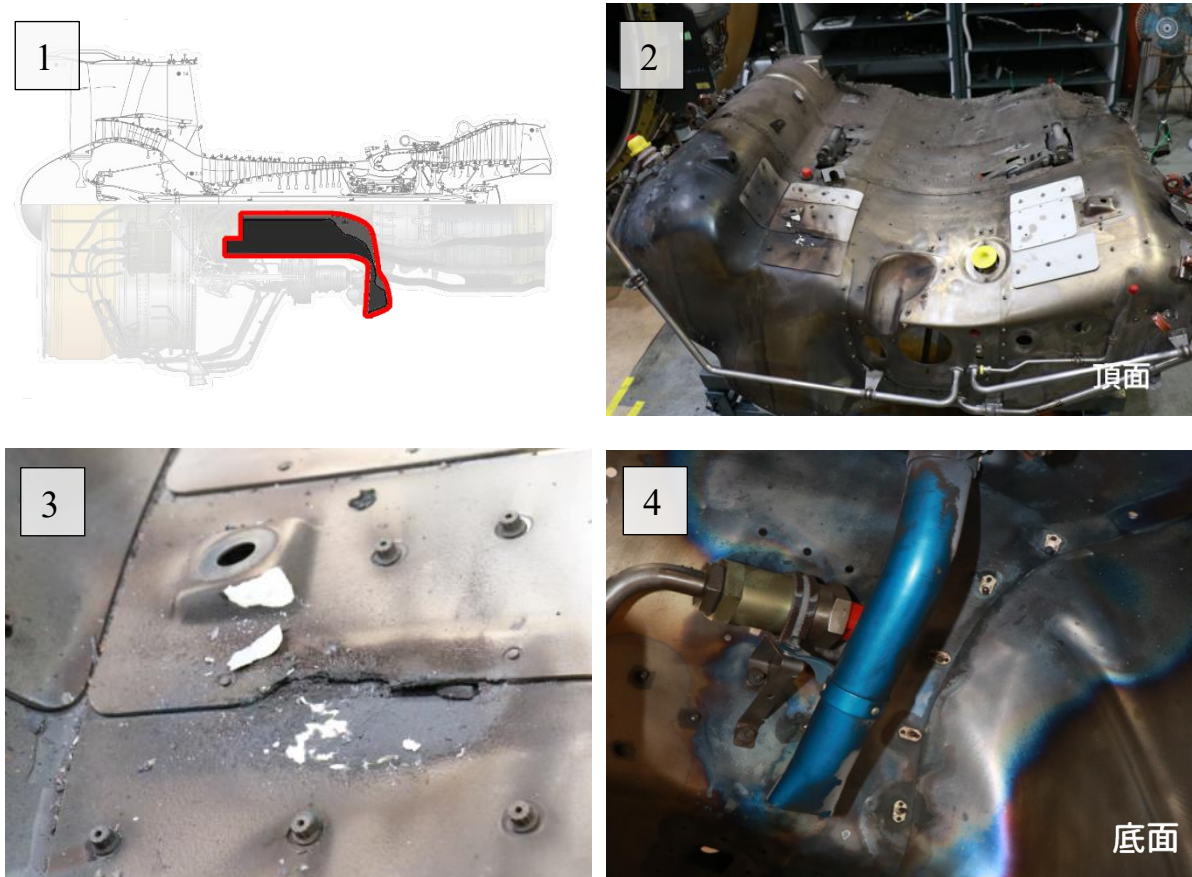
圖 1.16-13 ABG 隔熱罩高溫燒損

附件齒輪箱 (accessory gearbox, AGB) 隔熱罩頂部靠近發動機底部約 7 點鐘位置有明顯有炭色燻黑物質附著，詳圖 1.16-13-2，該處為其中之一區域有隔熱塗層 (thermal barrier coated) 板加強設計位置，隔熱塗層板邊緣有高溫燒損跡象，詳圖 1.16-13-3；自隔熱罩底部觀察，頂部有炭色燻黑物質處相對位置有金屬受熱高溫變色之情形，詳圖 1.16-13-4。

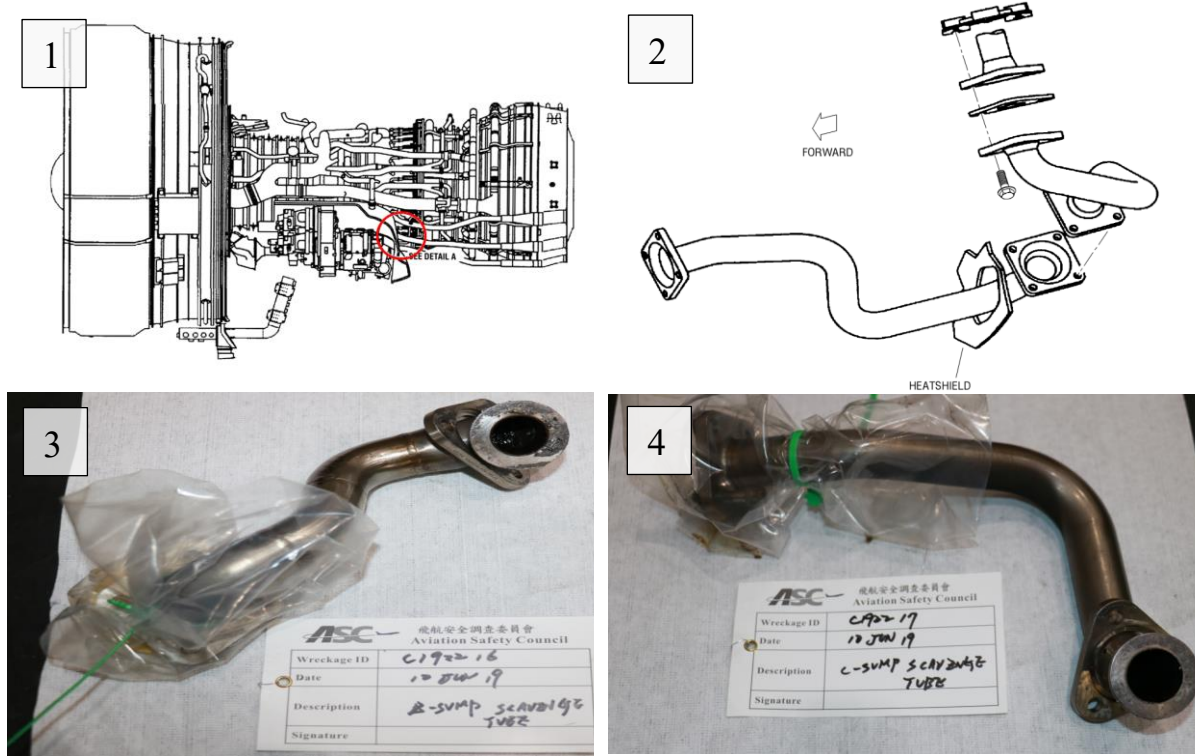
圖 1.16-14 B/C 油室回油管內受汙染

B 油室回油管(圖 1.16-13-1~2)內發現有油泥及金屬屑殘留，詳圖 1.16-13-3；C 油室回油管內部乾燥但有炭色燻黑物，詳圖 1.16-14-4。

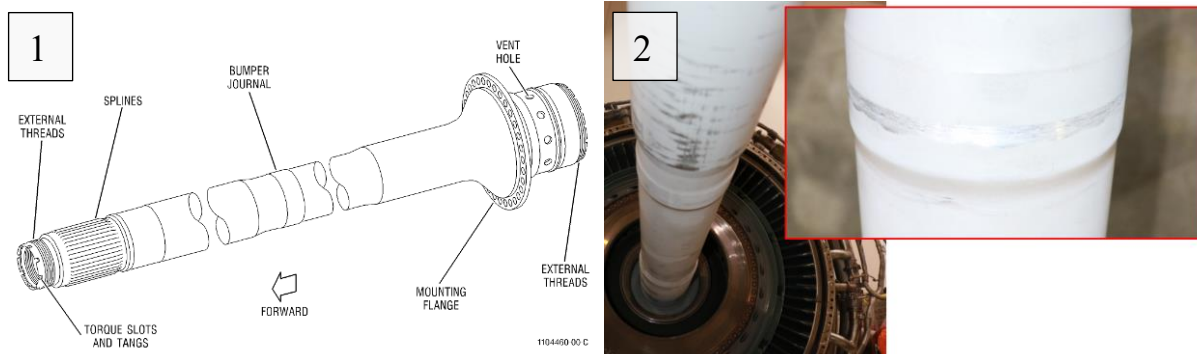
圖 1.16-15 LPT 軸磨損

LPT 軸齒鍵留有些微金屬粉末殘留，但目視狀況無特別異常。低壓渦輪軸中段於 bumper journal 區域有周向環型磨擦痕跡，其餘桿身部位有輕微軸向及周向外緣磨擦痕跡，詳圖 1.16-15-1~2。

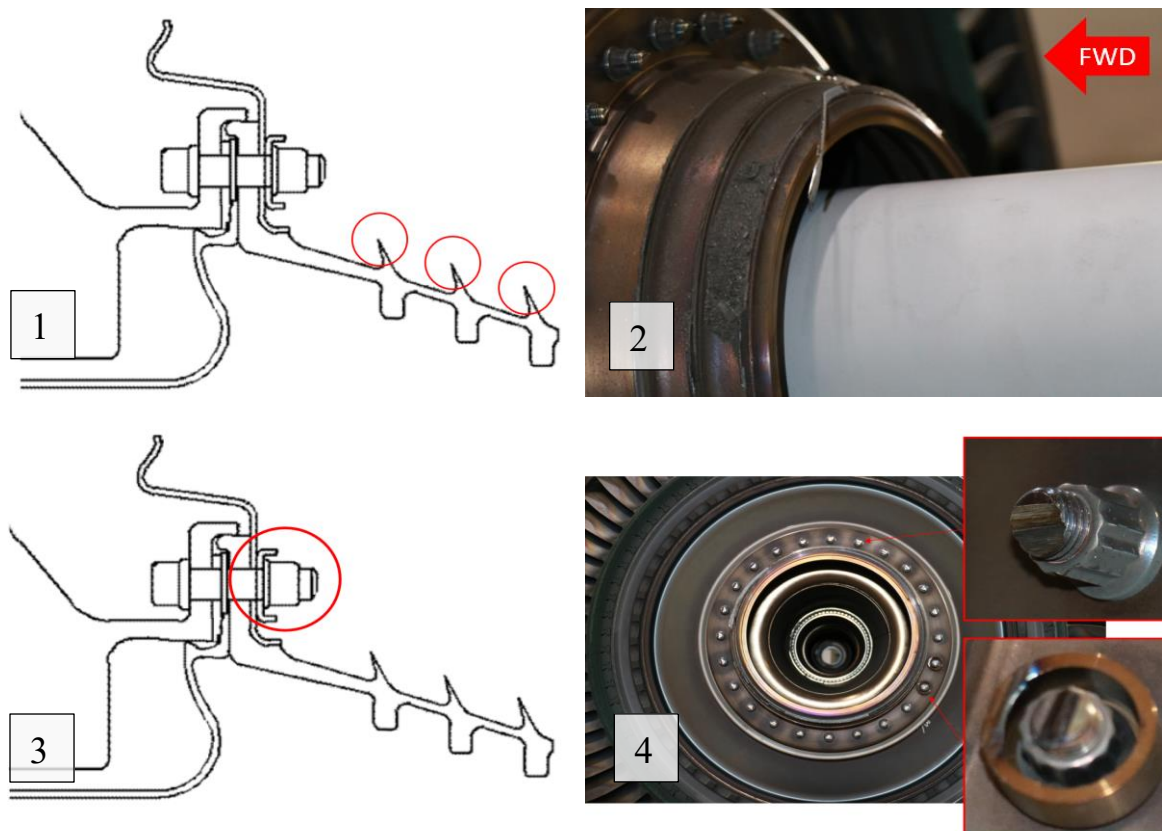
圖 1.16-19 HPT 轉子氣封後方氣封轉子

第 2 級 HPT 中間氣封轉子氣封後方氣封刀峰，詳圖 1.16-19-1，有環型磨擦削損及材料剝落，9-11 點鐘位置有材料噴濺附着情形，詳圖 1.16-19-2。24 個 HPT 氣封後方剪力螺桿螺帽端底面及其 2 個配重環有磨擦削損狀況，詳圖 1.16-19-3~4。

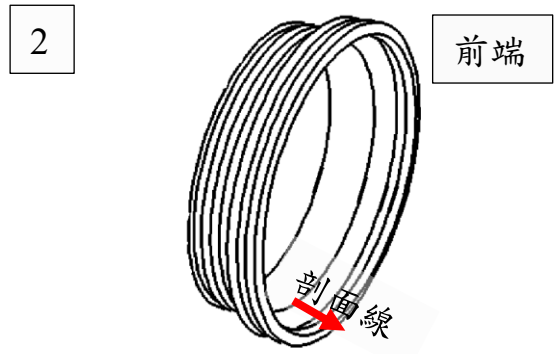
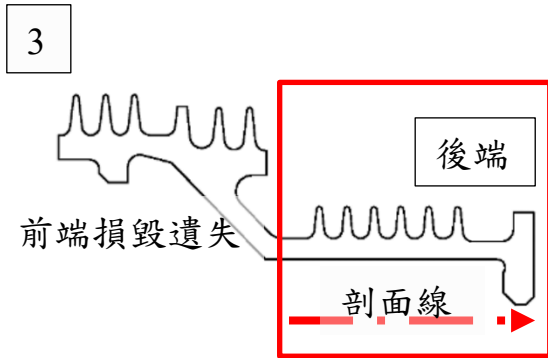
圖 1.16-22 4R 轉子氣/油封損傷狀況

4R 轉子氣/油封前段氣封斷裂遺失，斷裂處約莫位於後段刀齒第一級正前方至第三級左右位置一帶，詳圖 1.16-22-4，因部件受損但仍留有部分可辨識件號 1370M55P01 及序號 RAT02815-B，詳圖 1.16-22-5，轉子遺損的程度在圓周上非均勻分布，詳圖 1.16-22-6。後半部各級刀齒外緣大致完好仍可辨識基本外型，詳圖 1.16-22-7~8，惟前段刀峰有軸向明顯受擠壓造成塑性變形，後段刀齒部分材料遺損，且整體後半部結構有嚴重輻向往外側彎曲之變形，詳圖 1.16-22-9~10。

- Part severely damaged (轉子嚴重損壞)
- Forward seal teeth rack missing (前段氣封齒條失損)
- Aft seal teeth rack intact, but reduced in axial length by plastic deformation and loss of metal. (後段油封齒條完整，惟軸向長度因塑性變形而縮短且有部分金屬失損)
- The fracture surfaces were coated with metal splatter and could not be observed (斷裂表面因有金屬飛濺物覆蓋無法進行觀察)
- The part deformed radially outward from overheating/CF force. (有因受超溫及離心力所造成之徑向向外之變形)
- No material-type discrepancies observed (EDS¹¹, hardness, microstructure) (材料無不符合規範之情形(光譜分析、硬度、微觀結構))

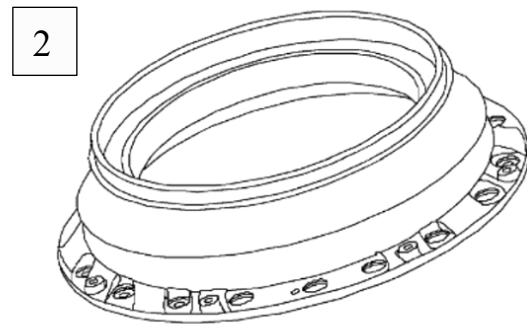
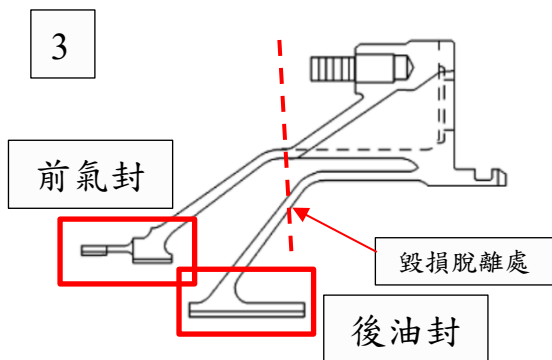
圖 1.16-23 4R 定子氣/油封損傷狀況

- Part severely damaged with evidence of fire（定子有嚴重火損情形）
- Both Outer (Air) and Inner (Oil) portions of seal support fractured（定子氣封和油封（原文報告以內、外部註解）支承結構均破損）
- Evidence of heavy rubs on both seal lands (Air and Oil)（兩處氣封磨擦面（氣與油封）都有嚴重磨擦的跡象）
- Evidence of incipient melting of rub land backing strips (pre-fire

damage) (磨擦面之支承結構條有初始熔化現象(火災前之損壞))

- Thickness of Nickel-Graphite bond coat conforming in undamaged locations (無損壞的石墨鎳合金之塗層厚度一致)
- Signs of melting with inter-dendritic separations observed. (支承結構條有樹枝狀晶間分離的熔融跡象)
- Thermal shield almost entirely missing (隔熱罩幾乎完全失損)
- Liberated fragments of part located in cavity under rotating CDP Seal bore. (定子脫離之破片留滯於 CDP 轉子氣封之孔洞空間中)

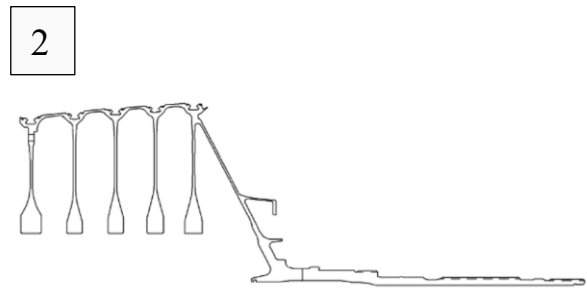
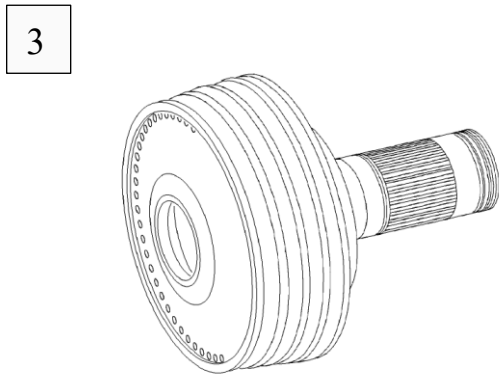
圖 1.16-28 HPC 段軸

- The HPC Spool was examined from the shoulder where the 4R rotating air/oil seal seats to the cavity forward of the CDP seal bore. (HPC 軸段起自安裝 4R 轉子氣/油封之軸肩檢查至 CDP 轉子氣封安裝孔前之空隙。)
- In those areas, debris had accumulated at multiple locations. The debris in the flange cavity consisted of a fine powder. (在上述區域中，多處積有碎片情形，且凸緣空隙中的碎屑則由更微細之粉末集成。)

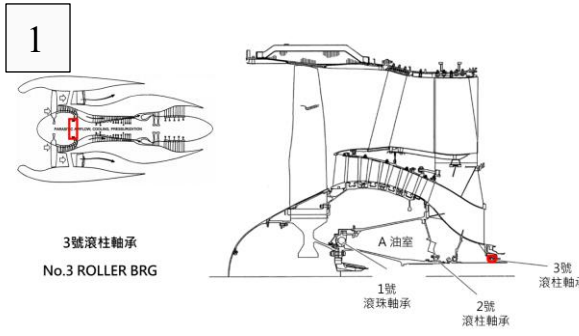
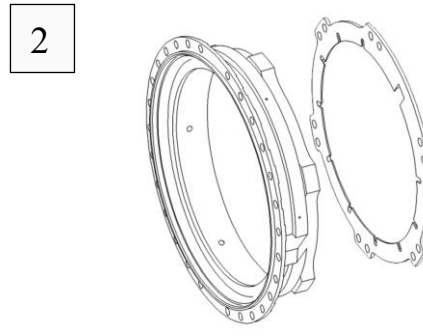
圖 1.16-29 3R 軸承

- 3R bearing received oil-wetted with some slight heat tinting and a fractured outer ring. (GE 公司接收時 3R 軸承外表仍呈現油潤狀況，略有些微熱損變色及外環破裂情形)
- Roller exhibited end wear and micro spalling from hard contact with outer ring shoulders. (滾柱因與外環肩部有硬接觸出現之邊緣磨損，和些微剝落之狀況)
- No corrosion or hard particle contamination. (無腐蝕或硬顆粒外物汙染)
- Minor denting of inner and outer ring raceways and roller surfaces, consistent with rolling over debris. (內環和外環滾道以及滾柱表面皆有輕微凹陷，與滾落碎屑的跡象吻合。)
- No material-type discrepancies observed. (未見材料不符的狀況。)
- The outer ring fracture originated at the double radius on the anti-rotate feature near the inner diameter of the part. Propagation was either overload, or high amplitude fatigue. (外環斷裂係源自軸承內徑靠近的止轉卡槽上約兩倍半徑處，該破裂的增展可能因過載或高震幅疲勞所致，詳圖 1.16-27-8。)
- Suggests 3R outer ring fracture due to loss of HPC Shaft support (after

4R, 4B, 5R Bearing failure) -> 3R is a “damper” bearing with clearance between outer ring OD and housing ID. This clearance can generate an impact load when shaft support is lost. (3R 的外環可能由於失去 HPC 轉軸的支撐而斷裂 (在 4R、4B 及 5R 軸承皆失效後)，3R 軸承與外環外緣和軸承室內環之間，具有間隙使此軸承有阻尼的作用，但是當軸失去支撐時，該間隙會因受載而造成衝擊損傷。)

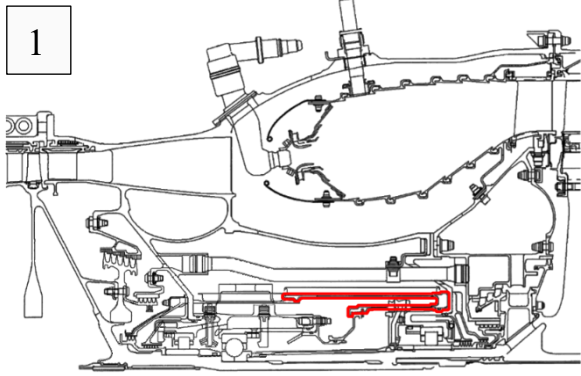
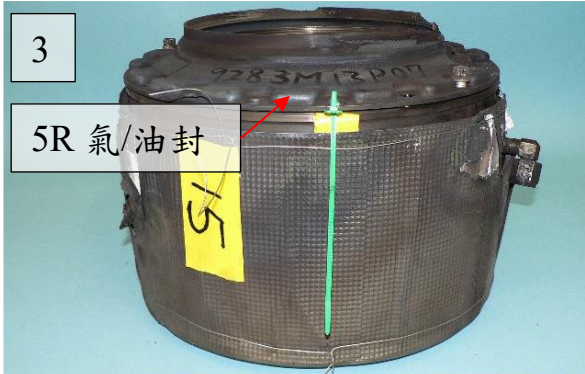
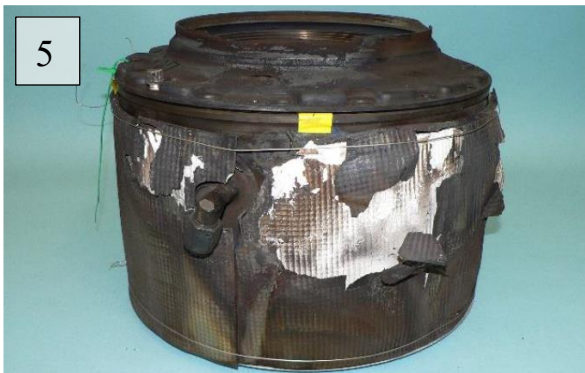
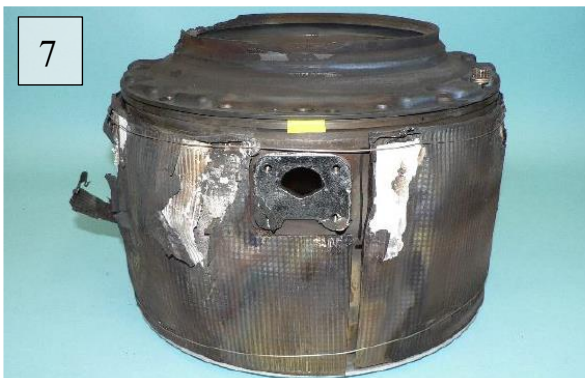
圖 1.16-36 後油室及隔熱罩

- Sub-assembly of Aft Sump Housing, 5R Stationary Air/Oil Seal and Thermal Blankets fit-up to show overall hardware condition. (試裝前油室次組件、5R 定子氣/油封和隔熱罩等次總成以觀察整體部件狀況。)
- Apart from localized distress to Thermal Blanket, Aft Sump Housing is generally in good condition. (除隔熱罩局部損壞之外，後油室整體狀況良好)
- Internal cavity of Aft Sump Housing is dry and exhibits evidence of fire damage. (油室的內部乾燥，且有火損的狀況。)

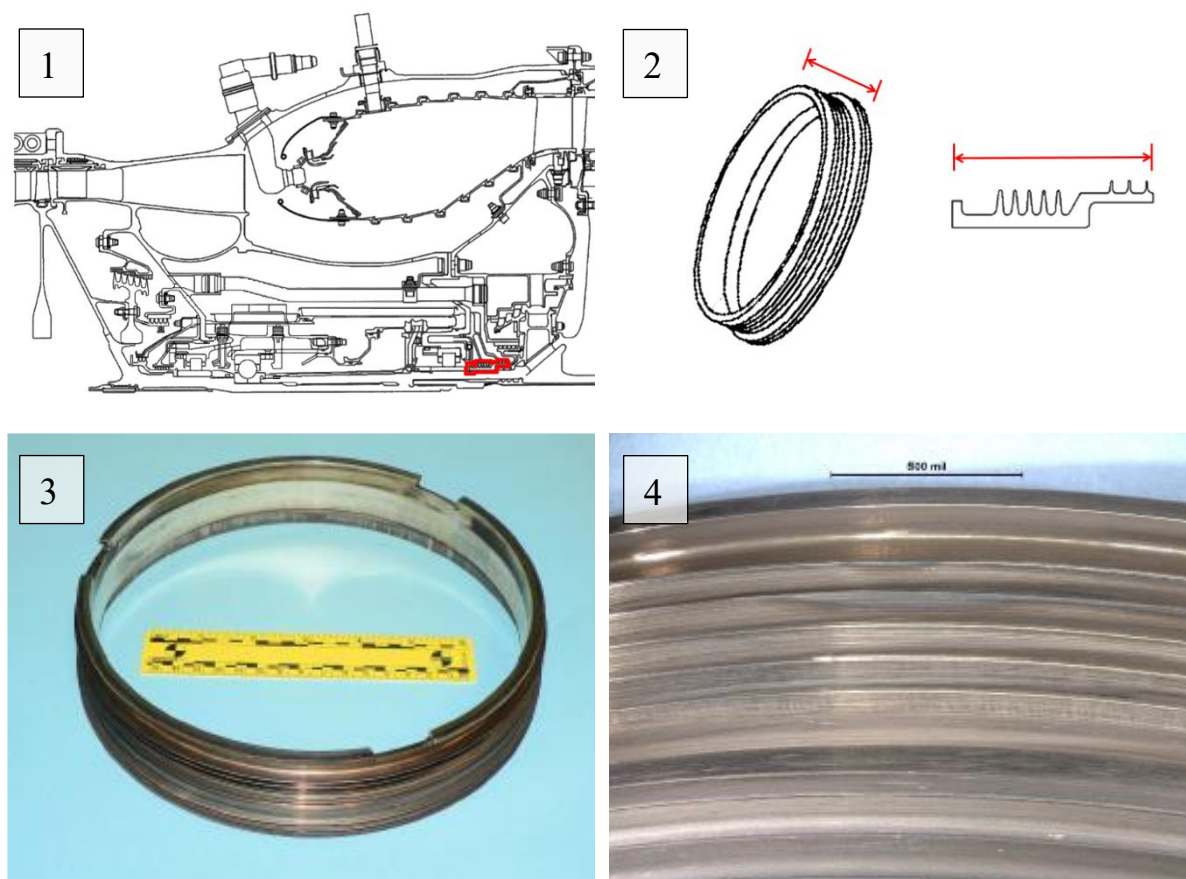
圖 1.16-38 5R 轉子氣/油封

5R 轉子氣/油封表面可見件號 1327M72G02 及序號 TEJK1238。轉子整體外觀狀況良好，惟於油封段最外緣的刀峰有熱損變色的狀況，詳圖 1.16-38-1~4。

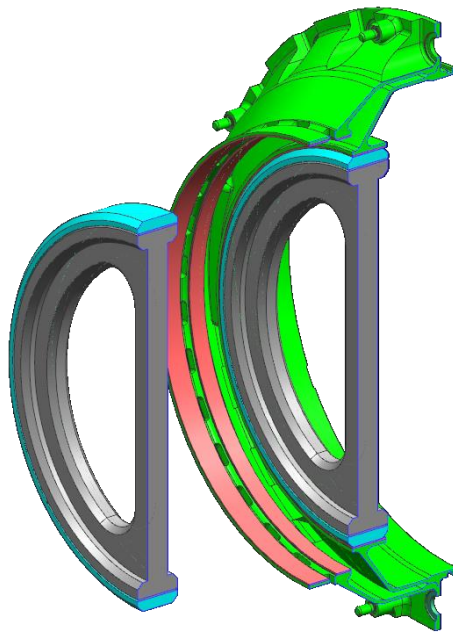
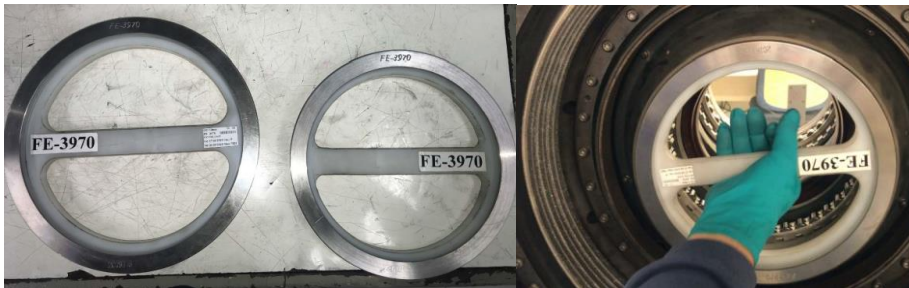
圖 1.18-3 件號 2C18118G01 特工

- *CF6-80C Subtask 72-34-00-220-187*
 - *CF6-80E Subtask 72-34-00-440-148*
- *This fixture simulates the 4R Rotating Air/Oil Seal to detect interference.*

- *Since this fixture was introduced in 2017, there have been no confirmed events on any engines that employed the fixture during engine build.*

- The 4R Stationary Air/Oil Seal installation process is sensitive to workmanship.
- The possibility of installing misaligned seal can be minimized by following good shop practices:
 - Cross-pattern bolt torquing
 - Shim check to ensure mating flanges are correctly seated
 - Verify seal min diameters after installation
 - Ensure no resistance on seal during installation of HPC rotor in CRF
 - Ensure HPC rotor rotates freely after installation
- As an additional preventative measure, GE developed fixture 2C18118G01 to detect a mis-installed seal and added this fixture to the ESM assembly procedure:
 - CF6-80C Subtask 72-34-00-220-187
 - CF6-80E Subtask 72-34-00-440-148
- This fixture simulates the 4R Rotating Air/Oil Seal to detect interference.
- Since this fixture was introduced in 2017, there have been no confirmed events on any engines that employed the fixture during engine build.

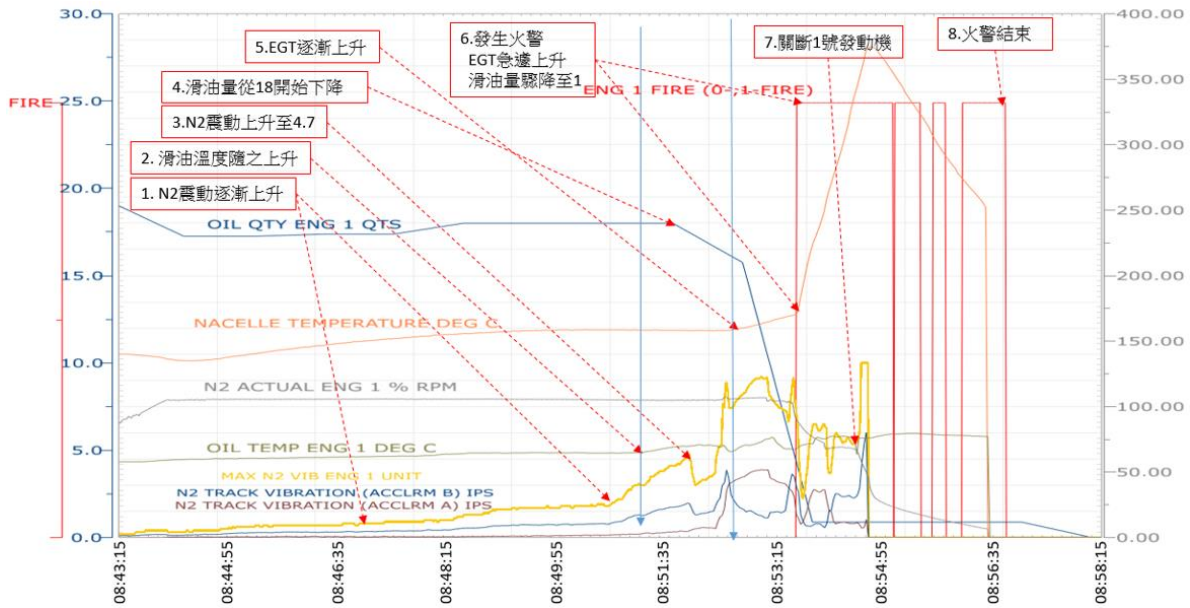
圖 2.3-1 事故過程 1 號發動機參數繪圖

2. 滑油溫度隨著 N2 振動逐漸上升亦跟著上升；於 0851:20 時較明顯之上升趨勢；
3. 於 0851:58 時，發動機 N2 振動上升到 4.7；
4. 於 0852:39 時滑油量從 18qt 開始下降，在 0852:51 時開始急速下降；
5. 於 0852:50 時，發動機 EGT 開始明顯上升；
6. 於 0853:39 時，EGT 急劇上升，滑油量已下降至 1，此時 1 號發動機發生火警，
7. 於 0853:48 時，滑油低壓警告；
8. 於 0854:33 時，飛航組員關斷 1 號發動機；
9. 於 0856:49 時，1 號發動機火警停止。

有關振動量與滑油之關係，從 0850:49 時，N2 振動開始較明顯上升，至 0851:58 時上升到 4.7，滑油溫度隨著振動幅度增加而上升，期間滑油量約在 18qt，而滑油壓力低警告出則直至 0853:48 時出現，當滑油壓力低警告時已在發生火警之後，以上資料顯示滑油量的降低是在高振動之後，高振動並非因滑油量不足或滑油壓力低所致。另外依據事故後殘骸檢視結果（如 1.16.2.12 節所述），4B 及 4R/4B 之滑油噴嘴皆是暢通無礙，因此高振動及後續發動機受損之原因可排除滑油系統。

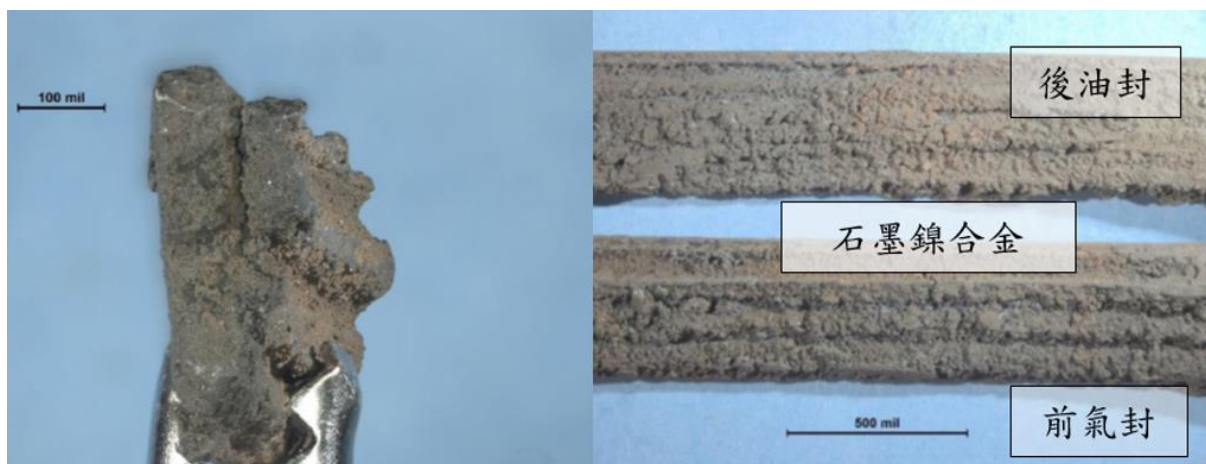
圖 2.4-1 4R 定子氣/油封石墨鎳磨擦面深度刻痕

- a) 殘骸碎片 4R 定子氣/油封石墨鎳磨擦面上深度刮痕，顯示 4R 氣/油封轉子與定子明確發生磨擦。(第 2 項)

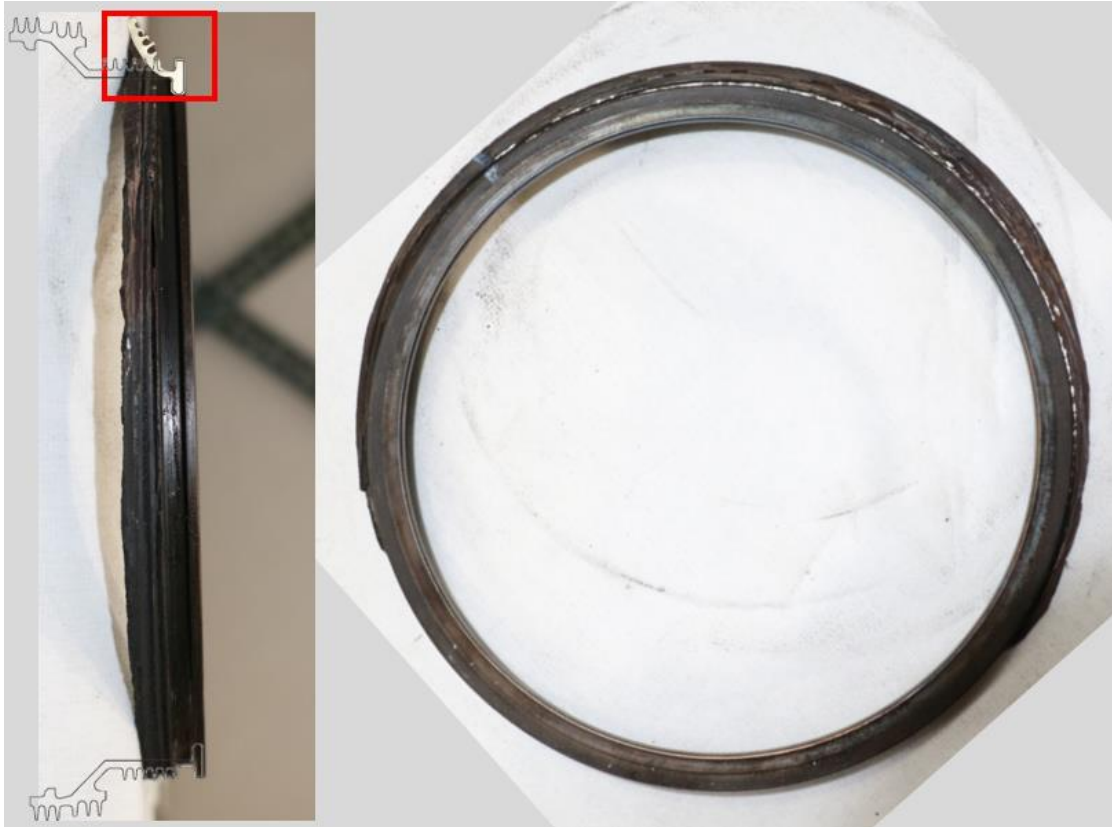
圖 2.4-2 4R 轉子氣/油封向外彎曲

- b) 4R 轉子氣/油封向外彎曲，顯示轉子受高溫熱損強度降低，轉子在高速旋轉離心力作用下，向外彎曲。(第 3、4 項)

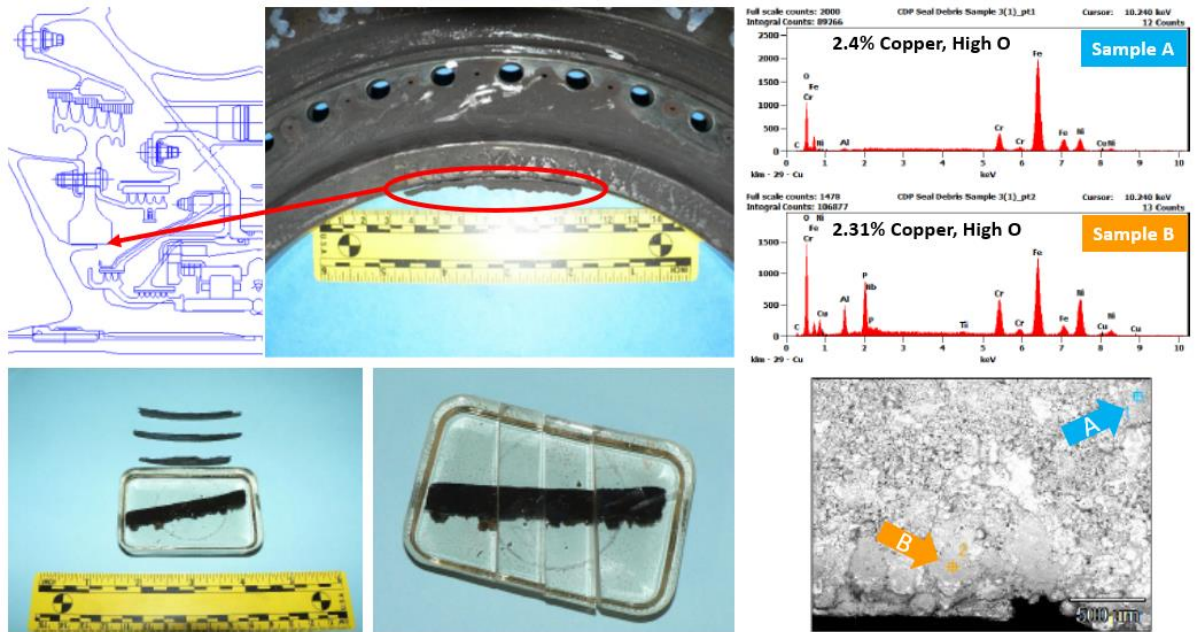
圖 2.4-3 CDP 氣封上殘骸之成分分析

- c) 檢驗黏著於 CDP 轉子氣封後端最貼近內孔徑表面上之金屬噴濺合金，該合金驗出含銅成分，此銅成分與 4R 轉子氣/油封軸承合金（17-4 不銹鋼）材質相符，顯示 4R 轉子氣/油封比黏著在此其他任何被發現之物質更早失效。17-4 合金材質之後，發現有小塊 IN-718 鑄件碎片，較可能為來自 4R 定子氣/油封，顯示 4R 定子氣/油封失效在轉子失效之後。（第 5 項）

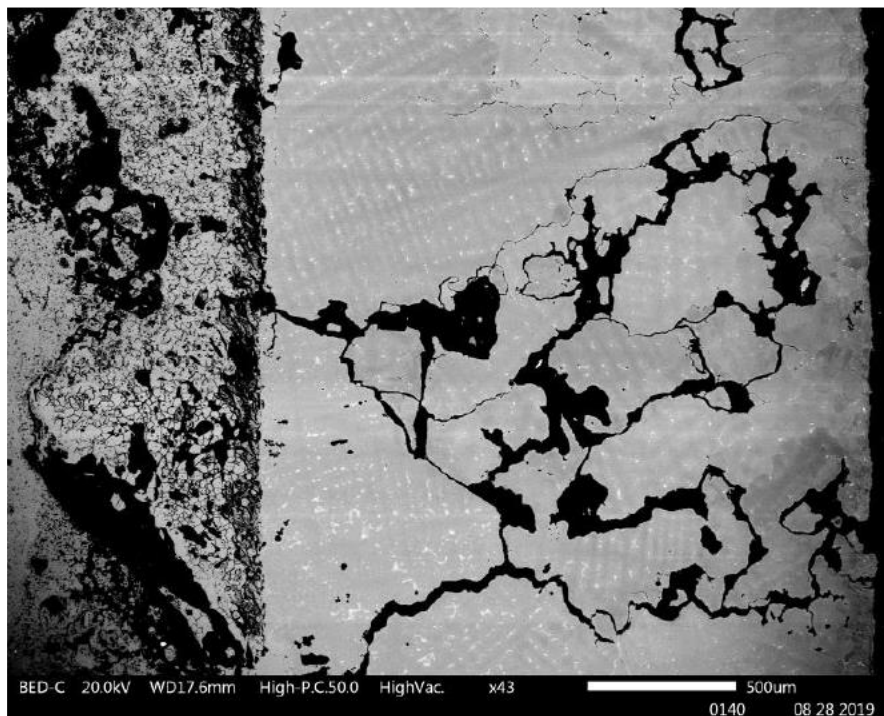
圖 2.4-4 4R 定子氣/油封磨擦面樹枝狀晶間分離狀況

This type of damage (melting/inter-dendritic separations) could not occur without deep/hard rubbing into the Ni-Gr coating. Such rubs would (at a minimum) require a strip and re-application of the Ni-Gr coating. Once the coating was stripped, this type of damage would be detected during visual inspection and/or FPI as required by the ESM repair procedure.

- d) 4R 定子氣/油封磨擦面基材上有樹枝狀晶間分離熔出，顯示定子磨擦面曾經受到高溫熱損。(第 5 項)

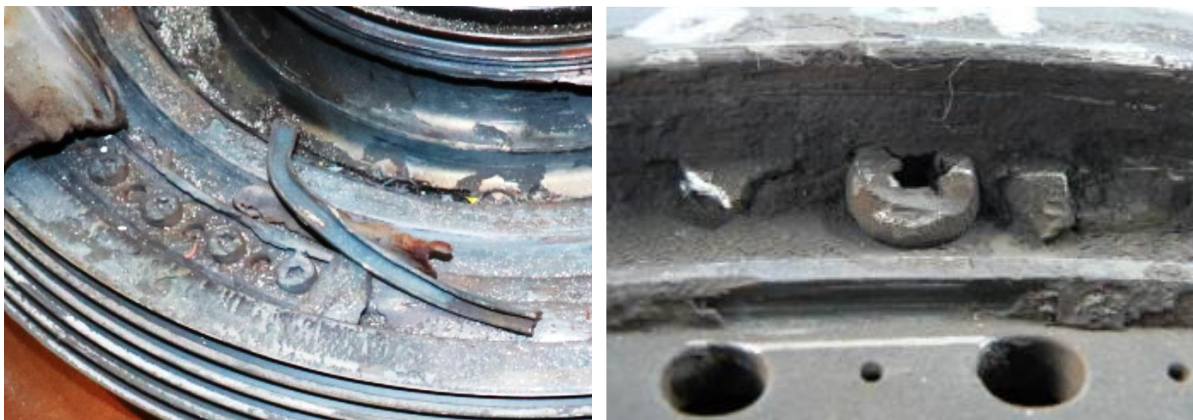
圖 2.4-10 CDP 轉子螺桿頭磨損

- i) 因轉軸位移後，CDP 轉子氣封上固定轉子排氣軸封上之螺桿頭與 4R 定子排氣軸封產生接觸而磨損。(第 12 項)

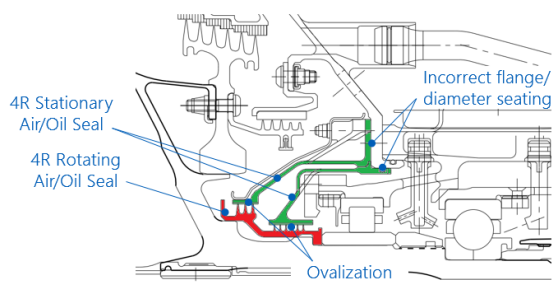
- Based on event details, QAR flight data, hardware condition and historical event information, the CAL 811630 event was determined to have initiated due to hard rubs between the 4R Rotating and Stationary Air/Oil Seals.
- The root cause of this condition was determined to be 4R Stationary Air/Oil Seal mis-assembly.
- An incorrectly seated 4R Stationary Air/Oil Seal can cause ovalization of the seal inner diameters. This can generate heavy rubs against the 4R Rotating Air/Oil Seal, resulting in failure of the 4R Rotating Air/Oil Seal and secondary damage as detailed in the previous slides.
- Apart from 811630, GE is aware of 5 other significant events attributed to this root cause dating back to 1996 (CF6-80C & 80E).

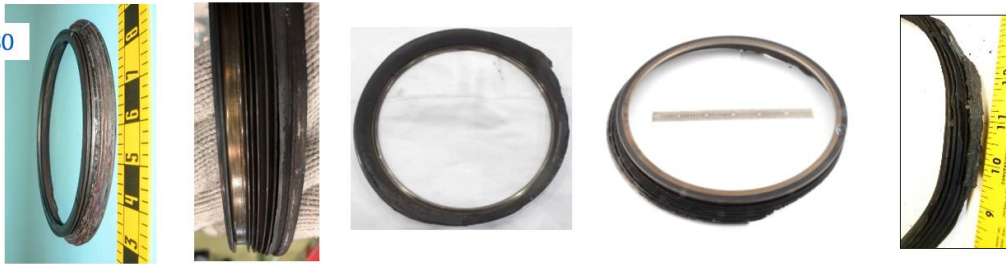
4R Rotating Air/Oil Seal

- Apart from CAL 811630, GE is aware of 5 other significant events for this root cause dating back to 1996 (CF6-80C & 80E).
- Of those 5 events, two have resulted in sump / engine fires.
- On the following slides is a comparison of hardware condition between 811630 and the previous events:

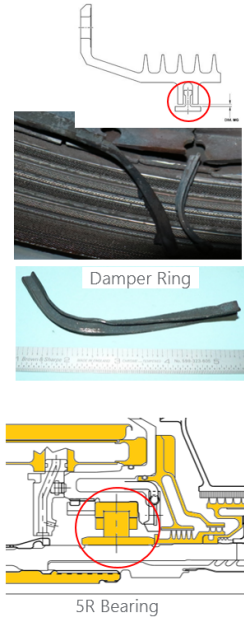
- 5R Bearing failure has previously resulted in a sump fire event. The inner ring fractured axially and penetrated the sump cavity wall, resulting in exposure of sump oil/vapor to hot air. This cause is also refuted as all 811630 bearing inner rings are intact. There are no known cases of 4B Bearing failure resulting in sump fire.
