**Elit'Avia Malta Limited Flight EAU52P**

**Bombardier BD-700-1A10, 9H-OJP**

**Abnormal Runway Contact during Landing at  
Taichung International Airport**

**Aviation Occurrence Investigation Final Report**

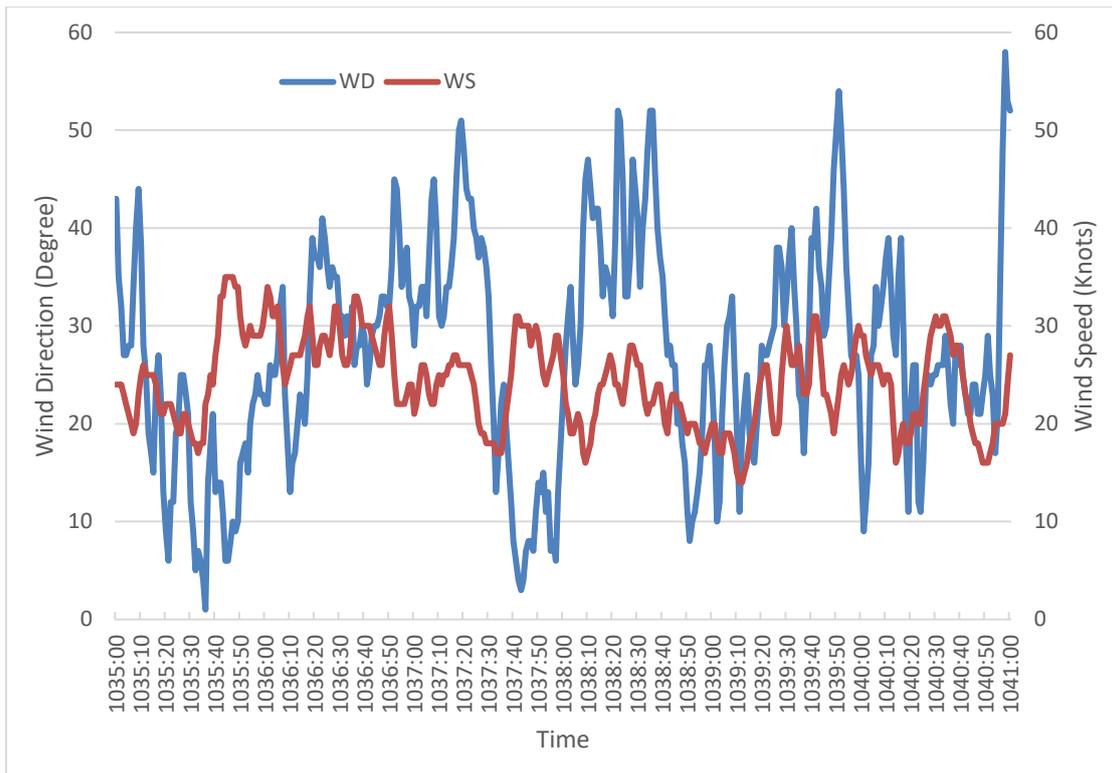
Figure 1.7-2 AWOS S wind speed/direction

The sensors of the automated weather observation system (AWOS) were located at the approach ends and midpoint of the runway, as shown in Figure 1.7-1, providing real-time weather information to the displays of the weather center and the tower. The wind information from 1035 to 1041 hours was shown in Figure 1.7-2 and 1.7-3. From 1037:56 hours (the radio altitude of the aircraft was 220 feet) to 1040:10 hours (the aircraft taxied into taxiway), the wind variations were from 010 to 050 degrees and from 14 to 31 knots for AWOS S, the wind variations were from 020 to 050 degrees and from 23 to 45 knots for AWOS C.

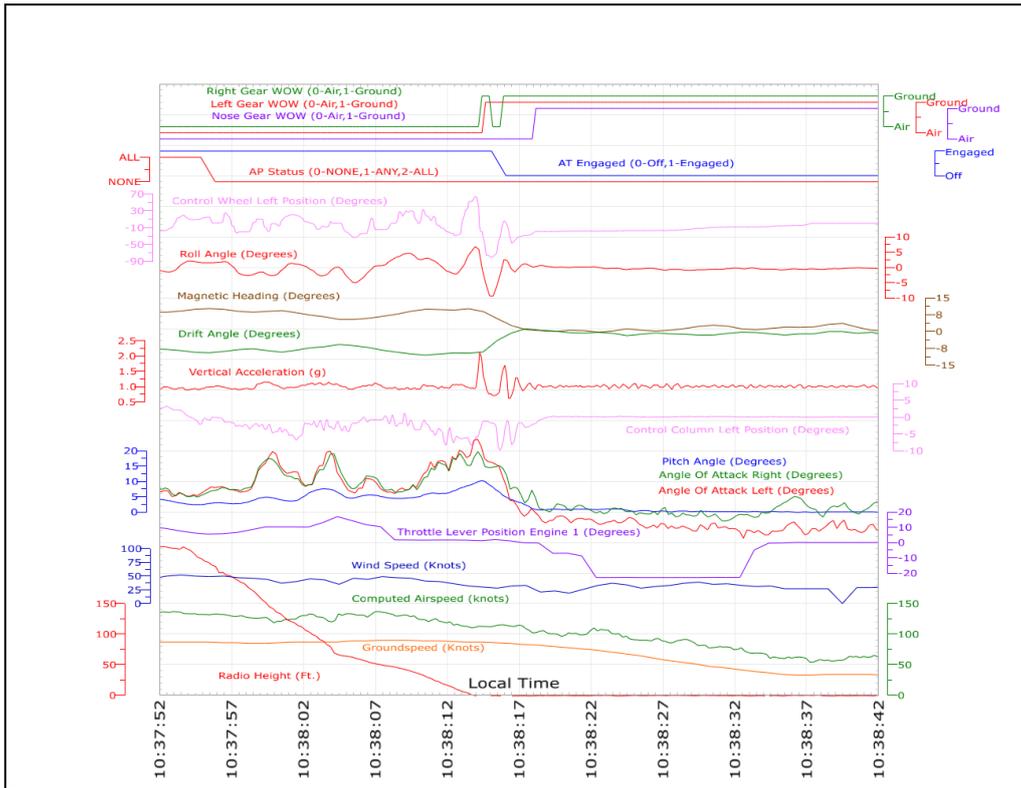
Figure 1.11-1 FDR readouts during landing phase (from AP disengaged)

7. At 1038:17 hours, autothrottle was disengaged, the airspeed was 114 knots, groundspeed 85 knots, magnetic heading 2.5 degrees, TLA 1.05 degrees (left) and 1.75 degrees (right).
8. At 1038:19 hours, the 「air/ground」 parameter of nose landing gear changed from air to ground, airspeed 102.75 knots, groundspeed 82 knots, pitch attitude 0.79 degrees nose-up, TLA -0.35 degrees (left) and -0.17 degrees (right).
9. At 1040:10 hours, the aircraft vacated runway 36.
10. The FDR stopped recording at 1253 hours.

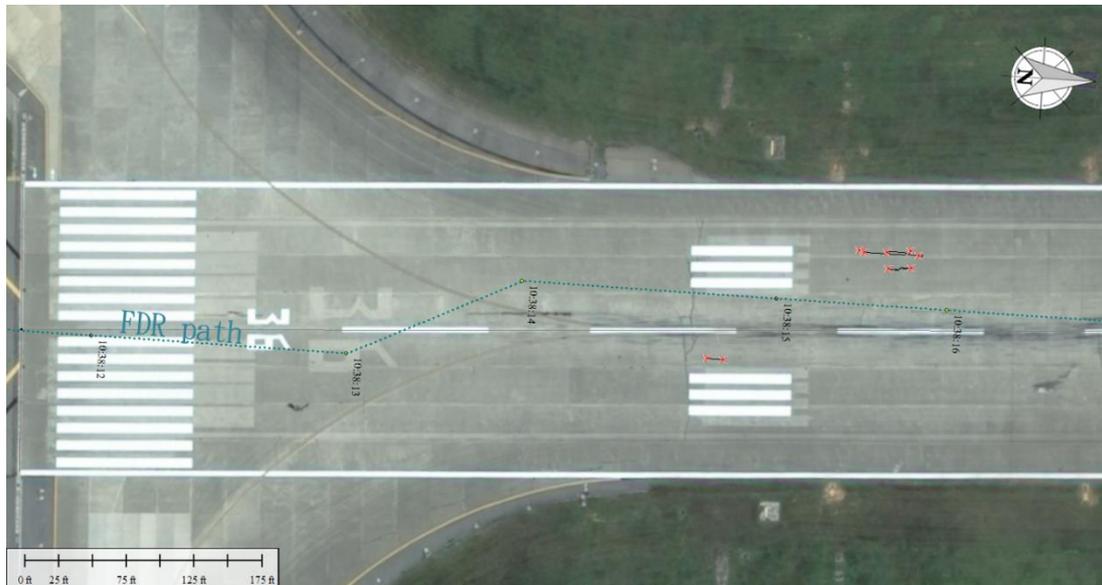
Figure 1.12-1 Superimposed site survey item and FDR flight path

No.	Survey item	Distance from runway 36 threshold (ft)	Length (ft)
1	First wing mark(R1)	503~515	12
2	Second wing mark(L1)	636~652	15
3	Third wing mark(L2)	618~658	42
4	Fourth wing mark(L3)	633~650	17

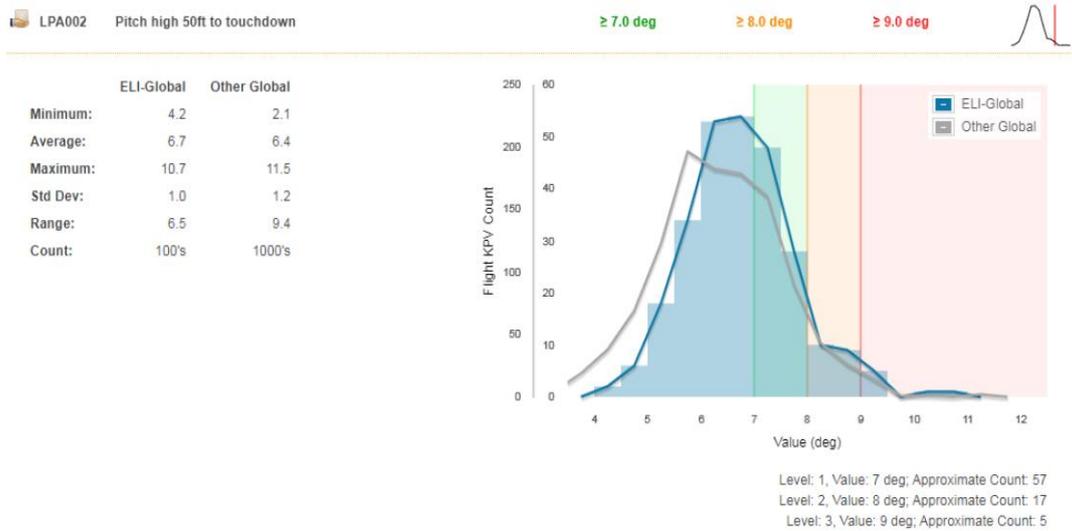
- e. Pitch angle 50 ft to touchdown: Event Code LPA002 with Level 1 set at 7 deg NU, Level 2 set at 8 deg NU and Level 3 at 9 deg NU.

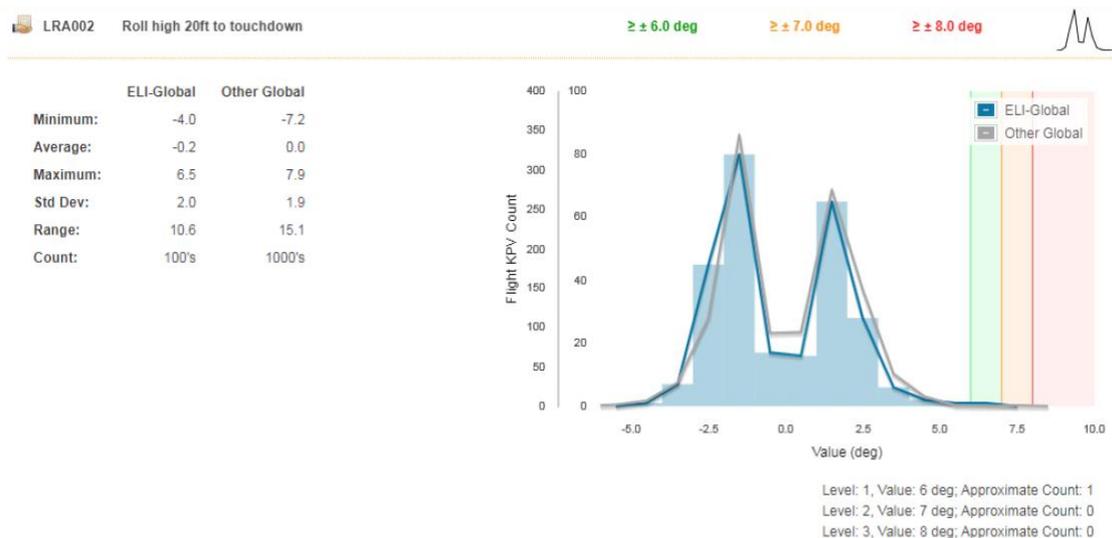
f. Roll angle 20 ft to touchdown: Event Code LRA002 with Level 1 set at 6 deg roll, Level 2 at 7 deg roll and Level 3 at 8 deg roll.

The FDMP provider has been requested to introduce an additional event for roll below 10 ft RA to monitor roll angle close to the ground set at:

Level 1: Roll +/- of 3 deg or more

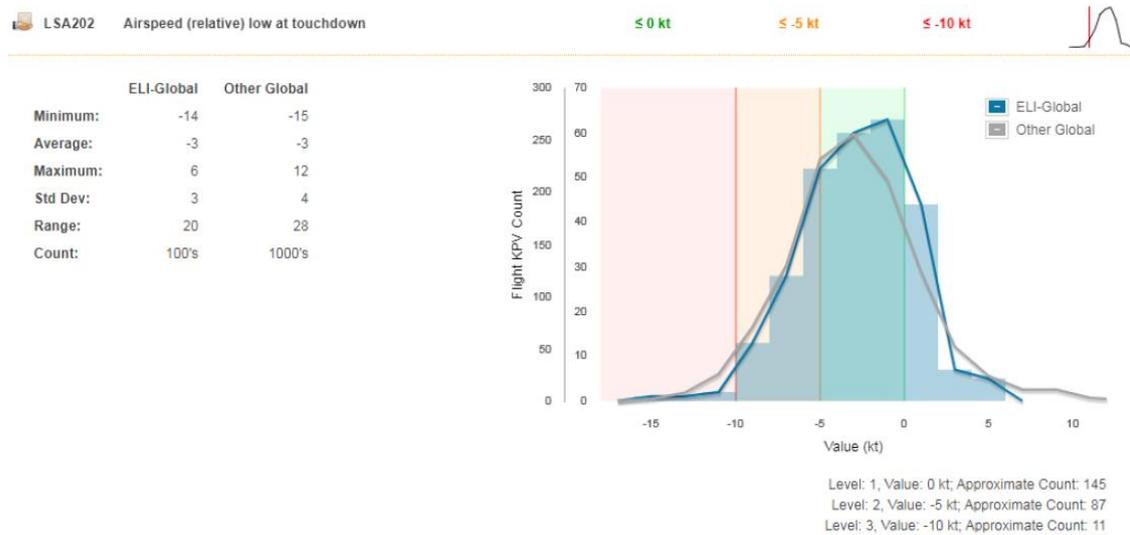
Finally, airspeed at touchdown is monitored by Event LSA 202. The trigger parameters and data spread is shown in schematic below:

It is proposed that the LSA202 parameters be changed to reflect that airspeed on landing is approximately 5% less than  $V_{app} / V_{ref}$ . The proposed Event Parameters:

Level 1 <  $V_{ref} - 5$  kts, Level 2 <  $V_{ref} - 7$  kts and Level 3 <  $V_{ref} - 10$  kts
