國家運輸安全調查委員會

重大運輸事故 調查報告

Elit'Avia Malta Limited 航空公司 EAU52P 班機

於臺中國際機場落地時翼尖接觸跑道

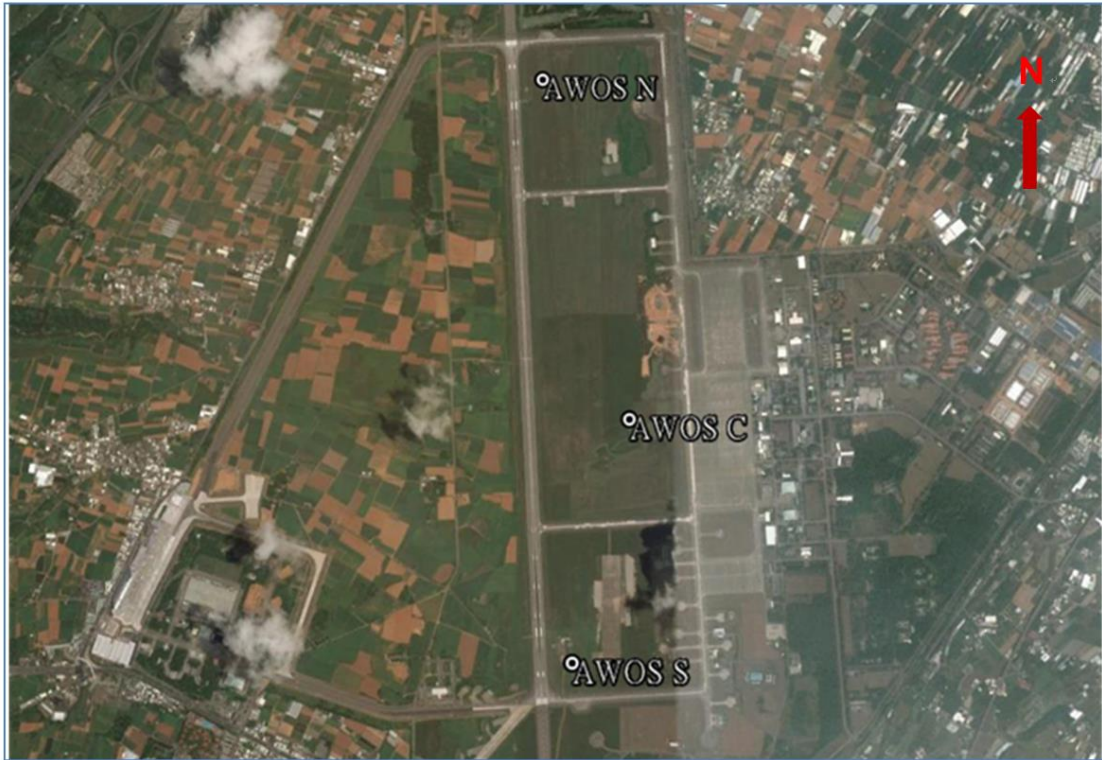
圖 1.7-1 AWOS 設置地點

臺中機場地面自動氣象觀測系統(automated weather observation system, AWOS)設置於跑道兩端及中段附近，如圖 1.7-1，提供臺中機場天氣中心及塔臺即時之天氣資訊顯示。1035 時至 1041 時之風向風速如圖 1.7-2、1.7-3，自 1037:56 時(該機雷達高度 220 呎)至 1040:10 時(該機進入滑行道)，AWOS S 風向為 010 至 050 度，風速 14 至 31 浬/時；AWOS C 風向為 020 至 050 度，風速 23 至 45 浬/時。

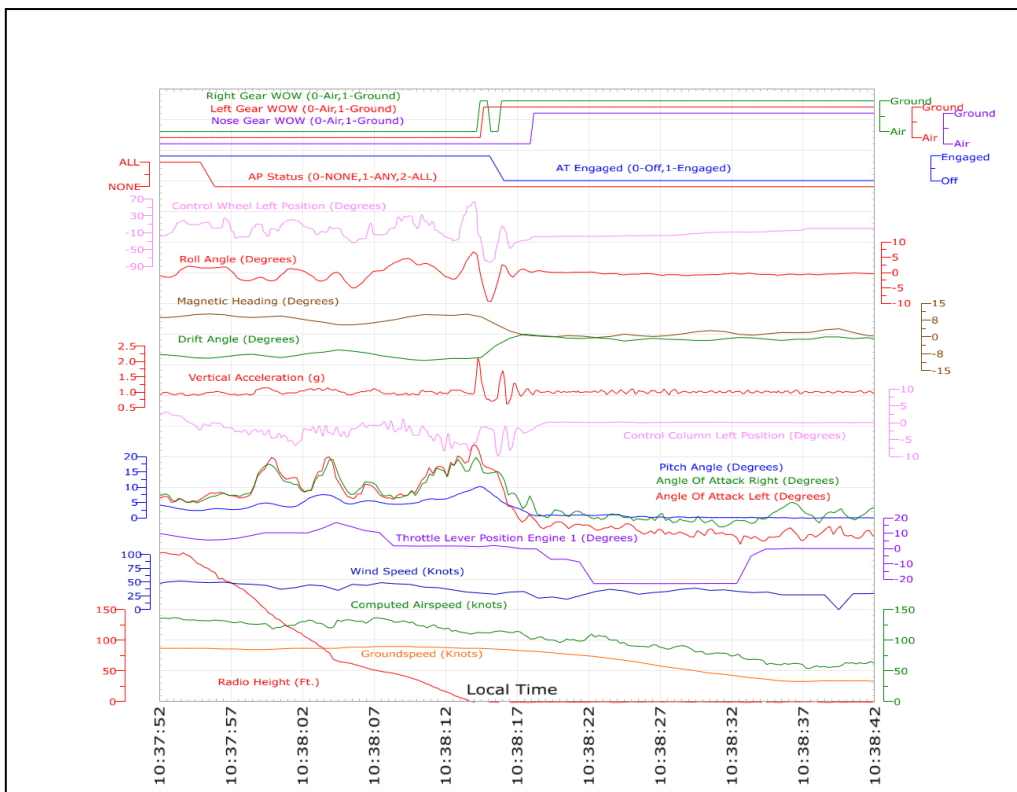
圖 1.11-1 落地階段之飛航資料繪圖（自動駕駛解除後）

圖 1.11-1 及圖 1.11-2 為事故航機落地階段之相關飛航資料繪圖，圖 1.11-3 為事故航班 FDR 紀錄之飛航軌跡。

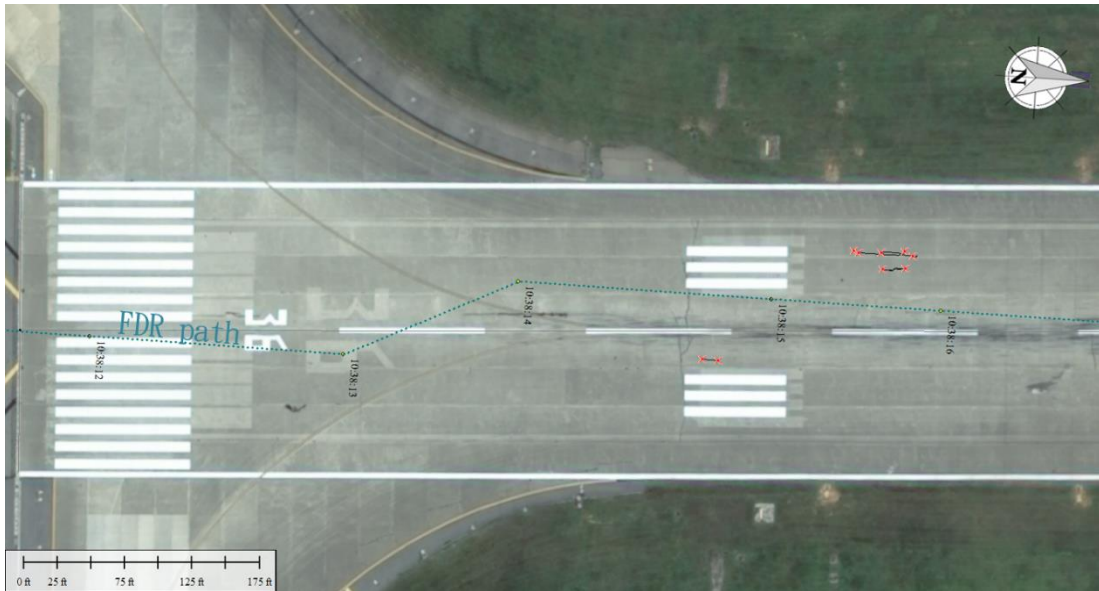
圖 1.12-1 現場測繪與飛航資料紀錄器飛行軌跡套疊

編號.	測繪項目	與 36 跑道頭之距離 (呎)	長度 (呎)
1	第一觸地痕跡 (R1)	503~515	12
2	第二觸地痕跡 (L1)	636~652	15
3	第三觸地痕跡 (L2)	618~658	42
4	第四觸地痕跡 (L3)	633~650	17

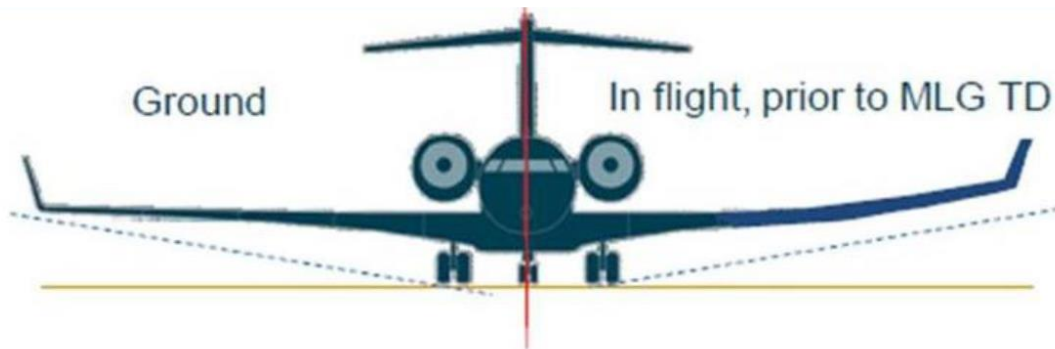
There is a direct correlation between pitch angle and roll angle with regards to risk of wing ground contact on landing. The following schematic is provided by Bombardier and is part of the e-learning module with regards to crosswind landings.

PITCH angle	Bank Angle for wing tip contact (ground, no lift)	In Flight (lift, increased dihedral)
0	10.6	13.5
3	9.6	12.3
6	8.5	11.2
9	7.4	10.1

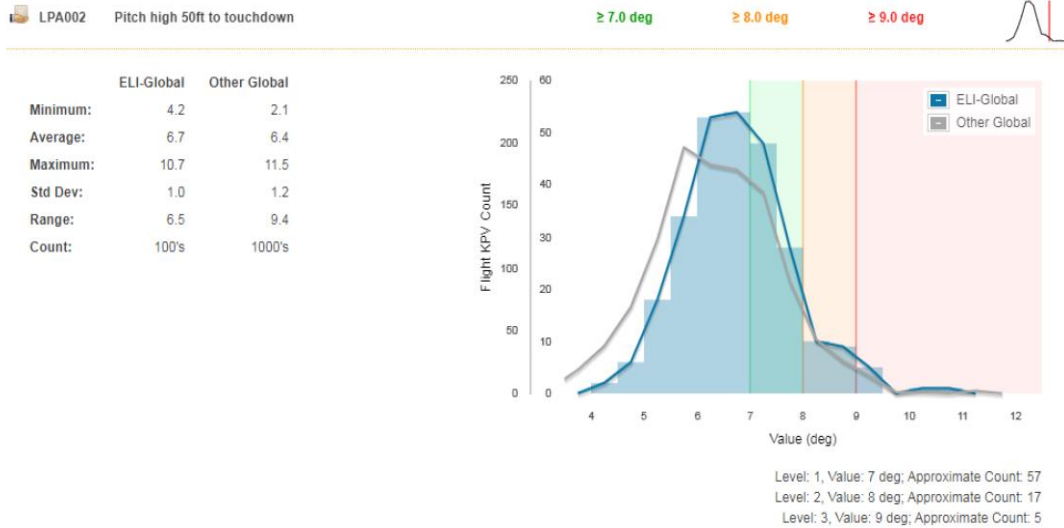
e. Pitch angle 50 ft to touchdown: Event Code LPA002 with Level 1 set at 7 deg NU, Level 2 set at 8 deg NU and Level 3 at 9 deg NU.

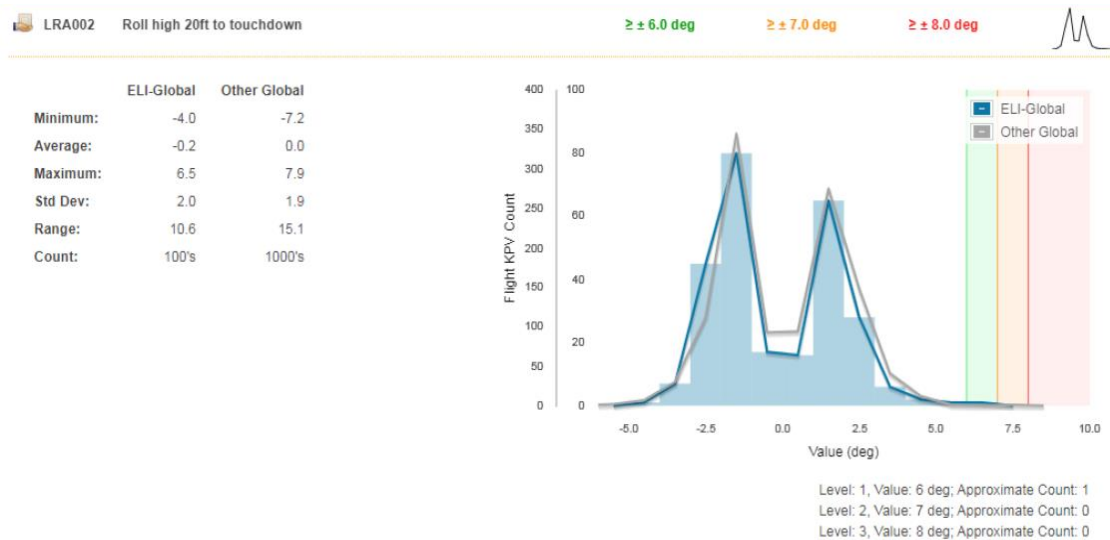
f. Roll angle 20 ft to touchdown: Event Code LRA002 with Level 1 set at 6 deg roll, Level 2 at 7 deg roll and Level 3 at 8 deg roll.

The FDMP provider has been requested to introduce an additional event for roll below 10 ft RA to monitor roll angle close to the ground set at:

Level 1: Roll +/- of 3 deg or more

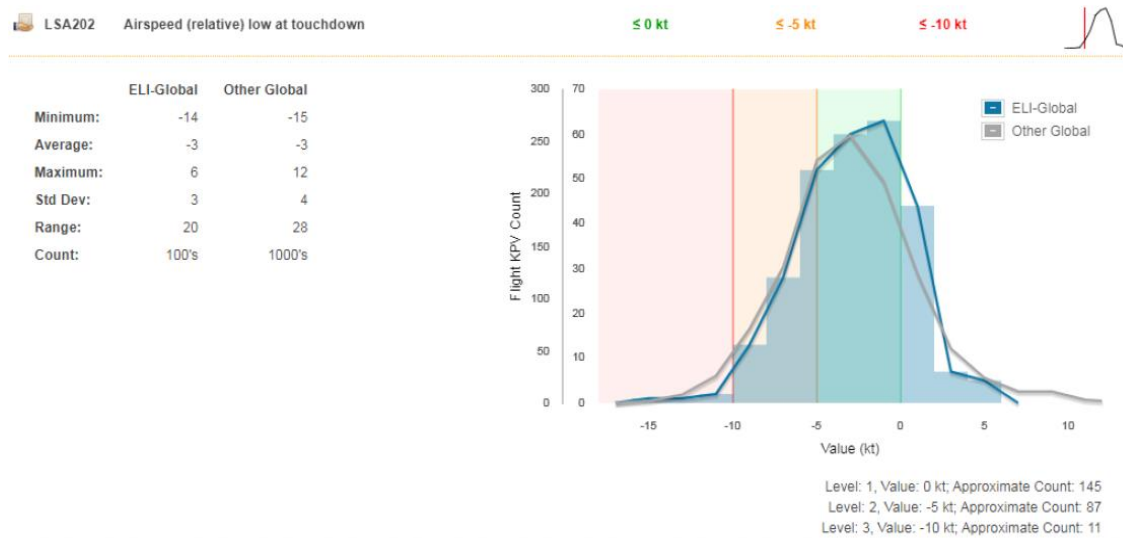
Finally, airspeed at touchdown is monitored by Event LSA 202. The trigger parameters and data spread is shown in schematic below:

It is proposed that the LSA202 parameters be changed to reflect that airspeed on landing is approximately 5% less than V_{app} / V_{ref} . The proposed Event Parameters:

Level 1 < V_{ref} - 5 kts, Level 2 < V_{ref} - 7 kts and Level 3 < V_{ref} - 10 kts
