Taiwan Transportation Safety Board

Major Marine Occurrence Factual Data Report

**The Palau-flagged Container Ship ANGEL Sank off
near the Port of Kaohsiung**

Report number: TTSB-MFR-24-01-001

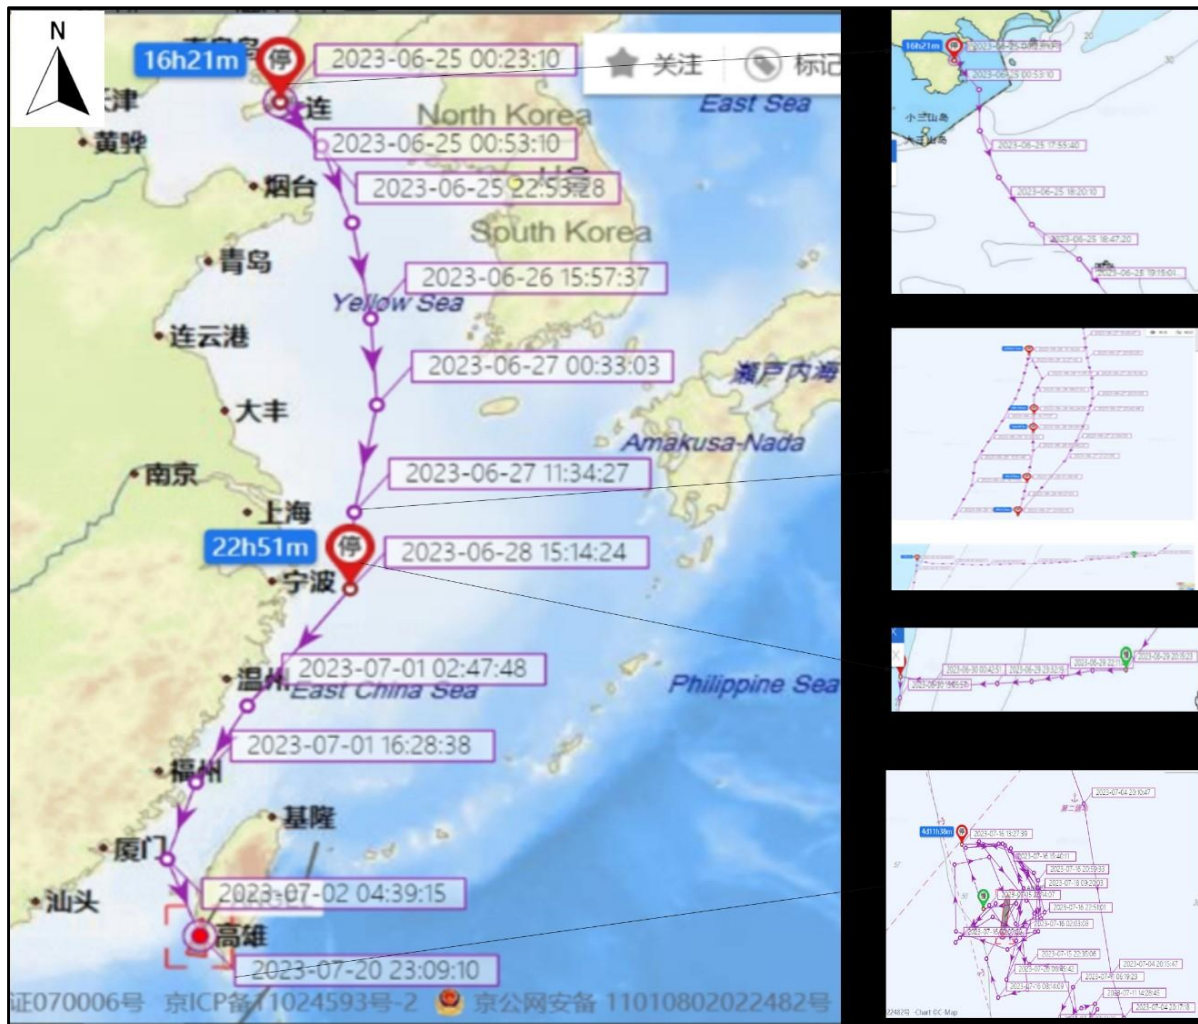
Figure1.10-1 AIS track data of the ANGEL occurrence voyage

Figure 1.10-1 shows the AIS track²⁵ of the ANGEL occurrence voyage. The recording time included the period from 0023 hours on June 25 to 2309 hours on July 20. Important changes in the ANGEL's sailing track are excerpted below:

- At about 2154 hours on July 4, the ANGEL reported the anchor position to Port of Kaohsiung VTS.
- At 2205:30 on July 20, the last ship position information of the ANGEL.

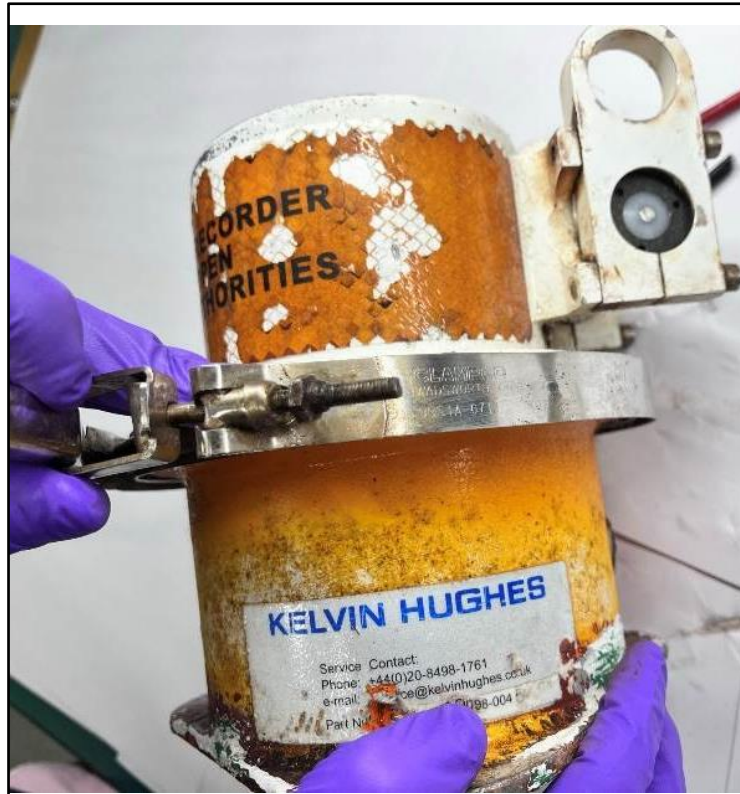
Figure1.10-2 Visual inspection of appearance of S-VDR CSM

The investigation team obtained the S-VDR on August 19, 2023, and no physical damage was found during the visual inspection (Fig. 1.10-2). After the VDR was disassembled, the memory module was removed, the CSM circuit board was cleaned and dried, and the CSM circuit board was inspected through a microscope and confirmed to be intact (Fig. 1.10-3).

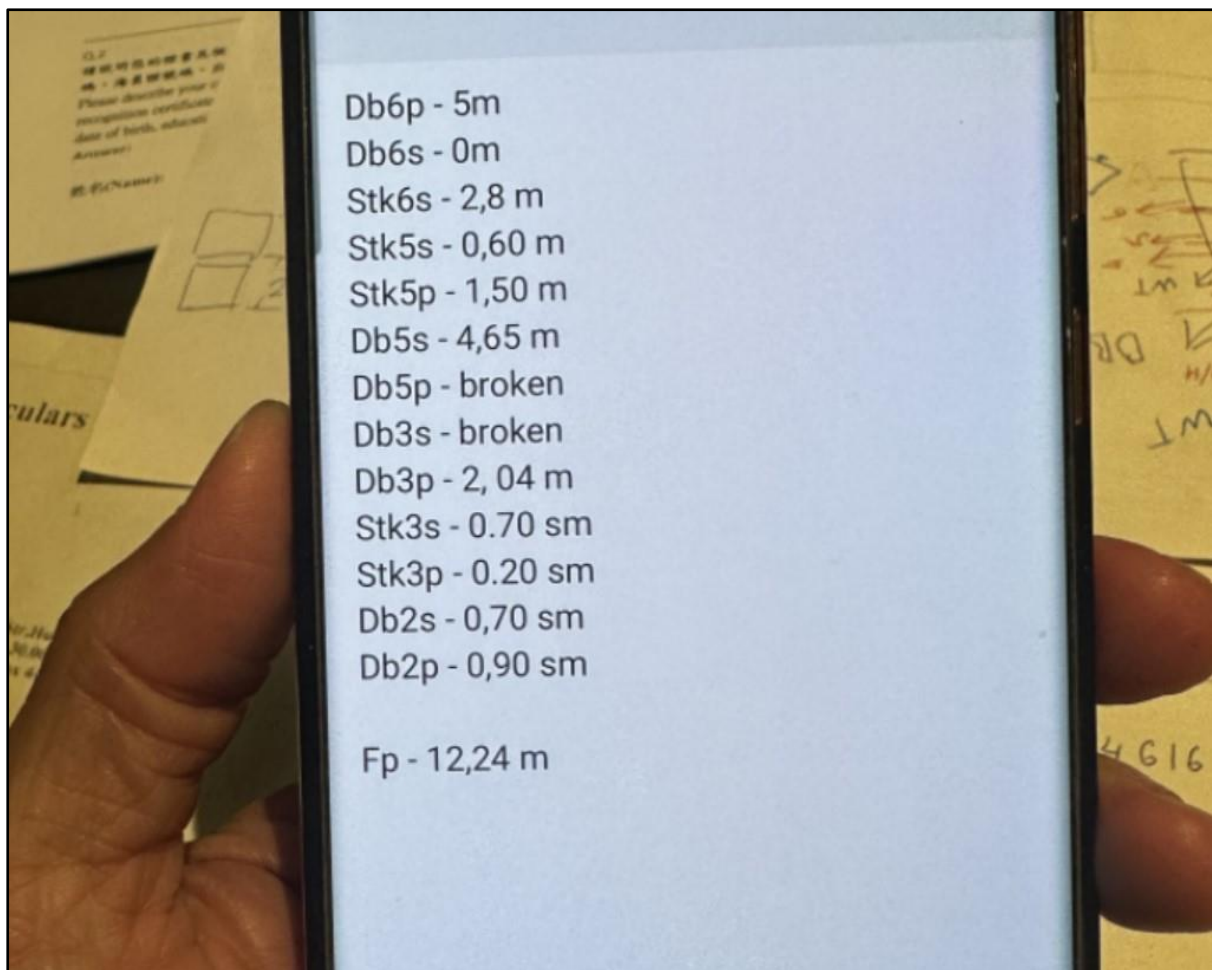
Figure1.11-1 Water depth data on the ANGEL's ballast water

During the interview, the interviewee presented water depth data of the ballast water tank (Fig. 1.11-1, obtained on July 24, 2023). The water measuring pipes in many places on the ANGEL were blocked due to blockage. The measurement data of the ballast water may be inaccurate. Some water tanks without water measurement records (Fig. 1.11-1 noted as "broken") were mostly water tanks that could not be measured or were inaccurate. Many pipelines were damaged, and the water depth of the ballast water tank was only approximate. The crew was unable to fully measure the water depth of the ballast water tank.
