Taiwan Transportation Safety Board

Major Marine Occurrence Final Report

**The Palau-flagged Container Ship ANGEL Sank off
near the Port of Kaohsiung**

Report Number: TTSB-MOR-25-01-001

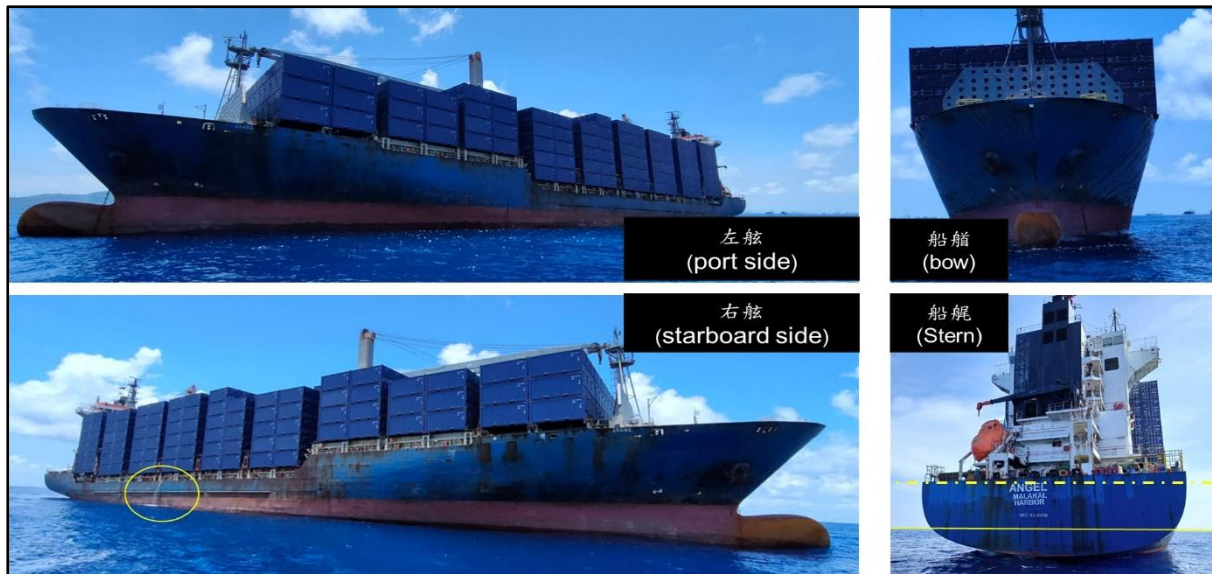
Figure1.1-2 Appearance of the ANGEL during Anchored. (taken on July 20, 2023)

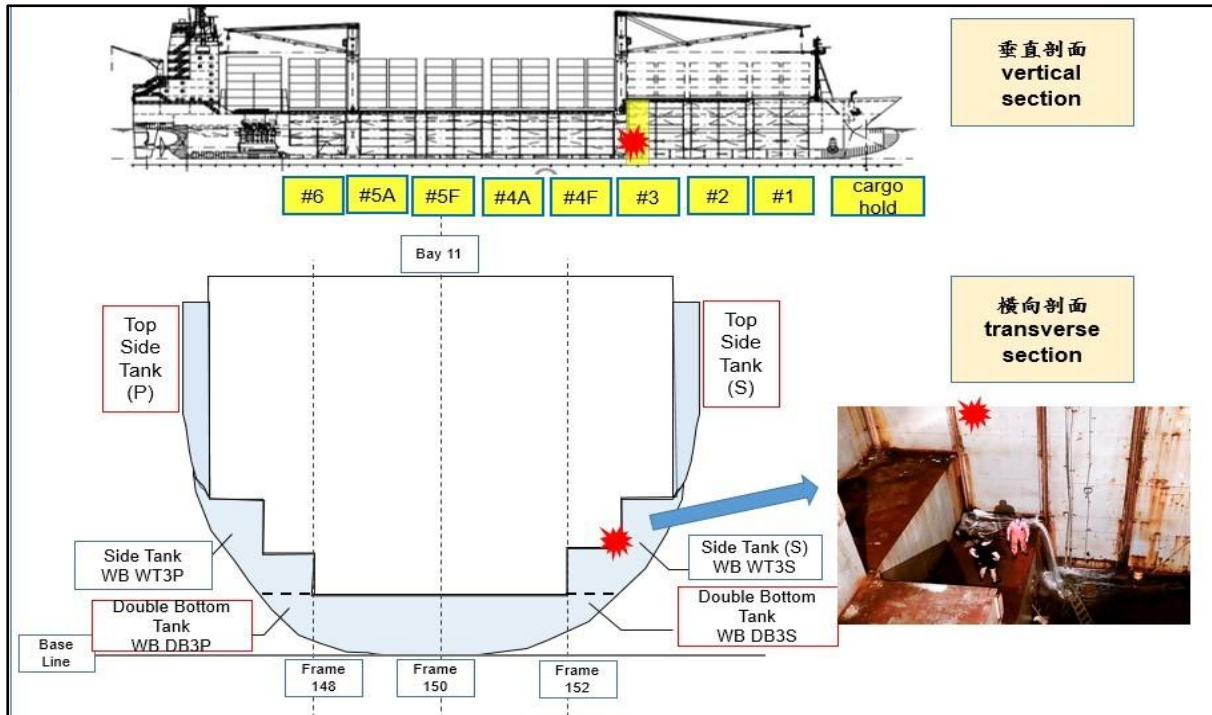
On June 26th, the Deck Log Book documented that the initial measurement of water ingress in cargo hold no.3 was 10 centimeters. Subsequent entries on June 27th indicated a rise in water ingress levels from 30 centimeters to 50 centimeters in cargo hold no.3, accompanied by a 5-degree listing to both the port side and starboard sides. The former master reported to the ZULU continued to operate the ballast water system and proceeded to engage the ballast water system and portable pumps for water pumping operations (refer to Figure 1.1-2).

Figure1.1-4 Schematic diagram of the cargo hold distributions on the ANGEL and the ballast water in the cargo hold no. 3.

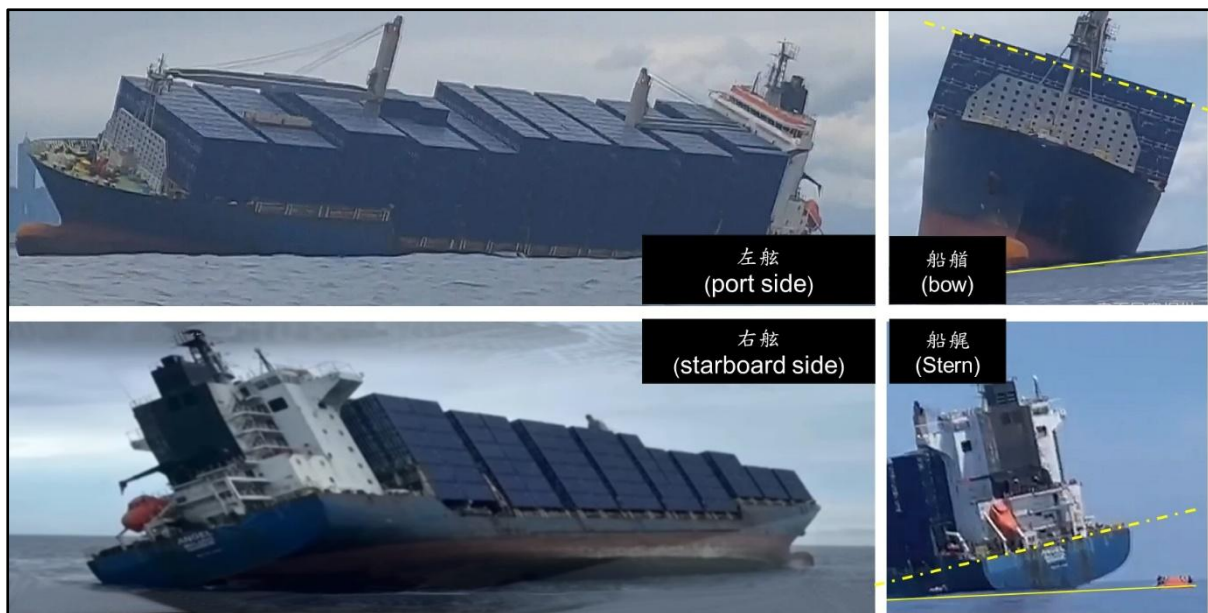
Crew interviews indicated that when all crew members gathered and began to abandon ship at 1000 hours, the ship's hull listed about 8 to 9 degrees to the portside (as detailed in Figure 1.1-6). At about 1015 hours, the TIPC-Kaohsiung established an emergency response team to respond; at 1235 hours, the Coast Guard completed the rescue of 19 crew members of the ANGEL.

Figure1.1-6 The exterior view of the ANGEL as the master abandoned the ship

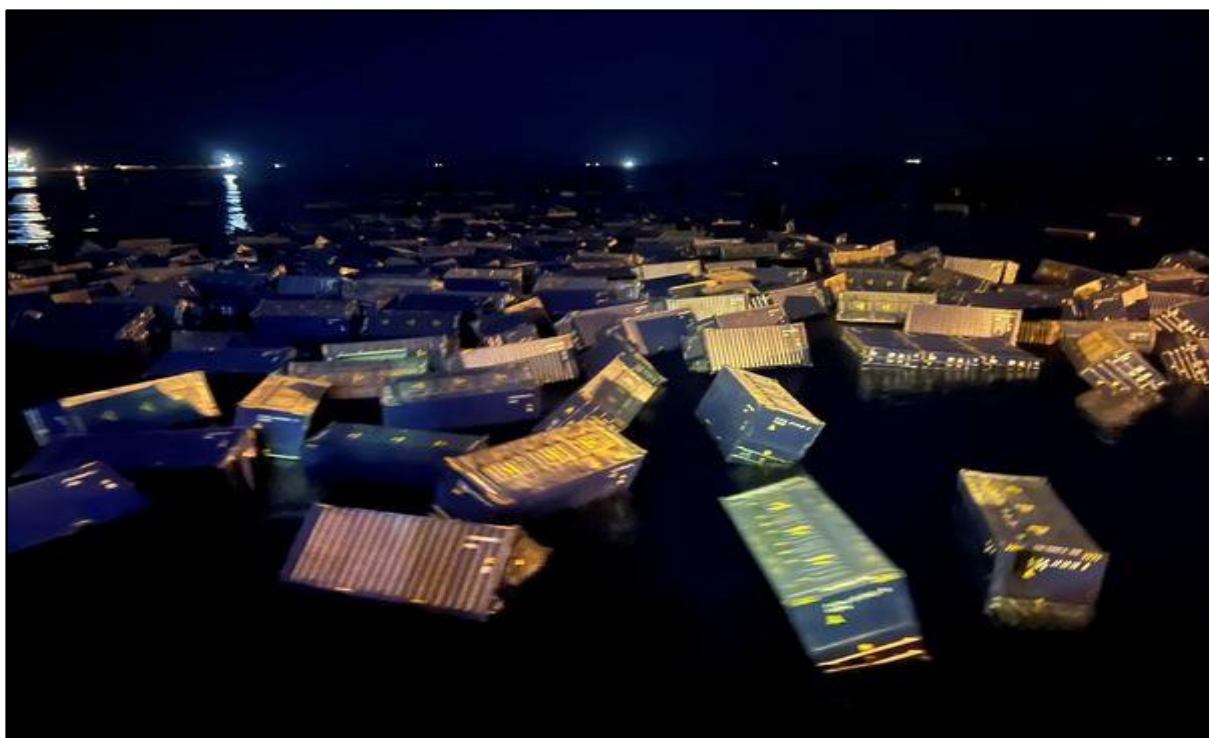
Figure1.1-7 Exterior view of the containers scattered from the ANGEL

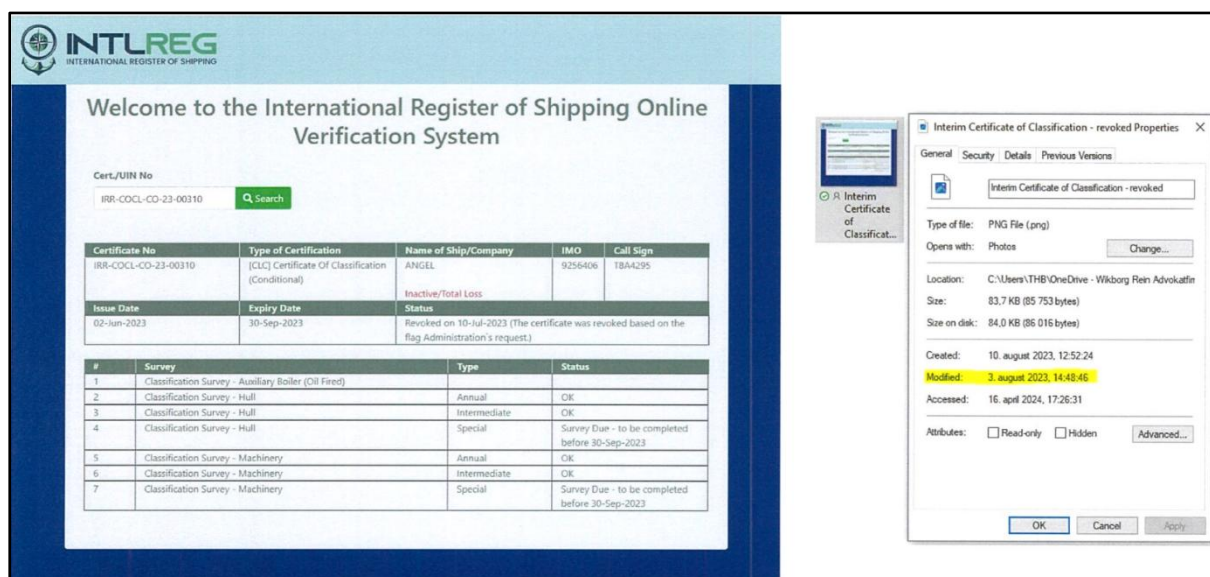
On April 20th, 2024, the TTSB received a letter from the attorney appointed by HYDOR AS. The letter also provided a screenshot of the status of the ANGEL's certificate on the Classification Society's website on August 3rd, 2023 (as detailed in Figure 1.7-6). The content shows "Inactive/Total Loss on 10-Jul-2023 (The certificate was revoked based on the flag Administration's request)".

Figure 1.7-6 Screenshot of the ANGEL's certificate status from the INTLREG (taken on August 3rd, 2023)

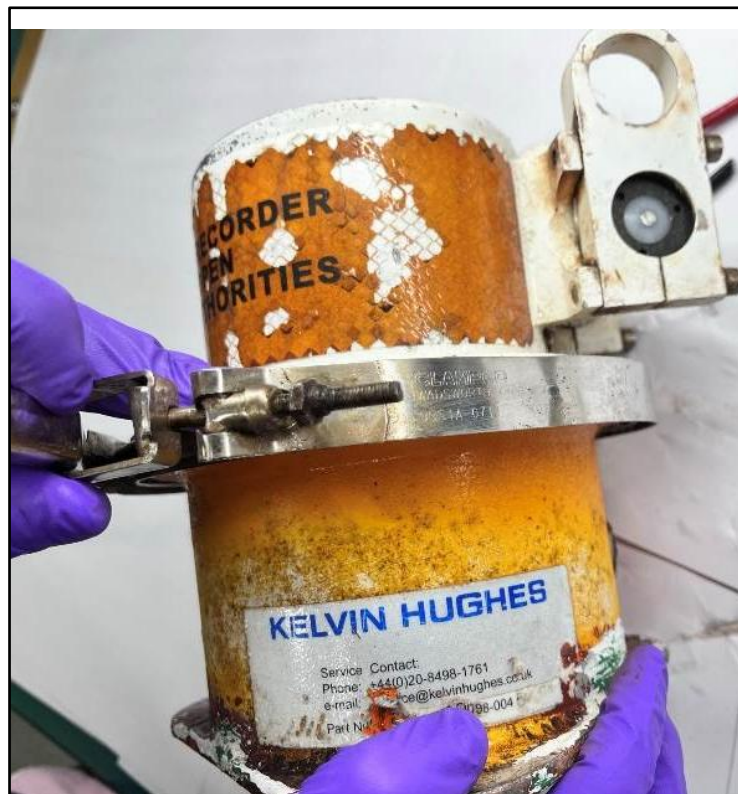
After the TTSB obtained the S-VDR, no physical damage was found during the visual inspection (Figure 1.10-2). The TTSB obtained technical assistance from the British Marine Accident Investigation Branch (MAIB) to download the original VDR data. The length of the ANGEL's S-VDR data was 23 hours, 50 minutes, and 20 seconds (from approximately 2327:46 on July 19th to approximately 2318:06 on July 20th, Taiwan time).

Figure 1.10-2 Visual inspection of the appearance of the S-VDR CSM.

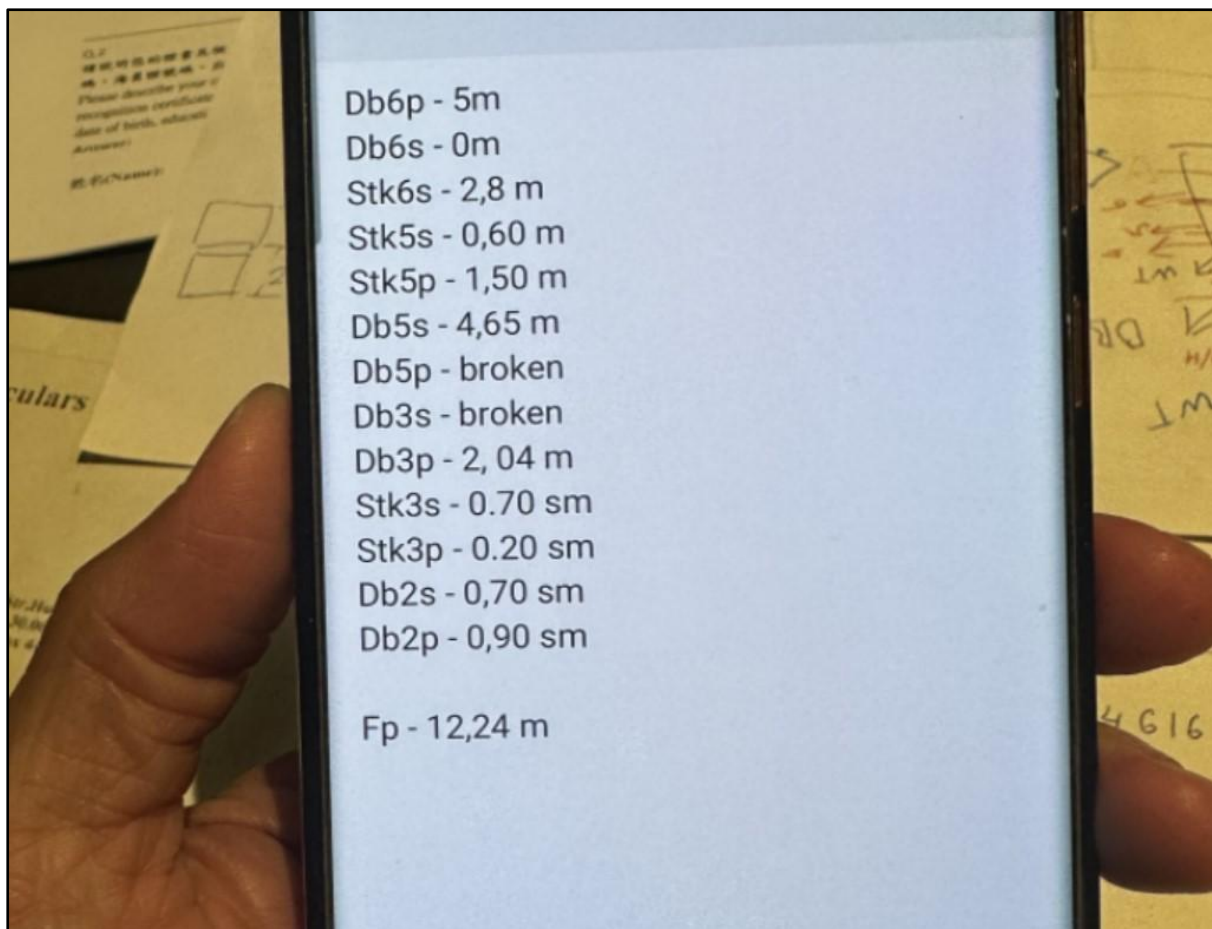
During the interview, the interviewee presented water depth data of the ballast water tank. The water measuring pipes in many places of the ANGEL were blocked. The measurement data of the ballast water may be inaccurate. Some water tanks without water measurement records (Figure 1.11-2 noted as "broken") were mostly water tanks that could not be measured or measurements were inaccurate. Many pipelines were damaged, and the water depth of the ballast water tank was only an estimation. The crew was unable to fully measure the water depth of the ballast water tank.

Figure 1.11-2 Water depth data on the ANGEL's ballast water

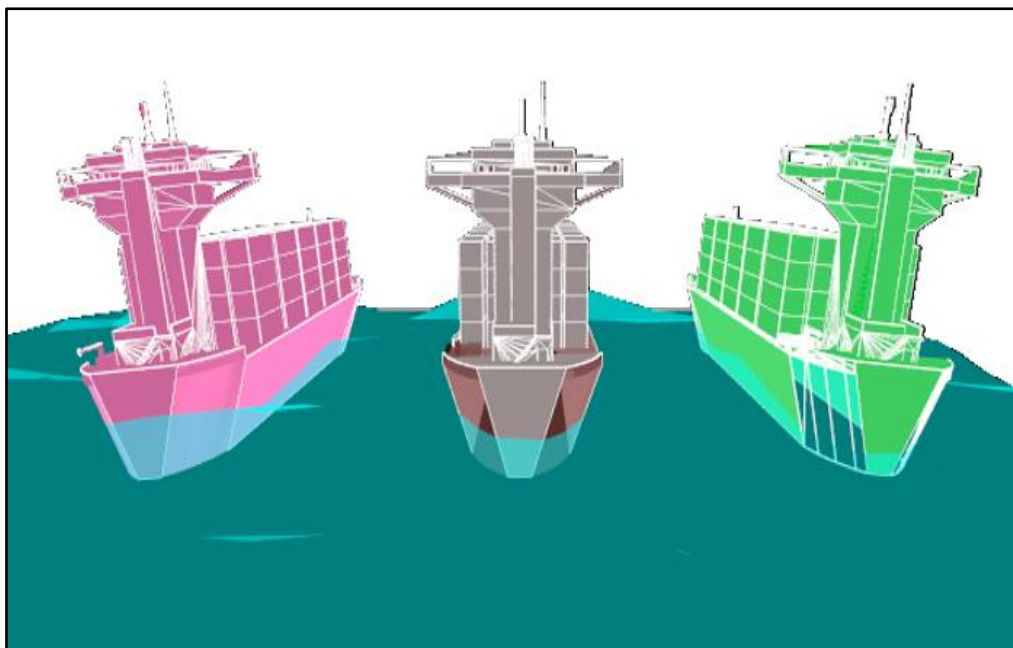
Figure 2.4-1 Schematic diagram of the ANGEL's irregular listing to port and starboard (within 5 degrees) after cargo hold flooding

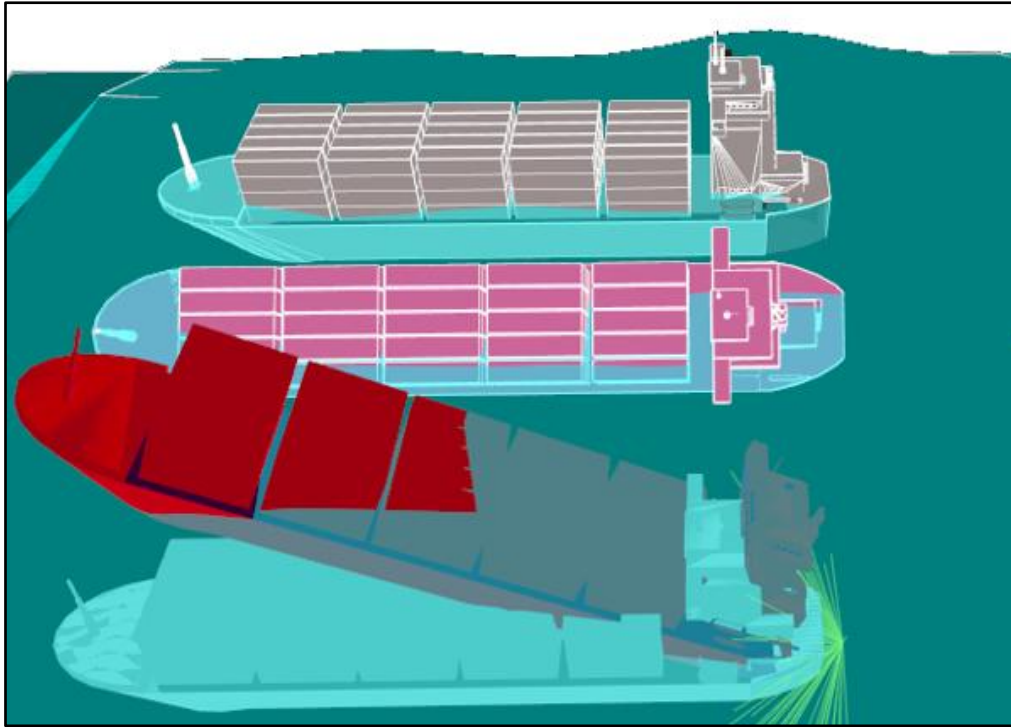
The TTSB believes that the long-term neglect of hull and piping system maintenance of the ship led to the breach of the cargo hold bottom and piping, massive flooding in the cargo holds, inability to measure most of the ballast tanks, and multiple failures and interconnections in the ballast water system. On the day of the occurrence, the main generator ceased operation, and the ship quickly listed 45 degrees to the port side, resulting in a large amount of seawater ingress into the cargo holds and engine room, leading to the complete sinking of the ship early the next morning.

Figure 2.4-2 Schematic diagram of the listing and sinking after the cargo holds of the ANGEL were flooded (plan view)

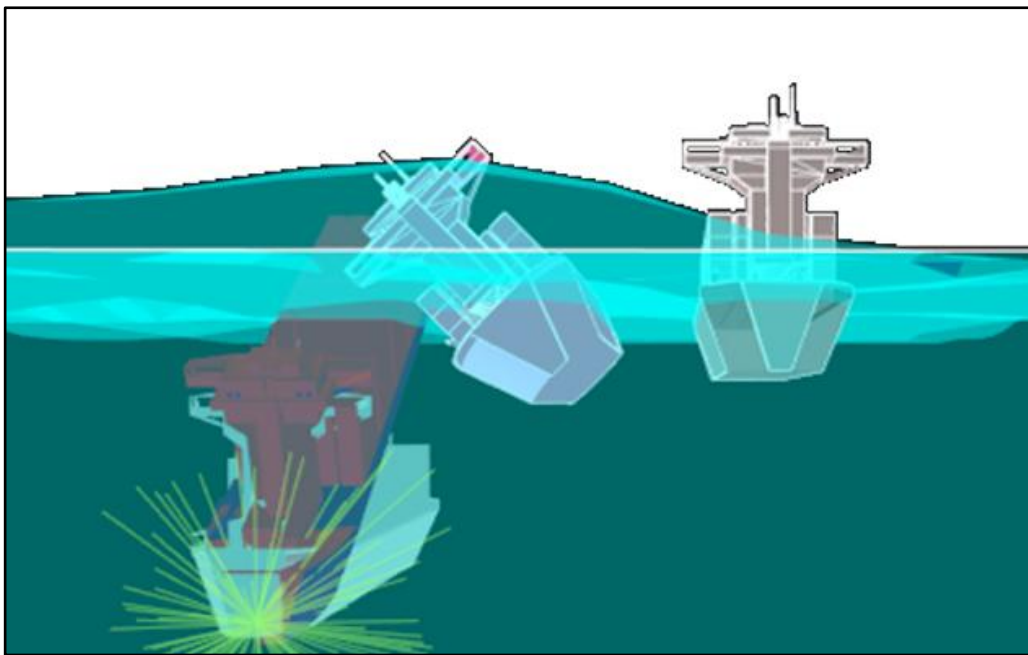
Figure 2.4-3 Schematic diagram of the listing and sinking after the cargo holds of the ANGEL were flooded (vertical cross-section view)

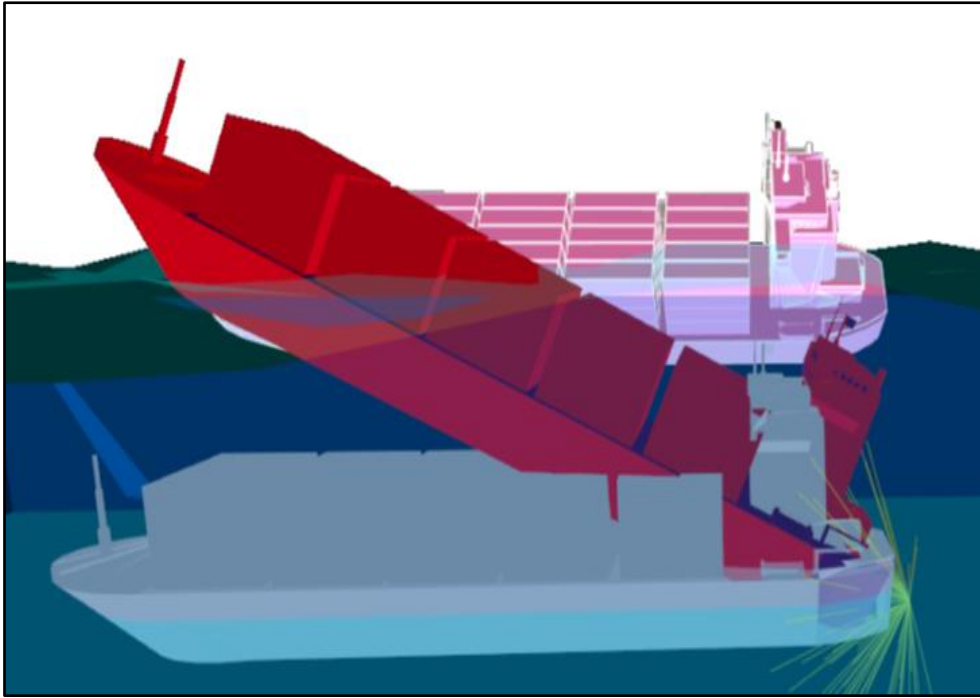
Figure 2.4-4 Schematic diagram of the listing and sinking after the cargo holds and engine room of the ANGEL were flooded. (plan view)

In summary, the ANGEL sailed with a full load of containers when the flooding issue in the cargo holds exceeded the crew's capacity to handle it due to a combination of factors, including: (a) damage to the hull, ballast water pipelines, and valves due to long-term lack of maintenance; (b) blockage, rust, or breakage of the sounding pipes; and (c) blockage of the bilge sewage wells and potential failure of the check valves to close properly.
