# Derailment with Airport Express train

RAIF Taiwan 21 – 24 October 2025

Mikael Hillbo, Senior Investigator Rail  
Swedish Accident Investigation Authority

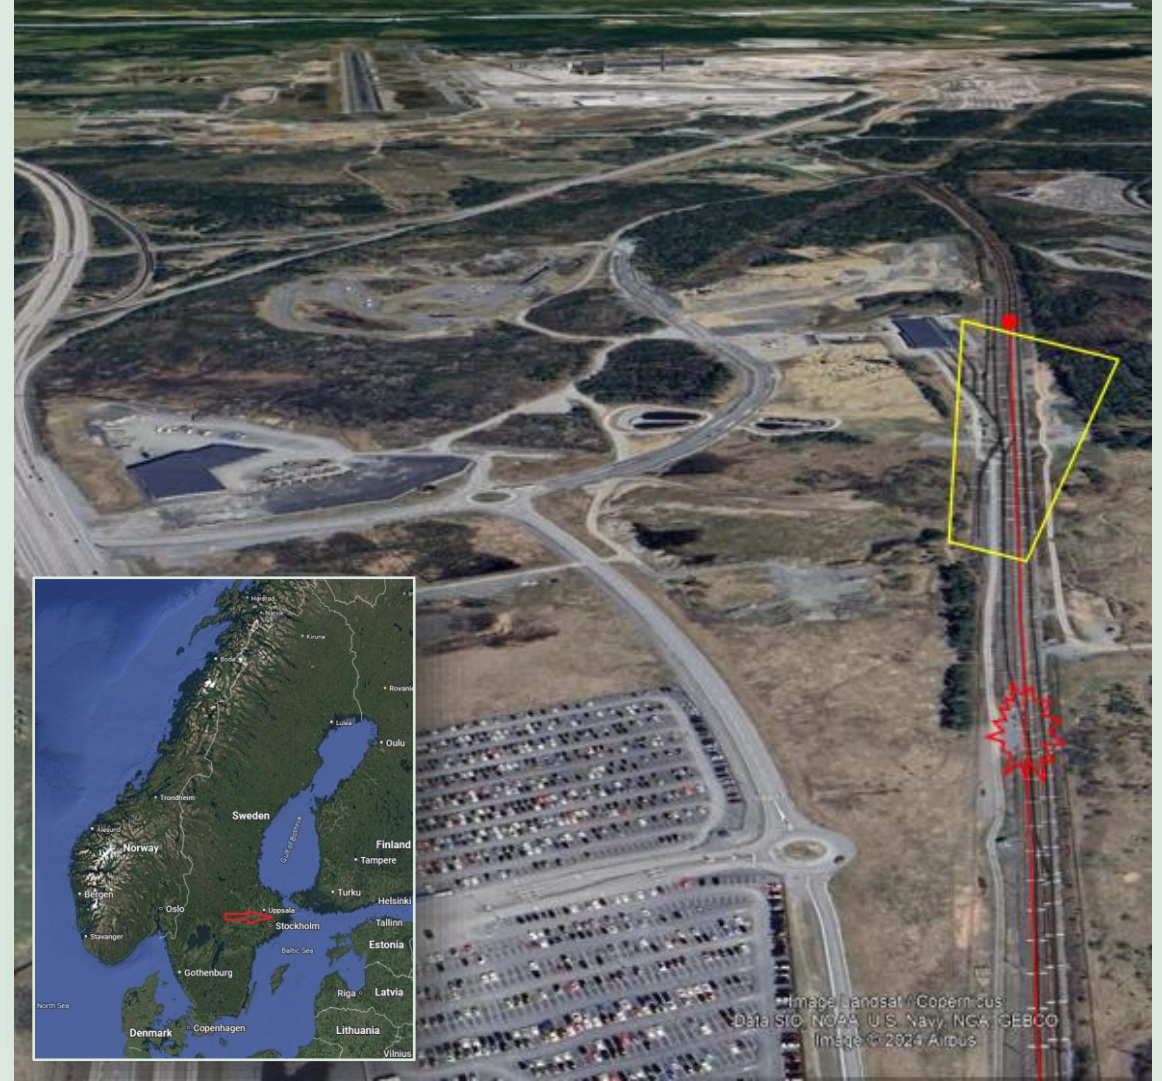
- May 27, 2023, at 4:35 AM
- At Blackvreten on A-Train AB's infrastructure
- The mornings first Arlanda Express train from Stockholm towards Arlanda airport
- 67 passengers onboard
- Driver and train attendant
- The train derailed at 178 km/h (110 mph)
- 900 meters before the train stopped
- One passenger suffered serious injuries

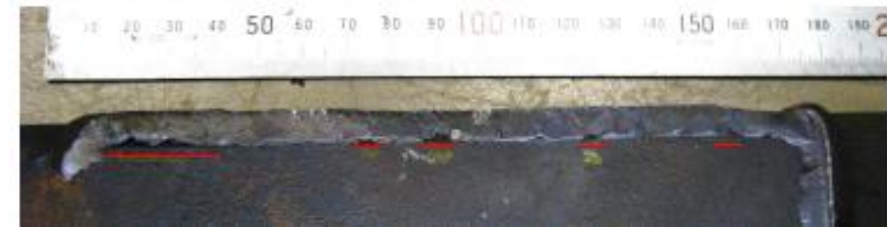
- Review of the crossing section together with our appointed metallurgical expert and specialists from the Swedish Transport Administration
- In-depth investigation of the crossing section in our workshop
- Molding of the plates under the moving crossing for microscope examination
- Diagonal marks on the plates clearly indicates the presence of movement and dynamics in the moving crossing

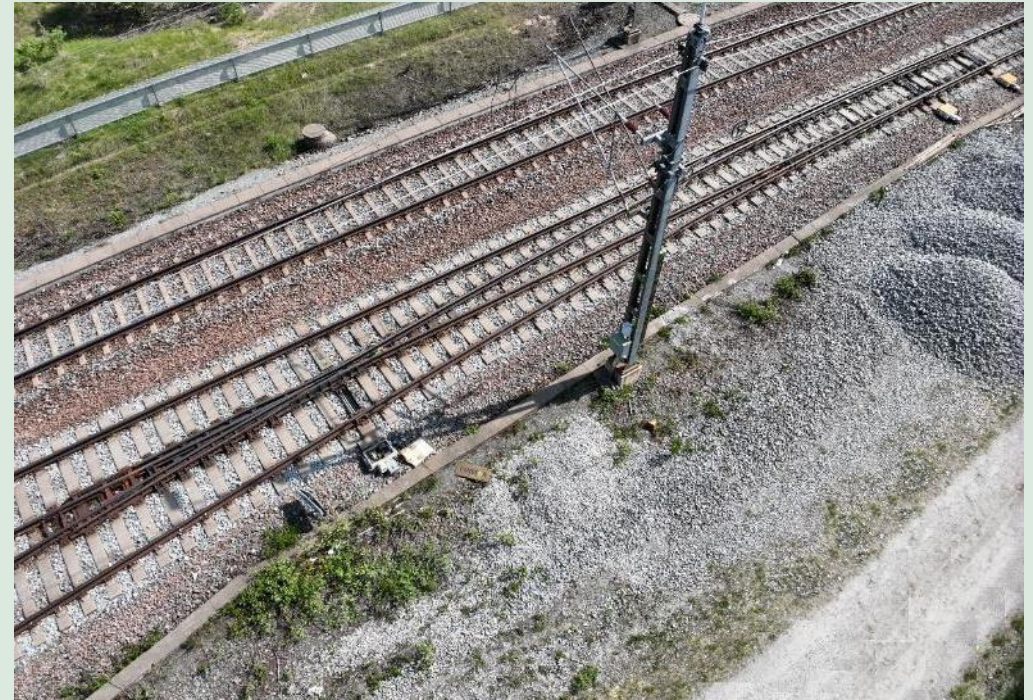
- Developed for the Arlanda Line between 2006 and 2008 to replace switches with high wear in fixed crossings
- Declaration that the switch met the applicable European standards for interoperability
- Approved for 200 km/h
- The drive connection plate was designed and dimensioned solely for static load and to last the entire lifetime of the switch
- Two switches delivered to A-Train AB, later nine switches to the Swedish Transport Administrations infrastructure
