# Passenger Train Derailment on Pingxi Branch Line

Jackie Chen  
2025.10.23

On February 12, 2024, Taiwan Railways Corporation, Ltd. (TRC) local train No. 4816, consisting of four cars, experienced a derailment after departing Lingjiao Station on the Pingxi Branch Line. The first and second axles at the front end of car No. 3 derailed.

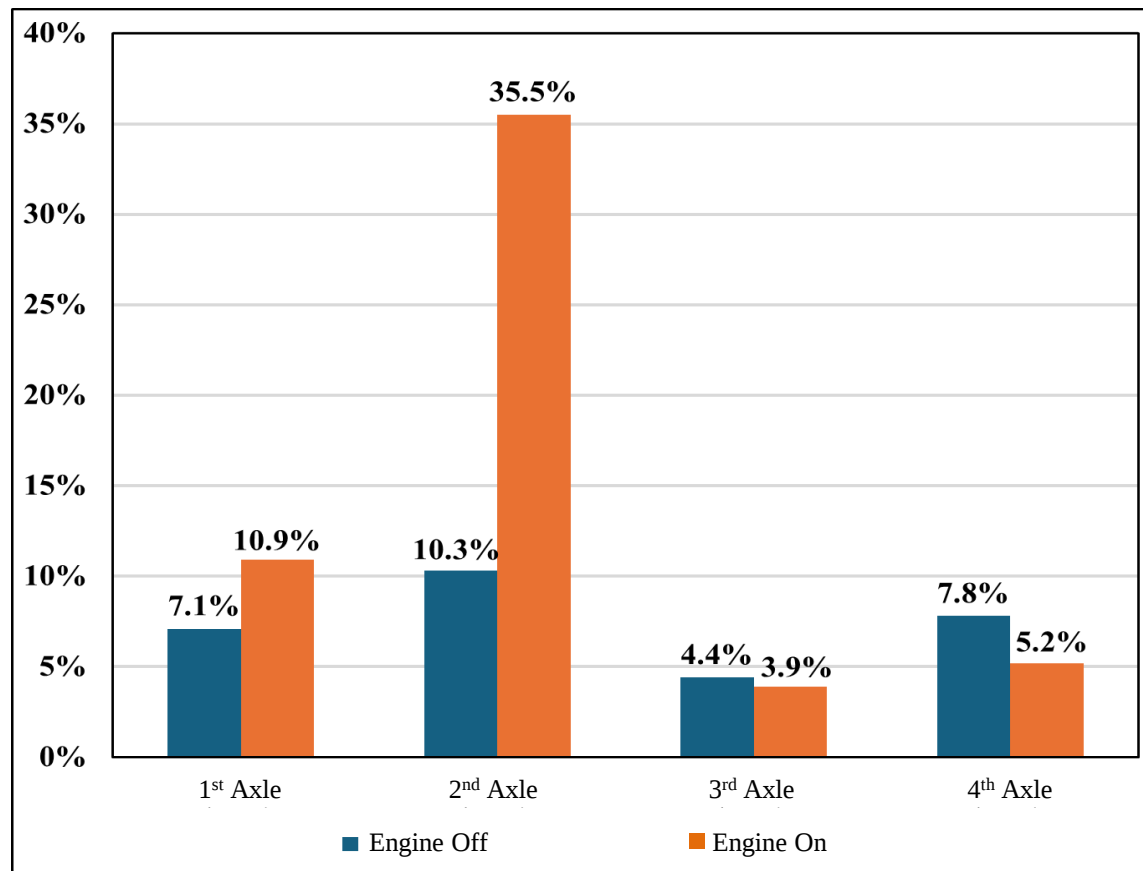
# Static Wheel Load Ratio

- No wheel load management measures

- Evaluate incorporating wheel load as a vehicle maintenance indicator and **establishing a wheel load management system.**
- Improve **drainage functionality** along the Pingxi Branch Line.
- Establish **repair deadlines** for rectifying track irregularities exceeding emergency maintenance thresholds and **reinforce post-maintenance inspection procedures.**
- Review and improve **rail wear inspection methods** to ensure compliance with regulatory standards.

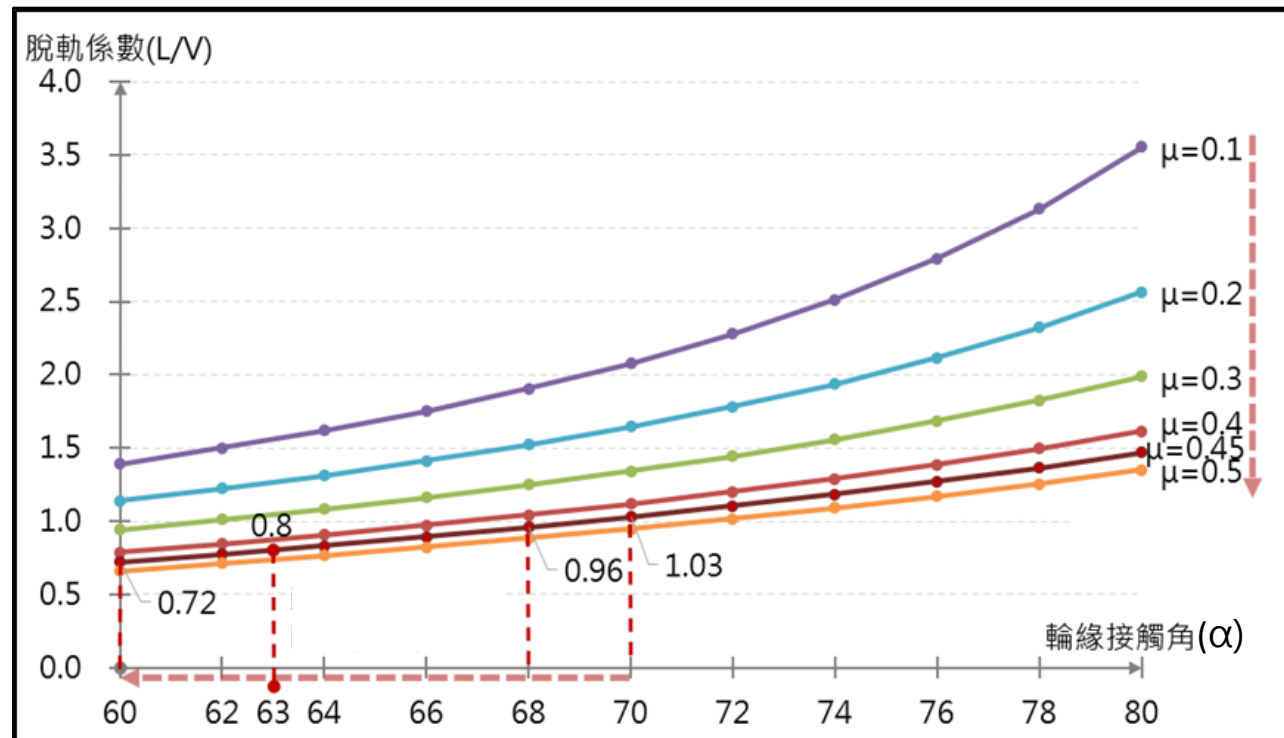
# Derailment Coefficient Threshold

The minimum derailment coefficient threshold dropped  
below international safety standards
