# Tosa Kuroshio Railway Nakamura Line, Train derailment accident

Japan Transport Safety Board

Accident Type : Train derailment

Date and Time of Occurrence : June 2, 2023 at around 08:58 a.m.

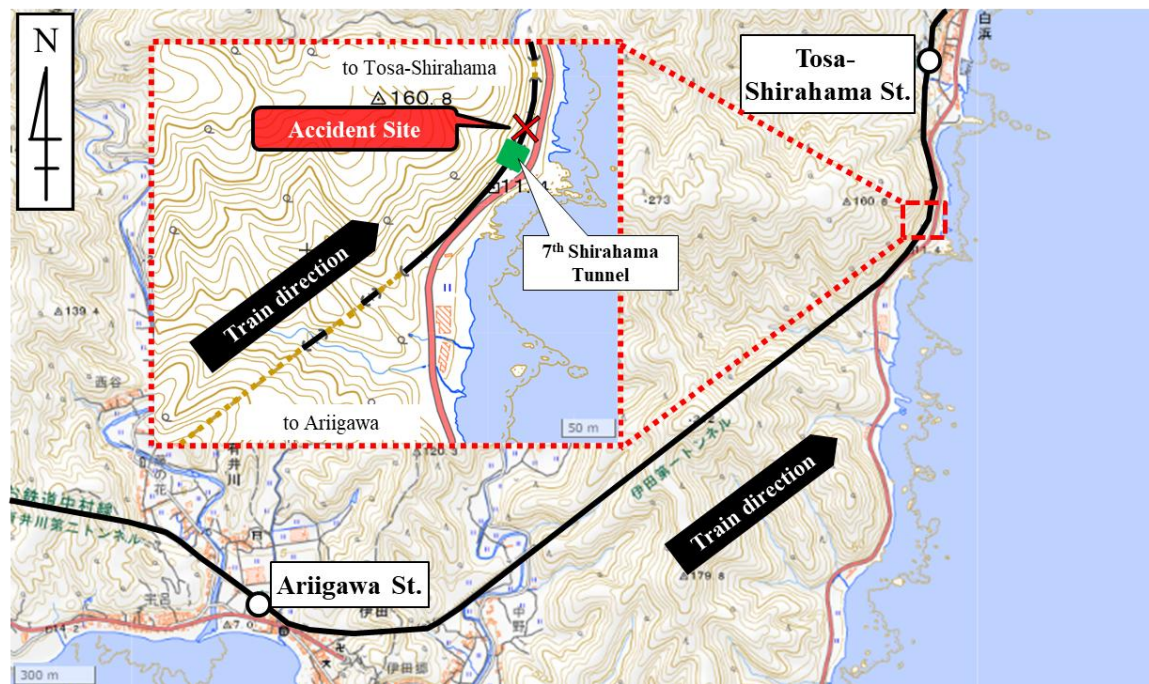
The 312D train, a single-car train bound for Kubokawa Station departed from Ariigawa Station on Friday, June 2, 2023, approximately 30 minutes later than the scheduled time (08:25) because of heavy rain. After entering the 7th Shirahama Tunnel, the driver of the train noticed some mud and sand on the track near the tunnel exit, so he applied the brakes while traveling at a speed of about 61km/h.
