# **Taiwan Transportation Safety Board**

### **Final Report**

**UPS Airlines Flight 5X61**

**Engine Nacelle Strike during Landing  
at Taiwan Taoyuan International Airport**

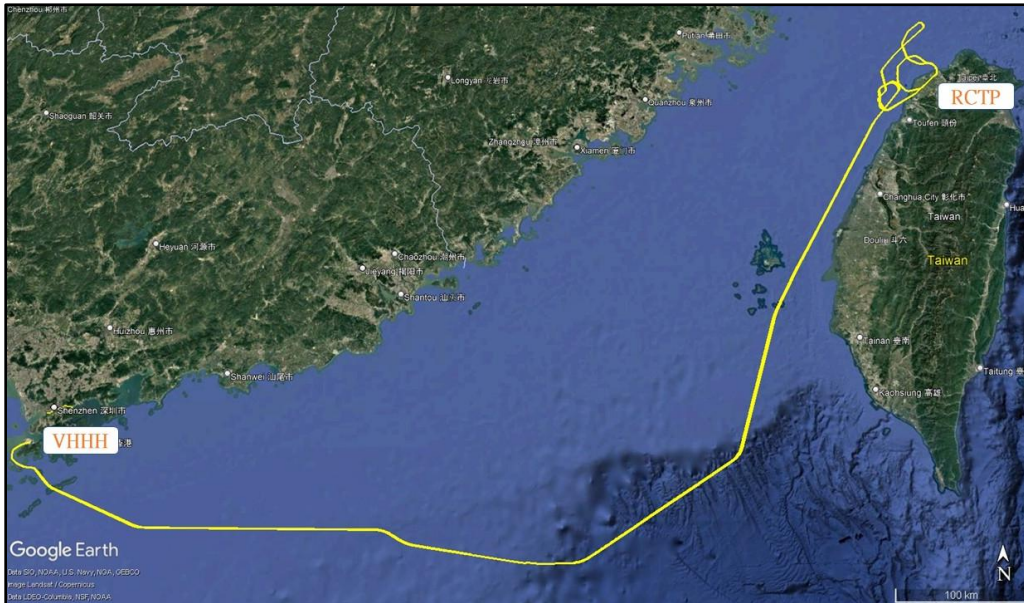
Figure 1.1-2 FDR recorded flight path of occurrence flight

During the post-landing walk-around, the crew discovered damage on the No. 4 engine and notified RCTP tower of the occurrence. Figure 1.1-1 shows the external appearance of the damage to No. 4 engine, while Figure 1.1-2 illustrates the FDR flight path of the occurrence flight.

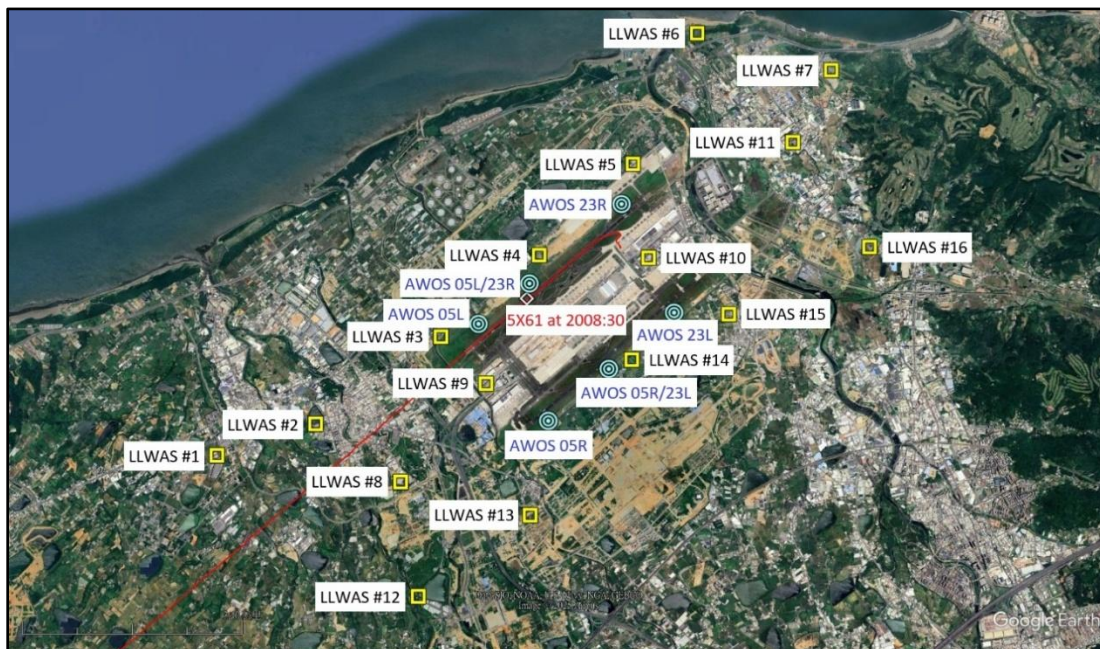
Figure 1.7-2 AWOS and LLWAS anemometer locations at RCTP

vicinity. The locations of the anemometers associated with the AWOS and the LLWAS at RCTP are shown in Figure 1.7-2. The AWOS anemometer height is 10 meters, while the LLWAS anemometer heights range from approximately 20 to 30 meters.

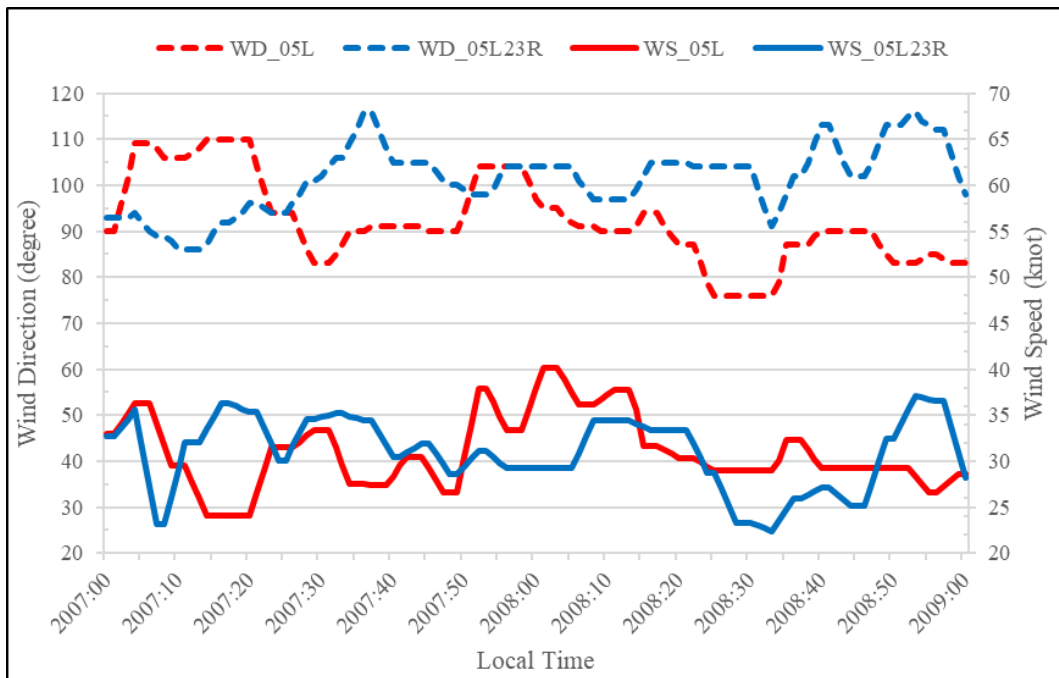
Figure 1.7-3 AWOS wind direction/speed

AWOS 05L and 05L/23R wind observations recorded between 2007 and 2009 are presented in Figure 1.7-3. Wind data from LLWAS sensors #3, #4, and #9, covering the period from 2007:05 to 2008:55, are shown in Figure 1.7-4.

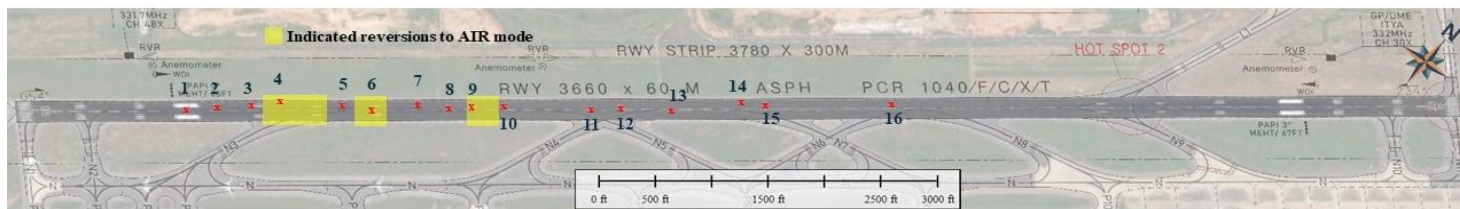
Figure 2.2-1 Sequence of events and FDR/CVR data during the landing roll

The aircraft touched down on Runway 05L at 2008:21. A sequence of events occurred during the landing roll between touchdown and the No. 4 engine nacelle strike at 2008:30. These events are analyzed in detail in the following subsections. Figure 2.2-1 provides an overview of the events during the landing roll. Figure 2.2-2 shows selected FDR-recorded parameters, including aircraft speed and attitude, flight crew control inputs, and the status of the engines and deceleration devices.
