# **Taiwan Transportation Safety Board**

### **Final Report**

**UPS Airlines Flight 5X61**

**Engine Nacelle Strike during Landing  
at Taiwan Taoyuan International Airport**

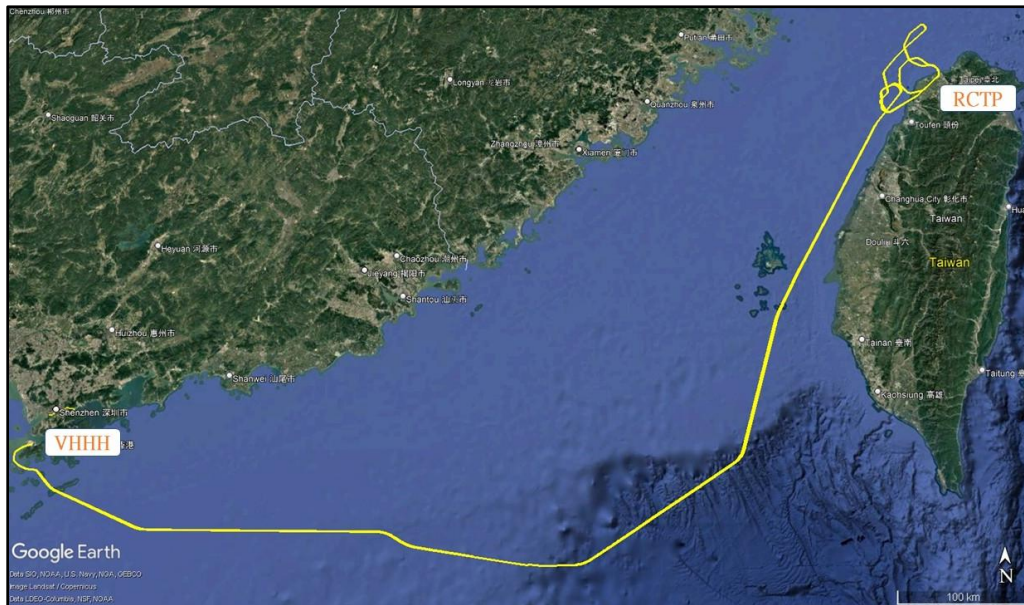
Figure 1.1-2 FDR recorded flight path of occurrence flight

During the post-landing walk-around, the crew discovered damage on the No. 4 engine and notified RCTP tower of the occurrence. Figure 1.1-1 shows the external appearance of the damage to No. 4 engine, while Figure 1.1-2 illustrates the FDR flight path of the occurrence flight.
