偏衝出跑道之風險管理

中華航空公司
企安室安全部副理
許榮祥

2018 IATA / TTTSB飛安數據
RE 風險因子
RE風險管理
綜合建議

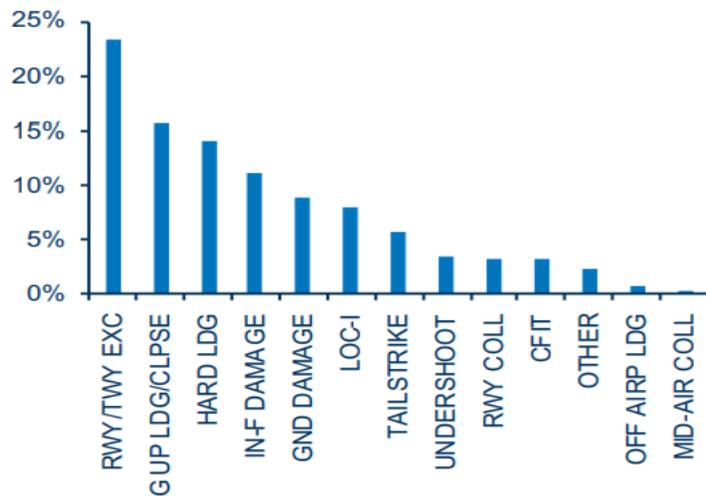
- 飛安事件率(2014-2018)

Accident Category Distribution (2014-2018)

Distribution of accidents as percentage of total

衝偏出跑道、滑行道為近年來發生
比例最高的事件類別

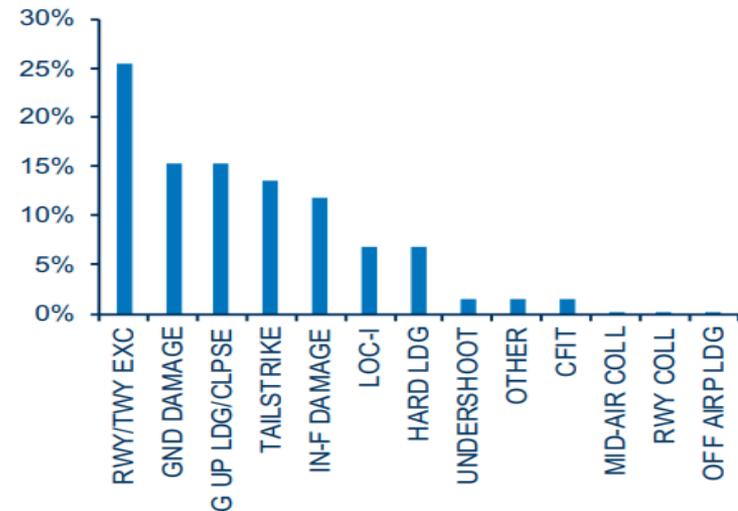
- 飛安事件率(2018)

Accident Category Distribution (2018)

Distribution of accidents as percentage of total

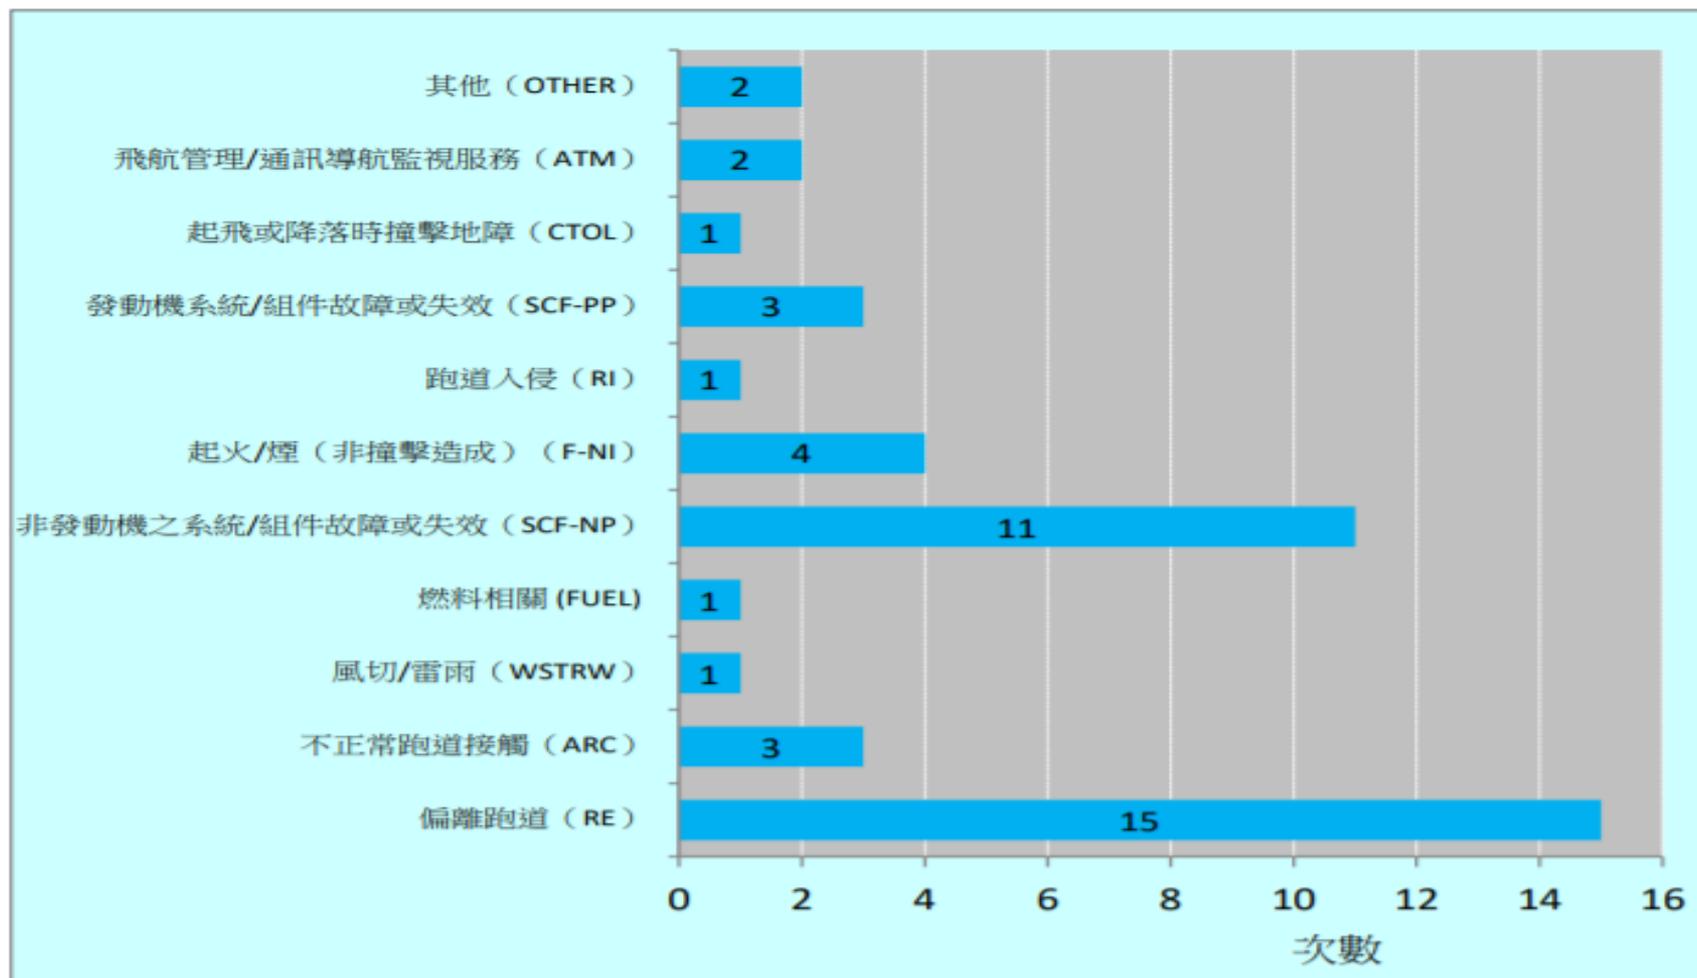
圖14： 2009-2018 年國籍民用航空運輸業飛航事故分類統計

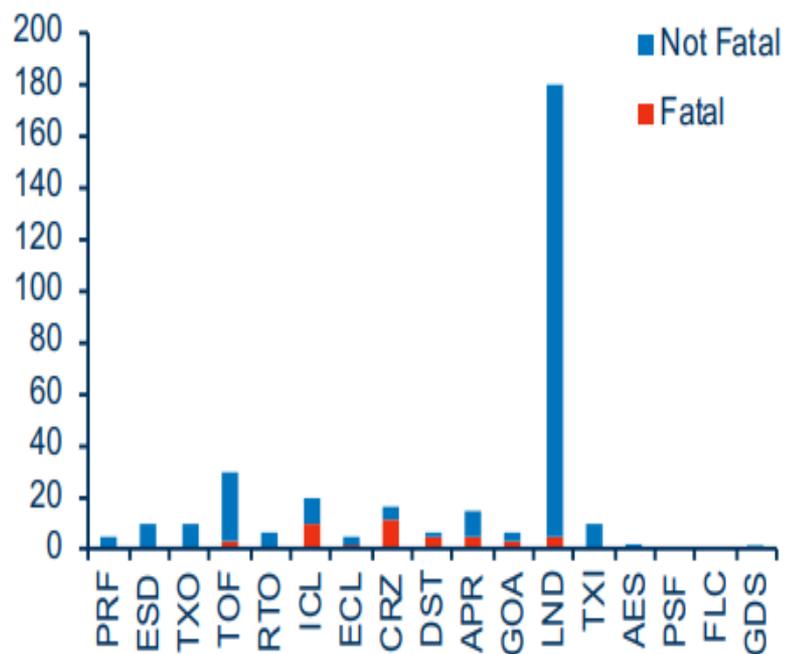
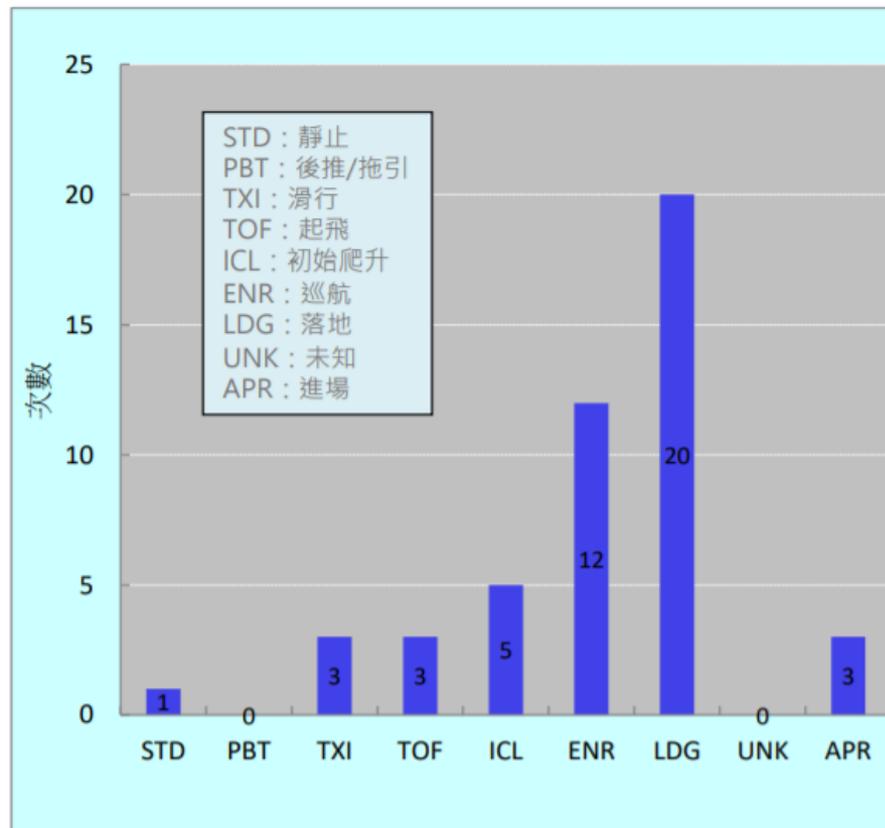
Accidents per Phase of Flight (2014-2018)

Total Number of Accidents (Fatal vs. Nonfatal)

圖13： 2009-2018 年國籍民用航空運輸業飛航事故發生飛航階段次數

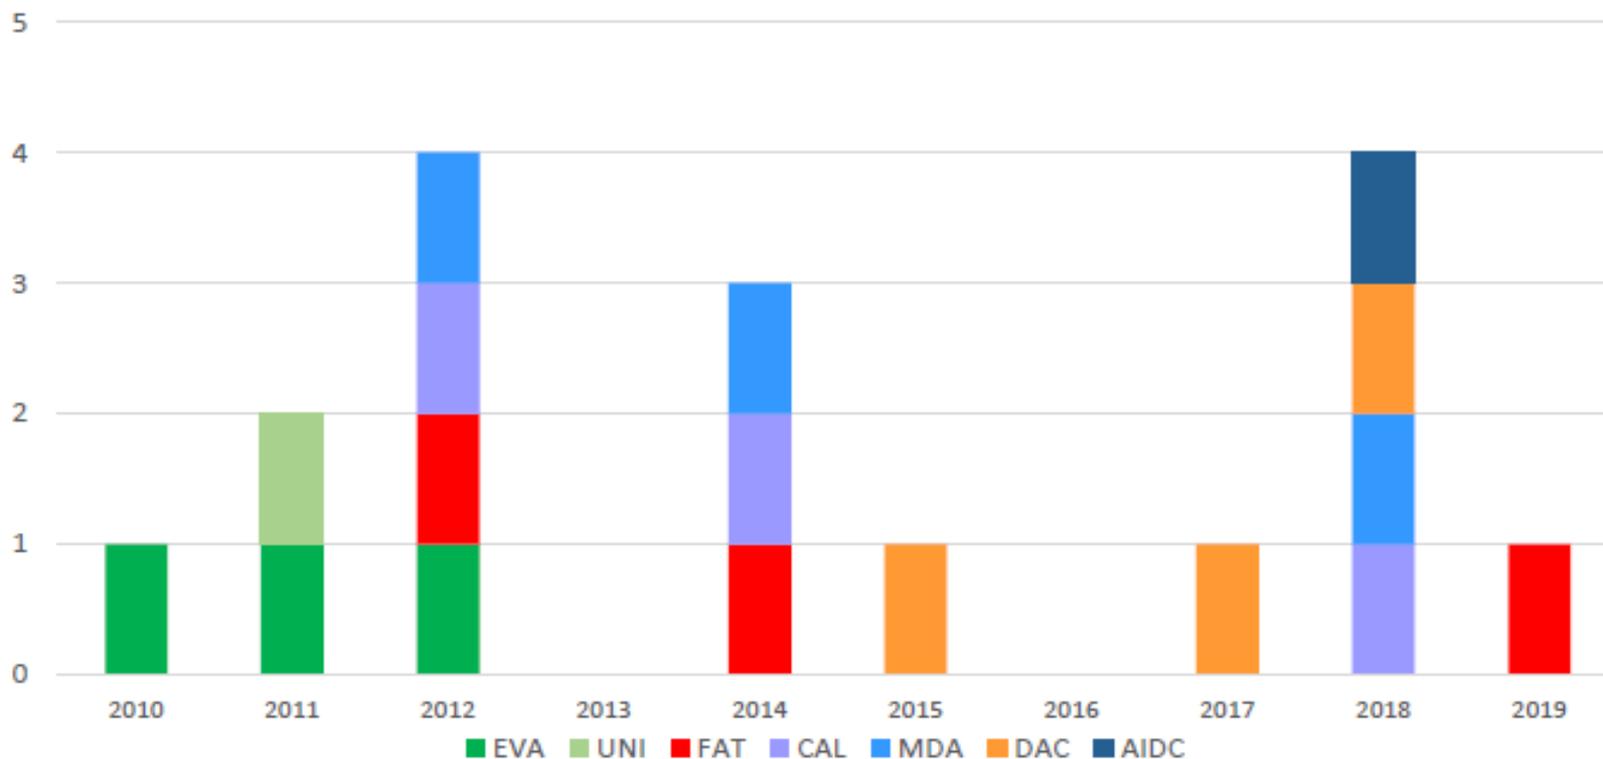
本國近10年跑道相關事件統計(1/2)

依ASC公佈之調查事件與報告，2010~2019年間於本國機場共17件跑道事件，計2起衝出跑道、14起偏出跑道及1起提早落地，其中7起發生於濕滑跑道。

機場 airport	跑道 runway	次數 times (RO/RV/USOS)
桃園機場	05R / 23L	0 / 4 / 0
	05L / 23R	0 / 1 / 1
台中機場	36	0 / 4 / 0
馬公機場	02 / 20	1 / 1 / 0
蘭嶼機場	13 / 31	0 / 2 / 0
金門機場	6	1 / 0 / 0
松山機場	10	0 / 1 / 0
高雄機場	9	0 / 1 / 0

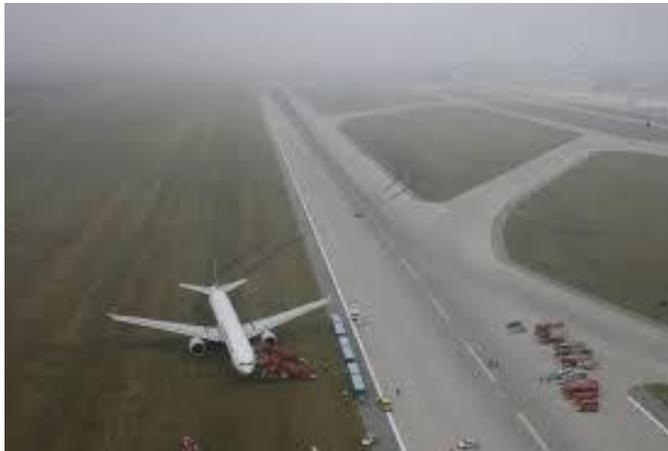
Veer off

- A veer off or overrun off the runway surface. (ICAO)

定義：航機于起飛或降落時，偏出或衝出跑道範圍。

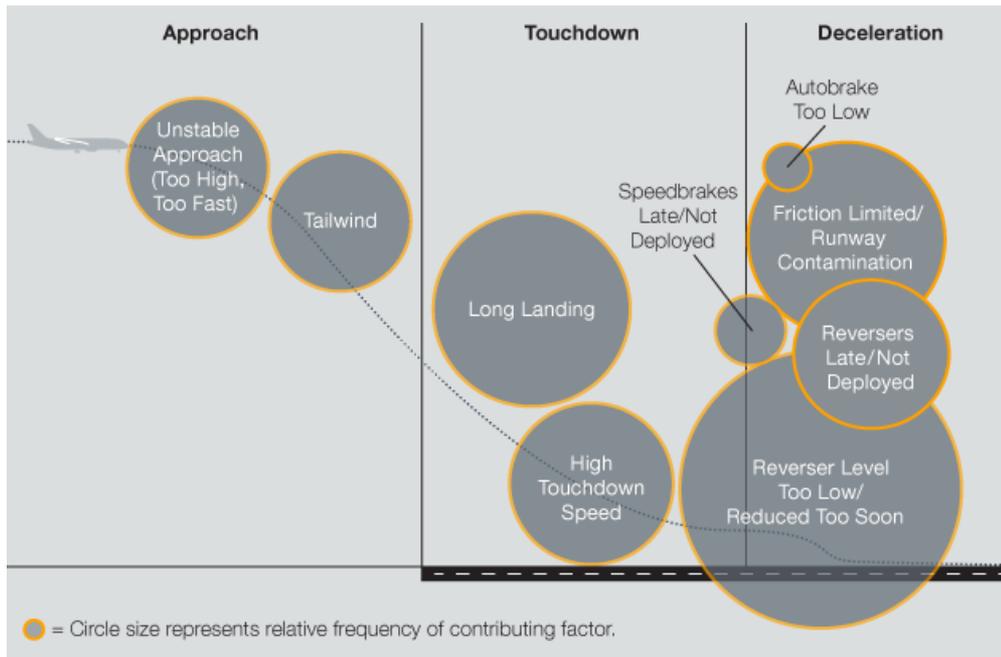
造成RE的可能原因

- 根據統計，大部分RE發生在落地階段，少數發生在起飛或者放棄起飛時。

根據Boeing的統計資料，造成RE的肇因有：

- 跑道濕滑
- 不穩定進場(高度太高或速度太快等)
- 減速時反推力設定不足、使用時間太短
- 延遲落地
- ...

➤ 2003-2010年,Boeing

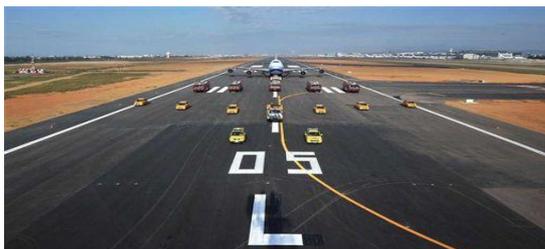
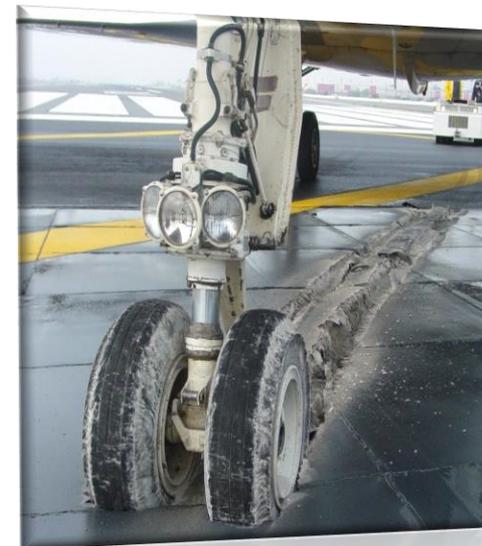
- 監控、回報和改善跑道表面狀況。
- 具完善的跑道摩擦係數測量及污染物去除的執行計畫和裝備。
- 跑道設備應符合法律規定
 - ICAO Annex 14機場規範/民用機場設計暨運作規範。
- 建置提升跑道安全設備，以降低跑道事故風險
 - 機場燈光系統升級與維護
 - 設置全鋪面之刮槽(Runway Grooving)
 - 工程材料攔截系統 EMAS。

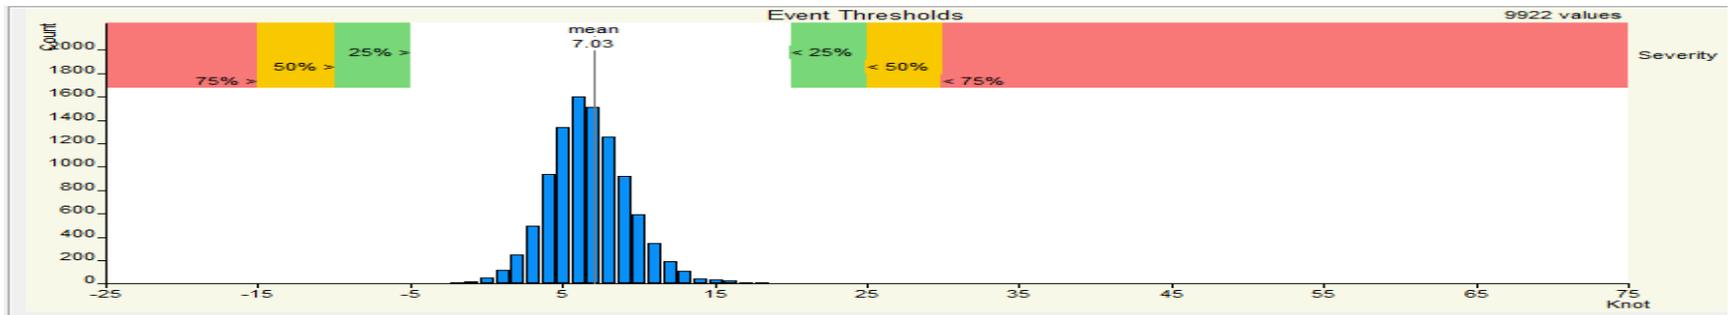
Approach Speed High(touchdown)，落地著陸時之空速。
以下為B738的分佈圖。

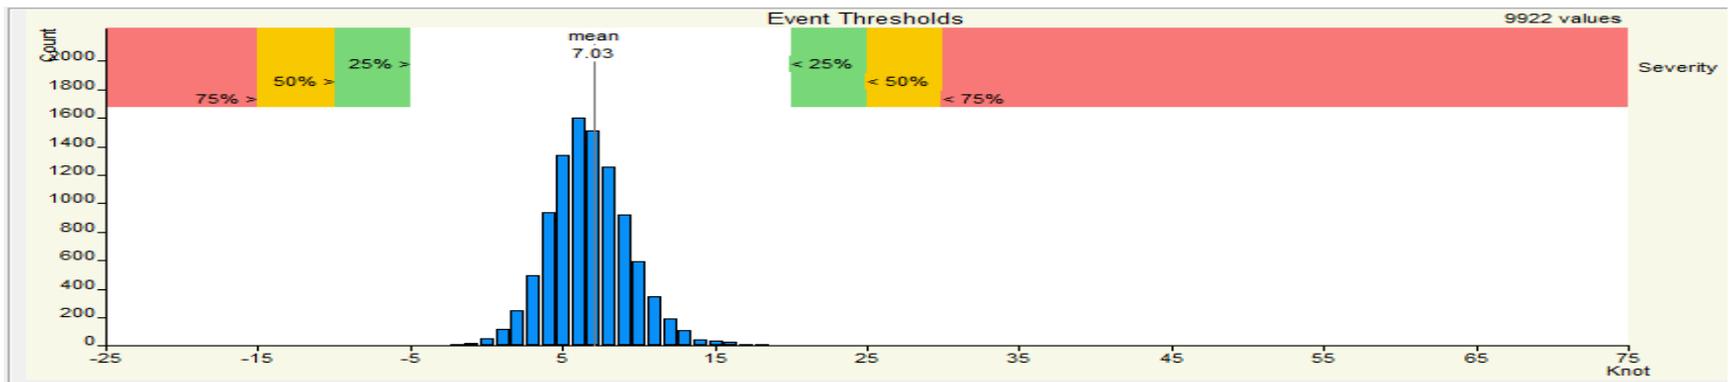
Rotation Speed High，起飛離地時之空速-Vr。

A350/B738/B744/B777皆可由此監控組員起飛帶桿情況，但A330飛行數據沒有記錄Vr(無法以此監控)，以下為A350的分佈圖。

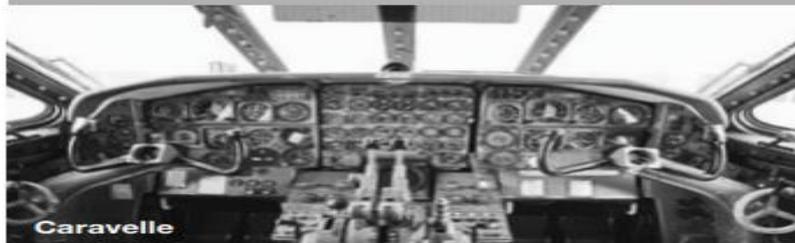
Dials & gauges in cockpit. Early auto-flight systems

Comet, Caravelle, BAC-111, Trident, VC-10, 707, 720, DC-8, Convair 880/890

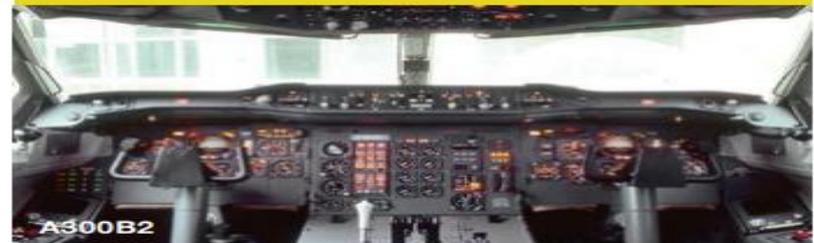
2 More integrated auto-flight

More elaborate auto-pilot and auto-throttle systems

Concorde, A300B2/B4, Mercure, F-28, BAe146, VFW 614 727, 737-100 & -200, 747-100/200/300/SP, L-1011, DC-9, DC-10

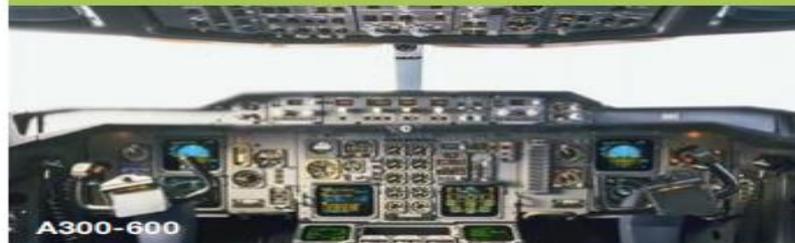
3 Glass cockpits & FMS

Electronic cockpit displays, improved navigation performance and Terrain Avoidance Systems, to reduce CFIT accidents

A300-600, A310, Avro RJ, F-70, F-100, 328JET, 717, 737 Classic & NG, 757, 767, 747-400/-8, Bombardier CRJ, Embraer ERJ, MD-80, MD-90

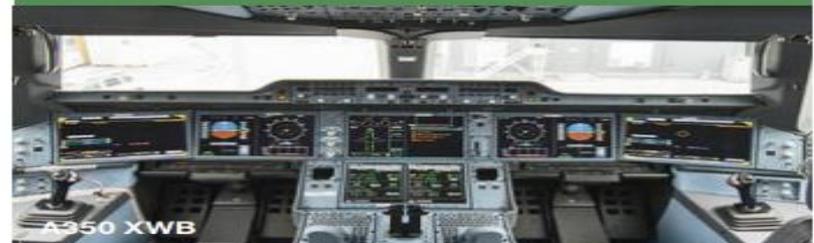
4 Fly-by-wire

Fly-by-wire technology enabled flight envelope protection, to reduce LOC-I accidents

A318/A319/A320/A321, A330, A340, A350, A380, 777, 787, Embraer E-Jets, Bombardier C-Series

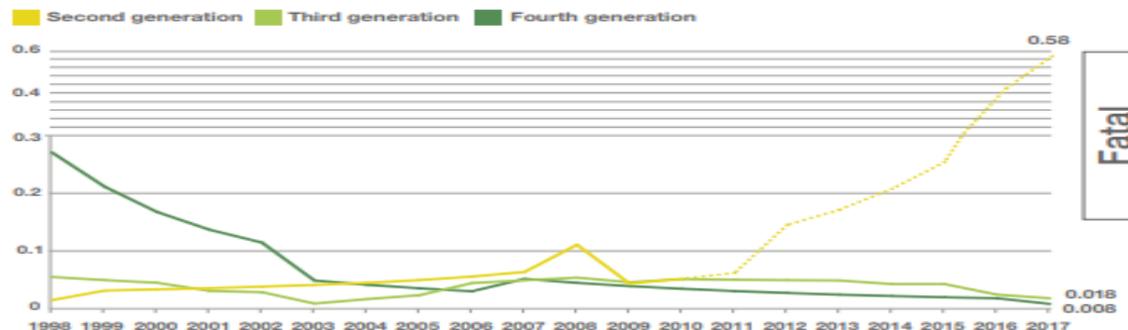
10 year moving average RE rate by aircraft generation per million flights

Most longitudinal Runway Excursions are related to aircraft energy management. Significant improvement of RE accident rates can be expected from the introduction of real time energy and landing performance based warning systems. Today, the proportion of aircraft equipped with such system is too low for the overall gain to be visible but this additional safety net is a promising step change to reduce longitudinal RE occurrences.

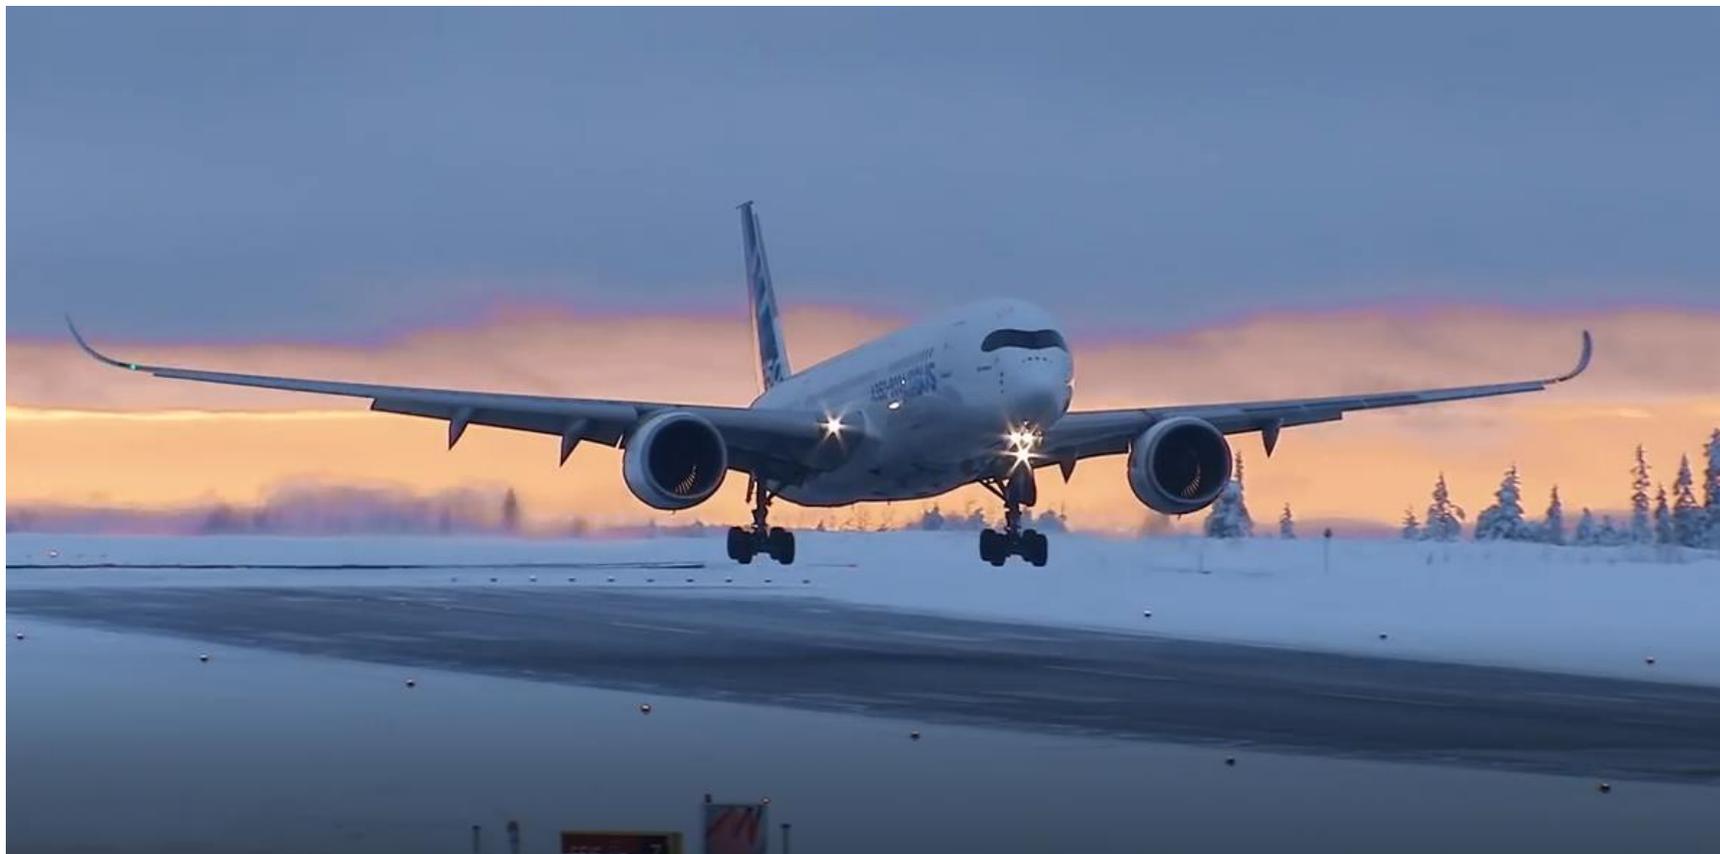
ROPS (Runway Overrun Prevention System) 提供了 飛行員即時的落地煞車性能與煞停距離的監控資訊

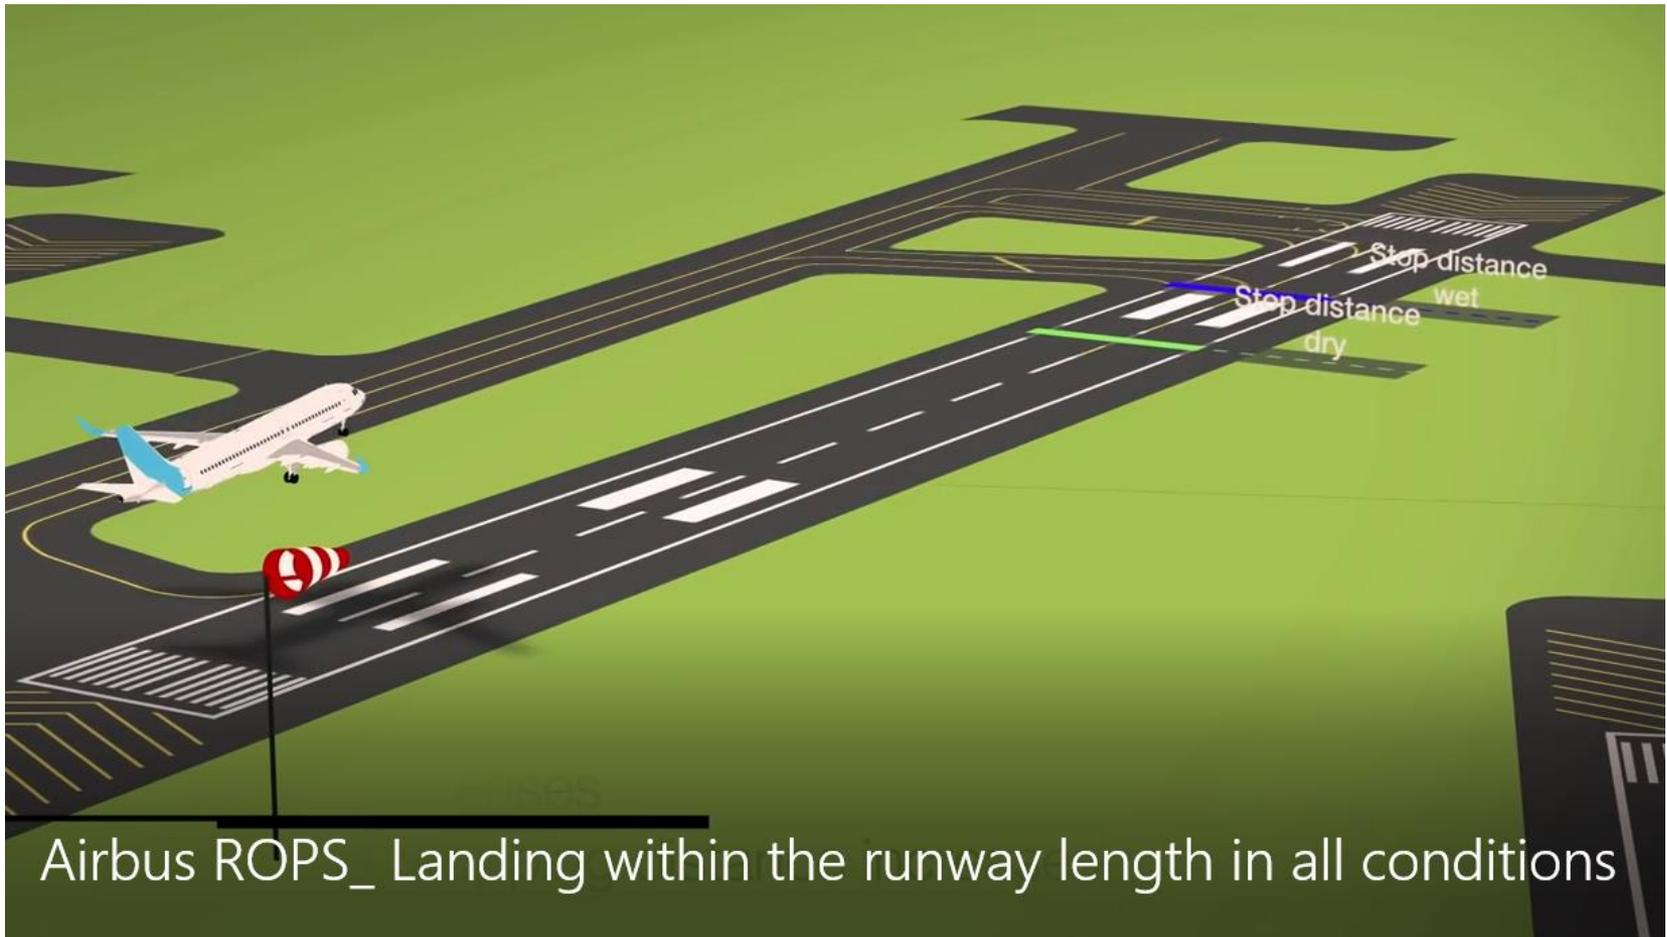
ROPS (Runway Overrun Prevention System) 提供了 飛行員即時的落地煞車性能與煞停距離的監控資訊

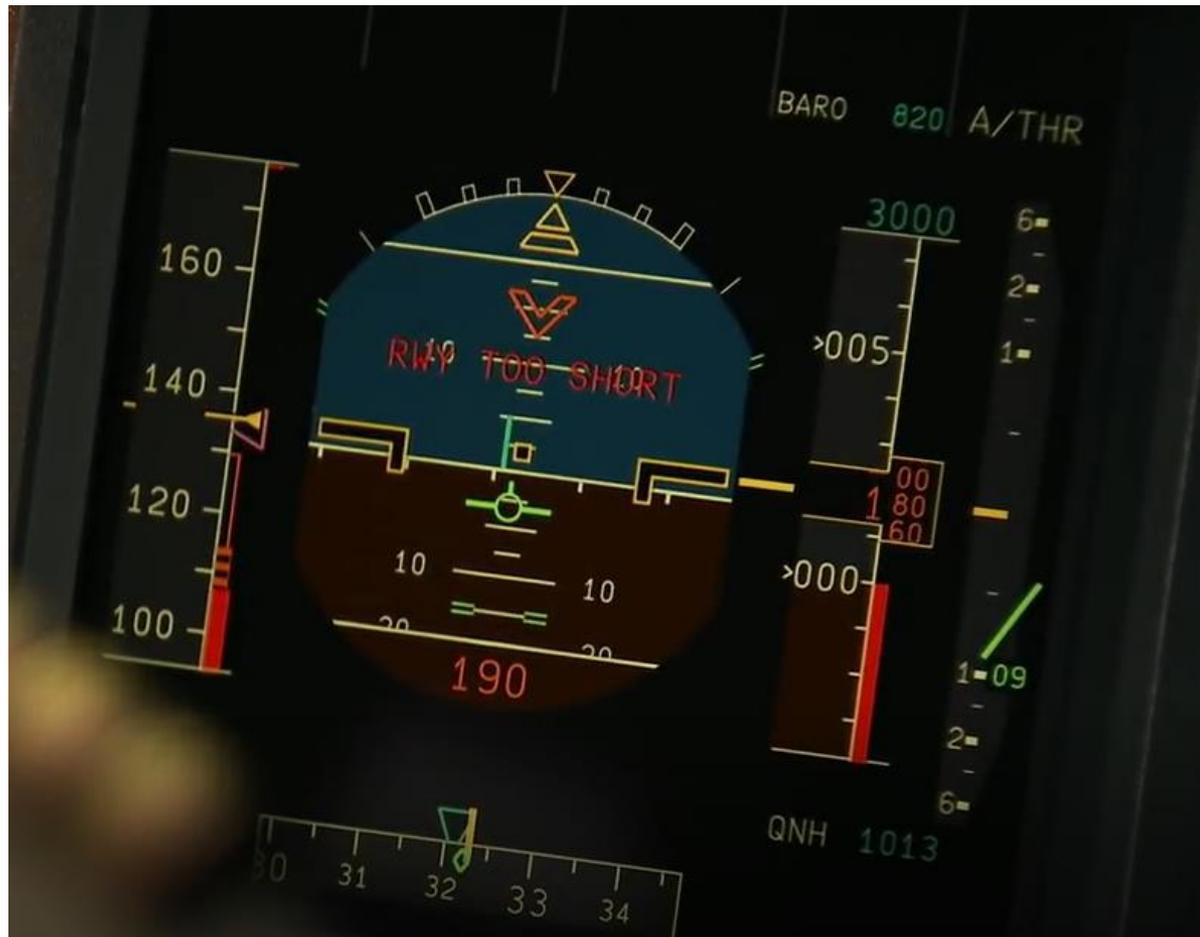
ROPS (Runway Overrun Prevention System) 提供了 飛行員即時的落地煞車性能與煞停距離的監控資訊

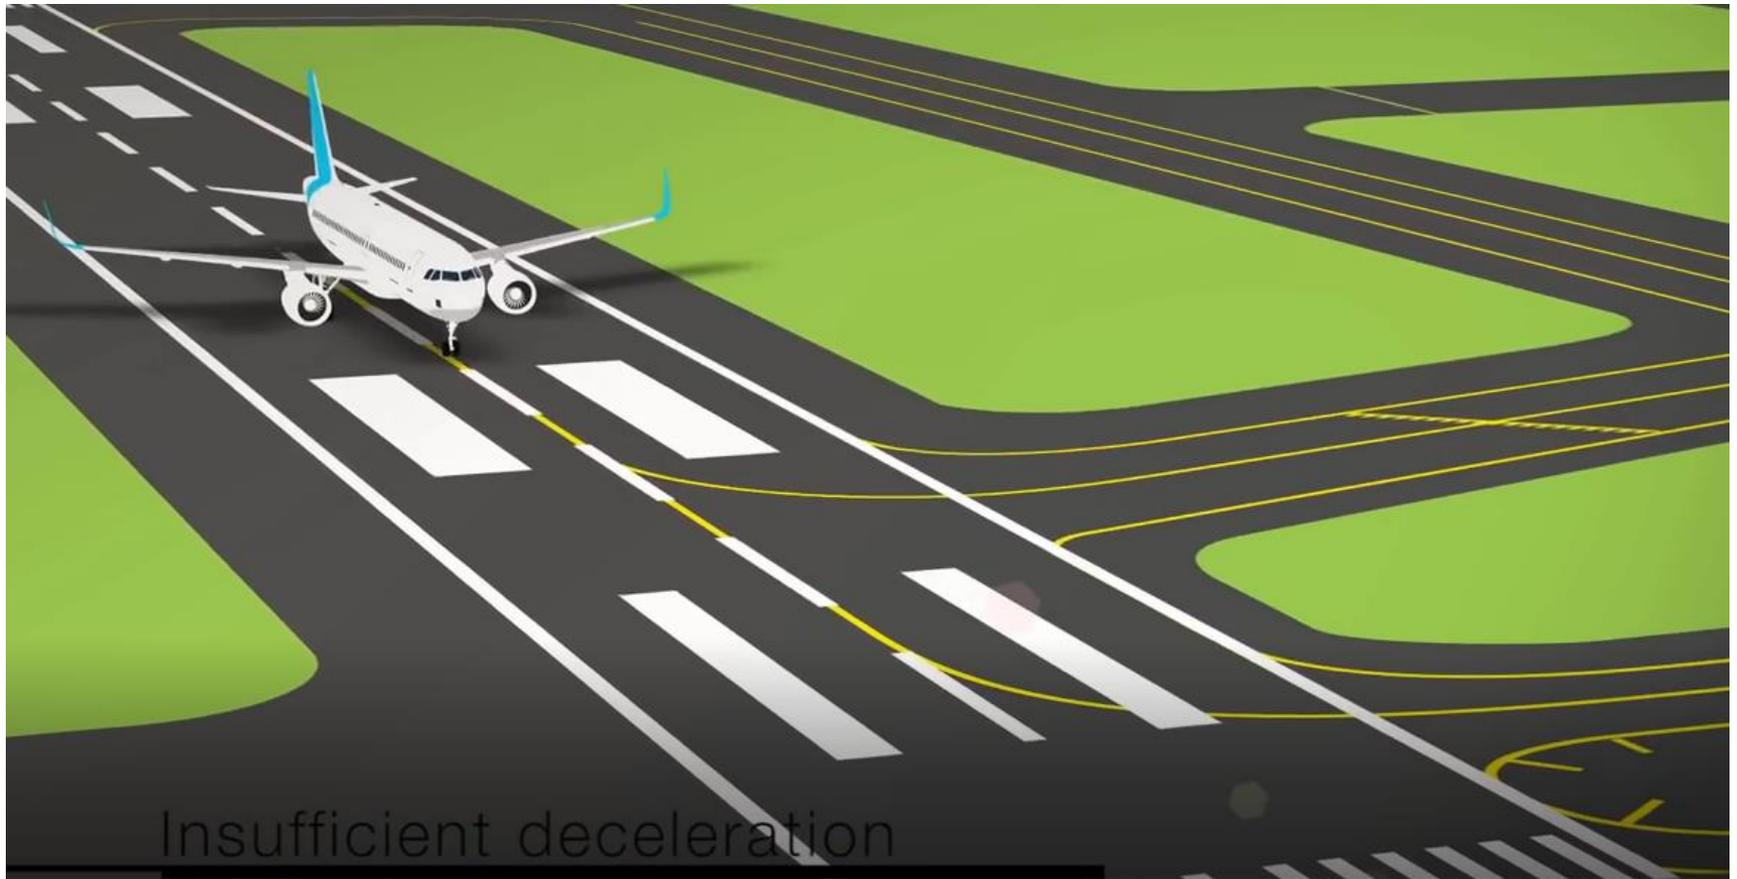
ROPS (Runway Overrun Prevention System) 提供了 飛行員即時的落地煞車性能與煞停距離的監控資訊

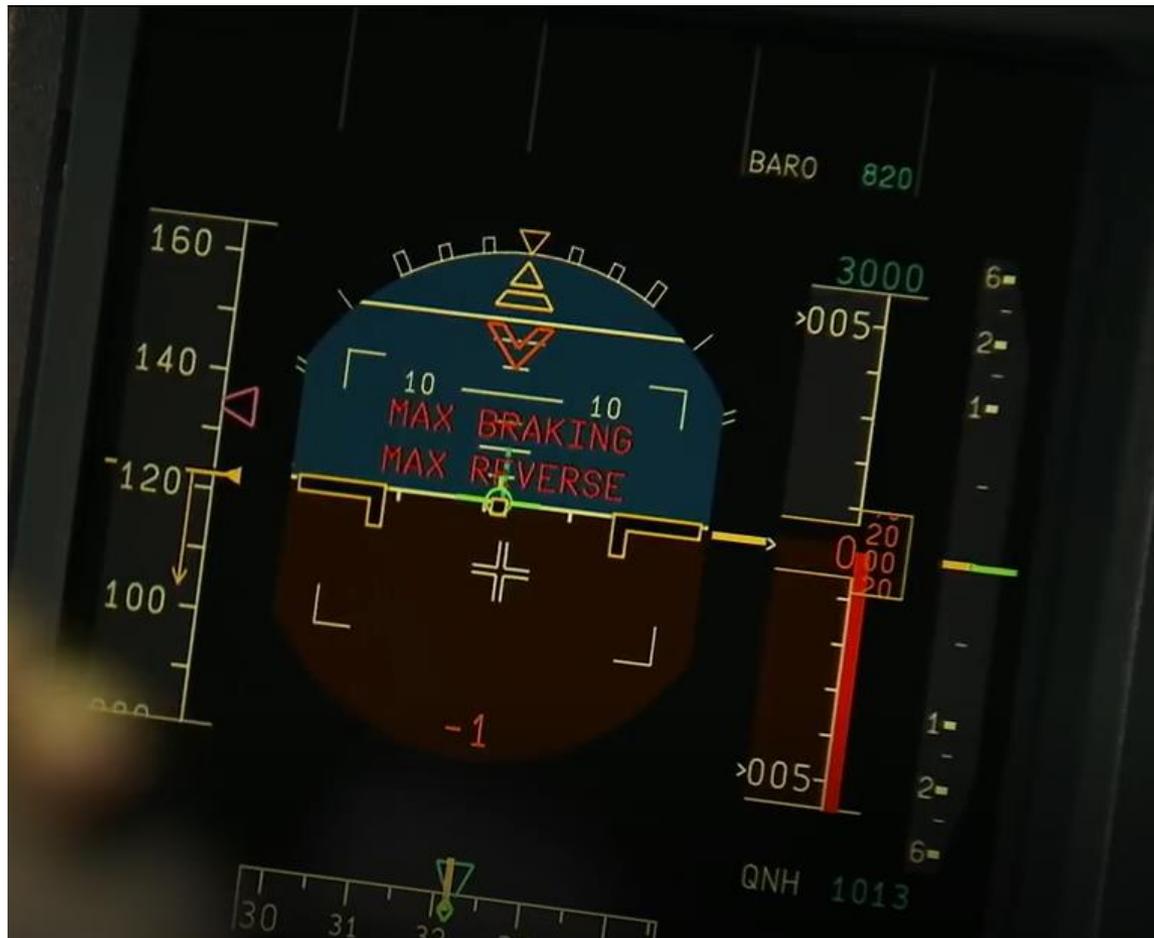
ROPS (Runway Overrun Prevention System) 提供了 飛行員即時的落地煞車性能與煞停距離的監控資訊

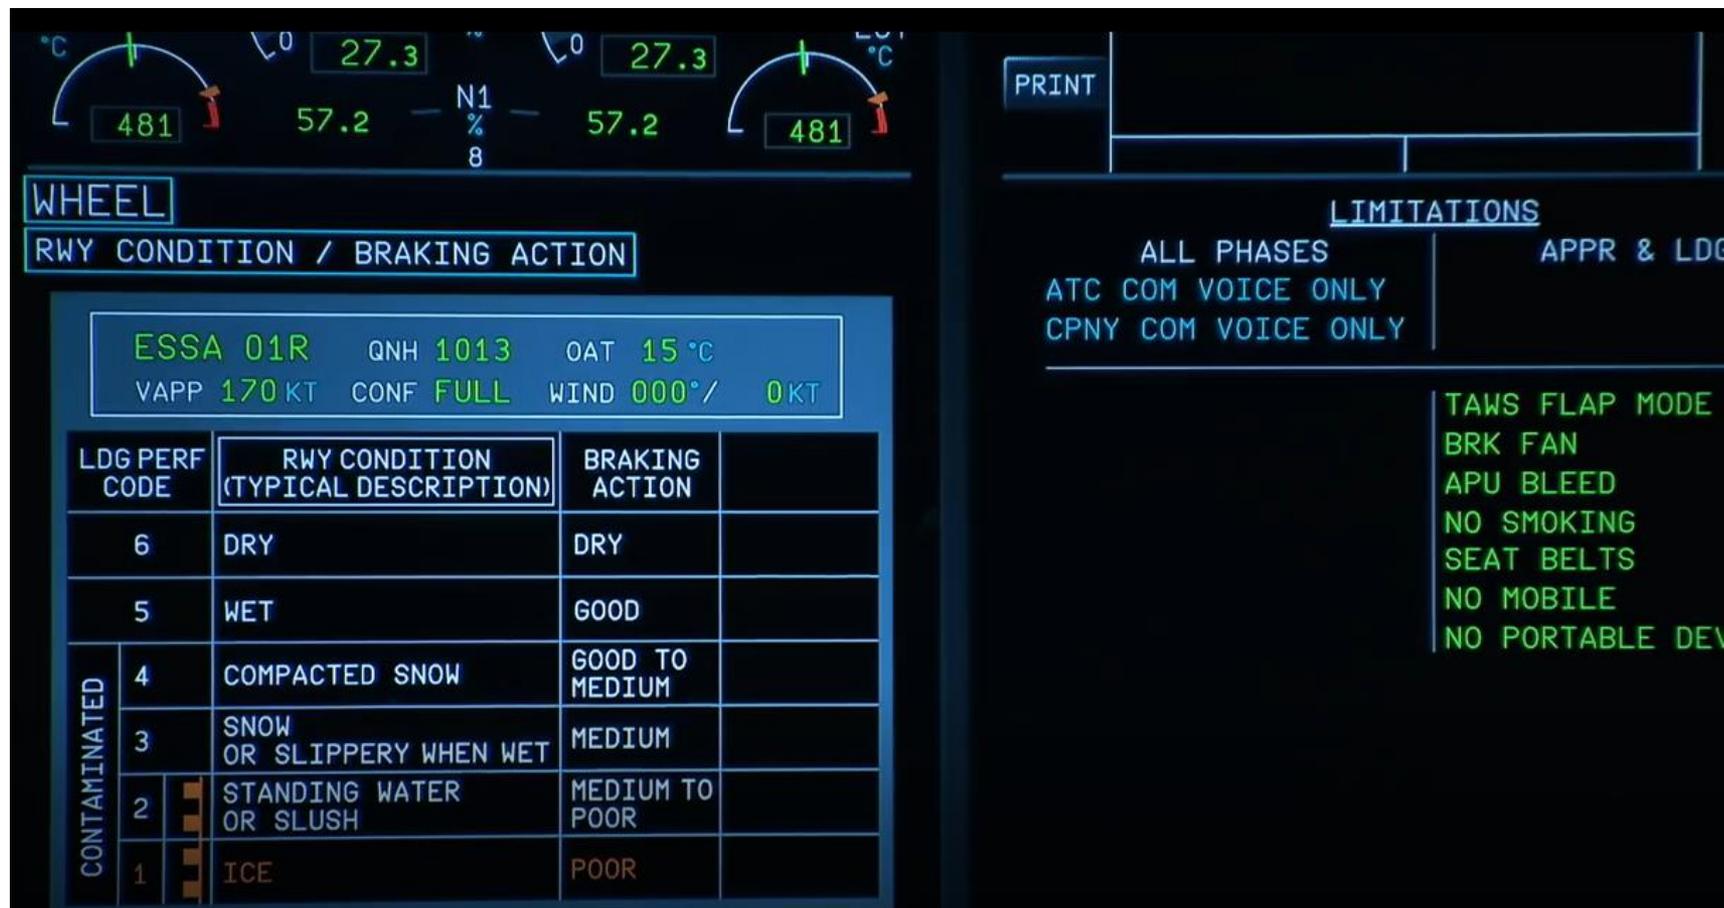
ROPS (Runway Overrun Prevention System) 提供了 飛行員即時的落地煞車性能與煞停距離的監控資訊

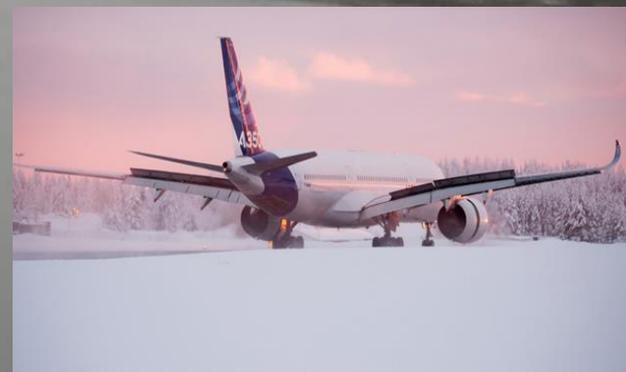
Using Aircraft as a Sensor on Contaminated Runways

In any analysis of aviation accidents, Runway Excursions (RE) are usually identified as the top cause of aircraft hull losses. Many of these accidents occur on runways where braking performance is degraded by runway surface contaminants.

- IATA 資料顯示 25% 的RE 事件發生在受汗跑道或濕滑道面。
- 在結冰或融冰的情況下，跑道煞車係數的資訊在報告發佈就已經過時了。
- 在強降雨或TSRA的情況下，道面煞車係數更是變化急遽。
