**Aviation Safety Council
Taipei, Taiwan**

**GE791 Accident Investigation
Factual Data Collection
Group Report**

Systems Group

ASC-GRP-03-10-001

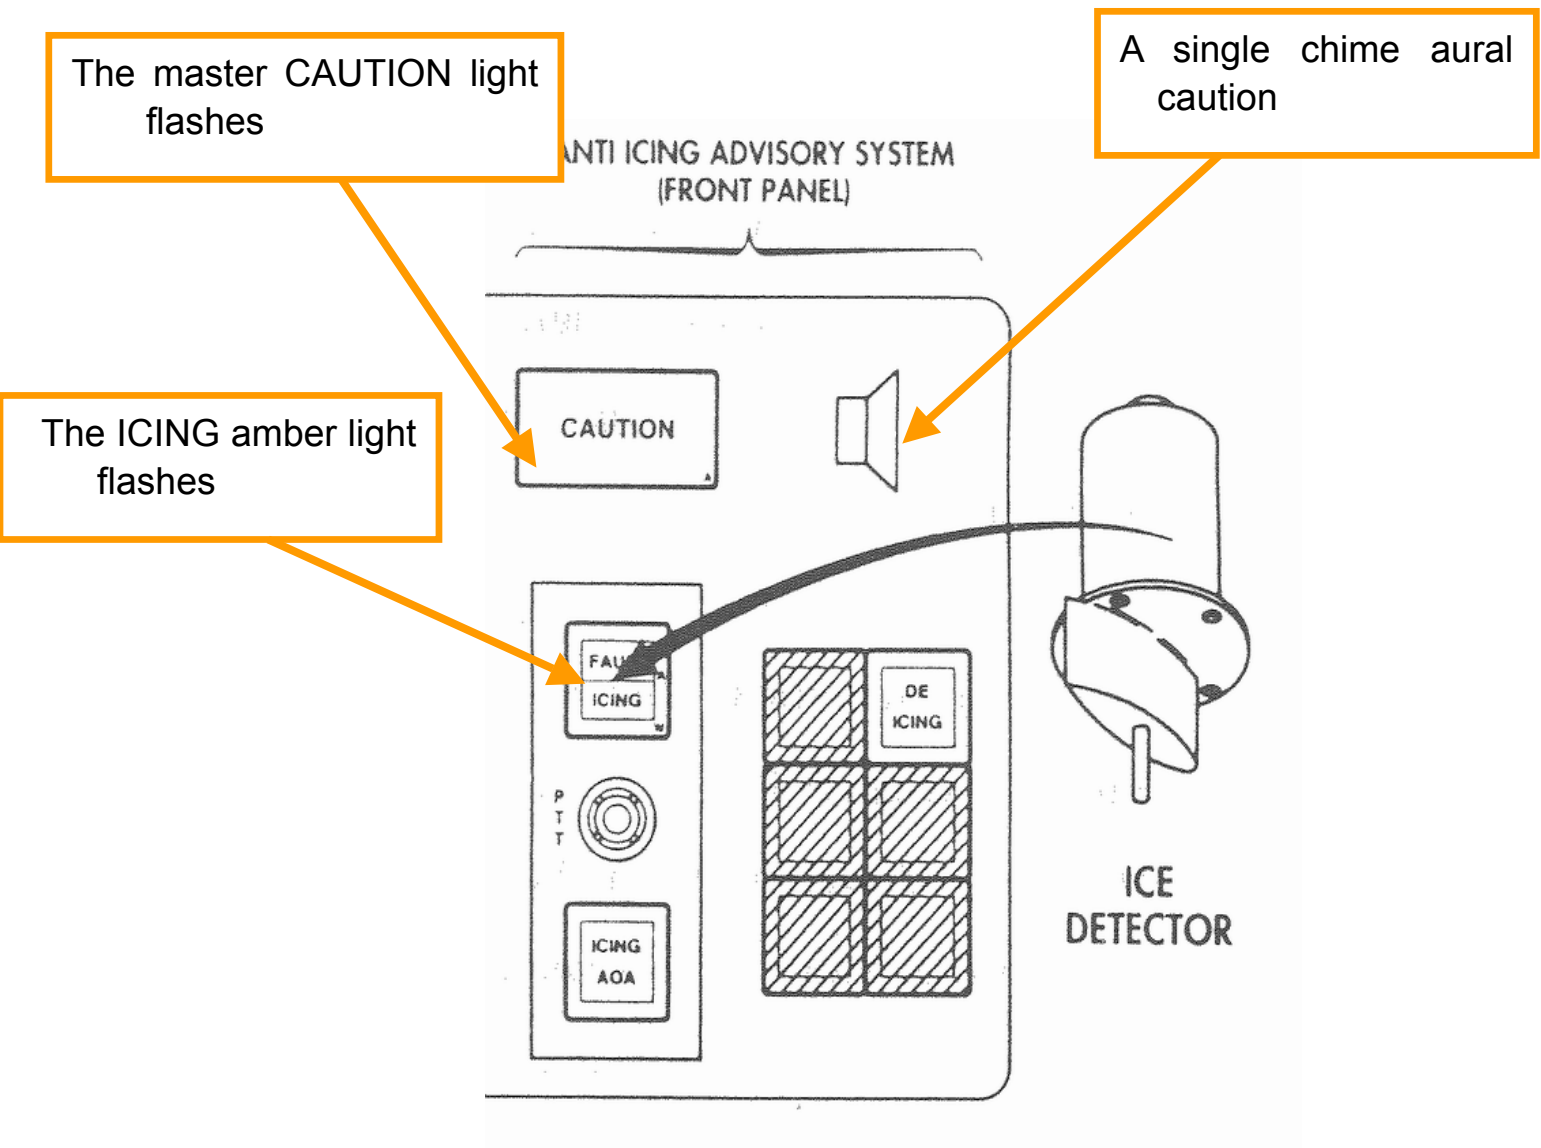
As long as ice is detected but the AIRFRAME de-icing has not selected ON, the following caution signals activate (figure 1.6-4):

Figure 1.6-4 AAS visual and aural alert signals

When ice is detected but the flight control surfaces and horns anti-icing/de-icing have not been selected ON, the ICING light flashes.

If the AAS probe has not detected ice accretion for more than 5 minutes the AIRFRAME DE-ICING is still " ON ", the DE ICING blue light will flash.

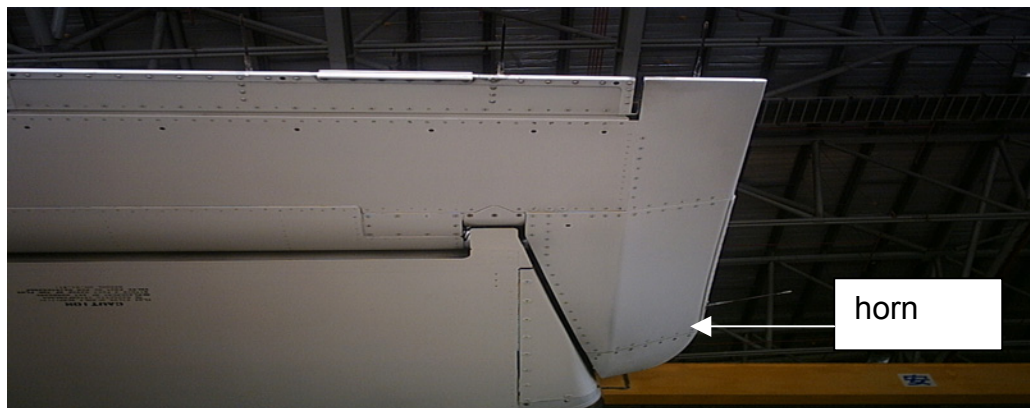
Figure1.6-7 ATR72 horn

The ATR72 lateral control systems composed of movable cable loop driven ailerons and the hydraulically actuated wing spoilers (figure 1.6-5). The ailerons are aerodynamically balanced through the use of an offset hinge line, geared trailing edge balance tabs, and exposed horns (see figure1.6-6 and figure 1.6-7)
