飛航事故調查報告 第二冊

ASC-AOR-05-02-001

中華航空公司 CI611 班機

行政院飛航安全委員會
AVIATION SAFETY COUNCIL
中華民國九十四年六月

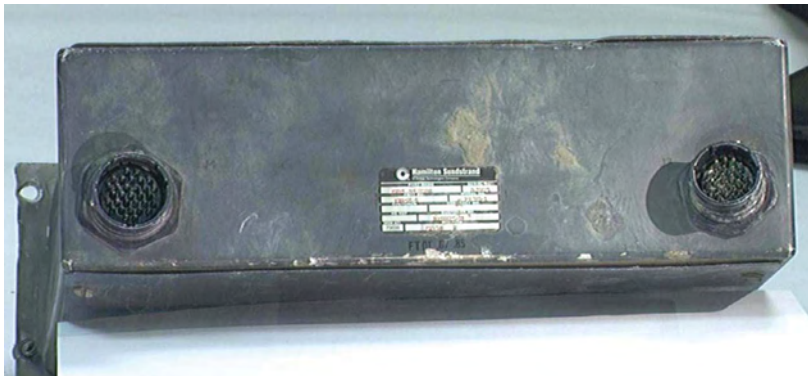
Figure 8: Flight Engineer's Cabin Pressure Control Selector Panel - (back view)

- J3 connector (right) misaligned due to deformation of rear chassis. Both connector (J3 and J4) pins are intact.
- Both connectors show contamination around multiple connector pins.

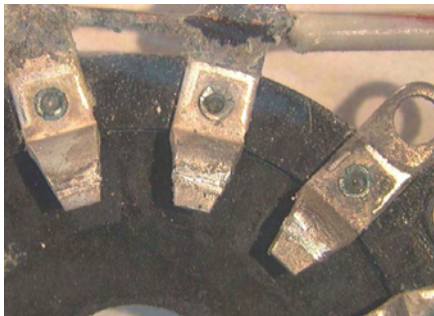
Figure 15: **MODE SELECT** Rotary Switch, Stationary contacts, deck 3, #1-2-3 (left to right).

- Contacts of rotary switch (S1), deck 3, #1-2-3, Wear marks on contacts appear to be normal.

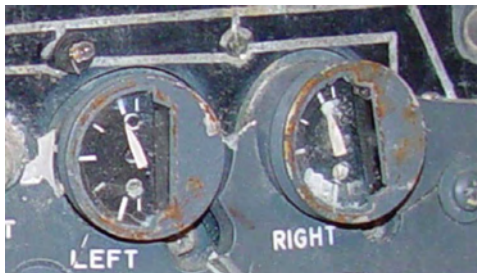
Figure 16: Panel, **OUTFLOW VALVES** Indicators.

- Internal surface of glass face: small surface anomaly observed as viewed from exterior.
- Case removed to inspect glass from inside. What appeared to be an anomaly on the inner side of glass was actually a debris deposit.
- No impact indications from needle impact were noted.

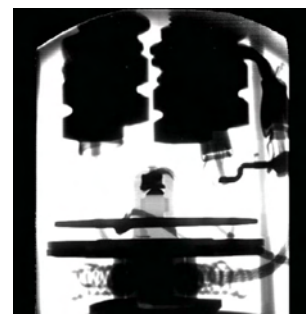
Figures 25a, 25b, 25c: X-rays of Pack Valve Switch #1

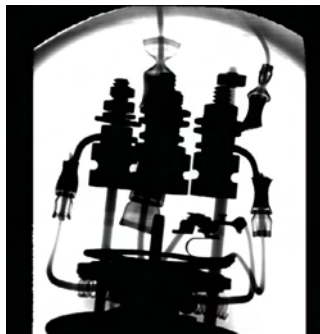
Figures 29A, 29B, 29C: X-rays of Pack Valve Switch #3

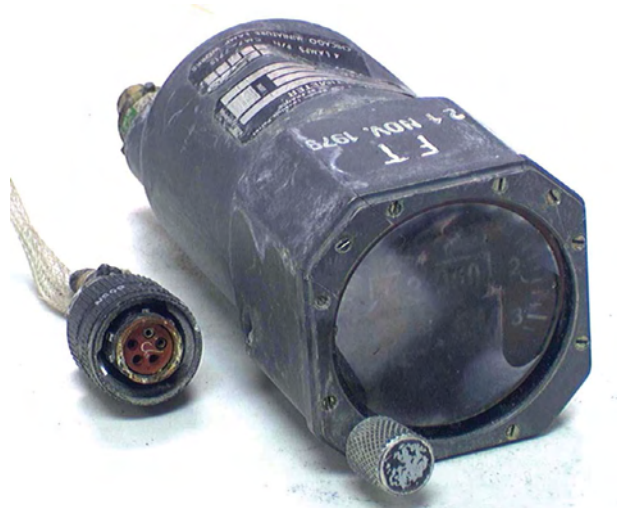
Figure 42: CABIN ALT Indicator (Ref. Figure 39, green arrow for location on module)

- 50% of face obscured by opaque discoloration inside of glass.
- BARO set knob bent upward.
- Dent in rear, top side of case.
- Dent on bottom side of case.
- Corrosion on sense line connection.
- Barrel Indicator reads approximately 13,000.
- Needle and barometric setting obscured by discoloration.
- Electrical connector appears undamaged.

- X-ray examination of internal parts revealed distorted bellows. No other observations made due to indistinguishable details.

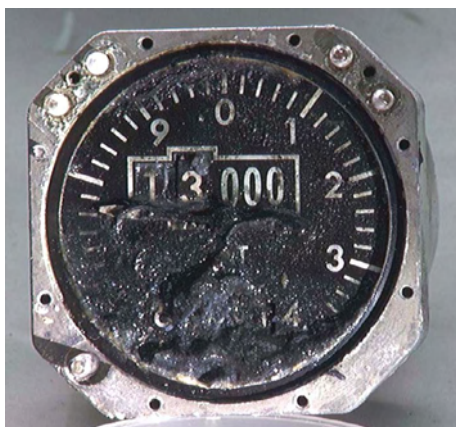
Figure 43: Cabin Altimeter Indicator, glass bezel removed

- Heavy coating of unknown sedimentary type debris on face of indicator (unknown black glutinous contaminant).
- After cleaning off debris, altimeter indicator reading confirmed to be 13,765 +/- 5.
- Microscopic examination of inner side of bezel shows no sign of impact damage.

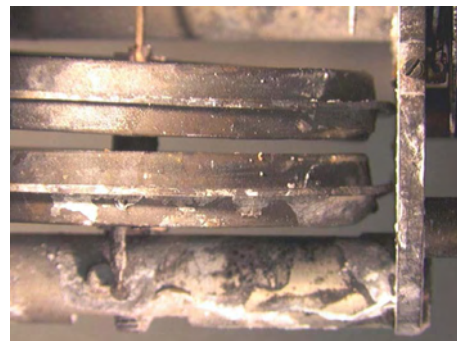
Figure 47: Cabin Altitude Indicator, bellows displacement

- The upper bellows is tilted with respect to its axis. The lower bellows is also tilted, but to a lesser degree.
- The upper bellows is in contact with the gear mounting plate. The lower bellows flange is deformed at the point nearest the gear mounting plate, but doesn't contact the plate.

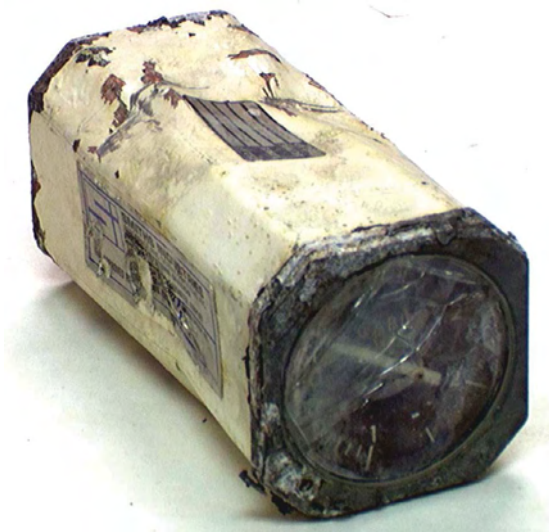
Figure 48: Cabin Vertical Speed Indicator

- Glass is broken.
- Numerous dents are on case.
- Needle is frozen at 500 FPM climb.

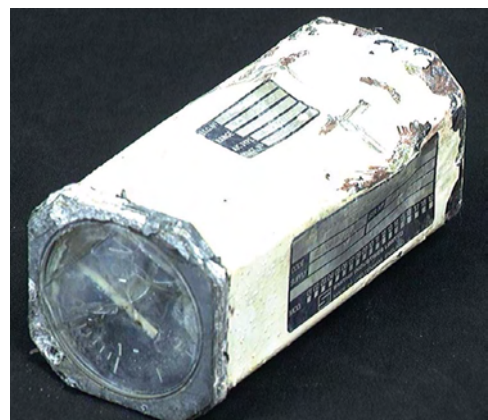
Figure 49: Cabin Vertical Speed Indicator (close-up overview)

- Safety wires at the rear of the case, 2 (each) were intact.
- Badly damaged housing; required milling for removal.
- Internal inspection revealed damage to internal components as a result of external impact to housing.
- No needle impact marks found on glass face and indicator face.
- Examination of the inside of the indicator glass face noted water marks (sediment deposit) that correspond to observed needle position (no needle impact marks).

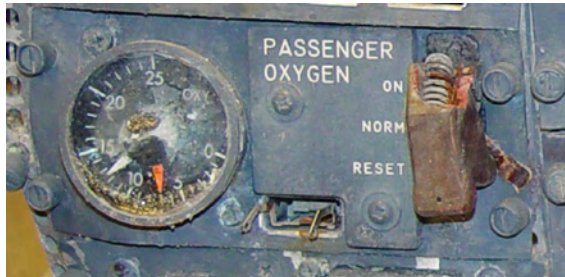
Figure 53: Passenger Oxygen Panel, module M183.

- Case removed indicator- found heavy corrosion and sedimentary deposits present internally.
- **PASSENGER OXYGEN** needle was disconnected from its driving rod, either on disassembly or prior to disassembly.
- No indication of needle strike on indicator face.
- Dial indicator needles at 700 PSI for passenger and 1250 PSI for crew.
- Residue visible through glass face of indicator.
- Power **ON** indicator legend plate, bulbs and retaining assembly are missing.
- Switch guard safety wire is broken.
- Switch guard broken and partially missing.
- Light plate is intact.

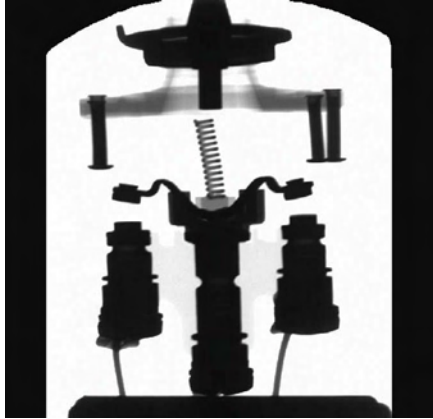
PASSENGER OXYGEN control switch of Module M183 was found to be in the **NORM** position as received. Continuity tests indicated that the switch functioned properly in the **ON**, **NORM** and **RESET** positions. See Figures 54 through 58.

Figure 54: X-ray of switch

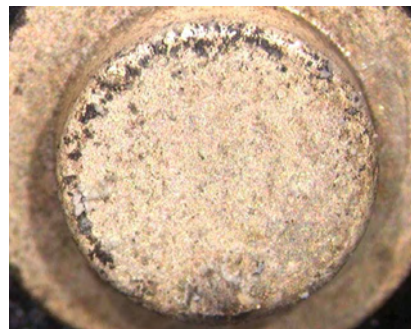
Figure 58: Stationary contact of oxygen control switch ("RESET" position).

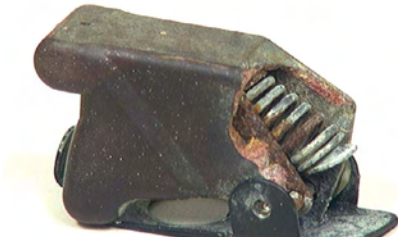
Figure 59: Switch guard overview, right side.

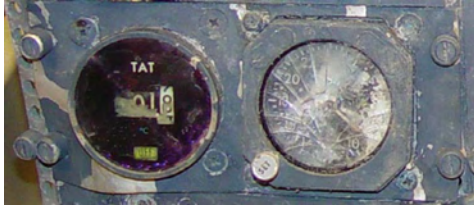
- Figure 65:** Clock Panel, module M184
- Clock glass is fractured.
 - Hands set at approximately 0825, partially obscured by broken glass.
 - **TAT** partially obscured by discoloration.
 - Reads 1.8 deg. C and **OFF**
 - After removal from Flight Engineer's Panel, slight impact damage to top rear of case was noted.

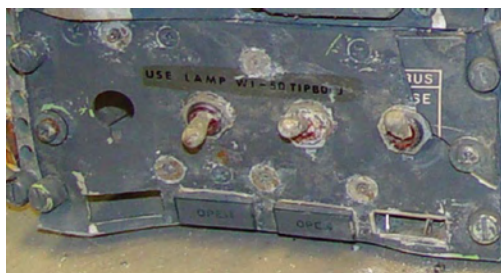
Figure 67: DC BUS ISOLATION panel, module M557

- Light plate is missing.
- All three switches' toggles are in up (**CLOSE**) position.
BUS 3 and **BUS ESS** toggles are bent upward.
- **ESS BUS**, & **OPEN** indicators legend plates, bulbs and retaining assemblies are missing.

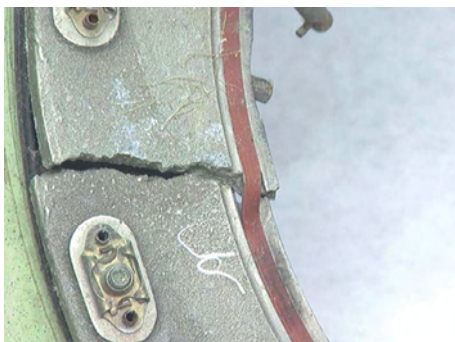
Figure 97: Non-metallic washer (gate seal) - continuous ring.

- Slight impression of knife-edge on seal.

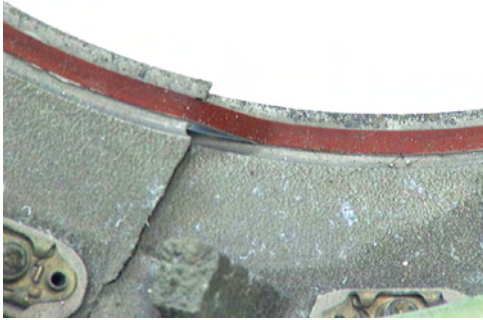
Figure 99: Another cut on the seal.

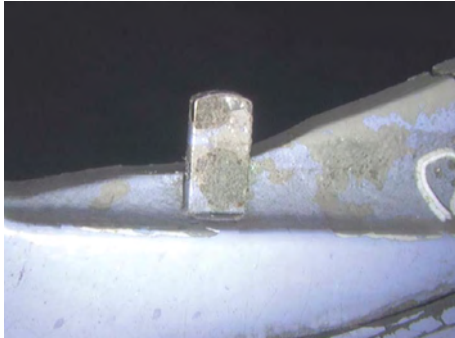
Figure 131: Overview of forward/lower stop pin, as viewed from outside.

- Pin is relatively straight.

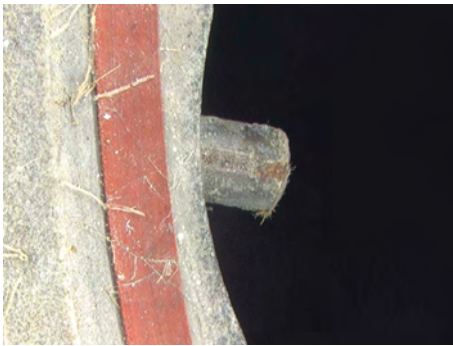
Figure 133: Overview of aft/lower stop pin, as viewed from inside.

- Pin is relatively straight.

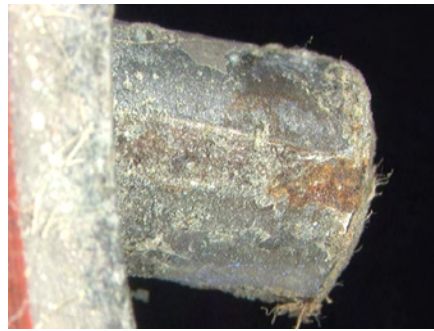
Figure 134: Aft/lower stop pin; close up of figure #133.

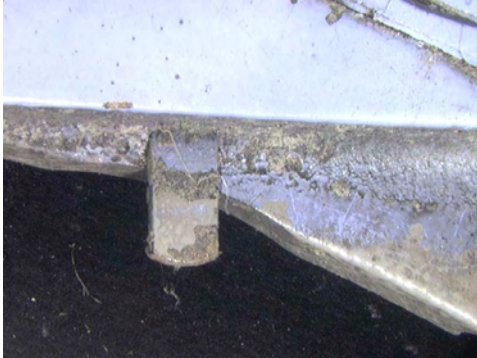
Figure 136: Aft/lower stop pin.
 • Overall, pin is relatively straight.

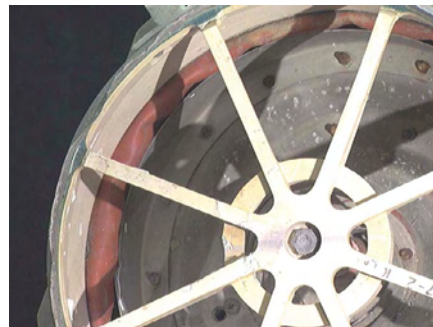
Figure 147: Diaphragm, apparently intact portion.

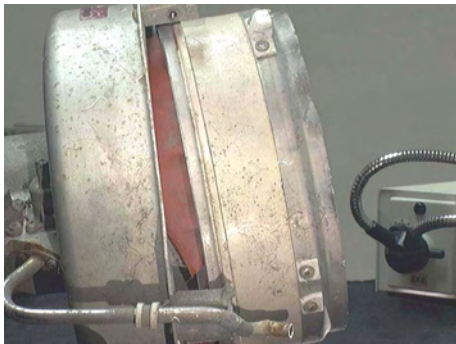
Figure 149: Offset angle between valve housing and gate.

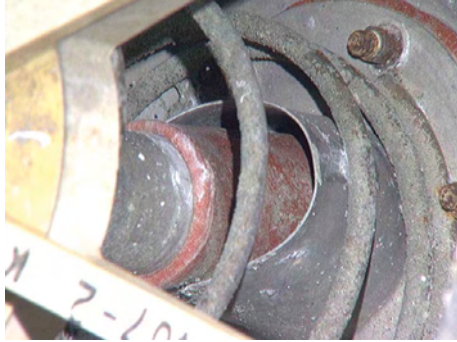
Figure 153: Center diaphragm & return spring.

- Diaphragm is intact and spring is unseated from valve cover.

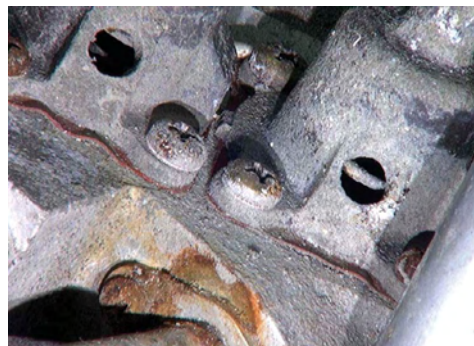
Figure 158: Cabin pressure sense ports on sensor adjustment springs.

- Holes look clear.
- Corrosion on tube retainer plate (HS P/N 727417-2).

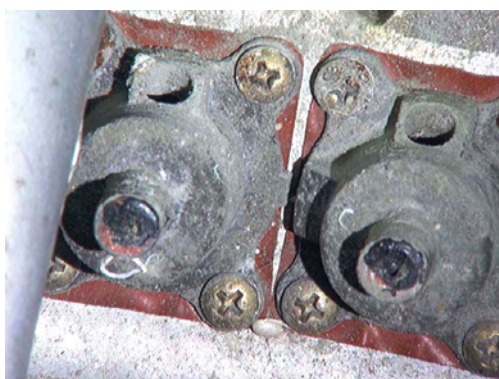
Figure 159: Control adjustment screws.

- Tamper proof seals are in place.

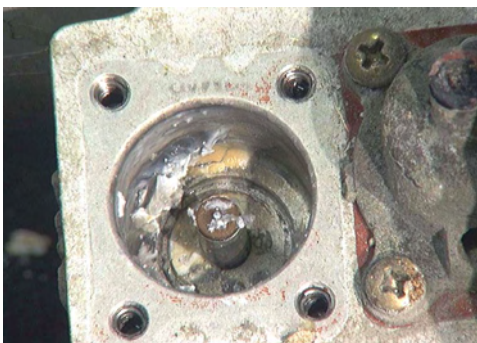
Figure 165: Remote ambient sensor housing bore.

- Salt & moisture present.
- Poppet is frozen.

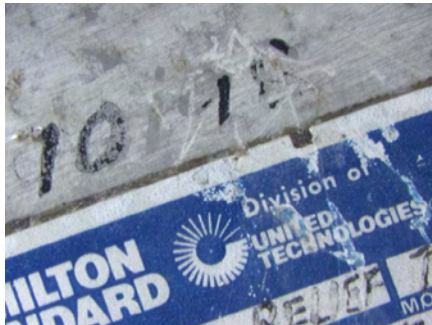
Figure 174: Lower Pressure Relief Valve data plate, identified FT 10/98 with microscope.

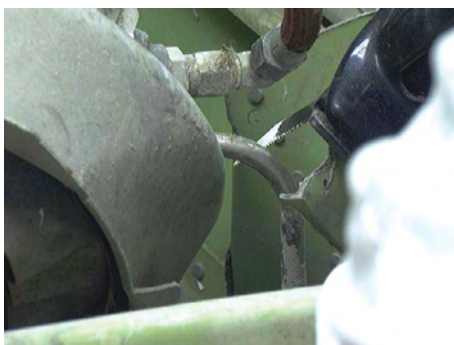
Figure 182: Lower Pressure Relief Valve. The integral ambient sensing tube, step 3, had to be cut in order to remove the lower valve.

- Performed boroscope examination of Lower Pressure Relief Valve at:
 - (1) Integral ambient port interior and
 - (2) Cut end of the same integral ambient tube. Cut end tube was unobstructed.

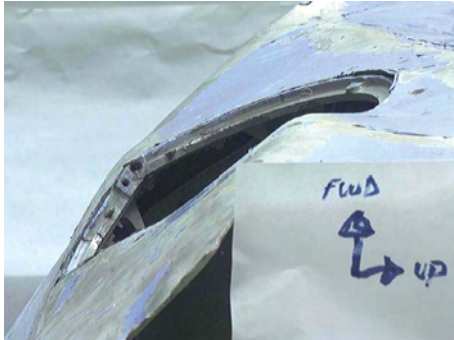
Figure 183: Skin distortion at valve mounting location.

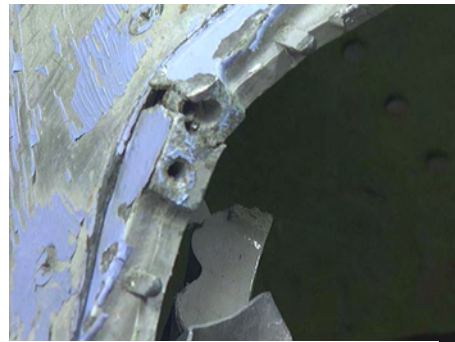
Figure 184: Exterior opening, close-up of fracture of valve housing at forward/upper hinge pin.

Figure 185: Exterior opening, close-up, another view of figure #184

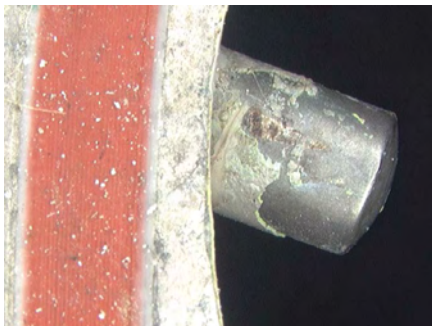
Figure 195: Forward/upper stop pin overview. View is looking from inside towards outside.

- Pin is relatively straight.

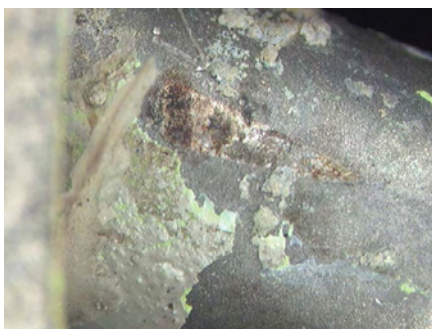
Figure 196: Forward/upper stop pin; close-up view of figure #195.

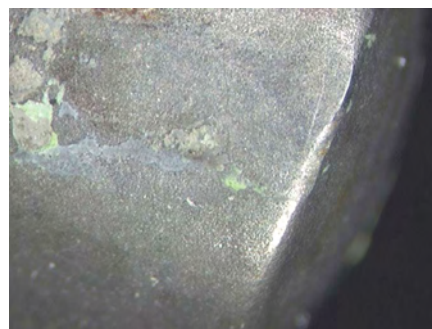
Figure 197: Forward/upper stop pin, close-up view of figures #195 and #196.

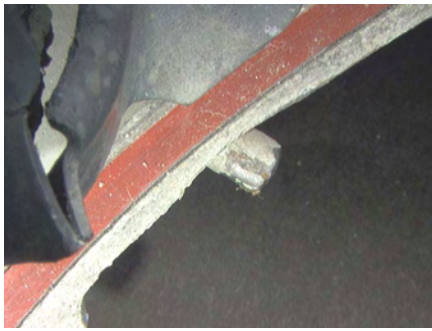
Figure 205: Forward/lower stop pin, overview as viewed from inside.

- Pin is relatively straight.

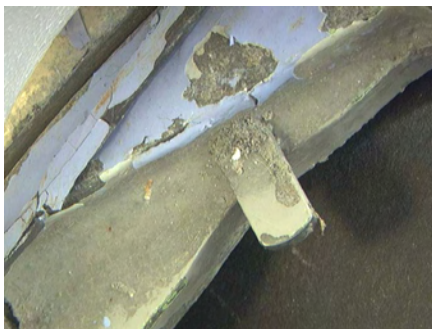
Figure 207: Forward/lower, stop pin as viewed form outside.

- Pin is relatively straight.
- Paint is chipped.

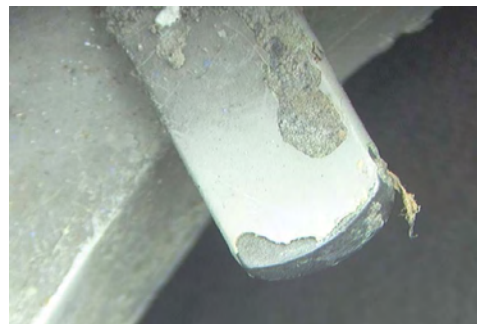
Figure 208: Forward/lower, stop pin, close-up of figure #207.

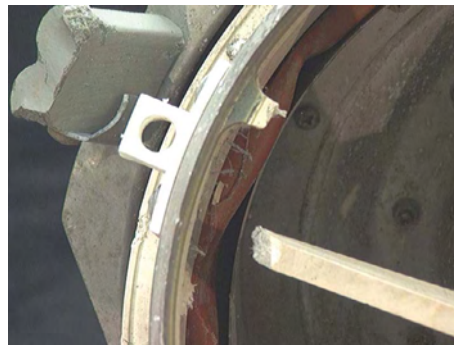
Figure 217: Broken web detail.

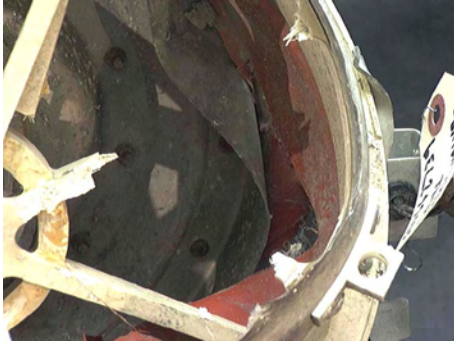
[Figure 218](#): Web damage.

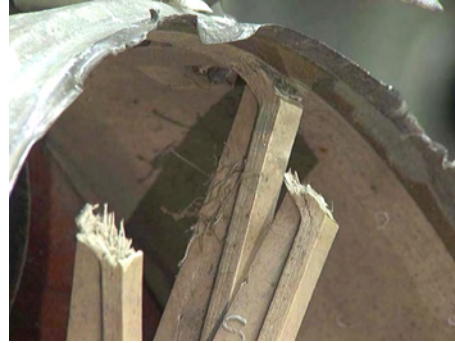
[Figure 219](#): Web damage.

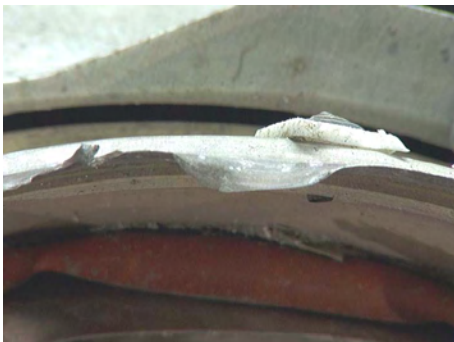
[222](#): Knife-edge damage.

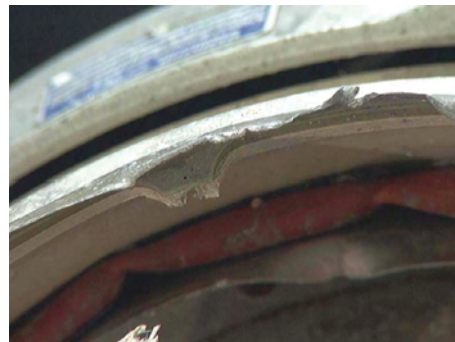
[Figure 223](#): Knife-edge damage.

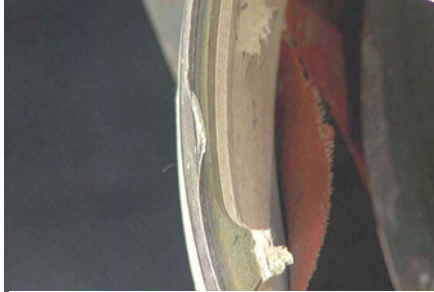
[Figure 224](#): Knife-edge damage.

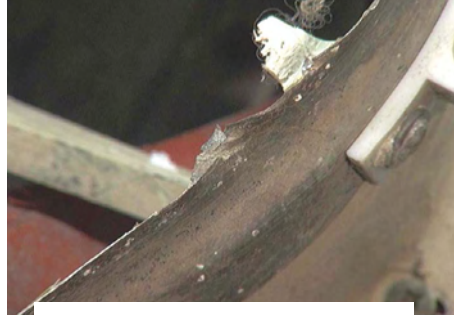
[Figure 225](#): Knife-edge damage.

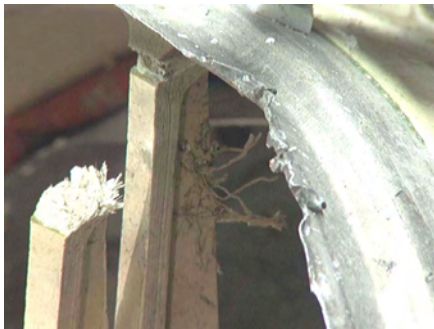
[Figure 226](#): Knife-edge damage.

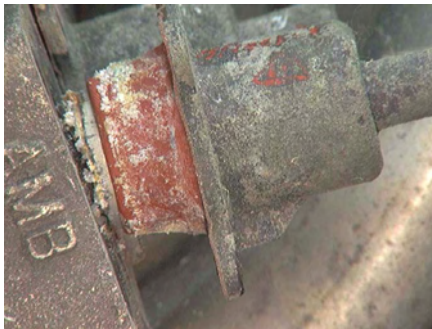
Figure 249: Remote ambient sensor, cover and diaphragm partially removed.

- Heavy salt deposits on spring, piston and diaphragm.

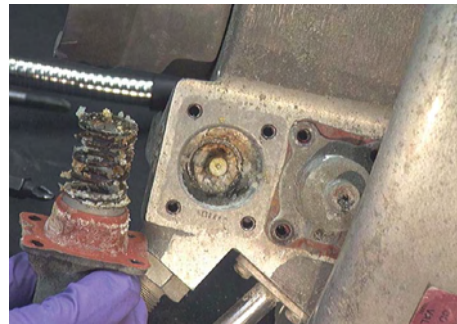
Figure 250: Showing remote ambient sensor removed.

- Heavy salt deposits on spring & housing bore.
- Diaphragm appears to be intact, poppet moves freely.

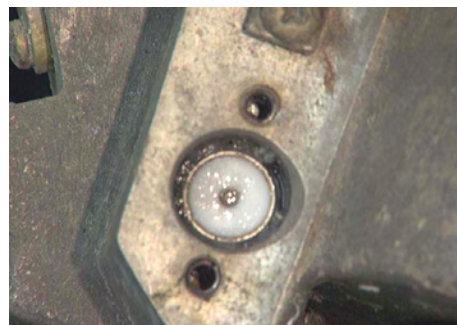
Figure 252: Remote ambient sensor, opposite end of poppet and guide.

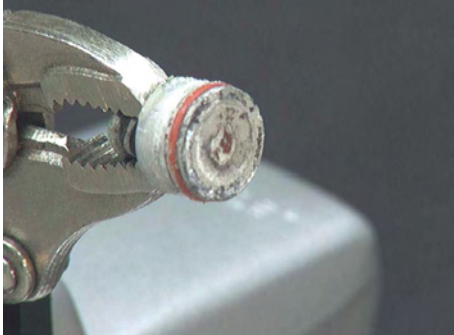
Figure 253: Plug HS P/N 719280-1 and seal, seal looks normal and uncut.

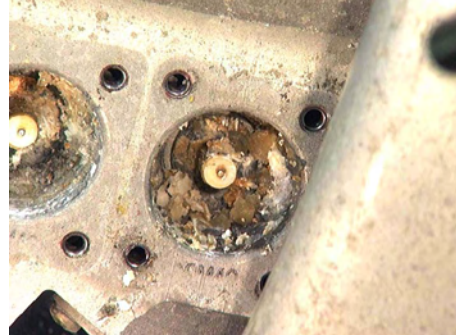
Figure 254: Integral sensor housing bore.

- Heavy deposits.
- Poppet appears to be frozen.
- Salt deposits on end of poppet.

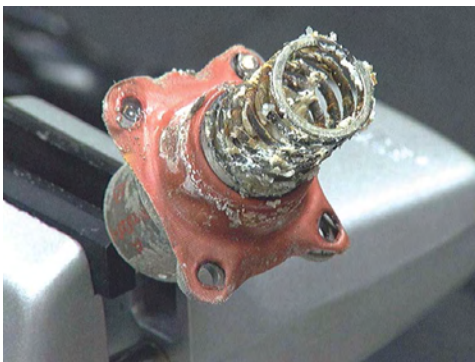
Figure 255: Integral sensor spring and diaphragm.

- Heavy salt deposits.
- Diaphragm intact.
- Spring has heavy salt deposits and possibly salt corrosion.

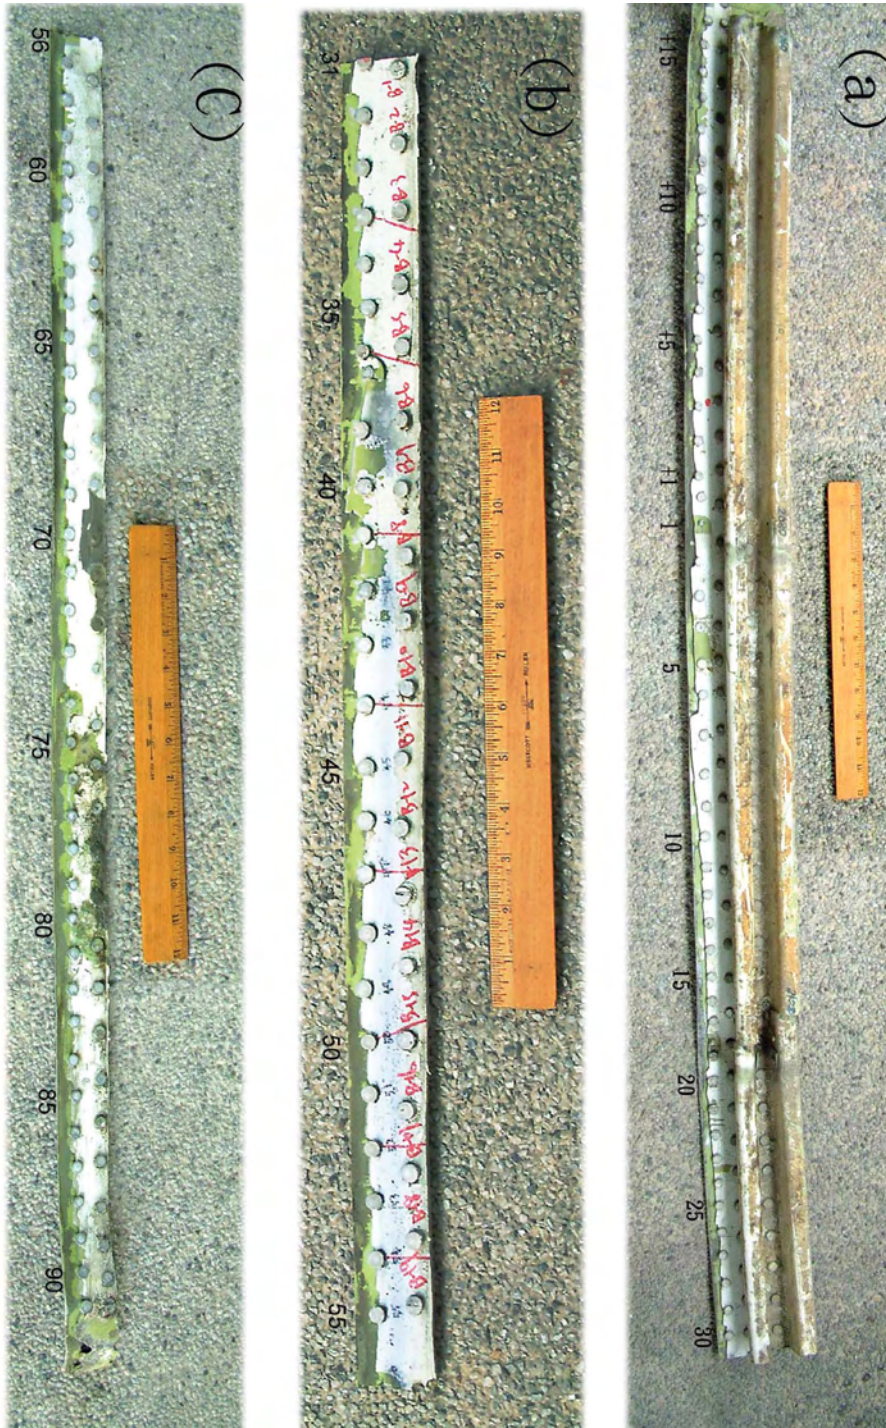
Figure 4

圖 3 中編號+17~91 間的破斷面首先使用低倍率巨觀顯微鏡觀察，以大致先確定疲勞的區域，然後再使用 SEM 觀察編號+17~56 間的破斷面，以進一步分析破斷面的疲勞區域、裂縫起始點與裂紋擴展方向等。整個蒙皮破斷面的巨觀觀察分成如圖 4 所示的三個試片分別執行，圖 4a、4b 與 4c 試片的區域其鉚釘編號分別是+17~30，31~56 與 57~97，三個試片是包含修補片與蒙皮一起觀察，是以電鋸自 640C1 殘骸中將三者取出。巨觀觀察是在航空研究所材料實驗室執行，下列單位共同參與此項的巨觀觀察工作

掃描式電子顯微鏡主要針對鉚釘編號+17~56 區域的破斷面(圖 4a、4b)做進一步的分析以確認疲勞裂縫區域範圍、裂紋起始點及裂縫擴展方向等。至於 56~91 鉚釘區域的破斷面(圖 4c)在巨觀觀察時發現非常少許的區域有疑似疲勞破壞的痕跡，但尚未使用掃描式電子顯微鏡做進一步的觀察。

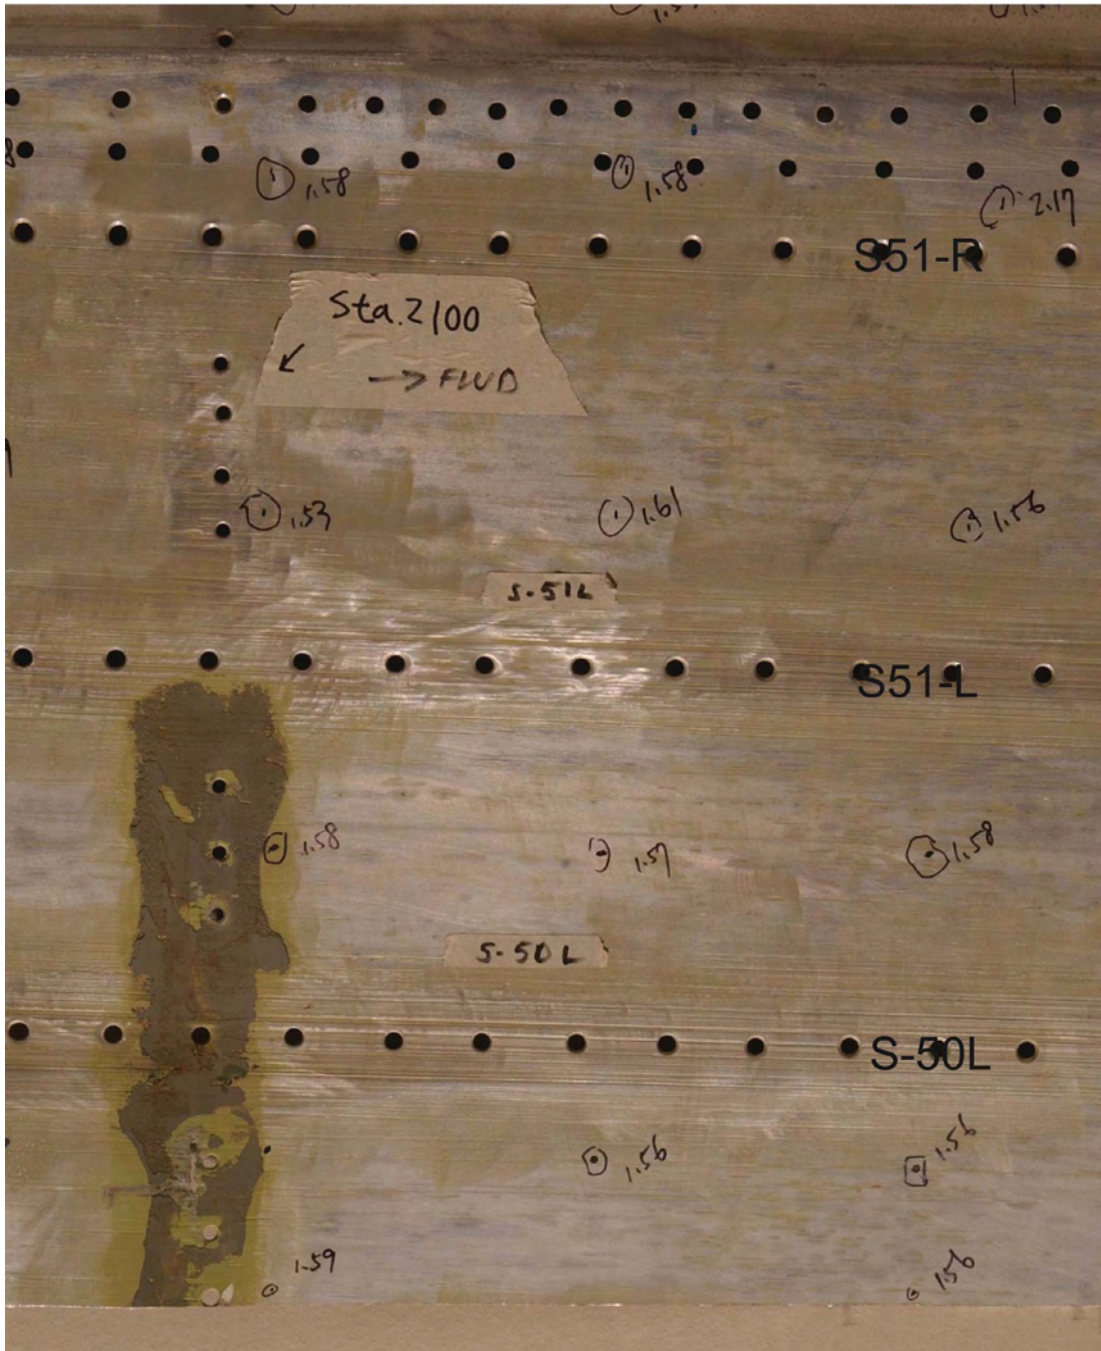
FIGURE 34. EXTENT OF DAMAGE CONSISTENT WITH A TAIL STRIKE

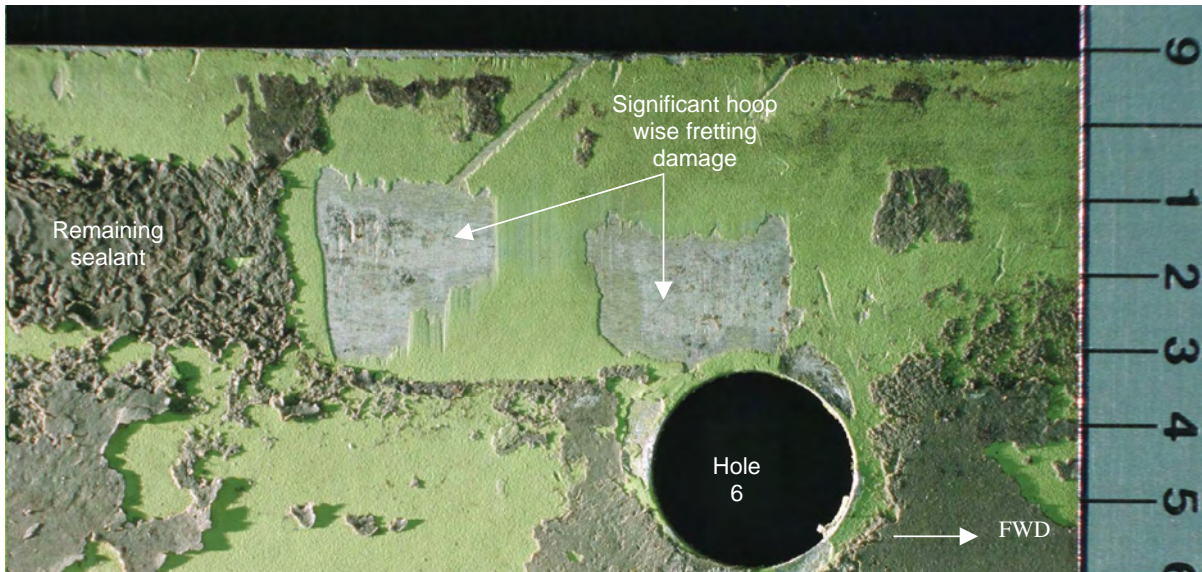
Figure 68.

(~STA 2061) to hole 49 (~STA 2132) with the most significant degree present between holes 8 and 43. Low power optical examination determined the fretting damage resulted from hoop-wise movement. The degree and position of this hoop wise fretting is documented in Table X with photographic examples provided in Figure 68 and 69. The source of this fretting damage was not conclusively determined but based on its location with respect to fatigue cracking and further progression of the crack in a quasi-stable manner, it most likely is the result of repeated crack opening during crack propagation prior to the accident flight.

Faying surface of doubler in the vicinity of hole 6 showing an example of significant fretting damage at the 10:00 to 11:00 and 1:00 to 2:00 clock positions.
