飛航事故調查報告

ASC-AOR-05-08-001

復興航空公司 GE006 班機

於松山機場落地滾行時發動機失火

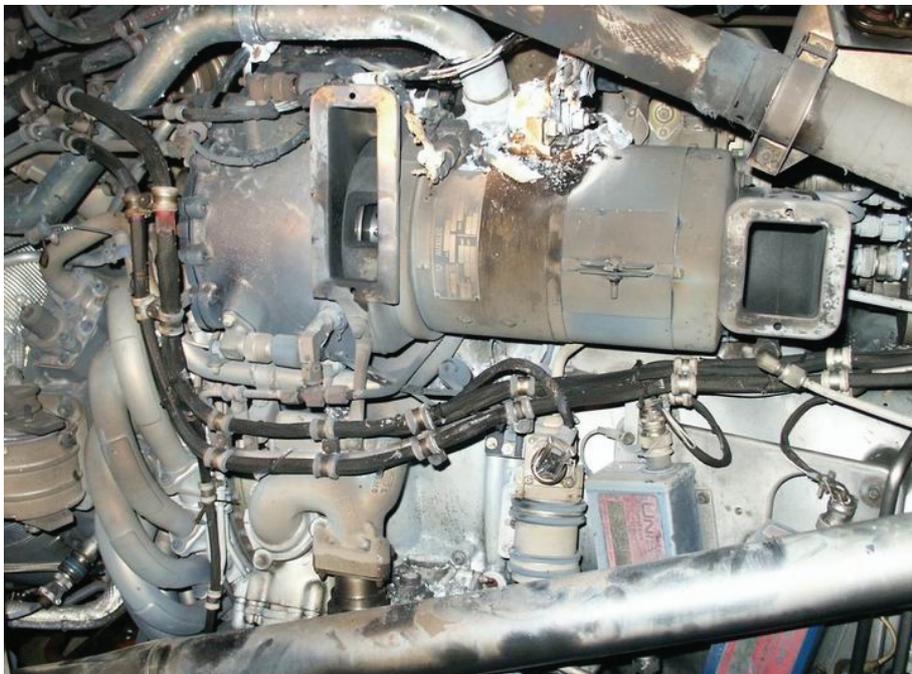
該機落地後滑至停機坪，機上人員依正常程序離機，人員無傷亡。該機結構經檢視未發現損害。檢視一號發動機內側（inboard）整流罩前方內部，發現局部受熱脫層，直流起動發電機線束保護套燒毀（如圖 1.2-1）。螺旋槳訊號/控制系統線束燒損，發動機上方火警偵測線燻黑，附件齒輪箱匣右上方穿洞（如圖 1.2-2）。

圖 1.2-1 直流起動發電機線束保護套燒毀

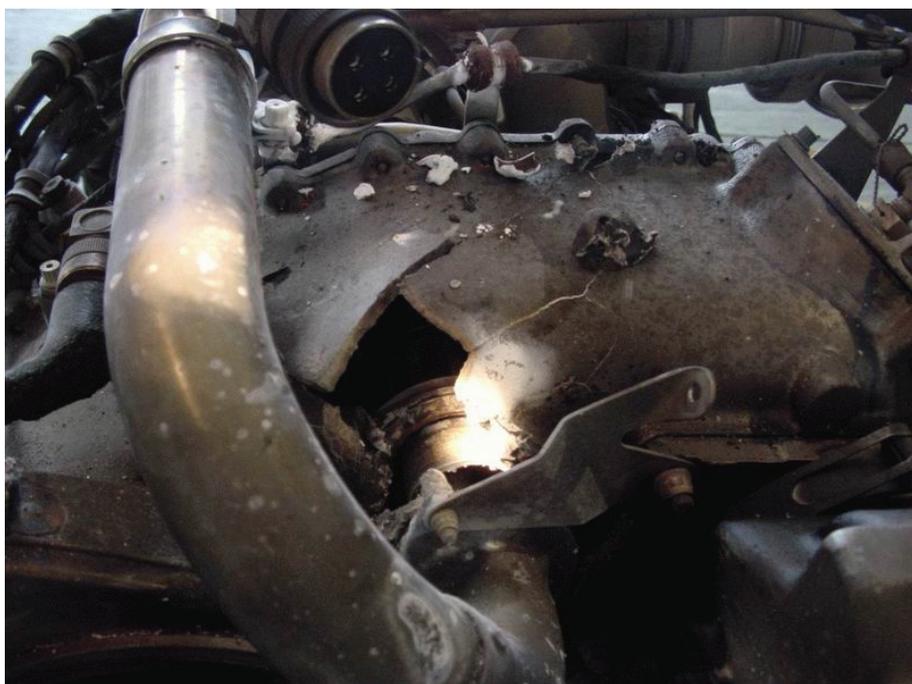
圖 1.2-2 附件齒輪箱匣右上方穿洞

發動機故障極可能因油氣分離葉輪碳軸封附近起火，火勢蔓延至齒輪箱，在溫度升高後，使油氣分離葉輪局部受熱膨脹，終致超負荷而崩裂。解體之葉輪碎片撞穿附件齒輪箱匣。

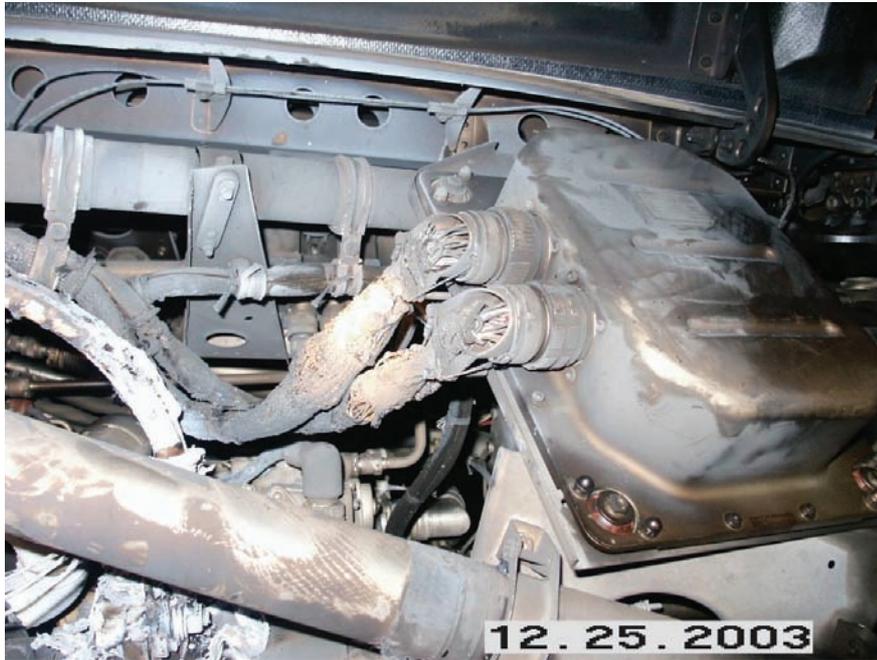
該機落地滑行時，出現火警信號警告。飛航組員關斷一號發動機並拉出 T 型斷油手柄，火警信號警告熄滅。停機後檢查發現一號發動機附件齒輪箱匣右上方區域有燻燒過熱痕跡（如圖 1.2-1），部分線束亦有燃燒痕跡（如圖 1.7-1）。

圖 1.7-1 部分線束有燃燒痕跡

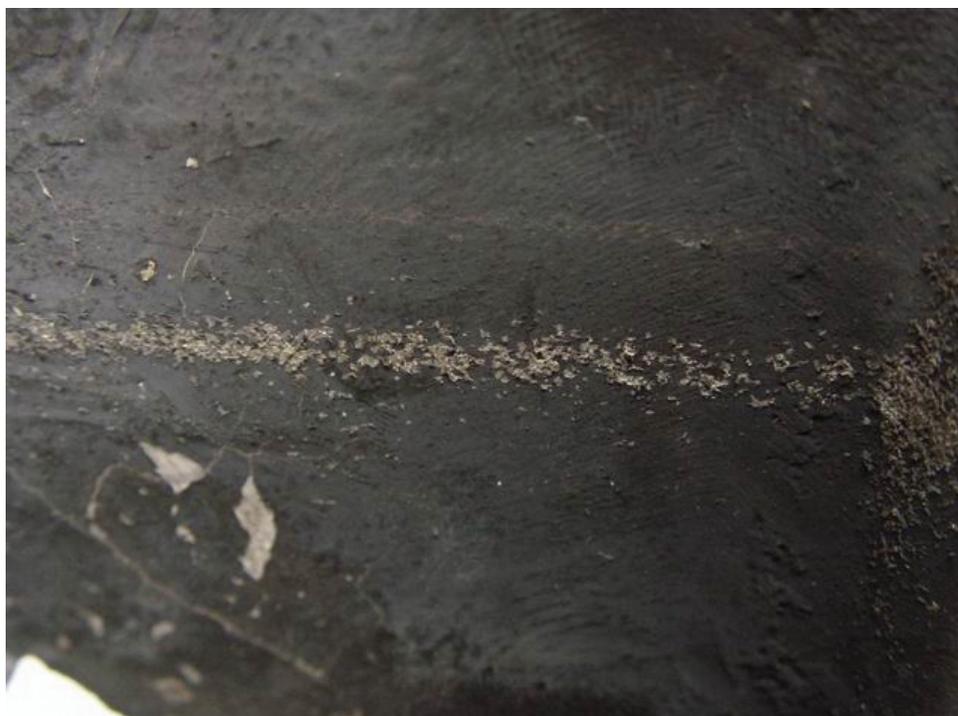
附著於附件齒輪箱匣內壁上之鎂鋁合金融熔顆粒，顯示油氣分離葉輪於運轉時受高熱，致葉輪金屬晶粒產生位移析出後（詳圖 2.3-4），被離心力甩出而附著於附件齒輪箱匣內壁上（詳圖 2.3-5,-6）。大量葉輪金屬晶粒析出及葉輪結構過熱使強度驟降，經快速旋轉所生強大離心力使葉輪解體飛脫。油氣分離葉輪解體原因雖有兩種不同說法，一為葉輪過熱晶粒析出以致強度變弱後離心飛脫；另一為葉輪軸膨脹致使葉輪崩裂。但不論葉輪過熱使材質強度改變或葉輪軸膨脹皆源於先有高溫之產生，飛安會與 PWC 對此看法一致。至於該熱源由何而來，如何導致油氣分離葉輪解體飛脫或葉輪軸受熱膨脹而崩裂，經本會與廠家一再調查仍無法確認。

圖 2.3-6 離心力甩出附著於附件齒輪箱匣內壁之葉輪溶解金屬顆粒

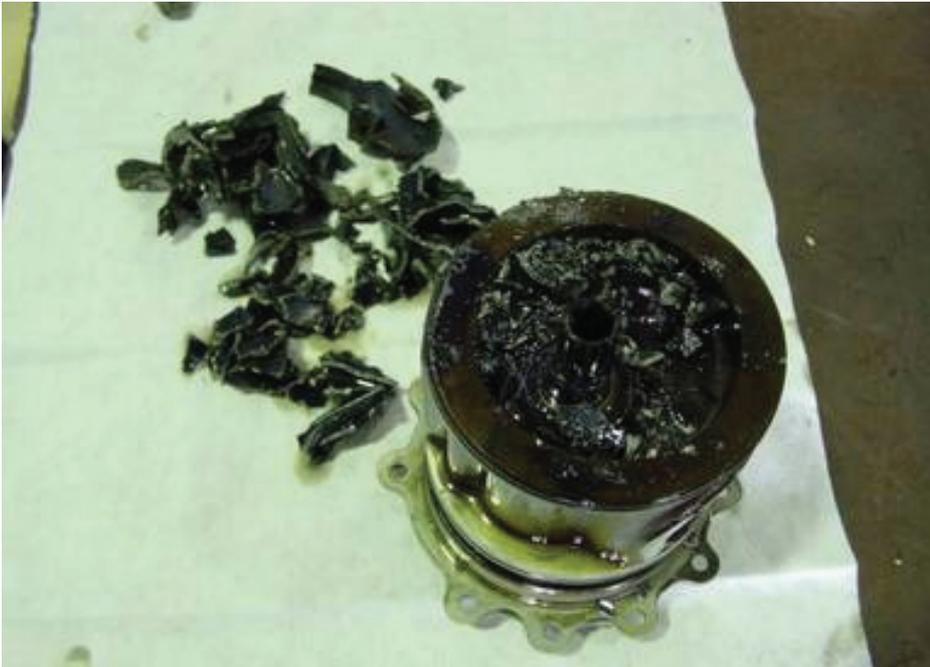
圖 6 由發動機拆下之滑油葉輪進口亦有逸氣葉輪輪解體碎片

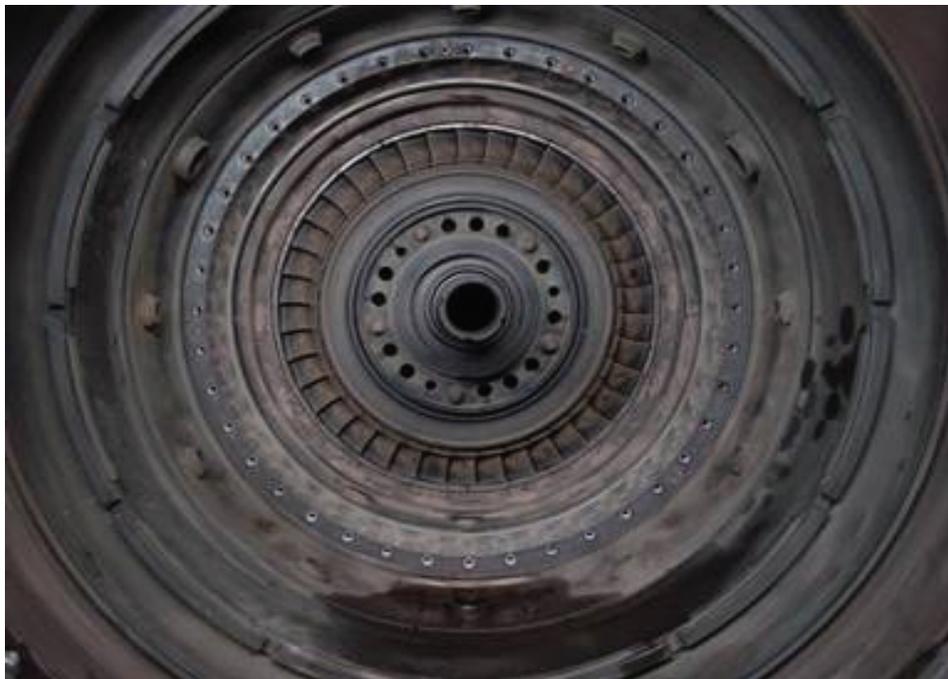
圖 7 發動機熱段轉子與定子葉片皆正常

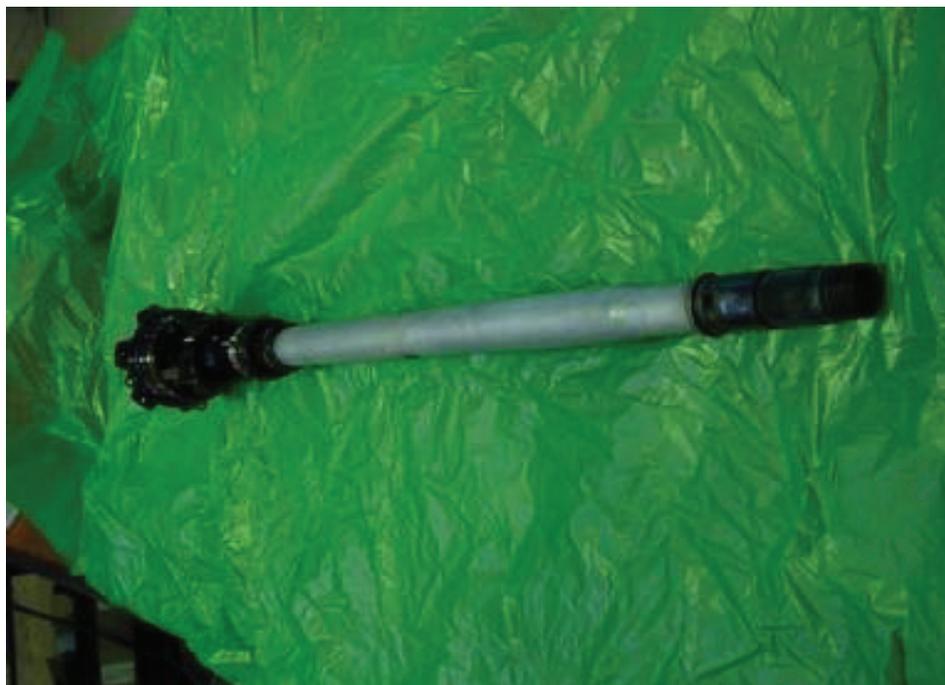
圖 8 發動機轉子及其七只軸承除六號軸承外皆正常

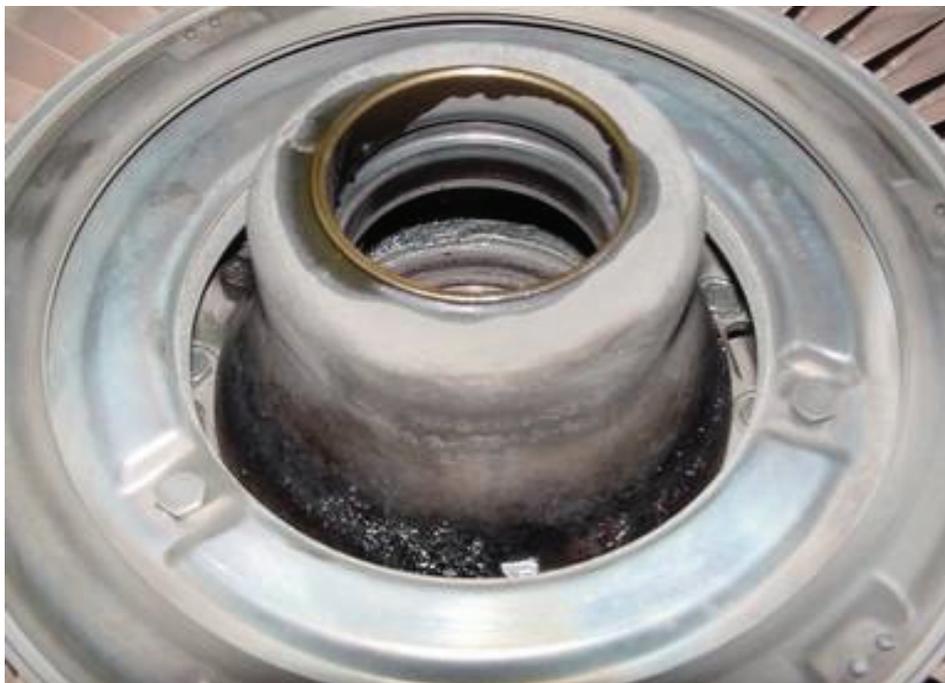
六號軸承室外有油垢堆積現象，詳圖 9。

圖 9 五、六號軸承室外有油垢堆積現象

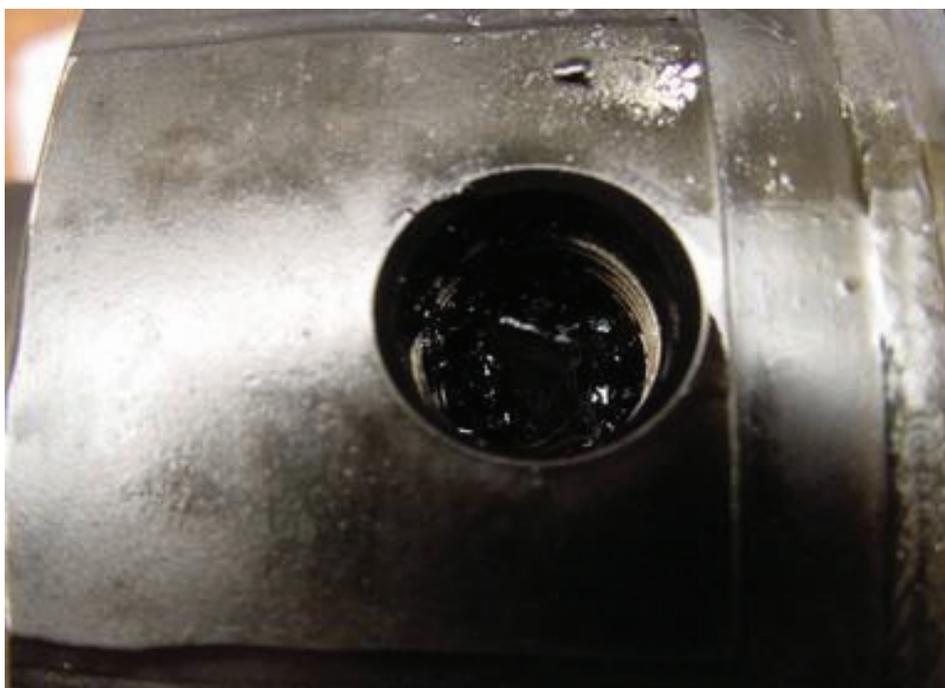
六號軸承滑油進口濾網處有油泥堆積，詳圖 10。

圖 10 五、六號軸承室滑油進口濾網處有油泥堆積

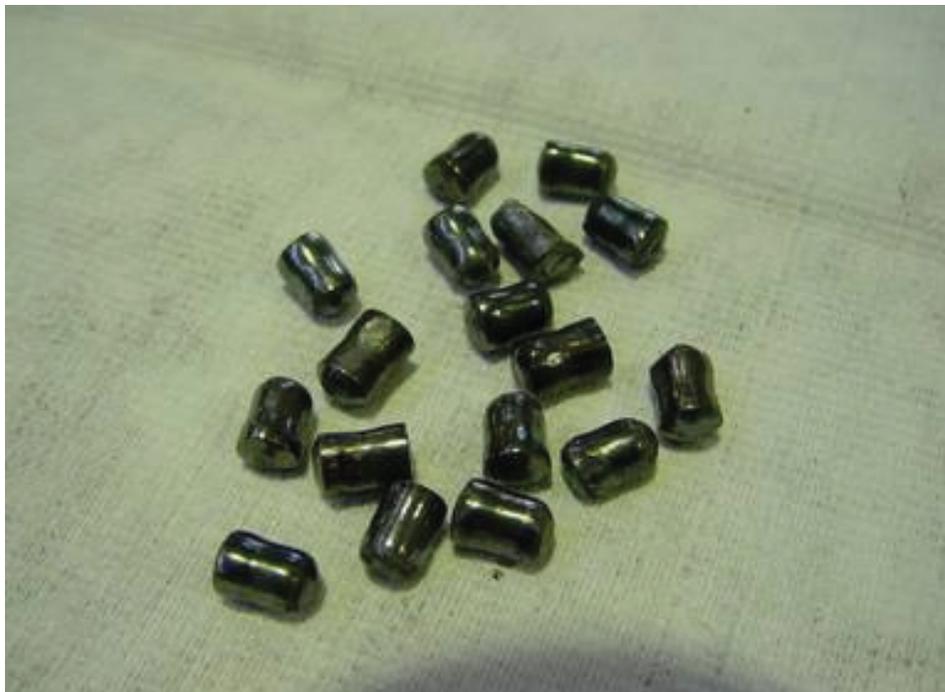
圖 11 六號軸承滾軸中心有磨損，滾軸呈凹型，無粗造摩擦及高溫熔融現象。

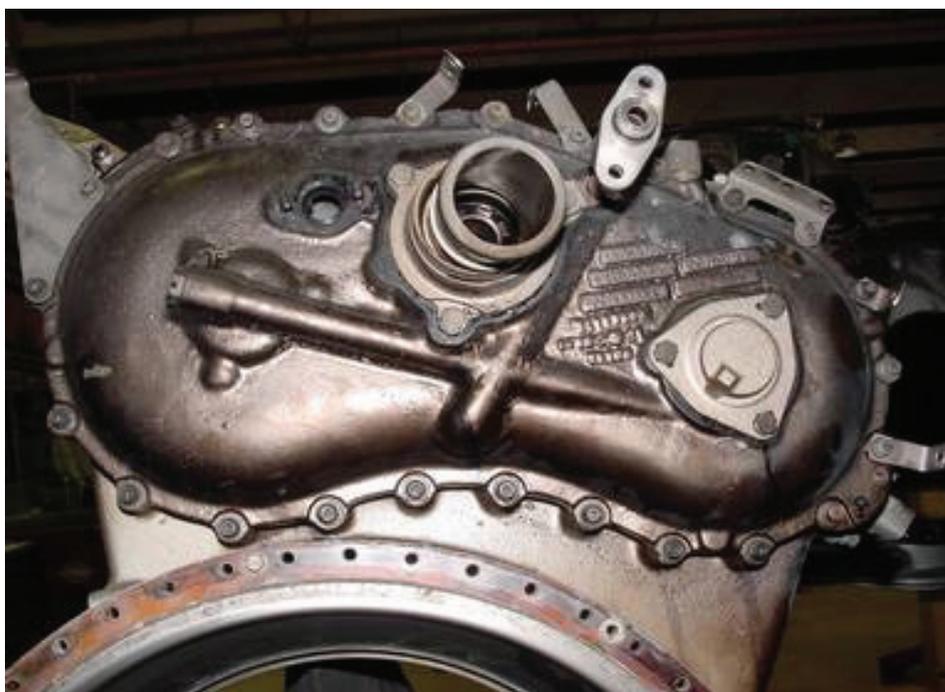
圖 12 減速齒輪箱後方機匣外部銀色塗料變成深褐色

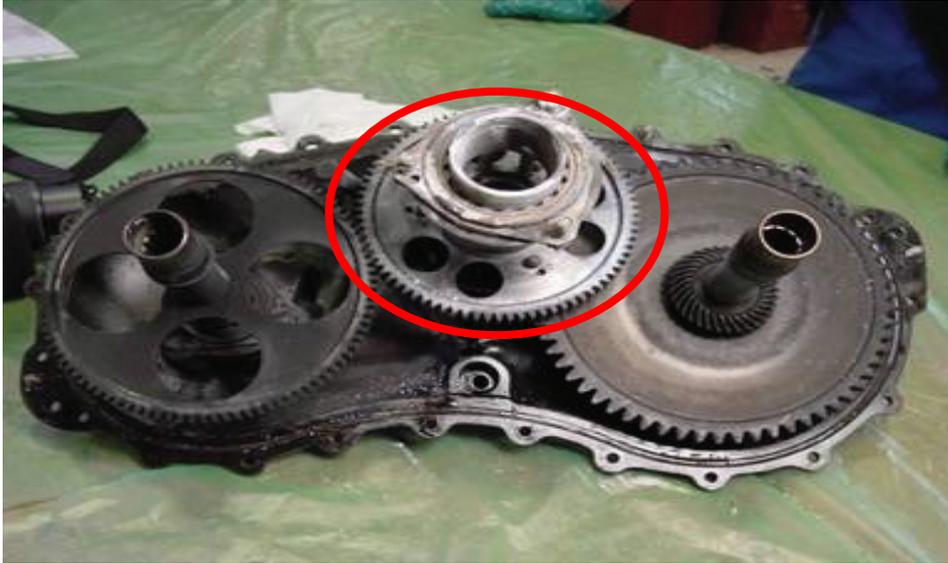
圖 13 減速齒輪箱後方機匣分解後內部齒輪及油氣分離葉輪失蹤情形（紅圈處為油氣分離葉輪原來位置）

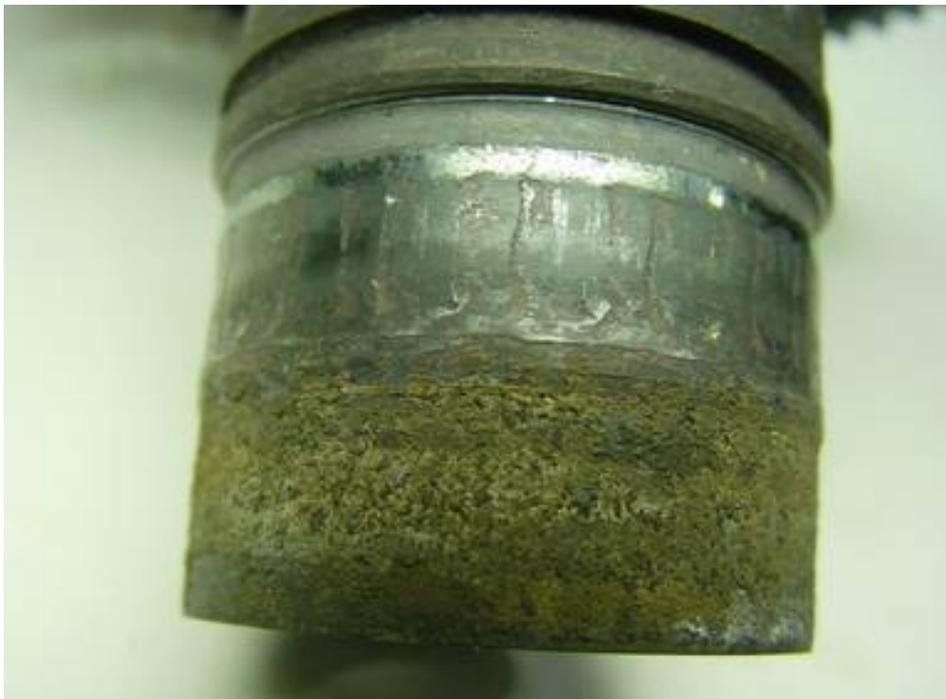
圖 18 油氣分離葉輪前端軸承處之轉軸有凹陷痕跡

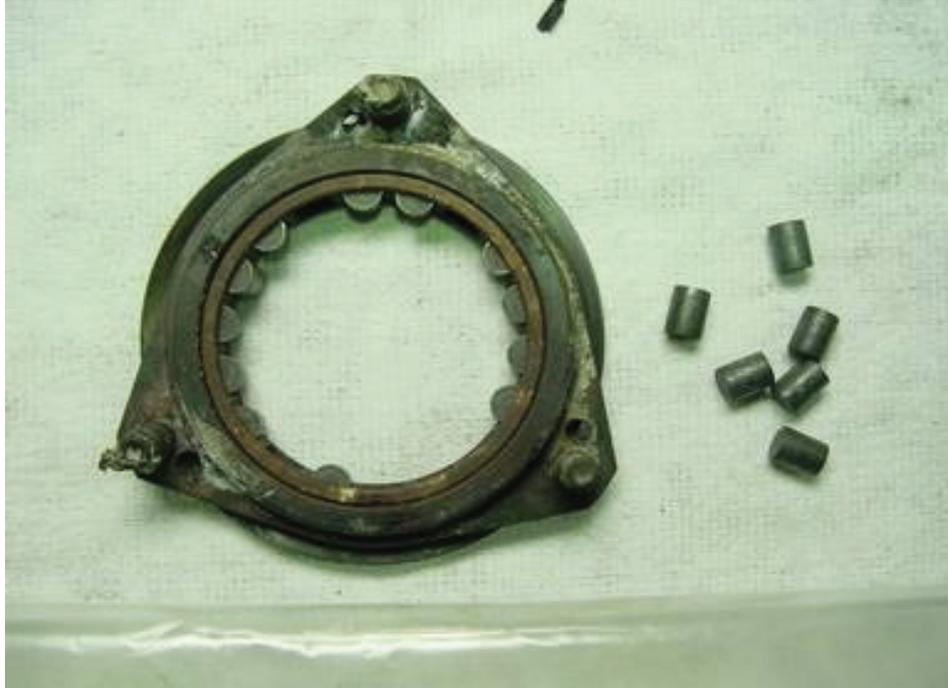
圖 19 油氣分離葉輪前端軸承拆解後，其軸承滾柱兩端磨損，滾柱呈凸型。

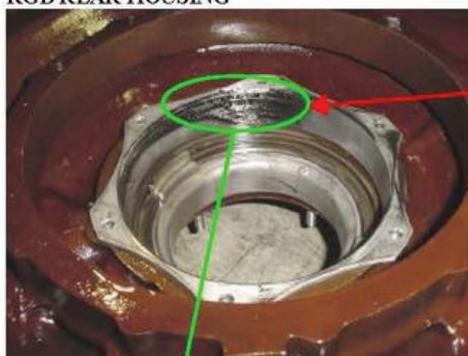
RGB REAR HOUSING

Deposits located on the inner diameter of the N° 15 Roller Bearing sleeve.

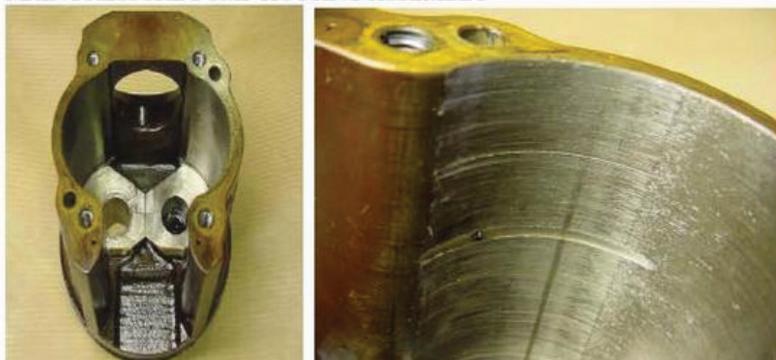
MAIN PRESSURE PUMP HOUSING ASSEMBLY

Circumferencial scratches on the inner diameter.

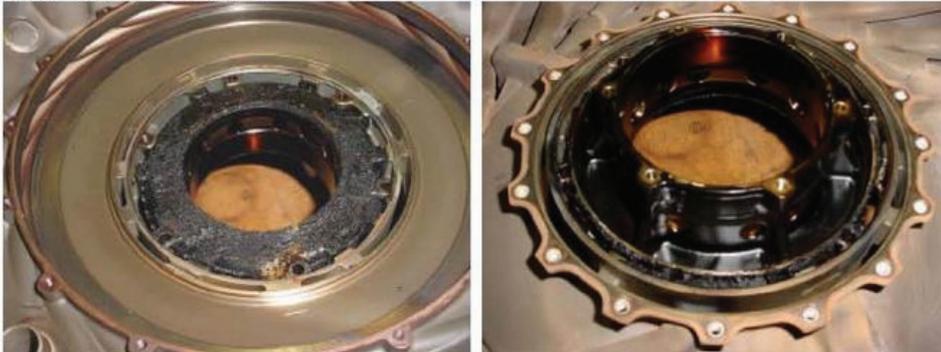
GAS GENERATOR CASE

The front and rear surfaces of the N° 5 Bearing area are covered by coked oil deposits.

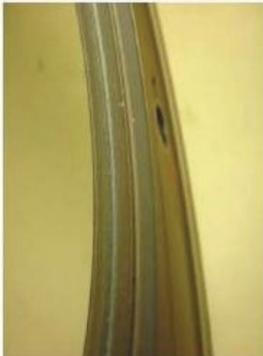
HP IMPELLER SEAL HOUSING

Loss of plasma coating on the air seal diameters.

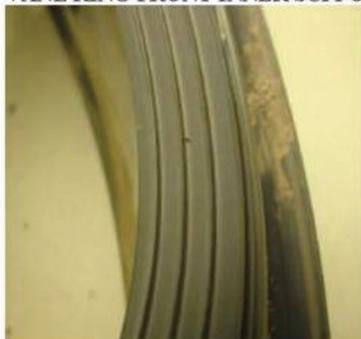
VANE RING FRONT INNER SUPPORT HOUSING

Loss of plasma coating on the air seal diameters.

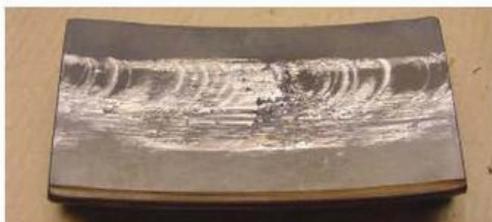
LP SHROUD SEGMENTS

Prints and rubbing traces.

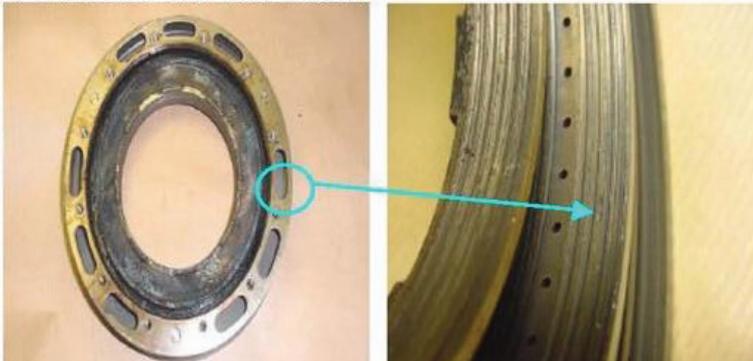
N° 6 & 7 BEARING HOUSING SEAL.

All the internal surfaces are covered by coked oil deposits.
The two air seal diameters are grooved.

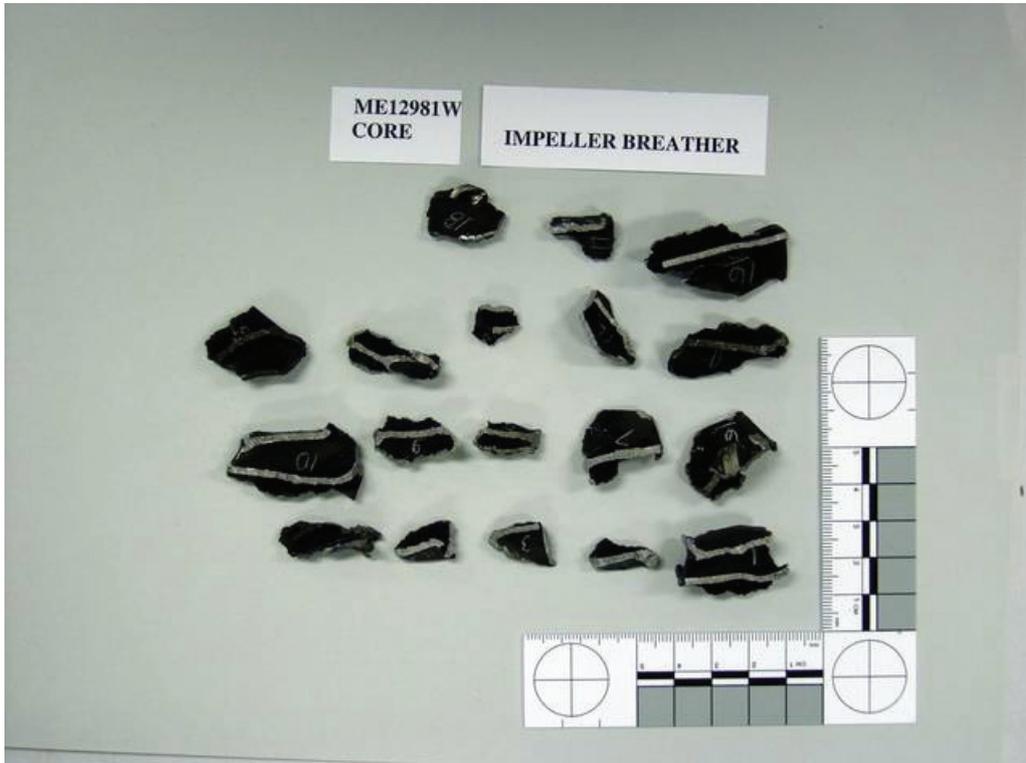
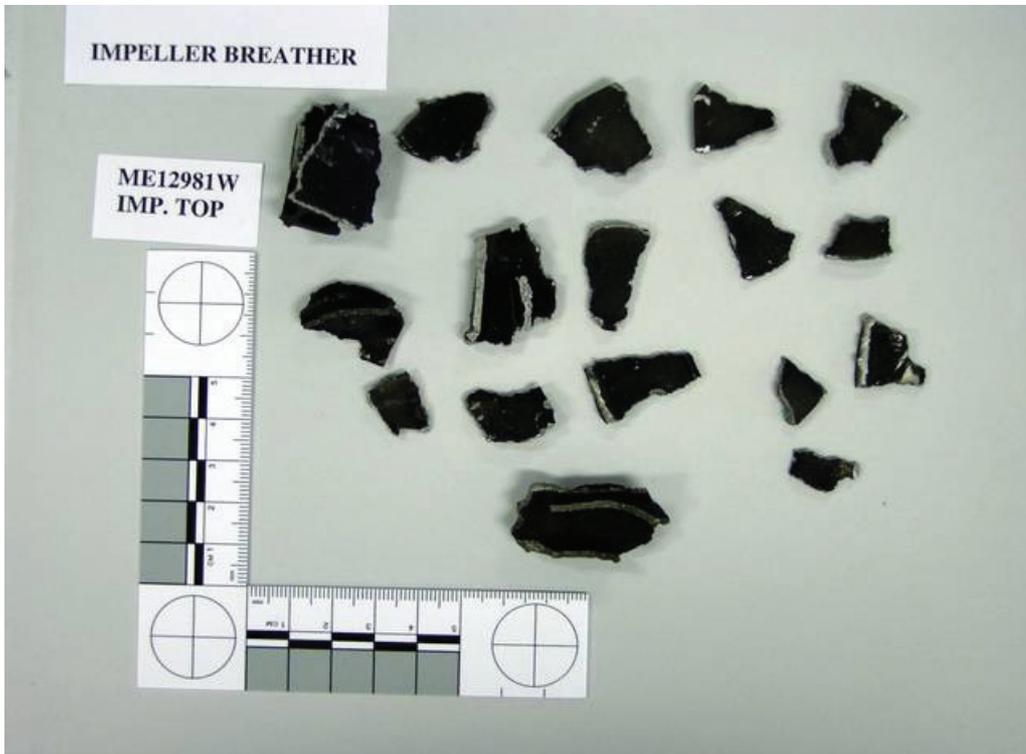
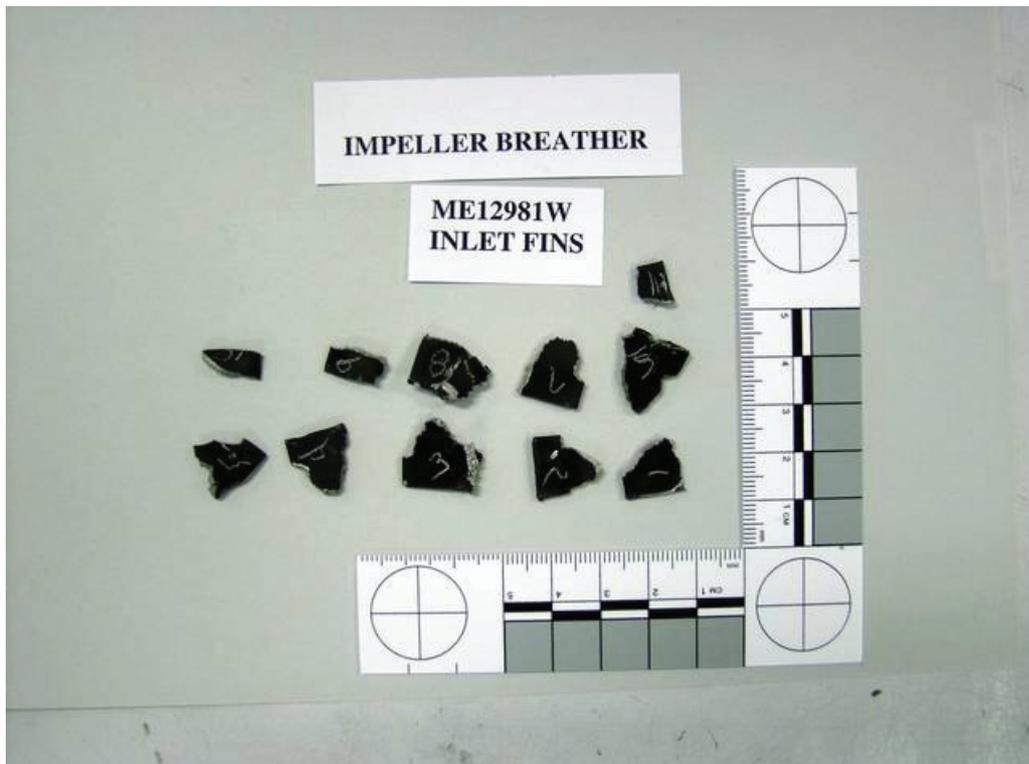
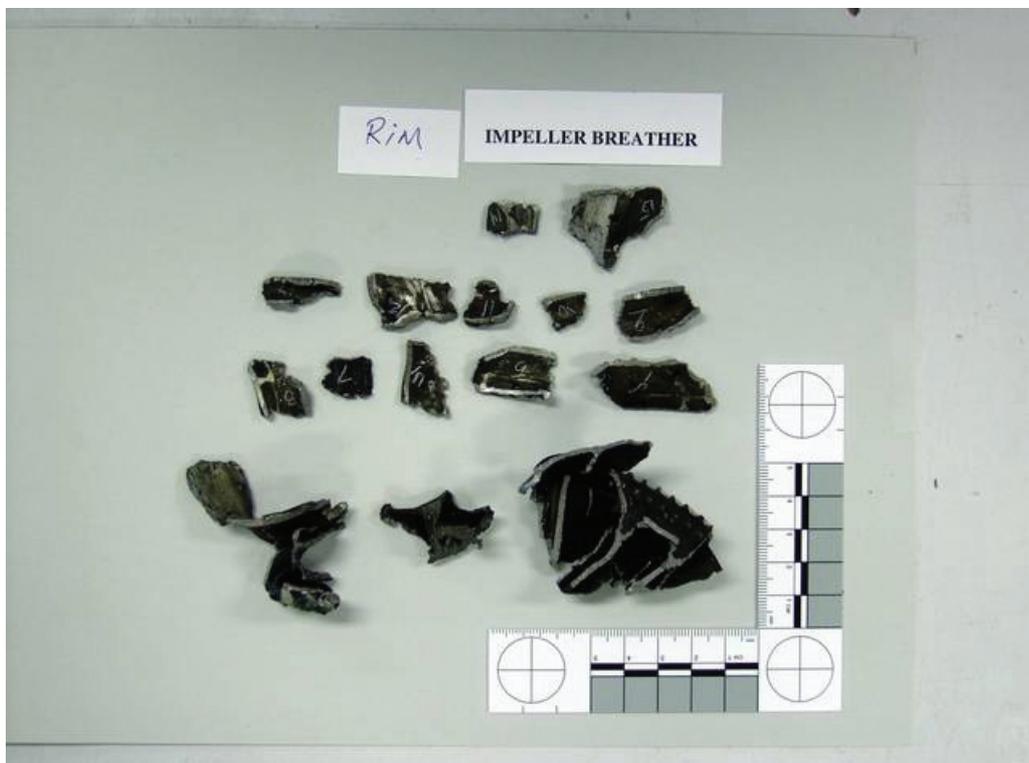
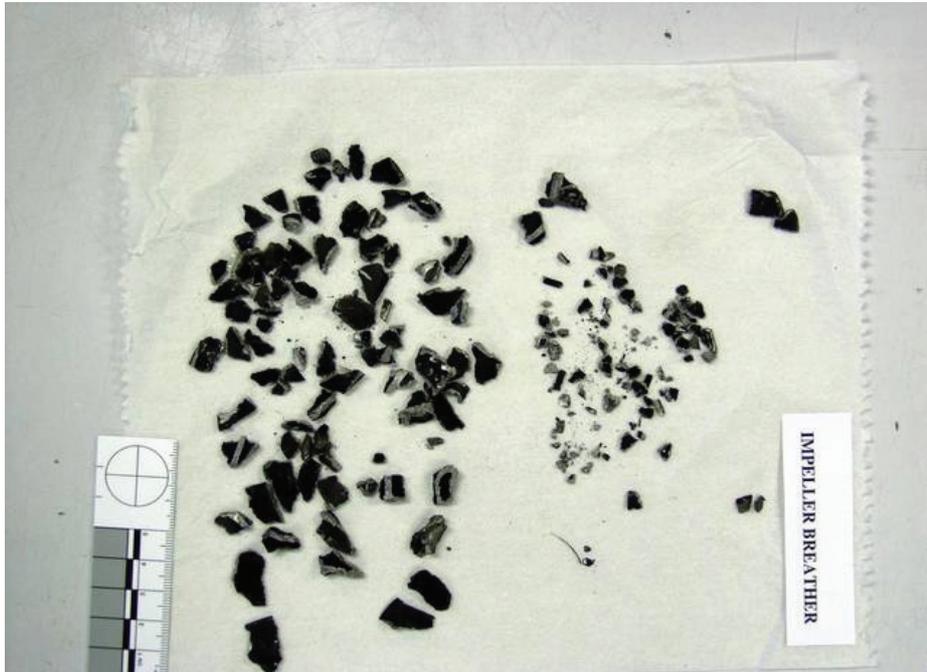
圖 14 油氣分離葉輪各碎片積碳特徵 (a)

圖 15 油氣分離葉輪各碎片積碳特徵 (b)

圖 16 油氣分離葉輪各碎片積碳特徵 (c)

圖 17 油氣分離葉輪各碎片積碳特徵 (d)

圖 18 油氣分離葉輪各碎片積碳特徵 (e)

圖 19 油氣分離葉輪各碎片積碳特徵 (f)

1. 取樣油氣分離葉輪、X 射線螢光元素成分分析，有鎂鋁反應與油氣分離葉輪規格相符。
2. SEM 物理特性檢驗油氣分離葉輪白、金、藍、黑四種碎片斷面，表面皆有晶體熔融現象，其嚴重程度依序為金、藍、白、黑。
3. 觀察油氣分離葉輪各碎片積碳特徵，黑色積碳佈滿油氣分離葉輪內部，然裂紋多為白色。
4. 由 FDR 資料得知，發動機轉速與扭力同時驟然消失，且飛操控制面無補償動作，判斷其轉速及扭力仍然存在，應屬電線燒毀訊號中斷之故。

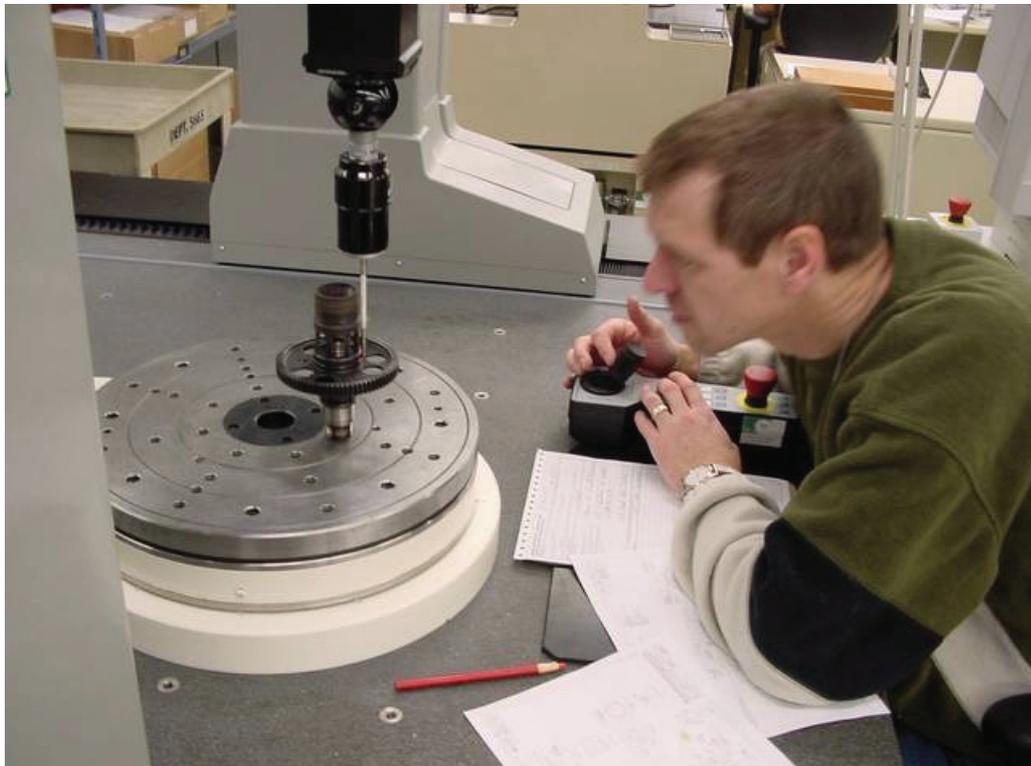
圖 21 量測葉輪軸直徑

1. 檢視油氣分離葉輪固定栓內牙及量測葉輪軸直徑發現：葉輪體經推力及離心力拉力破壞。
2. 取樣#25 前軸承外環及滾柱完成。
3. 探漏測試燃油加熱器：狀況正常無洩漏跡象。

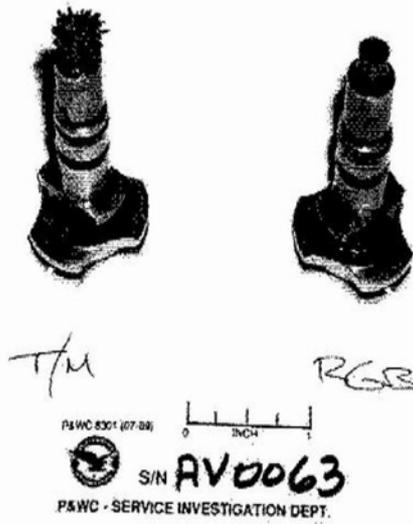
2.2 Preliminary examination of the engine revealed that the Power Turbine (PT) rotor was free to turn. The Low Pressure (LP) rotor was difficult to turn and the High Pressure (HP) was seized. The turbomachine chip detector was heavily contaminated by magnetic metallic debris (Photo No. 1). The reduction gearbox chip detector was free of any contaminants. The operator indicated that the main oil filter impending bypass indicator was found activated. A small amount of oil was drained from the engine and it showed a high viscosity and a dark brown coloration.

Photo No. 1
Chip detectors

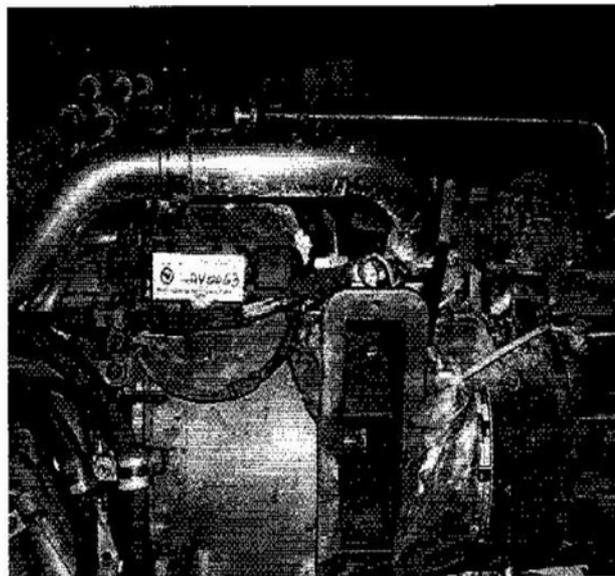
- 2.3 The engine external surfaces around the RIC exhibited evidence of fire damage and were sooty (Photos No. 2 to 4). The wiring harnesses in that region were charred including the wire leading to the NH probe, which is most likely, the cause for the loss of torque indication to the cockpit; a loss of NH signal to the EEC would cause a loss of torque indication, EEC fault and a reversion to manual control of the engine.

Photo No.2
Engine right hand side

Photo No. 3
Engine right side (RIC area)

Photo No. 4
Starter / breather pipe area

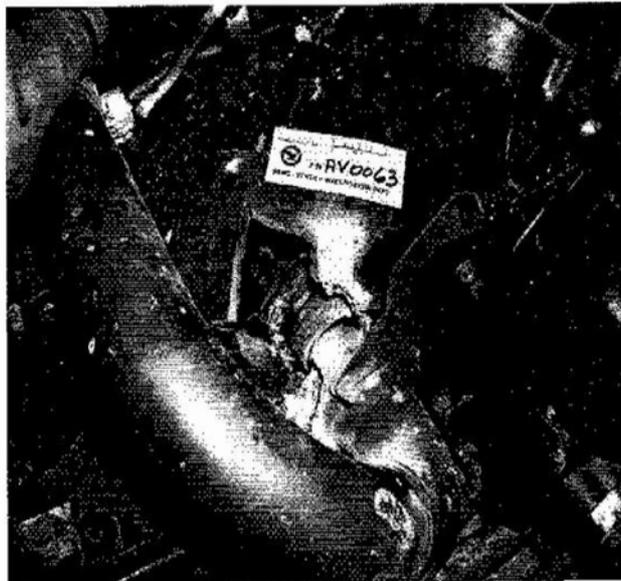
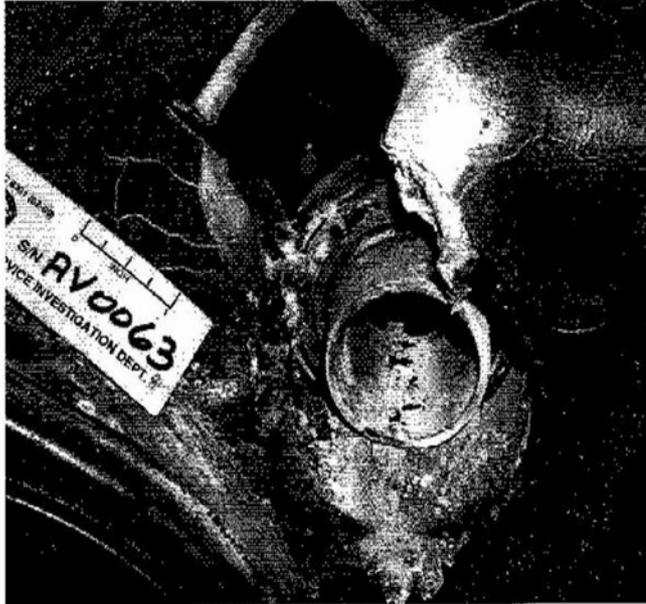
- 2.4 A large perforation was found on the top portion of the RIC immediately behind the breather carbon seal (Photo No. 5). The breather gear and its front bearing were exposed. The fire consumed the housing containing the carbon seal (Photos No. 6 & 7). Some melted remains were found lying on top of the RGB oil scavenge filter housing (Photo No. 8 & 9). A large amount of melted and re-solidified material was found on the inner surfaces of the breather tube leading to the exhaust case. This material most likely originated from the carbon seal housing and RIC.

Photo No. 6
Breather carbon seal area

Photo No. 7
 Breather gear (pipe removed)

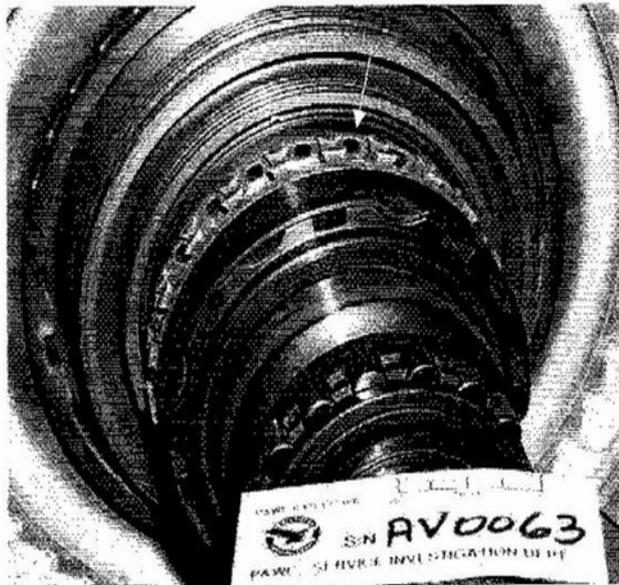
- 2.7 Removal of the No 6 & 7 bearing housing showed distress to No. 6 bearing; all of the rollers exited the bearing cage upon disassembly (Photos No. 11 to 13). The bearing was heavily worn and significant material transfer and smearing could be seen on both races (Photo no. 14). The bearing cavity was dry indicating that a lack of lubrication is at the origin of the bearing distress. The oil transfer tubes showed light deposits of coked oil on their internal surfaces.

Photo No. 11
LP disk and No. 6 bearing

Photo No. 12
No. 6 bearing

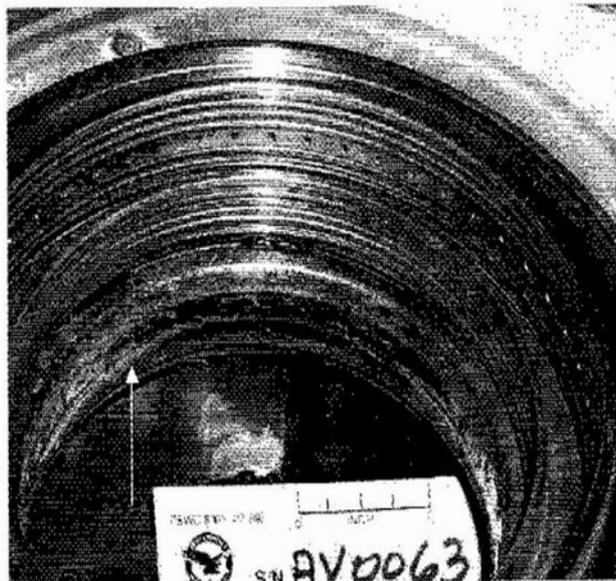
Photo No. 14
No. 6 bearing outer race

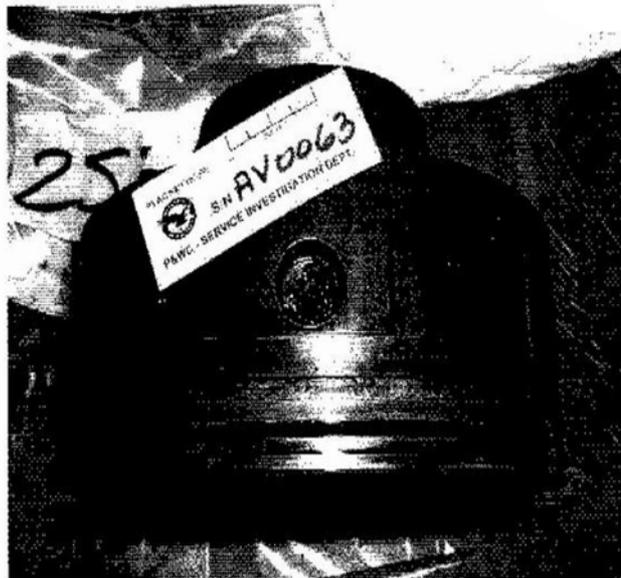
Photo No. 16
6 & 7 bearing housing and oil inlet

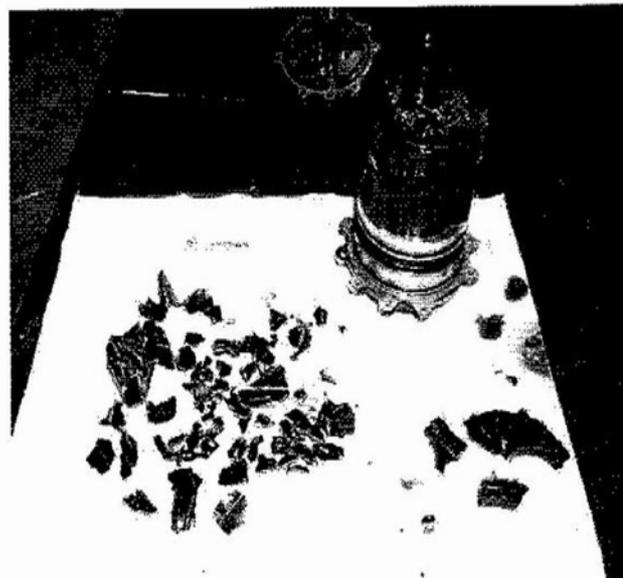
Photo No. 24
Debris recovered from the oil pump pack cavity

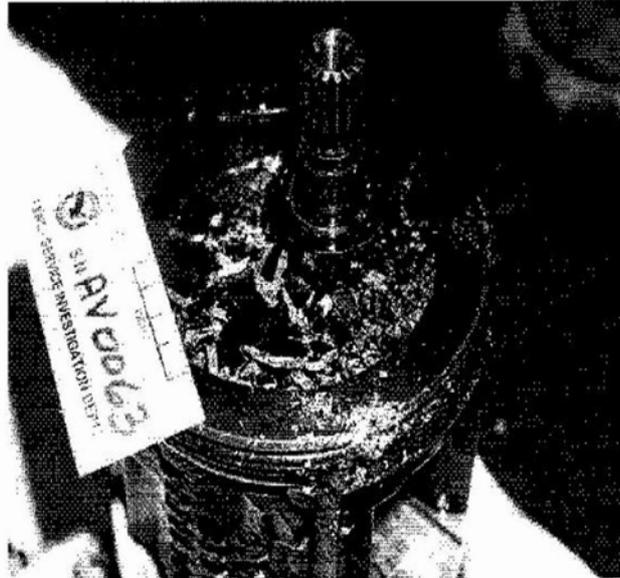
Photo No. 25
Debris on top of the oil pump pack

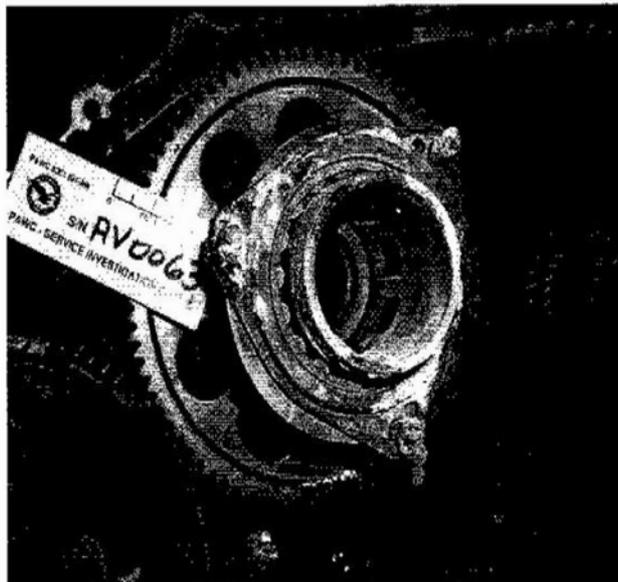
- 2.21 The front bearing of the impeller breather gear was found partially seized on the gear and it exhibited heavy burning and brinelling damage (Photo No. 33). Removal of the bearing from the shaft revealed heavy smearing and some wear on the rollers however the bearing was capable of rotation and the cage was not fractured (the cage was later cut to enable disassembly of the bearing). Its 3 retaining bolts were found still attached to the gears and the locking washer was found properly secured to the bolts (Photo No. 34).

Photo No. 34
Impeller breather gear and front bearing

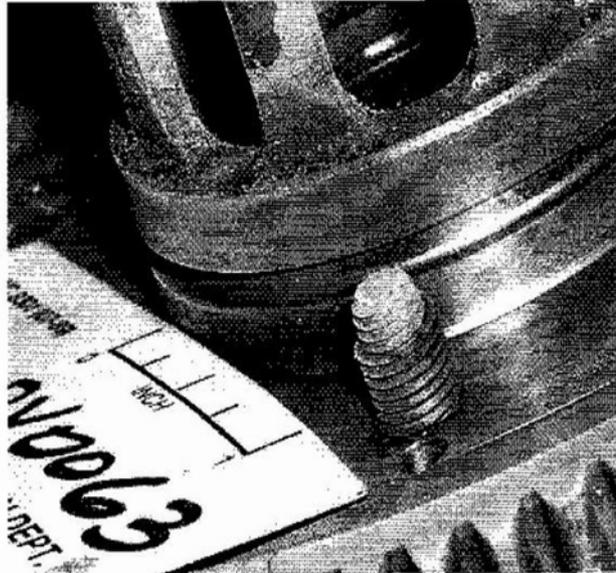
- 2.22 Upon removal of the breather shaft, no o'rings were found in the grooves normally located under the breather impeller (Photo No. 35). Heavy burning damage was noted on the front portion of the shaft. Wear was noted on the gear teeth. The retaining bolts of the impeller were found on the gear with the helicoil inserts (normally installed on the impeller) holding them in place. The locking washers were still in their position and properly locked.

Photo No. 35
 Breather gear showing the absence of o'ring

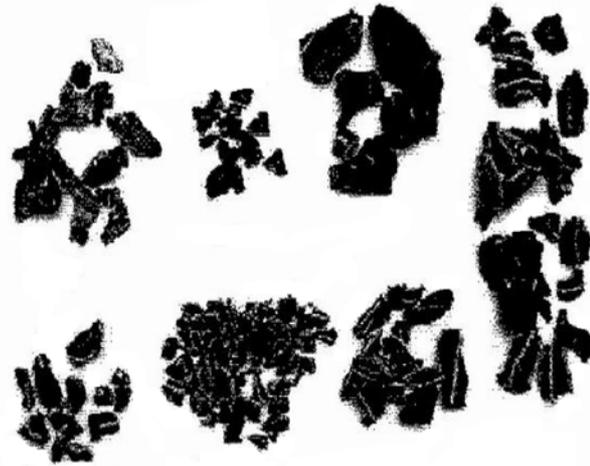
- 2.23 The pieces recovered from the impeller were sorted according to their approximate location on an intact impeller (Photo No. 36). Approximately 85% of the breather impeller was recovered. The complete tight fit spigot was recovered in large pieces (Photo No. 37). All these pieces along with the breather gear, front bearing and all debris were forwarded to P&WC's Material Laboratory for examination. The results are as follows:

Photo No. 36
 Recovered pieces of the impeller breather

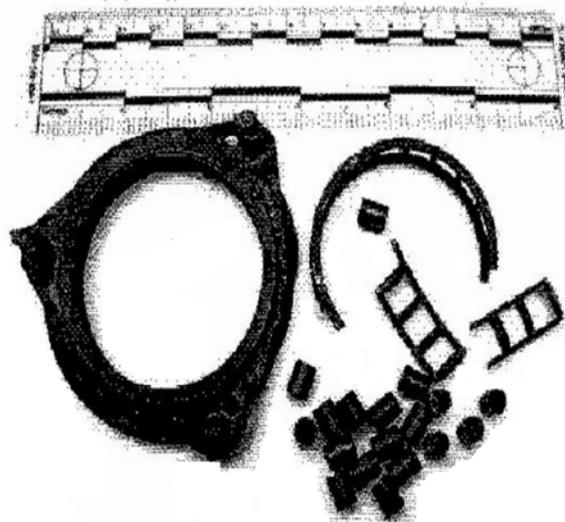
- 3.5 Some black coloured deposits were noted on a piece of the breather impeller. This deposit was identified as mostly carbon (Photo No. 51).
- 3.6 The front bearing of the breather gear (Photo No. 52) was examined under the microscope; the presence of material partially filling the outer race oil groove was noted (Photo No. 53). This material consisted of silver consistent with the bearing cage plating (Photo No. 54). The microstructure of the outer race and rollers showed an over tempered martensite which is consistent with exposure to high temperature (likely from the fire) (Photo No. 55). The hardness varied from 24 to 33 HRC for a minimum limit of 58 HRC. Although severe burning and mechanical damage was observed on the bearing rollers cage and outer race (Photos No. 56 & 57) (note that the cage was fractured during the disassembly of the bearing), there was no major structural damage which could suggest that this bearing was the initiating factor of engine distress. The material composition of the outer race and rollers met drawing requirements.

Photo No. 52
Front bearing of the impeller breather

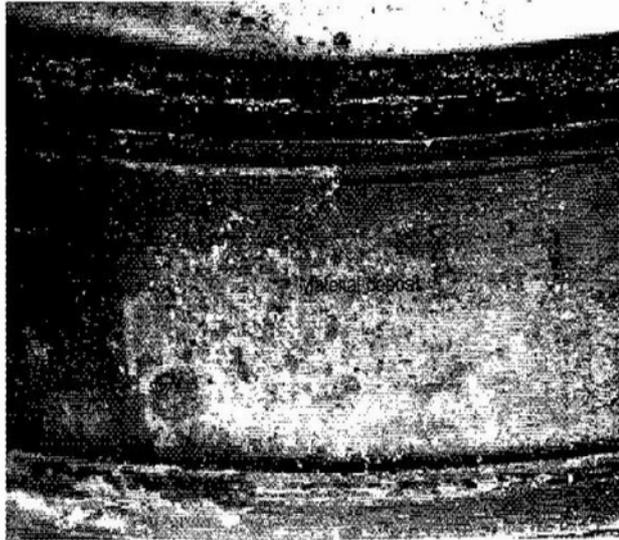
Photo No. 53
Bearing outer race showing material deposit

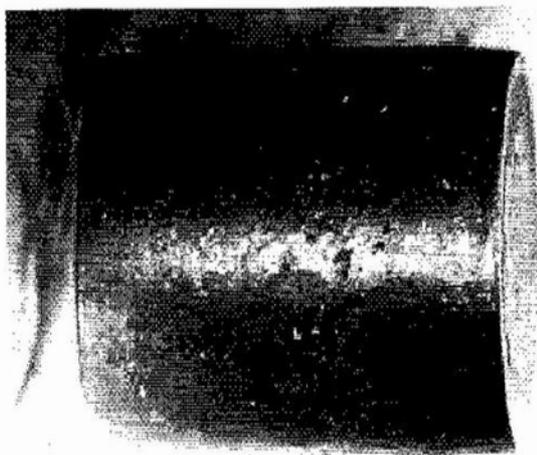
Photo no. 57
Typical bearing roller
